Report of Marine Survey

Vessel: 2007 Searay 310 Sundancer

Purpose: Inspection and Valuation

Date of Survey: December 17th, 2019

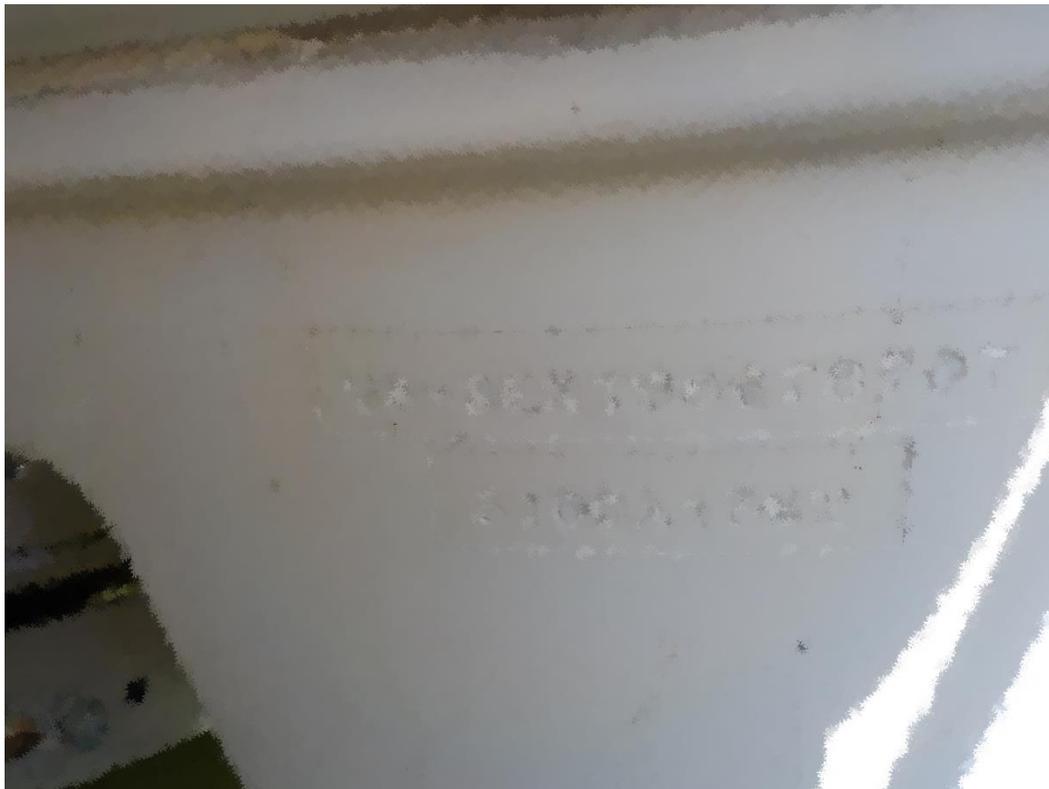
USCG Documentation#:	
State Validation sticker:	June 2020
Documentation valid and number sighted as per regulations:	Yes.
Vessel Type:	Fiberglass Express Cruiser w/ Deep Vee hull
Manufacturer:	Searay Boats, Knoxville TN
Year of Vessel:	2007
Length of Vessel:	<i>Length overall:</i> 33' 4" <i>Length on Deck:</i> 31'
Vessel Draft:	2' 11"
Vessel Beam:	10' 5"
Vessel Weight:	14,000 pounds

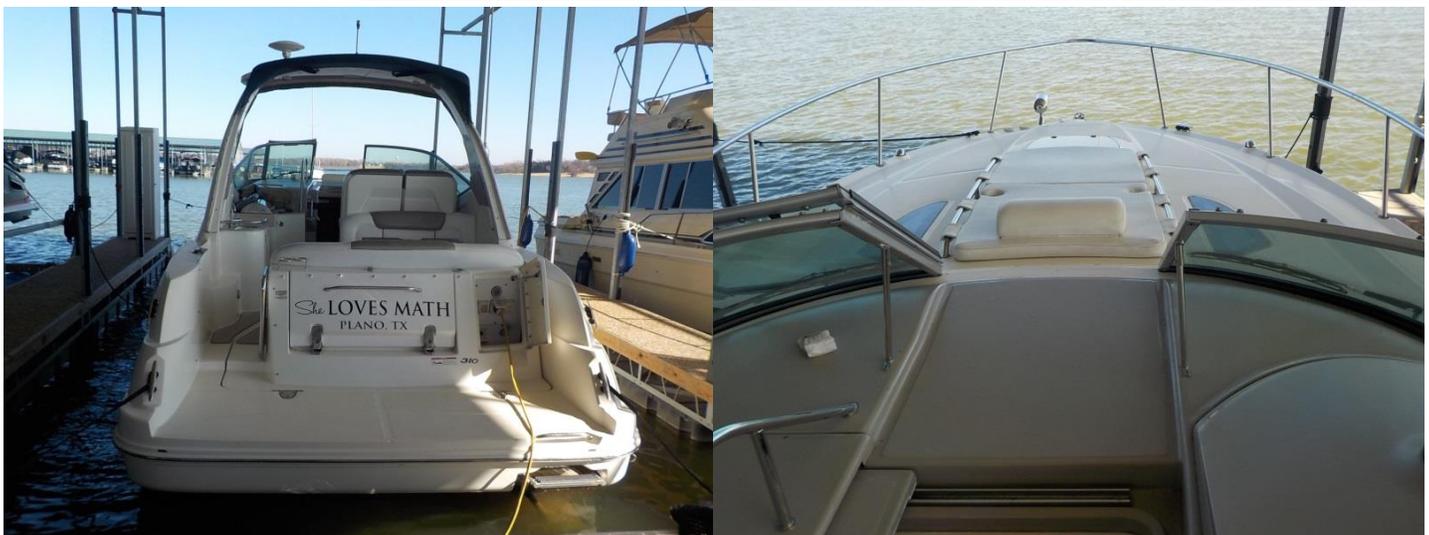
Cockpit & Helm

Helm Station:	Helm located on starboard side of cockpit and equipped with frp molded instrument dash, control station and seating.
Sole/Deck:	FRP with non-skid and tan colored snap-in carpet throughout cockpit and helm location. Good clean overall condition.
Bimini Top:	Stainless framed bimini top with blue colored "Sunbrella" covering aft deck. No damages sighted, well secured.
Radar Arch:	FRP reverse radar arch. Well secured, no damages sighted.
Cabin Door:	Sliding lexan door next to helm. Opens and closes correctly.
Exterior Seating:	Vinyl covered bench seat at helm location. Aft cockpit has reverse facing bench seats with wooden dinette table. Vinyl throughout is white in color with grey highlights and in good condition with no rips, tears or nicks sighted.
Engine Hatch:	Electric-lift (12v) engine compartment cover on aft deck. Operational via helm control. NOTE: Insulation on engine compartment cover is falling off in places. Repair.

Refrigerator:	"Norcold" refrigerator located in cockpit on port side. Powers on.
Cockpit Sink:	Molded sink/wet bar with stainless faucet located in cockpit. Appears operational. NOTE: Unable to test due to water system being winterized. Be advised.
Storage Hatch(s):	Storage hatches located below helm seat and on aft deck along bulkheads and under seating.
Cooking Grill:	"Kenyon" (110v) grill located in cockpit next to sink on port side. Powers on.
Cockpit Cover:	Blue colored canvas snap-on cockpit cover. Average condition.
Windshield/Wipers:	Windshield is a five piece aluminum framed design with glass windows and opening walk-through center. Windshield wipers power on. NOTE: (1) Windshield frame has bubbling paint along sides in multiple areas. Treat for corrosion and re-paint frame for cosmetic purposes and to prevent further corrosion. (2) Windshield wiper blades are in bad condition. Replace both wiper blades.

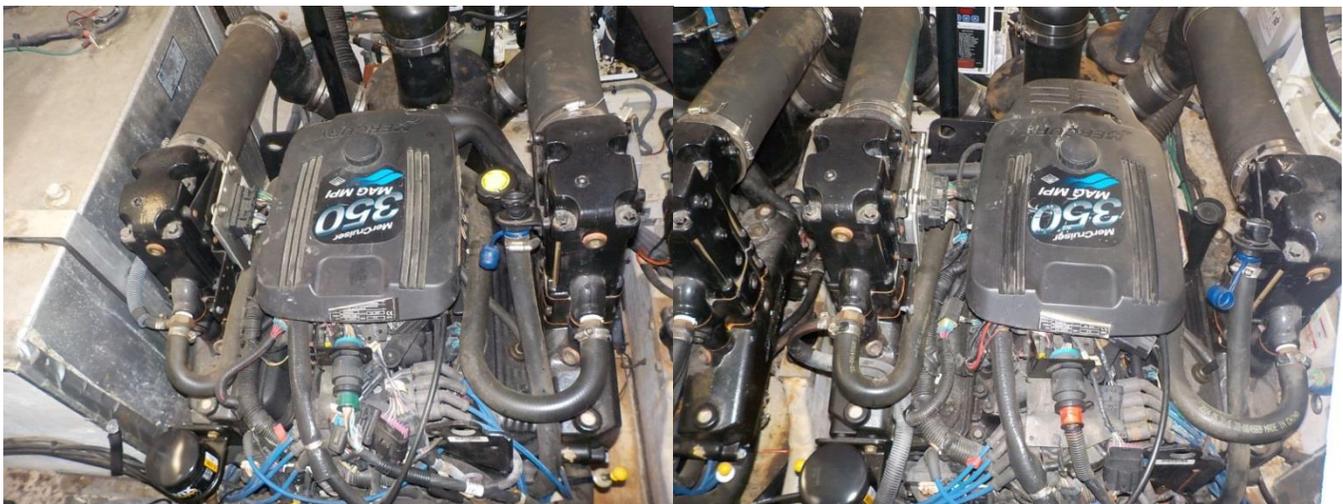
Starboard Engine

Port Engine
