Report of Marine Survey

Vessel: 1998 Searay Aft Cabin 415

Purpose: Condition and Valuation

Date of Survey: January 14th, 2020

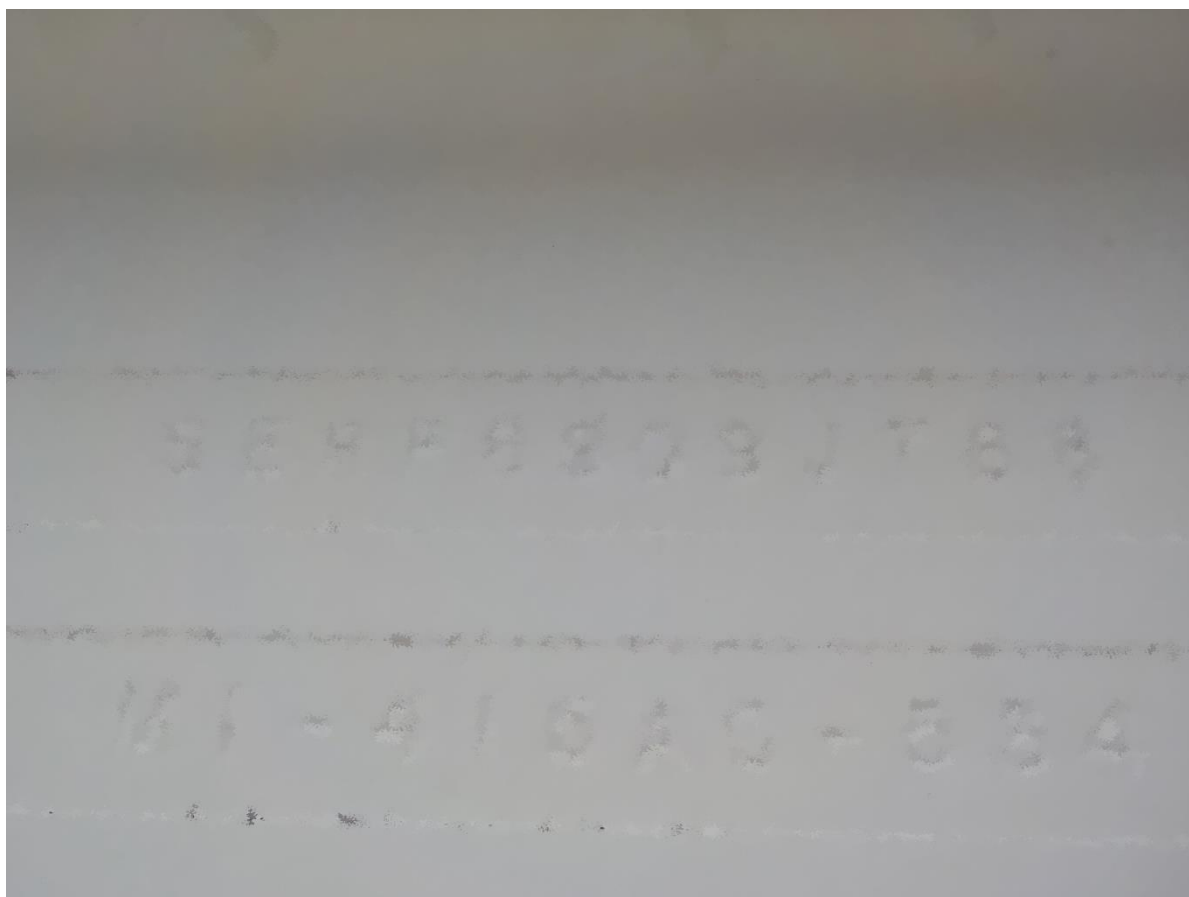
**Vessel Name:** N/A**Hailing Port:** N/A**Hull ID number verification:**

State Registration #:	
State Validation sticker:	NOTE: State validation sticker expired. Renew sticker.
Registration valid and sighted on vessel hull as per regulations:	No. See above finding.
Vessel Type:	Fiberglass Motor Yacht with Flybridge and Deep Vee hull
Manufacturer:	Sea Ray Boats, Knoxville TN (Div of Brunswick Corp)
Year of Vessel:	1988
Length of Vessel:	Length overall: 40' 7" (as per Buc value)
Vessel Draft:	2' 7" (as per Buc value)
Vessel Beam:	13' 11" (as per Buc value)
Vessel Weight:	22,500 pounds (as per Buc value)

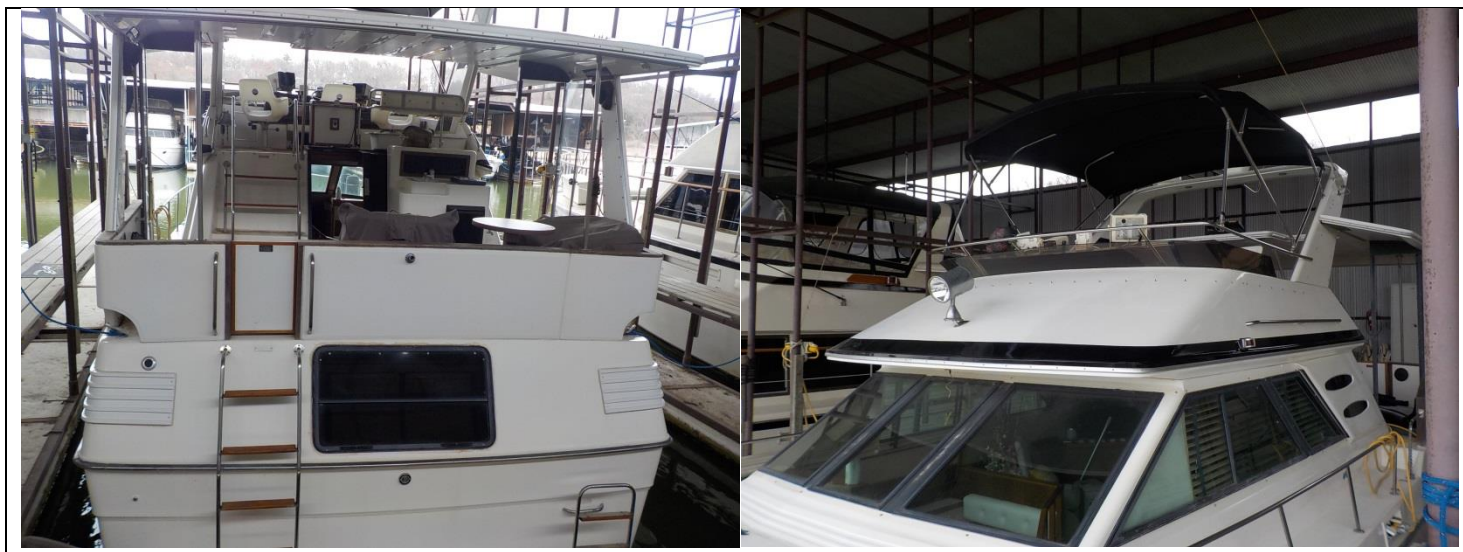
Exterior Seating:	Flybridge helm equipped with three swiveling captains chairs and bench seat. Outdoor patio furniture located on aft deck.
Cabinetry/Sink:	Molded cabinetry in aft cockpit with sink and faucet. Storage throughout flybridge under seating and cabinetry.
Window Covers:	None sighted.
Enclosure:	Canvas and isinglass snap-on enclosure for flybridge and aft cockpit. Black colored. Average condition. Stored inside cabin.
Refrigerator:	“Uline” ice maker in aft cockpit. NOTE: Uline ice maker is not operational. Repair.

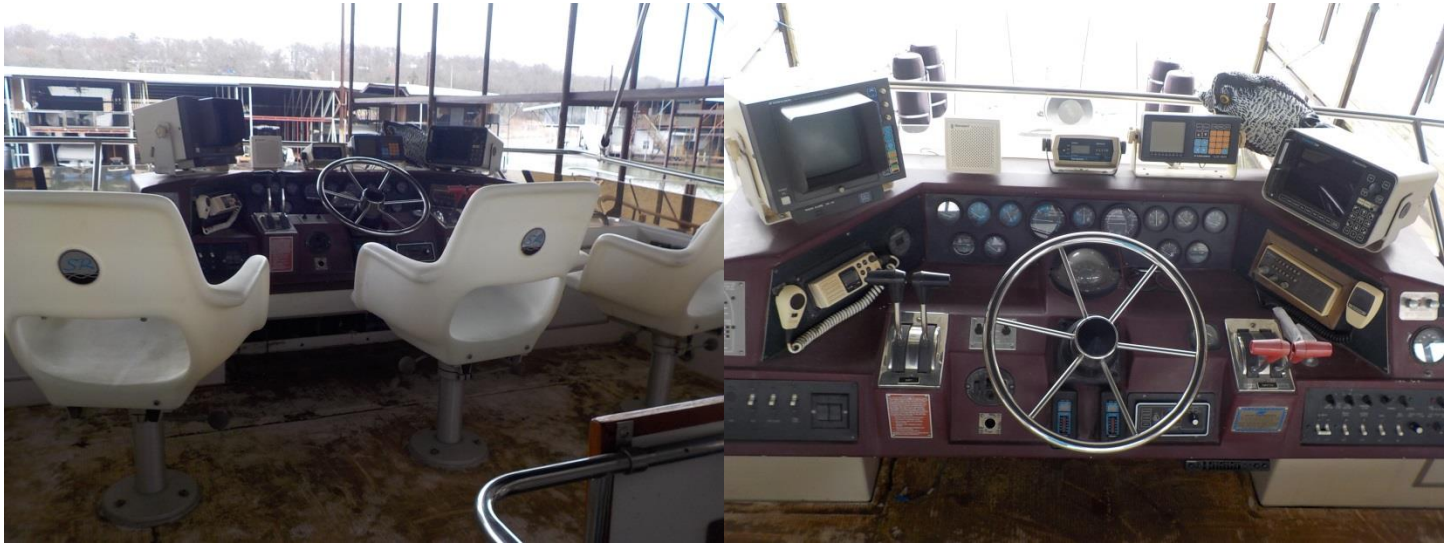
Datamarine Chart-link chart display screen with gps. Powers on. **NOTE: Chart display is obsolete and no longer adequate for navigating. Replace with modern chart plotter.**

Lowrance 3400 depth gauge. Sandpiper SL speed gauge/log. Floscan GPH gauge. **NOTE: Lowrance depth gauge and Floscan gph gauge will not power on. Repair.**

Furuno RA48 radar. **NOTE: Radar will not power on. Repair.**

“Ritchie” 6” magnetic compass on helm dash. **NOTE: Compass is not operational and compass fluid has leaked out. Repair compass.**

12v “Standard” vhf radio, powers on. Antenna mounted on side of flybridge. **NOTE: VHF radio handset/mic is broken. Repair.**

Port/Starboard/Fwd Steaming/Anchor and stern light. **NOTE: Navigation lights are not operational. Repair.**

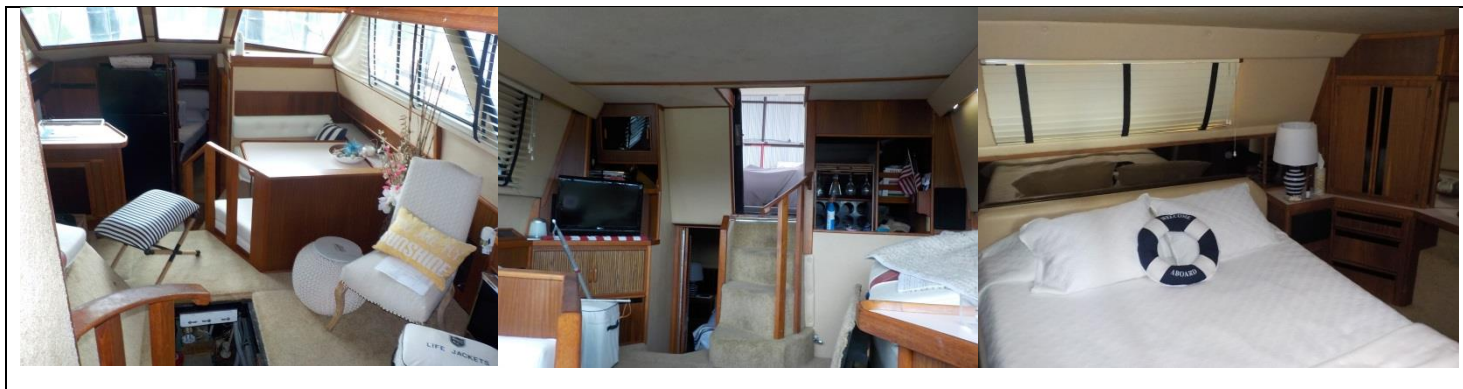
Raritan ice maker in salon. **NOTE: Raritan ice maker in salon does not power on. Repair.**
