# Draft Capital Efficiency Plan™

Wayland, Massachusetts

**TATA & HOWARD**  
INCORPORATED

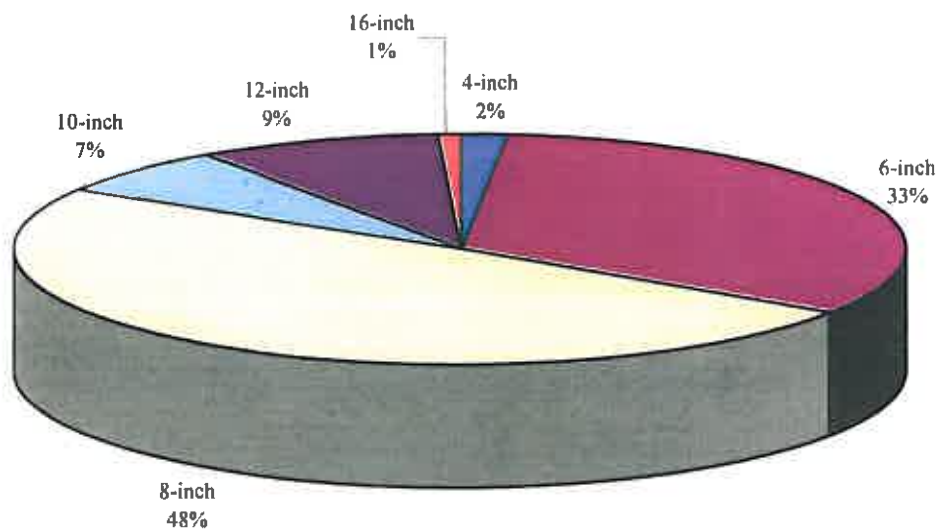
**Figure No. 2-1**  
**Water Main Size Distribution**  
**Capital Efficiency Plan™**  
**Wayland, Massachusetts**

The Wayland Water Department (WWD) was formed by an act of the legislature in 1878. Since that time, the water system has expanded throughout the Town and currently provides water service to 95 percent of the Town's population. The current system is comprised of approximately 100 miles of water main with pipe diameters ranging from 4 to 16 inches. Figure No. 2-1 shows a breakdown of the water main sizes of the existing water system. Approximately 1 percent of the system is 16-inch diameter pipe, 9 percent is 12-inch diameter pipe, 7 percent is 10-inch diameter pipe, 48 percent is 8-inch diameter pipe, 33 percent is 6-inch diameter pipe, and 2 percent is less than 6-inch diameter pipe.

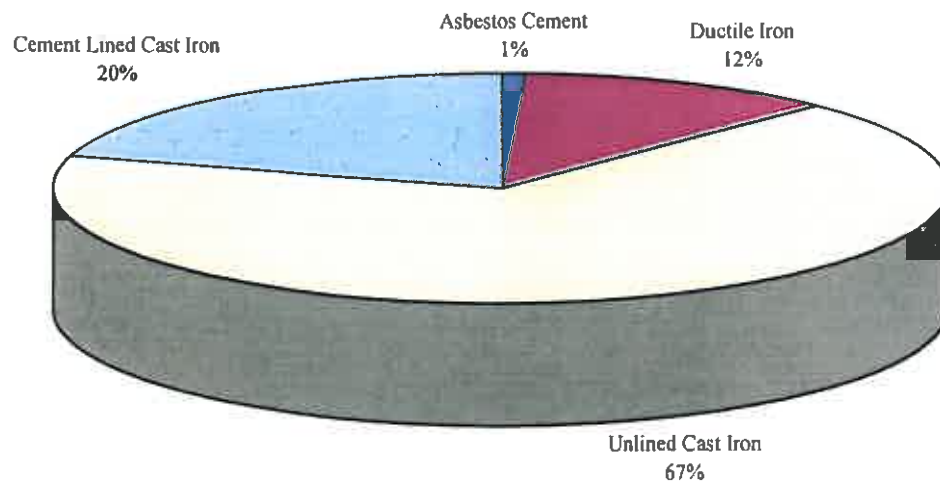
**Figure No. 2-2**  
**Water Main Material Distribution**  
**Capital Efficiency Plan™**  
**Wayland, Massachusetts**

The existing water mains are constructed of various materials including unlined and cement lined cast iron, asbestos cement and ductile iron. Figure No. 2-2 shows a breakdown of water main material. There is approximately 12 percent ductile water main, which was installed after 1970. Approximately 67 percent of the system is comprised of unlined cast iron, approximately 20 percent is cement lined cast iron and the remaining one percent is asbestos cement. Further discussion of material characteristics is provided in Section 5.

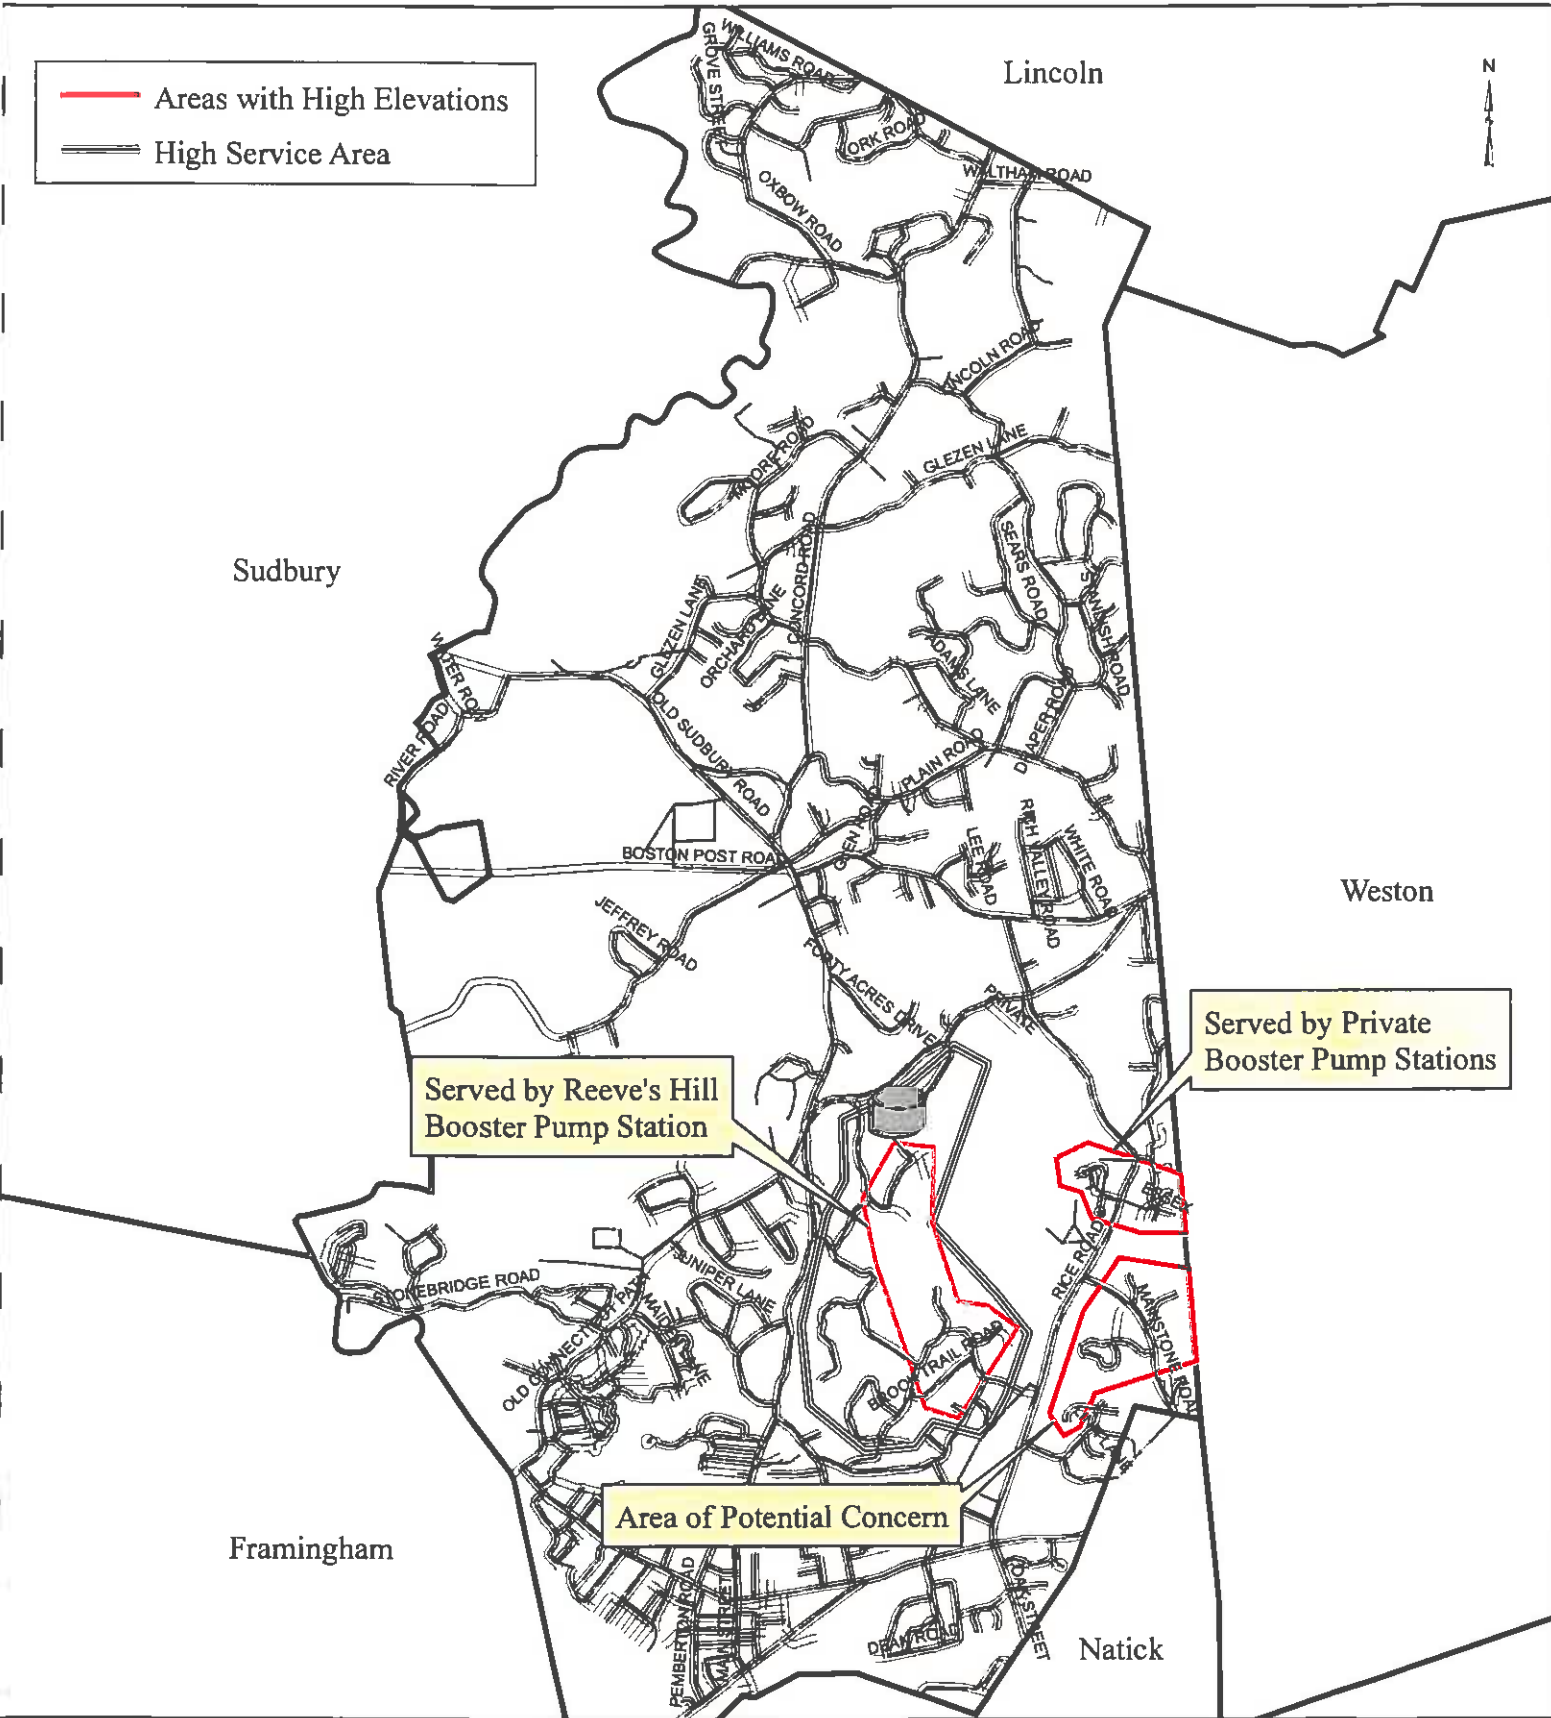
- Areas with High Elevations
- High Service Area

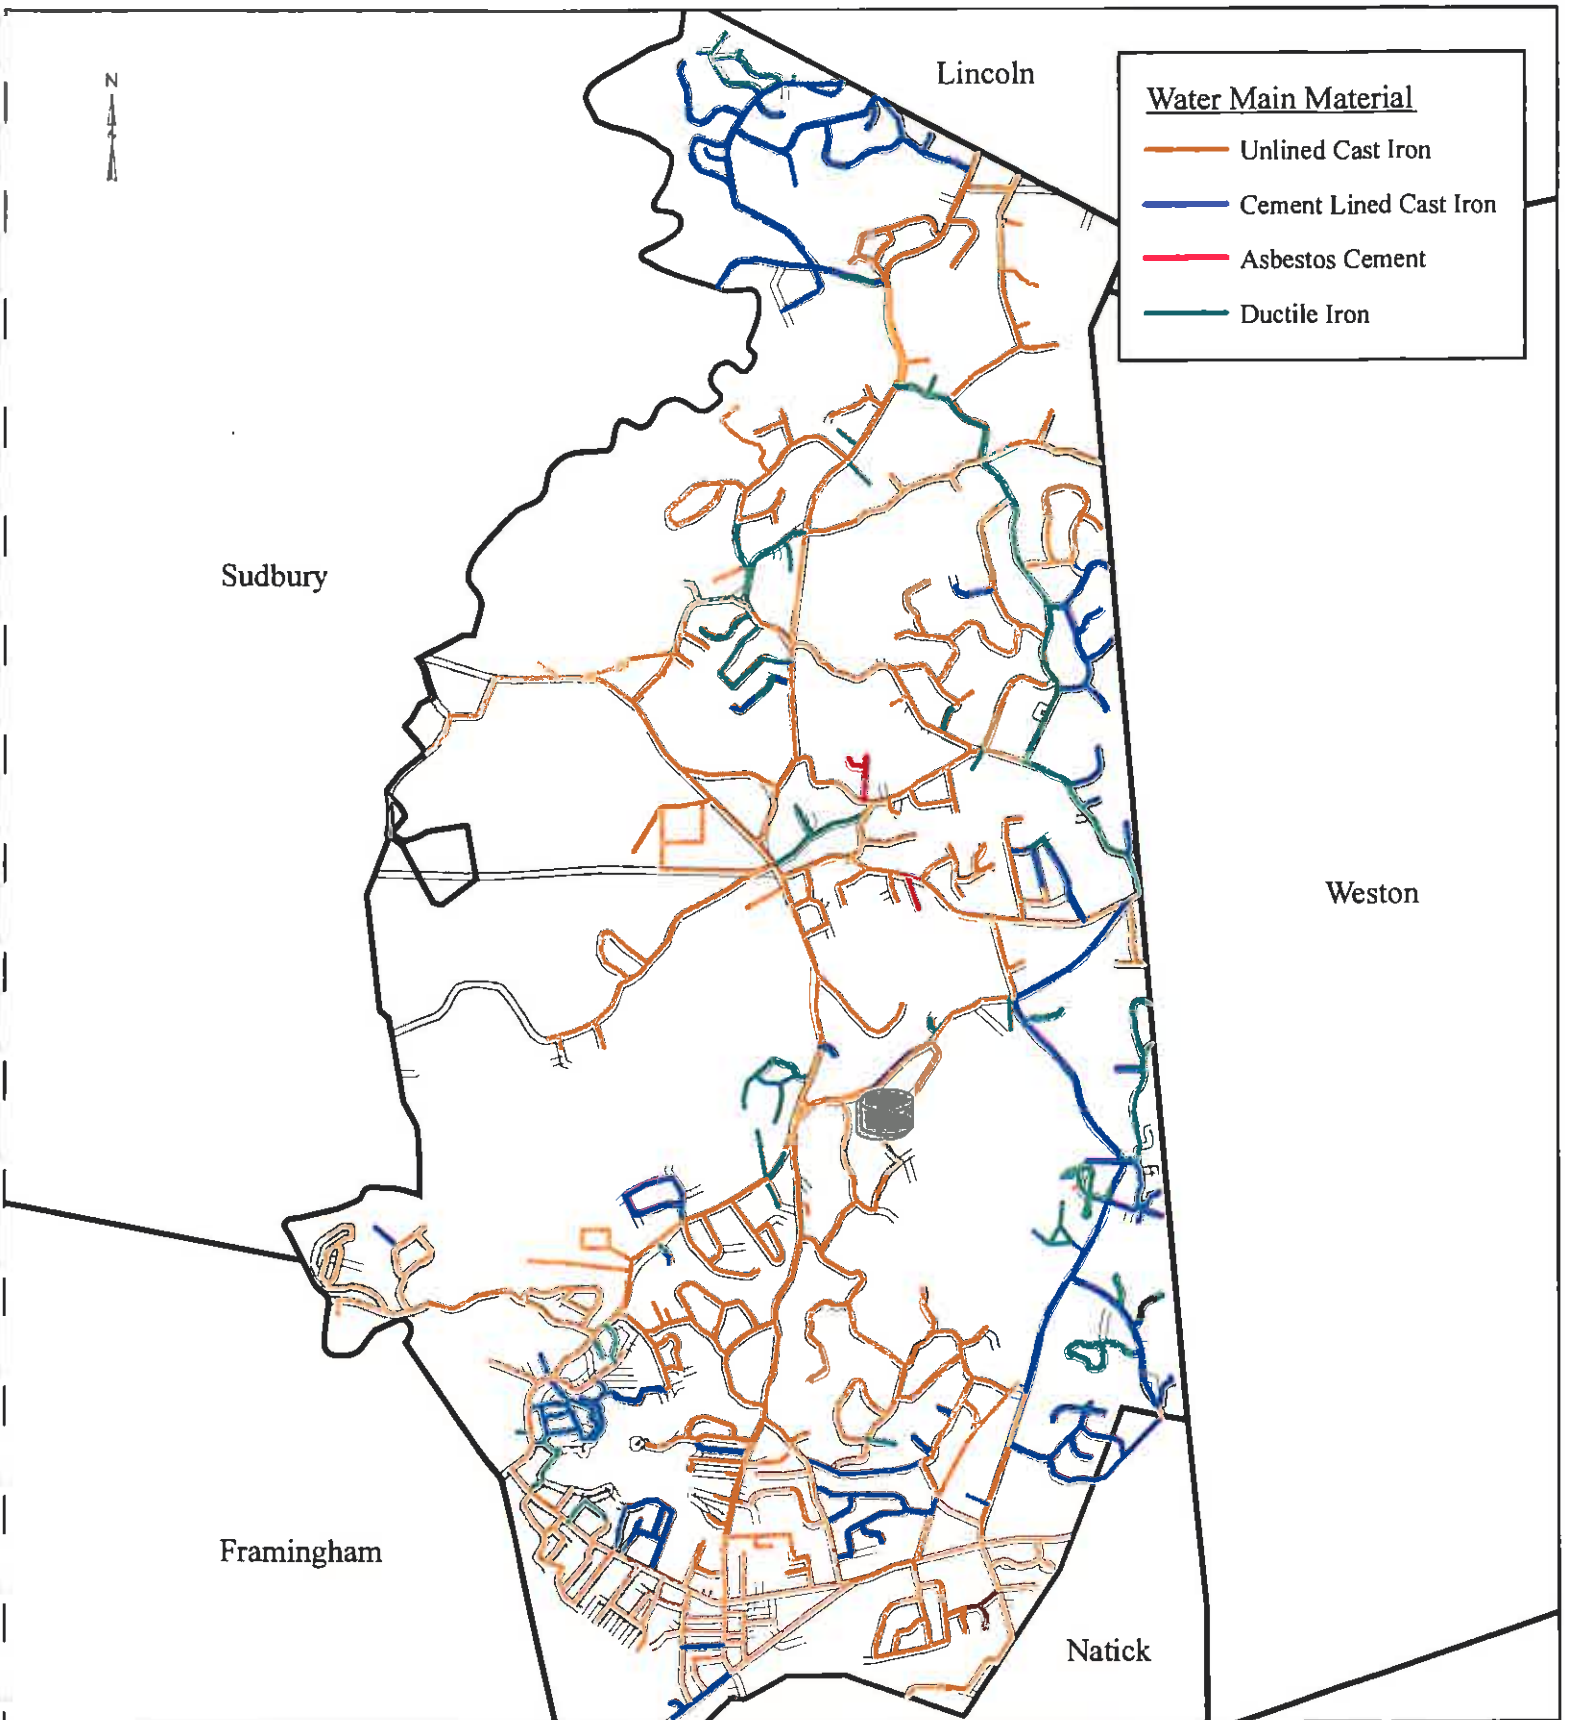
In general, the oldest water mains in the system received a high rating of 100, while the newest received a rating of zero. A ratings decrease occurs after 1932, which reflects the switch in Wayland from a surface water source to groundwater sources. Surface water in this area of the country is typically more corrosive to the interior of water mains than groundwater and this is reflected in the rating decrease. Another significant rating decrease can be seen in the materials score around 1958, which reflects the introduction of factory lining. Figures No. 5-1 and 5-2 present the installation year of the water mains and the materials, respectively.

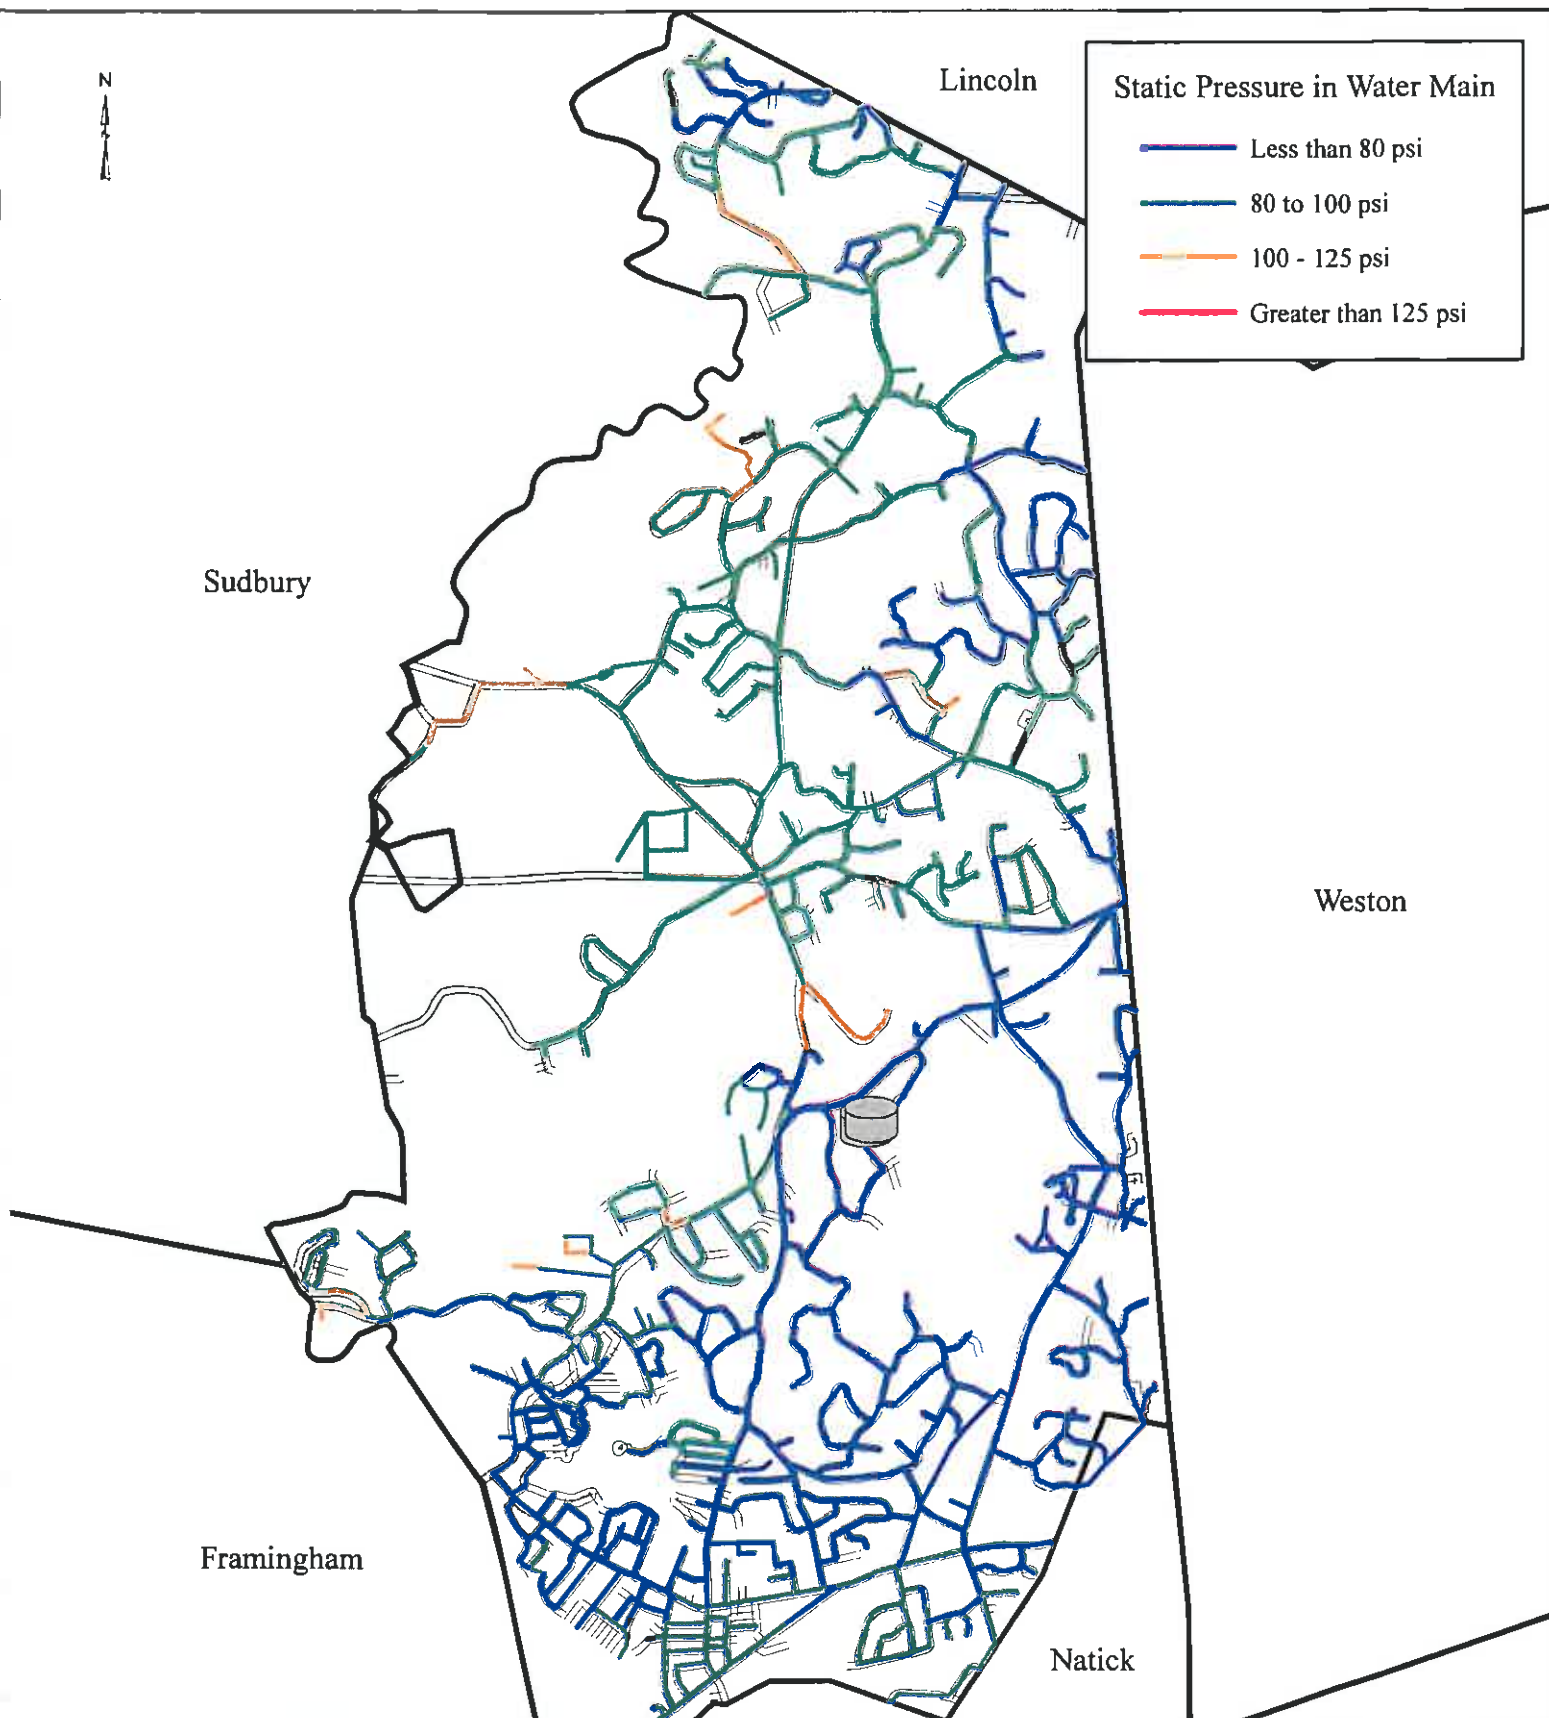
5-6

- Water Main
- Water Mains Within Potentiall Corrosive Soils
- Water Mains Within Identified Corrosive Soils
- Potentially Corrosive Soils\*

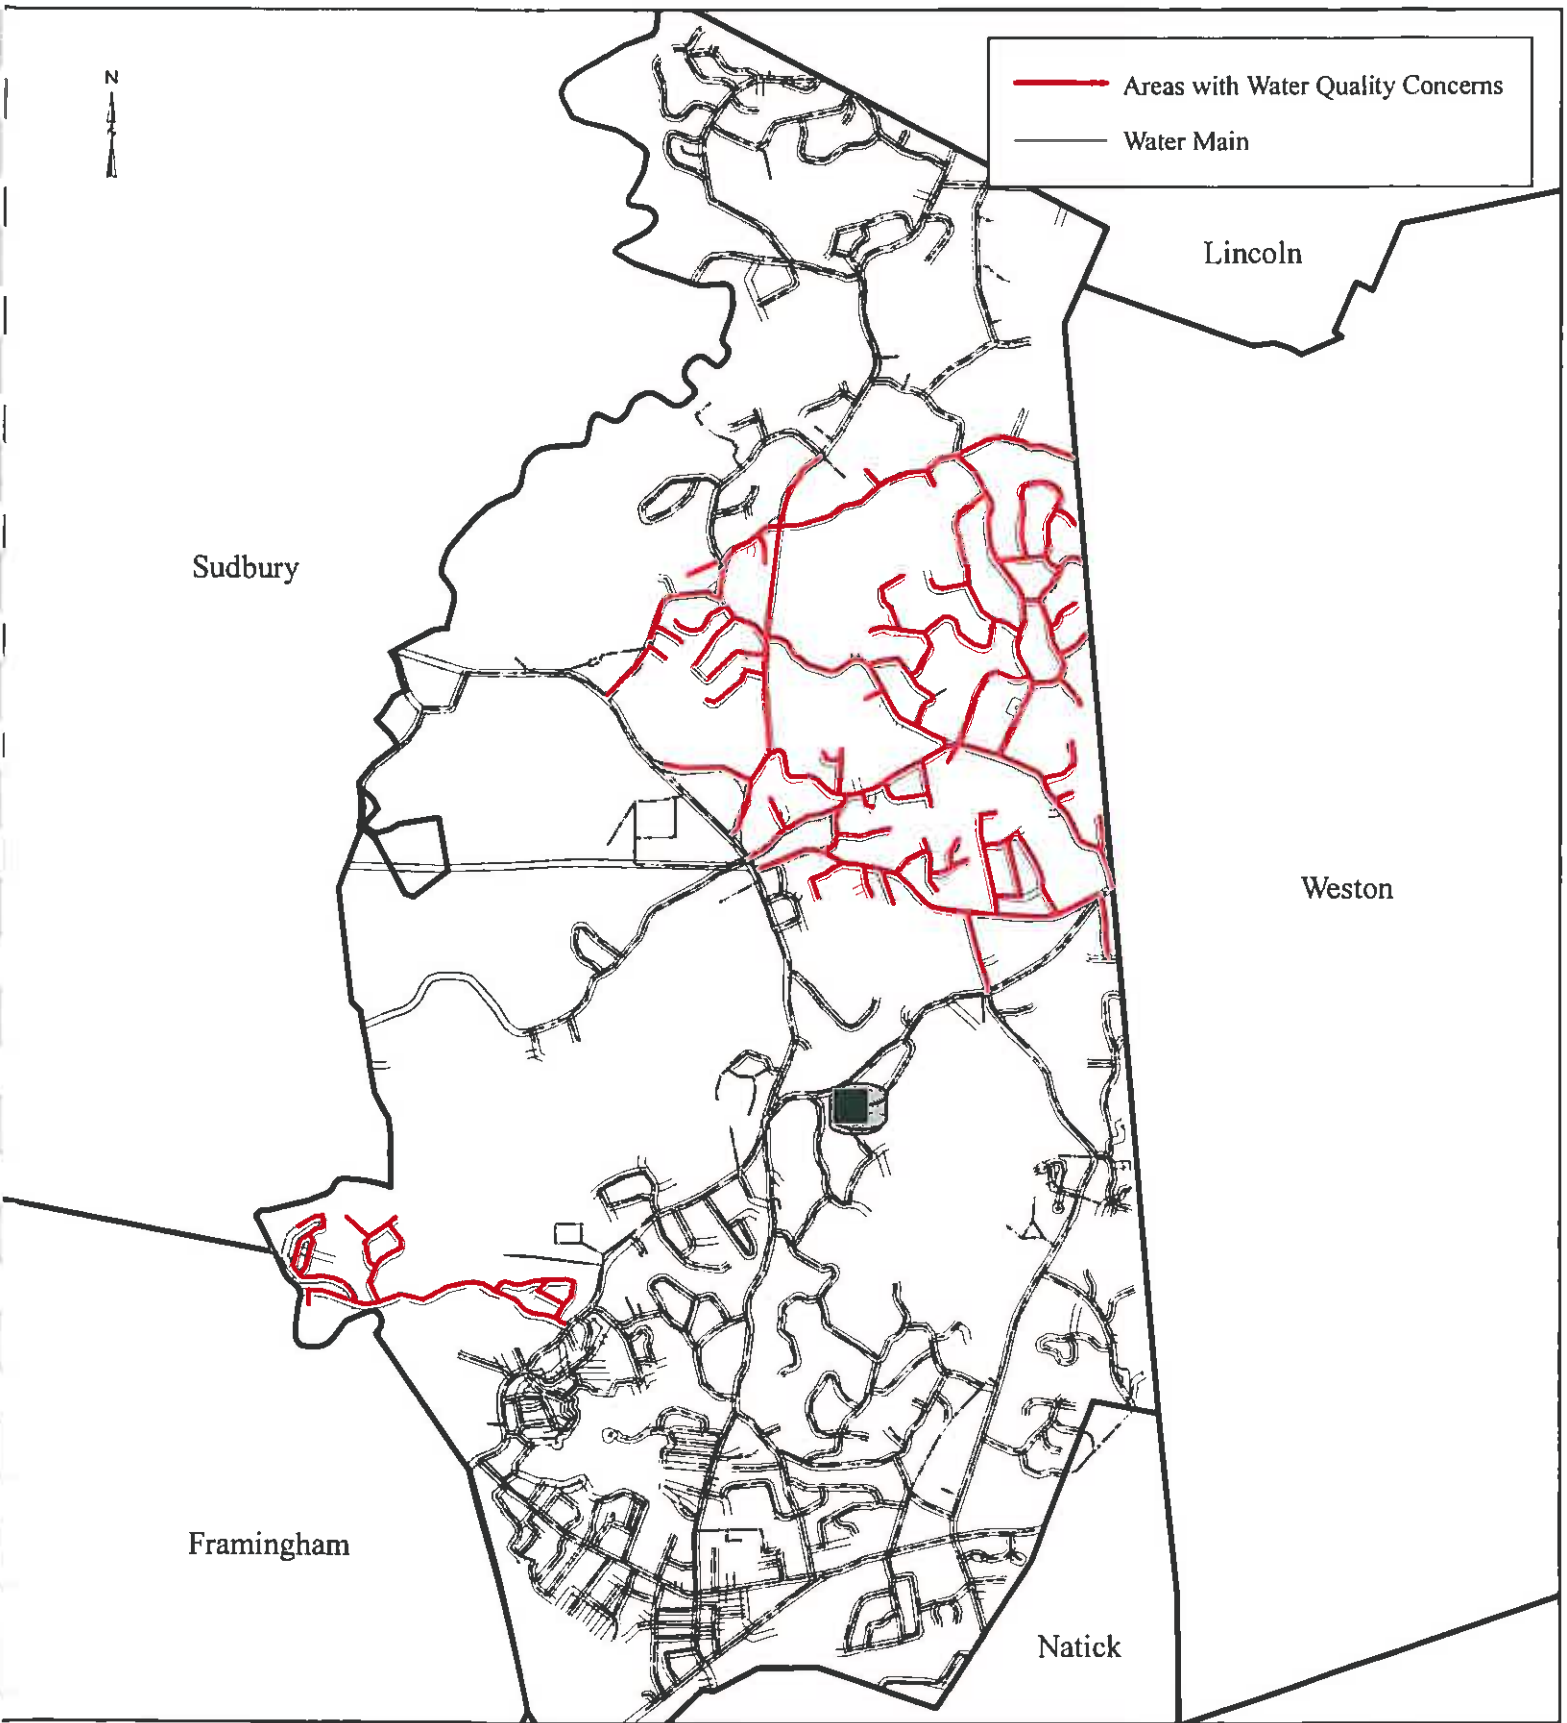
Also, there have been numerous brown water complaints over the years in the north-eastern portion of Town. Much of the water main in this area is unlined cast iron, which is most likely in poor condition and resulting in increased iron in the water. Finally, Baldwin Pond Wells No. 1 and 2 are currently not used due to high iron and manganese levels. The proposed Baldwin Pond Water Treatment Facility should alleviate this problem and allow for these wells to be used again. Figure No. 5-7 represents the areas with water quality concerns.
