TATA & HOWARD
INCORPORATED

Section 5 Asset Management Considerations

Capital Efficiency Plan
Wayland, Massachusetts

Section 6 Above Ground Facilities

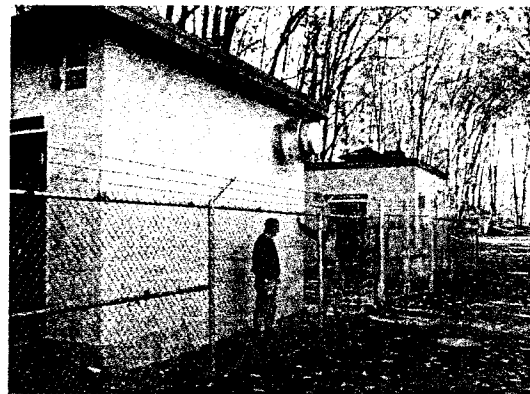
A new building was constructed near the Well No. 1 building for chemical storage in 1999. All of the chemicals for Well No. 2 are stored here, along with some of the chemicals for Well No. 1. Chemical injection occurs in a manhole outside of the building.
