DISCOVERY
RV SERVICES, LLC.

RV Inspection Report

Prepared for: Kelly Hanna

Inspection Date / RV Model:
11-04-2021 ; 2020 Keystone Alpine 3851RD

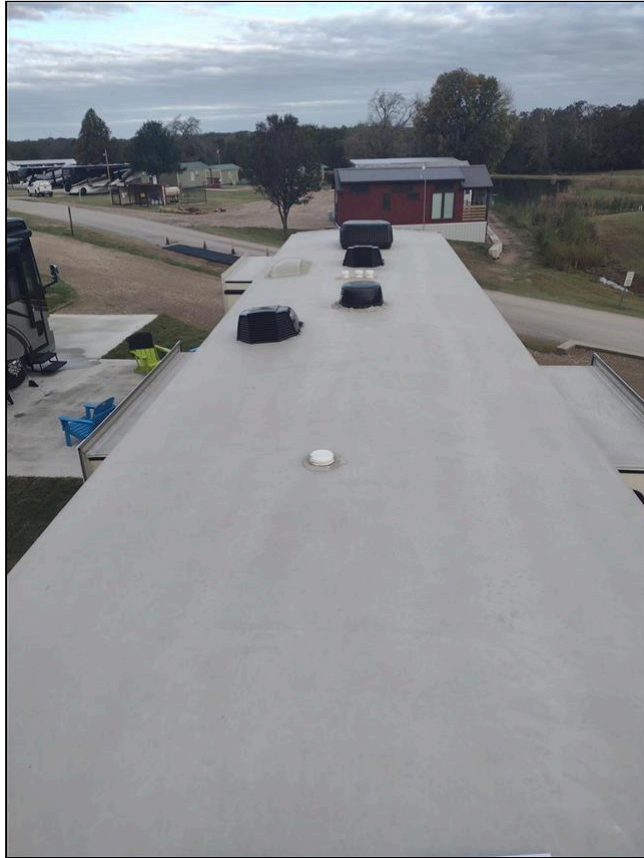
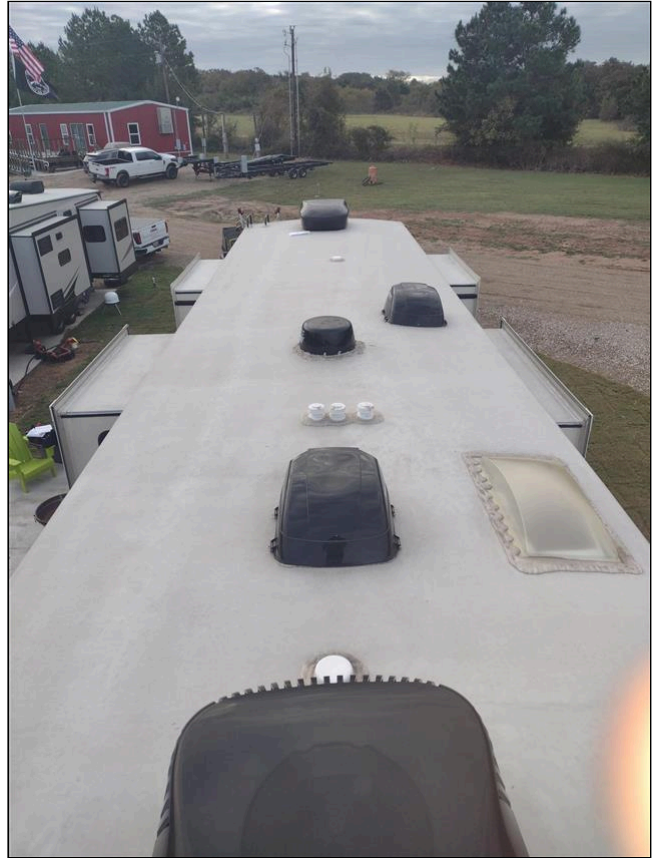
Inspector noticed two location's with unknown item's under rubber roof material which are causing elevated areas. It is recommended that these two areas be evaluated by a qualified RV technician.

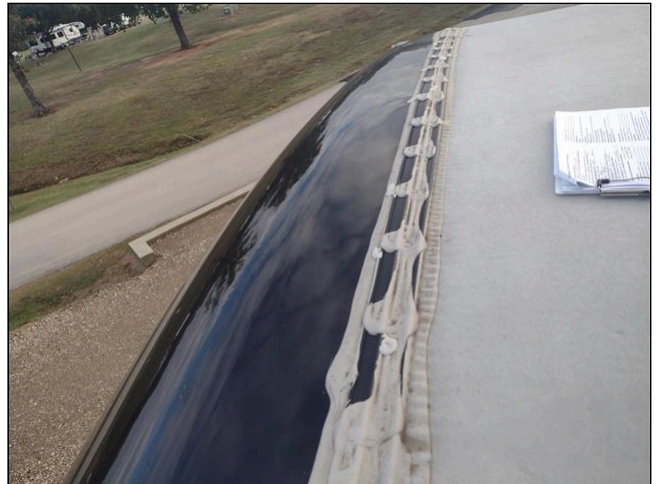
Front Cap Seal

Inspector noticed that there is a hole in the cap mounting screw hole sealant. It is recommended that this area be repaired by a qualified RV technician.

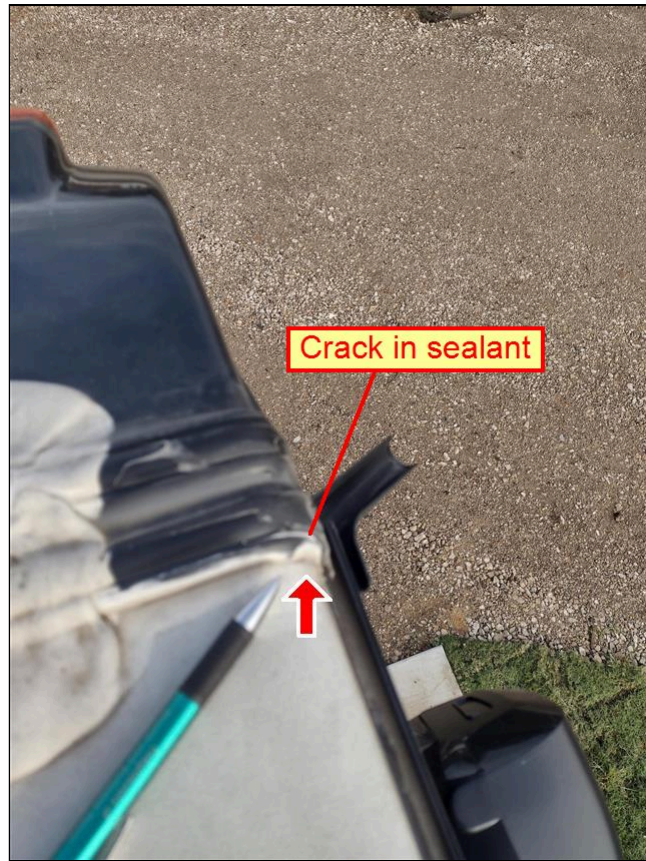
Front Curbside Cap Joint Corner

On the curbside front corner joint there is a crack in the sealant. It is recommended that this area be repaired by a qualified RV technician.

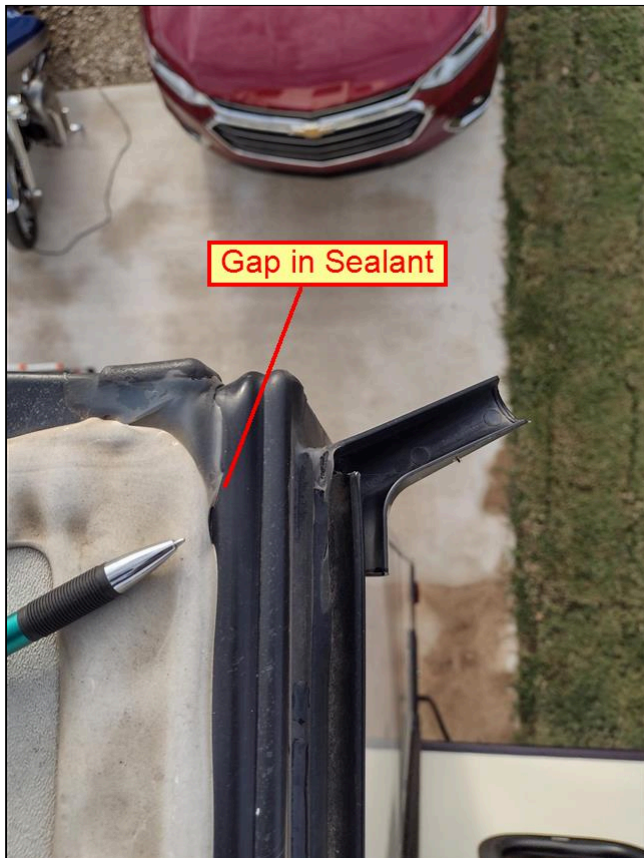
On the Streetside rear corner joint there are two cracks in the sealant. It is recommended that these areas be repaired by a qualified RV technician.

Streetside Rear Cap Seal - Gap in Sealant

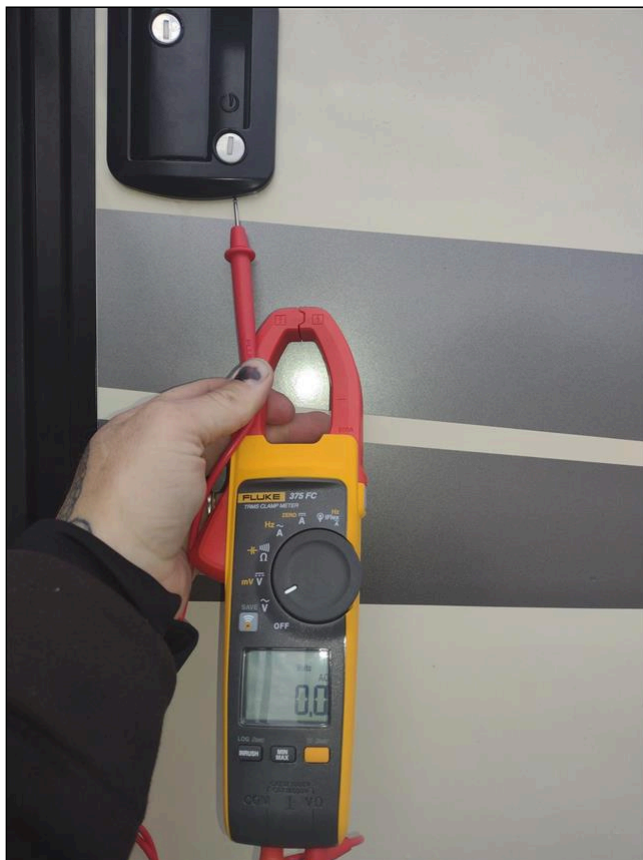
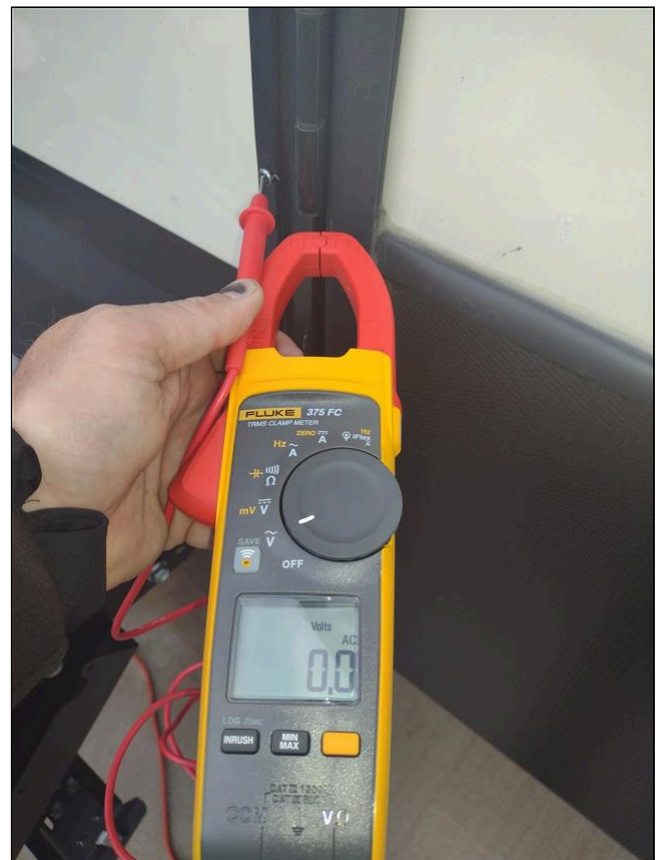
Inspector found that at the time of inspection there was not any voltage found during the Hot Skin Testing

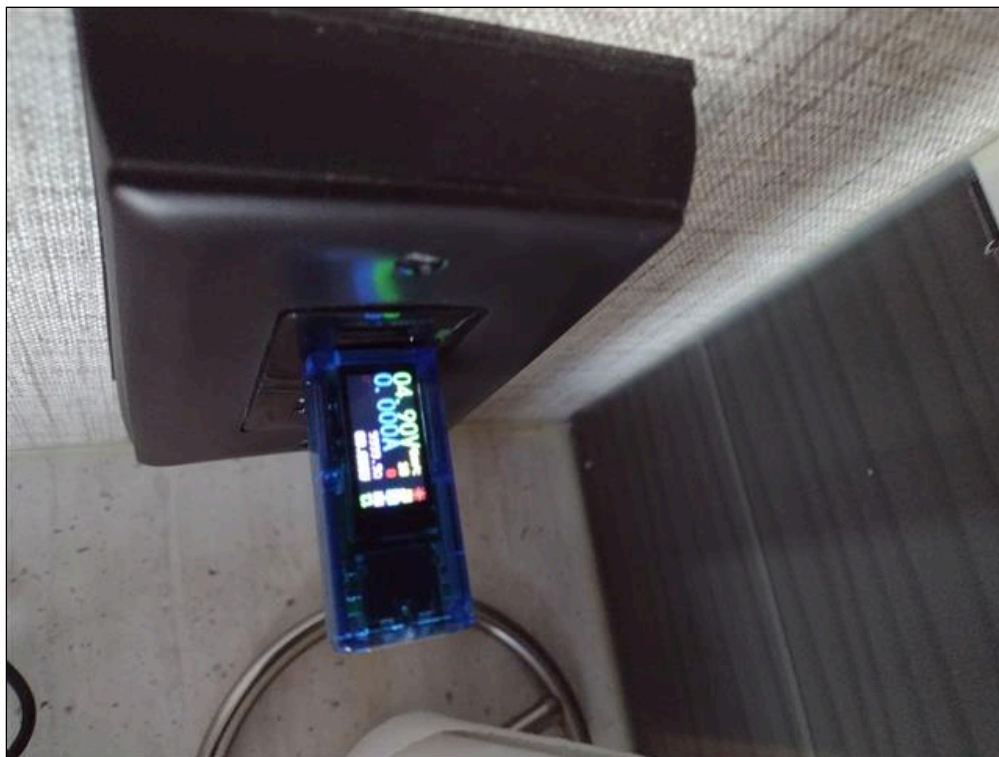
Inspector tested USB Port at 4.9V

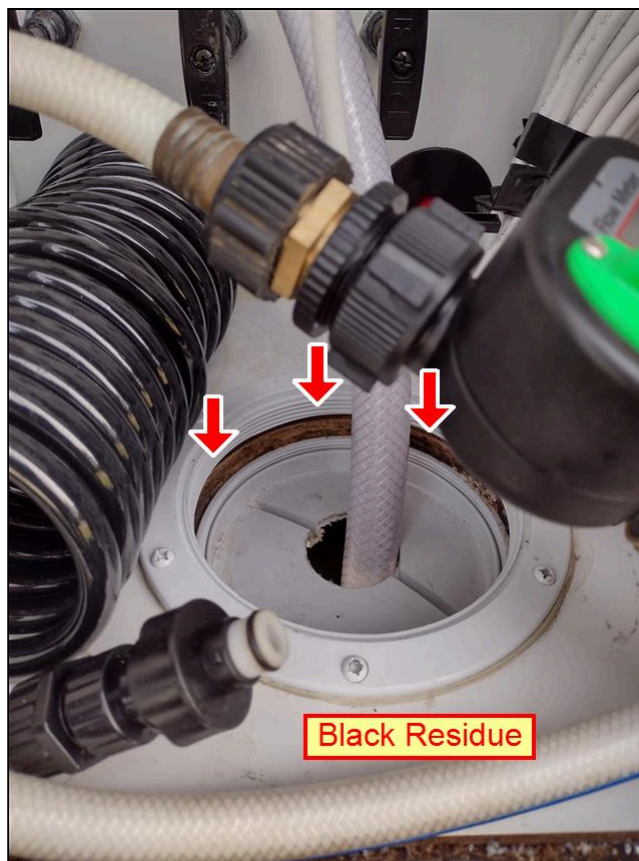
Access Port

Wet Bay. Inspector noticed that there is a cable installed through the wall and some black residue located on the wood in the pass-thru port. Inspector recommends these areas be evaluated by a Qualified RV Technician.

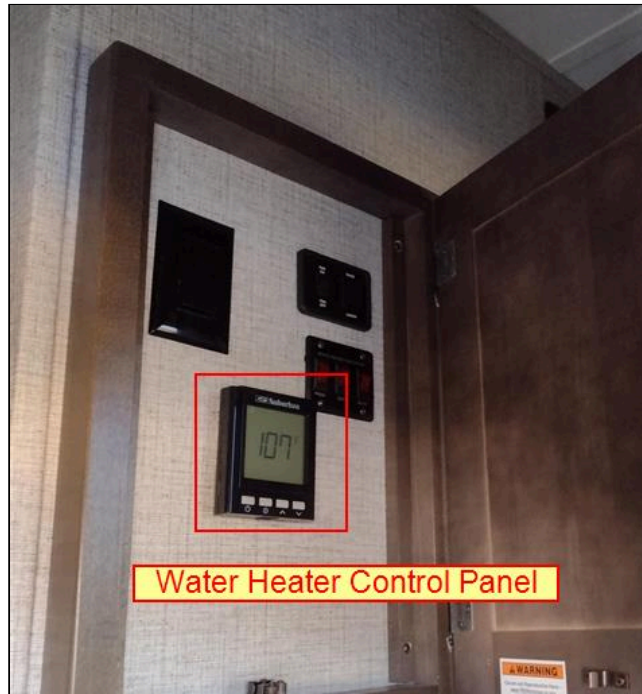
Water Heater Controls

🔍 Inspector found that the Suburban Nautilus Water Heater is a sealed unit. It is recommended that a Qualified RV Technician evaluate the condition.

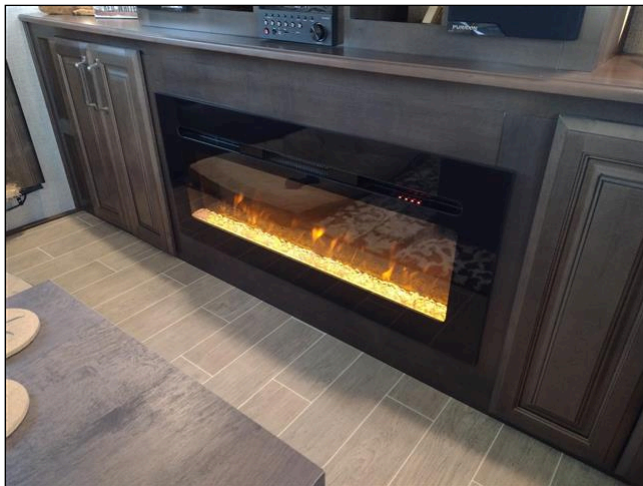
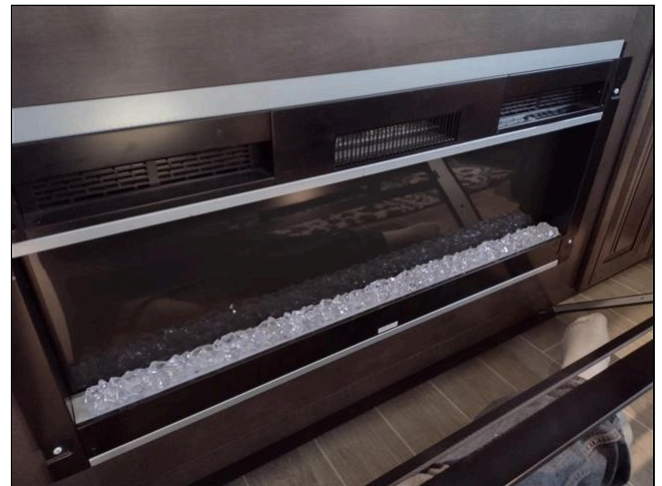
Inspector was unable to verify Brand / Model / Serial Number of Fireplace. It is recommended to have a Qualified RV Technician perform future maintenance.

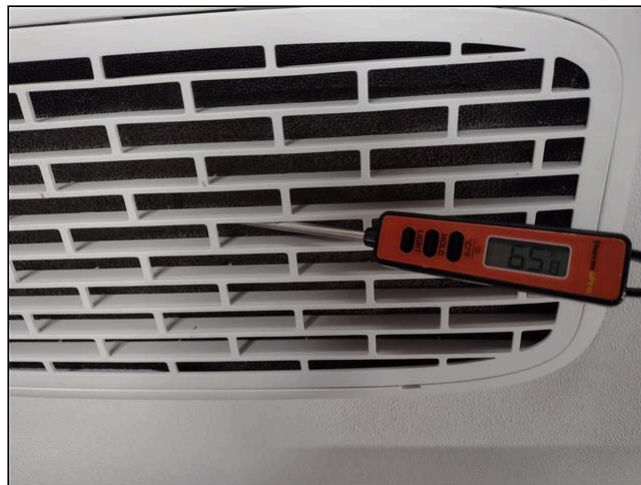
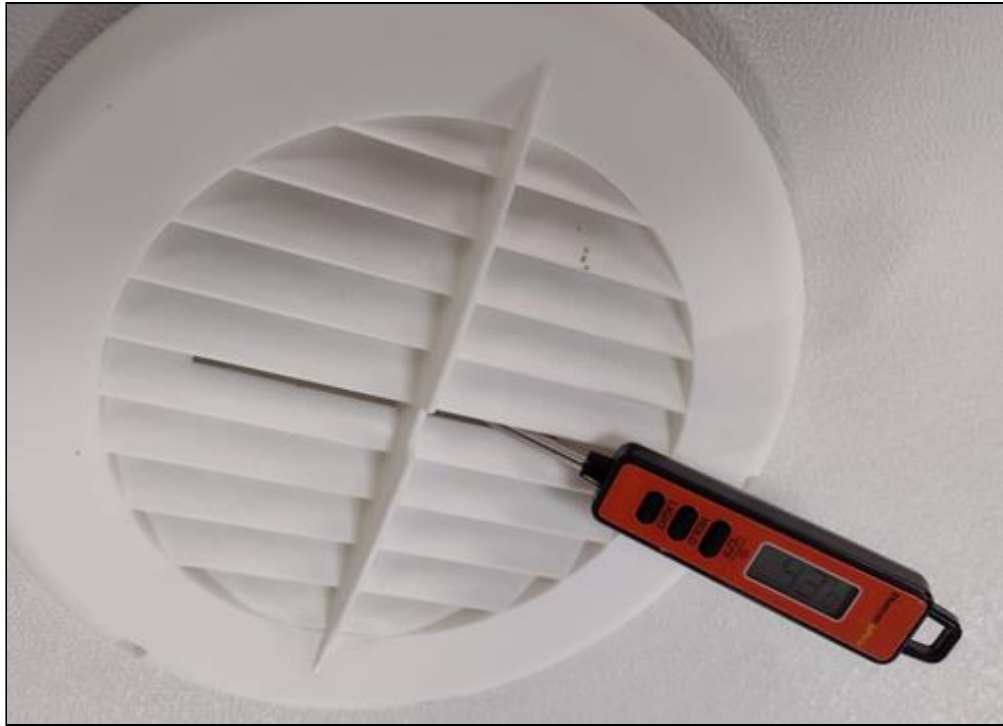
The Delta-T test resulted in a value of 27.5 Degrees.

Starting Temperature of 65.8 Degrees

Ending Temperature of 43 Degrees

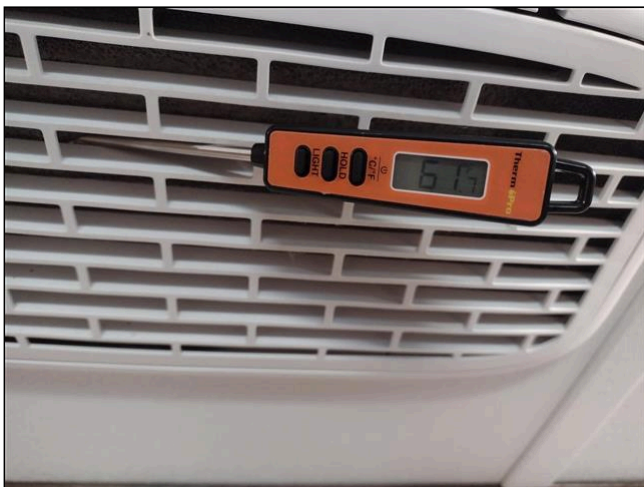
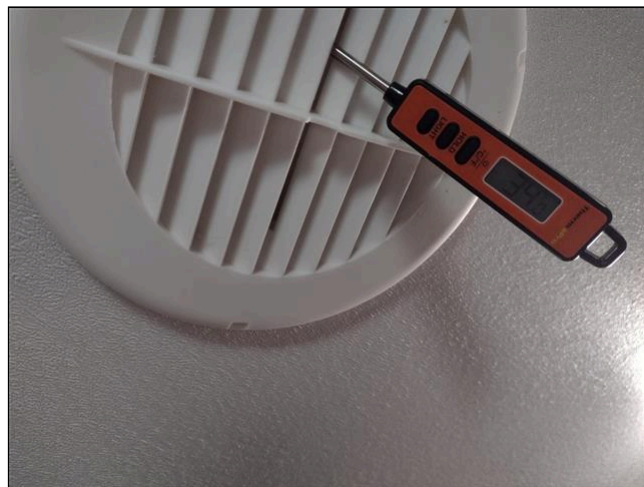
The Delta-T test resulted in a value of 22.8 Degrees.

Starting Temperature of 61.7 Degrees

Ending Temperature of 34 Degrees
