Learning from failures I

STEP lecture E27

To describe some structural failures caused by snow, wind or landslide.

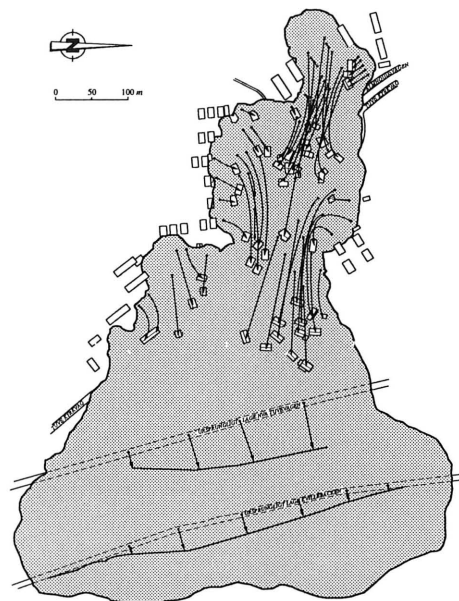
Figure 15 Map of the slide area with the direction the houses slid indicated.

The slide area was about 27 hectares with a maximum length of 750 m. The slide width in the area where most of the houses were situated, was about 200 m. The number of houses in the landslide was 65 and about 100 houses close to the slide area were evacuated. Most of the houses moved about 100 m horizontally and 10 m vertically. The maximum transportation of any of the houses was 180 m. In Figure 15 a map of the slide area is shown. The map also shows the house slide paths.

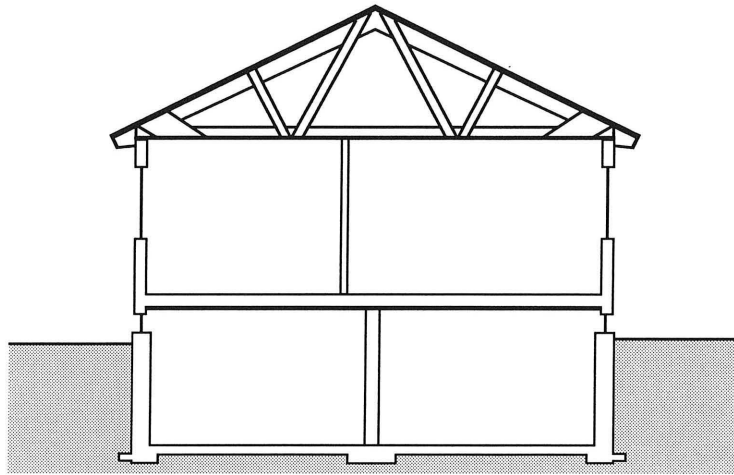
Figure 24 Section of the house.

There was one house in the slide area of the same type, except for the floor structure. This house had a timber floor structure, which made the whole house function as a closed square box. The concrete cellar was destroyed but the wooden superstructure was nearly intact, just a little deformed.

This house was very interesting. Although it had lost approximately 75% of its supporting basement walls, it did not break down, although it showed some deformation and a few broken windows. This is an excellent example of "box-function". A box with 4 stiffened walls (the inner walls act as stiffeners) and an intact top and bottom is rather stiff and safe. This was proved many times in the slide area. Figure 25/26 shows the building, resting on "nearly nothing".
