# INSPECTION REPORT

For the Property at:  
**123 MAIN ST**  
BLUFFTON, SC 29910

Prepared for: MR. SMITH  
Inspection Date: Saturday, June 25, 2022  
Prepared by: Charles Mullins

Report No. 1010

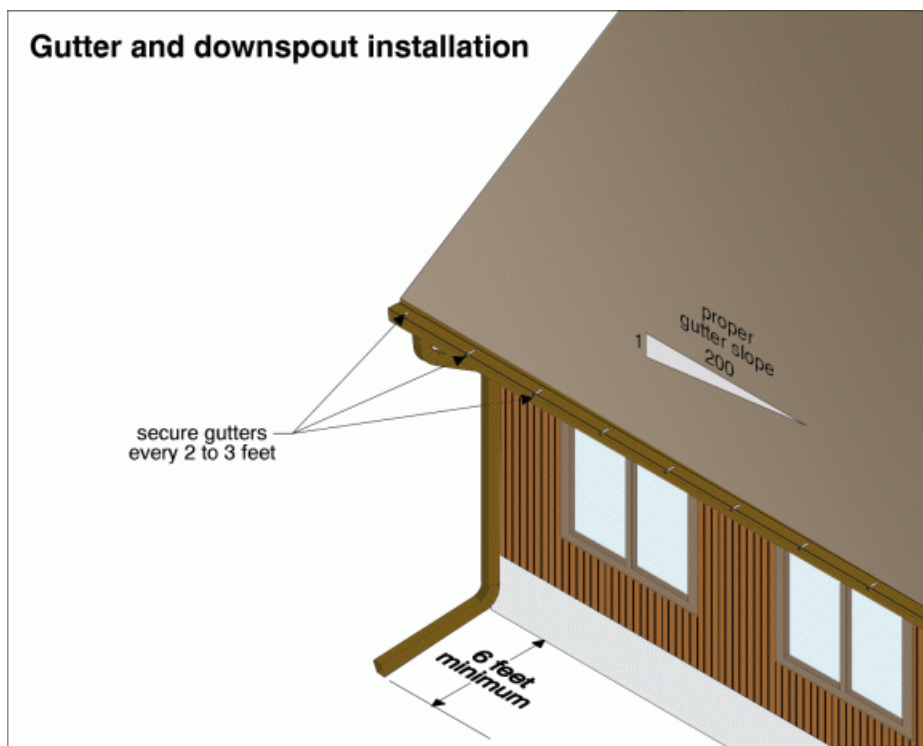
**Condition:** • [Discharge too close to building](#)

The downspout should be extended so the gutters will drain 6' away from the foundation.

**Implication(s):** Chance of water damage to structure, finishes and contents

**Location:** Rear Exterior

**Task:** Improve

**Time:** As soon as possible

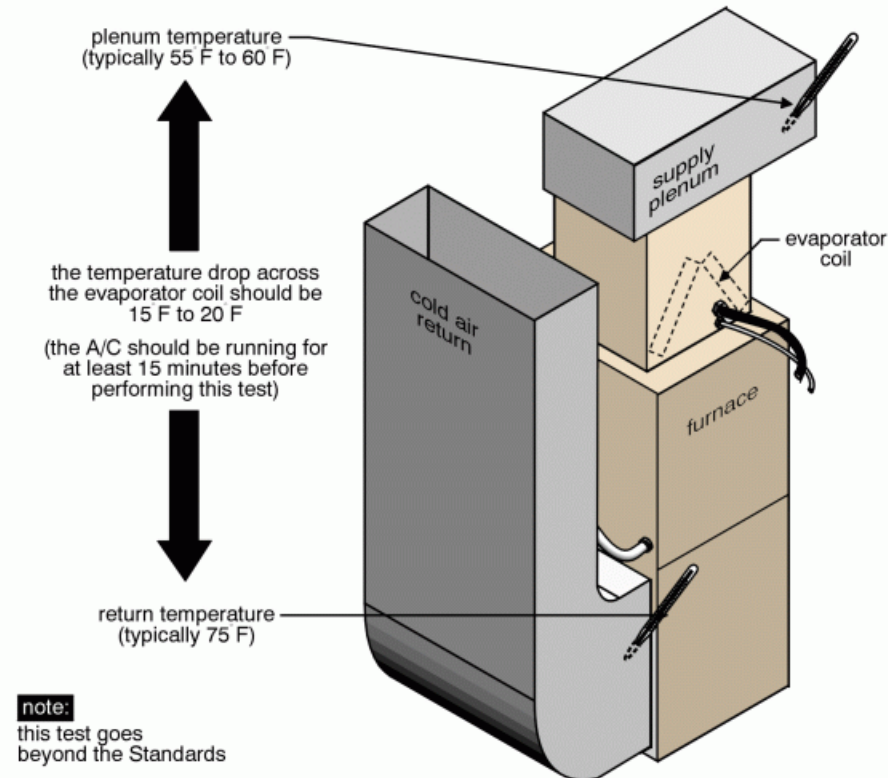
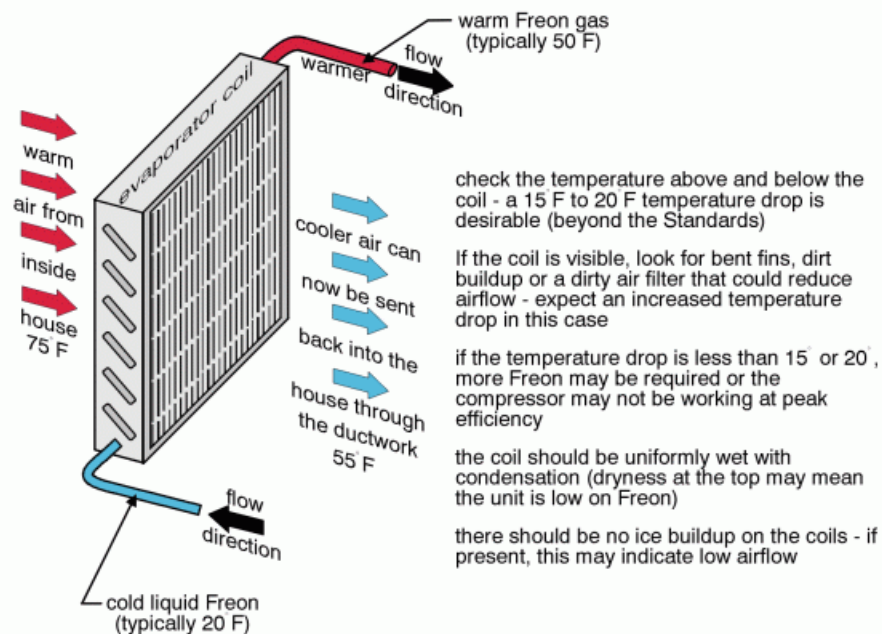
## Measure temperature drop across inside coil

**Condition:** • [Inadequate cooling](#)

The temperature difference in the supply to return was only 10 degrees. It should be in the range of 14 to 22 degrees. Recommend further evaluation by a HVAC technician.

**Implication(s):** Increased cooling costs | Reduced comfort

**Task:** Further evaluation

**Time:** Immediate

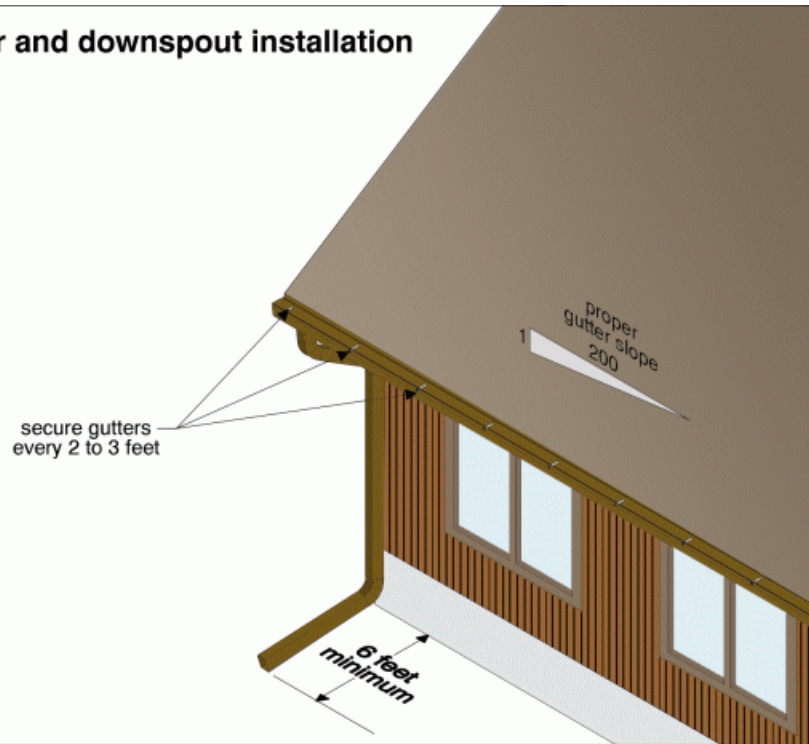
7. Discharge too close to building

**1. Condition:** • [Discharge too close to building](#)

The downspout should be extended so the gutters will drain 6' away from the foundation.

**Implication(s):** Chance of water damage to structure, finishes and contents

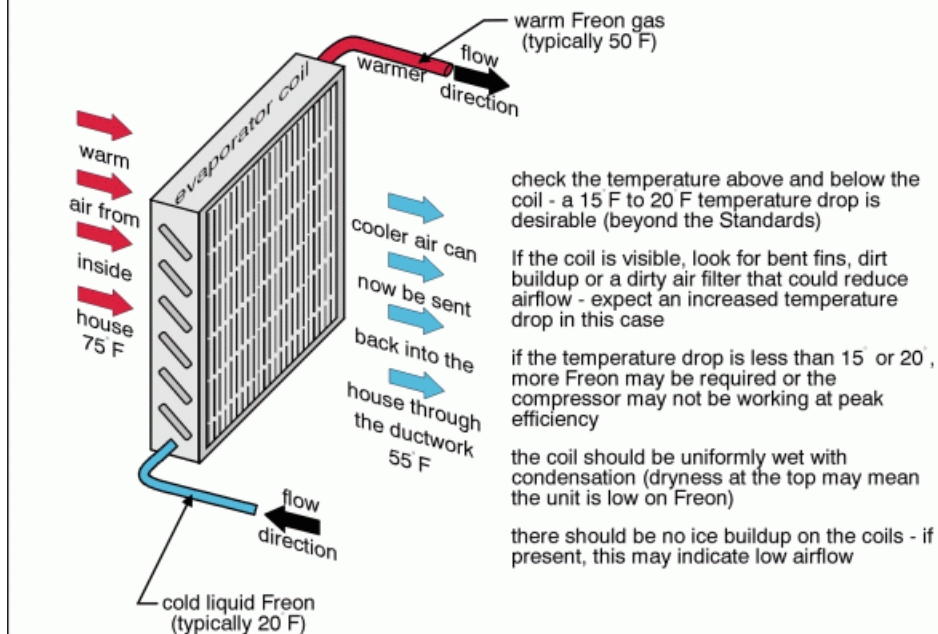
## Evaporator coil - inspection procedures

**3. Condition:** • [Inadequate cooling](#)

The temperature difference in the supply to return was only 10 degrees. It should be in the range of 14 to 22 degrees. Recommend further evaluation by a HVAC technician.
