January 29, 2018

RE: 146 Santa Fe Ave
Lawson, MO 64062

Confidential Inspection Report

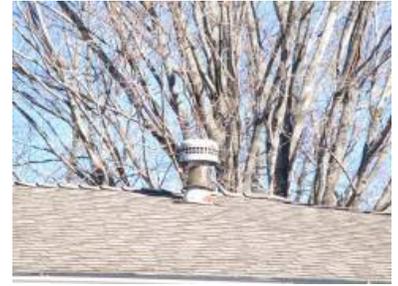
2.5 CONDITION:

Raised flashing viewed at roof. The storm collar sealant was missing. A storm collar is a necessary flashing around chimney flue piping to prevent water entry. Replacement of sealant recommended. Consult qualified roofing contractor for further evaluations and necessary repairs.

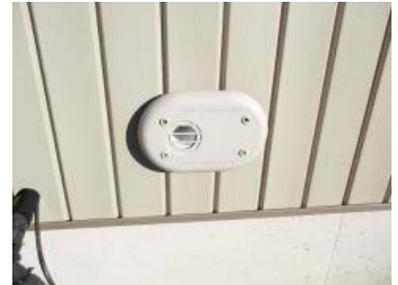
2.6 TYPE:

Plastic vent was not in use.

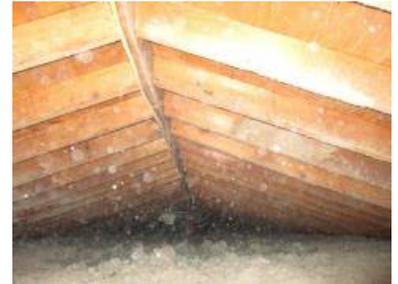
4.3 CONDITION:

The attic framing appears to be serviceable. Not all reaches of the attic area were available for inspection due to framing, insulation, equipment, storage, and/or lack of walkways.

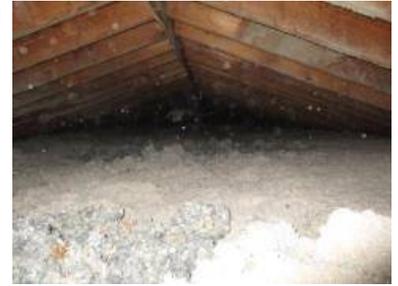
4.5 CONDITION:

The insulation level was 12 inches thick, approximate value of R-30. Insulation was installed between the ceiling joists on the floor in the attic. The attic insulation appears to be sufficient and meets the modern standard in this area.

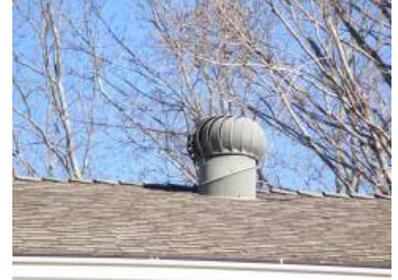
Attic/roof ventilation was provided by soffit vents, and roof turbine vents. The attic ventilation appears to be serviceable.

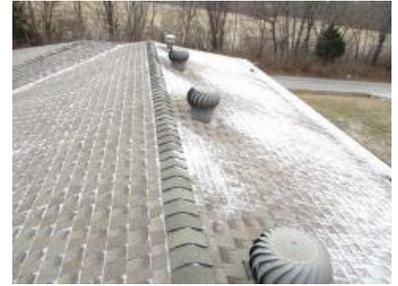
4.9 CONDITION:

The approximate age of the roof appears to be 1-5 years. One layer of roofing appears to be present. The roof appears to be serviceable.

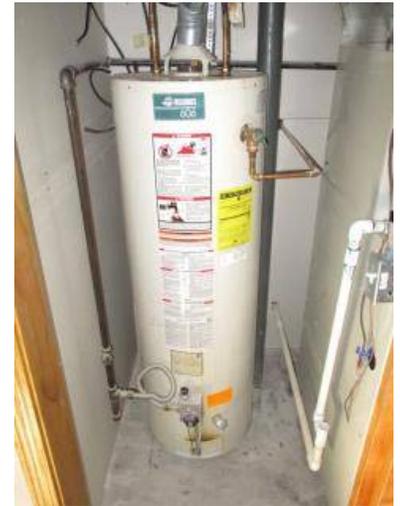
5.9 CONDITION:

The water heater has exceeded the end of its average economic life. Short remaining life should be anticipated.

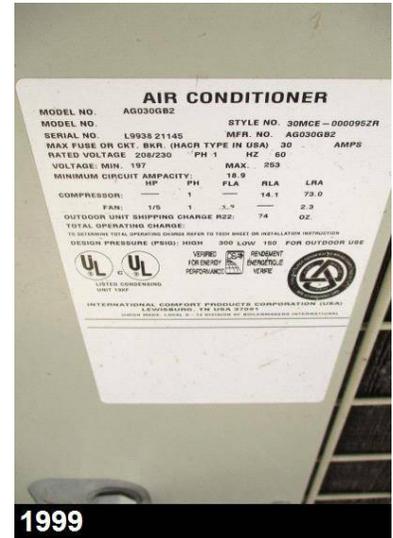
6.15 SYSTEM CONDITION:

The cooling system could not be operated due to the low outdoor temperature. Operation of the outdoor compressor/condenser unit when the temperature is below 65 degrees Fahrenheit could result in system damage. Have the cooling system evaluated by the appropriate professional when the conditions are favorable. The cooling system has exceeded the end of its average expected economic life. Short remaining life should be expected.

The fins over the coils of the outdoor condensing unit were bent. Dirt, and or bent fins can block air flow and reduce cooling performance or cause damage to the system. Combing of the fins is recommended.

The cooling system could not be operated due to the low outdoor temperature. Operation of the outdoor compressor/condenser unit when the temperature is below 65 degrees Fahrenheit could result in system damage. Have the cooling system evaluated by the appropriate professional when the conditions are favorable.

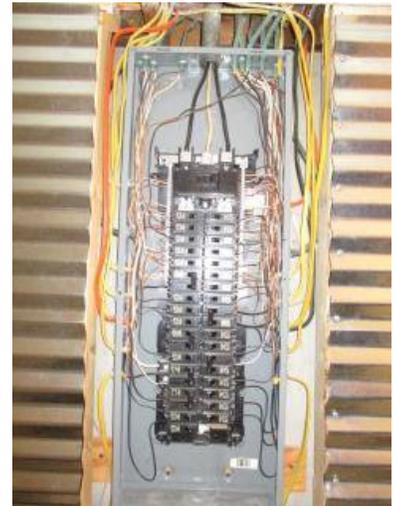
7.3 MAIN PANEL: TYPE & CONDITIONS:

Circuit breakers were present in the main panel box. The electrical panel box appears to be serviceable.

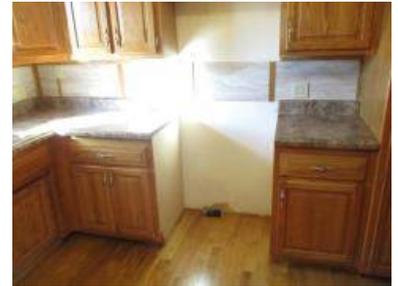
VENTILATION:**9.3 TYPE & CONDITION:**

No ventilation was present. Installation of ventilation may be desired.

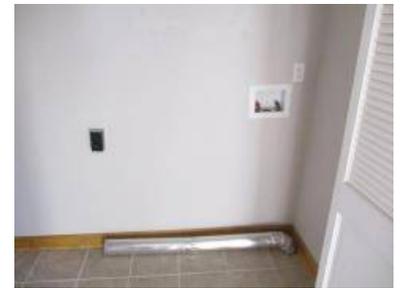
10.2 CONDITION:

The plumbing hook-ups for the clothes washer appear to be serviceable. The washer discharge and drain appear to be serviceable. Provisions for an electric powered (220 v.) clothes dryer were provided. An older 3-hole 220 volt power outlet was provided. The 110 volt electrical outlet was grounded. A vent was provided for the clothes dryer. The visible portions of the dryer vent appeared to be serviceable.
