InSight Inspections NW, LLC

Inspection Report

**1234 ABCD Street
Seattle, Washington 98111**

Inspection Date January 21, 2018
Inspector Yuriy Nyzhnykevych
lyst4u@yahoo.com
State of Washington license # 1663

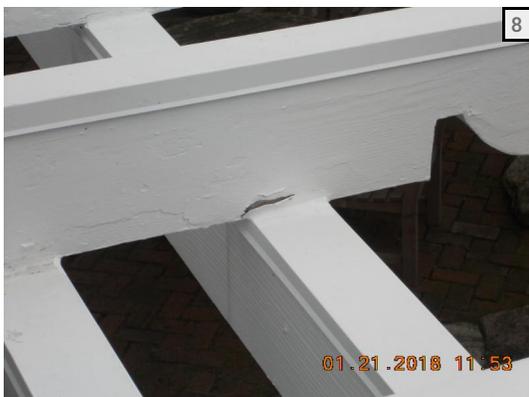
Wooden elements have paint peeling off

Location	Exterior: Ground View
Impact	If not repaired, will lead to further damage

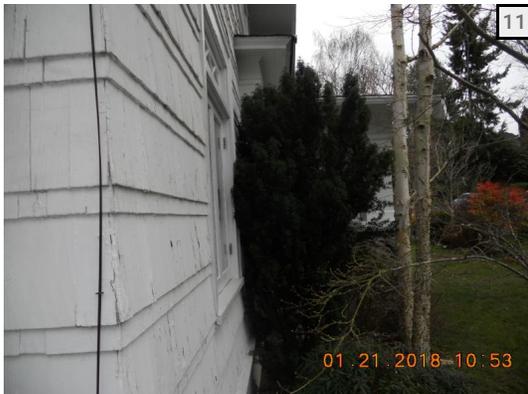
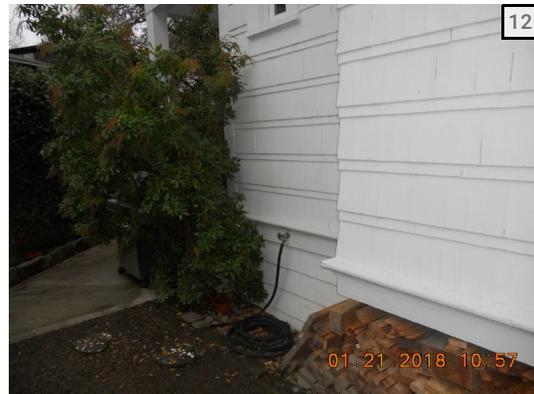
Vegetation too close and/or touching the siding

Location Exterior: Ground View
Impact Vegetation in contact with wall coverings prevents siding from drying out, and serves as a bridge for insects and small creatures.
Suggested Action Cutting vegetation back a foot is the general suggestion, but even 6" to 8" is a great start
Other Information Branches can scrape siding, compromising its strength. As the protective surface is worn away, scraping branches can cause the premature failure of paint, vinyl and aluminum. Trees and bushes can also push into siding, opening cracks where insects and other pests can gain ingress. • Lush greenery may prevent air circulation and evaporation, potentially leading to rot or mold. Bushes may trap moisture near the foundation, leading to damp, moldy basements. • Large dead branches can fall and rip away siding.

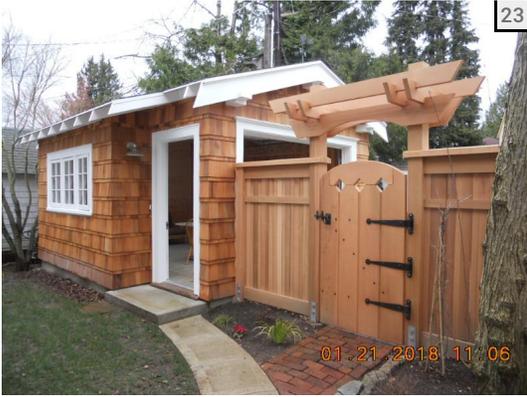
Tree branches are in contact with building

Location	Exterior: Ground View
Impact	The tree branches provide an environment where moisture and/or insects could intrude and also may cause damage or excess wear to the siding or roofing material
Suggested Action	Regularly trimm the trees to achieve a clearance of at least 6 - 8 feet

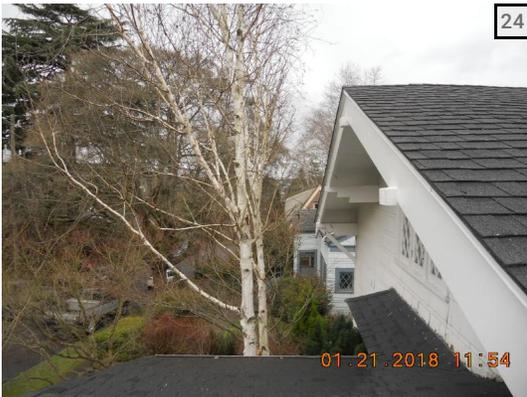
Organic growth noted

Location	Exterior: Ground View
Impact	Moss and organic growth gradually deteriorate mortar and concrete; they also may be a slipping hazard when wet.
Suggested Action	Recommend cleaning all patio surface with an organic growth inhibitor.

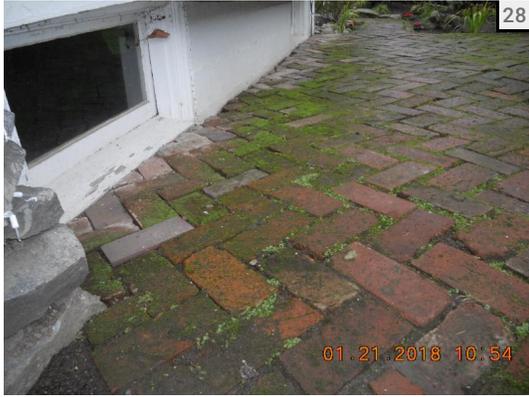
Brick patio/walkway near SE exterior wall slopes towards the house

Location	Exterior: Ground View
Impact	Accumulation of water and retention of moisture near the foundation increases the risk of moisture intrusion
Suggested Action	Monitor the area for moisture buildup. Should it repeatedly occur, and cause moisture buildup in the basement, re-grading the area may be necessary to achieve a slope away from the home

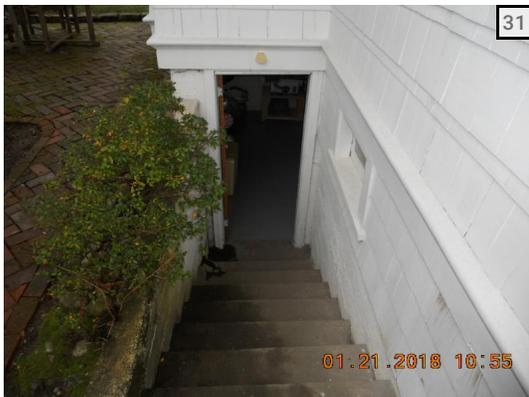
Impact Absence of a safe grasping element increases risk of fall injuries while traveling up or down the stairs

Suggested Action Install a handrail

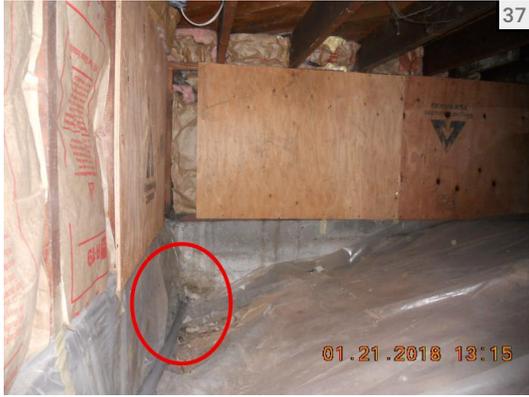
A penetration in the foundation wall for a water pipe not sealed.

Location Crawl Space
Impact Risk of water intrusion into the crawl space.
Suggested Action The penetration should be sealed with hydraulic cement available at most hardware stores.

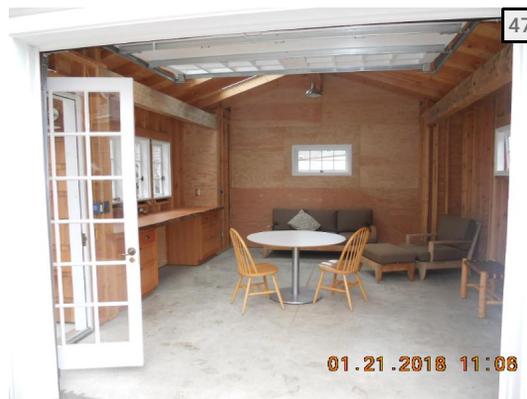
New slab, contains expansion joints. No deficiencies noted.

Location	Detached Garage
Impact	Expansions joint material will deteriorate over time and create a void which could become a location for insects to enter the home
Suggested Action	Monitor the expansion joint annually to ensure it is properly sealed. When caulking is necessary, use a weather-resistant expandable joint caulk

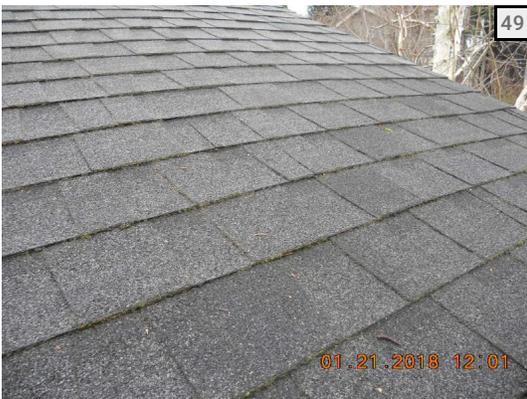
Minor moss build-up noted

Location	Exterior: Roof View
Impact	If not removed, the moss will grow under the shingles damaging the underlying sheathing
Suggested Action	Recommend gentle cleaning to remove moss/organic growth now and as needed.
Other Information	Moss grows in a shady or wet environment with specific PH levels. To remove the existing moss, use a roof cleaner targeted at moss growth to adjust the PH level below that which moss flourishes (e.g. Spray and Forget)

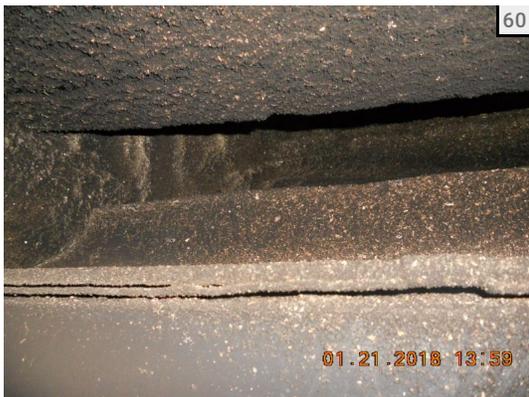
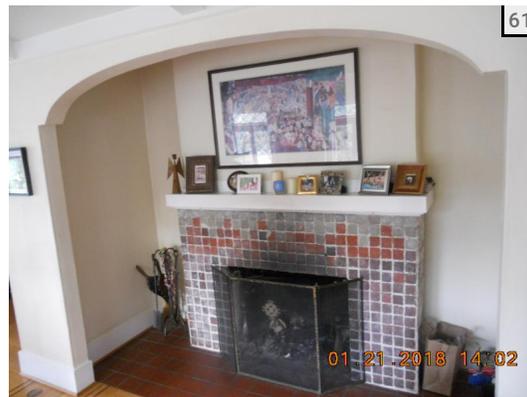
Flue has substantial creosote buildup

Location Living Room
Impact With too much creosote, the chimney could ignite
Suggested Action Have cleaned by a chimney sweep

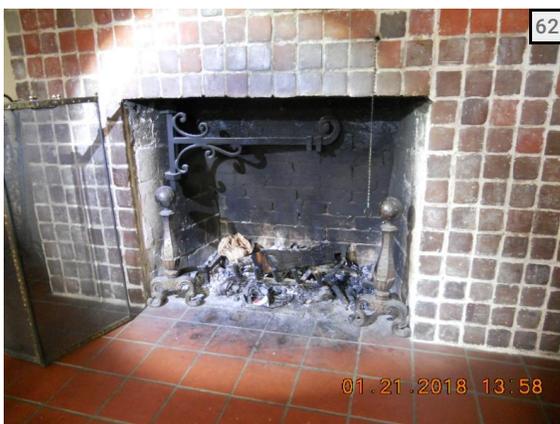
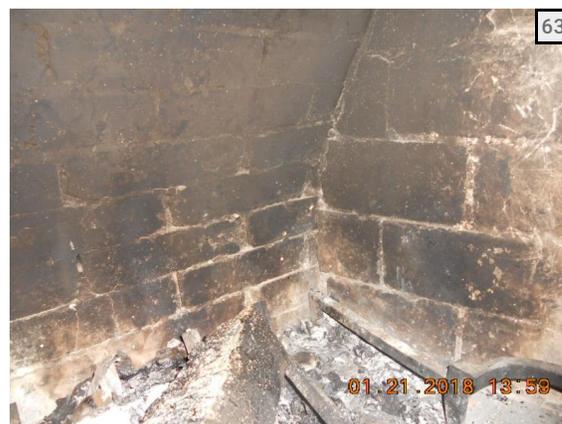
A limited fuelwood fireplace & chimney inspection was performed. Signs of normal usage/damage were noted in the fire chamber. We recommend: 1) complete chimney sweep 2) full fireplace cleaning and an NFPA Level 2 inspection by a qualified fireplace contractor

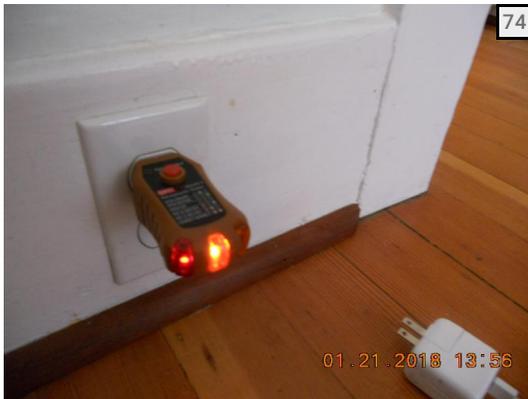
Reverse polarity at the outlet near the door

Location	Main Bedroom
Impact	Reversed polarity at outlets is a shock hazard, but it's usually an easy repair.
Suggested Action	Have this repaired by a licensed electrician

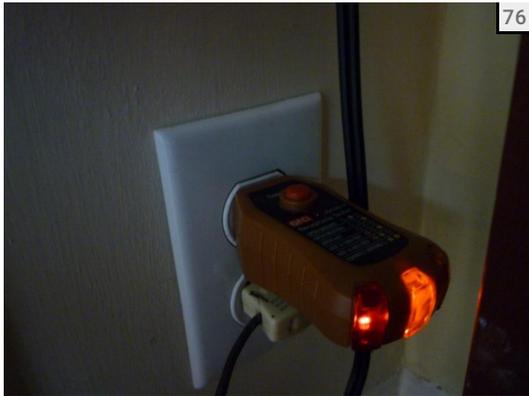
Reverse polarity in outlet under the printer table

Location	Office/Library
Impact	Reversed polarity at outlets is a shock hazard, but it's usually an easy repair
Suggested Action	Have this repaired by a licensed electrician

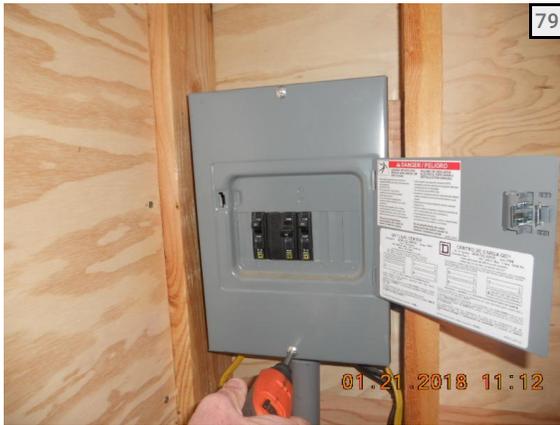
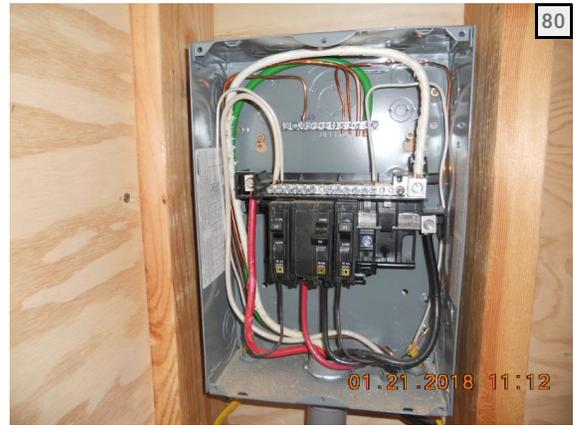
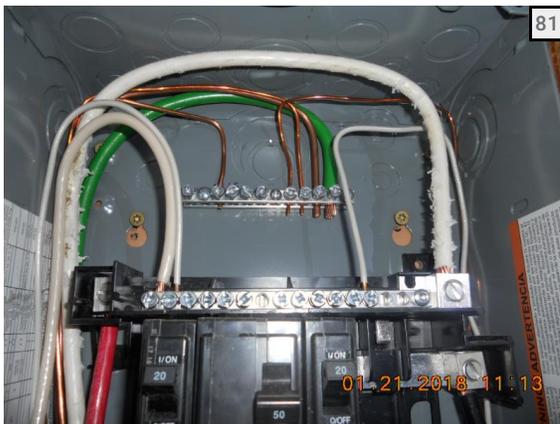
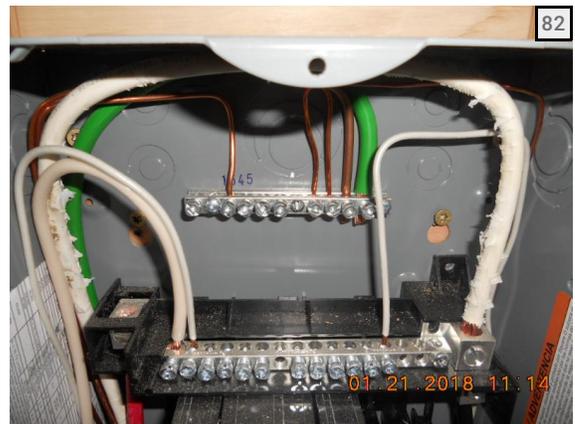
Location Detached Garage

No deficiencies noted

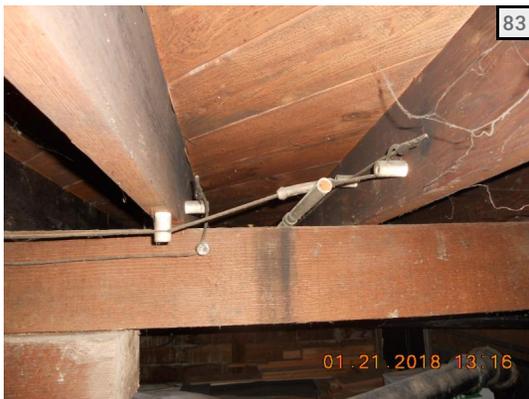
Location Crawl Space

Live knob and tube wire

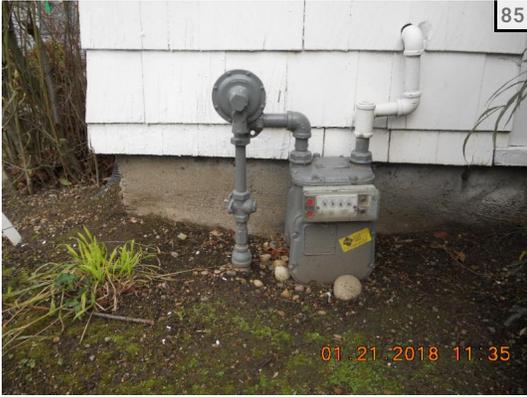
Bottom of the gas meter is in contact with soil

Location	Exterior: Ground View
Impact	If not corrected, the moisture in the soil may cause damage to the metal components of the gas meter
Suggested Action	Remove soil to create min 2" space between soil and gas meter

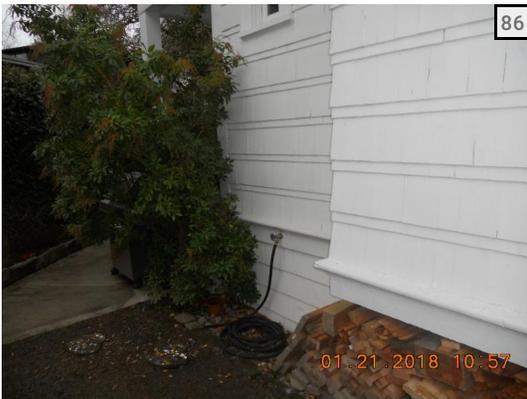
No anti siphon devices were observed.

Location	Exterior: Ground View
Impact	These backflow prevention devices are vacuum breakers that prevent contaminated water from entering the potable water system.

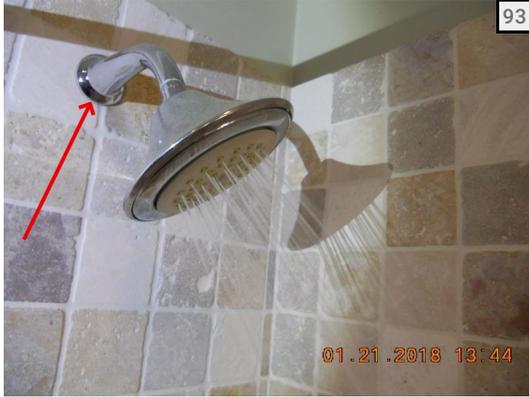
Shower head stem is not secured

Location Bathroom, main level, full
Impact The loose shower stem may allow water penetration behind the wall
Suggested Action Either install a shower stem collar with a set screw. If this does not hold, consider consulting a plumber for repair

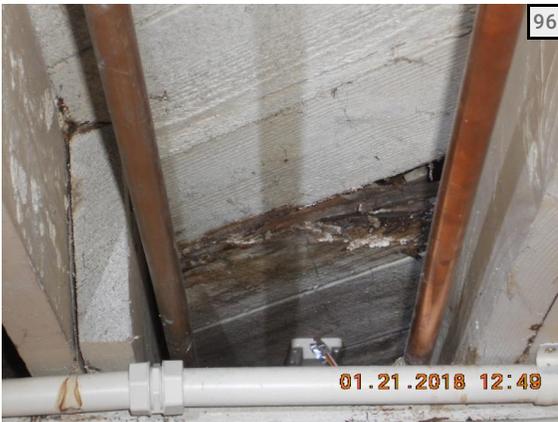
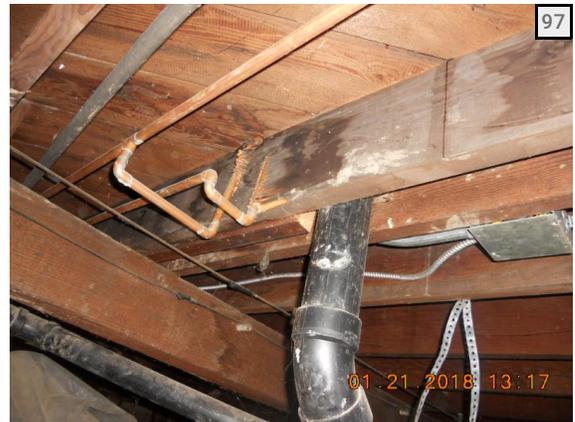
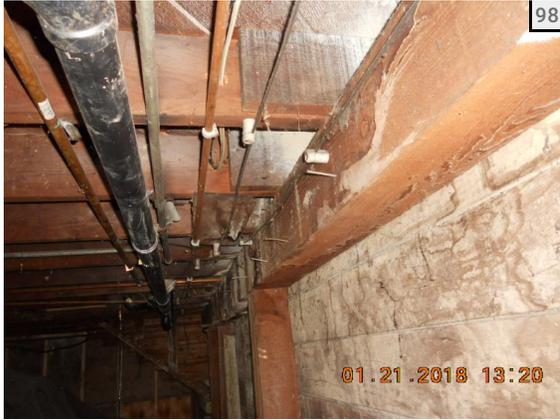
Water supply pipes are uninsulated

Location Basement, Crawl Space
Impact Significant thermal loss
Suggested Action Insulate the pipes

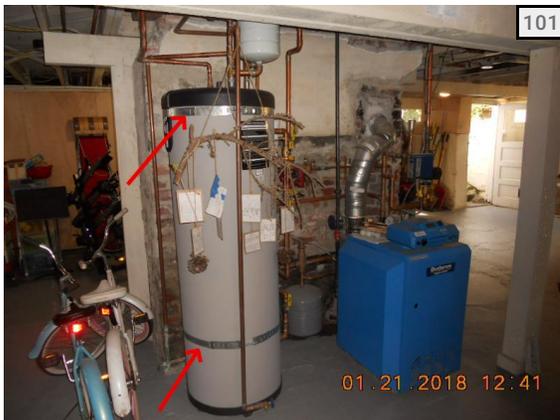
Proper seismic restraints for water heater tank were noted. These restraints were properly spaced and properly strapped to the wall

Location Basement

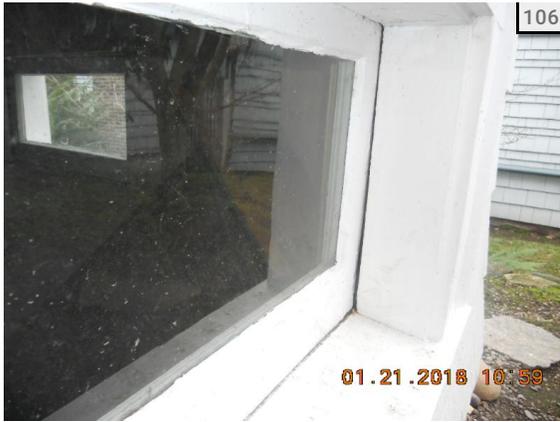
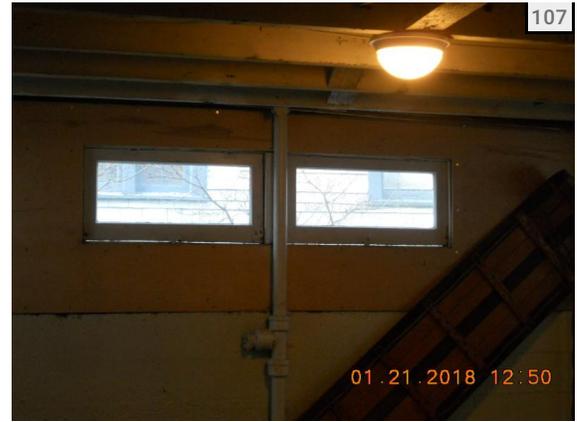
Passive ventilation in the basement is provided through gaps between windows and window frames. This also contributes to heat loss during cold periods of the year.

Location Exterior: Ground View

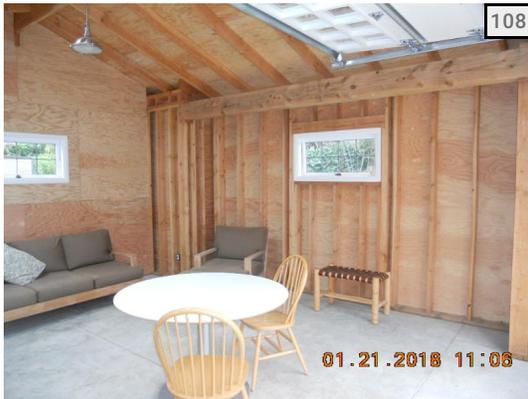
Not present

Location Detached Garage

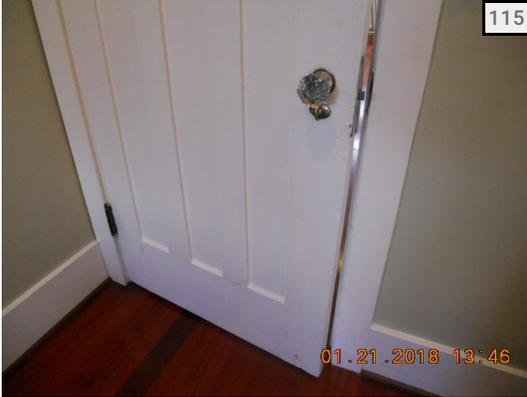
Hardware needs adjustment

Location	Bathroom, main level, full, Bathroom, upper level, 3/4
Suggested Action	Repair/replace hardware

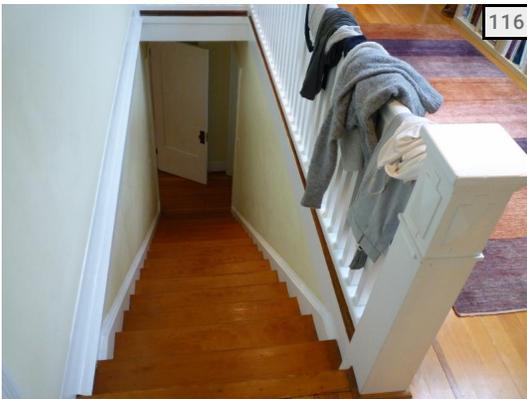
Handrail is missing

Location	Hallway and Stairs
Impact	A missing handrail could hinder the stair user an opportunity to stop or reduce the extent of a fall
Suggested Action	Install a handrail

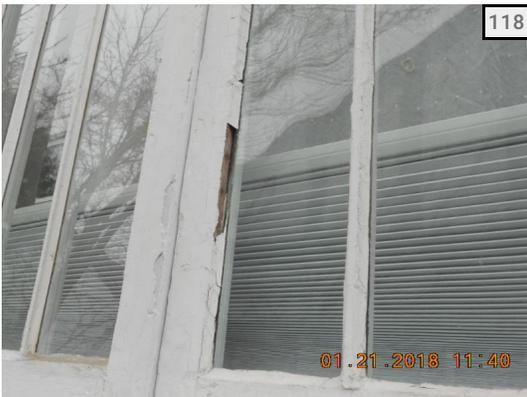
The window glazing putty should be checked and repaired as needed.

Location Exterior: Ground View

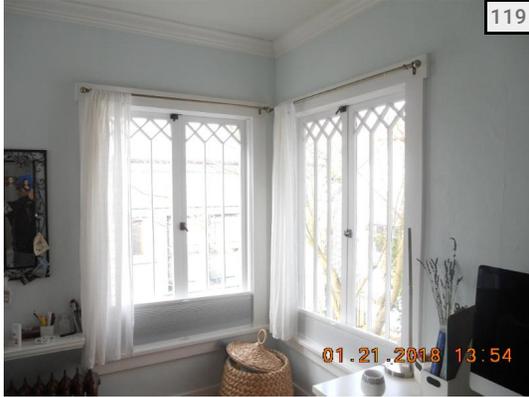
In need of adjustment and weatherstripping

Location Basement, Bedroom, NE side, Main Bedroom
Impact Thermal loss, easy access for insects
Suggested Action Install weatherstrip

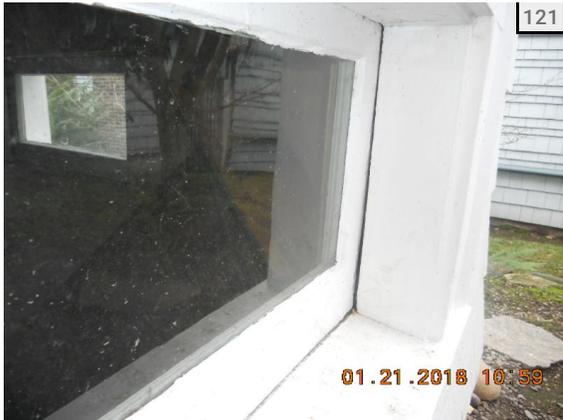
This old house would benefit from having weatherstrip seals installed at all windows.

Location Exterior: Ground View
Impact Heat loss
