“Can Tilting Pad Bearings Whirl?”

Talmadge D. Ward Jr.
Duke Energy Florida

Piedmont Chapter Vibration Institute Meeting
May 17, 2019 - Lake Junaluska N.C.

Intermittent Fluid Film Instability was observed on a GE 7A6 80 MW generator with tilting pad bearings which caused high vibration and sub-synchronous frequencies. Direct shaft vibration as measured by proximeter probes was above 10 mils. Cause was determined to be a combination of excessing bearing clearance, excessive pad pre-load and misalignment.

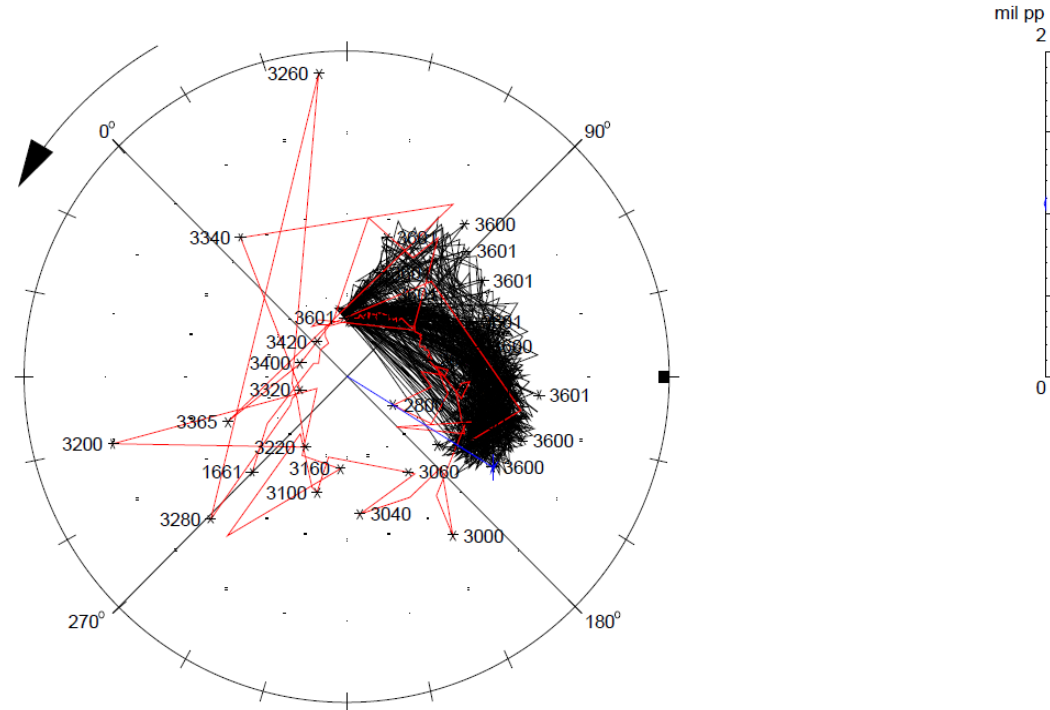
POINT: 5 GEN BRG #1A $\angle 45^\circ$ Left 1X UNCOMP
MACHINE: 5 GEN BRG #1A
From 15FEB2016 15:14:51.1 To 15FEB2016 16:05:22.2 Startup

1.06 $\angle 167^\circ$ @3600 rpm

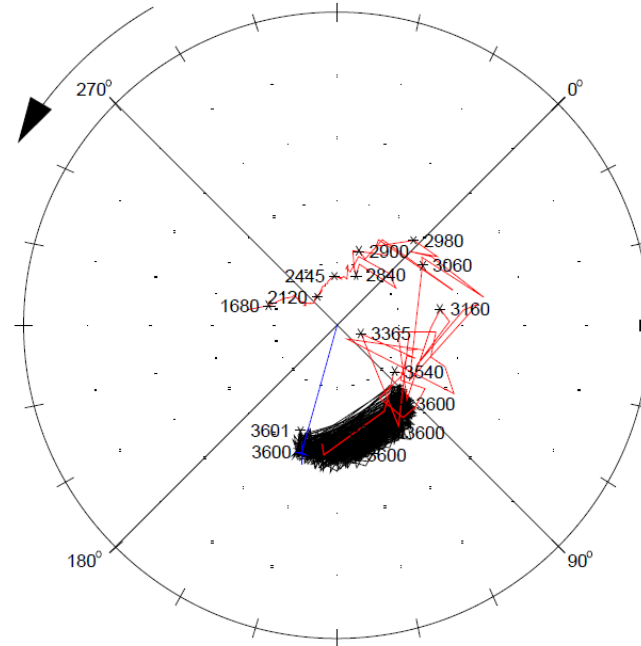
POINT: 6 GEN BRG #1B $\angle 45^\circ$ Right 1X UNCOMP
MACHINE: 6 GEN BRG #1B
From 15FEB2016 15:14:51.1 To 15FEB2016 16:05:22.2 Startup

2.10 $\angle 151^\circ$ @3600 rpm

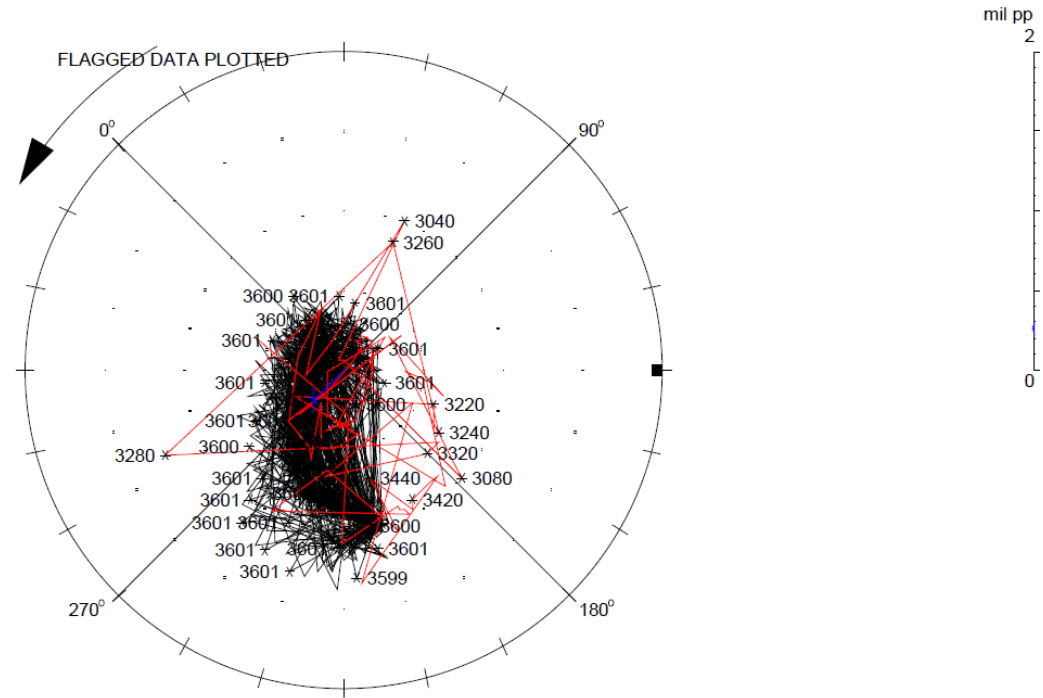
POINT: 7 GEN BRG #2A $\angle 45^\circ$ Left 1X UNCOMP
MACHINE: 7 GEN BRG #2A
From 15FEB2016 15:14:51.1 To 15FEB2016 16:05:22.2 Startup

0.267 $\angle 270^\circ$ @3600 rpm

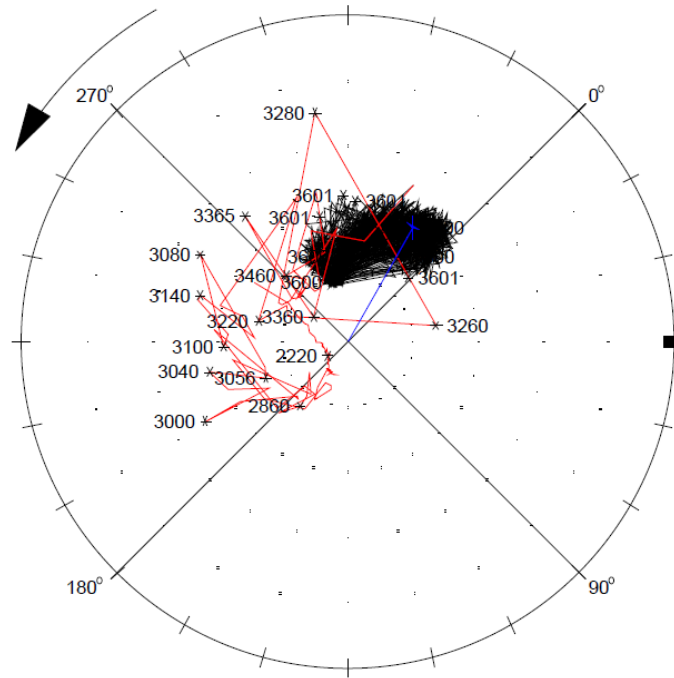
POINT: 8 GEN BRG #2B $\angle 45^\circ$ Right 1X UNCOMP
MACHINE: 8 GEN BRG #2B
From 15FEB2016 15:14:51.1 To 15FEB2016 16:05:22.2 Startup

2.00/ $\angle 345^\circ$ @3600 rpm
