ELECTRIC MOTORS

OPERATION AND VIBRATION CASE HISTORIES

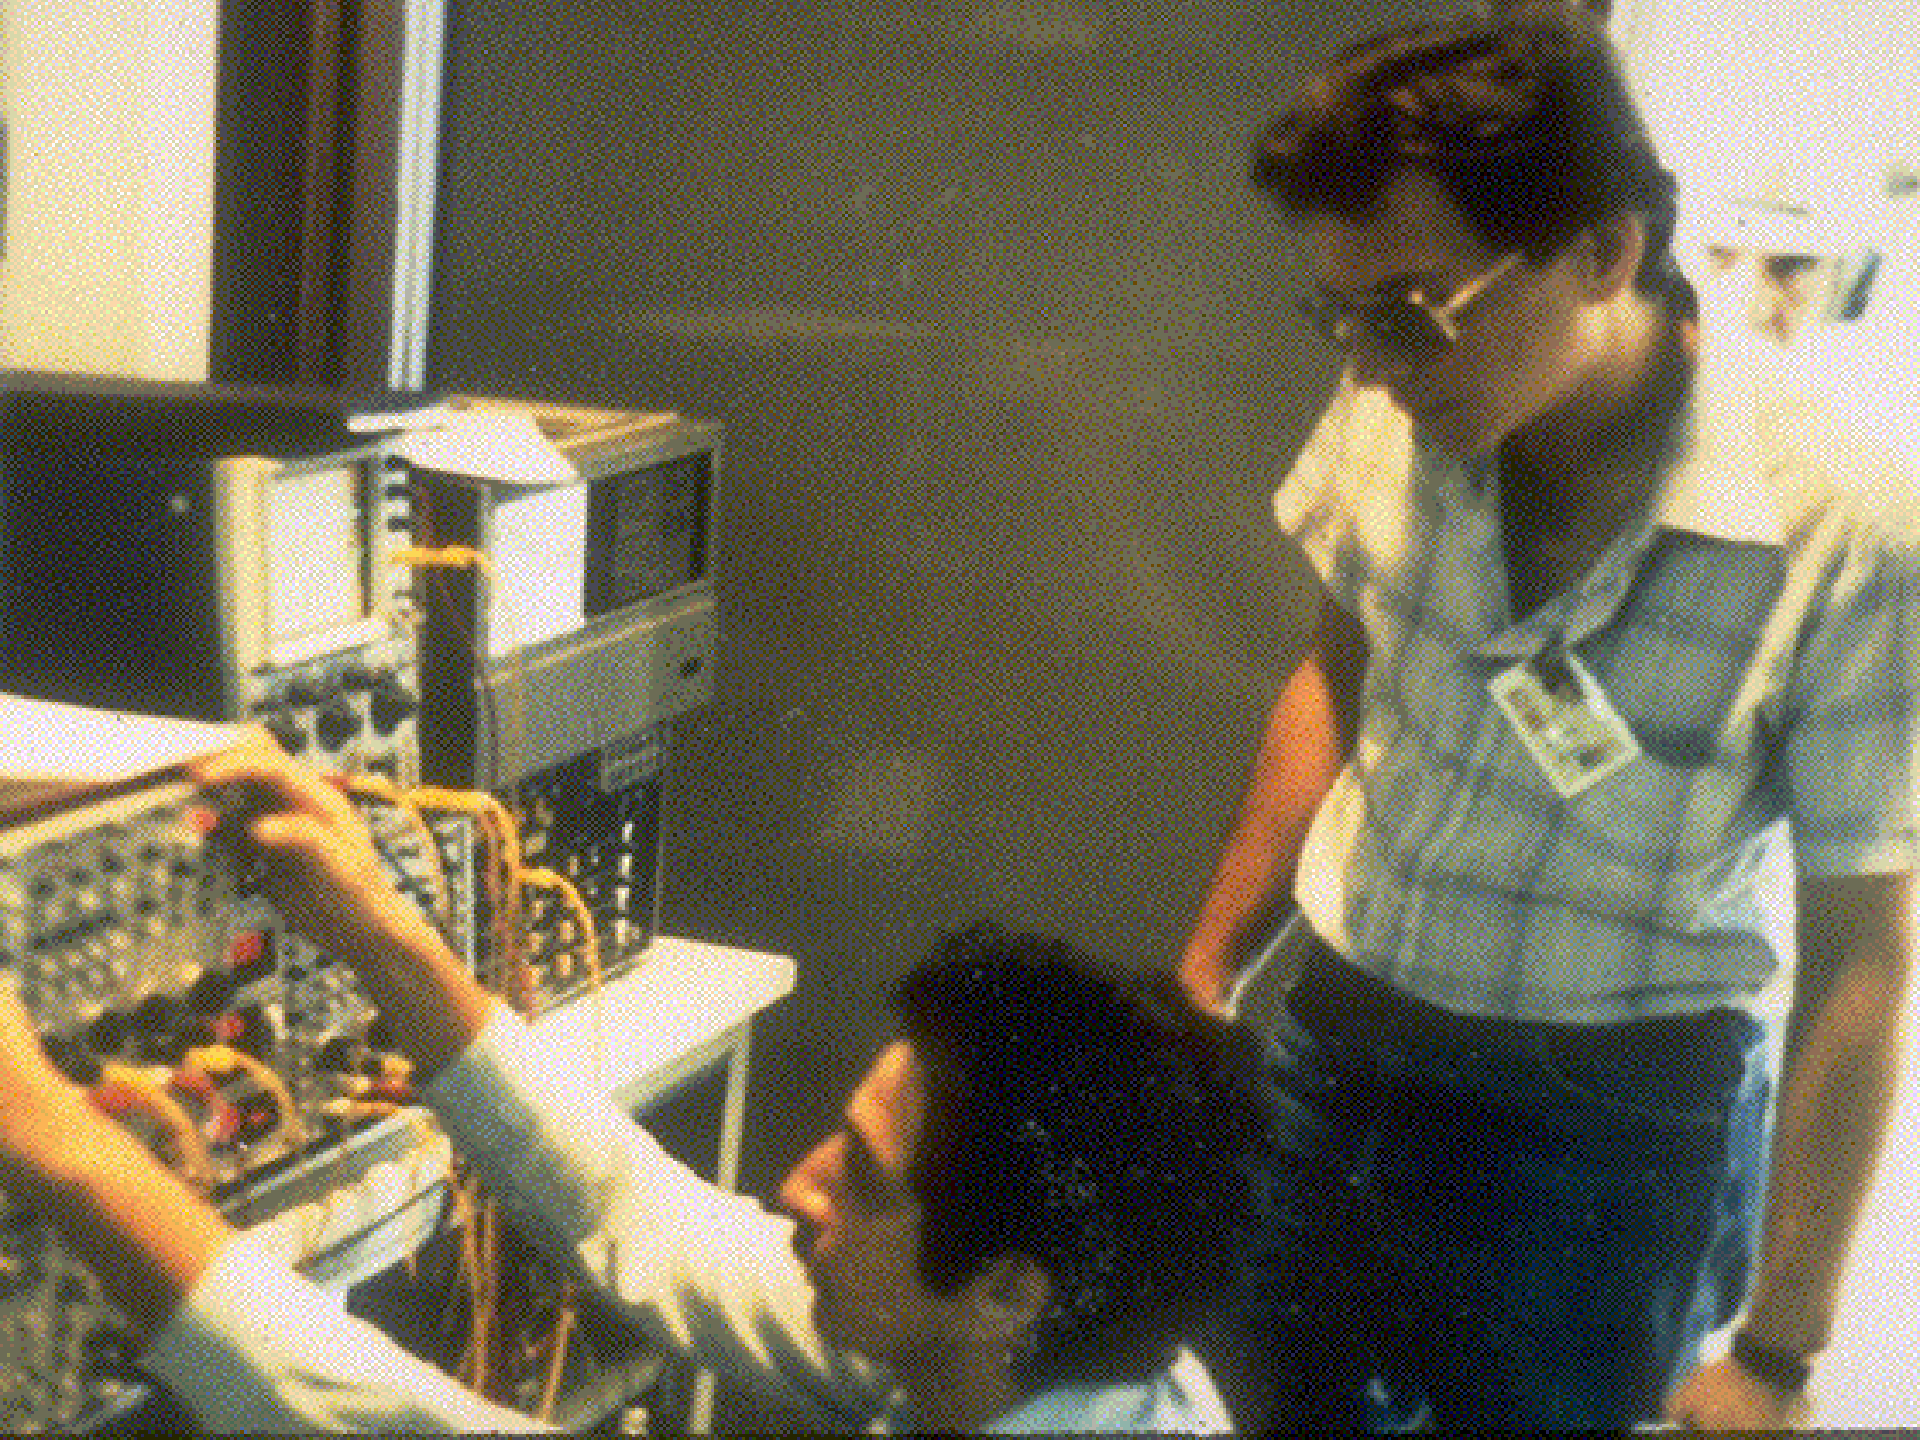
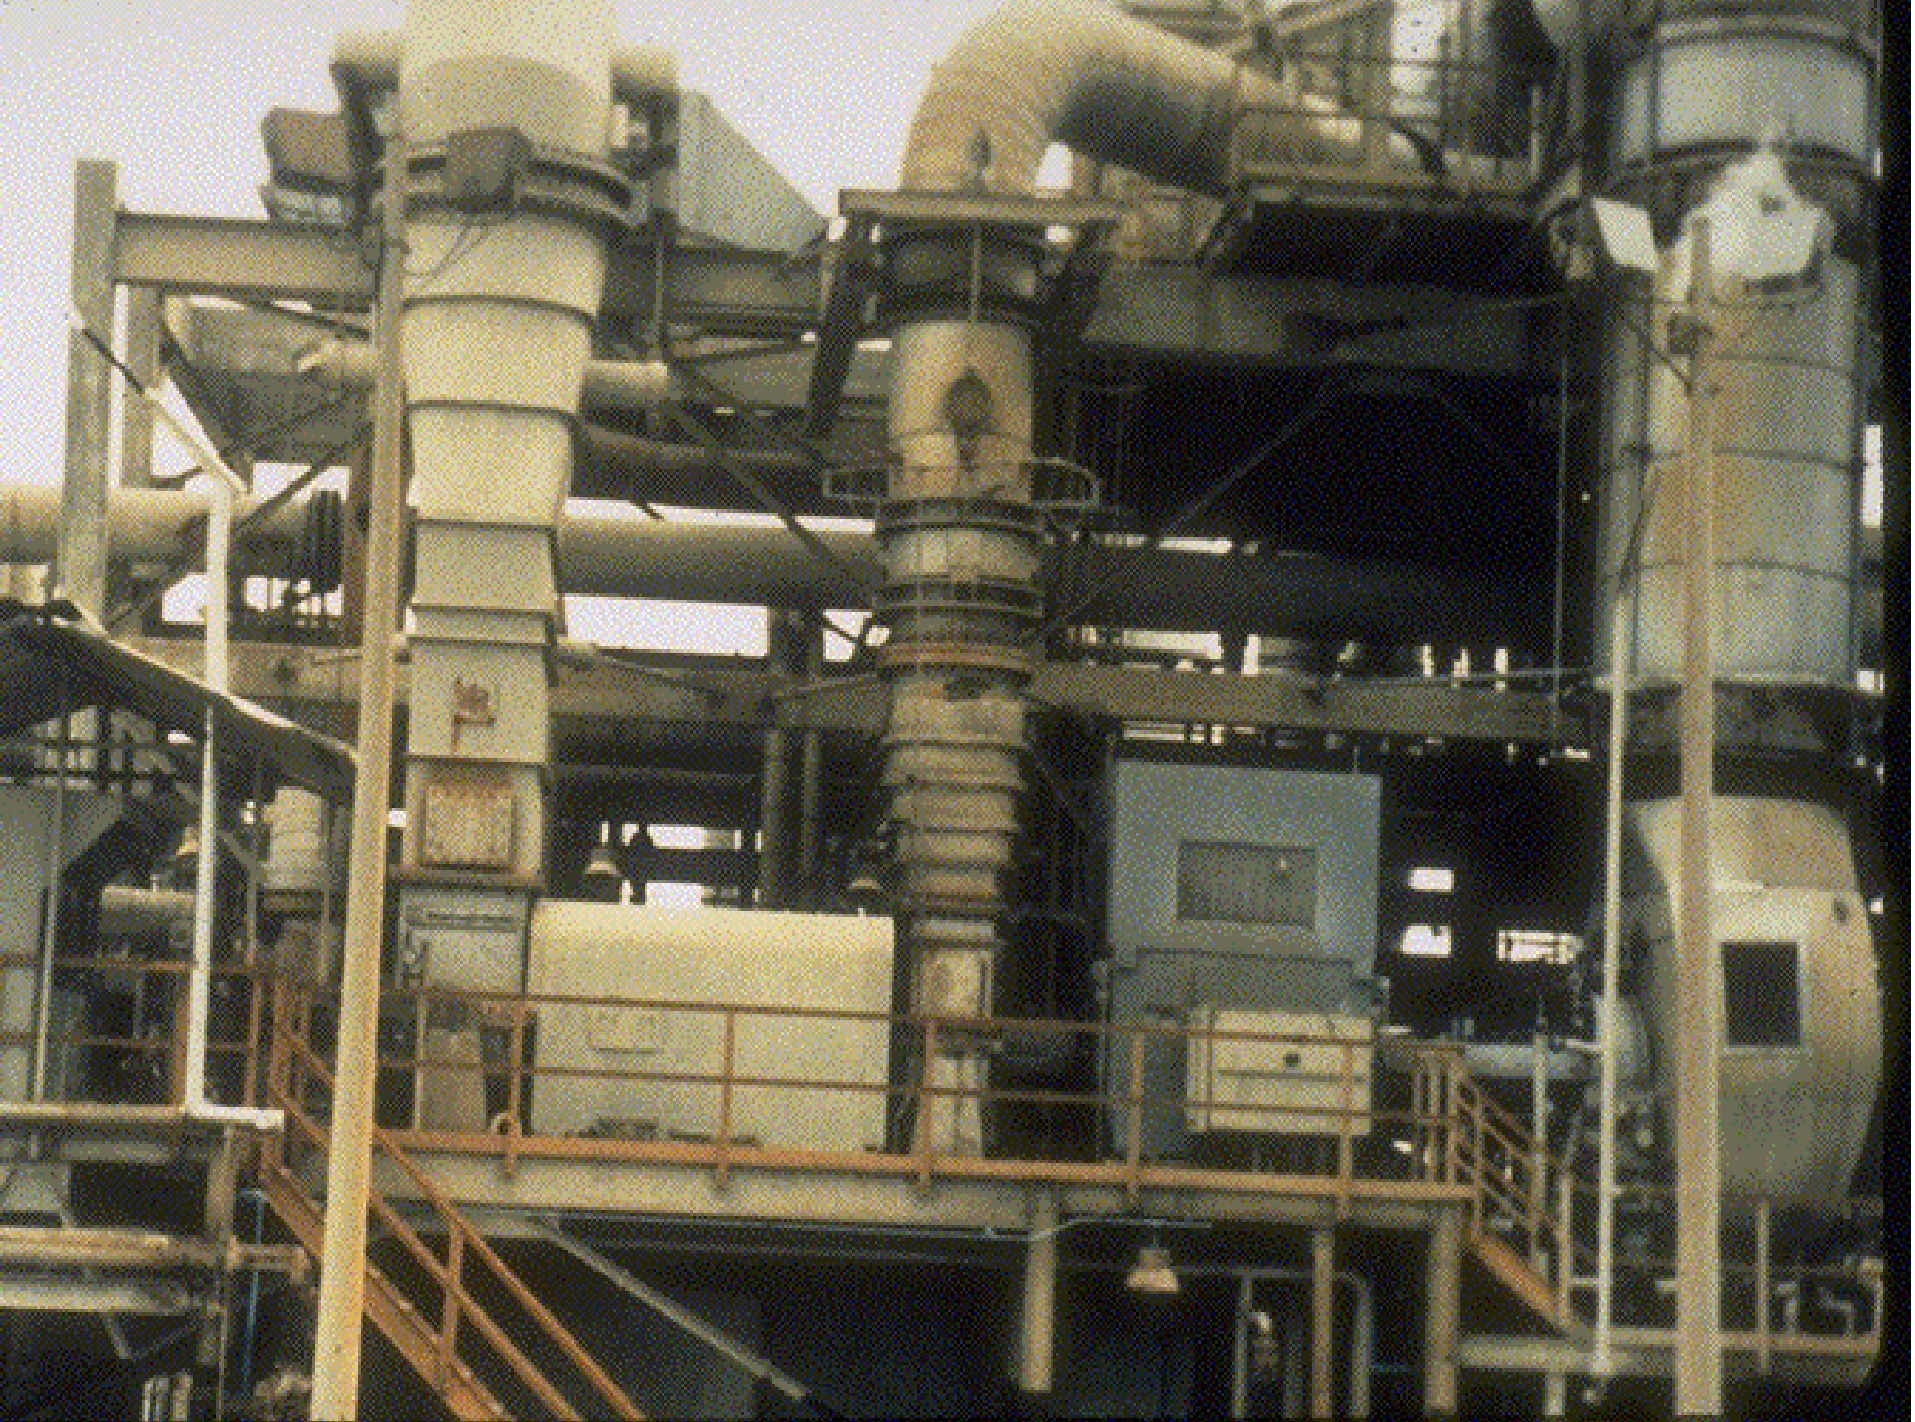
Case 1- LARGE MOTOR IN VENEZUELA WITH THERMAL LOAD BASED UNBALANCE SENSITIVITY

- RECEIVED CALL THAT STATED “ THE MOTOR IT DOES NOT RUN ANY GOOD ANY MORE SINCE WE BALANCED IT”

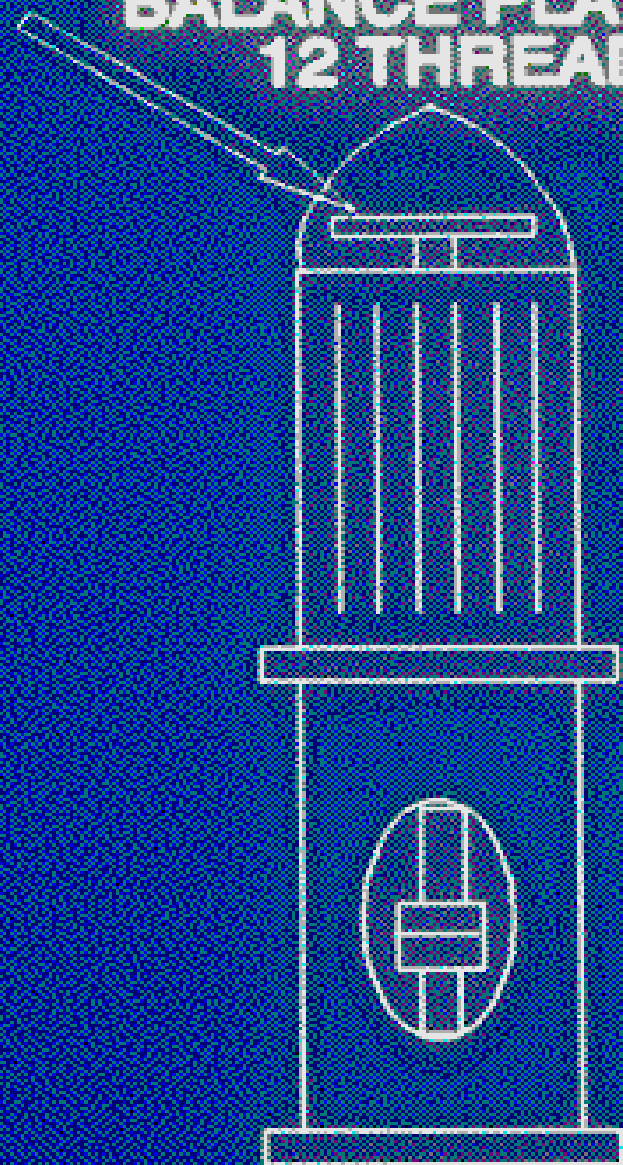
**BALANCE PLATE WHICH CONTAINS
12 THREADED HOLES**

VERTICAL PUMPS WITH HIGH MOTOR VIBRATION

**IF PUMP IS KNOWN TO BE IN
GOOD CONDITION AND
RESONANCE HAS BEEN
ELIMINATED AS A POSSIBILITY
THEN INSTALLATION OF A
BALANCE PLATE ON THE
MOTOR HAS PROVEN TO BE
A VERY EFFECTIVE METHOD
OF ELIMINATING RUNNING
SPEED VIBRATION.**

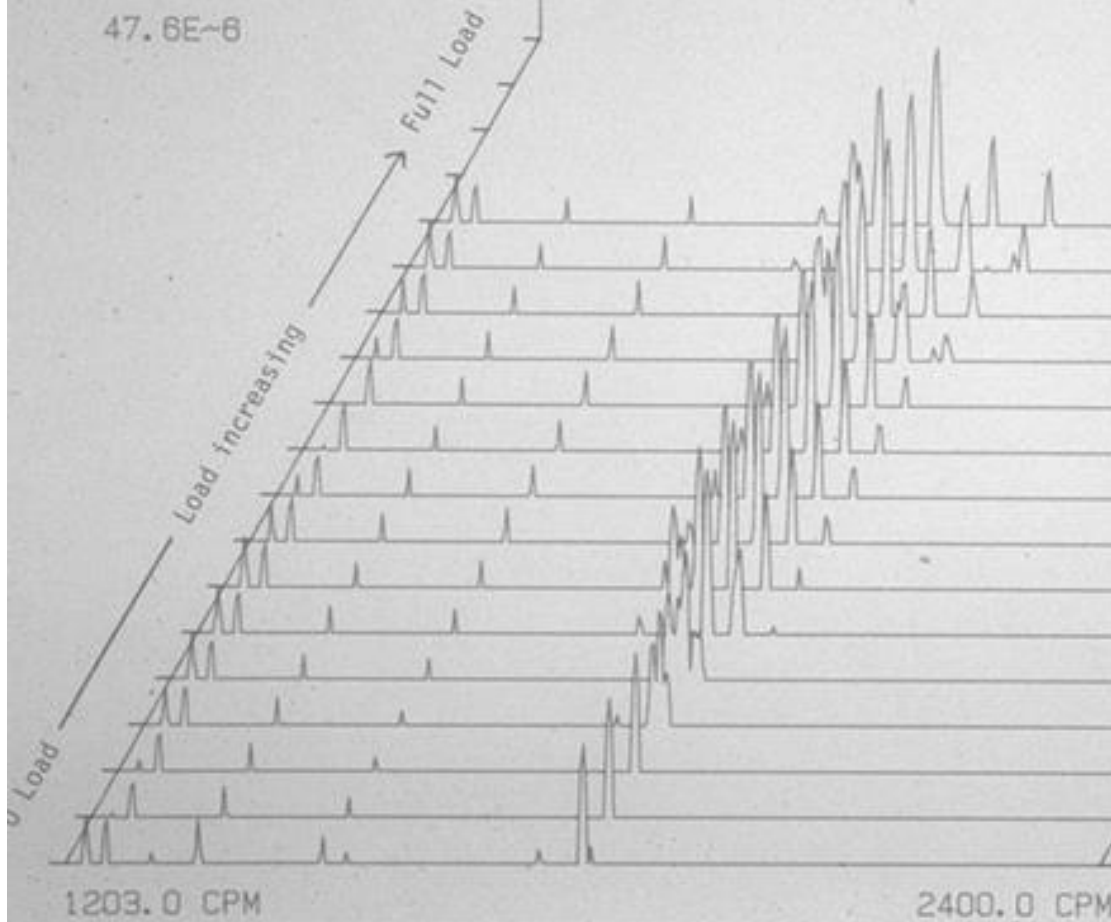
Vibration Spectra. In some cases, the no. poles X slip modulation will also show up in the vibration spectra.

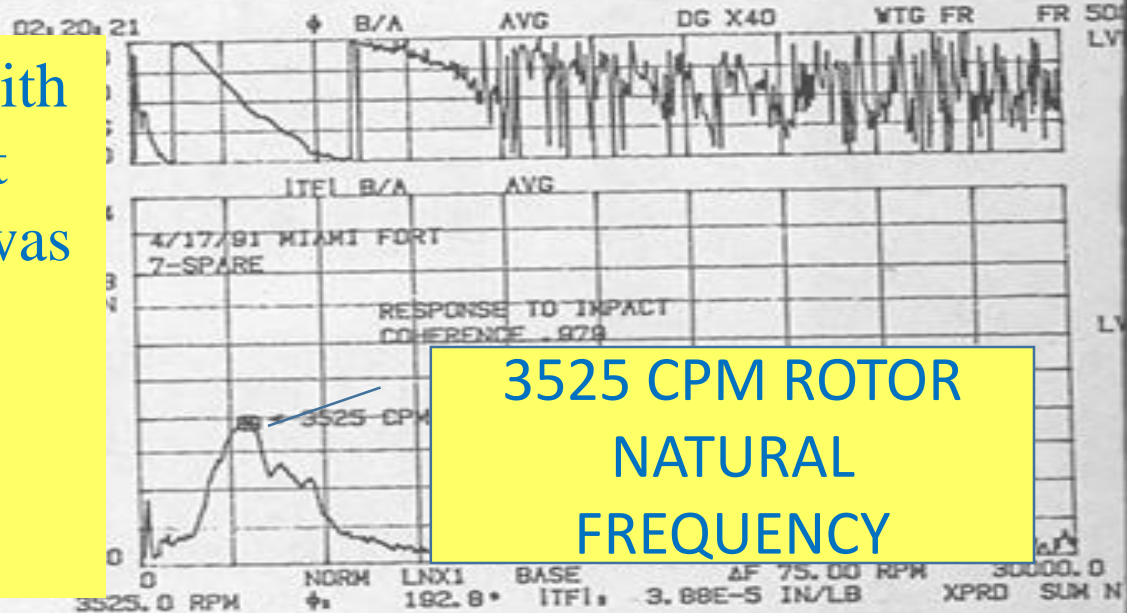
An accelerometer with a long cable was put on the rotor which was slowly turned to get shaft up on oil film while an impact test was performed.

What caused this problem to occur

- Motor had originally had an aluminum cast rotor
- Owner decided to have someone build a copper bar steel lamination rotor.
- The change in mass resulted in pulling the rotor natural frequency down close to the operating speed.
- This caused the rotor to bow introducing rotating eccentricity.
- The rotating narrow air gap then interacted with the rotating stator's magnetic field. The interaction rate just like a broken rotor bar is no. poles times slip. This causes the vibration to modulate, but has no effect on current flow.
- By doing a precision field balance, the amount of rotor bow was reduced and the modulation was significantly lower.

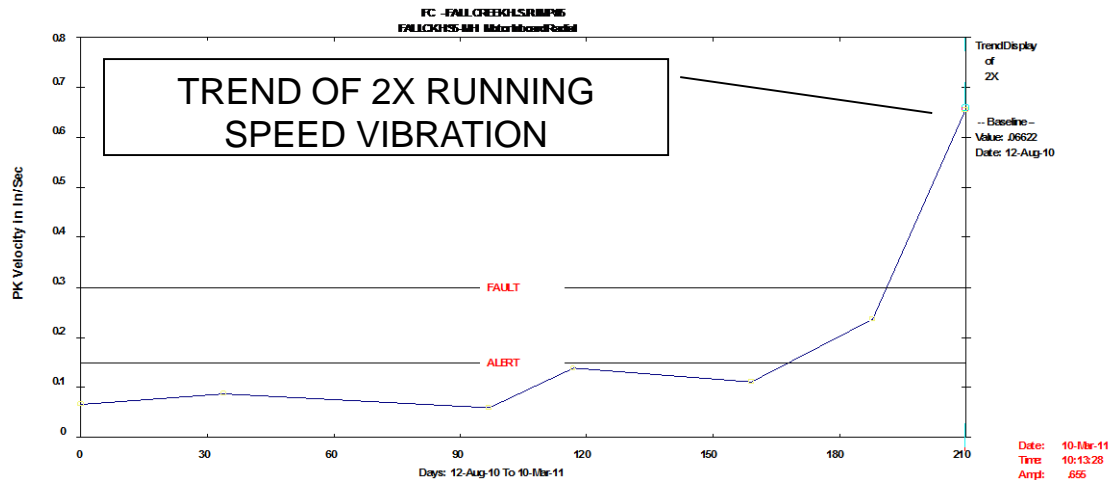
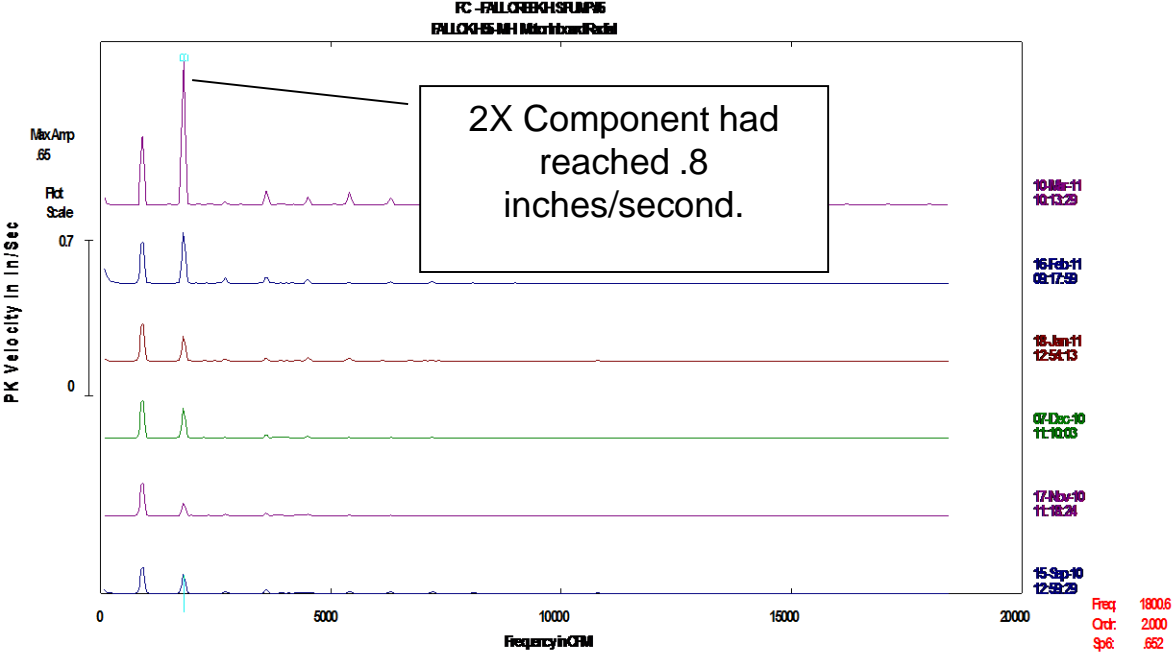
Spectral History

Mystery High 2X

- Vibration had been trending up. Most of the vibration was at 2X running speed.

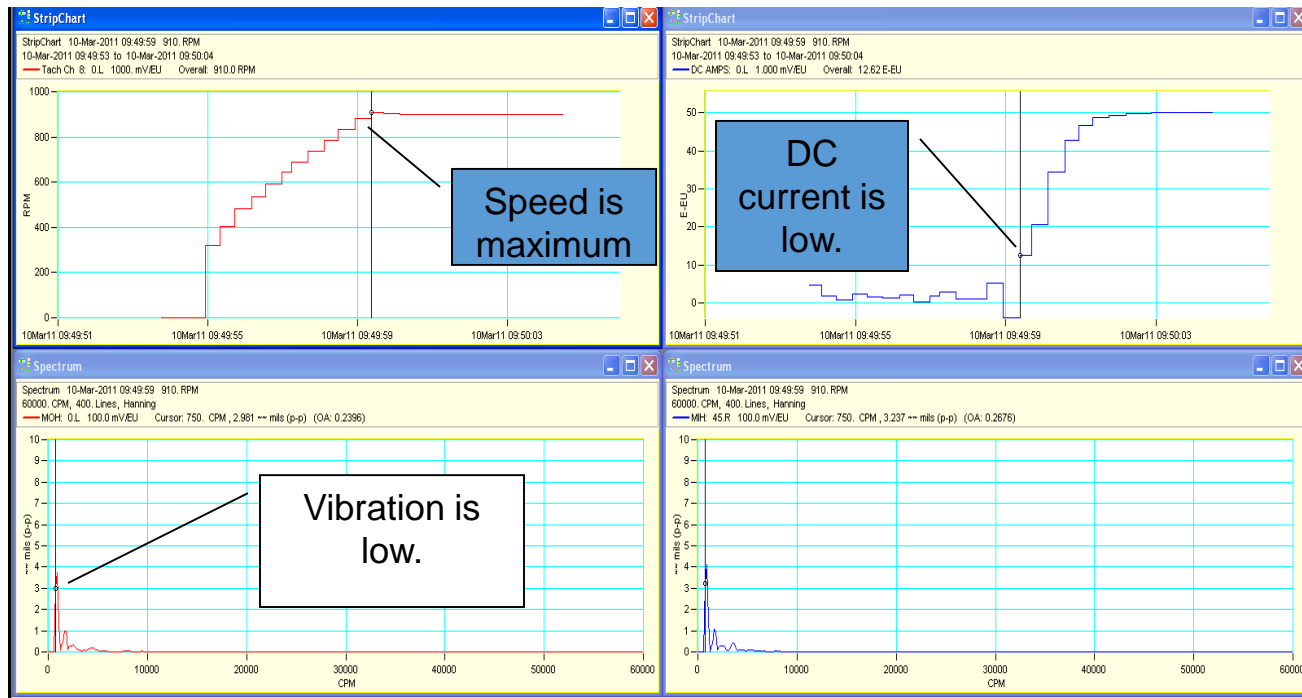
Test Results- At full speed, initially there was not problem.

DC CURRENT IS APPLIED .4 seconds later high vibration

Problem was a shorted field coil that caused uneven magnetic field.

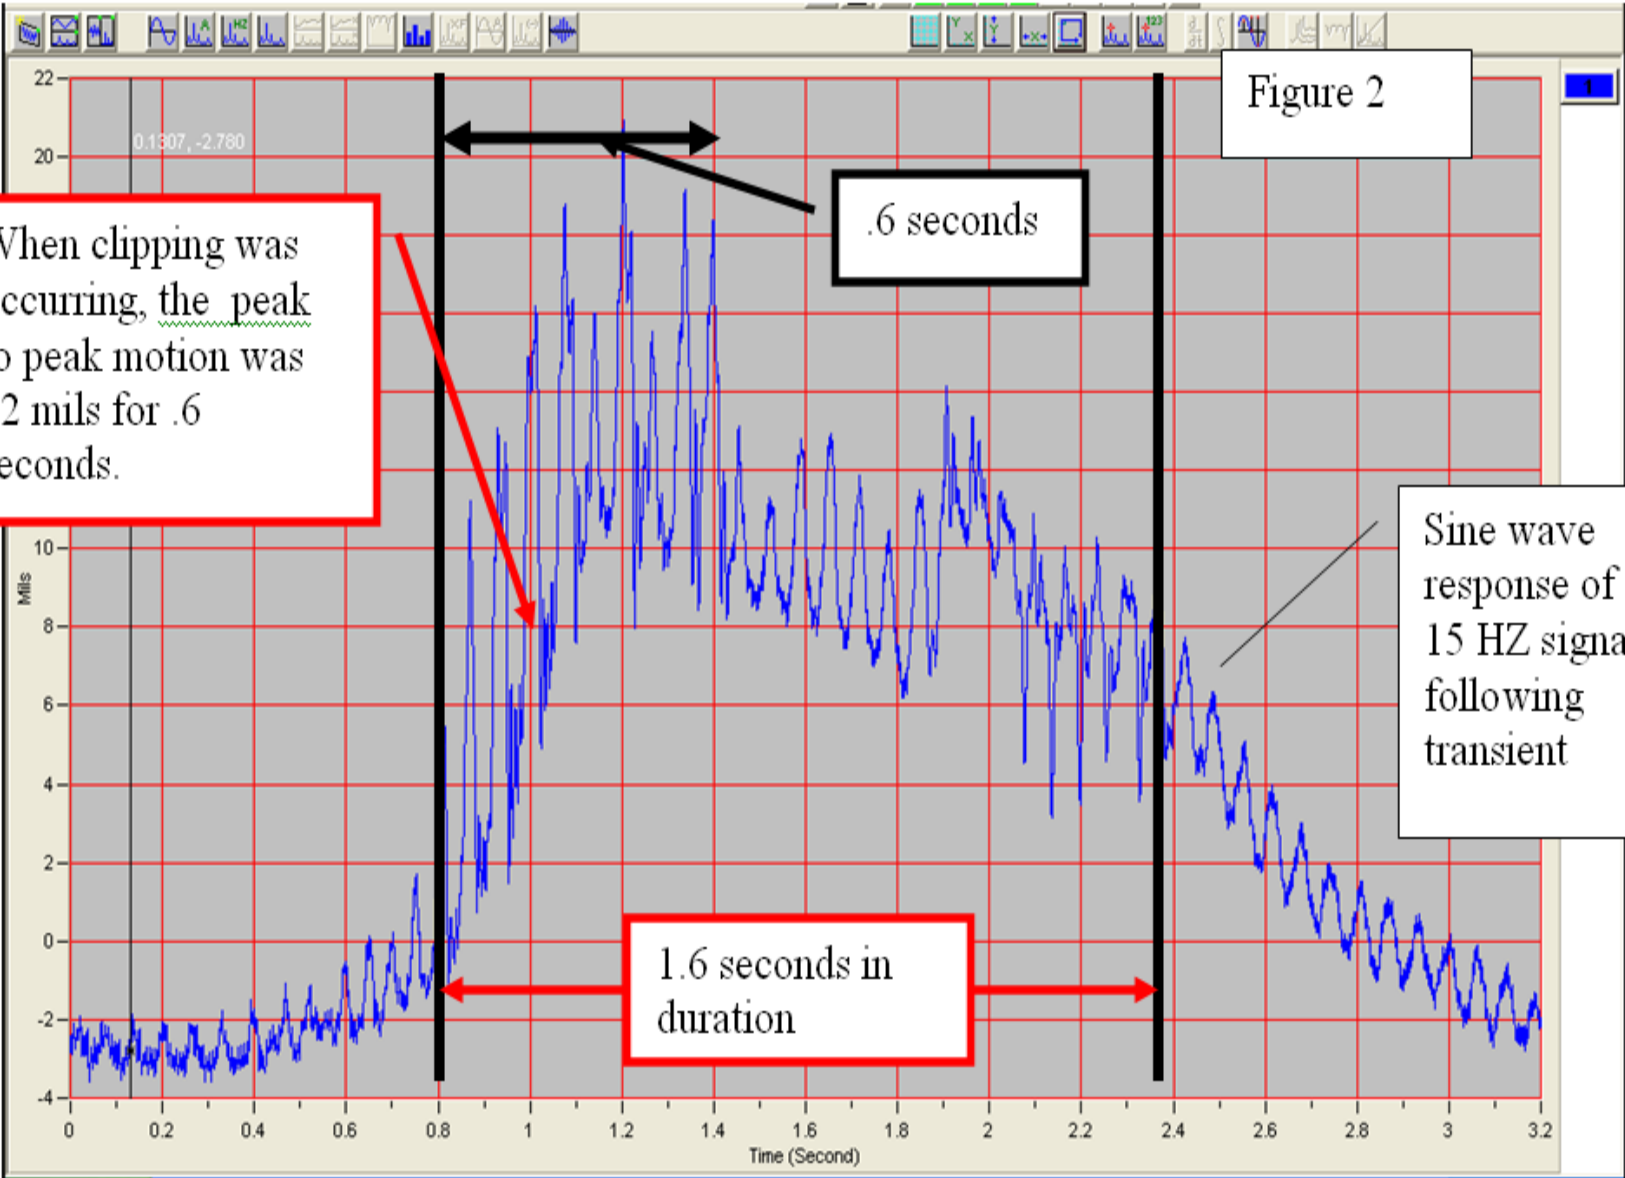
Vibration just prior to synchronization

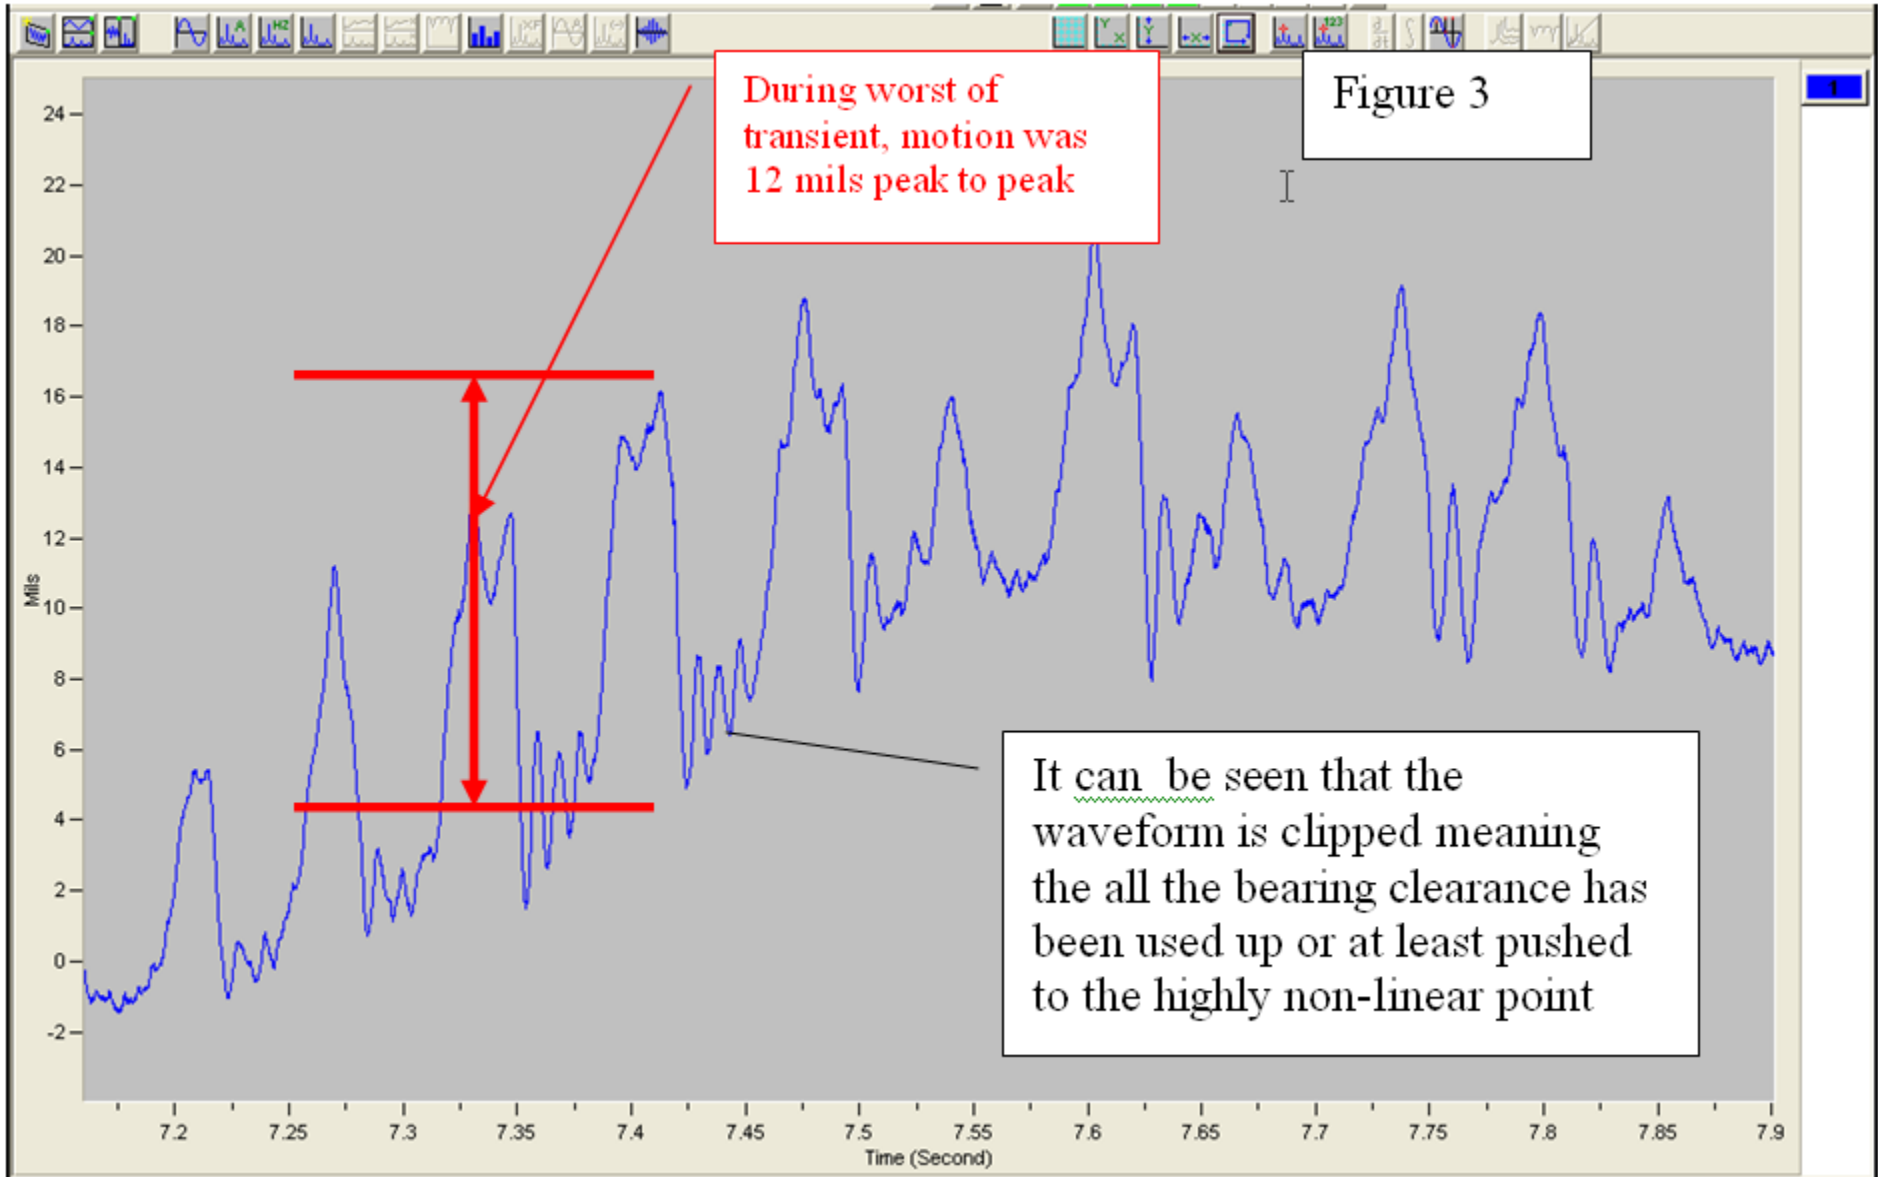
At Synchronization 900 CPM is still ringing down

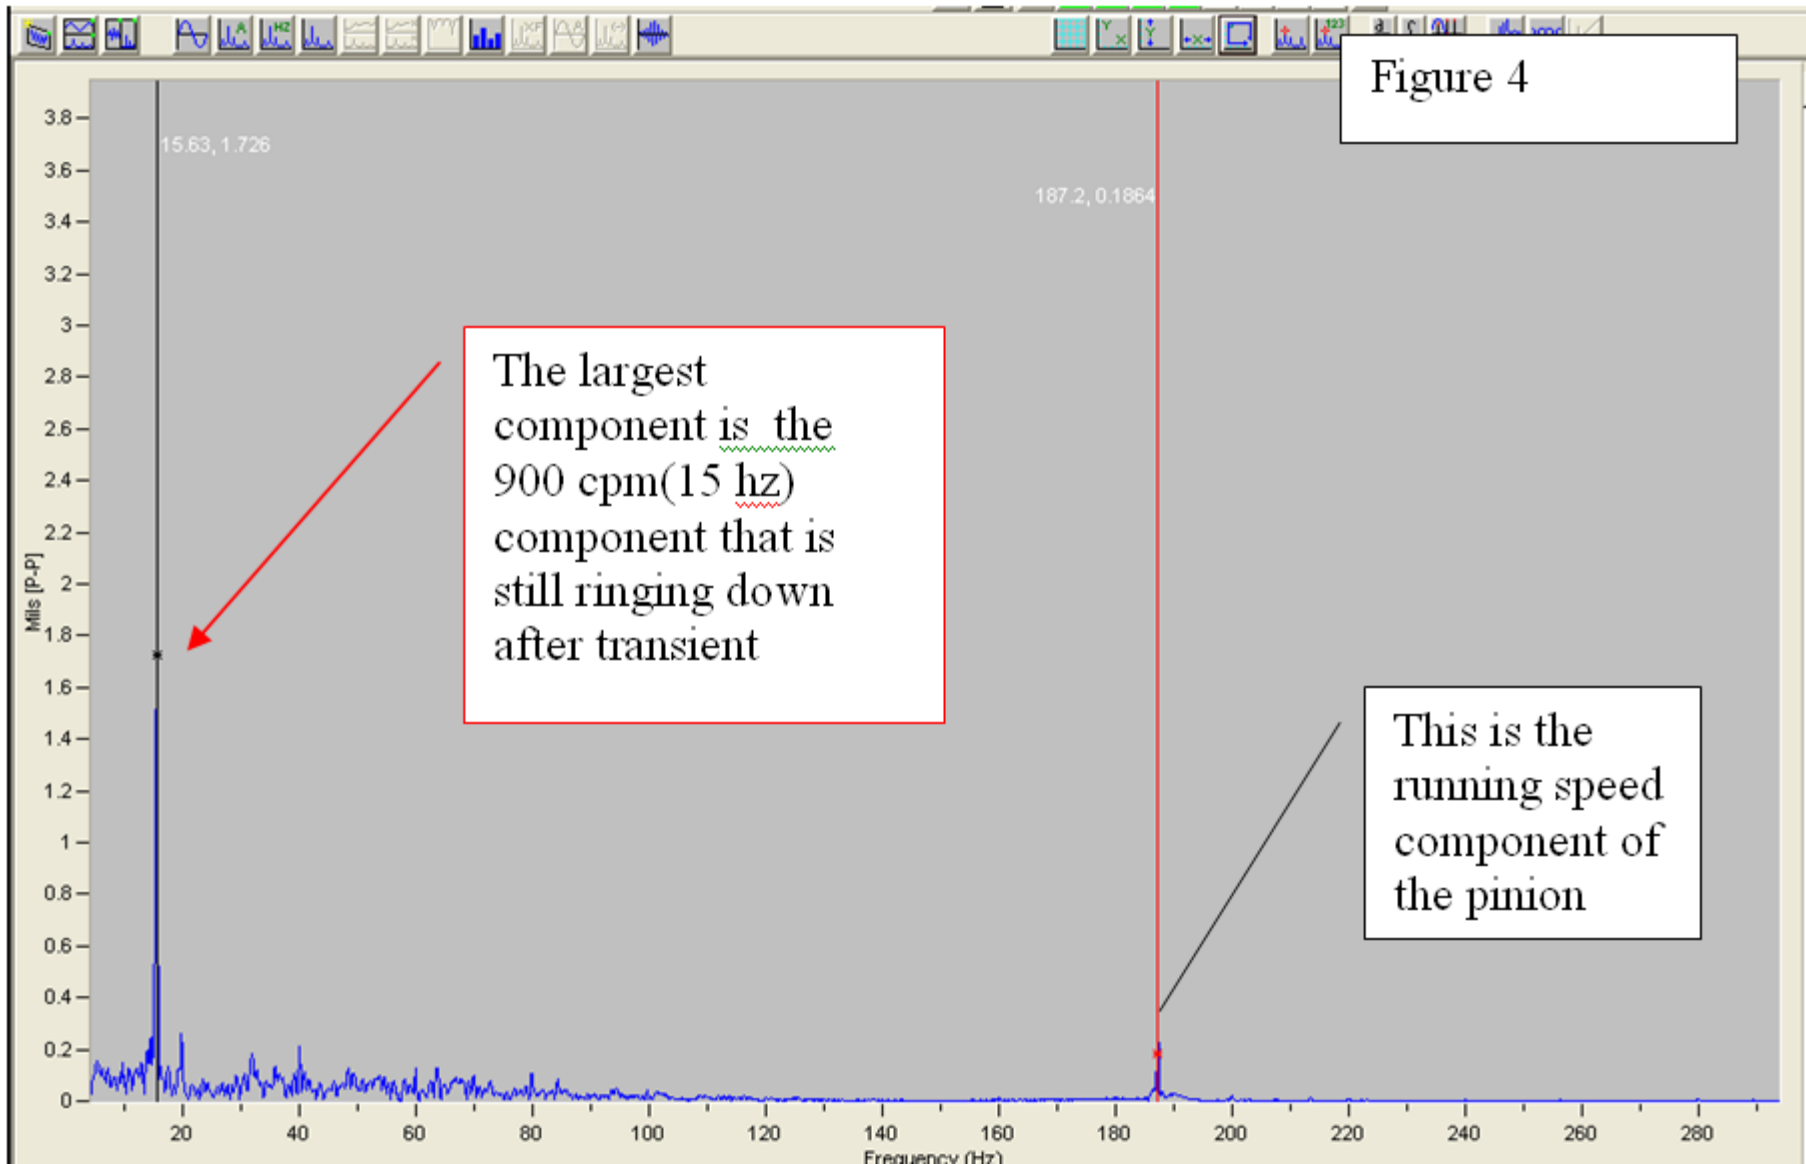
Coupling was badly worn. When it was replaced response dropped significantly. The 915 cpm component was still present, but at much lower levels.

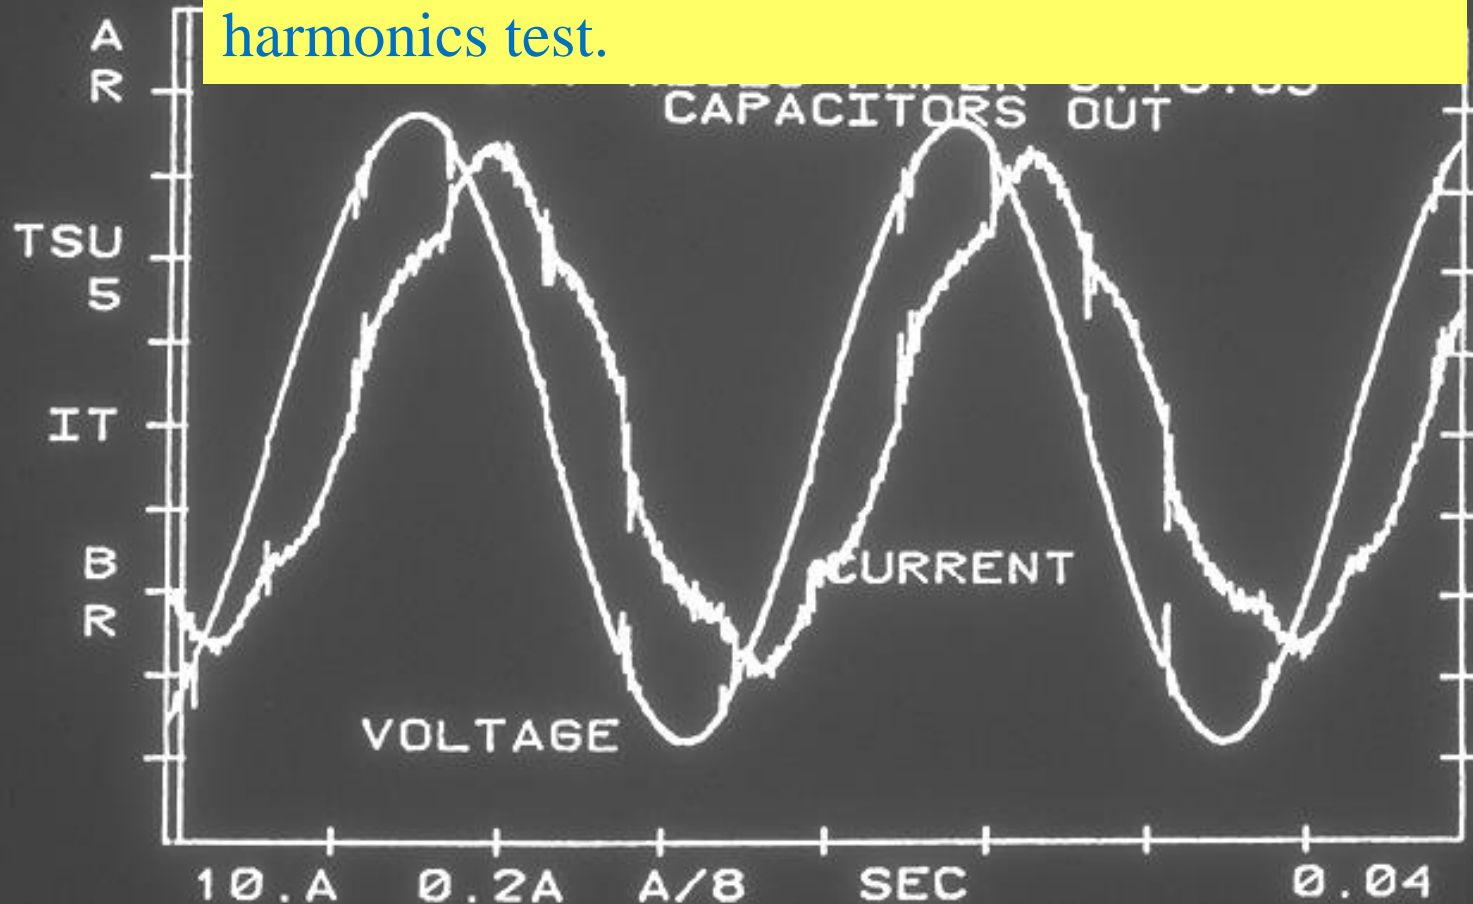
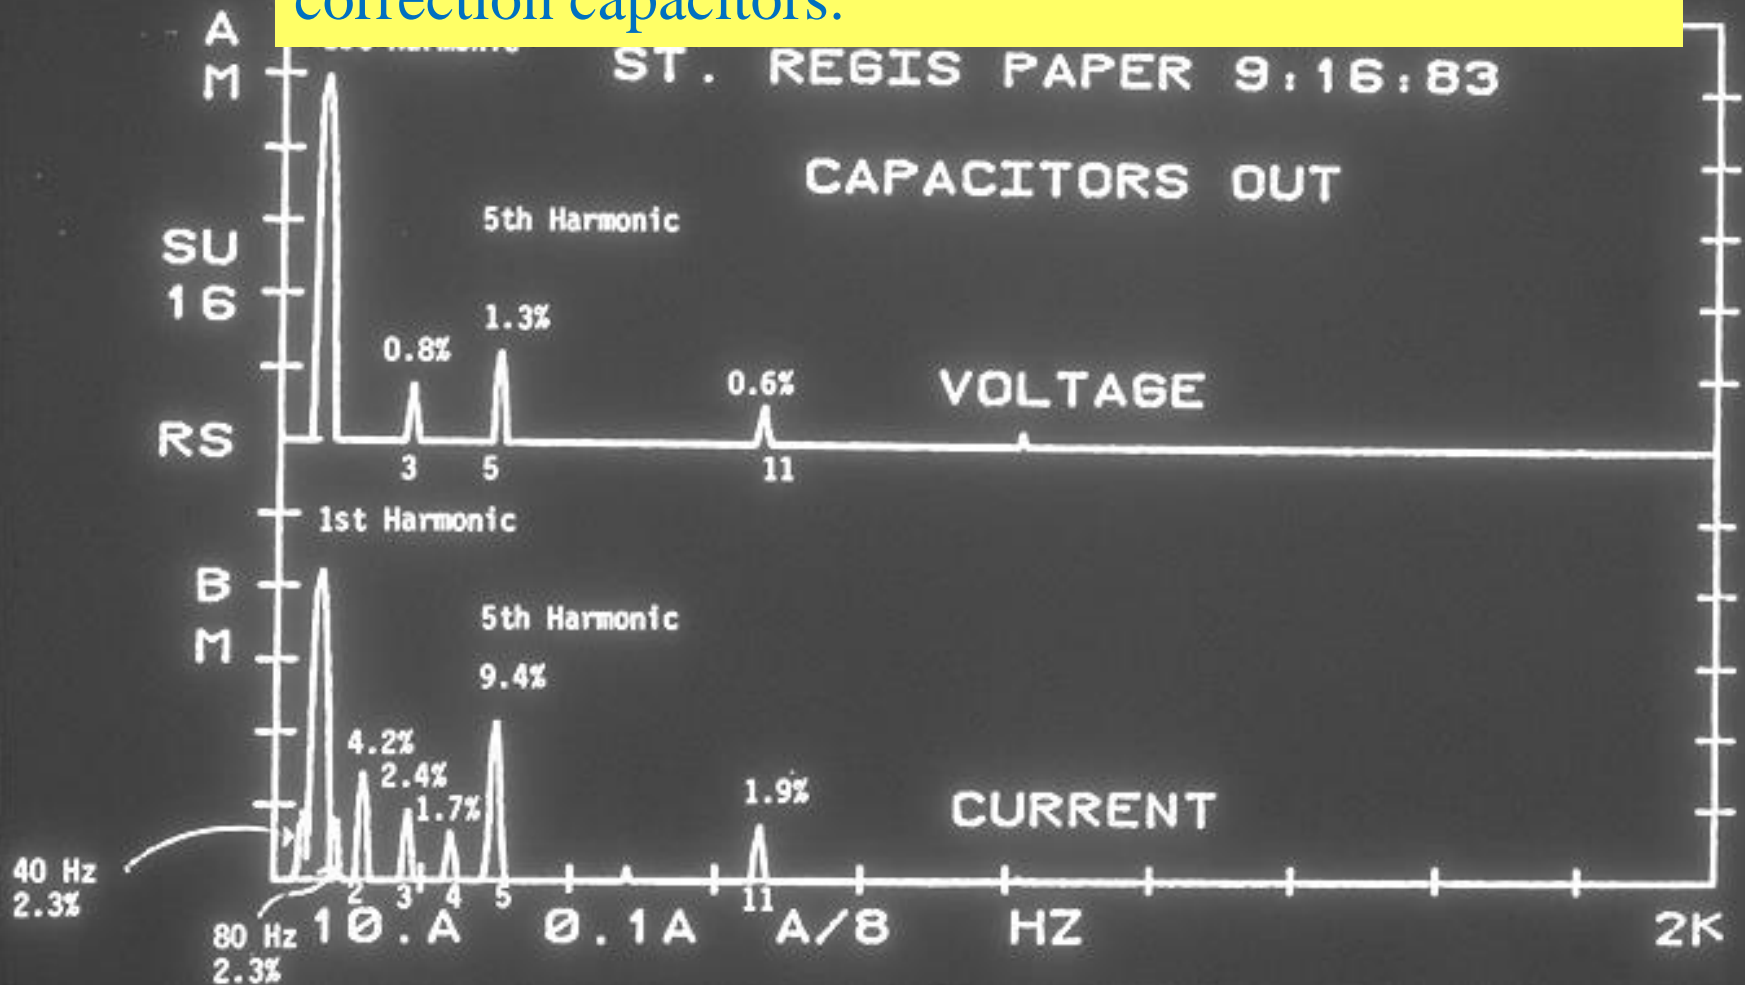
A paper company was having an abnormal number of motor failures so requested a line harmonics test.

When asked if anything had changed at their facility, they said that they had installed some power factor correction capacitors.

- Excessive current at the 5th harmonic of line frequency was detected at this facility.
- The amplitude of the 5th harmonic nearly tripled when all the power factor correction capacitors were racked in.
- The 5th harmonic is a counter rotating field, so it was trying to drive the motor backwards at 5 times the operating speed. That energy was thus turned to heat.
- The 5th harmonic was most likely produced by some on site variable frequency drives.
- Electrical circuits can have resonances, just like mechanical system.
- Electrical circuits resistance to current flow (impedance) is a function of the resistance, capacitance and inductance.
- Recommendation: Have an expert in electrical power circuits model system and try to reduce harmonics with filters or alter system impedance.

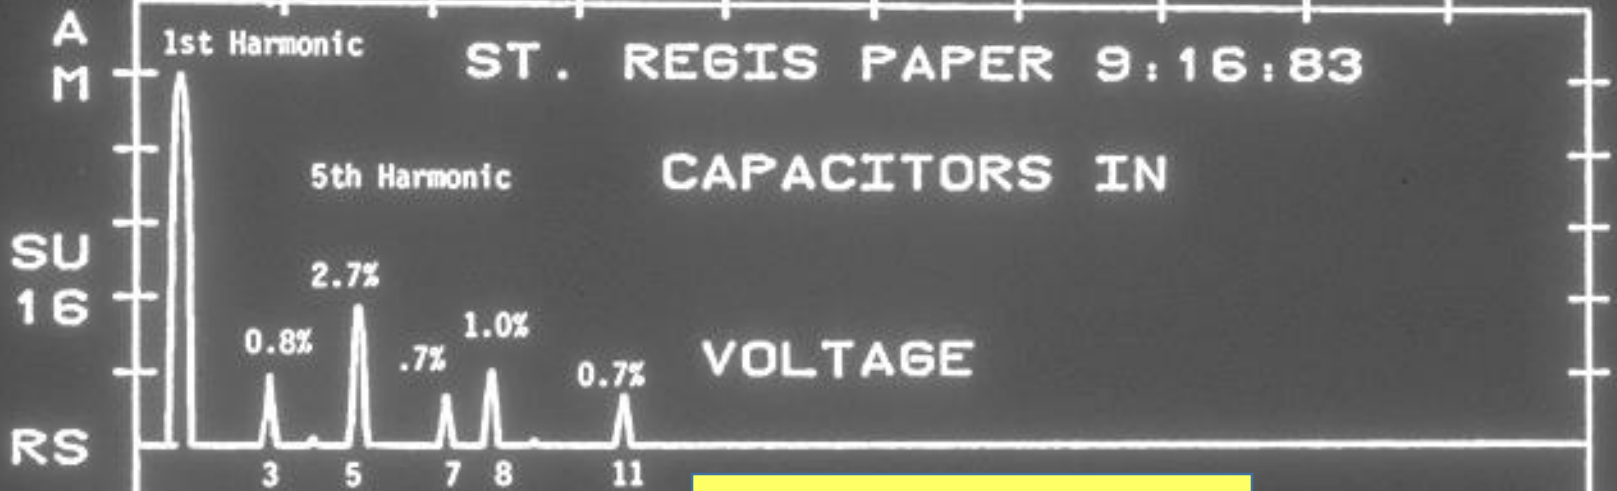
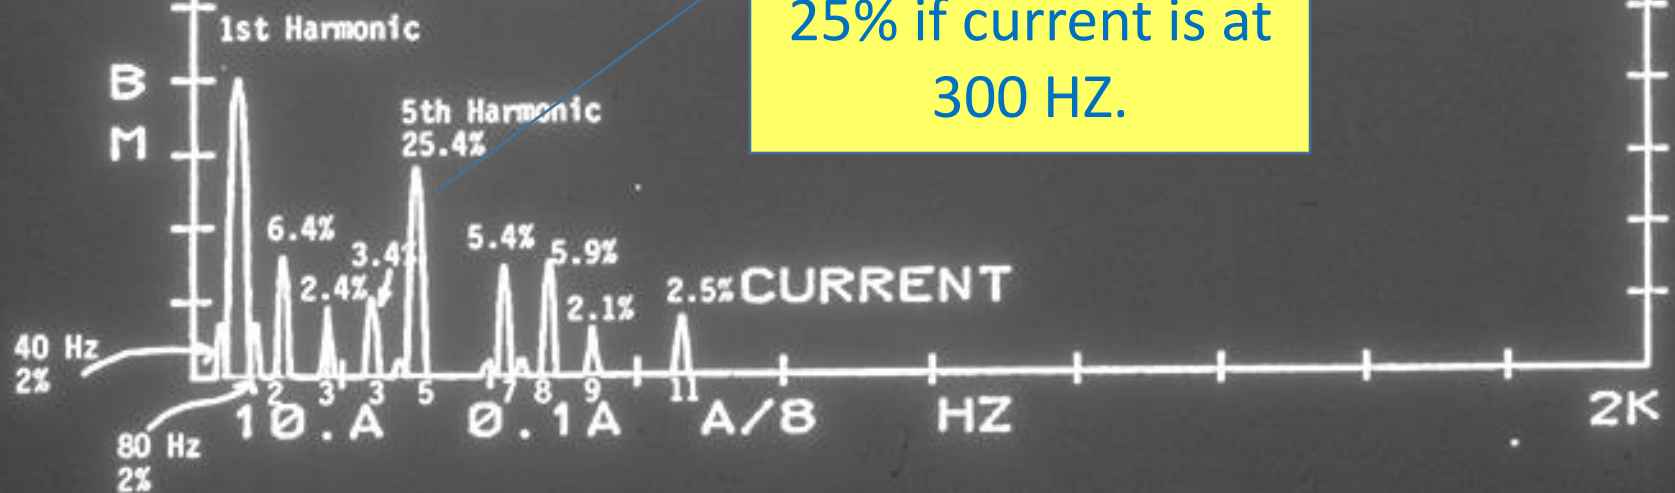
CAPACITORS IN

25% if current is at
300 HZ.
