Four Vibration Case Histories

Barry T. Cease
Cease Industrial Consulting
ceasevibration@icloud.com
(843) 200-9705

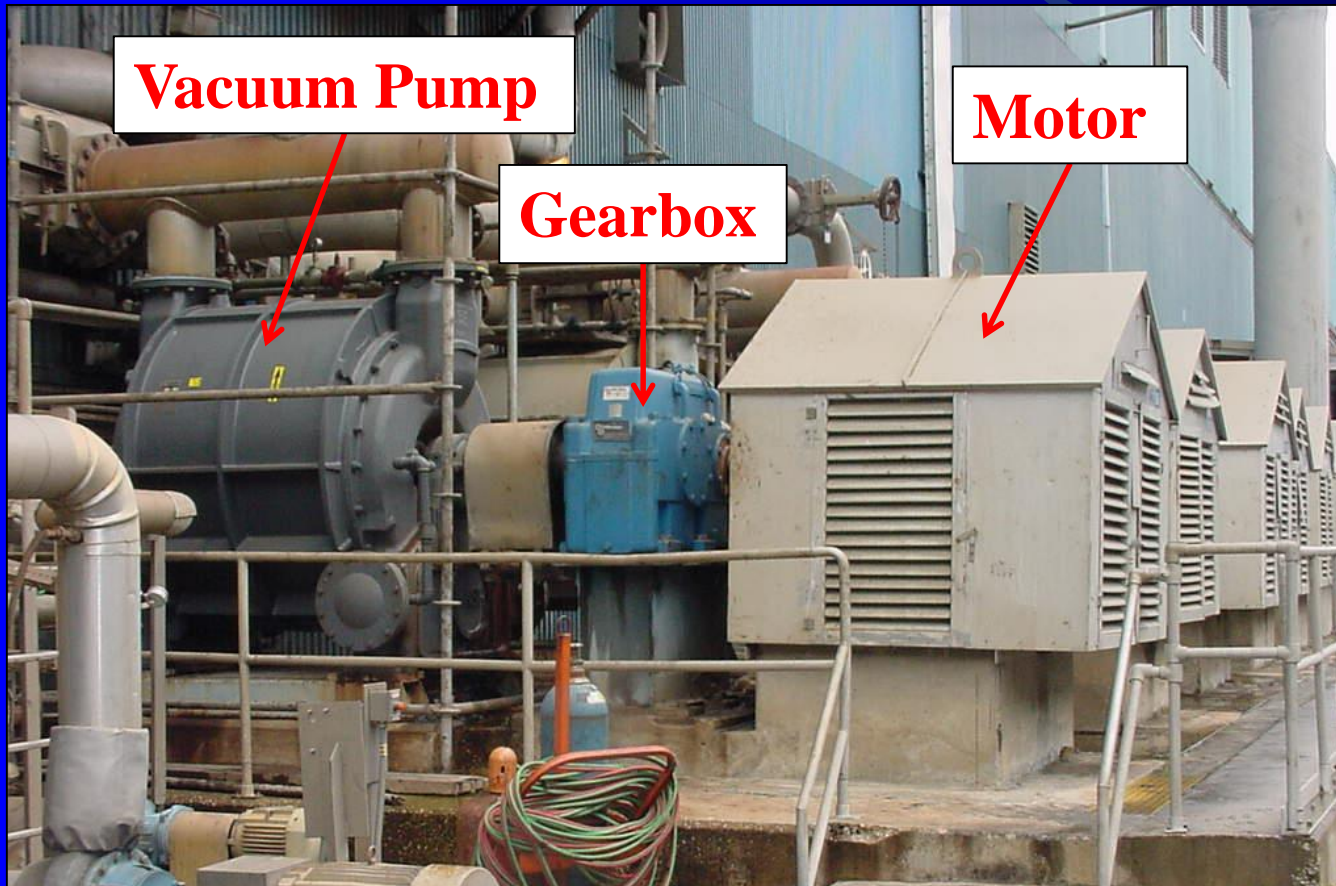
CH#1 – Equipment Layout

- Excessive & noisy vibration at the motor.
- This problem could be heard & felt clearly at the motor.
- It sounded like something was rubbing and/or loose.

- It was recommended that the gearbox be changed out when possible due to a probable gear fault.
- The gearbox was changed in 5/03.
- An inspection of the gearbox showed many gear teeth broken off on the pinion gear with significant wear on both gears.
- Follow-up data on both machines after the gearbox change showed much lower vibration levels – the problem vanished.

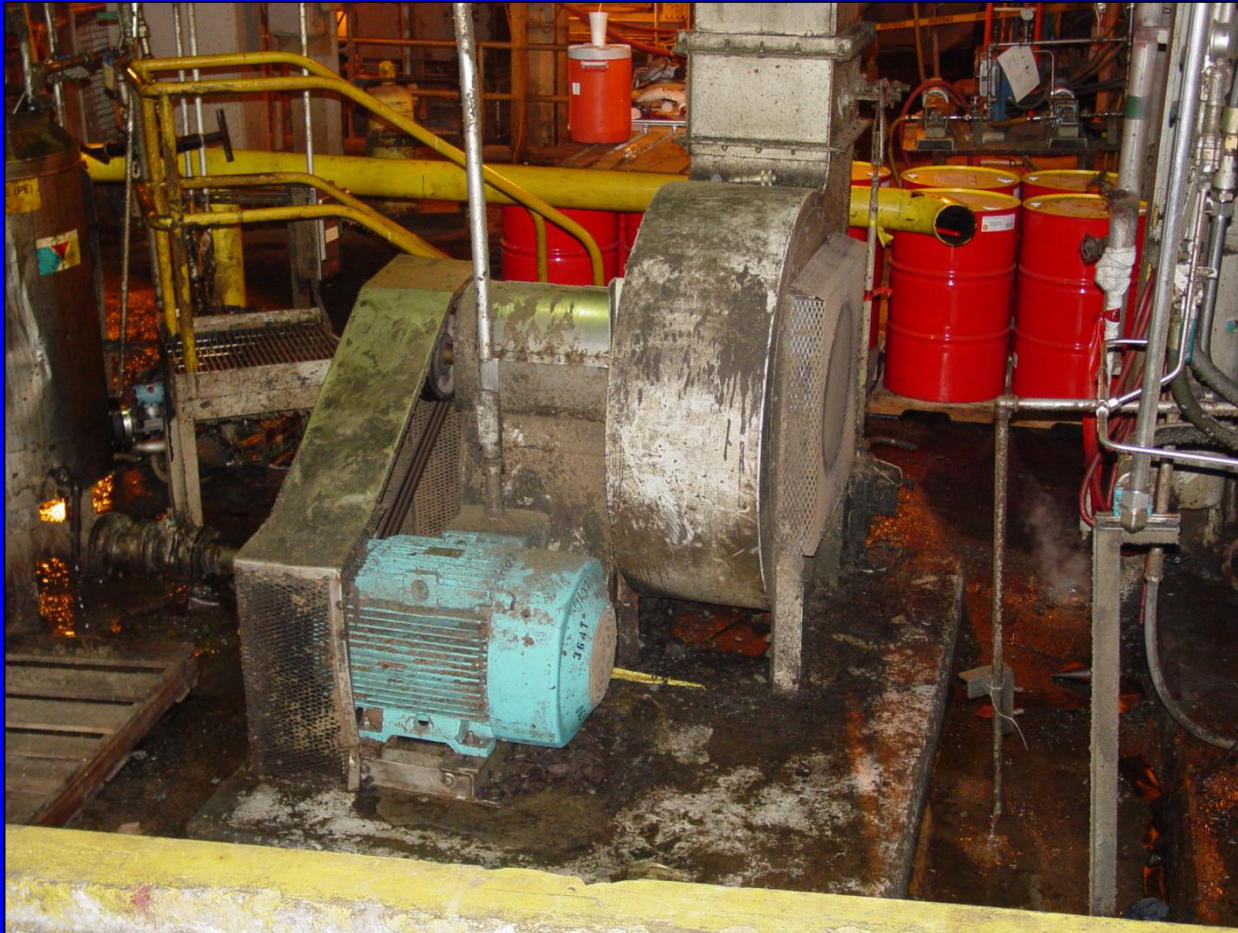
CH#3 – Equipment Layout

- Repeat fan bearing failures.
- In one instance, vibration detected bearing faults on this fan less than a month after their changeout.
- Predictive maintenance was able to detect these failures early enough to perform repairs during scheduled outages, but after three fan bearing changeouts in 12 months, we knew something had to be done differently.

- The relatively tight alignment tolerances of the existing tapered roller bearings combined with the poor condition of the fan base made for short bearing life.
- We asked our bearing supplier for a replacement bearing that would carry similar loads, but be more forgiving for misalignment.
- We also had our machine shop fabricate a new fan base that was machined flat & line bored to perfectly fit the new pillow block bolt pattern.

- After installation of the new type bearings & new fan base we have not had another bearing failure.
- Our bearing life has went from an average of 4-months to 26 months and counting.
- Further inspection of maintenance history showed a fan speed increase which corresponded quite well to our increased rate of failure.
