HIGH VIBRATION AT A VERTICAL AGITATOR

Barry T. Cease

Cease Industrial Consulting

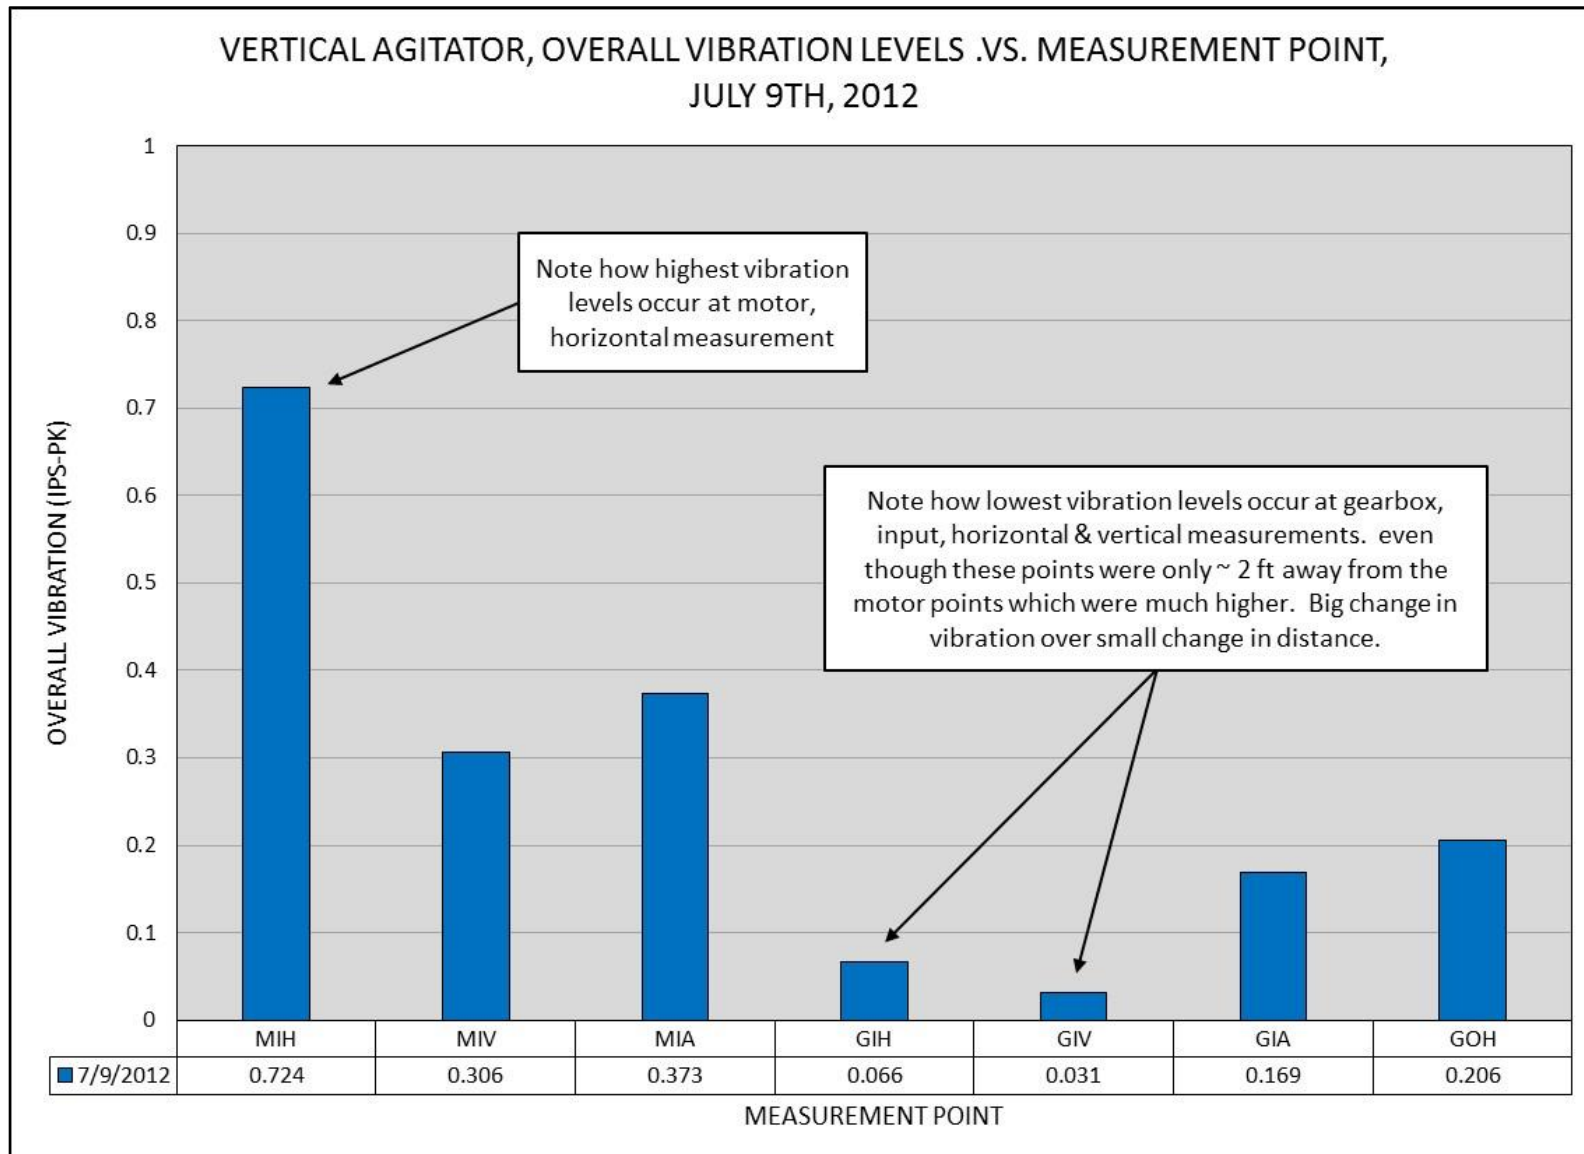
MACHINE PROFILE PLOT – OVERALL VIBRATION LEVELS

- Spectral analysis on the agitator showed the highest vibration occurring at the motor in the horizontal direction with dominant vibration occurring at the motor speed of ~ 1,780 rpm.

- Vibration levels were very low at the gearbox input bearing, but higher at the opposite end of the gearbox (opposite motor end).
- After analysis of the route vibration data, the recommendation was made to verify the alignment condition between the motor & gearbox and inspect the coupling for wear or damage.

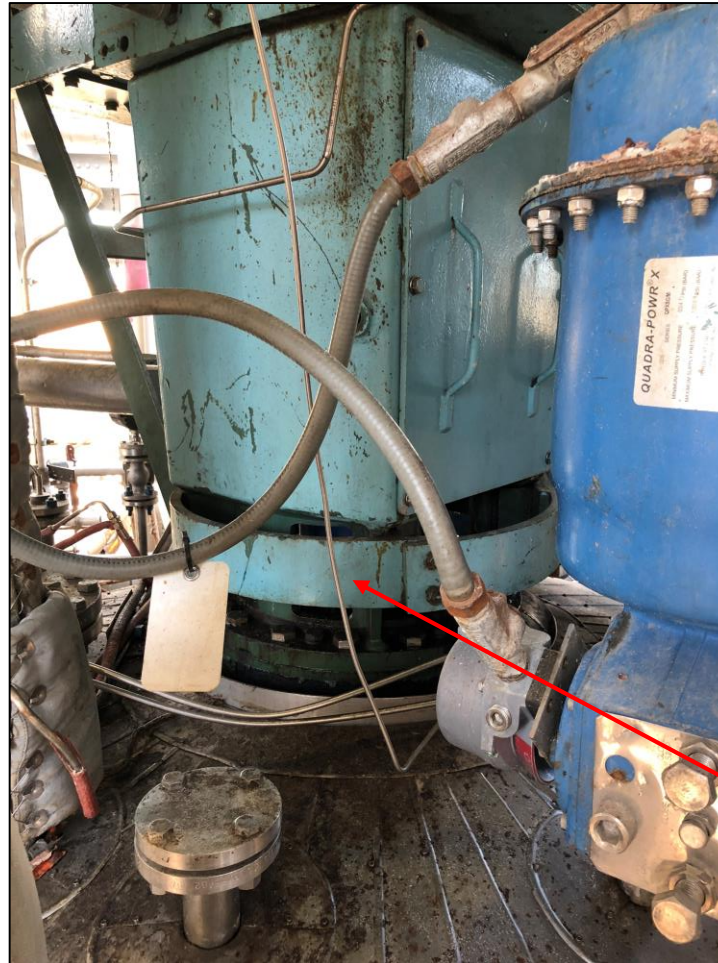
Note how the agitator column is supported by a bolted flange attached to the column via essentially 6-ea individual pieces of angle (not continuous).

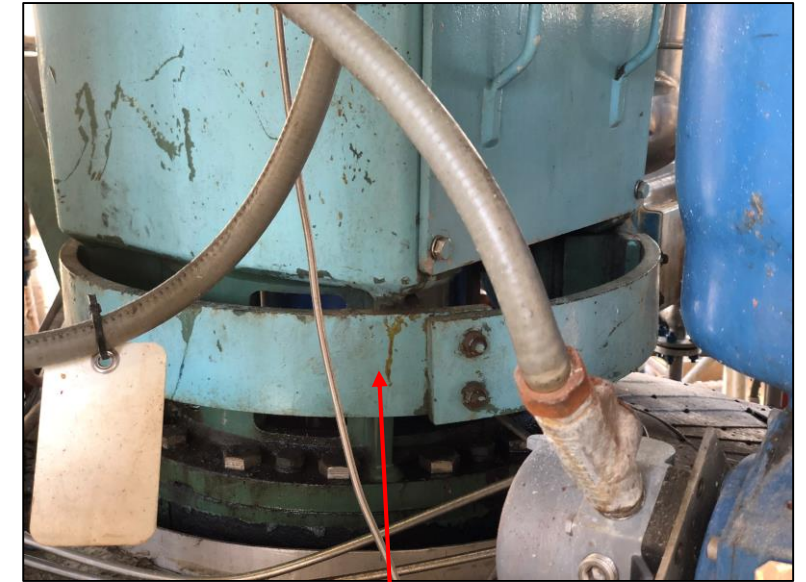
The addition of the bolted aluminum door and the bottom collar acted to increase the torsional stiffness of the agitator column.

In addition to replacing the plastic door with an aluminum bolted door, the OEM decided to connect all six supporting angles together with a steel collar sized for this purpose. The collar was designed to bolt tightly to the existing angle.

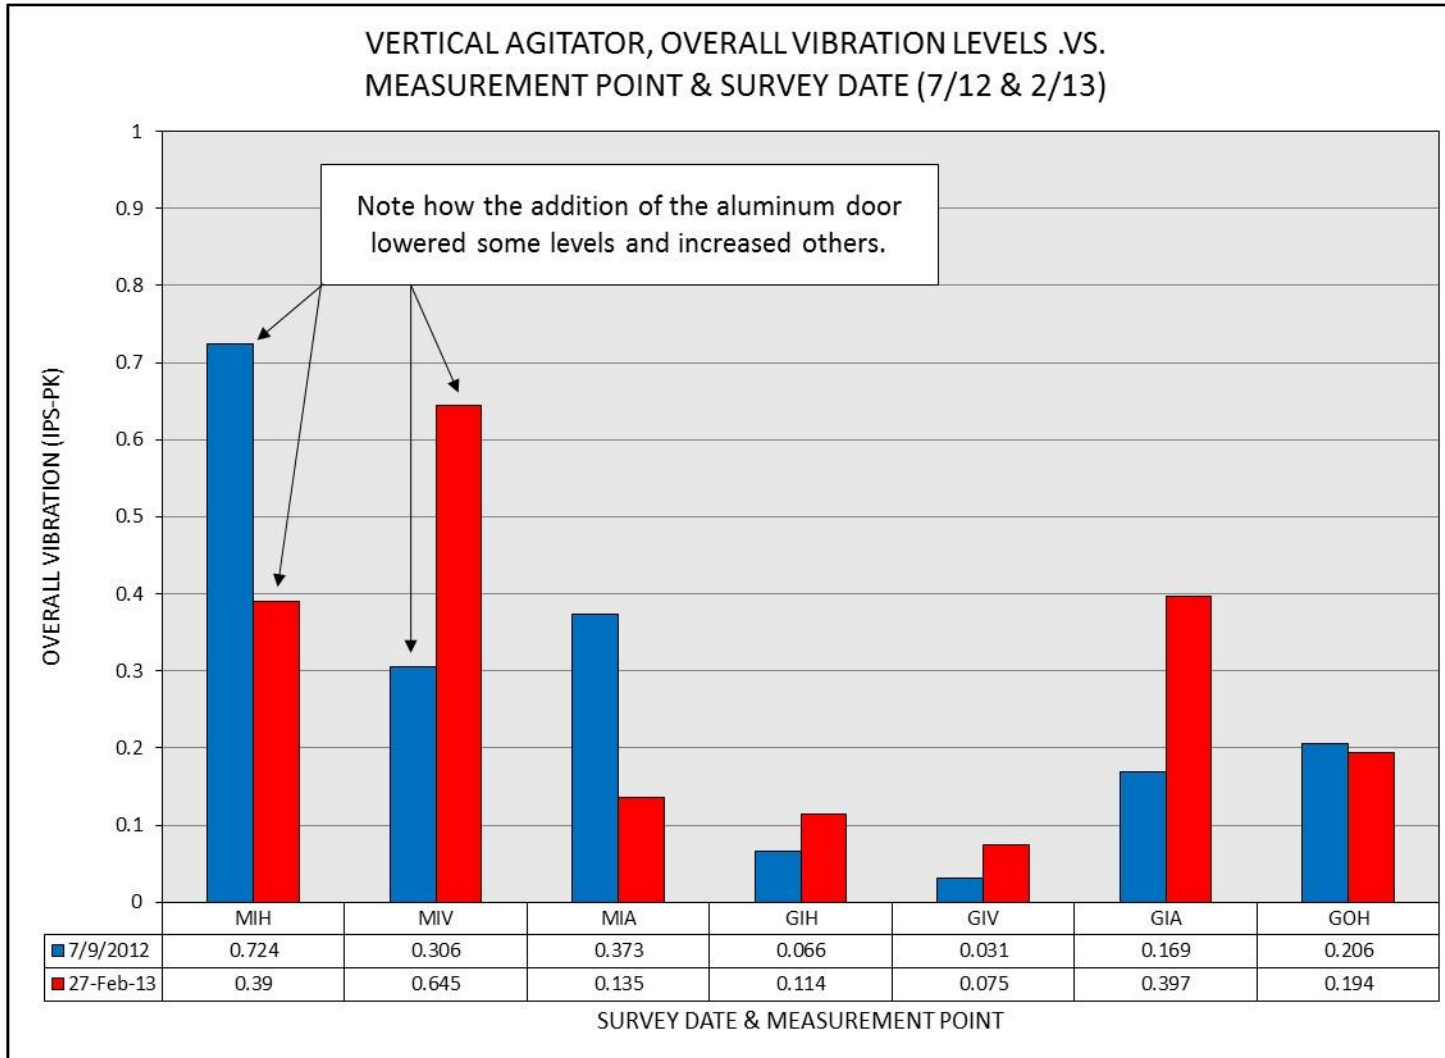
FOLLOW-UP VIBRATION DATA – OA PROFILE PLOT

- The aluminum door was installed at the void on the backside of the agitator column and the collar installed near the agitator-tank flange.
- Follow-up vibration data after these modifications showed a 50% drop in vibration levels at the motor speed of ~ 1,784 rpm at the point of highest vibration (MIH).
- Unfortunately, all the recommendations from the July 2012 analysis were not yet completed, namely, the bracing of the motor base was not yet installed.

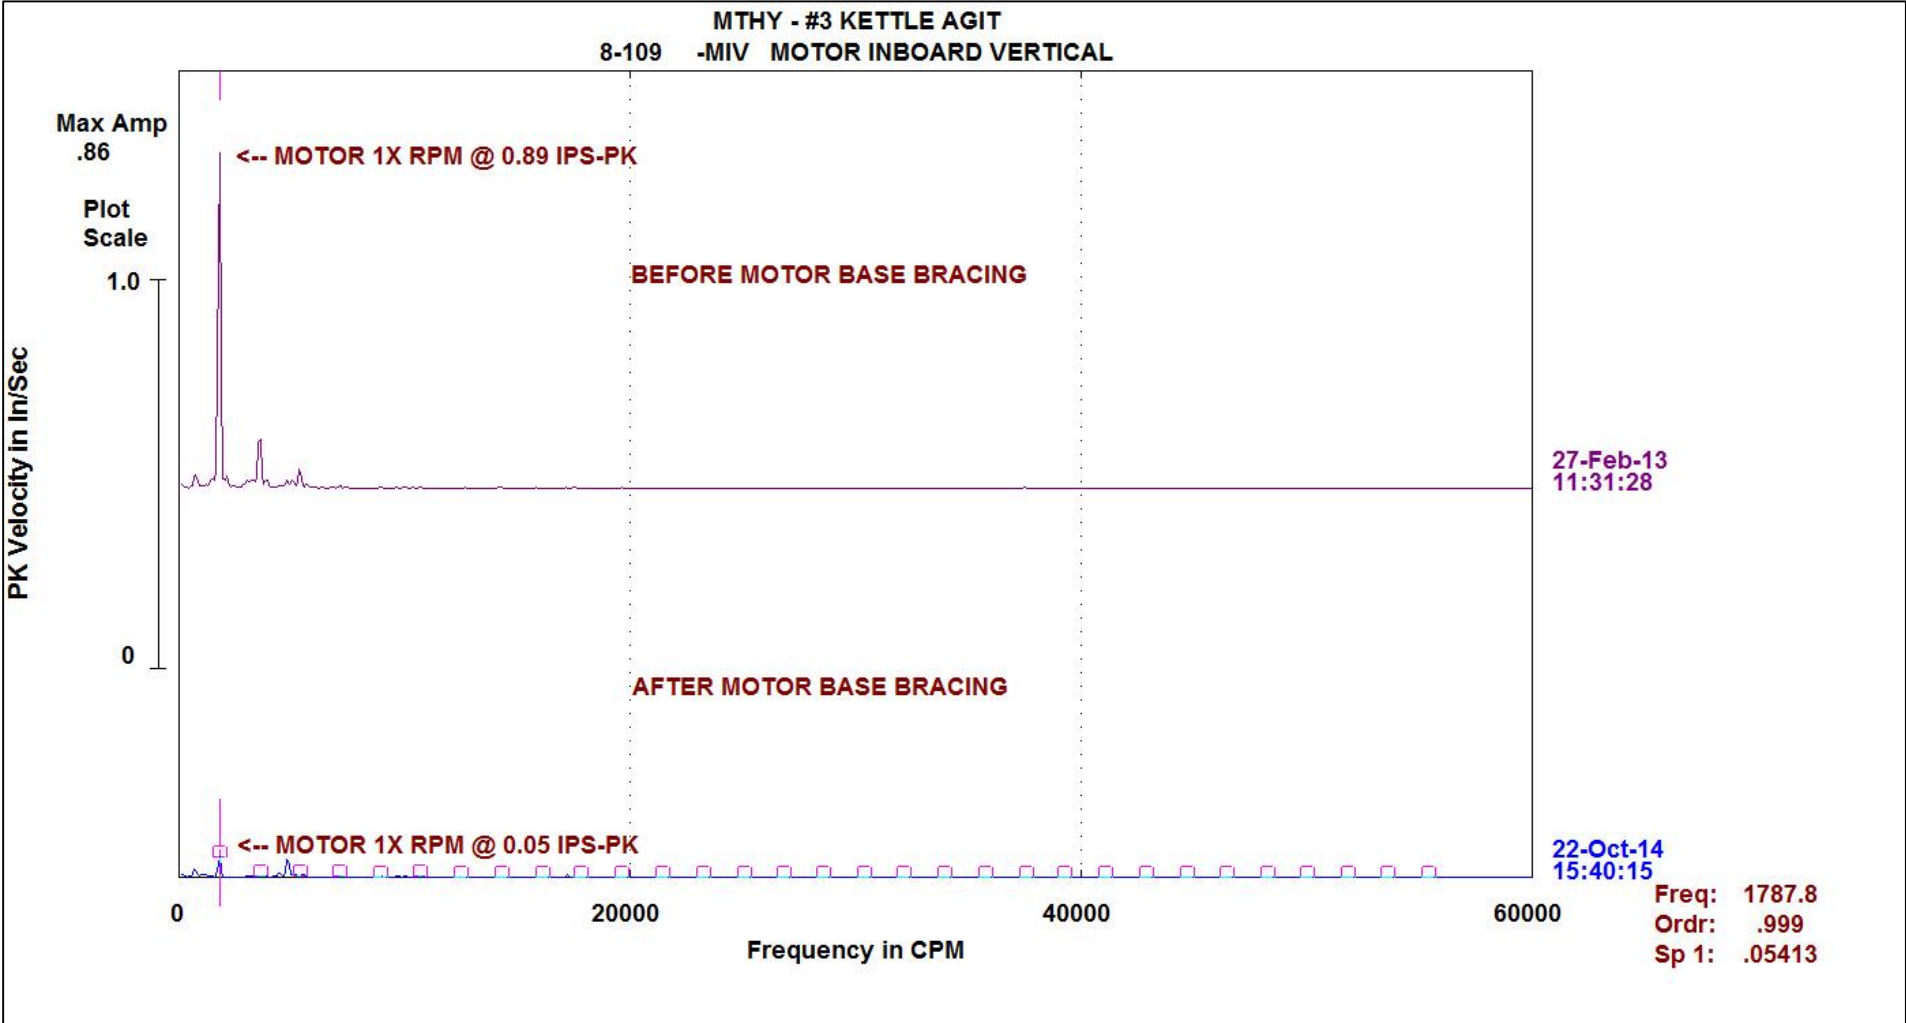
FOLLOW-UP VIBRATION DATA – MOTOR, VERTICAL (MIV)

- The motor brace was installed and follow-up vibration measurements were made.
- The follow-up vibration data showed a significant drop in vibration levels and acceptable levels across the entire machine.

Bracing was designed & fabricated for the agitator by the OEM and installed in the Fall of 2014 during a scheduled outage. Follow-up vibration data were collected on the agitator after start-up.

Bracing was installed between the agitator column and the motor base. No connections were possible between the tank itself or nearby structure and the motor base.

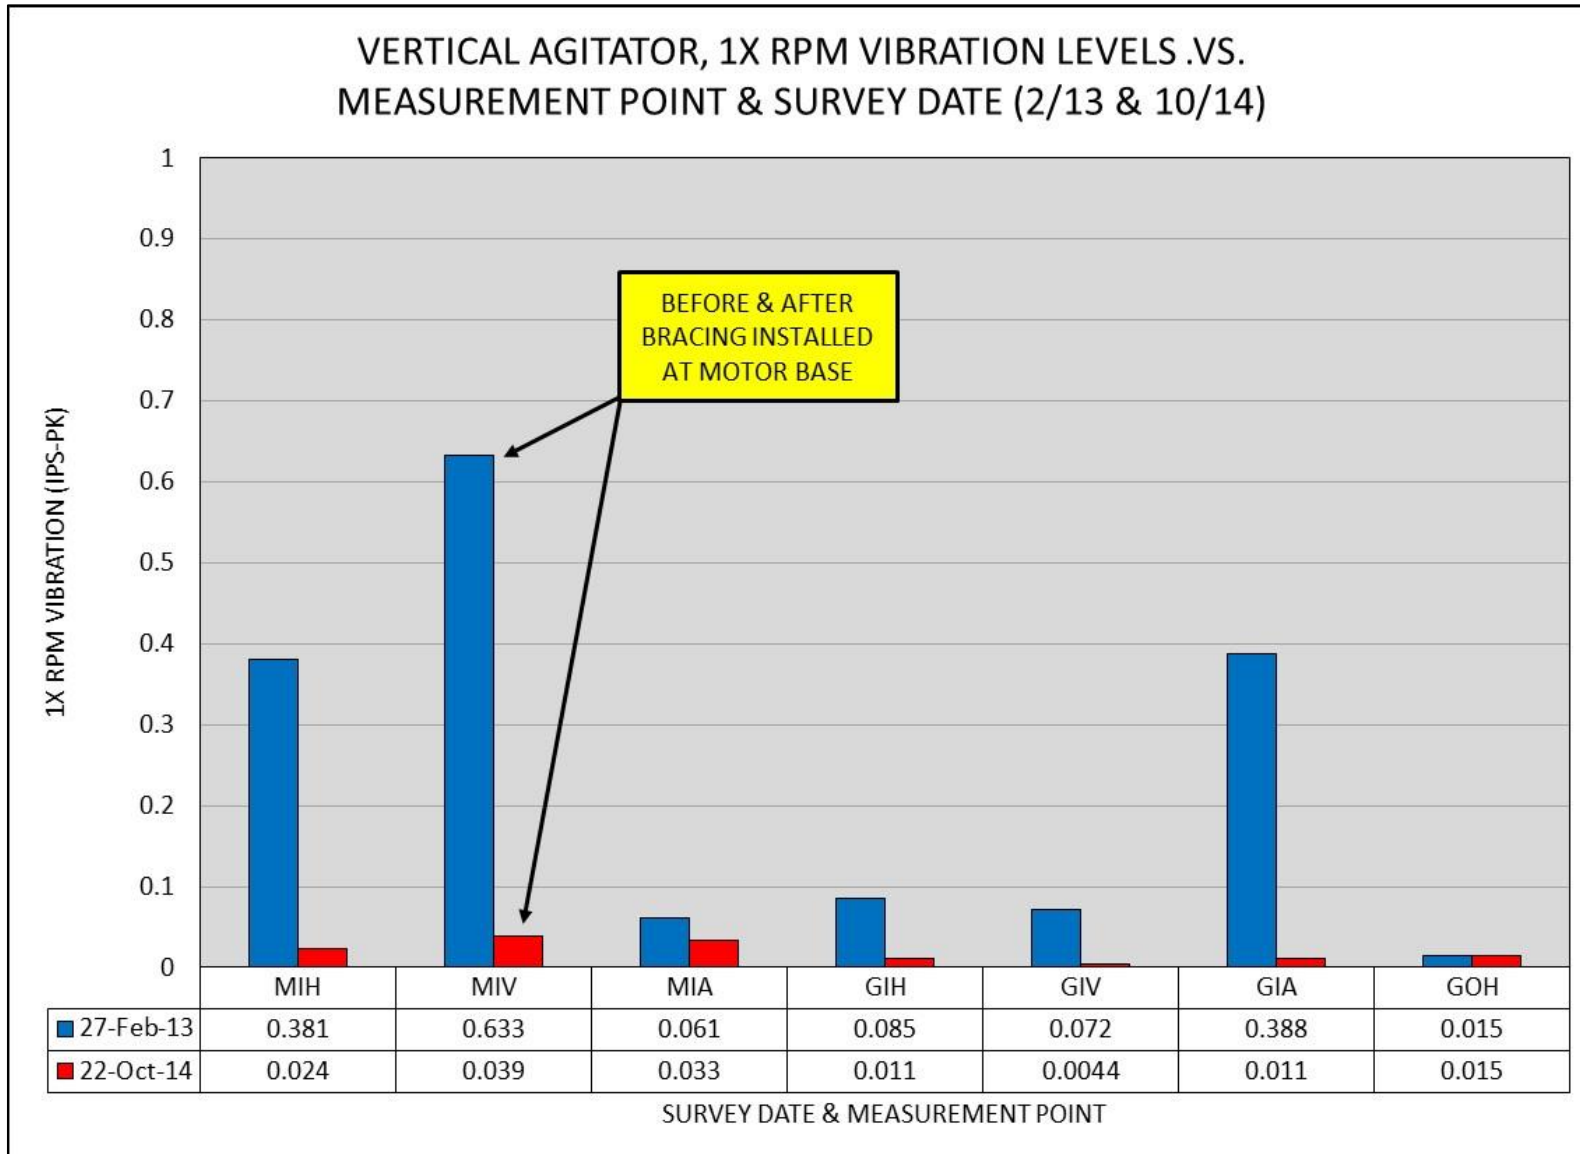
FOLLOW-UP VIBRATION DATA – 1X RPM PROFILE PLOT

- All measurements across the entire machine are now < 0.10 ips-pk (excellent).
