### MOTOR AND RELATED EQUIPMENT PROBLEMS

SHARING PICTURES AND STORIES FROM AN ELECTRO-MECHANICAL REPAIR SHOP

WAYNE HALL and EDWARD JENKINS
Vibration Institute, Piedmont Chapter #14
20 January 2017

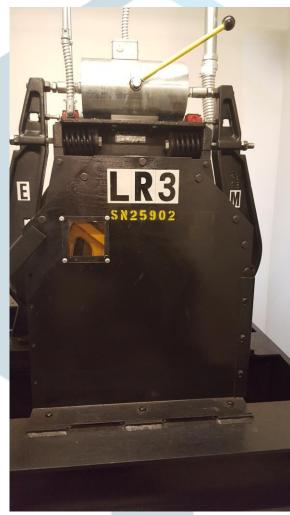
#### **Rotor Moves Before Shaft Starts Turning**

- Gearless Elevator Drive built into an office building
- After it warmed up, it would "clunk" every time it started or stopped.
- Rotor loose on shaft, keyway bad
- Some temporary repairs are done with epoxy
- Other attempts involve welding.

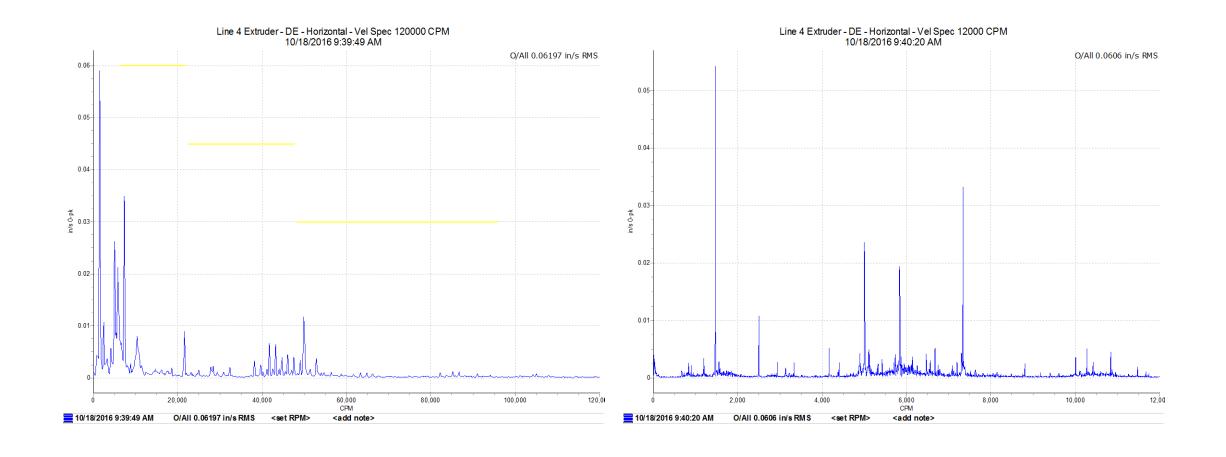
# Spectrum a month ago

- Note that the maximum vibration level observed was at running speed and well below alarm.
- No unusual peaks occurred at bearing frequencies
- No evidence bearing was greased in service

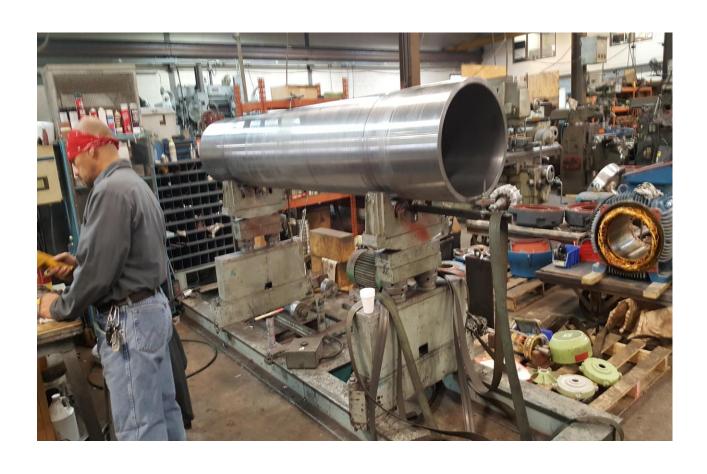
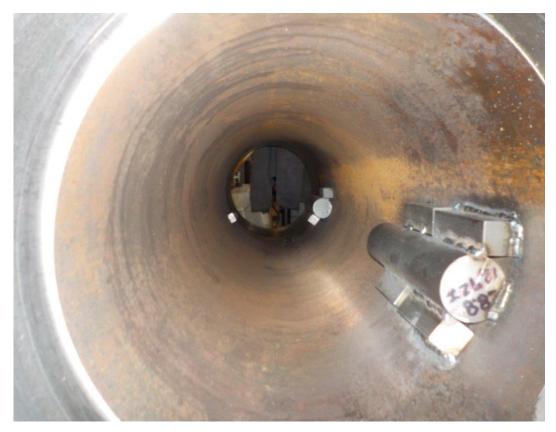
# Roll Balance

- ⊕Two plane balance
- Operating speed 1150 rpm
- ☼ Target Residual Unbalance 5 grams, regardless of roll size or weight??
- **Results:** 
  - €0.001 and 0.003 inch/second
  - €0.91 and 2.12 grams Residual
  - €0.04 and 0.13 mils

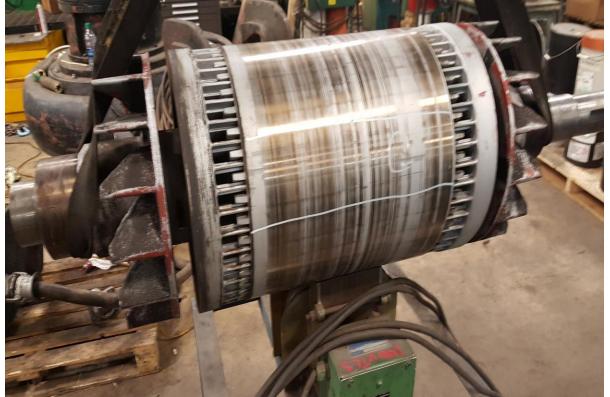
#### **High Frequency Vibration in Motor**

Here is the Vibration data taken on the Charlotte Pipe with loose rotor bars.

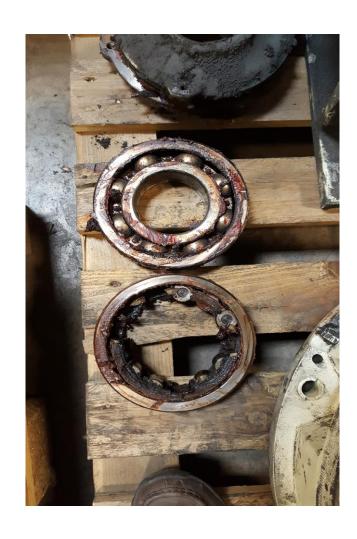
## As Received, 125 hp, 1750 rpm Compressor Motor

- Motor received with both end brackets oversize and one journal undersize.
- Repairs made, but DE end bracket slipped in the lathe and was bored cocked, 0.004 inch.
- ♥Vibration levels OK (0.02 in/sec), but Roller bearing was noisy.
- ODE readings out 170 degrees.

Cocked Bearing will generate considerable axial vibration. Will cause Twisting Motion with approximately 180° phase shift top to bottom and/or side to side as measured in axial direction of same bearing housing. Attempts to align coupling or balance the rotor will not alleviate problem. Bearing must be removed and correctly installed.
