Nuggets of Gold

- Troubleshooting Tips For diagnosing vibration problems
- Balancing
- Alignment
- Motors
- Pumps
- Signal Processing Considerations
- DC Drives

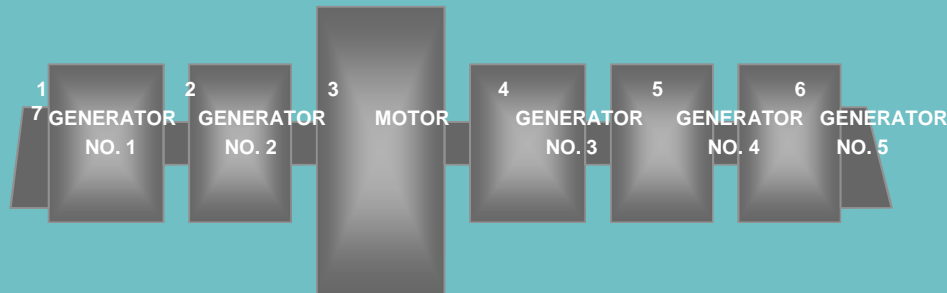
MOTOR GENERATOR SET ON DRAG LINE

SIX ROTORS WITH SEVEN SHARED BEARINGS SOLIDLY COUPLED ON A METAL DECK.

After a weight was installed, Horizontals went down Verticals went down. This is a strong sign that you are adding weight to wrong plane

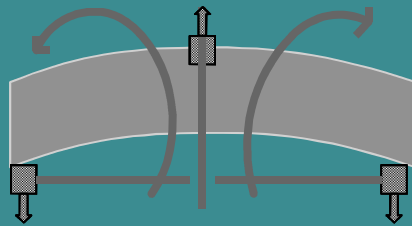
BOWED FLEXIBLE ROTOR REQUIRING MID SPAN SHOT

CREATES INTERNAL BENDING MOMENTS

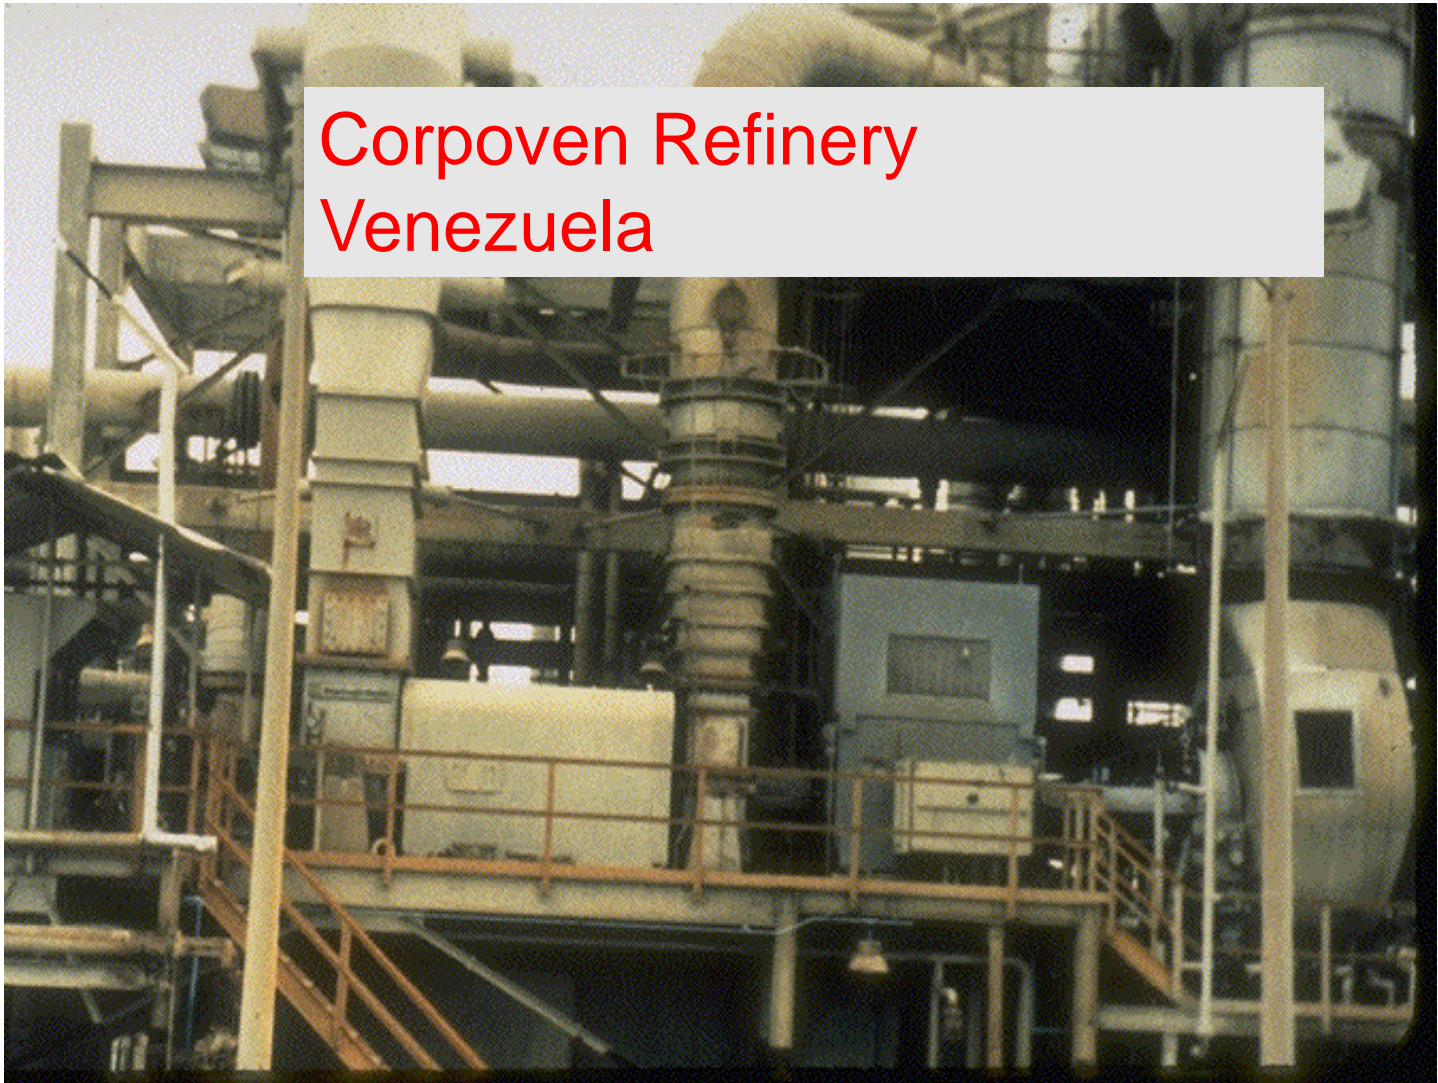
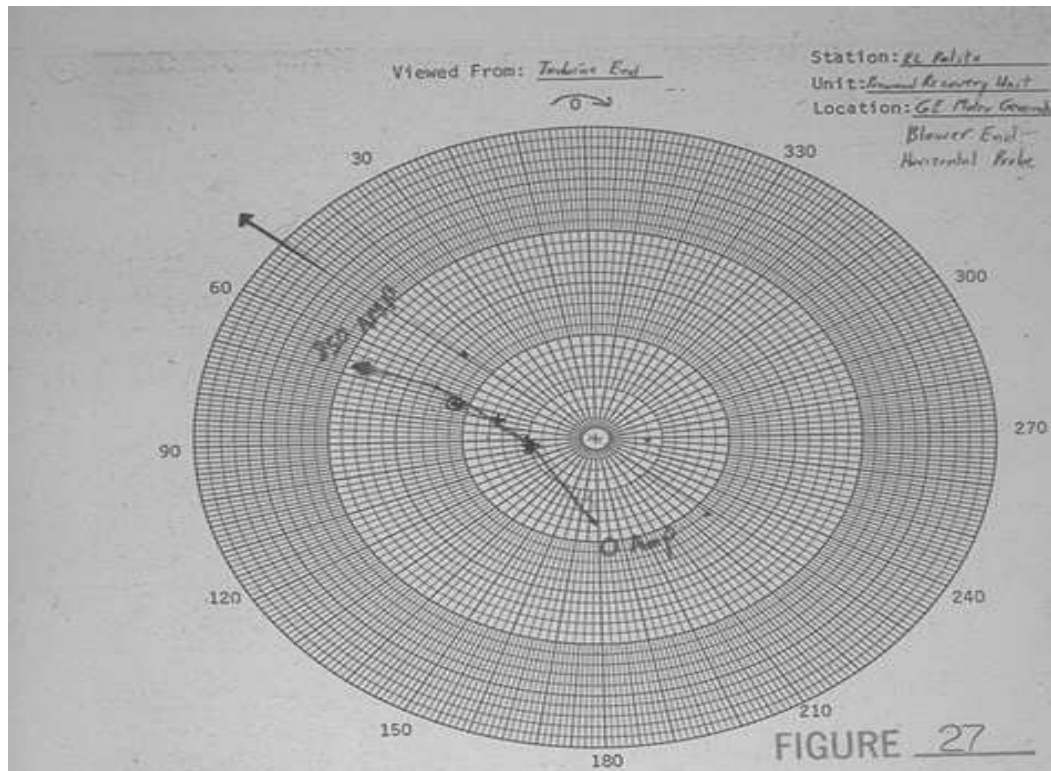
Corpoven Refinery
Venezuela

3: When balancing 2 pole motors which are above 1000 HP, beware of thermal vectors. This class of rotor will operate well uncoupled, but will often have high levels of vibration when pulling full current. This is because the rotor can bow as a function of heating by the current flow.

Date	Overall	IX	Phase	AMPS	TAPE-HP	TEAC
6-22-85		1.6	176°	0	A 185 Ft.	
"	*	1.0	97°	240	A 90	25-50
"		2.6	66°	690	A 120	
"		3.9	68°	830	A 985	412-460
AFTER Balancing						
15-7-85	⊙	2.2	70	700	II 250	505-545
27-1-86	+	1.5	74	200	V 100	671-690

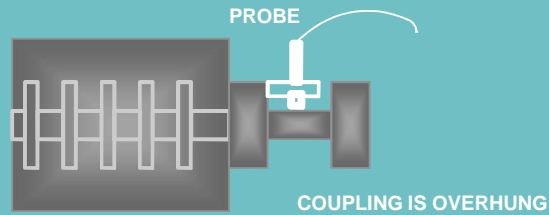
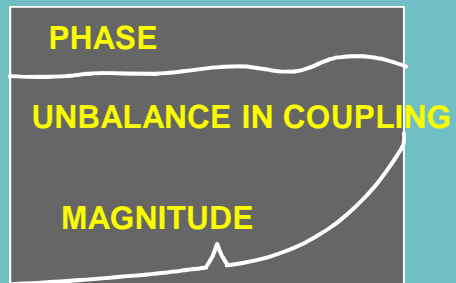
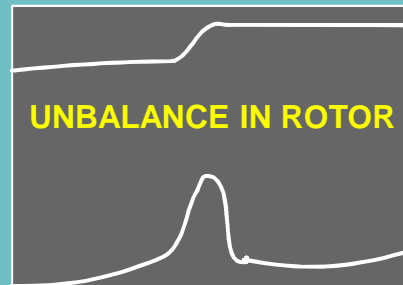
COMPRESSOR WITH UNBALANCE IN COUPLING

4: During a startup, if a high speed compressor has low response as it passes through its critical, but the level increases steadily with RPM, without much of a phase shift, then suspect unbalance in the coupling. On a polar plot, the response line will point straight outward because the amplitude increases without any shift in phase.

7000 RPM COMP.
BEFORE BAL.
3.8 MILS 240 DEG
WT. ADDED
23.7 GM @ 50DEG
AFTER BALANCE
.6 MILS 203 DEG

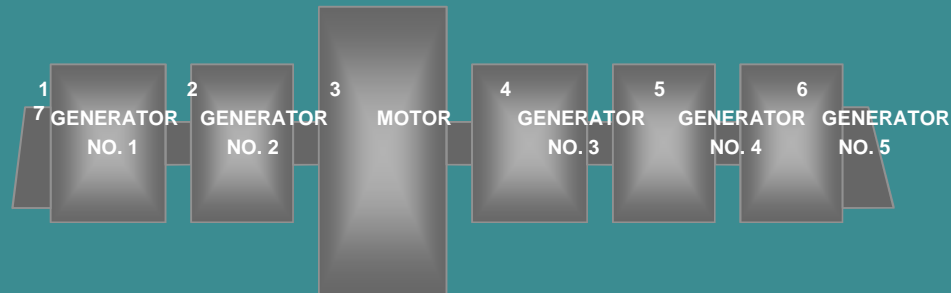
MOTOR GENERATOR SET ON DRAG LINE

SIX ROTORS WITH SEVEN SHARED BEARINGS SOLIDLY COUPLED ON A METAL DECK.

PERFORMED RESONANCE TEST- STRUCTURE FOUND TO BE OPERATING NEAR RESONANCE

5: When balancing a large machine with multiple rotors, if there is no other clear indication, then on the first trial weight attempt, add weight in the rotor with the largest inertia. Learned from Art Crawford. Once that is done, refer to balancing tip No. 1

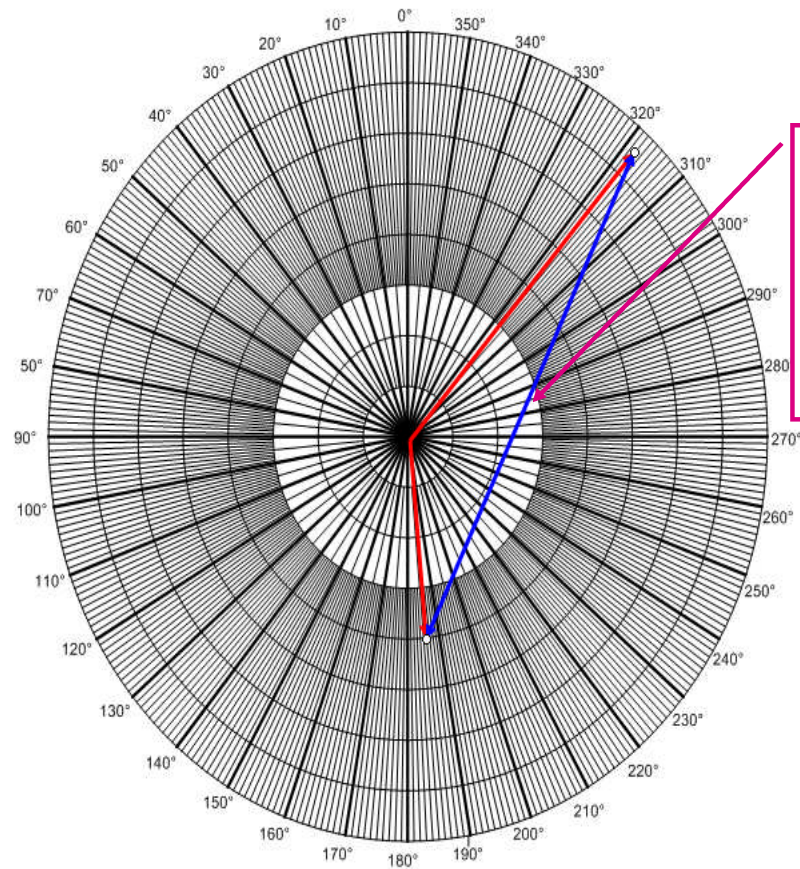
EXAMPLE OF A LARGE FAN WITH APPARENT COUPLE UNBALANCE

Vectors showed what appeared to be a large amount of couple unbalance

- The large couple component raised the level of suspicion.
- The results of a previous balance person showed the response to be highly non-linear
- The base bolt tightness was therefore checked and all the bolts were all found to be significantly loose.
- The bolts were tightened, the couple component disappeared and the levels dropped to 1/4th their original values.
- Following bolt tightening, the fan was then easily balanced.

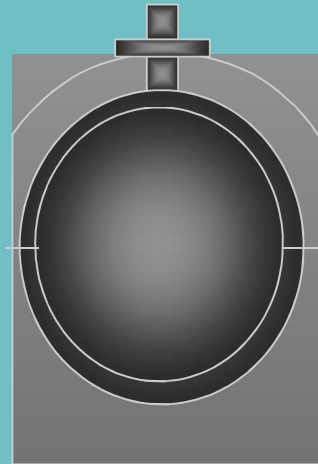
PLUNGER BOLT HOLDS BEARING TIGHT WITHIN HOUSING.

IF PLUNGER BOLT IS NOT TIGHT, THEN BEARING WILL MOVE RELATIVE TO HOUSING. THIS MOVEMENT RESULTS IN A NON-LINEAR SYSTEM. BALANCING IS VERY DIFFICULT, IF NOT IMPOSSIBLE IN THIS SITUATION.

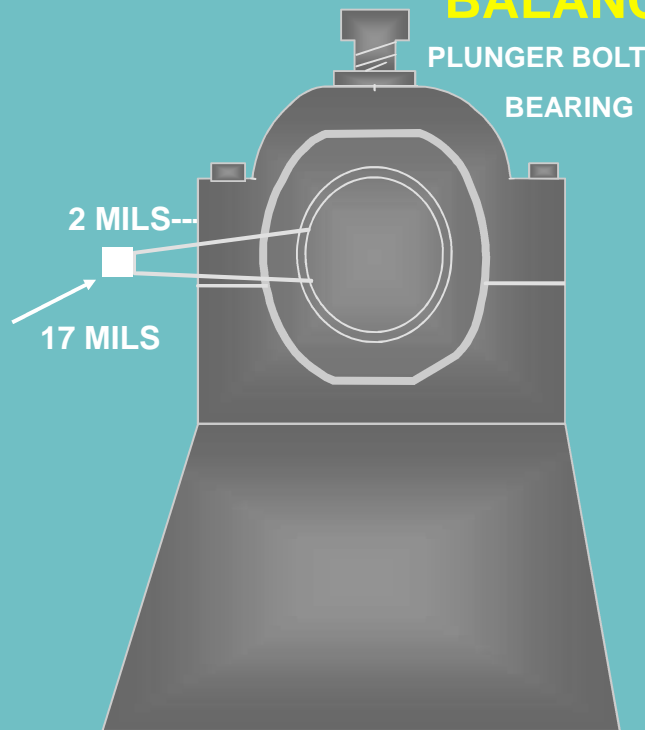
LOOSE BEARING IN HOUSING COMPLICATES BALANCING

IF A BEARING IS LOOSE IN ITS HOUSING, A NONLINEAR SYSTEM IS CREATED AND BALANCING IS ALMOST IMPOSSIBLE.

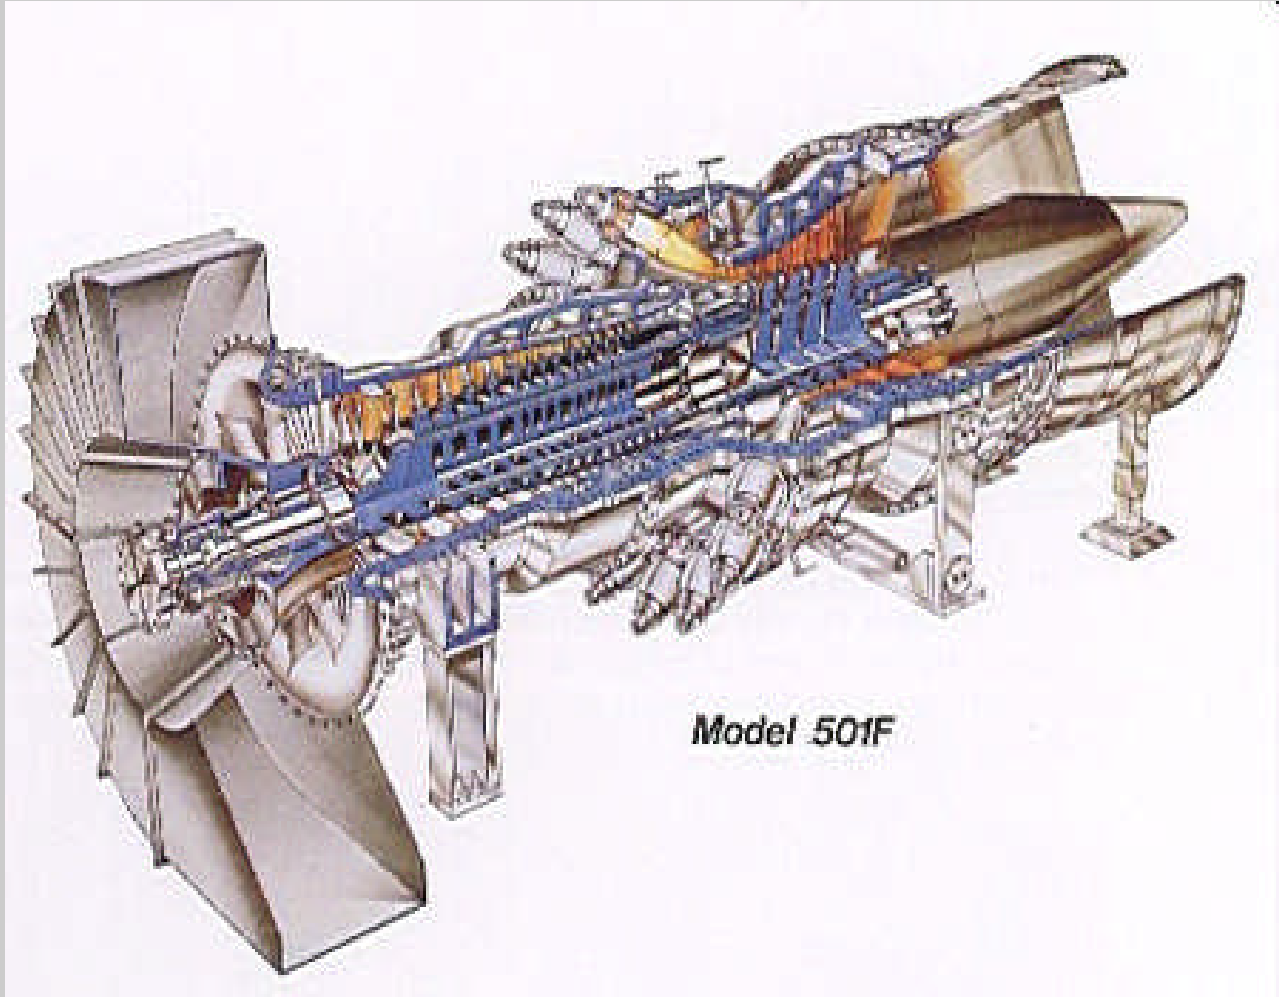
DIRECT AND CROSS EFFECT WESTINGHOUSE 100 MW 501 GT

Compressor end shot on Compressor end 18 oz/mil 353 degree lag

Compressor end shot on Exhaust end 8.6 oz/mil 30 degree lag

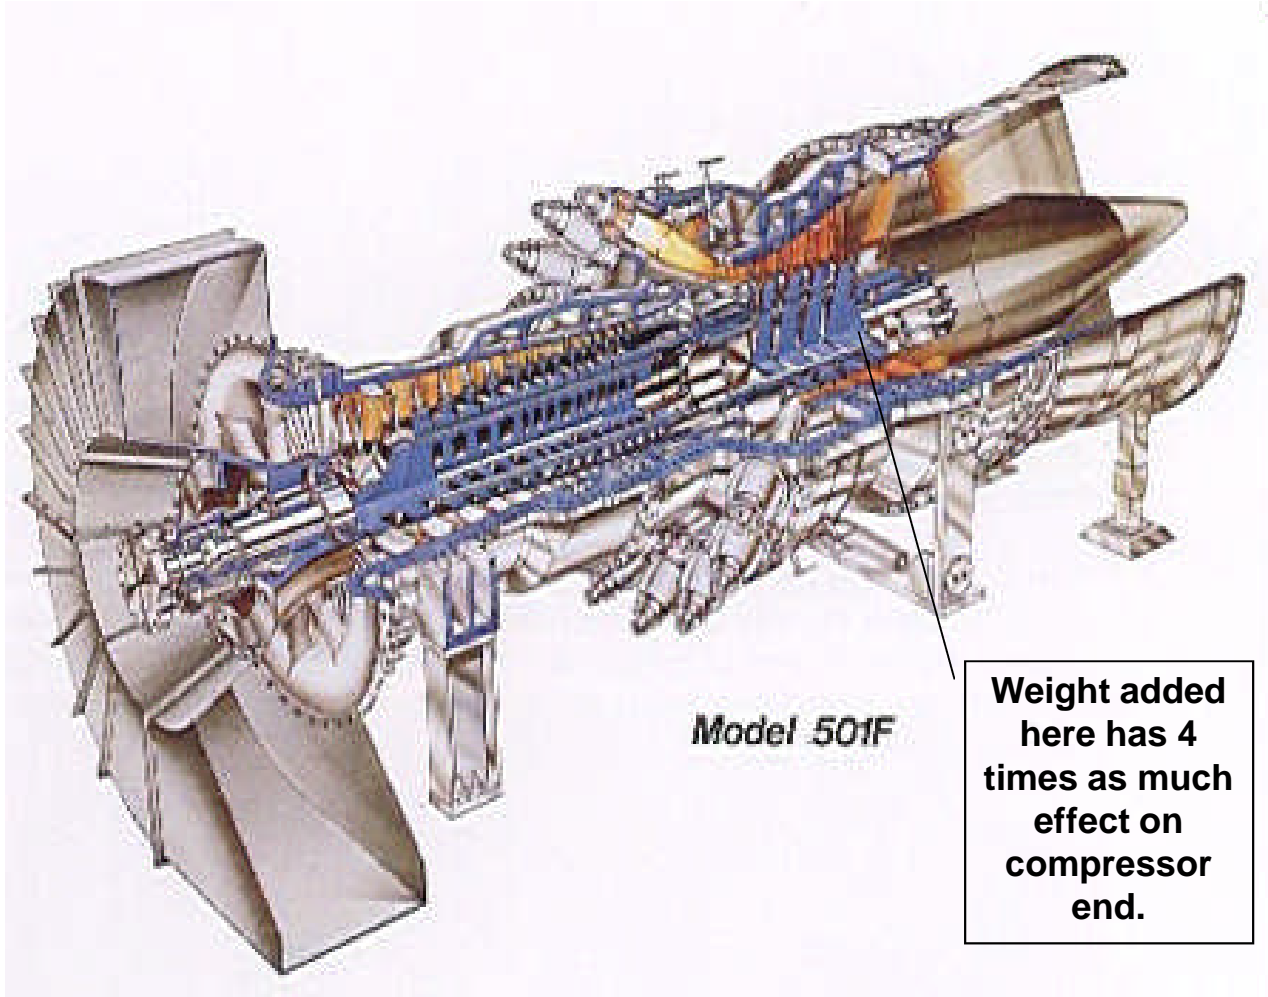
Weight added here has 4 times as much effect on compressor end.

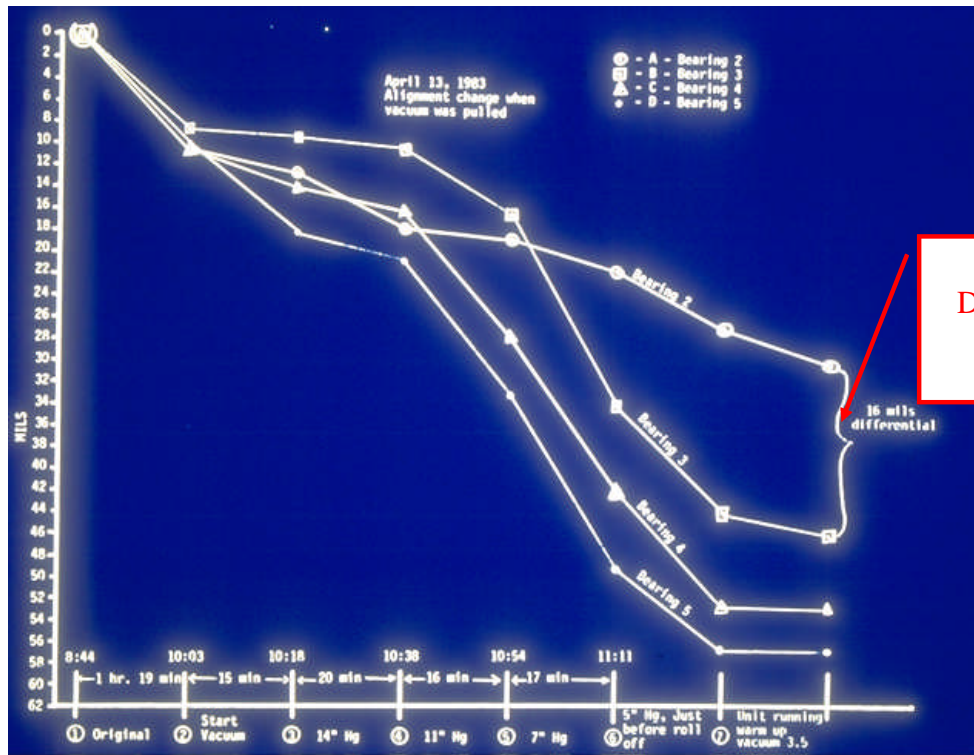
TEST RESULTS

MILS MOVEMENT VERSUS VACUUM

VACUUM DRAW DOWN COMBINED WITH THERMAL DIFFERENTIAL GROWTH UNLOADED BEARING CAUSING IT TO GO UNSTABLE. WHEN BOTH WERE COLD, IT WOULD BE STABLE. WHEN BOTH WERE HOT, IT WOULD BE STABLE. THE PROBLEM OCCURRED AFTER A TRIP, WHEN THE THINNER LP SECTION WOULD COOL DOWN QUICKER THAN THE THICK HP SECTION. THIS DIFFERENTIAL ADDED TO THE VACUUM DRAW DOWN WAS TOO MUCH.

BEARING METAL TEMPERATURE CONFIRMED THIS FINDING.

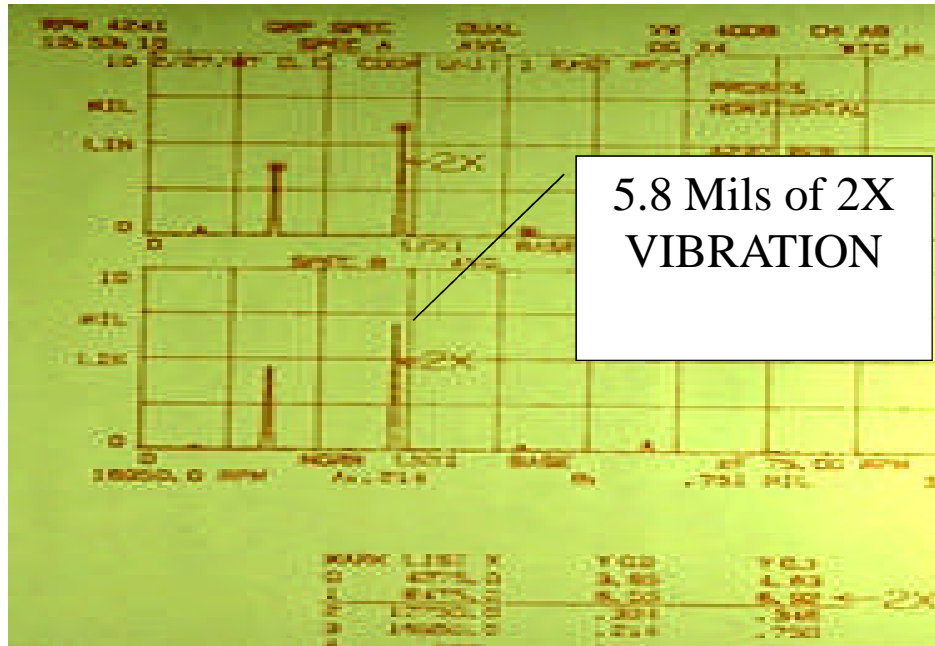
VIBRATION SPECTRUM

COUPLINGS BEING DESTROYED ON STEAM
GENERATOR FEED PUMP AT NUCLEAR
STATION

PROBLEM-ALIGNMENT SPEC. WAS WRONG

- Vacuum draw down was 20 mils
- Even though pump was center mounted, it was growing.
- Turbine was growing unevenly

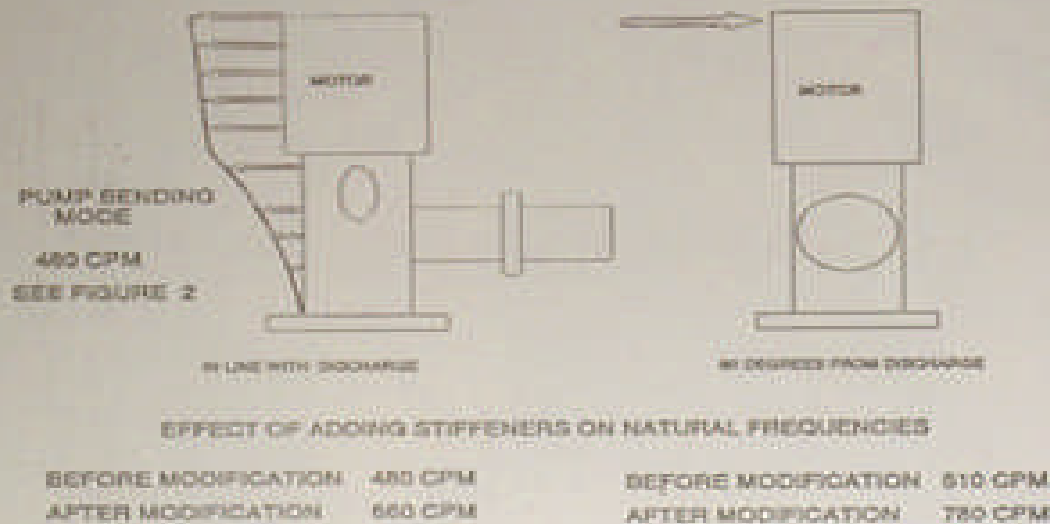
VERTICAL PUMP BENDING MODE NATURAL FREQUENCY SOLVED BY INSTALLING STIFFENERS TO ALTER NATURAL FREQUENCY

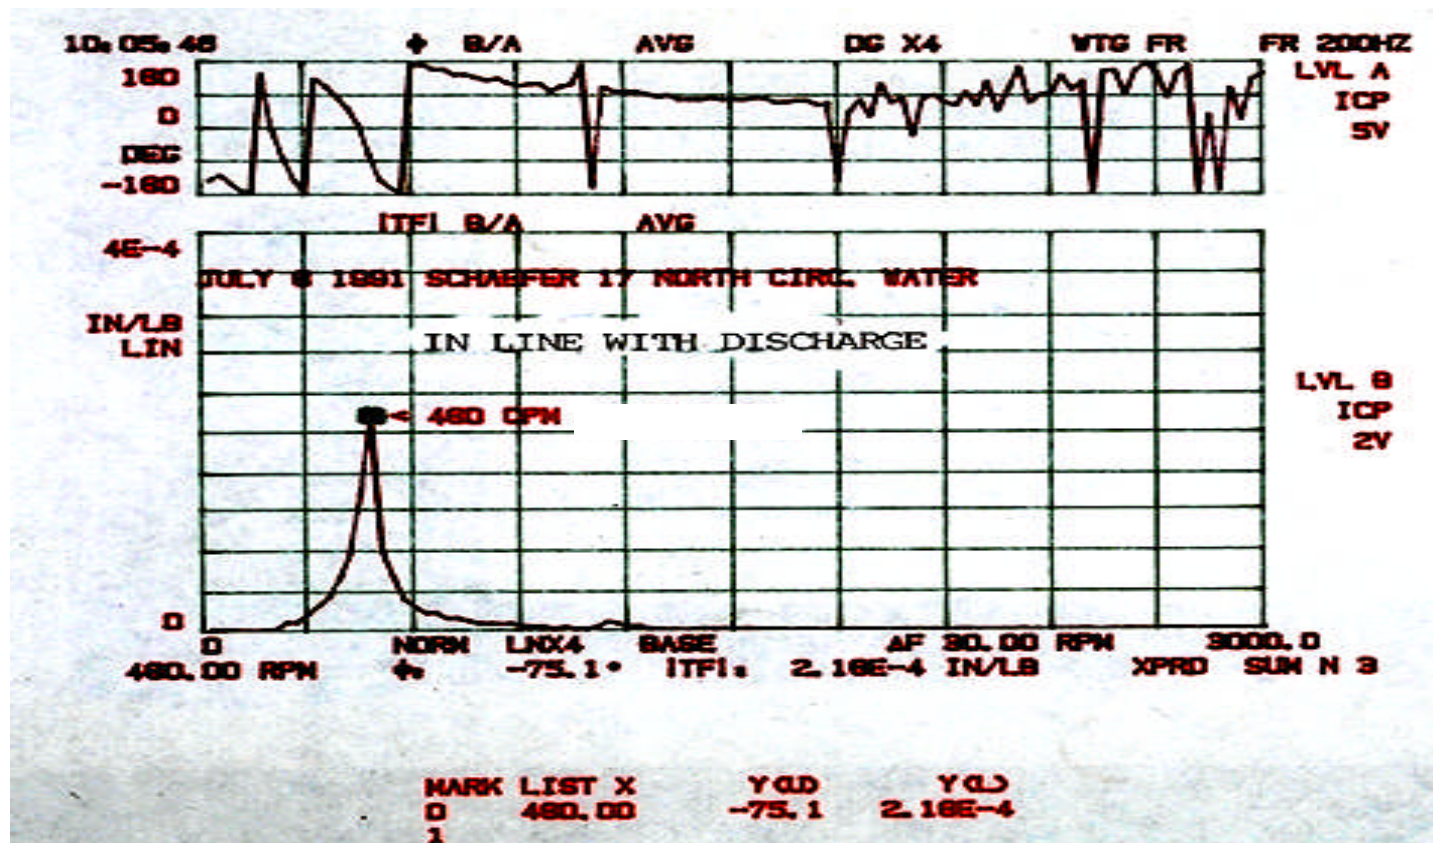
NATURAL FREQUENCY OF LARGE VERTICAL PUMP IN LINE WITH DISCHARGE

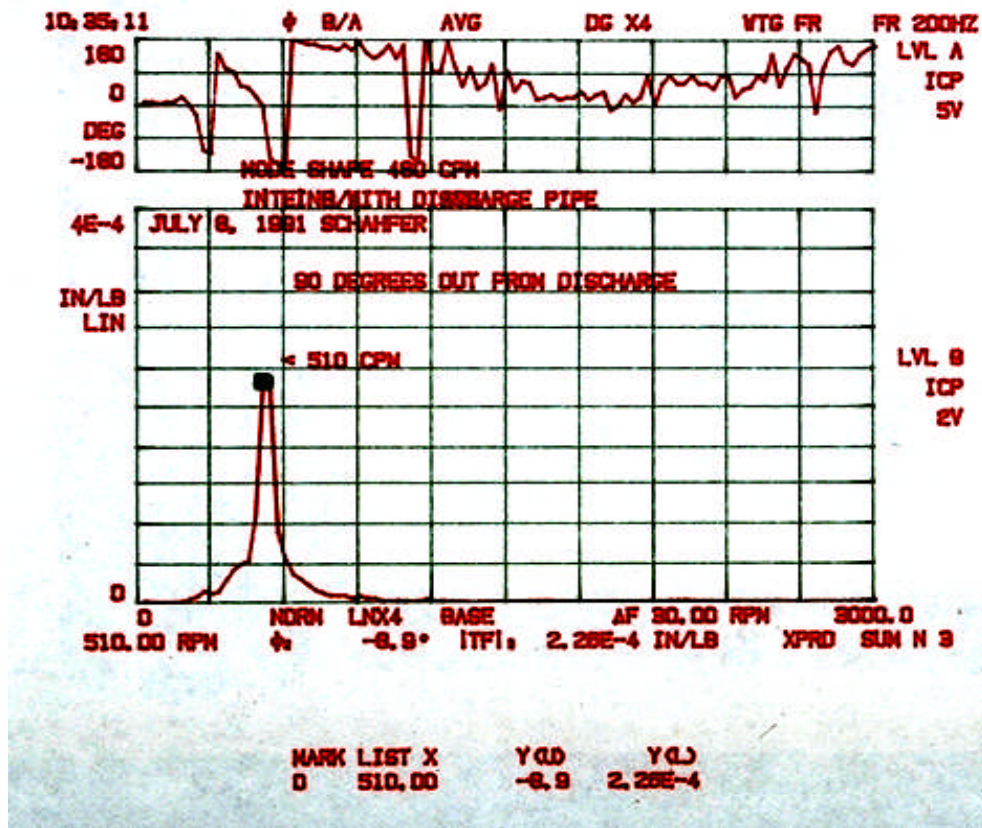
90 DEGREES OUT FROM DISCHARGE

FIGURE 3
FREQUENCY RESPONSE OF
17 NORTH PUMP 90 DEGREES
OUT FROM DISCHARGE PUMP.

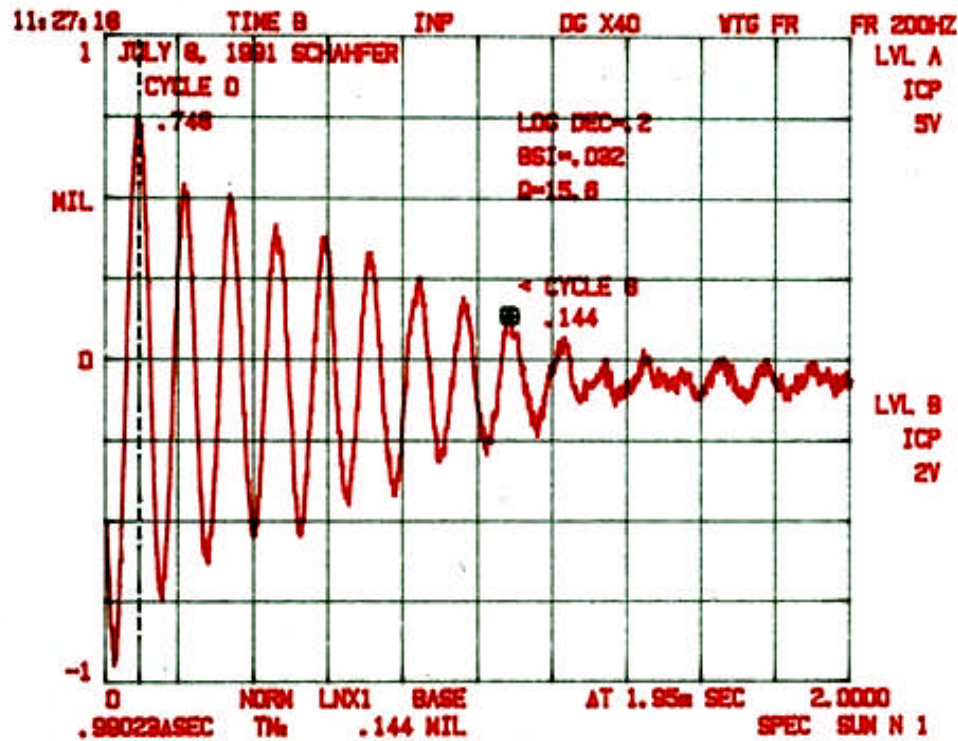
AMPLIFICATION FACTOR CALCULATION USING LOG DEC APPROACH

FIGURE 4
RESPONSE PLOT AFTER
IMPACT ON 17 NORTH
PUMP. RESPONSE INDICATES
THAT DAMPING IS LOW
RESULTING IN 16:1
AMPLIFICATION FACTOR.

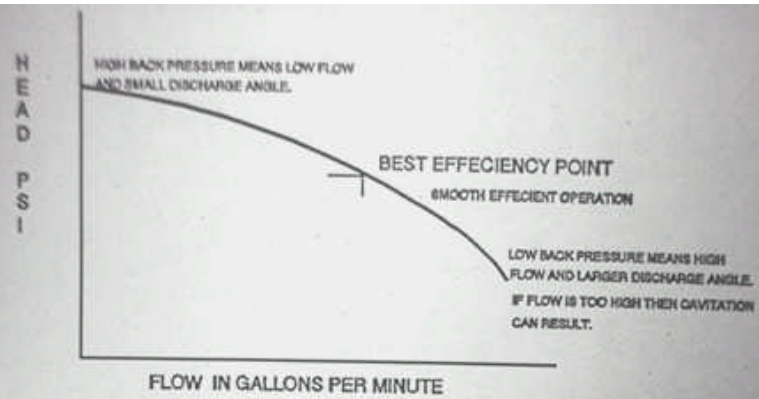
AS BACK PRESSURE IS DECREASED FLOW THROUGH PUMP INCREASES AND FLUID DISCHARGE ANGLE INCREASES.
