**POWER HOUSE FD & ID FANS
ANALYZING CONCRETE FOUNDATION RESONANCE**

Ken Singleton

**Bob McGinnis, P.E.
McGinnis Engineering LLC, Kingsport TN**

Abstract: A request was received to investigate high amplitude vibration of forced draft (FD) and induced draft (ID) fans at a coal fired power plant. Operating deflection shape analysis (ODS) and experimental modal analysis (EMA) were specifically requested. Of most concern was reported vibration amplitude over 0.40 in/sec pk on the ID Fan A outboard bearing. Steel bracing had been bolted to the ID Fan's outboard pedestals in an attempt to reduce vibration. In-place balancing had been performed but was not effective in reducing the primarily axial direction vibration. Vibration data on the motor and fan bearing housings were monitored by a System 1 online acquisition system acquiring data from velometers. Proximity probes were not installed in the fluid film bearings. During three days onsite, test data were measured that included standard vibration data, ODS, EMA and multi-channel continuous data acquisition. Natural frequencies of the outboard pedestal of ID Fan A, inadequate hold down bolt tightness, inadequate and improper bracing

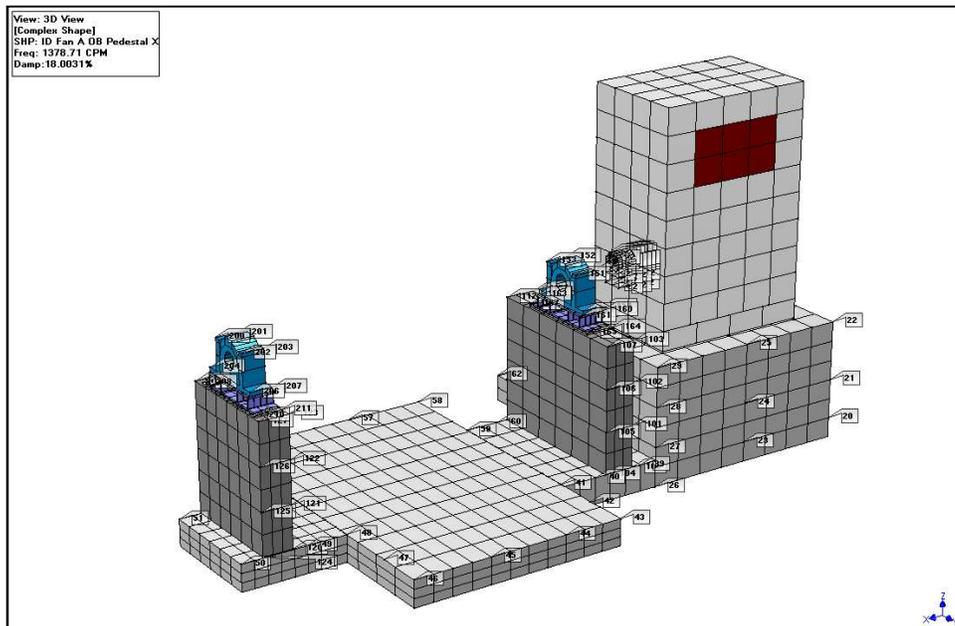
Figure 16. ME’scopeVES Model of ID Fan A.

ODS Analysis: The ODS Model was developed using ME’scopeVES [Ref 2]. The 3D computer model included the concrete foundation, concrete pedestals, motor, fan bearing housings, fabricated steel base supporting the fan bearing housings and soleplates, see **Figure 16**. ME’scopeVES provides drawing tools to develop very realistic models. Our models are typically drawn to scale as was this model.

The overall dimensions of the concrete foundation were 386” X 199”. The fan concrete pedestals were 67” wide X 18” thick X 77” tall. The model was drawn using individual components so that any relative motion

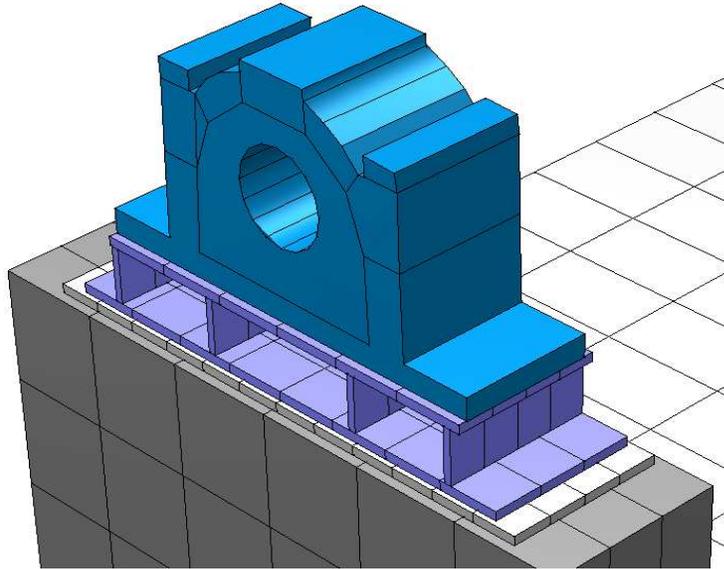
Figure 17. Detail of Fan Outboard Bearing, Fabricated Base, Soleplate and Concrete Pedestal.

could be displayed when animated. It is important to generate the model animation equations correctly in order to accurately show any relative motion between the bearing housing, fabricated base, soleplate, pedestal, etc. A close up view of the outboard bearing and pedestal ME'scopeVES model is shown in **Figure 17**.

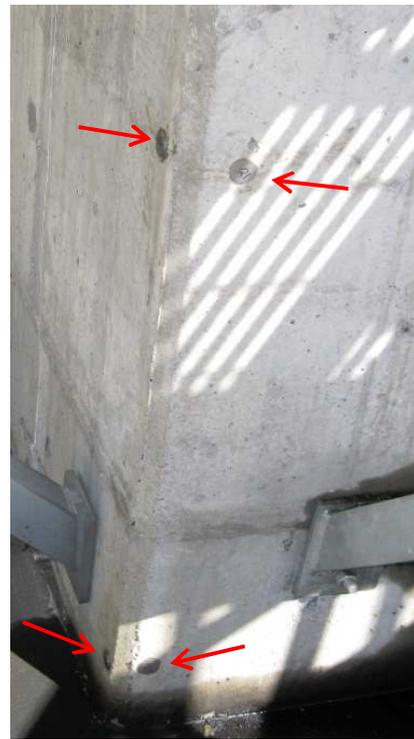
Figure 18. ID Fan A Outboard Pedestal With 410 SS Targets Epoxied.

Prior to measuring vibration data at the DOFs on the concrete, targets of 410 SS were epoxied at DOF coordinates measured using a steel tape. A recently introduced epoxy, Loctite Epoxy Metal/Concrete [Ref 1], with high strength bonding in 5 to 10 minutes was used. Approximately one hundred twenty five targets were epoxied to the concrete foundation and pedestals. ID Fan A outboard pedestal, East side is shown in **Figure 18** with epoxied targets.

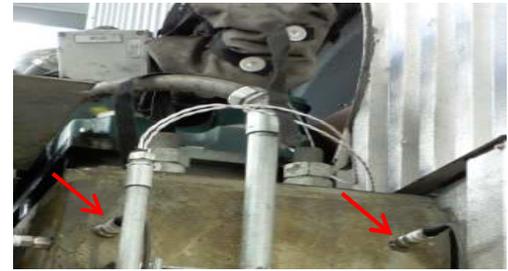
Figure 19. Flat Rare Earth Magnets Attached 500mV/g Low Frequency Accelerometers.

The ODS FRF Data were measured using a two channel CSI 2130 Analyzer and low frequency CTC AC133 500 mV/g accelerometers [Ref 5]. Flat rare earth magnets were used to attach the accelerometers to the 410 SS targets, see **Figure 19**. Data was also measured on the motor, fan bearing housings, fabricated supports and soleplates. After uploading the data to the Emerson AMS software, the ODS FRF were exported to ME'scopeVES for generation of 3D structural animations.

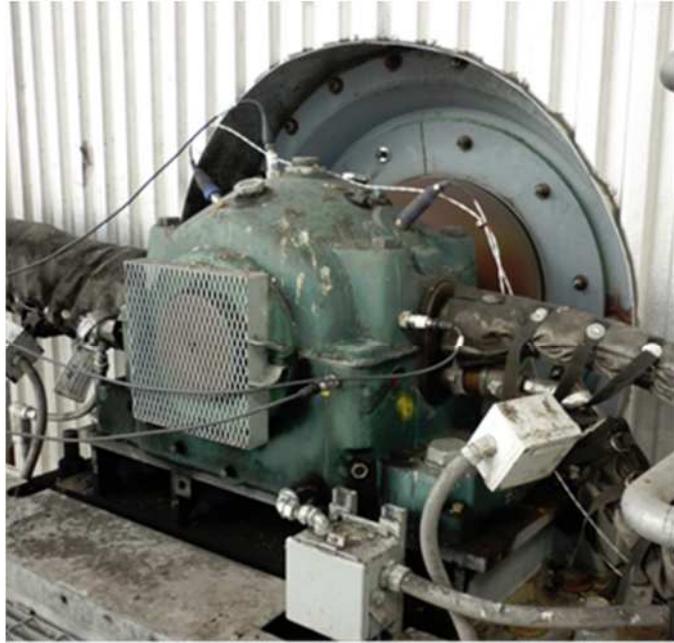
Figure 21. ID Fan A, Outboard Bearing Housing.

A photo of ID Fan A outboard bearing housing and pedestal is shown **Figure 21**.

ODS Analysis of Vibration at 2X: ODS data at 2X rotor run speed showed much higher amplitude vibration of the outboard bearing housing and pedestal. The ME'scopeVES model is shown in **Figure 24** with some DOF labeled with vibration amplitude. Slippage of the soleplate on the concrete pedestal was indicated which could be caused by inadequate tightness of the anchor bolts. Continual slippage would wear the grout.

- Bearing pedestal rocking side-to-side (Y Axis) and axially (X Axis) with highest amplitude vibration at 2X run speed.
 - Bearing pedestal low amplitude vibration relative to the concrete foundation.

- Bearing housing relative slippage to the steel fabricated base indicating inadequate bolt tightness.
3. Experimental modal test data measured on ID Fan A outboard bearing pedestal indicated the following:

5. Insure that the Dodge Sleeve Bearing plunger bolts are torqued to 3600 in/lb_f = 300 ft/lb_f as stamped on the plunger stud.
 6. Remove the steel bracing connecting the ID Fan A & B outboard pedestals. Replace with individual bracing bolted to a massive concrete pad per drawings, see **Figure 35 & 36**. Install the pedestal reinforcing plates per **Figure 35**.

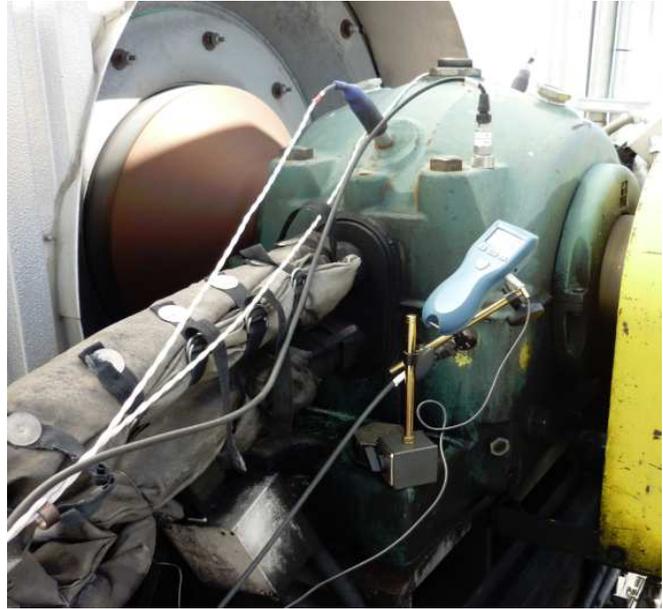
Figure 23. ID Fan A Inboard Bearing.

The ODS model of the inboard bearing housing, fabricated base, soleplate and pedestal are shown in **Figure 22**. Some DOF are labeled with vibration amplitude at 1X. Low amplitude slippage of the bearing housing on the fabricated steel base was indicated by the ODS data. However, very little relative vibration of the soleplate to the concrete was indicated.

A photo of ID Fan A inboard bearing housing is shown in **Figure 23**. The laser tachometer used to generate a once per revolution signal for our multi-channel data acquisition system is also shown in **Figure 23**. A piece of reflective tape had been attached to the shaft by a previous consultant.

2. ODS Data measured on ID Fan A indicated the following:
 - Fan IB Bearing Position:
 - Bearing housing steel fabricated base and soleplate showed low amplitude slippage relative to the concrete pedestal. Inadequate tightness of the anchor bolts was indicated.

- Bearing housing low amplitude slippage on the steel fabricated base indicated inadequate tightness of the bearing housing hold down bolts.
 - Fan OB Bearing Position:

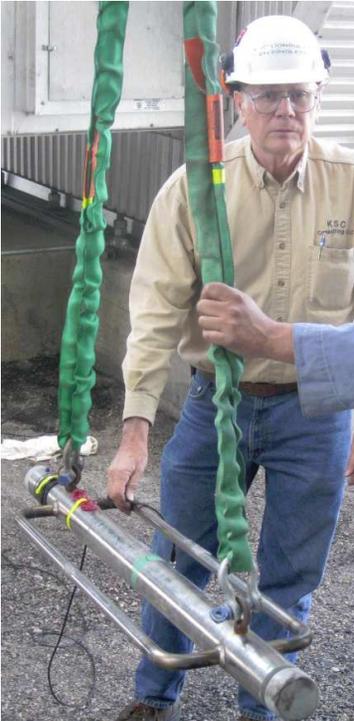
Figure 26. Author (Singleton) With Steel Ram Equipped With 50,000 lb_r Force Head Supported by Nylon Slings.

ID Fan A Outboard Bearing Pedestal Modal Test: The outboard bearing pedestal was modal tested using a 130 lb_f steel ram with a 50,000 lb_f force head stud mounted. A soft grey tip was attached to the force head to limit the excitation frequency band width from about 0 to 10,000 CPM. The ram was supported by Nylon slings and a motorized man lift, see **Figures 26 & 27**.

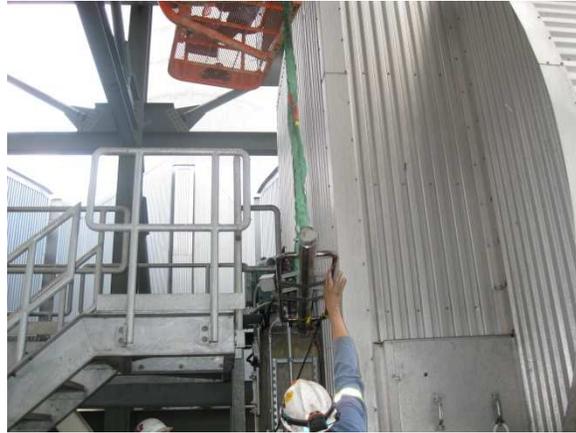
Figure 27. ID Fan A, OB Bearing Pedestal. Modal Test in Y Direction (Side-to-Side).

The pedestal modal test in the Y (side-to-side) direction, see **Figure 27**, was conducted by impacting with the force head at the top of the concrete pedestal at one corner. Impacts were on the left side (as viewed from the motor). Response was measured with low frequency CTC AC133 500 mV/g accelerometers magnetically attached to the 410 SS targets. Eight FRF were measured along both sides of the pedestal taking five averages for each DOF. The magnitude portion of the FRF driving point with units of g/lb_f is shown in **Figure 28**. The cursors in the plot are located at the fan 1X and 2X frequencies. Curve fitting the data found the following:

- Natural frequency at 1432.84 CPM with 14.59 % of critical damping.
- Natural frequency at 2508.71 CPM with 3.20 % of critical damping.

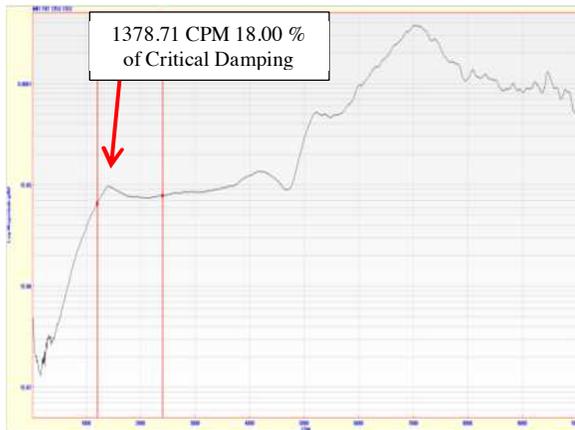
**Figure 28. ID Fan A, OB Pedestal FRF Reference
DOF 135X:135X.**

The modal test in the axial direction (X) was conducted by impacting the base of the bearing housing since the concrete pedestal was not accessible, see **Figure 29**. The driving point FRF is shown in **Figure 30**. The cursors are located at the fan's 1X and 2X run speed frequencies. Curve fitting the FRF data found the following:

- 1378.71 CPM 18.0 % of Critical Damping (Just above 1X)
- 5107.24 CPM 3.85 % of Critical Damping
