Mariners' Alerting and Reporting Scheme

MARS Report No 362 December 2022

Deadly MOB while rigging pilot combination ladder

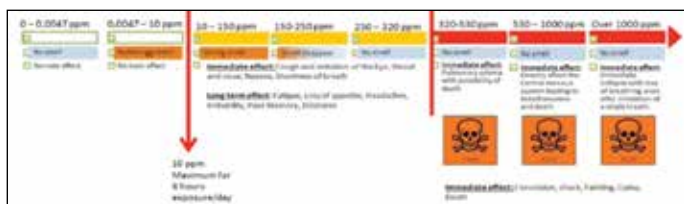
Seawater in bilge tanks, and in particular engine room bilges, mixed with other residues and bio-degradable detergents created conditions favourable for the formation of dangerous levels of H2S gas.

Very! The pictogram below found on the referenced Safety Alert gives an excellent idea of the consequences (see the full alert for full size version). Even 10 ppm is acceptable only if exposure is restricted to eight hours per day.

Anything at or above 320 ppm is dangerous or lethal and cannot be detected by smell.
