Mariners' Alerting and Reporting Scheme

MARS Report No 363 January 2023

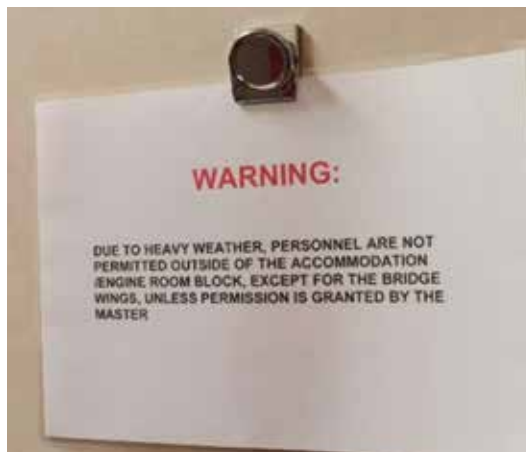
The Bosun was seen lying on the walkway near the port anchor winch, but the Chief Officer was still not visible. The general alarm was sounded and an announcement was made. The vessel was slowed yet further and manoeuvred to have the waves astern, at which point a rescue team went forward. The rescue team found the Chief Officer and Bosun as indicated on the diagram and the victims were brought to the ship's hospital.

The investigation found that a wave, significantly higher than the observed waves, hit the vessel while the Chief Officer and the Bosun were at the bow. The investigation also found, among other things, that communication by portable satellite phone was not possible from the ship's hospital. Radio Medical Advice (RMA) was received by satellite phone on the bridge, but the hospital was five decks below. Immediate and critical medical treatment of the victims based on communications with RMA had to be relayed verbally from the bridge satellite phone to the caregiving personnel in the hospital either by internal phone, or in person. The report did not speculate on whether having communications directly to the ship's hospital would have made a difference in saving lives.

- Even when a wave pattern is coming from what appears to be one direction, it can combine with other wave patterns and occasionally create a wave that is significantly higher than the observed average.
- When observed average wave height is approximate to the vessel's freeboard, extreme caution should be taken when going on deck. An errant wave could sweep the deck with terrible consequences.
