AMP gauges at the dash are troublesome.

They should be by-passed, and then install a VOLT gauge.

by Mark Hamilton

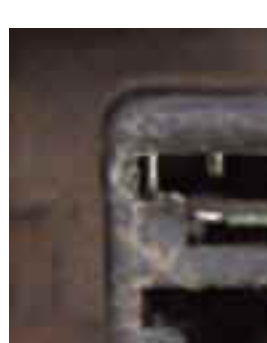
The original tape has been removed for this photo to expose the "welded splice."

Pressure and heat fused the copper wire strands together when making the splice. The method seems to be reliable, as in thirty years of workshop experience the author has never seen a failure with this splice. When electrical power loss occurs, this is certainly not the first place to look for the problem.
