Fouries Home Inspection

COMPLETE HOME INSPECTION
Prepared Exclusively For: Sample Report

1234 Somewhere, County, TX,

Inspected by Paul Fourie, Lic.#: 22325 on 04/14/2018
Phone: (972)989-2479, Email: paul@fourieshomeinspection.com

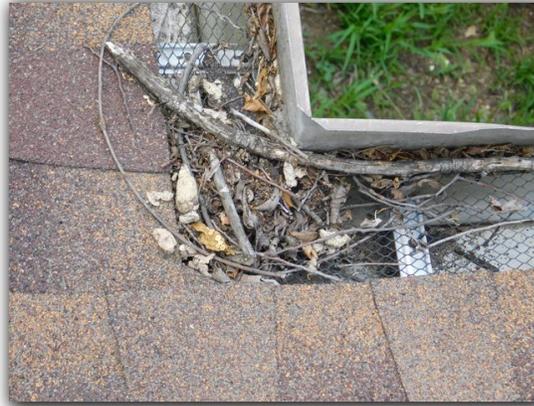
The gutters and downspouts contained leaves and other debris and should be cleaned out to allow for proper drainage.

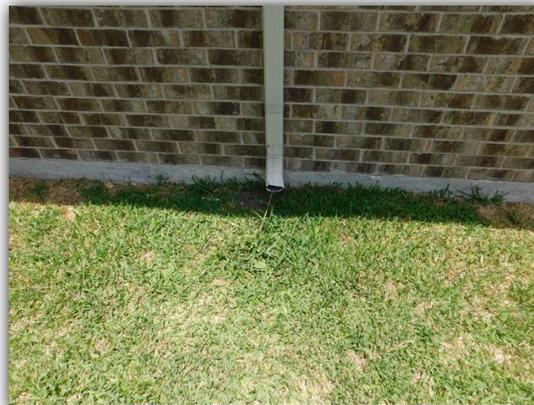
All gutter downspouts should have downspout extensions or splash blocks installed to move run off water away from the foundation and to prevent erosion. Missing splash blocks and downspout extensions should be replaced.

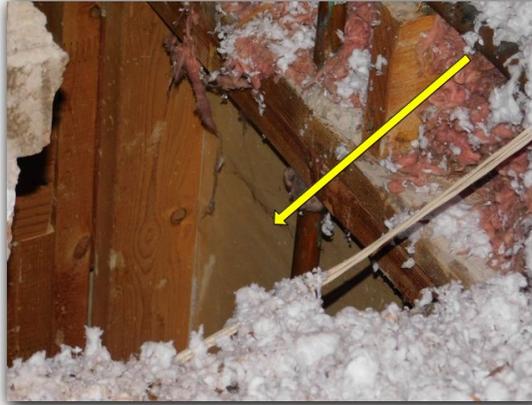
Insulation voids were observed in the attic space. Insulation voids may allow greater than normal loss of conditioned air and should be repaired.

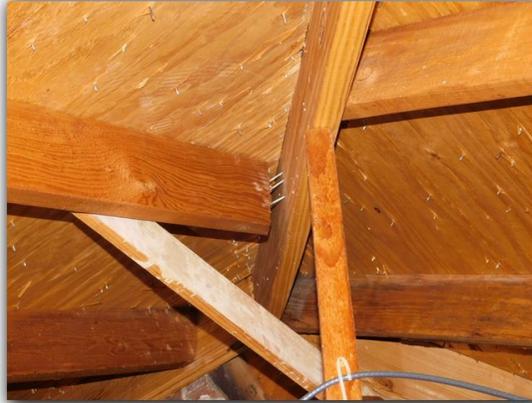
Separations between roof framing members was observed which is an indication of structural movement, settlement, inadequate workmanship or other defects. The cause of separations between roof framing members should be determined. The inspector recommends that an expert in this field be consulted for further evaluation of the structure and foundation and to provide suggestions as to what, if any, corrective actions should be taken.

- ☑ Separations between roof framing members was observed which is an indication of structural movement, settlement, inadequate workmanship or other defects. The cause of separations between roof framing members should be determined. The inspector recommends that an expert in this field be consulted for further evaluation of the structure and foundation and to provide suggestions as to what, if any, corrective actions should be taken.

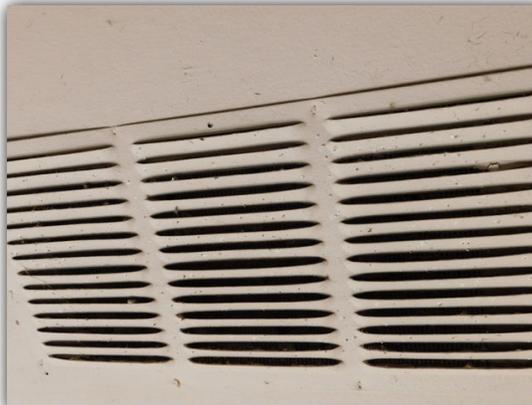
Soffit vents were observed to be dirty, blocked by insulation or debris. Clogged soffit vents are an indication of inadequate attic ventilation and should be repaired as needed.

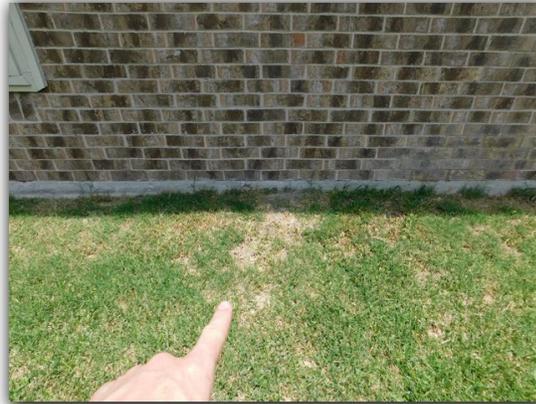
Weep holes were missing at the lower brick of the exterior walls. Weep holes should be installed and properly spaced to provide proper wall ventilation.

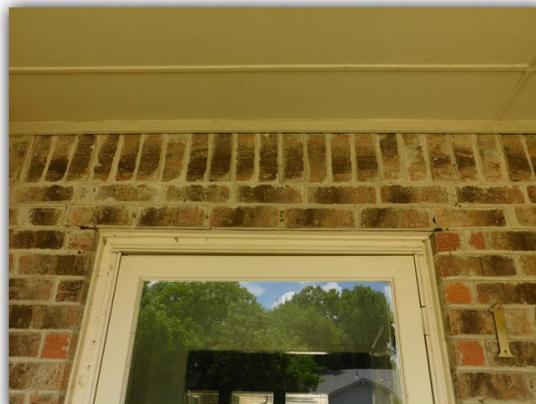
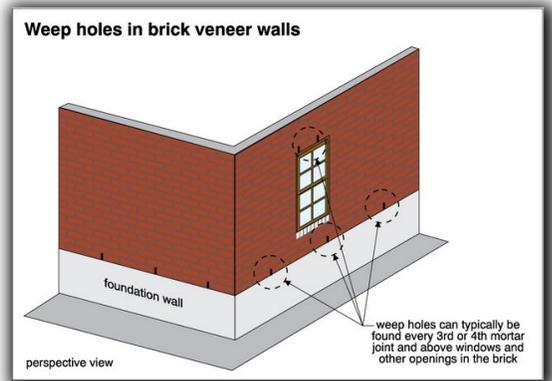
Weep holes were not installed in the brick masonry above the exterior doors in required locations. This may be an "as-built" condition, however, under current building standards, weep holes should be installed in the brick/stone masonry above exterior doors to provide proper wall ventilation.

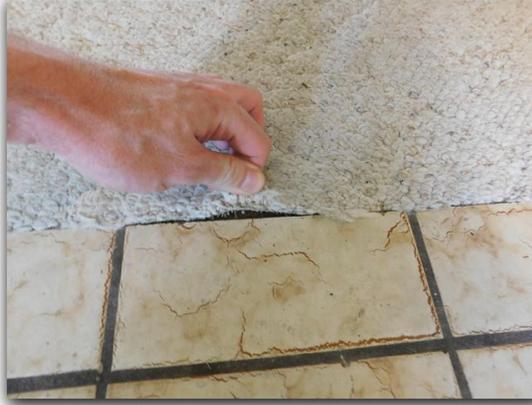
Missing floor covering transition strips should be repaired to avoid additional damage and trip hazards.

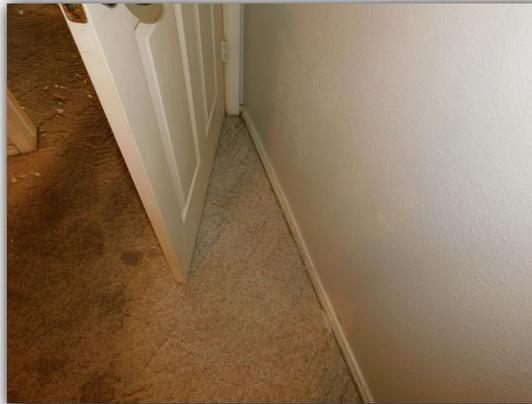
All interior doors should have door stops installed to prevent damage to adjacent interior wall coverings.

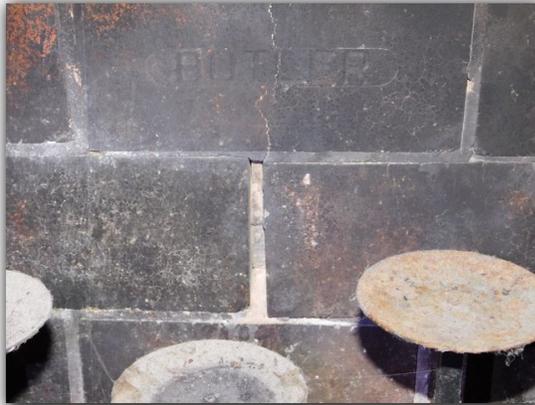
The fireplace firebox brick and or brick mortar have been damaged. Damaged firebox brick or mortar may allow heat to transfer to flammable materials and is a SAFETY HAZARD that should be repaired by a qualified fireplace specialist.

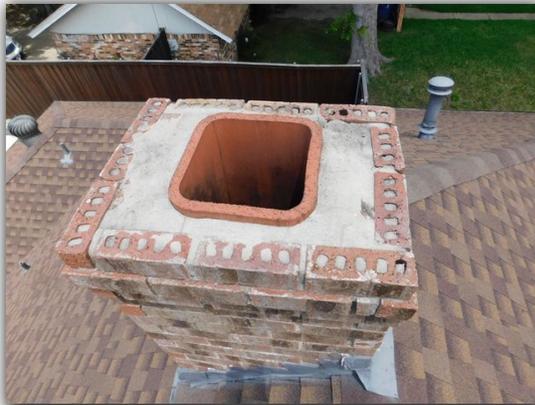
The fireplace chimney lacks a metal cap and spark arrestor. This condition should be further evaluated and corrected as necessary. Masonry chimney caps are often not visible and are known to crack which allows moisture to penetrate the structure. Masonry chimney caps are considered inadequate by current building standards and should be replaced with metal caps.

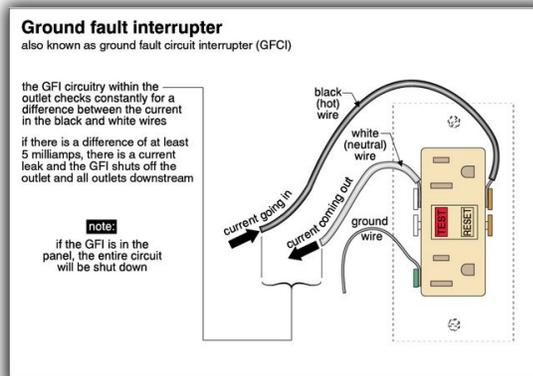
Kitchen counter top electrical receptacles were observed to lack ground fault circuit interrupter (GFCI) device protection. Under current electrical standards, all of the kitchen counter top receptacles should have GFCI protection. Lack of GFCI protection in required locations is a SAFETY HAZARD.

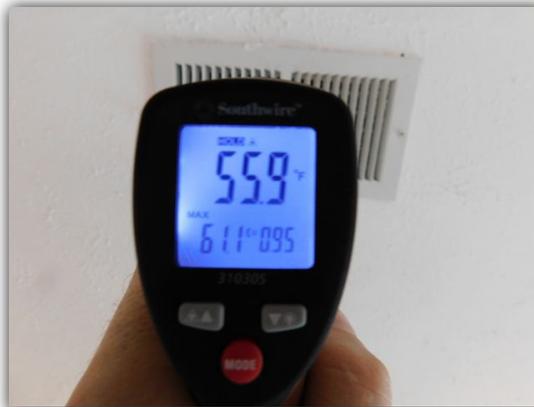
Return Air Temp: 75.0 °F

Temp. Differential: 19.1 °F

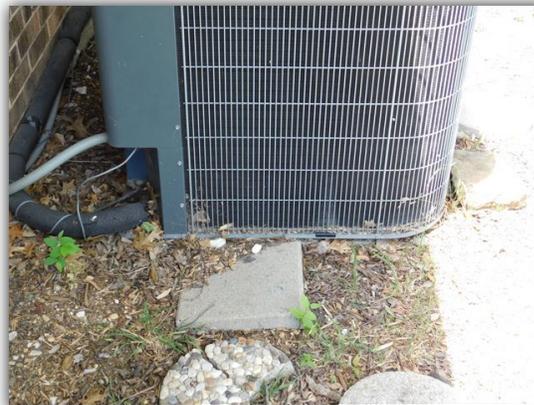
The exterior HVAC equipment was not installed 3" above grade and was in need of repair. Inadequate elevation of the exterior HVAC equipment may allow moisture to penetrate the equipment, reduce equipment life and may affect performance.

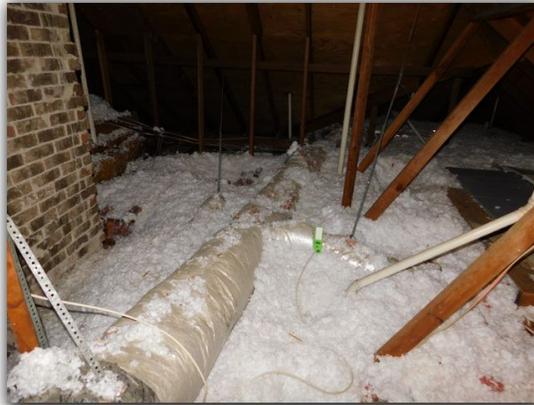
The ductwork was installed with inadequate support. Inadequately supported ductwork can reduce or block air flow at HVAC registers. Unsupported ductwork may be an "as-built" condition and was an accepted building practice at the time this home was constructed. Under current building standards this condition is a deficiency and should be corrected.

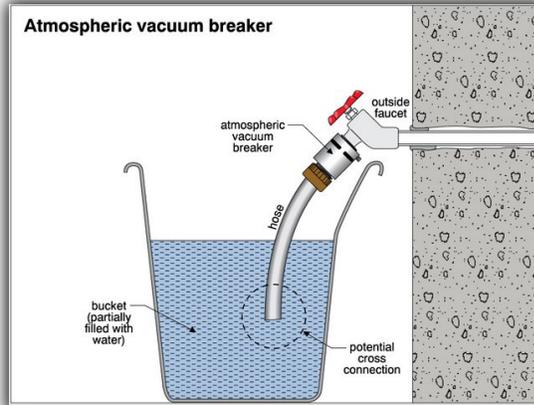
Exterior water supply faucets were missing an anti-siphon device to prevent contaminants from entering the water supply. Lack of anti-siphon devices at exterior water supply faucets is a SAFETY HAZARD. Current building standards require non-removable vacuum breakers on all hose faucets.

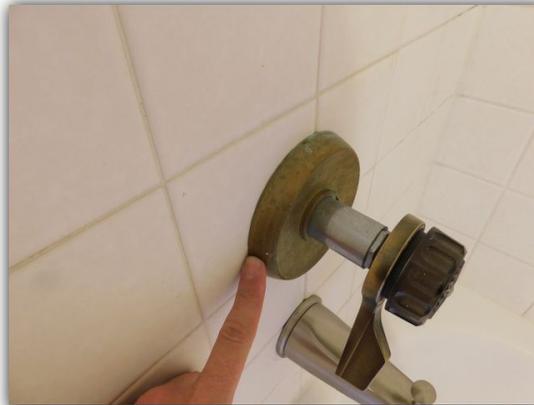
The tub/shower water supply fixtures lacked adequate sealant at the wall. Tub/shower water supply fixtures should be properly sealed at the wall to prevent water damage.

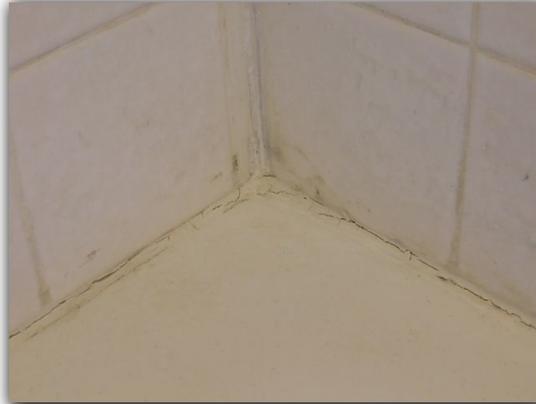
The tub/shower tile grout and sealants were observed to be in need of repair or replacement to prevent water penetration at interior walls. When tub/shower tile grout and sealants are damaged, there may be concealed water damage and or wood destroying insect damage.

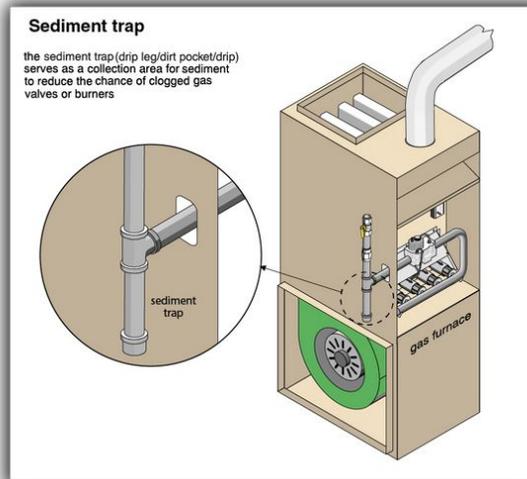
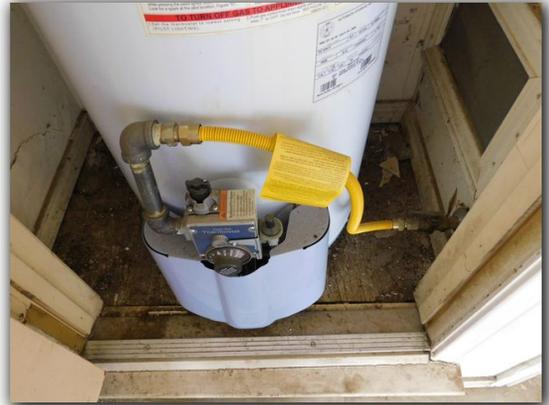
There were gas fired appliances that did not have a "drip leg" installed. Under current construction standards, drip legs are required at the black iron gas pipe prior to a flexible gas line connection.

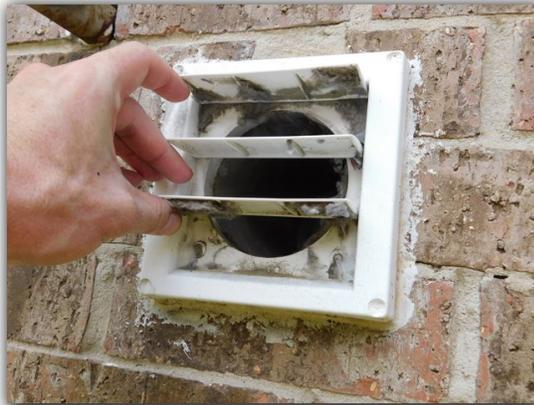
The dryer vent and duct were in need of cleaning. Flammable lint and other debris should be removed from the dryer vent and duct for reasons of SAFETY.
