Fouries Home Inspection

1 YEAR WARRANTY HOME INSPECTION

1234 Somewhere, , TX,

Inspected by Paul Fourie, Lic.#: 22325 on 06/05/2018
Phone: (972)989-2479, Email: paul@fourieshomeinspection.com

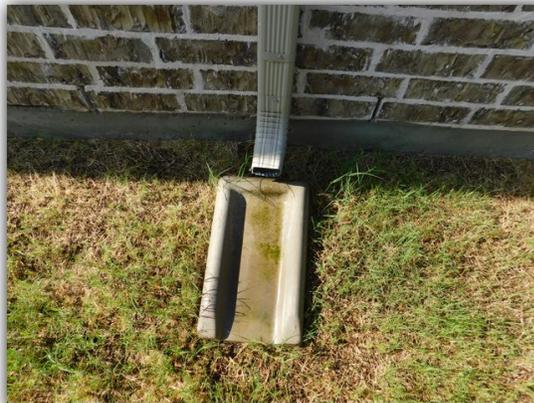
The rain gutter downspout splash blocks were installed backwards. Splash blocks that are installed backwards do not perform as intended and may contribute to erosion.

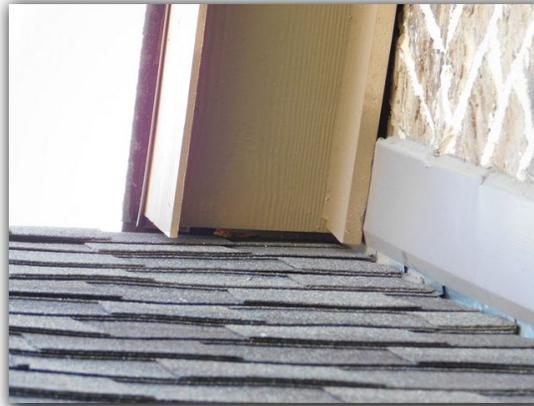
Openings in the eave returns (areas where the soffit meets an adjoining roof surface) should not be large enough to allow entry by pests according to industry standards.

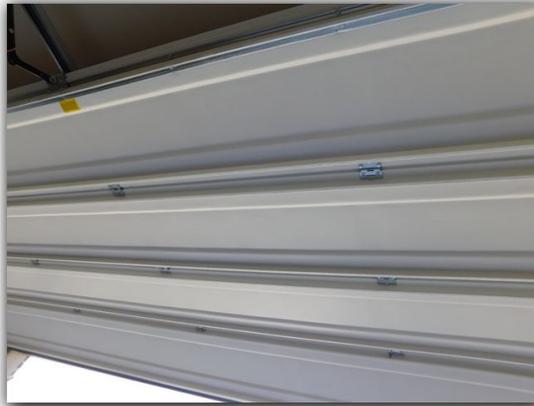
The overhead garage door appeared to lack a lift handle. Garage overhead doors should have installed at least one interior lift handle in accordance with manufacturer's instructions.

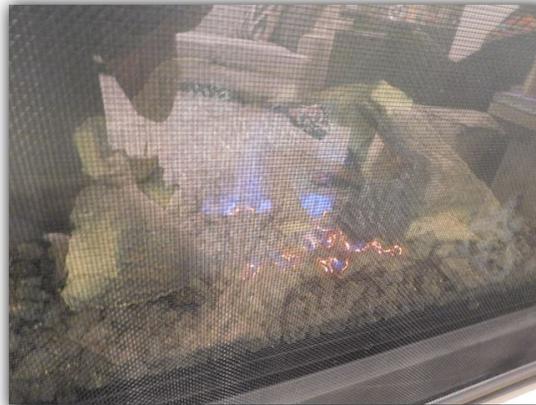
The visible areas of the fireplace and chimney were inspected according to today's Texas Standards of Practice and were performing as intended at the time of the inspection.

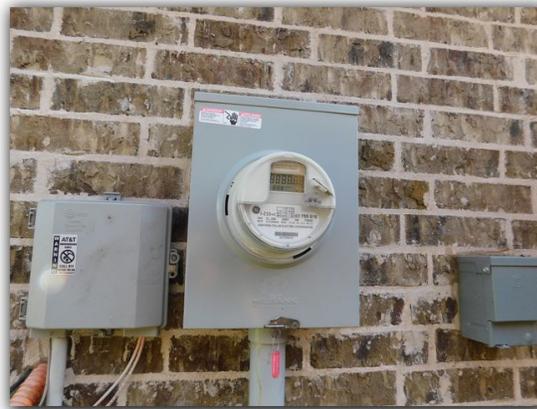
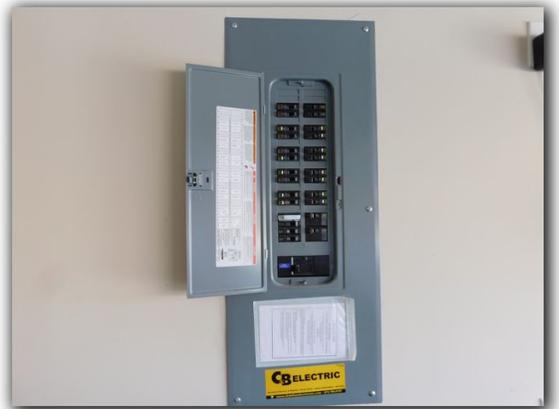
Location: Garage

The main electrical service entrance and service panel was inspected according to today's Texas Standards of Practice and was performing as intended at the time of the inspection.

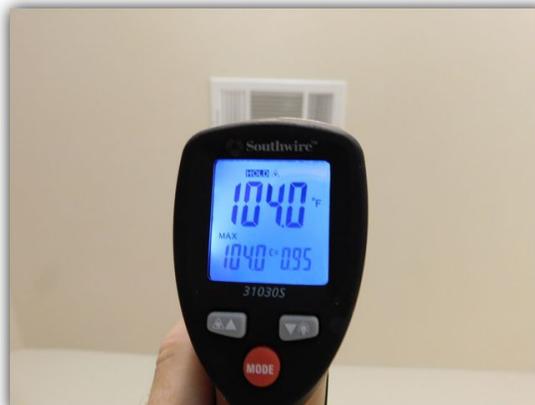
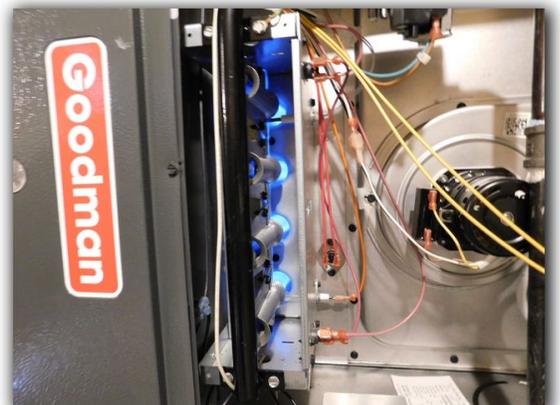
The heating equipment temperature output reading: 104.0 °F

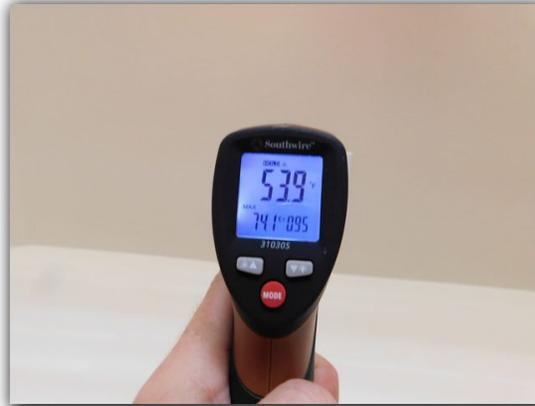
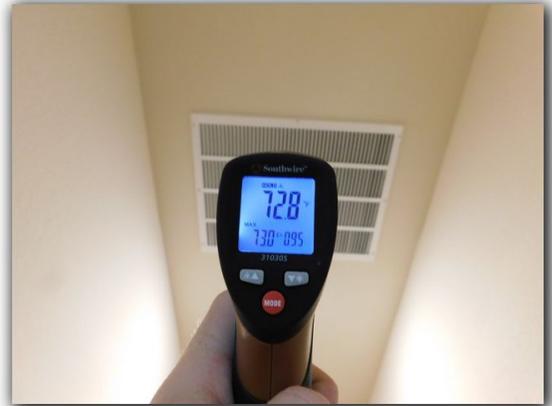
Temp. Differential: 18.9 °F

Debris was observed in the cooling equipment condensation drain pan. Debris should be removed from the cooling equipment condensation drain pan to prevent clogging of the drain and or drain plumbing. Clogged cooling equipment condensation drain pans or plumbing may result in water damage or other defects.

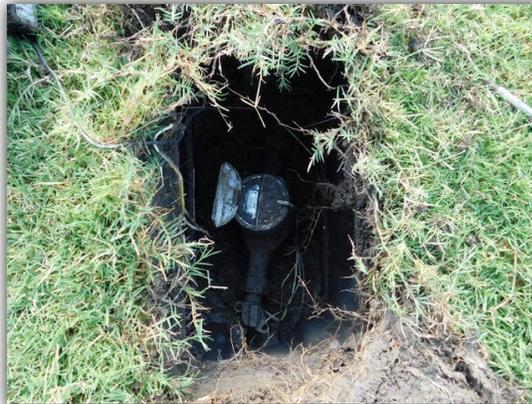
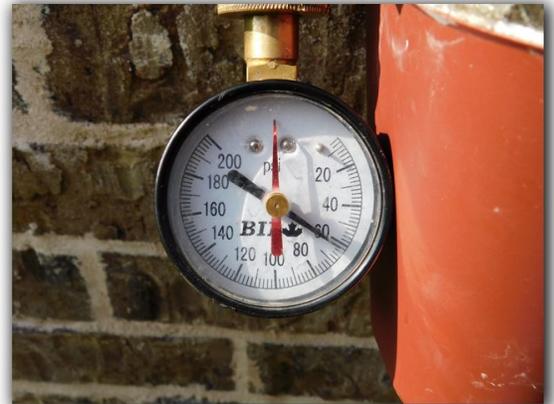
Location of Main Water Valve: At The Water Meter

Static Water Pressure: 60-70 psi

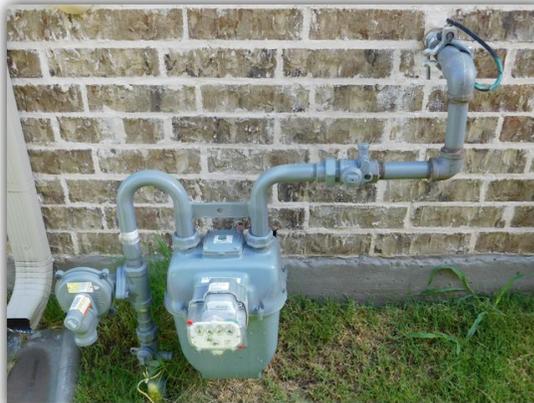
The gas supply system was inspected according to today's Texas Standards of Practice and was performing as intended at the time of the inspection.

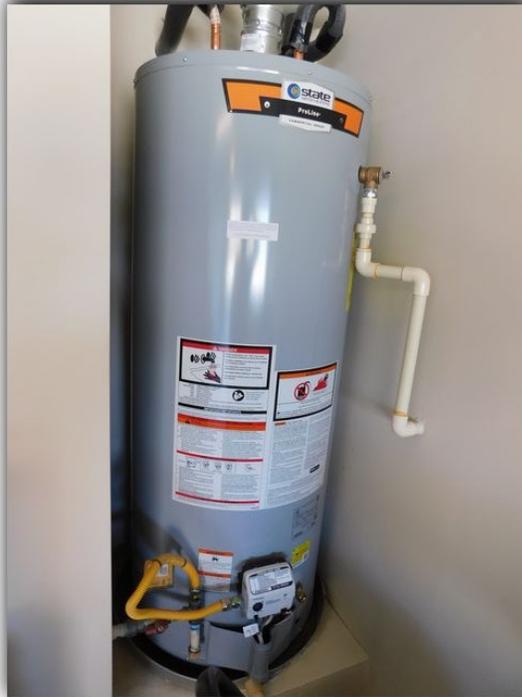
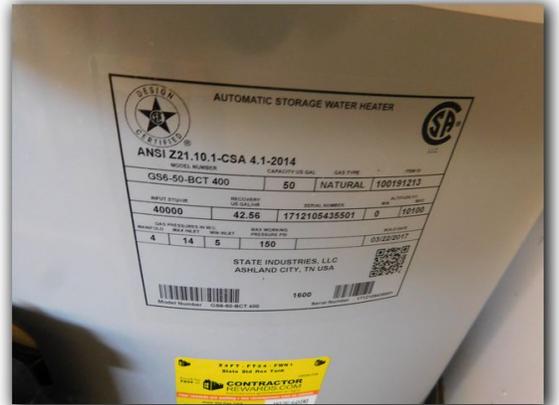
The water heating equipment was inspected according to today's Texas Standards of Practice and or local code and was performing as intended at the time of the inspection.

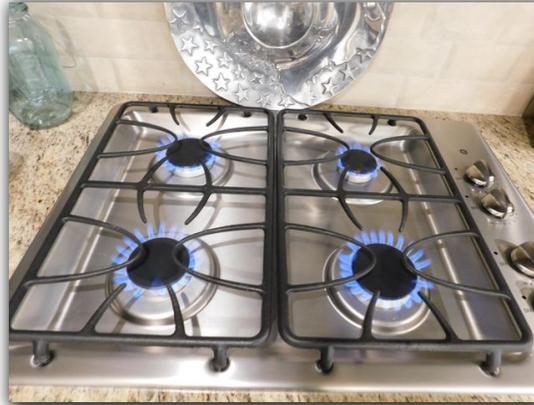
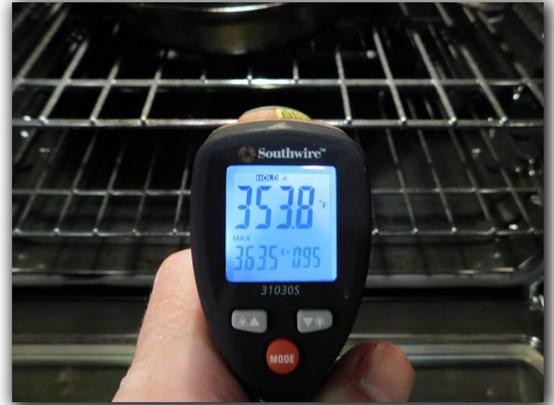
The range, cooktop and ovens were inspected according to today's Texas Standards of Practice and or local code and were performing as intended at the time of the inspection.

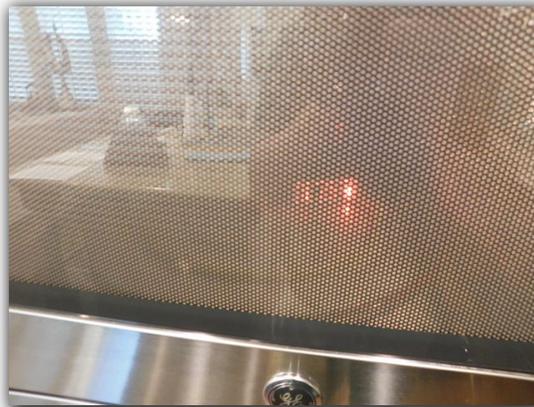
The microwave oven was inspected according to today's Texas Standards of Practice and or local code and was performing as intended at the time of the inspection.

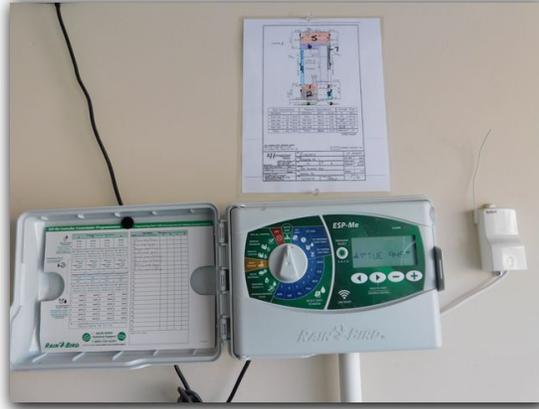
The landscape irrigation system was inspected according to today's Texas Standards of Practice and or local code and was performing as intended at the time of the inspection.
