# Fouries Home Inspection

COMPLETE HOME INSPECTION  
Prepared Exclusively For: Sample Report

1234 Somewhere, County, TX,

Inspected by Paul Fourie, Lic.#: 22325 on 04/14/2018  
Phone: (972)989-2479, Email: paul@fourieshomeinspection.com

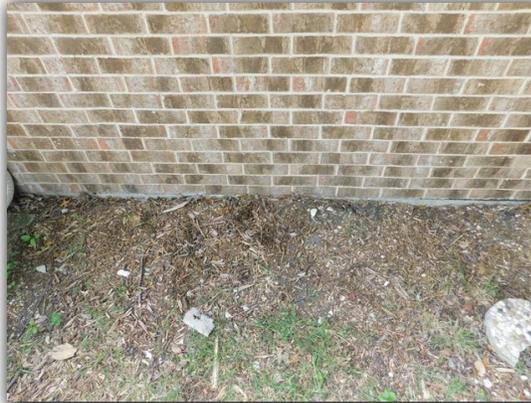
High soil levels were observed at the foundation/brick line. 4 to 6 inches of the foundation perimeter beam should be visible. High soil levels may block weep holes and prevent proper wall ventilation. High soil levels create conducive conditions for wood destroying insects and water intrusion. High soil levels prevent the inspector from observing the foundation perimeter beam. Correction of inadequate grading clearance to exterior wall and foundation surfaces is recommended.

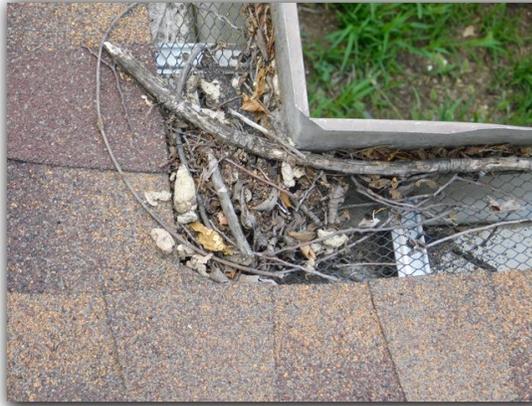
The gutters and downspouts contained leaves and other debris and should be cleaned out to allow for proper drainage.

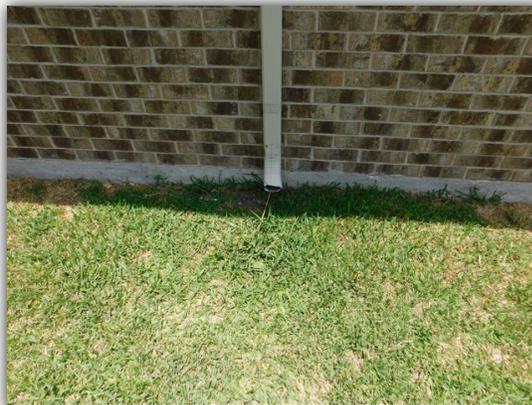
All gutter downspouts should have downspout extensions or splash blocks installed to move run off water away from the foundation and to prevent erosion. Missing splash blocks and downspout extensions should be replaced.

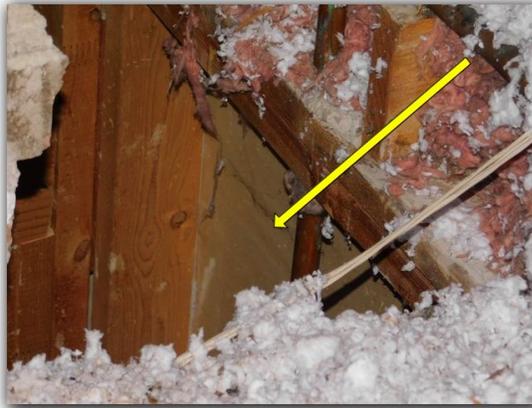
Insulation voids were observed in the attic space. Insulation voids may allow greater than normal loss of conditioned air and should be repaired.

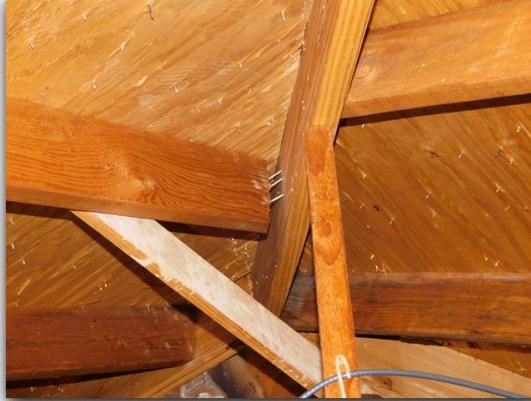
Separations between roof framing members was observed which is an indication of structural movement, settlement, inadequate workmanship or other defects. The cause of separations between roof framing members should be determined. The inspector recommends that an expert in this field be consulted for further evaluation of the structure and foundation and to provide suggestions as to what, if any, corrective actions should be taken.

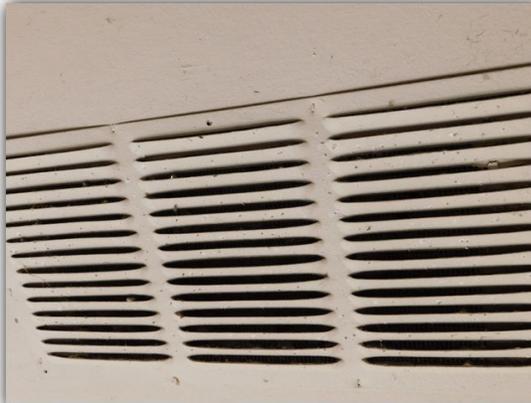
Soffit vents were observed to be dirty, blocked by insulation or debris. Clogged soffit vents are an indication of inadequate attic ventilation and should be repaired as needed.

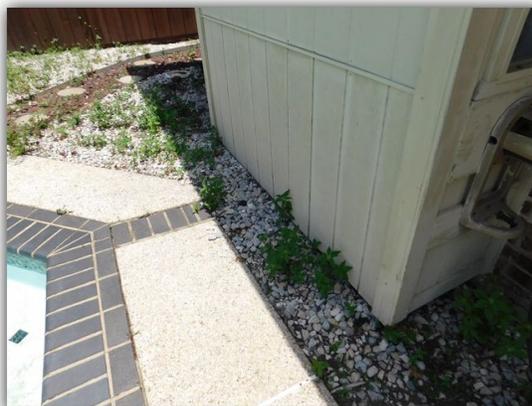
Inadequate clearance between the exterior wall cladding and grade (high soil or mulch) was observed. Inadequate clearance between the exterior wall cladding and grade should be corrected to prevent conducive conditions for wood destroying insects, water intrusion and deterioration of exterior siding materials.

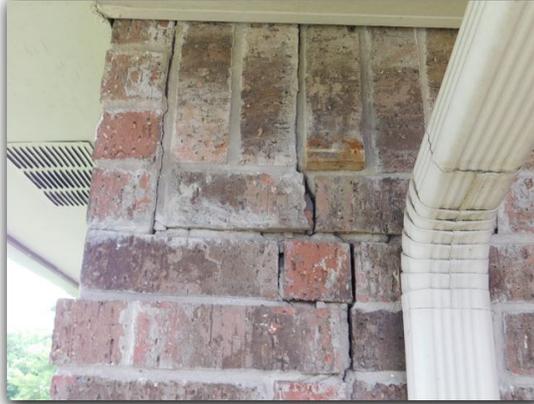
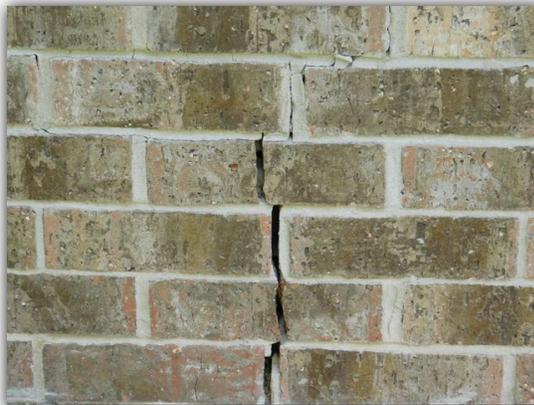
Multiple cracks in the exterior brick veneer masonry walls were observed. These cracks in the exterior brick veneer wall cladding were an indication that greater than normal movement or settlement has occurred. Further evaluation of the foundation and structure by a certified, licensed foundation and structural specialist is recommended prior to closing.

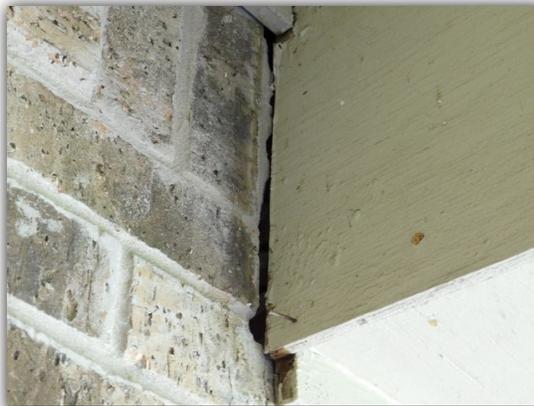
Exterior sealants (caulking) were deteriorated or missing in some areas. Sealants applied in appropriate locations prevents moisture intrusion and insect penetration.

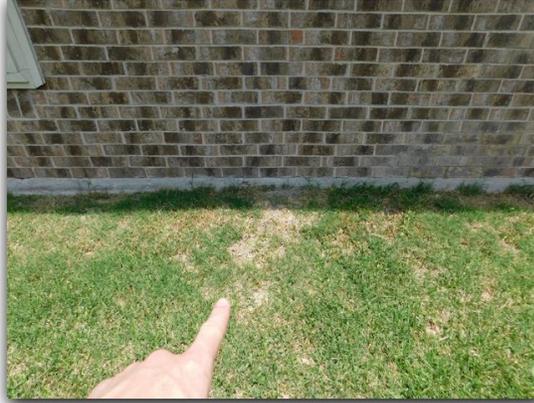
Weep holes were missing at the lower brick of the exterior walls. Weep holes should be installed and properly spaced to provide proper wall ventilation.

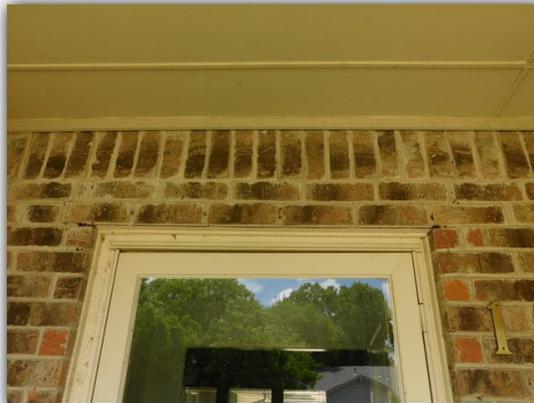
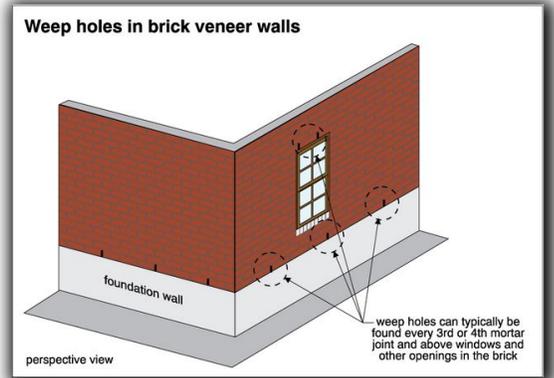
Weep holes were not installed in the brick masonry above the exterior doors in required locations. This may be an "as-built" condition, however, under current building standards, weep holes should be installed in the brick/stone masonry above exterior doors to provide proper wall ventilation.

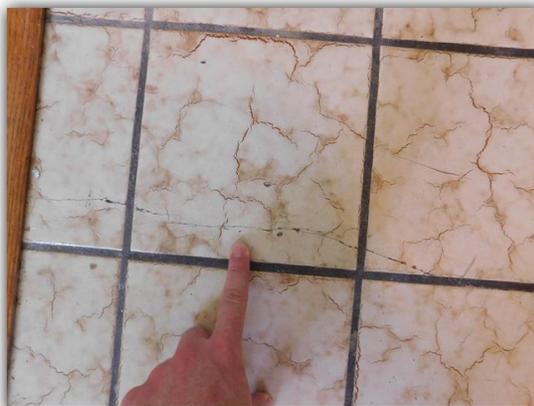
Linear cracks in floor tiles were observed. Linear cracks in floor tiles may be an indication of movement, settlement, improper installation or other defects. The cause of linear cracks in floor tiles and grout should be further evaluated and repaired as needed.

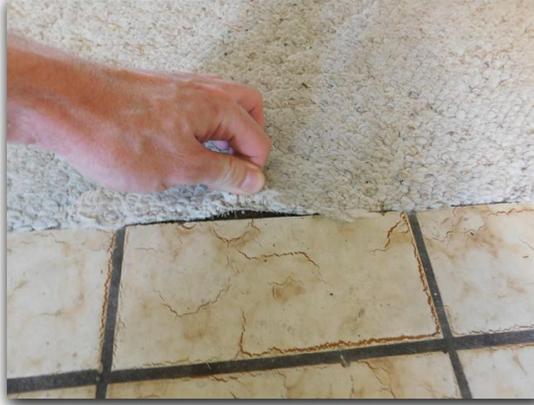
Missing floor covering transition strips should be repaired to avoid additional damage and trip hazards.

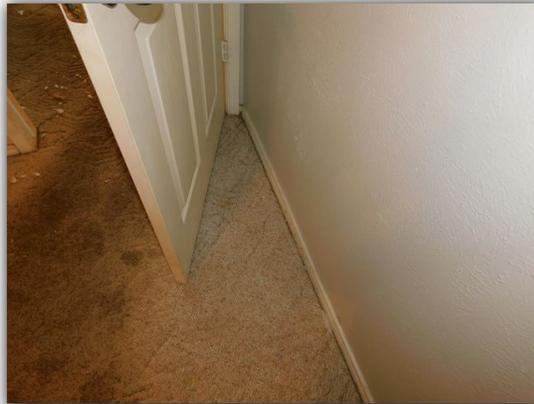
All interior doors should have door stops installed to prevent damage to adjacent interior wall coverings.

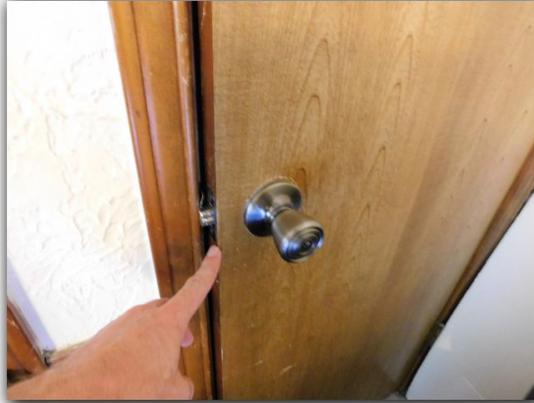
- Interior doors which do not latch as intended should be repaired.

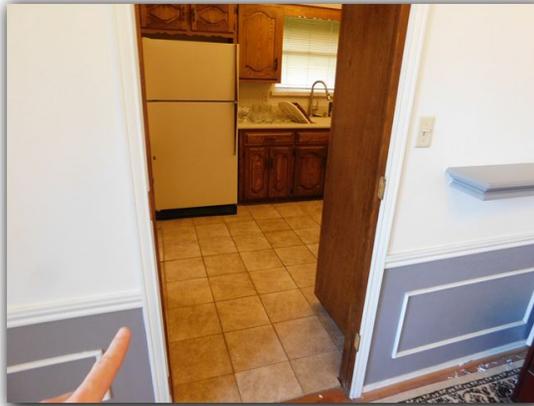
- There were missing interior doors. Missing interior doors should be replaced or the door frame should be repaired if a door has been permanently removed.

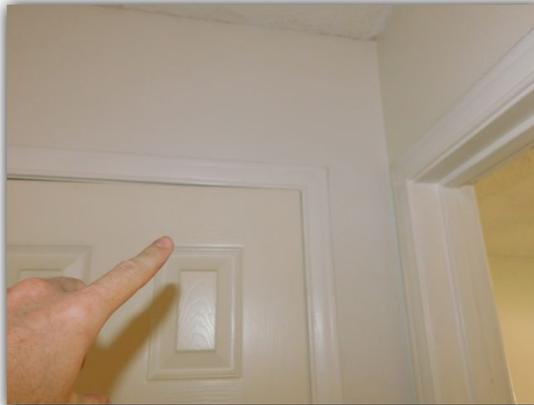
- Interior doors were observed to rub, stick or hit the door frames. Interior doors, that stick or hit the door frame may be an indication of movement, settlement or other defects. The cause of doors sticking or hitting door frames should be determined and repaired as needed.

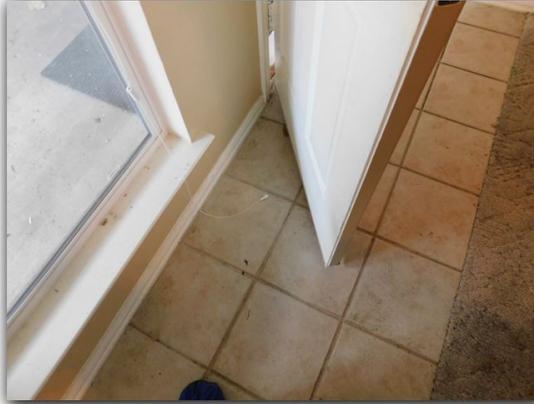
All exterior doors should have door stops installed to prevent damage to adjacent interior wall coverings.

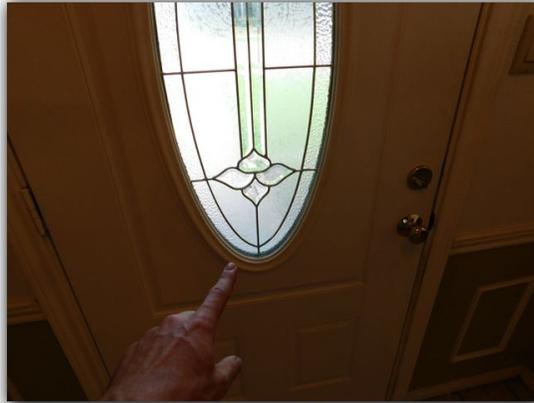
Safety glass was not installed in exterior doors in required locations. Lack of exterior door safety glass in required locations is a SAFETY HAZARD.

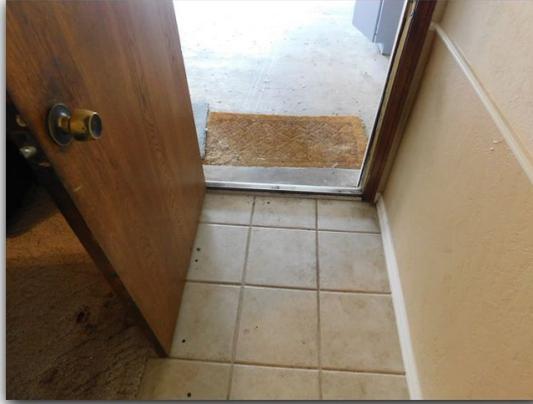
Garage entry doors should have installed self closing hinges according to today's Texas Standards of Practice - This may be an "as-built" condition and was an accepted building practice at the time this home was constructed. Per Texas Standards of Practice we are required to report this condition as a deficiency because it is no longer an excepted building standard.

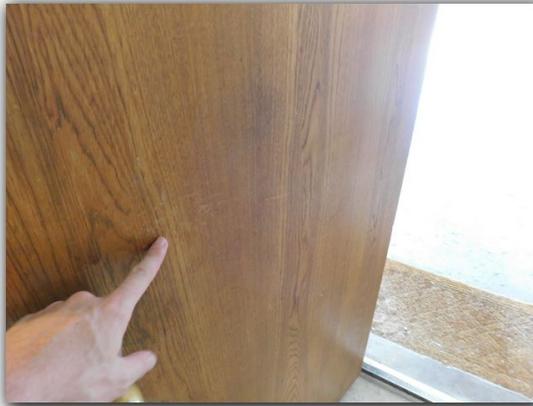
The garage entry door was observed to be a non-fire rated door. Under current building standards, the entry door between the garage and the living area should have a minimum of a 20-minute fire block rating for improved FIRE SAFETY. Lack of a fire rated garage entry door is a SAFETY HAZARD.

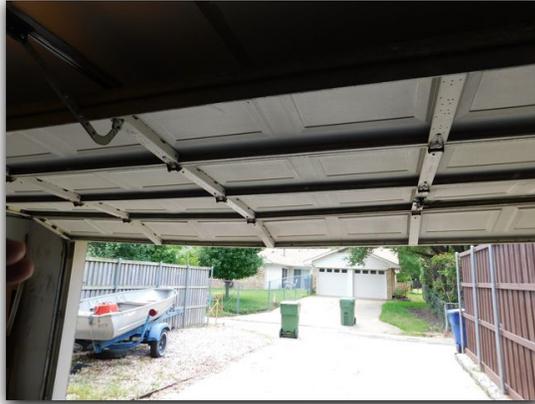
Sagging garage door panels were observed. The cause of sagging garage door panels should be determined and repaired or replaced as needed.

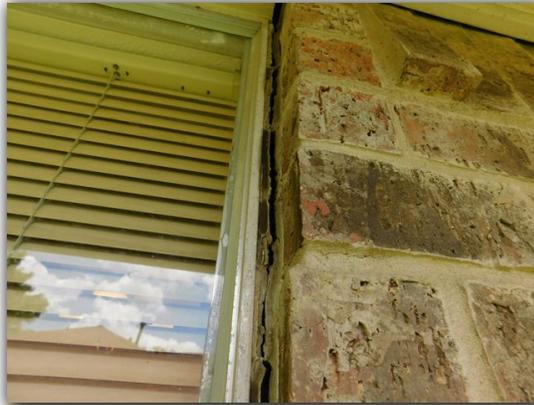
The windows need sealant between the window frames and exterior wall cladding. Lack of, damaged or deteriorating sealant around window frames may allow moisture and insect penetration and should be repaired as needed.

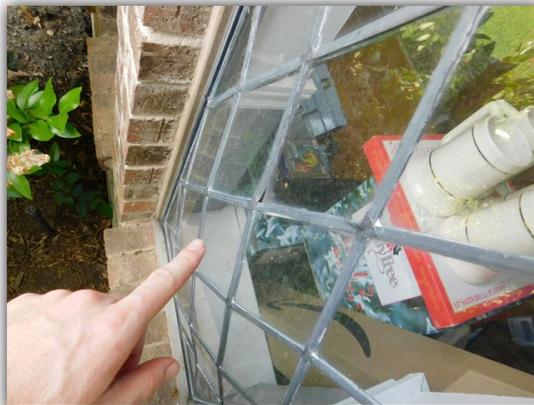
Damaged leaded glass window were observed. Damaged leaded glass window should be repaired or replaced.

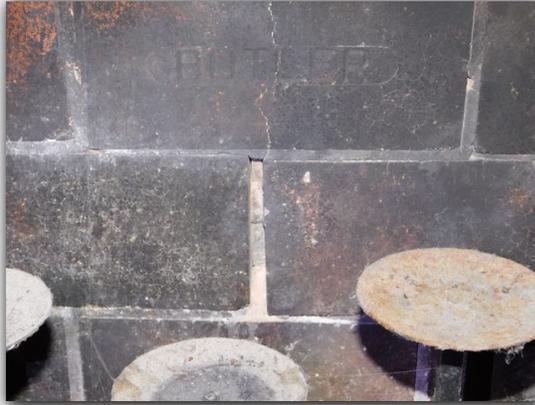
The fireplace firebox brick and or brick mortar have been damaged. Damaged firebox brick or mortar may allow heat to transfer to flammable materials and is a SAFETY HAZARD that should be repaired by a qualified fireplace specialist.

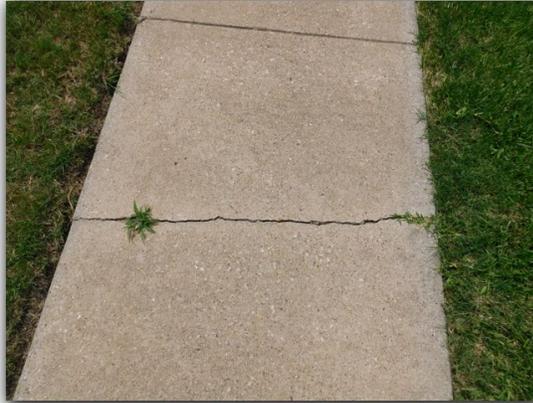
Cracks were observed in the poured concrete such as sidewalks, driveways, garage floors, porches and or patios. Cracks in poured concrete may be an indication of material defects, lack of maintenance, movement or settlement. Cracks and other defects in poured concrete should be repaired and monitored over time for movement, deflection and deterioration.

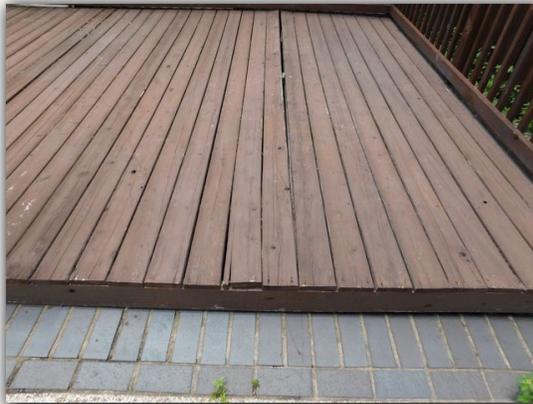
Weathered, deteriorated and damaged wood deck materials were observed and should be repaired or replaced as needed.

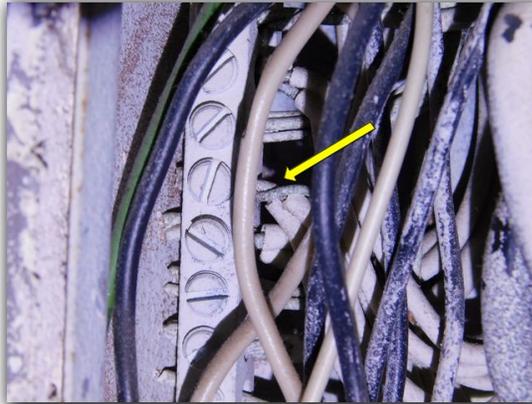
Neutral electrical conductors were observed to be “double tapped” on the neutral bus bar in the electric service panel. Each neutral electrical conductor in the electric service panel should terminate individually unless the terminals are made for more than one conductor. Double tapped neutral electrical conductors should be further evaluated and repaired as needed by a qualified electrical specialist.

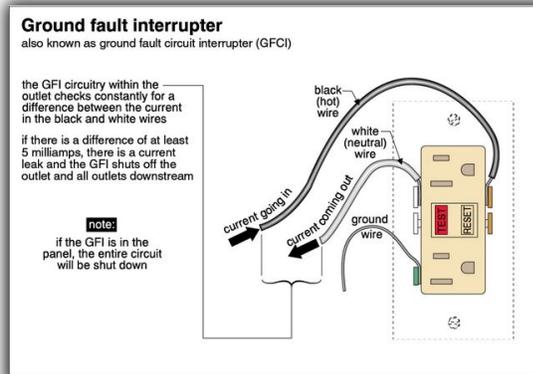
Kitchen counter top electrical receptacles were observed to lack ground fault circuit interrupter (GFCI) device protection. Under current electrical standards, all of the kitchen counter top receptacles should have GFCI protection. Lack of GFCI protection in required locations is a SAFETY HAZARD.

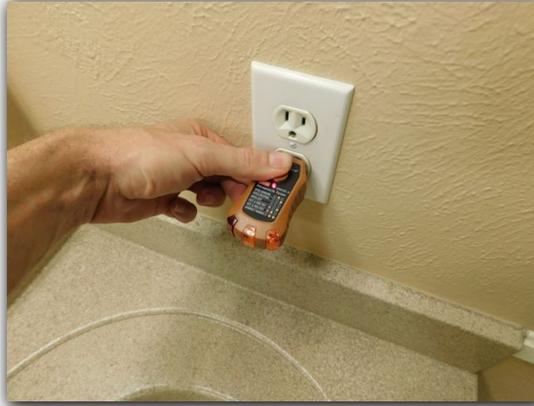
Bathroom electrical receptacles were observed to lack ground fault circuit interrupter (GFCI) device protection. Under current electrical standards, all of the bathroom receptacles should have GFCI protection. Lack of GFCI protection in required locations is a SAFETY HAZARD.

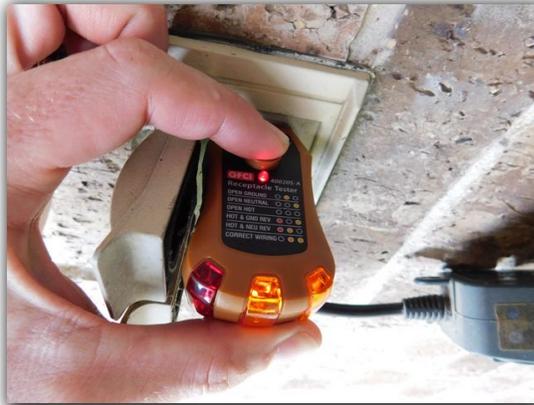
Exterior electrical receptacles were observed to lack ground fault circuit interrupter (GFCI) device protection. Under current electrical standards, all of the exterior receptacles should have GFCI protection. Lack of GFCI protection in required locations is a SAFETY HAZARD.

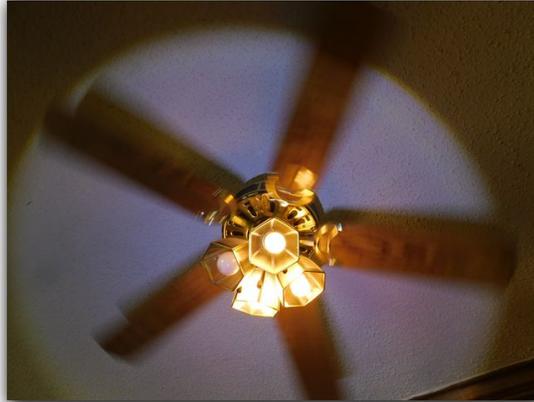
Light fixtures that are inoperative, missing bulbs or have burned out bulbs should be repaired or replaced as needed.

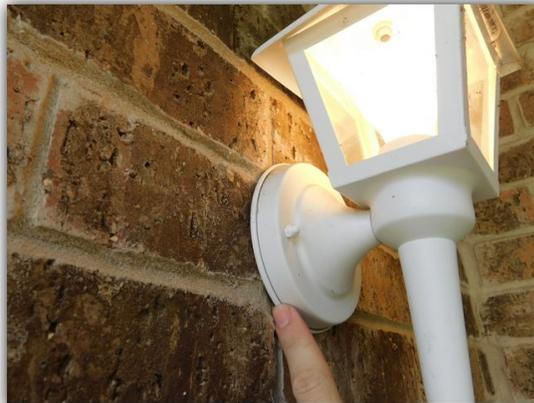
Exterior light fixtures should be sealed at the wall to prevent water intrusion for reasons of SAFETY.

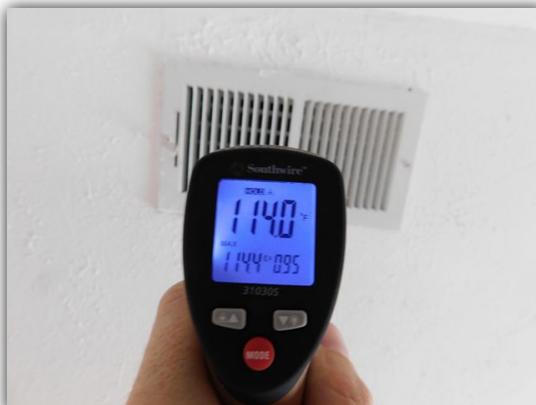
- Unit 1: Attic  
 Within Normal Range    Inadequate - In need of service, repair or replacement  
The heating equipment temperature output reading: 114.0 °F

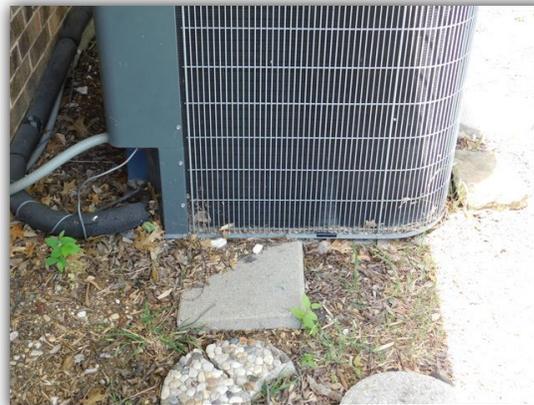
- The HVAC cooling line service valve caps were missing. The service valve caps prevent dirt, debris and damage to the service valves and should be replaced.

- The HVAC condenser unit coil fins were dirty and in need of service, repair or replacement. Dirty or damaged HVAC equipment coil fins may result in equipment damage, inadequate performance, reduced equipment life or other defects.

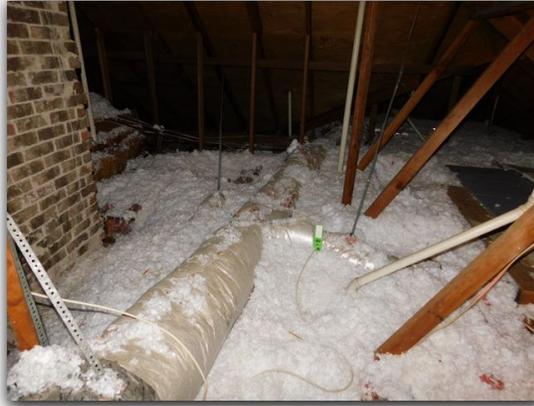
The ductwork was installed with inadequate support. Inadequately supported ductwork can reduce or block air flow at HVAC registers. Unsupported ductwork may be an "as-built" condition and was an accepted building practice at the time this home was constructed. Under current building standards this condition is a deficiency and should be corrected.

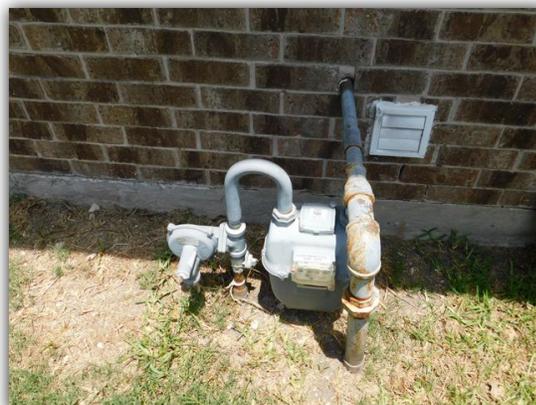
There were gas fired appliances that did not have a "drip leg" installed. Under current construction standards, drip legs are required at the black iron gas pipe prior to a flexible gas line connection.

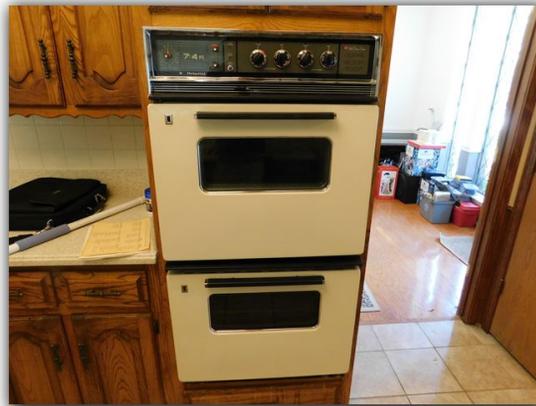
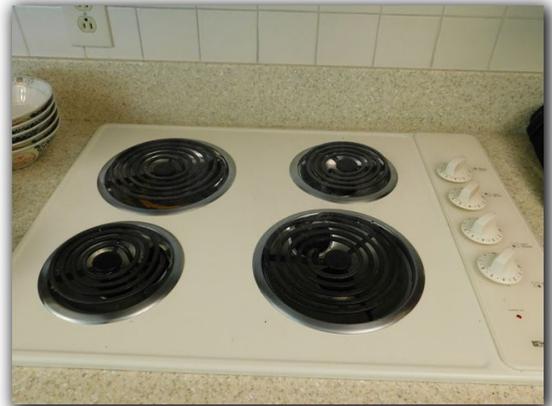
It is the opinion of this Inspector, the range, cooktop and or ovens are an older component and the future life expectancy cannot be determined. You can continue to use and service this component until replacement is necessary.

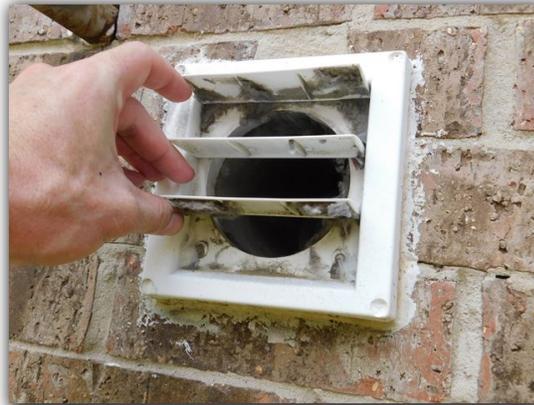
The dryer vent and duct were in need of cleaning. Flammable lint and other debris should be removed from the dryer vent and duct for reasons of SAFETY.
