Fouries Home Inspection

NEW HOME INSPECTION
Prepared Exclusively For: First Name Last Name

9999 Somewhere, Dallas, TX,

Inspected by Paul Fourie, Lic.#: 22325 on 07/18/2018
Phone: (972)989-2479, Email: paul@fourieshomeinspection.com

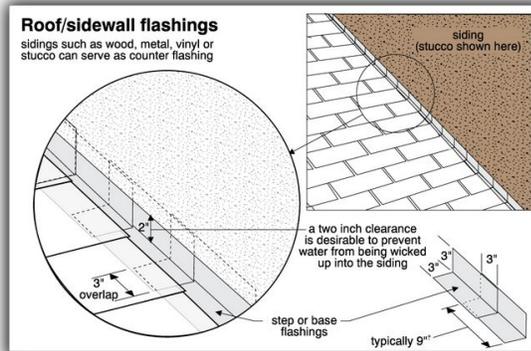
Inadequate clearance between exterior siding and roof covering materials was observed. There should be a space between the siding and roof covering. Space between the roof covering and siding provides proper ventilation and prevents water damage to the siding.

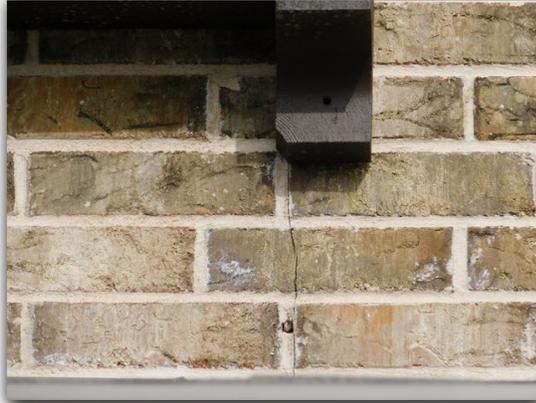
Areas of the exterior brick veneer siding overhang the foundation and appeared to be improperly installed. Brick veneer siding that does not rest on the foundation may not be properly supported.

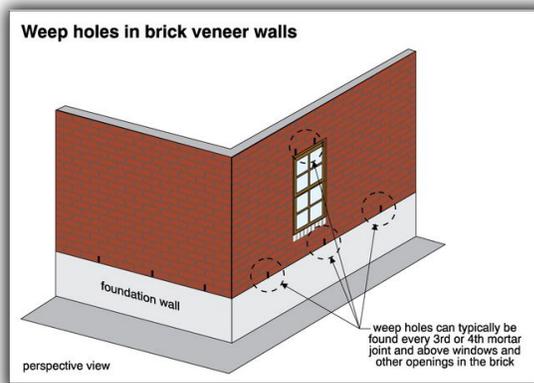
Weep holes were not open in the brick/stone masonry above the windows in required locations. This may be an "as-built" condition, however, under current building standards, weep holes should be installed in the brick/stone masonry above windows to provide proper wall ventilation.

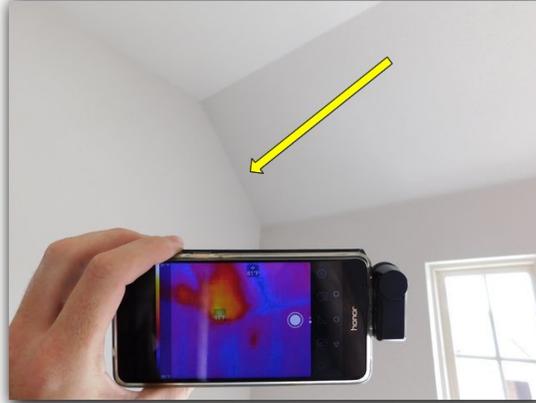
which may be indication of missing or damaged insulation. The reason for the temperature anomalies should be further evaluated and repaired as needed.

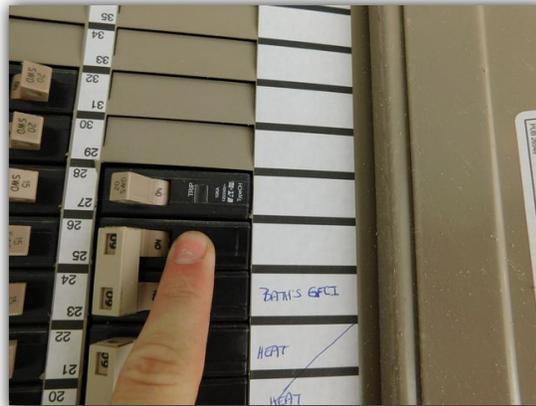
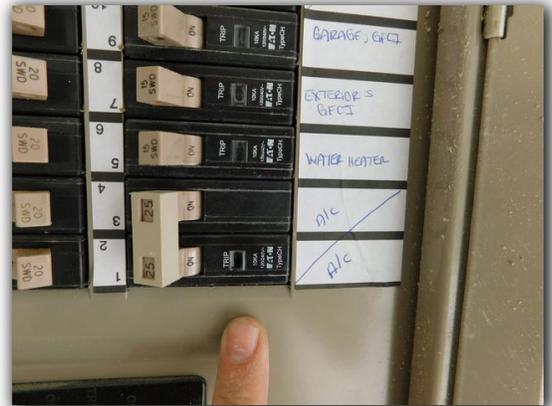
The electric service panel breaker use was not correctly labeled. Each electric service panel breaker should be adequately labeled as to what appliance or circuit it serves.

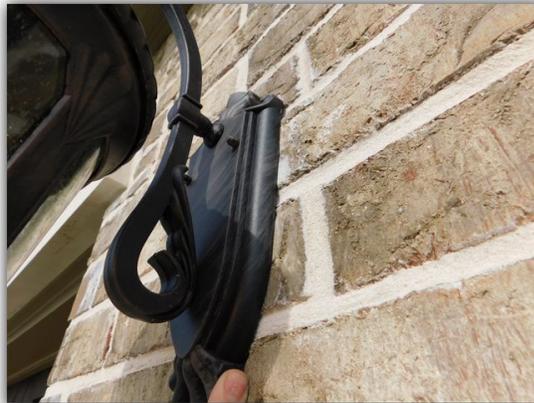
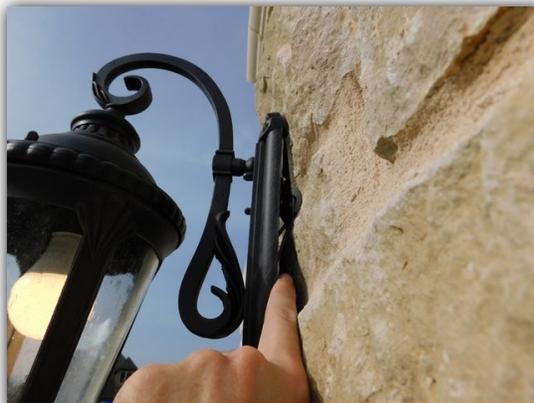
Exterior light fixtures should be sealed at the wall to prevent water intrusion for reasons of SAFETY.

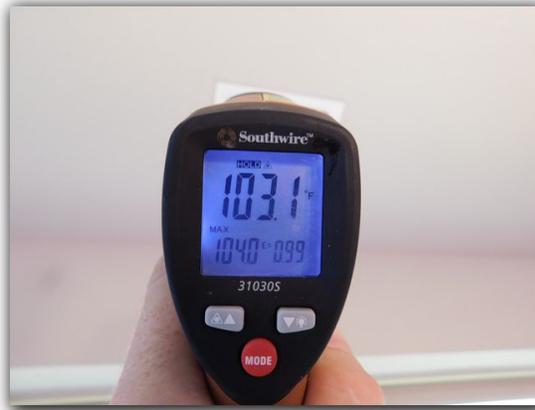
- Unit 1: Attic
 Within Normal Range Inadequate - In need of service, repair or replacement
The heating equipment temperature output reading: 103.1 °F

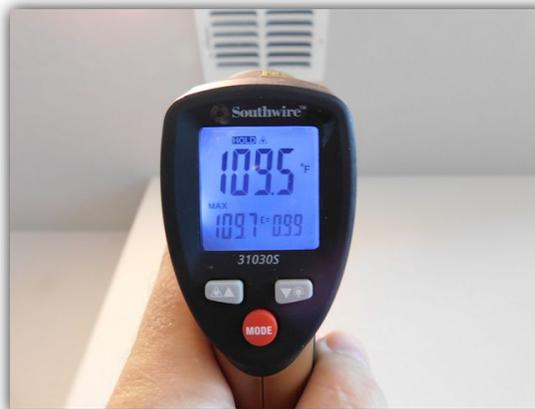
- Emergency Heat:
 Within Normal Range Inadequate - In need of service, repair or replacement
The emergency heating equipment temperature output reading: 109.5 °F

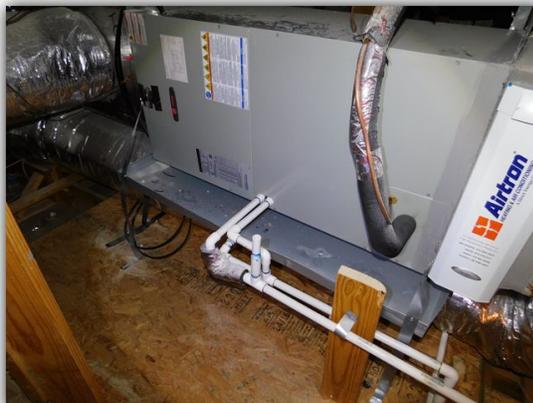
The cooling equipment condensation overflow pan or drain lines installed above ceilings were not equipped with water or moisture sensors/alarms. Cooling equipment condensation drain pans or drain line sensors and alarms should be installed at cooling equipment installed above ceilings for additional protection against water damage.

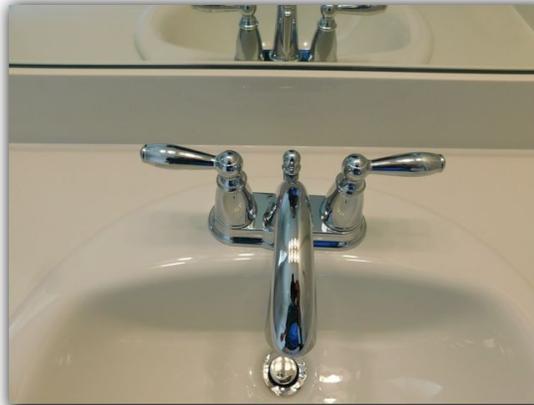
The temperature indicators are missing at the lavatory water supply fixture. Missing water temperature indicators is considered a SAFETY HAZARD.

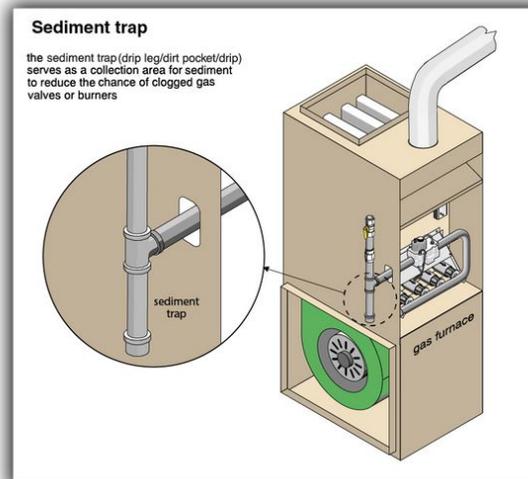
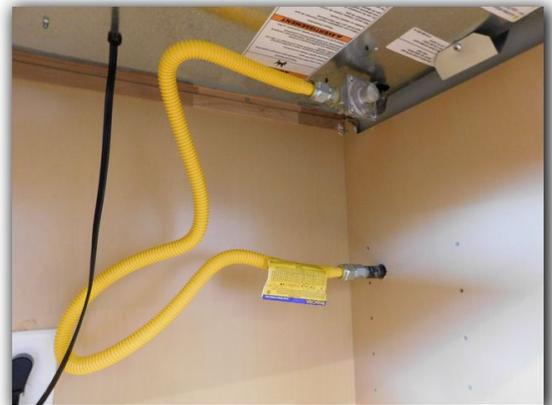
There were gas fired appliances that did not have a "drip leg" installed. Under current construction standards, drip legs are required at the black iron gas pipe prior to a flexible gas line connection.

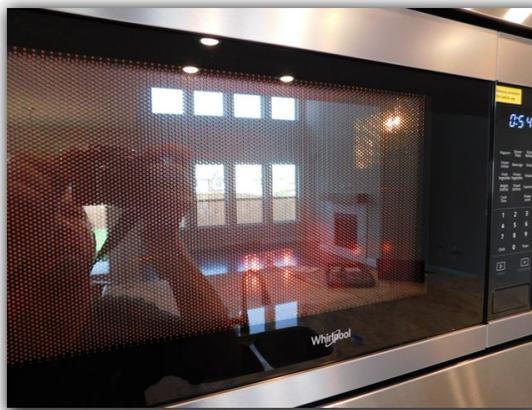
E. Microwave Ovens

- The microwave oven was inspected according to today's Texas Standards of Practice and or local code and was performing as intended at the time of the inspection.

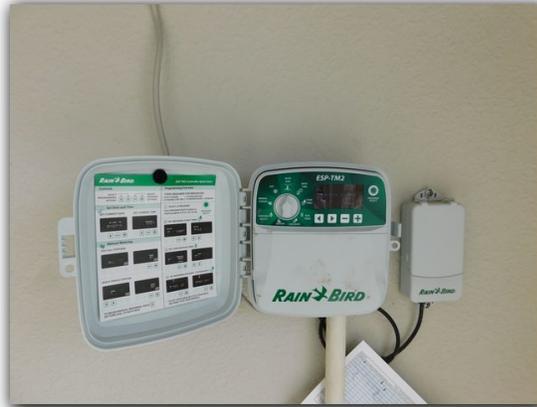
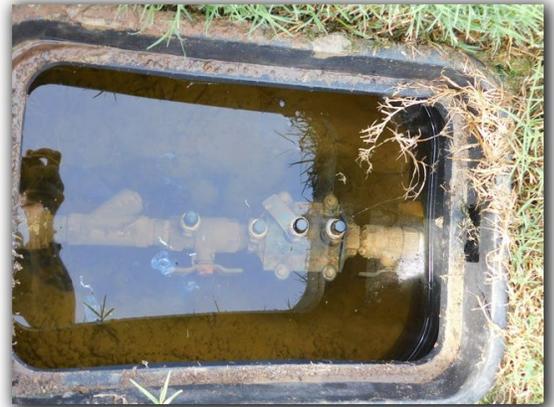
The landscape irrigation system electrical conduit needs to be sealed at the wall.

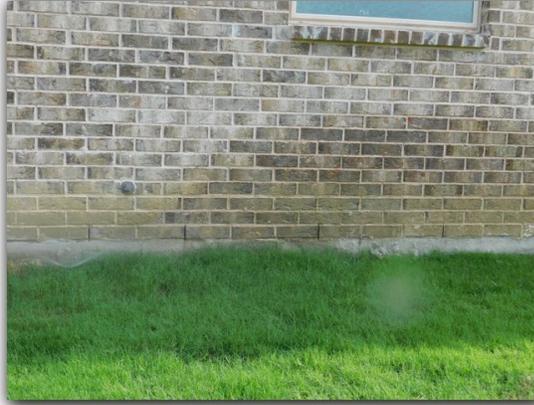
The landscape irrigation system sprinkler heads were observed to spray the structure or in unwanted directions and require repair, replacement or adjustment.
