# Fouries Home Inspection

COMPLETE HOME INSPECTION  
Prepared Exclusively For: First Name Last Name

Built in 1897  
(122 year old home), , TX,

Inspected by Paul Fourie, Lic.#: 22325 on 01/01/2019  
Phone: (972)989-2479, Email: paul@fourieshomeinspection.com

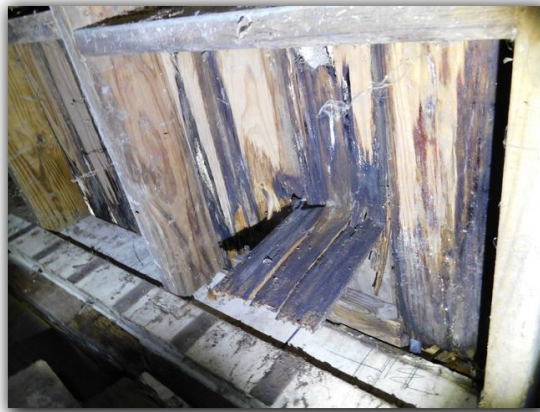
Sub-floor damage was observed in the crawl space. The cause of the sub-floor damage should be determined and the damaged sub-floor materials should be repaired as needed.

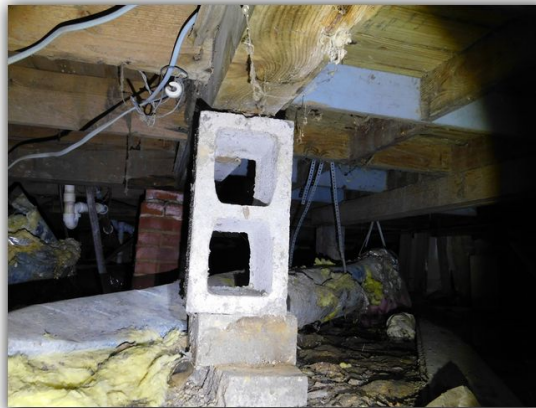
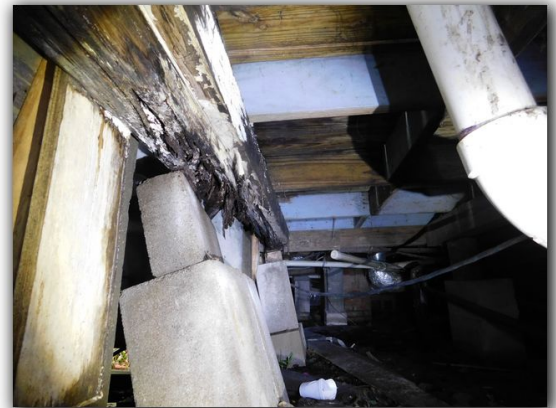
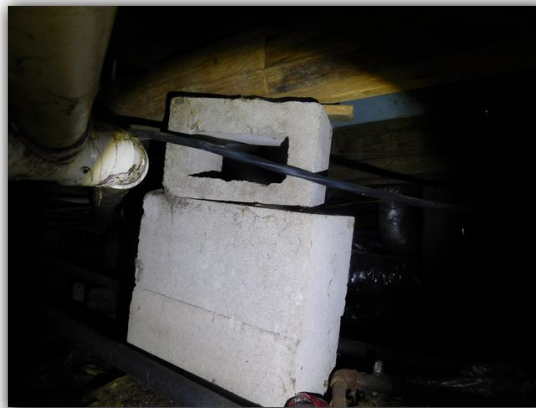
Deteriorated pier and beam conditions were observed. Deterioration of pier and beam supports should be repaired to prevent adverse effects to the foundation and structure. Deteriorated pier and beam components should be repaired or replaced by a certified, licensed foundation specialist.

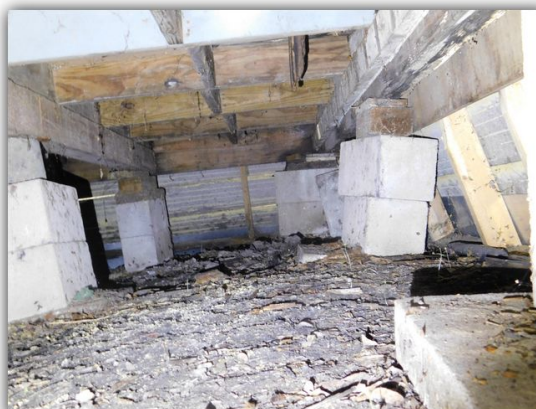
Leaning piers were observed in the crawl space. Leaning piers may not provide adequate support for the structure. The inspector recommends that the foundation be further evaluated and repaired as needed by a certified, licensed foundation specialist.

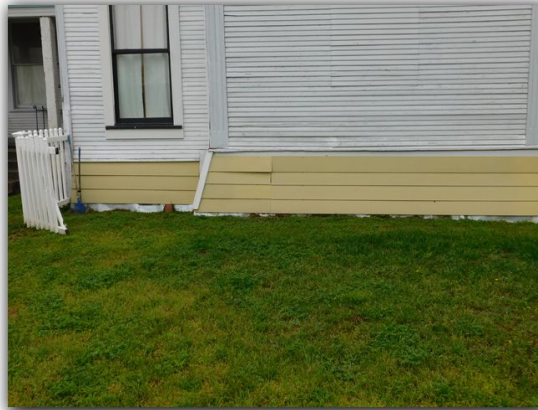
Crawl space vents should be installed within three feet of building corners. The crawl space ventilation was inadequate. Inadequate crawl space ventilation creates conducive conditions for structural damage, wood rot, moisture damage and wood destroying insects.

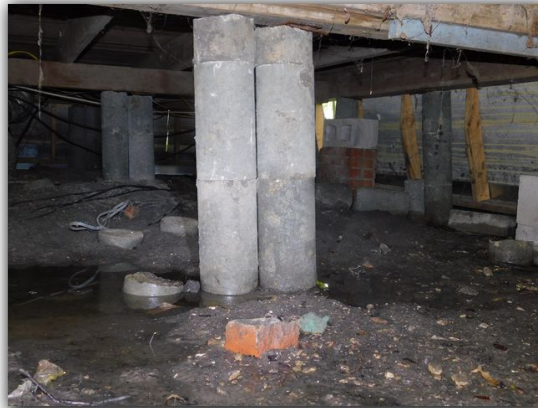
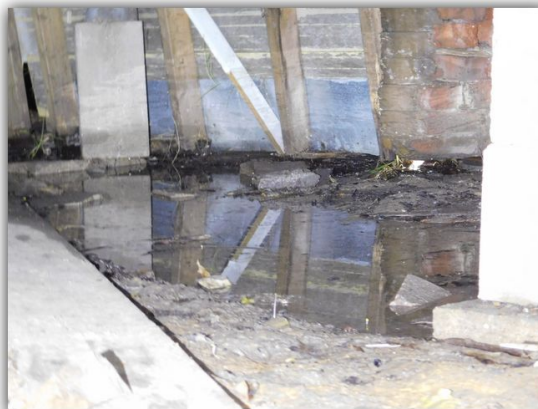
The crawl space was flooded in numerous areas.

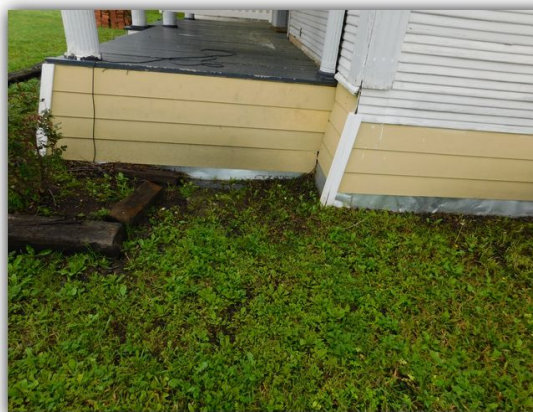
Inadequate grade slope away from the structure was observed. The recommended grade slope away from the structure is 6 inches per 10 feet. Improper grade slopes away from the structure create conducive conditions for water intrusion and inadequate foundation performance. Improper grade slope away from the structure is in need of repair.

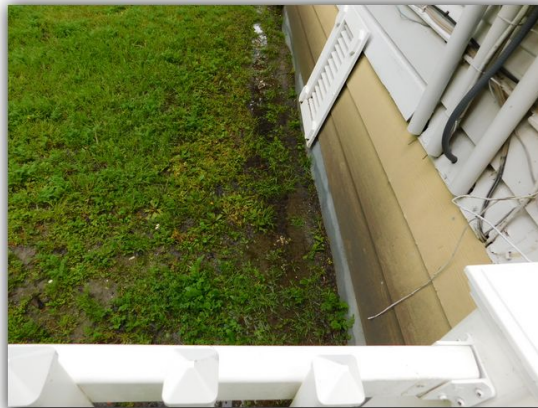
Ponding next to the foundation was observed. Any area where the ground or grade does not slope away from the structure is to be considered an area of improper drainage. Corrective measures may be needed if the water stands within 10-feet of the foundation perimeter beam for more than 24-hours. Grading improvements are needed to direct run off water away from the structure. Recommended slope away from the foundation is 6 inches per 10 feet.

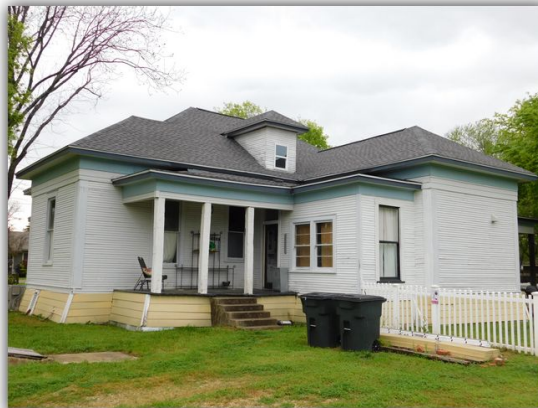
The structure has been built below the public street grade. Extra caution should be taken to prevent any possible water intrusion to the structure. Do not build flowerbeds that will cause a damming effect and hold water next to the structure. Positive drainage should always be maintained.

Grading and drainage could be improved with the installation of rain gutters. Properly installed rain gutters can prevent erosion and water ponding and help direct water away from the foundation.

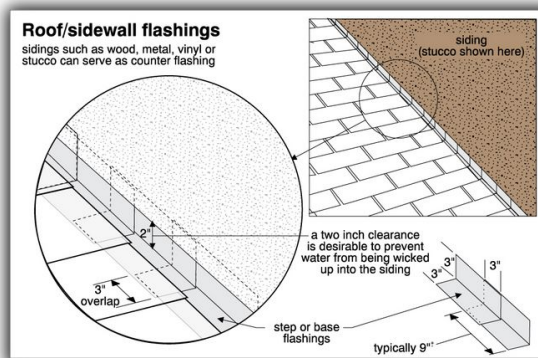
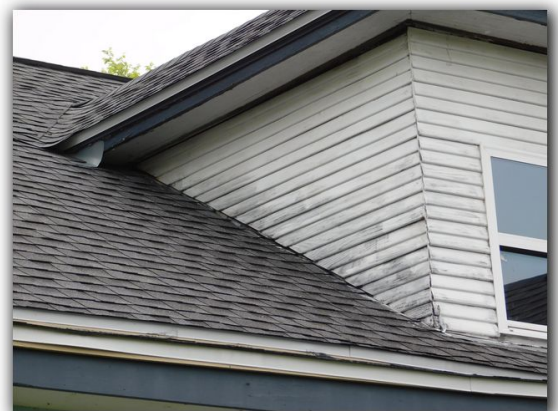
Inadequate clearance between exterior siding and roof covering materials was observed. There should be a space between the siding and roof covering. Space between the roof covering and siding provides proper ventilation and prevents water damage to the siding.

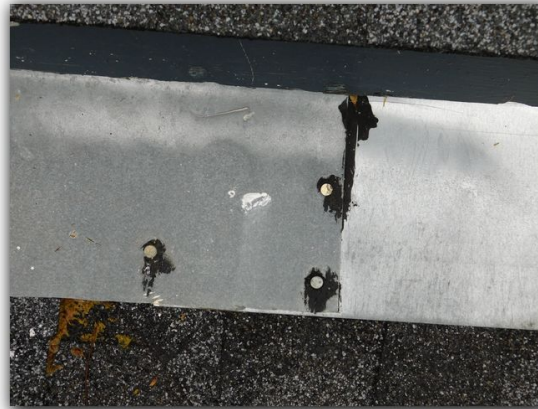
Exposed or lifting fasteners or nail heads were observed at the roof coverings. Exposed or lifting fasteners or nail heads may allow water penetration and were in need of repair.

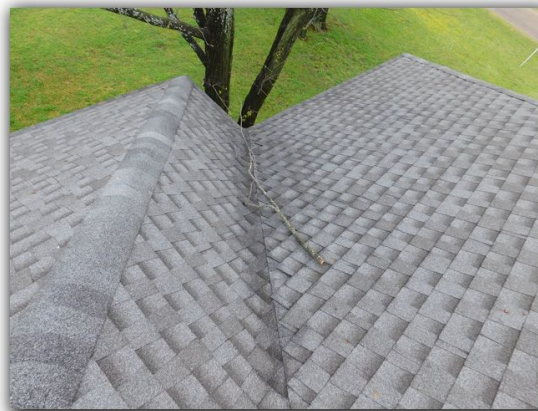
Leave, sticks, branches and other debris were observed on the roof covering and may contribute to roof covering material damage and water penetration. The roof covering surfaces should be free of leaves, sticks, branches and debris.

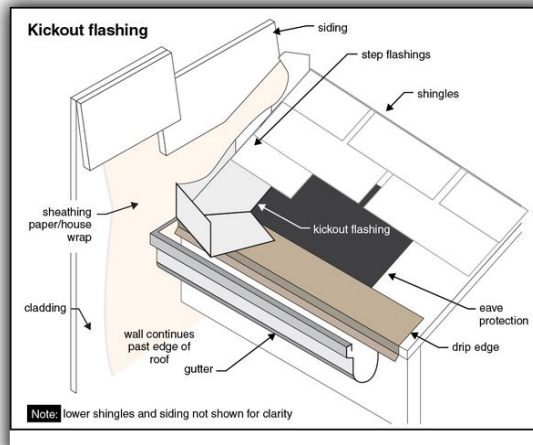
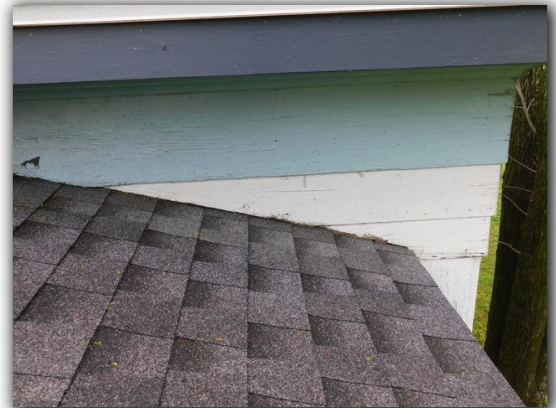
Current construction standards require a kick out flashing at the roof coverings and wall intersections. Kick out flashings prevent water leaks, damage and discoloration to walls.

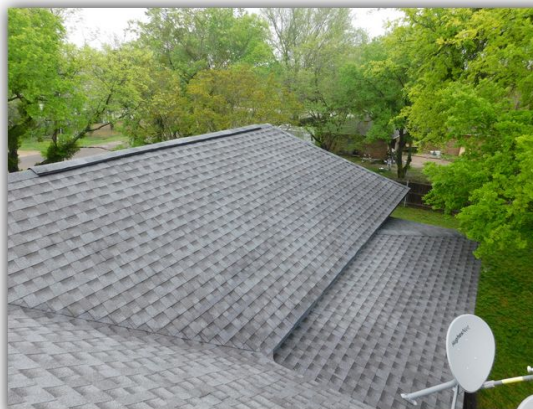
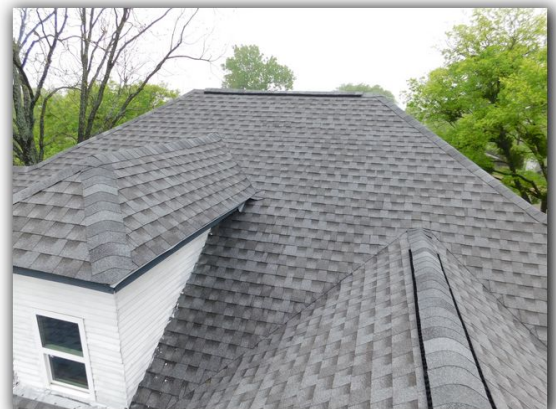
Ridge vents were installed without the benefit of passive soffit/eave vents. The lack of, inadequate or blocked soffit/eave vents is considered inadequate attic ventilation. Inadequate attic ventilation creates conducive conditions for deterioration of structural components, deterioration of roof covering materials, moisture damage, wood destroying insects, duct work damage and other defects.

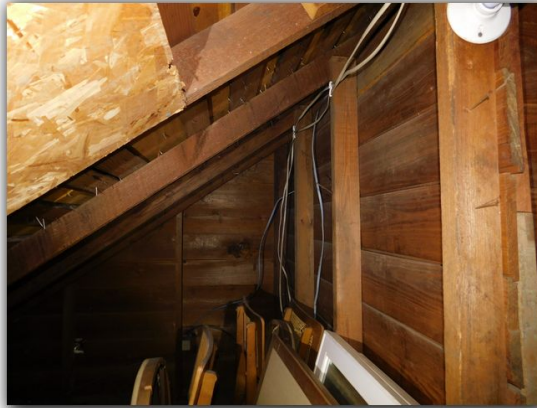
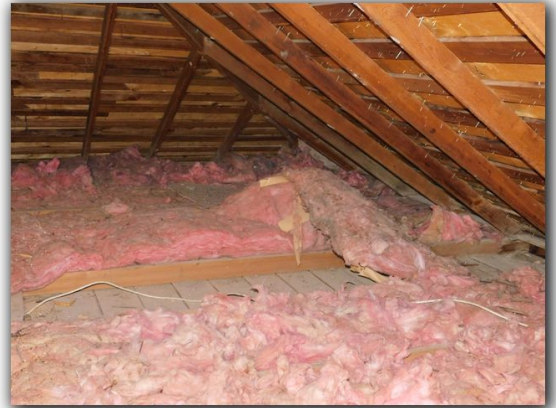
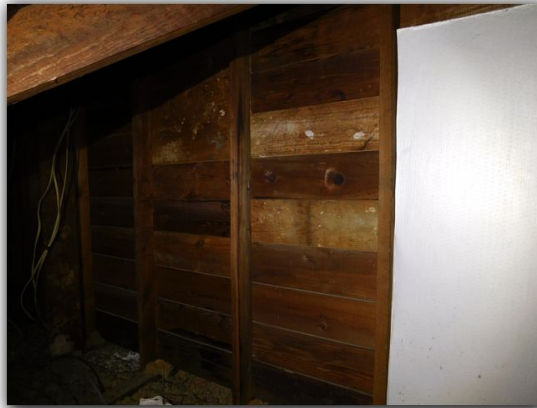
Insulation voids were observed in the attic space. Insulation voids may allow greater than normal loss of conditioned air and should be repaired.

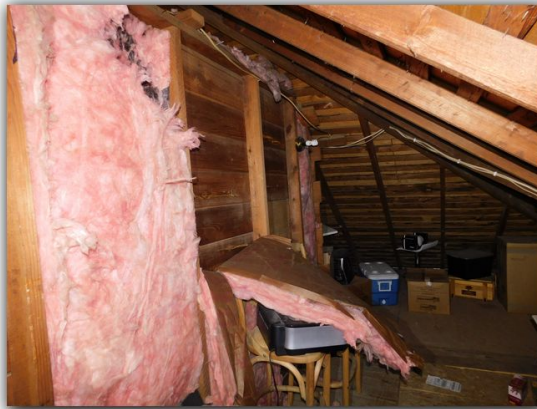
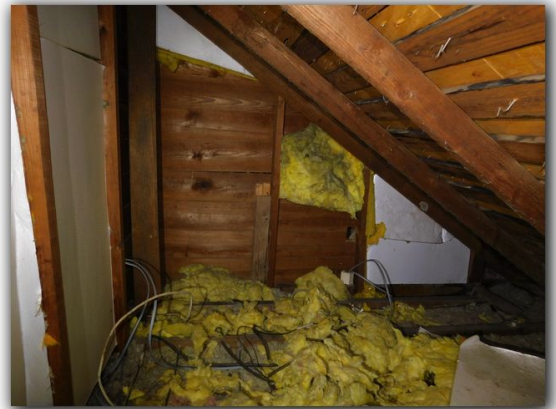
Loose and or damaged insulation was observed in the attic space. Loose or damaged insulation may allow greater than normal loss of conditioned air and should be repaired.

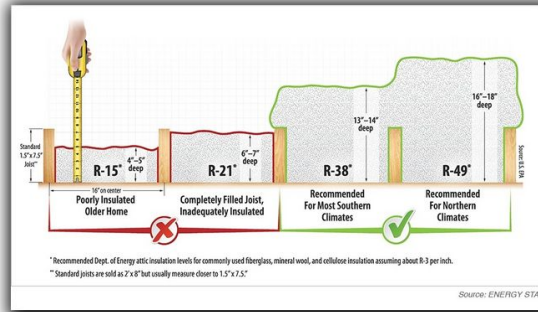
The attic insulation depth or thickness was inadequate. The recommended depth of attic floor insulation is 13+ inches to achieve an R38 rating. Inadequate attic insulation depth or thickness may allow greater than normal loss of conditioned air.

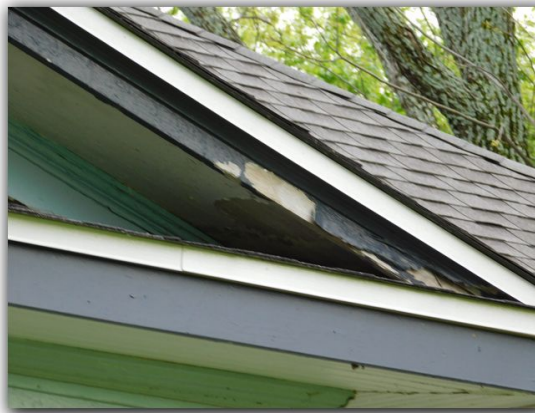
Fascia, soffit, eaves and or trim materials were observed to be damaged. Damaged fascia, soffits, eaves and trim materials should be repaired as needed to prevent further damage, wildlife penetration and moisture penetration.

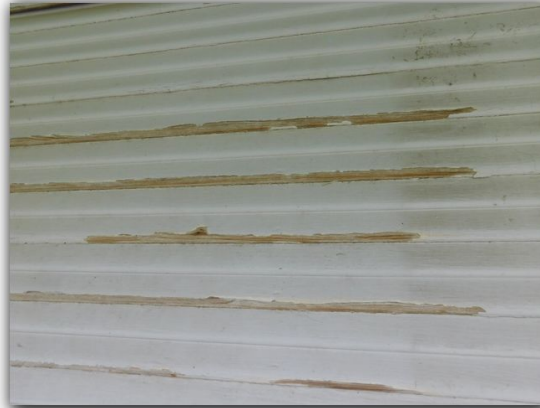
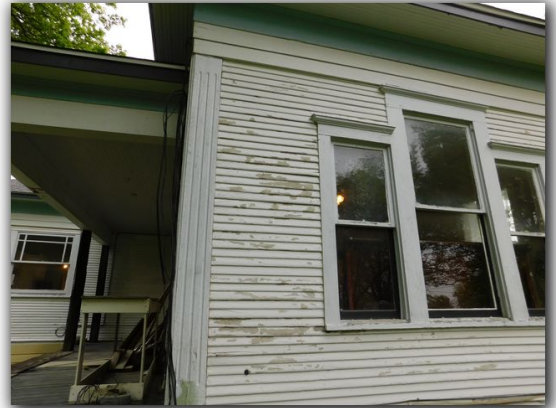
Peeling, damaged or deteriorating paint, stain and/or sealant was observed at the exterior wall cladding. Peeling, damaged and deteriorating paint or sealant should be repaired to prevent moisture penetration and deterioration of materials.

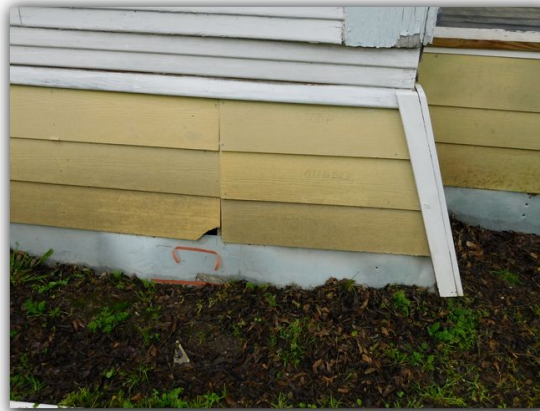
Peeling, damaged or deteriorating paint, stain and/or sealant was observed at the exterior trim. Peeling, damaged and deteriorating paint or sealant should be repaired to prevent moisture penetration and deterioration of materials.

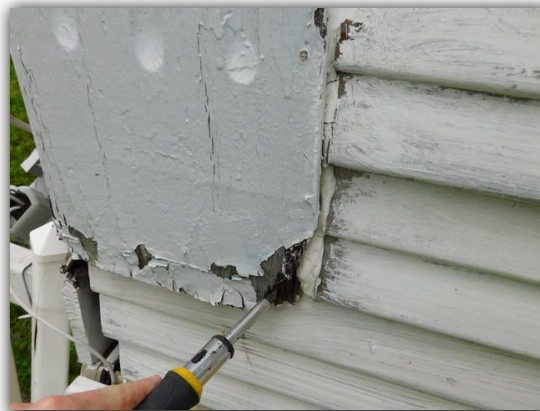
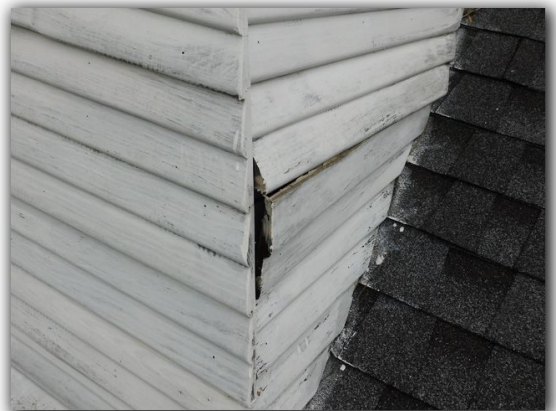
The exterior wood veneer siding was observed to have some deterioration and/or damage. Damaged and deteriorated exterior wooden siding should be repaired to prevent wall damage, moisture penetration and wood destroying insects.

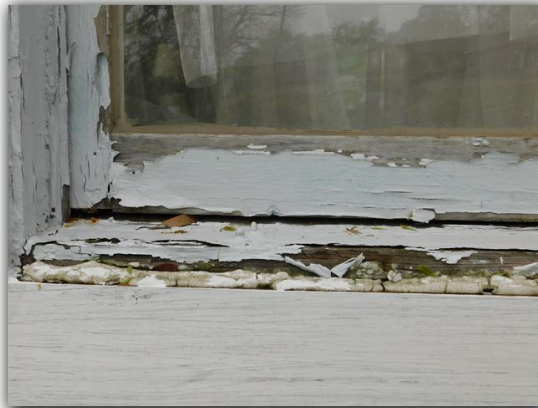
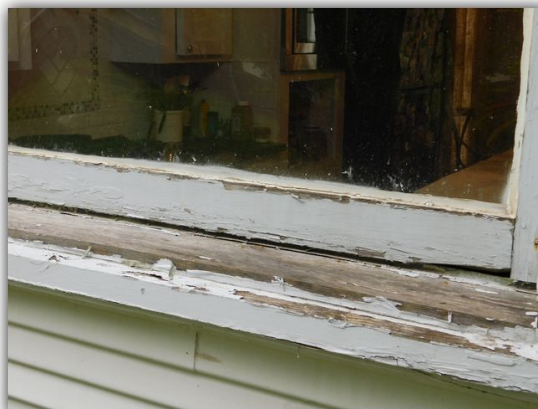
The exterior wood trim was observed to have some deterioration and/or damage. Damaged and deteriorated exterior wood trim should be repaired to prevent wall damage, moisture penetration and wood destroying insects.

The exterior wood window casing and trim materials were observed to have some deterioration and/or damage. Damaged and deteriorated exterior wood window casing and trim should be repaired to prevent wall damage, moisture penetration and wood destroying insects.

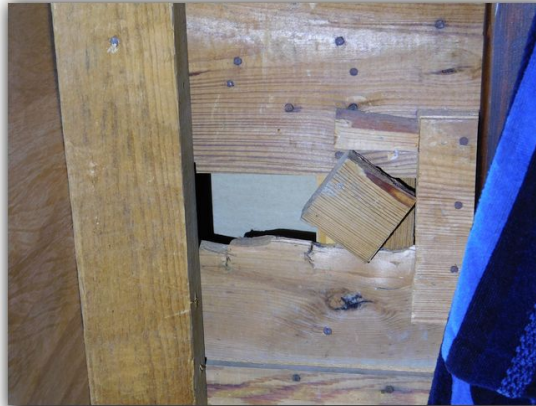
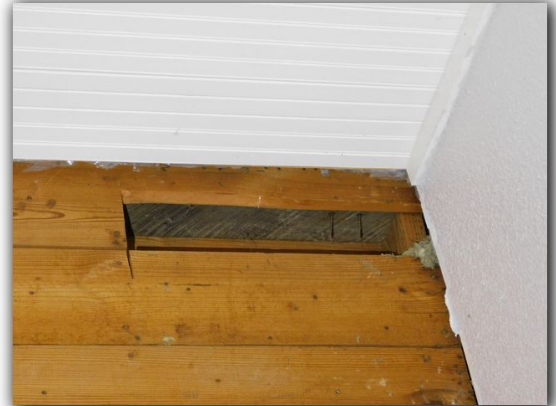
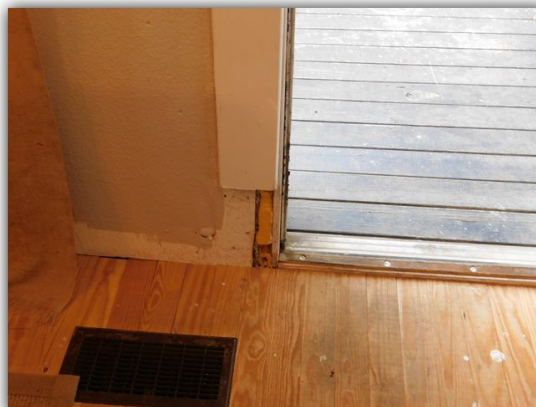
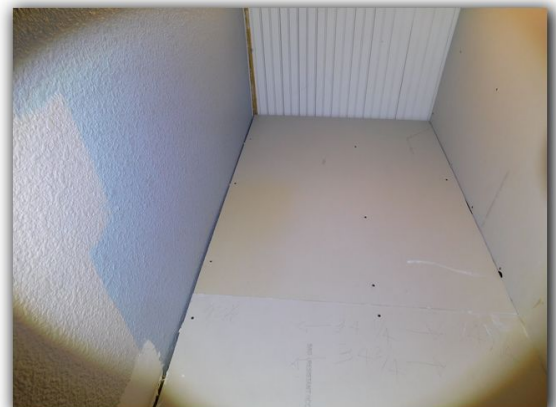
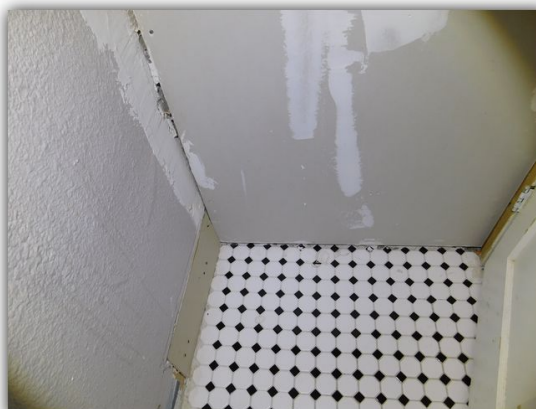
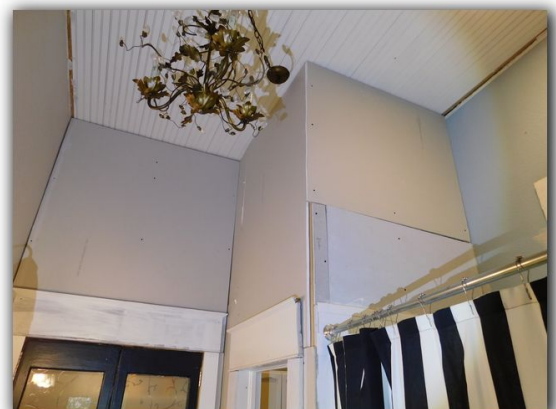
Damages to interior walls were observed to be in need of repair.

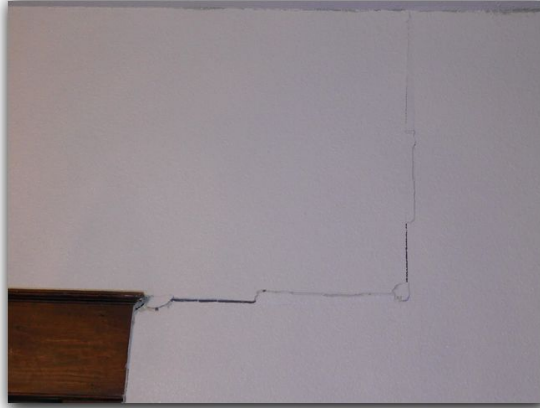
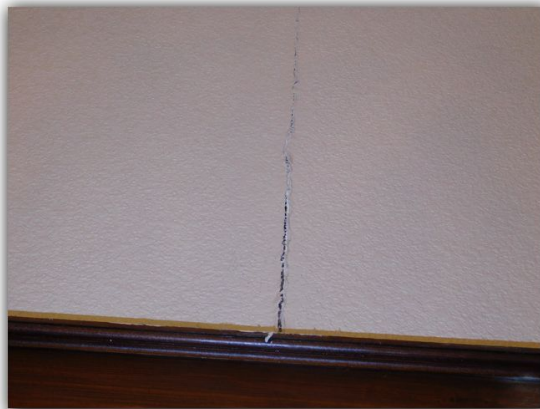
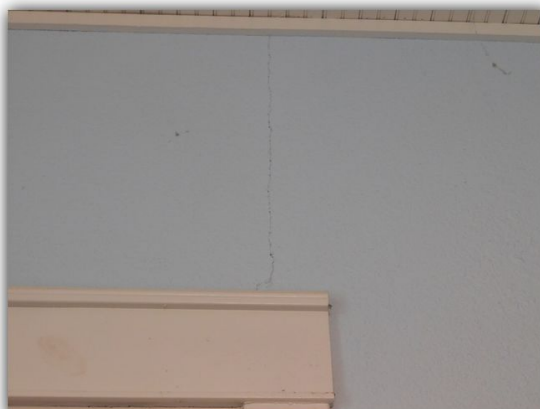
Multiple interior wall cracks were observed and were an indication of structural settling,

movement or other defects. The cause of any interior drywall, texture and paint wall cracks should be determined and repaired as needed and monitored over time for additional movement. Further evaluation of the foundation and structure by a certified, licensed foundation and structural specialist is recommended.

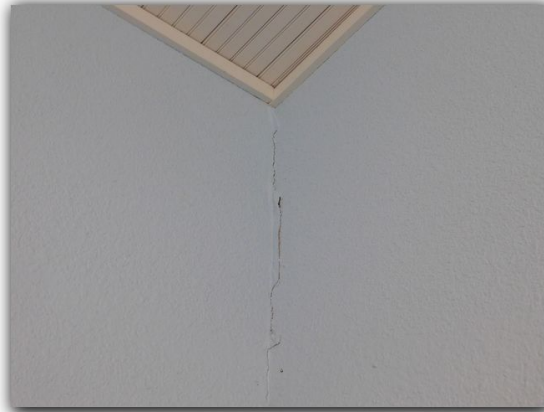
Interior drywall corner tape was observed to be pulling and twisting where walls and or ceilings intersect. This condition is related to adverse foundation or structural performance and should be further evaluated by a foundation or structural specialist and repaired as necessary.

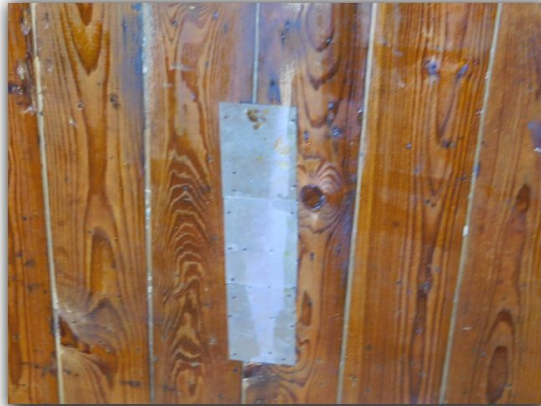
Cosmetic damages to ceiling should be repaired.

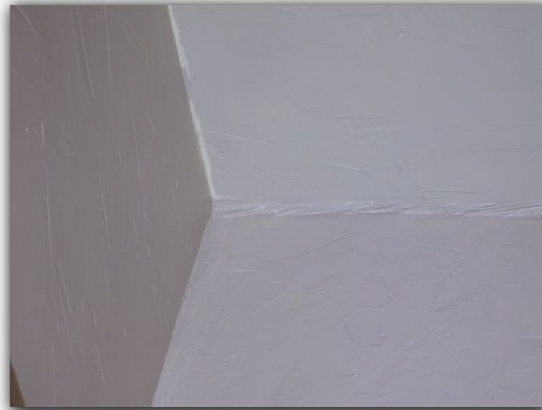
The ceiling drywall corner tape was observed to be pulling and twisting where walls and ceilings intersect. This condition is related to adverse foundation or structural performance and should be further evaluated by a certified, licensed foundation or structural specialist and repaired as needed.

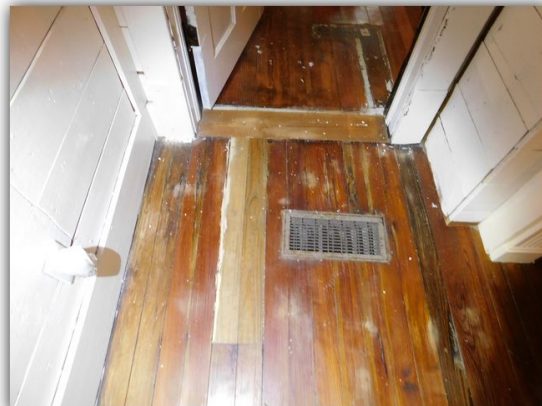
The floor covering was noticeably worn or damaged and was in need of cleaning, repair or replacement.

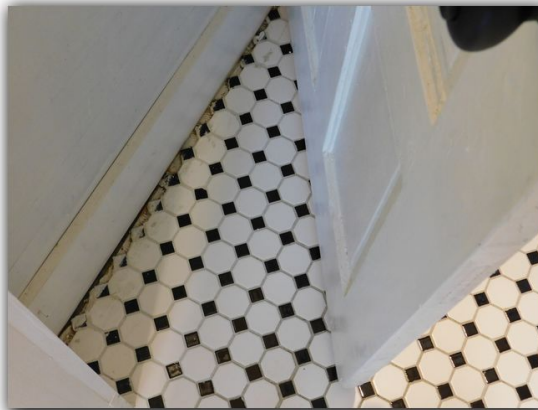
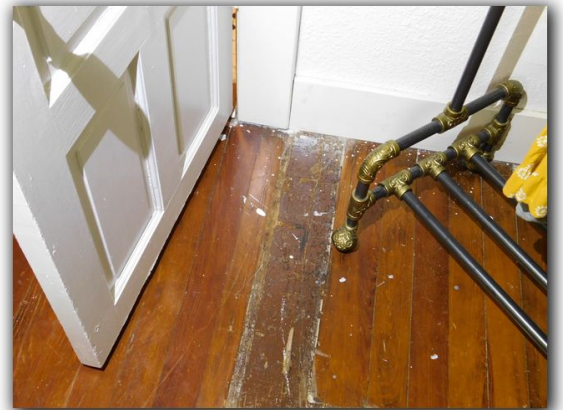
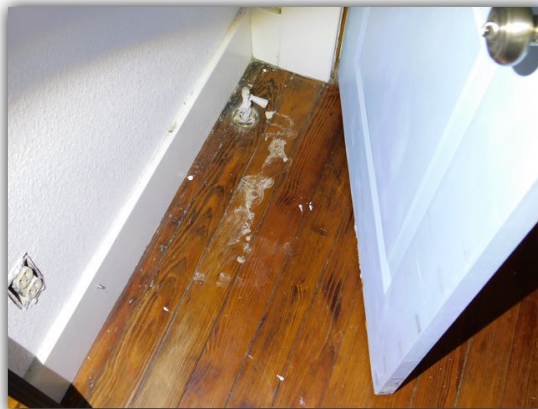
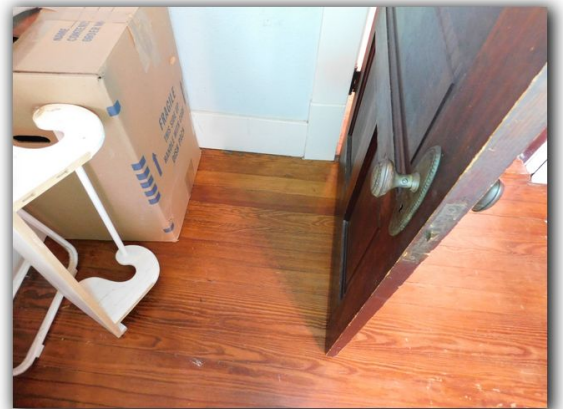
All interior doors should have door stops installed to prevent damage to adjacent interior wall coverings.

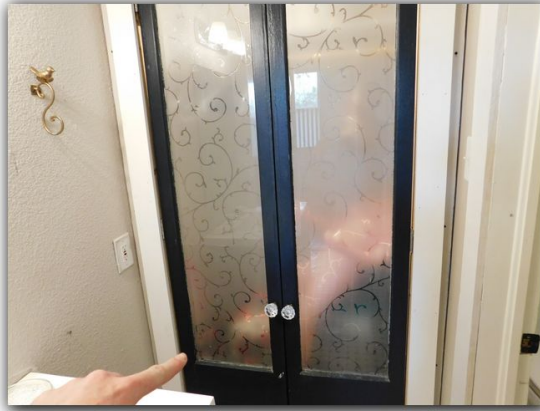
Safety glass was not installed in doors in required locations. Lack of door safety glass in required locations is a SAFETY HAZARD.

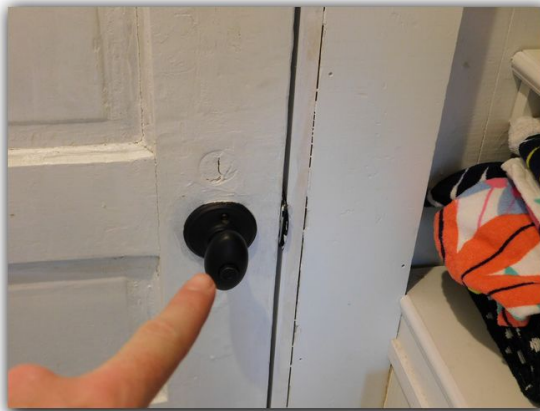
Interior doors which do not latch as intended should be repaired.

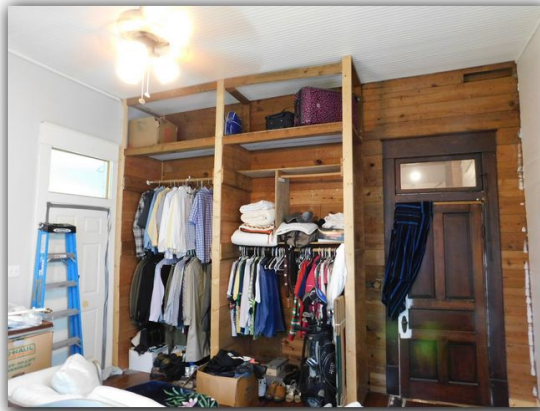
There were missing doors. Missing doors should be replaced .

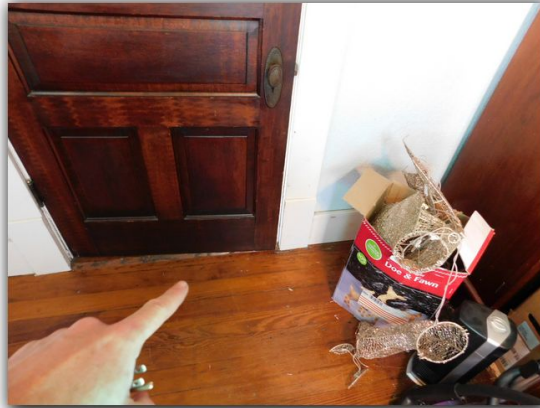
Interior doors were observed to rub, stick or hit the door frames. Interior doors, that stick or hit the door frame may be an indication of movement, settlement or other defects. The cause of doors sticking or hitting door frames should be determined and repaired as needed.

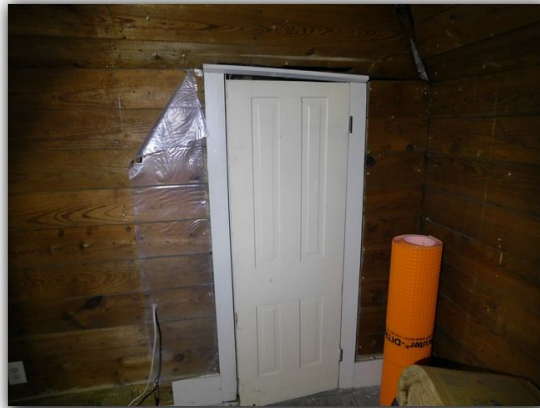
Deficient hardware was observed at interior doors and should be repaired or replaced.

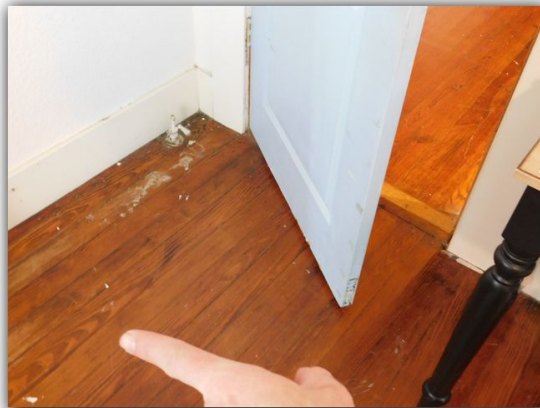
Interior doors which drift closed were observed. Interior doors, which drift, are an indication of movement, settlement or other defects. The cause of door drift should be determined and repaired as needed.

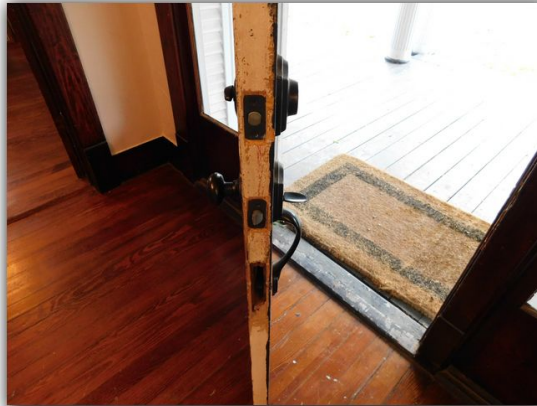
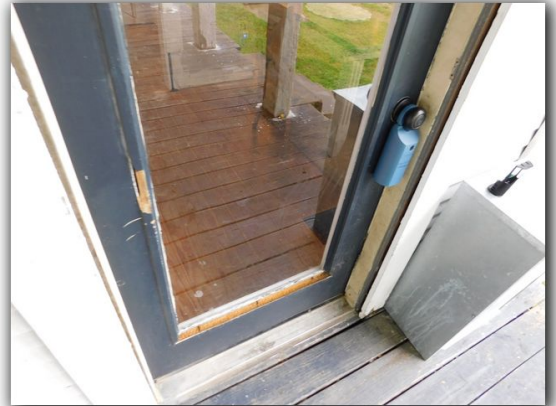
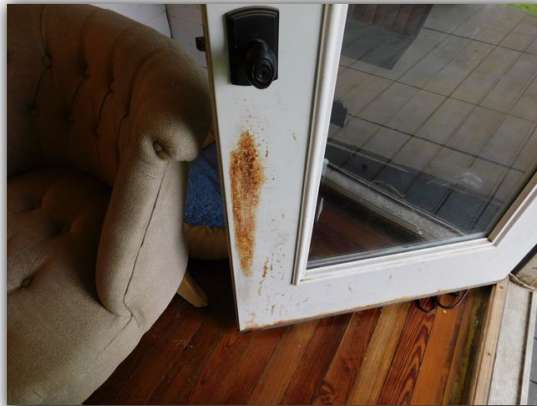
Cosmetic damage to exterior doors should be repaired.

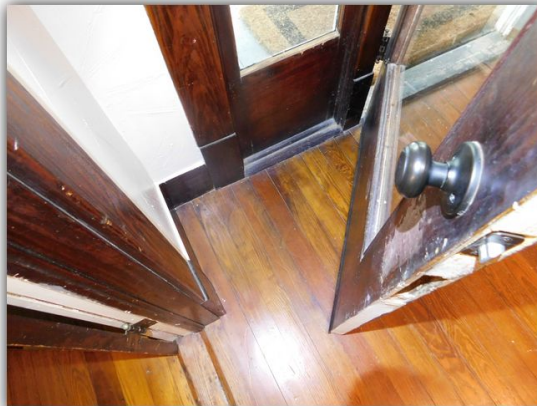
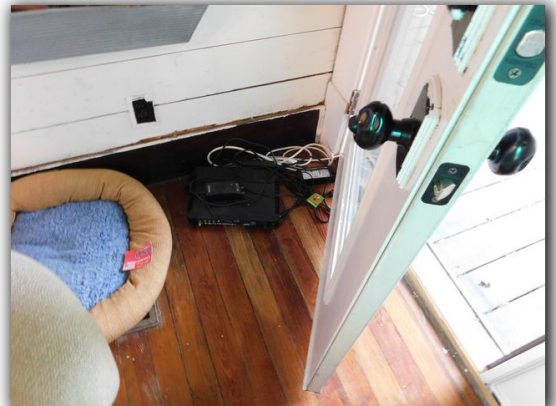
All exterior doors should have door stops installed to prevent damage to adjacent interior wall coverings.

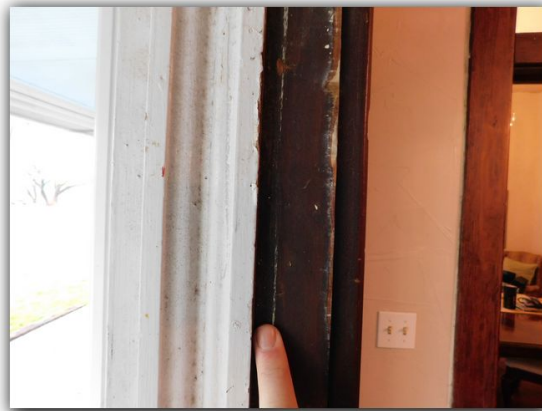
Damaged or missing exterior door weather stripping should be replaced. Missing or damage exterior door weather stripping creates conducive conditions for moisture intrusion and conditioned air loss.

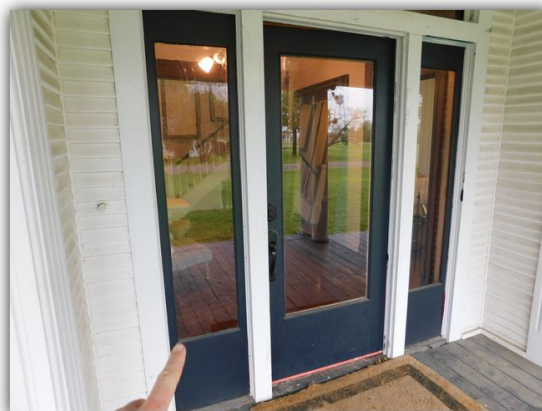
Safety glass was not installed in exterior doors side lights. Lack of exterior door side light safety glass is a SAFETY HAZARD.

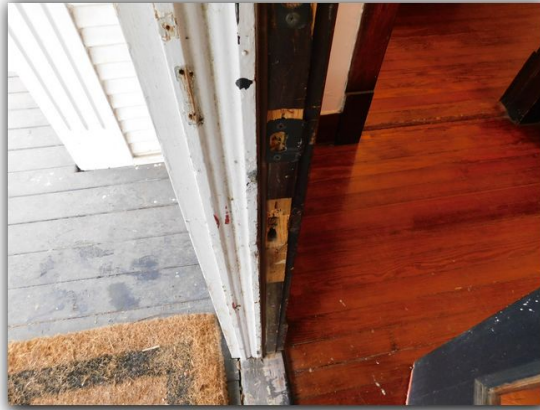
Damaged exterior door frames were observed and should be repaired or replaced.

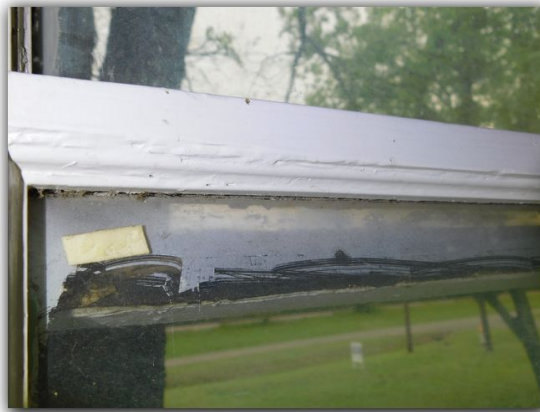
The window weather-stripping was observed to be damaged. Damaged or missing weather stripping around windows may allow moisture penetration, conditioned air loss and insect penetration and should be repaired.

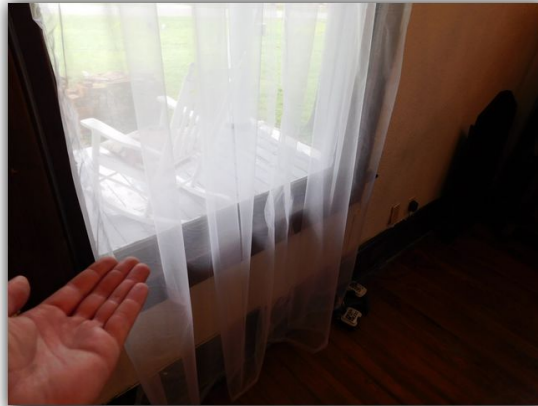
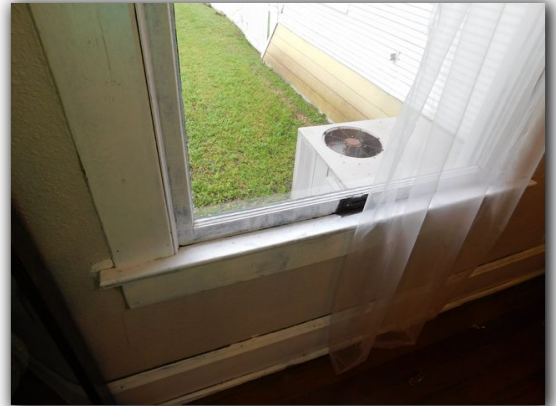
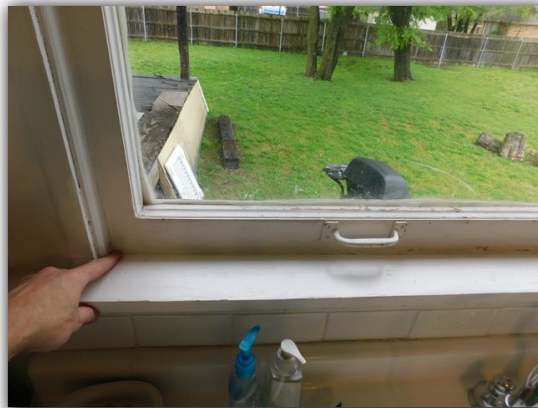
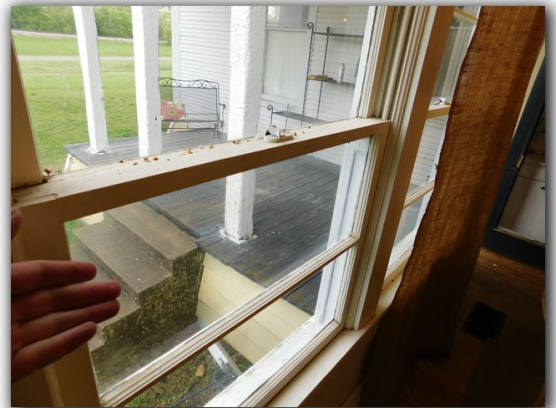
One or more of the living area windows have been painted shut. Living area windows that have been painted shut or do not open as intended should be repaired.

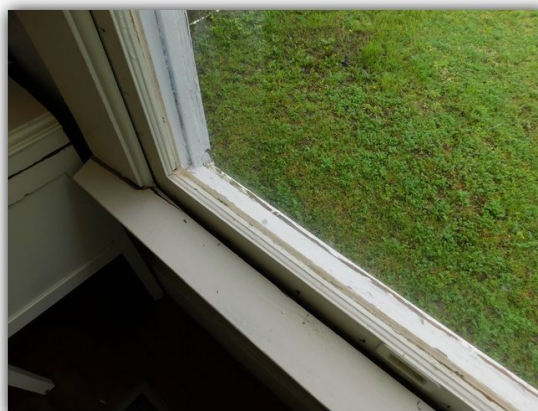
One or more of the bedroom windows have been painted shut. At least one window in each bedroom should open fully, with free access to the outdoors. Lack of an operable window in each bedroom is a FIRE SAFETY HAZARD and should be repaired prior to being occupied.

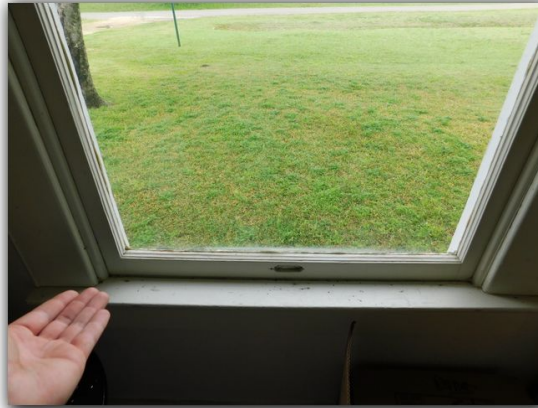
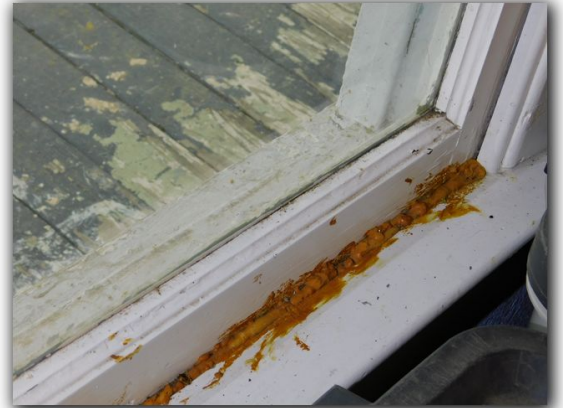
Cracked and/or broken window glass was observed. Cracked or broken window glass may allow discoloration of the window glass, allow moisture intrusion, contribute to the loss of conditioned air. Cracked or broken window glass may be a SAFETY HAZARD and should be replaced as needed.

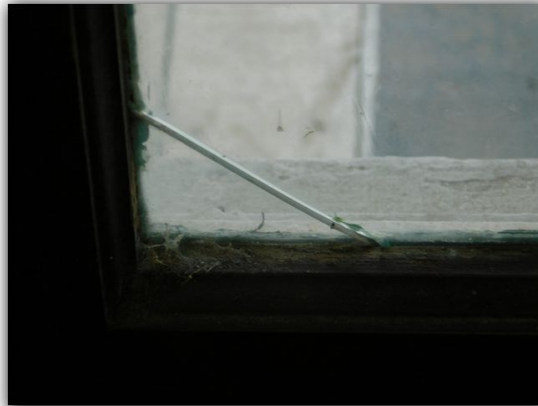
Windows were observed to be missing window screens. Window screens help protect window glass from minor impact damage and prevent insect penetration at the windows. Missing window screens should be replaced.

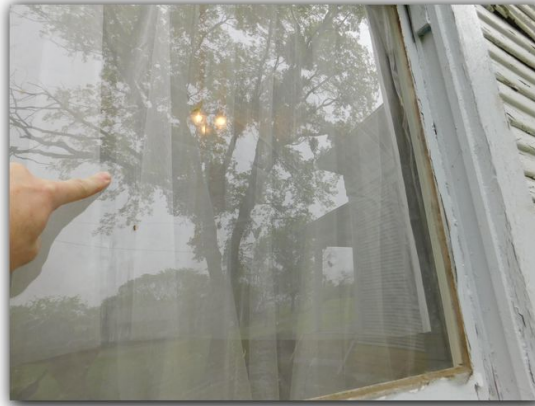
Windows were observed to be acrylic. Acrylic window screens should be replaced.

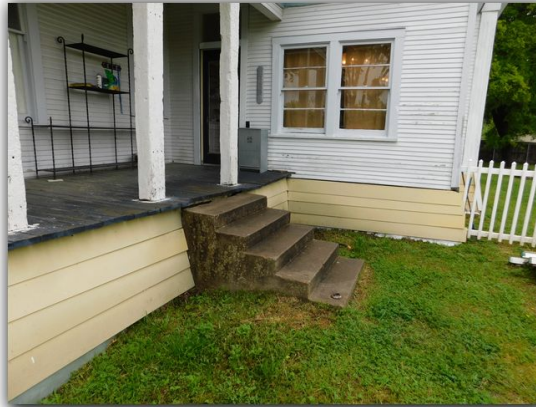
No handrail was installed for stairs or steps with 4 or more risers. For improved safety, a handrail should be installed at all stairs and steps with 4 or more risers. Lack of properly installed stairway handrails is a SAFETY HAZARD.

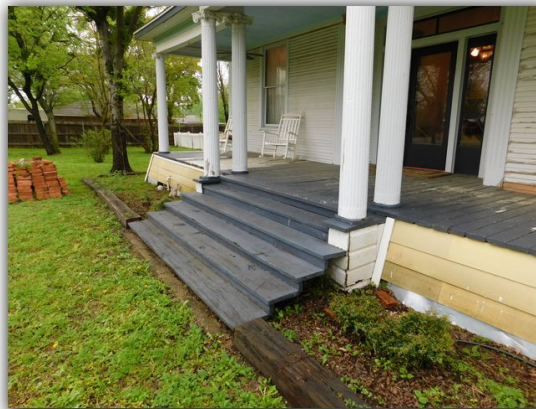
The stairway handrail height was observed to be inadequate and was a SAFETY HAZARD. Under current building standards, the stairway handrail height should be 34"-36" and should be corrected prior to closing.

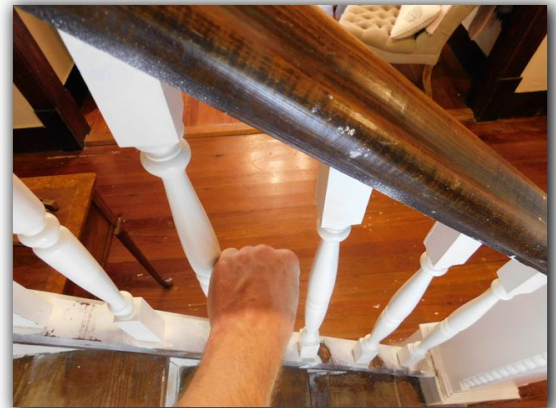
☑ Inadequate stairway headroom was observed. Under current building standards the minimum headroom in all parts of the stairway shall not be less than 6 feet 8 inches measured vertically from the slope of the plane adjoining the tread nosing or from the floor surface of the landing or platform.

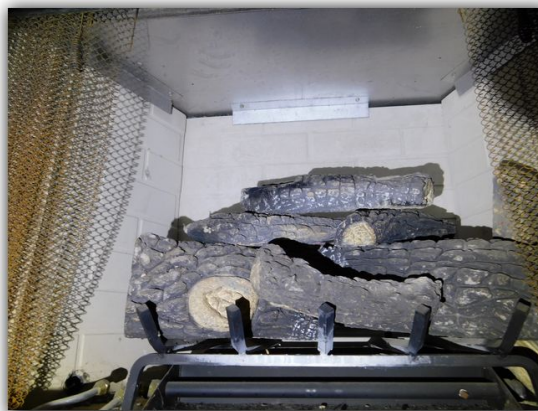
Gas fireplace equipment that is not vented to the exterior of the structure is a SAFETY HAZARD. Improperly vented gas heating equipment may allow carbon monoxide or other vapors to accumulate in the living area.

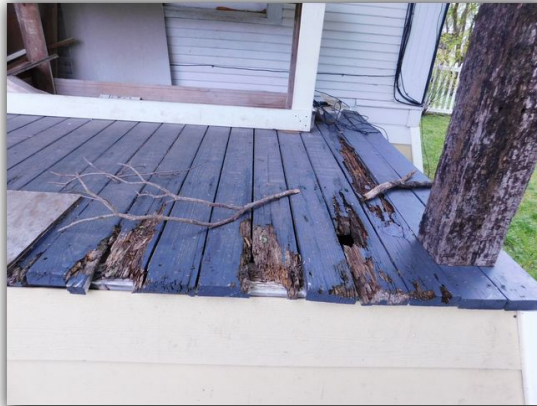
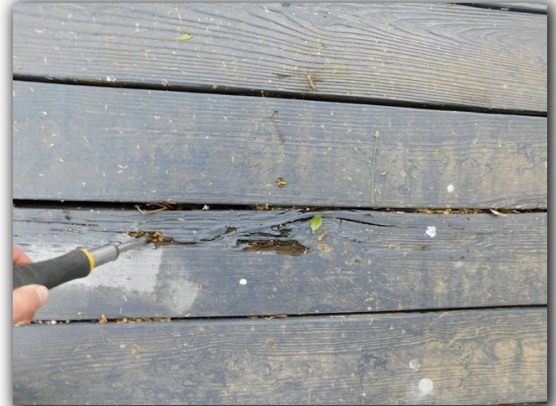
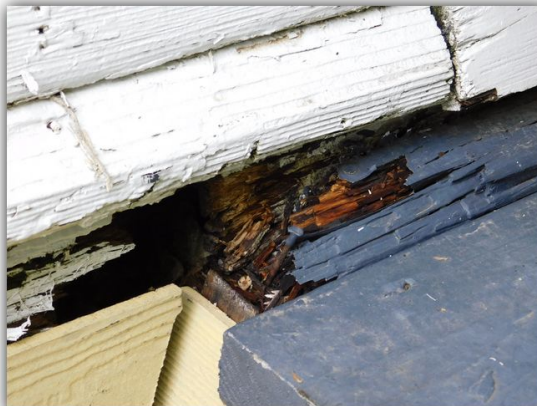
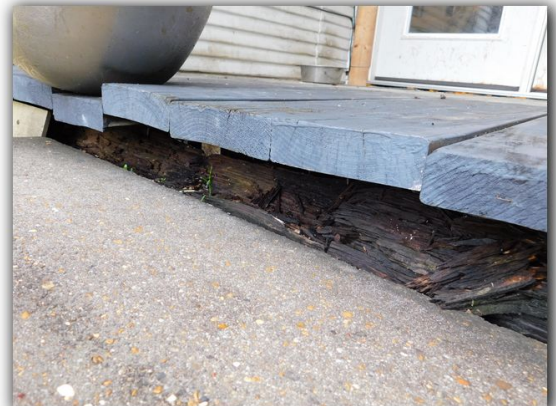
Weathered, deteriorated and/or damaged wood deck materials were observed and should be repaired or replaced as needed.

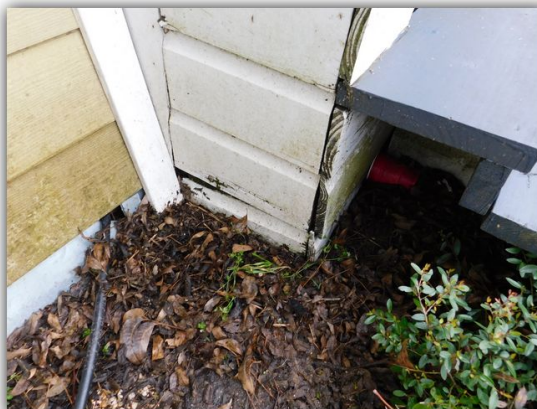
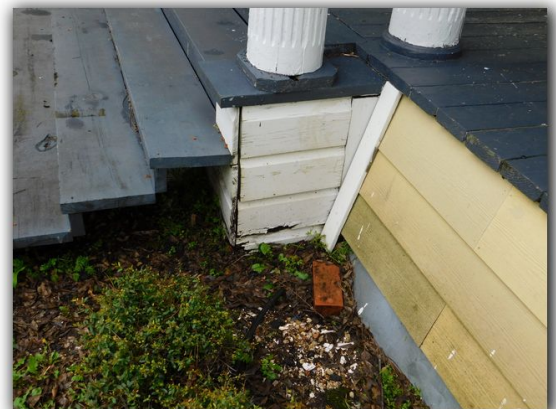
Wooden deck construction materials were observed to be in contact with the ground. Wood to ground contact at decking construction materials creates conducive conditions for wood rot and wood destroying insects.

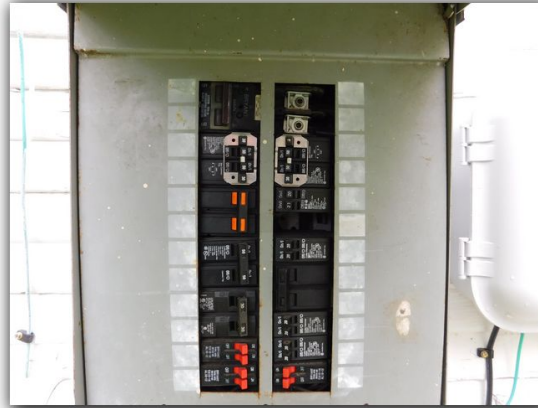
The electric service panel breaker use was not labeled. Each electric service panel breaker should be adequately labeled as to what appliance or circuit it serves.

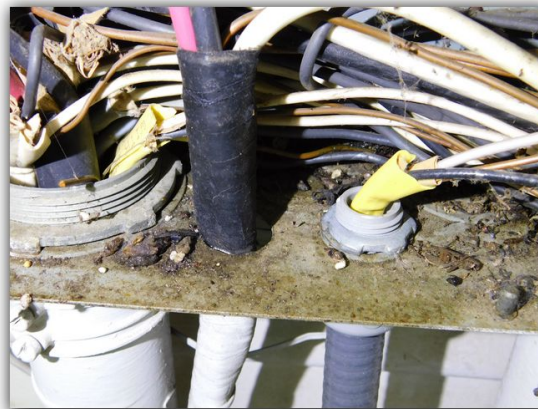
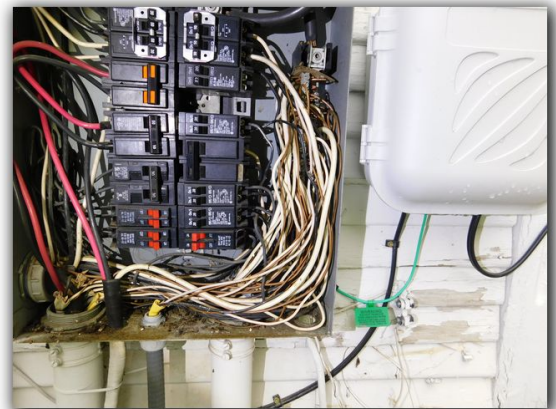
The electric service panel electrical conductors have not been properly secured or protected from the sharp edges and or the dead front cover of the cabinet. Electrical conductors that are in contact with the service panel dead front cover and not protected from sharp edges are a SAFETY HAZARD and should be repaired by a qualified electrical specialist.

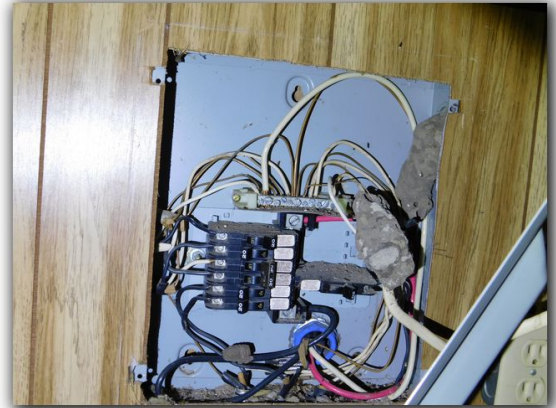
☑ Neutral electrical conductors were observed to be “double tapped” on the neutral bus bar in the electric service panel. Each neutral electrical conductor in the electric service panel should terminate individually unless the terminals are made for more than one conductor. Double tapped neutral electrical conductors should be further evaluated and repaired as needed by a qualified electrical specialist.
