# Fouries Home Inspection

COMPLETE HOME INSPECTION  
Prepared Exclusively For: First Name Last Name

Built in 1897  
(122 year old home), , TX,

Inspected by Paul Fourie, Lic.#: 22325 on 01/01/2019  
Phone: (972)989-2479, Email: paul@fourieshomeinspection.com

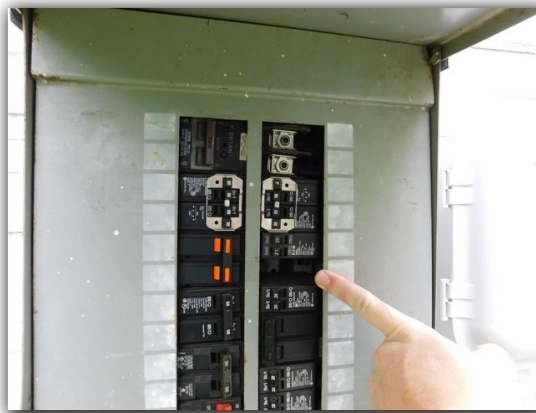
☑ Blank spaces (missing breakers) in the electrical service panel were observed to be missing filler covers. Missing or unused breaker slots should be covered with electrical fillers to prevent the unwanted entry of pests, moisture or other items. Lack of a cover filler at missing or unused breaker slots is considered a SAFETY HAZARD and should be repaired as needed by a qualified electrical specialist.

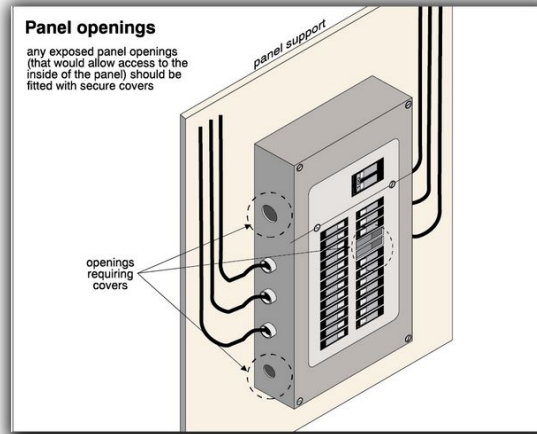
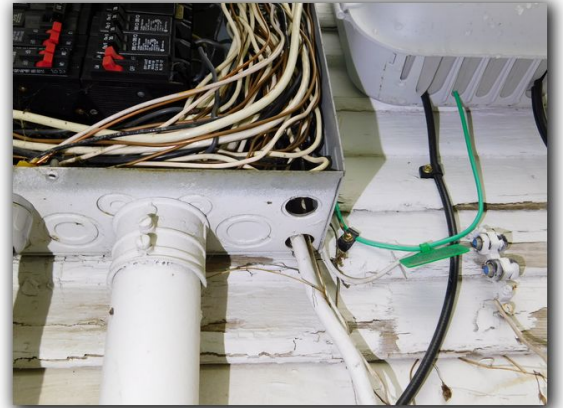
☑ Unused knockouts in the electric service panel were observed to be missing knockout covers (where conductors may pass through electrical cabinet walls). Missing knockout covers or unused conductor openings should be covered with electrical knockout covers to prevent the unwanted entry of pests, moisture or other items. Lack of an electrical knockout cover at unused conductor openings is considered a SAFETY HAZARD and should be repaired as needed by a qualified electrical specialist.

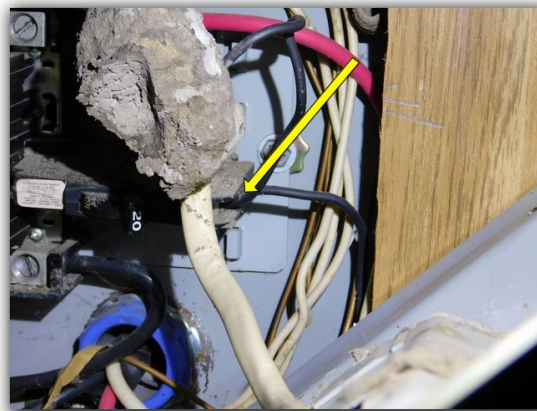
☑ Double tapped breakers / fuses were observed to be a SAFETY HAZARD in the electric service panel. Each breaker should provide electric service to only one circuit. The inspector recommends that the electric service panel be further evaluated and repaired or replaced as needed by a certified, licensed electrician.

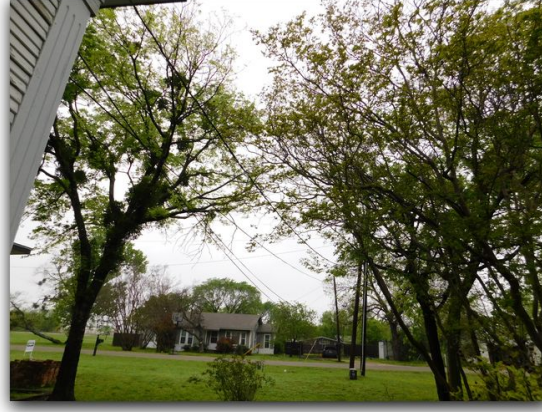
☑ The overhead service drop electrical conductors had inadequate clearance from tree branches. This condition may result in abrasion and damage to the electrical conductors. The inspector

recommends correction by a qualified contractor. Work around electric service conductors should be performed by a qualified contractor only. Injury or death may result from attempts at correction by those without proper qualifications.

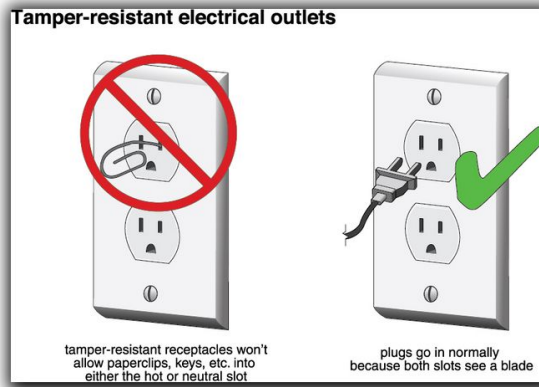
Electrical receptacles within five feet of the floor should be tamper resistant safety receptacles according to current building standards. This may be an "as-built" condition and was an accepted building practice at the time this home was constructed. Lack of tamper resistant electrical receptacles is no longer an excepted building standard according to current National Electric Code (NEC).

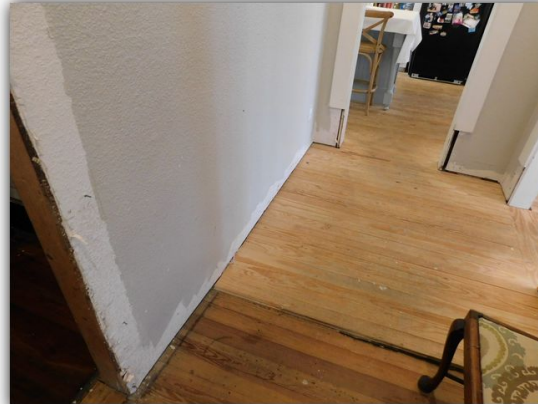
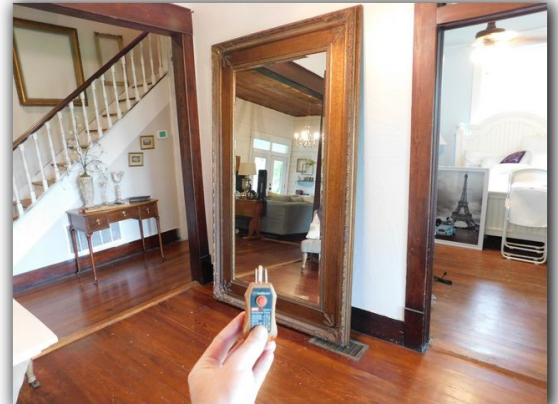
There were one or more areas of the interior walls that lacked an electrical receptacle or the electrical receptacles were improperly spaced.

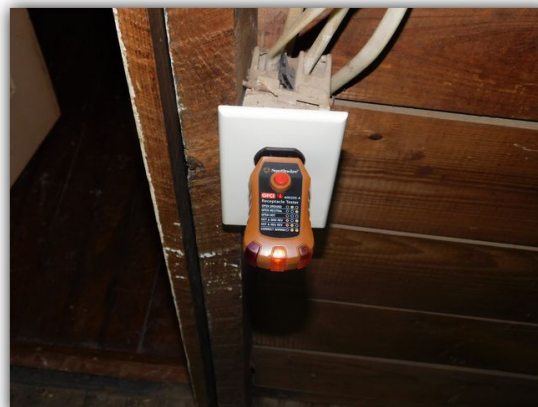
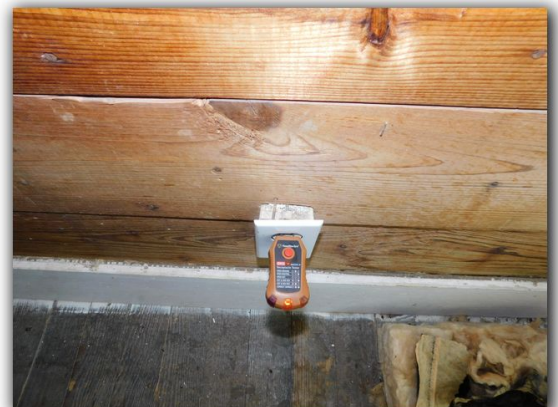
Open ground connections were observed at electrical receptacles. Open ground electrical receptacles are a SAFETY HAZARD and may cause damage to modern electric appliances. The cause of open ground electrical receptacles should be determined and repaired or replaced as needed by a certified, licensed electrical specialist.

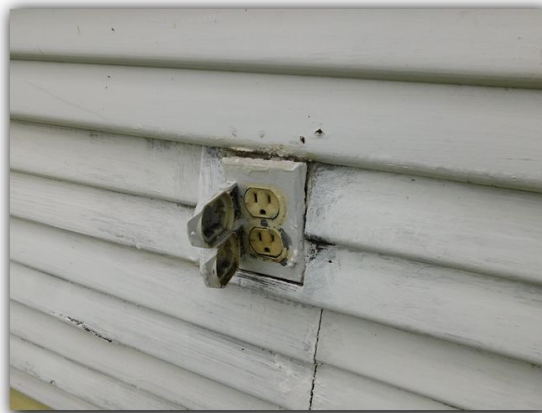
Exterior electrical receptacles in wet locations were observed to lack weather tight bubble covers. Lack of weather proof bubble covers at electrical receptacles in wet locations is a SAFETY HAZARD and should be repaired by a certified, licensed electrical specialist.

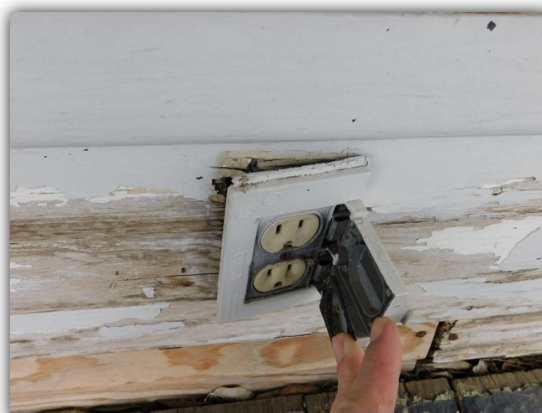
Painted electrical receptacles were observed. Painted electrical receptacles are considered damaged and should be replaced by a certified, licensed electrical specialist for improved safety and performance.

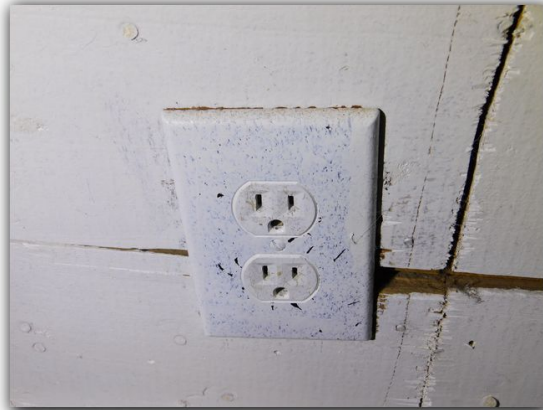
Electrical receptacles, switches and or covers were observed to be loose, damaged, missing or missing screws and were in need of repair. Damaged or missing electrical receptacles or switches should be repaired by a certified, licensed electrical specialist.

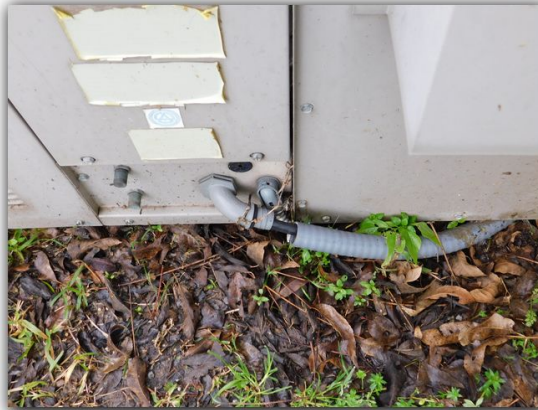
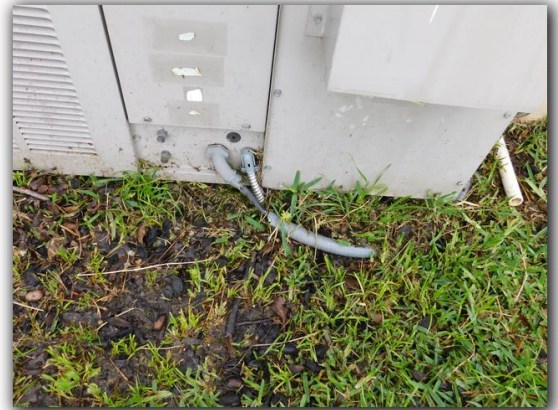
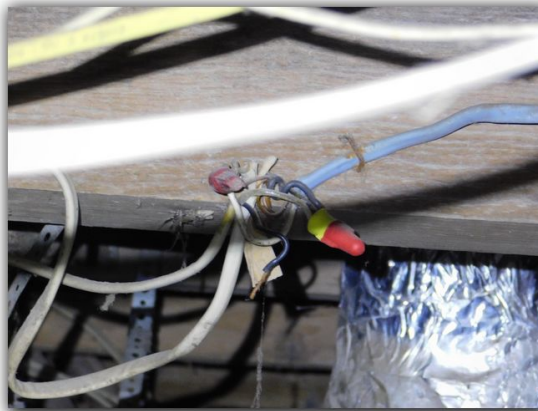
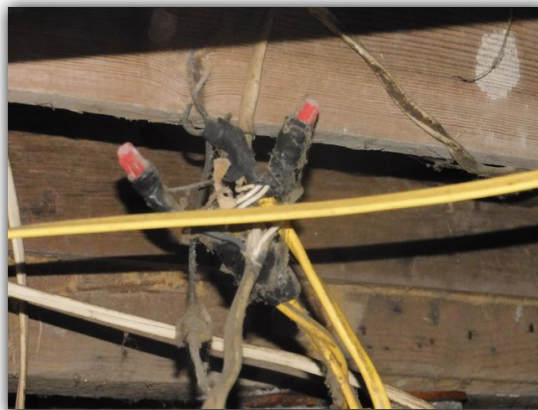
Unprotected electrical conductors were observed at the exterior. Unprotected electrical conductors should be relocated or protected by a rigid conduit. Unprotected electrical conductors should be repaired by a certified, licensed electrician.

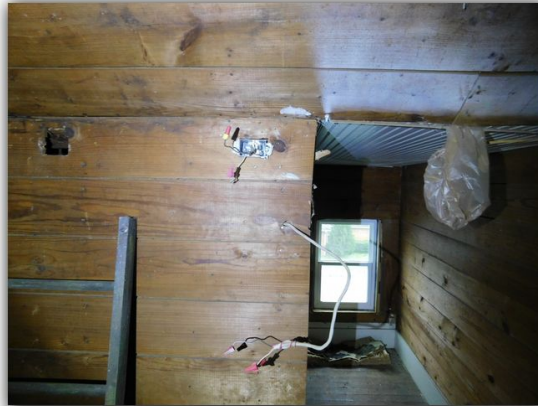
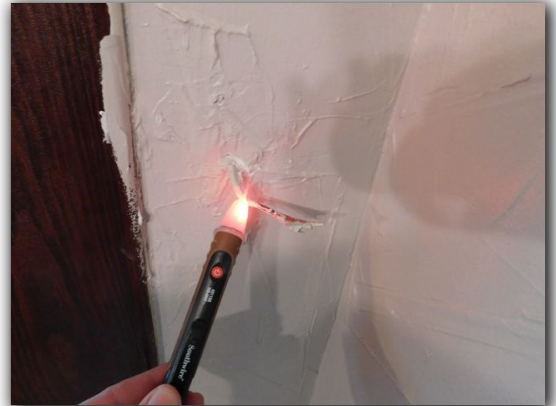
Improperly terminated electrical conductors were observed. All electrical conductor connections should be installed in sealed junction boxes for reasons of safety. Improperly terminated electrical conductors should be repaired by a certified, licensed electrical specialist.

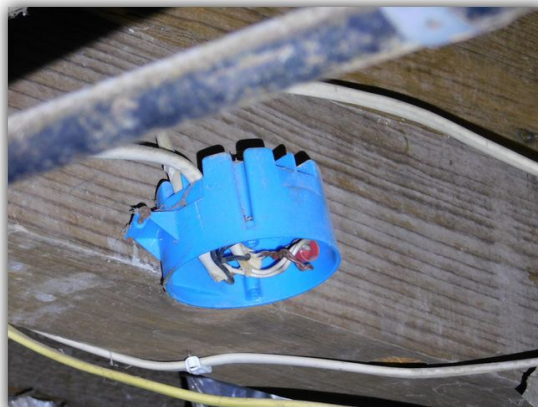
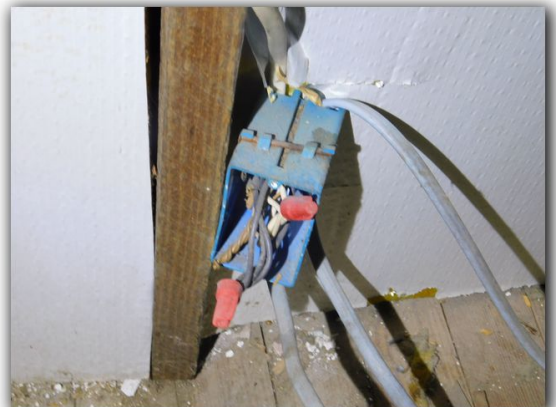
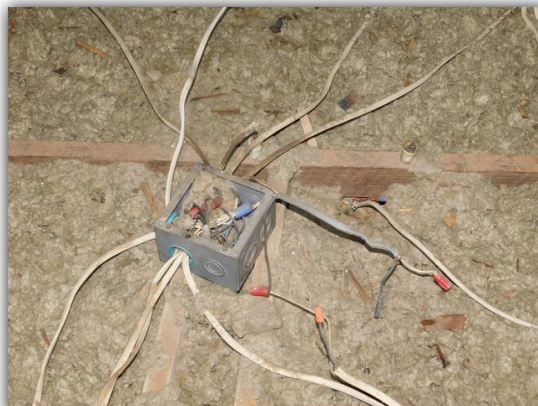
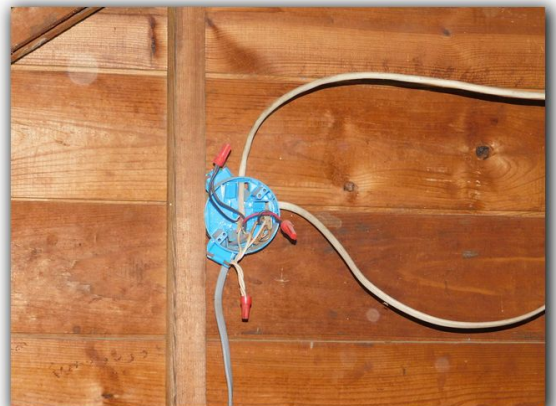
Electrical junction / receptacle boxes were observed to be missing covers. All electrical conductor connections should be installed in sealed junction boxes for reasons of safety. Improperly terminated electrical conductors should be repaired by a certified, licensed electrical specialist.

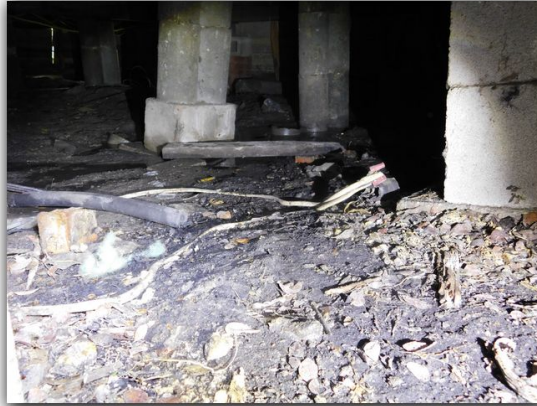
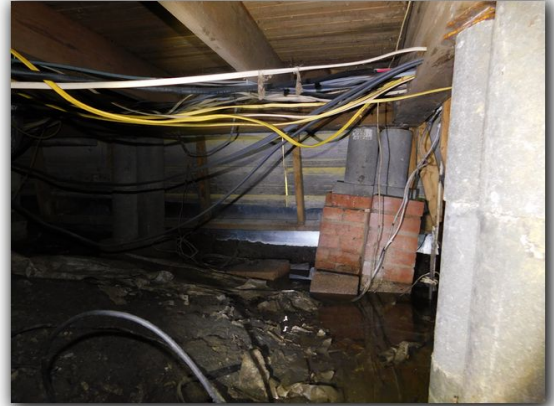
Electrical conductors were in contact with the ground in the crawl space and are a SAFETY HAZARD. Electrical conductors that are improperly supported or are in contact with the ground in the crawl space should be further evaluated and repaired by a certified, licensed electrician.

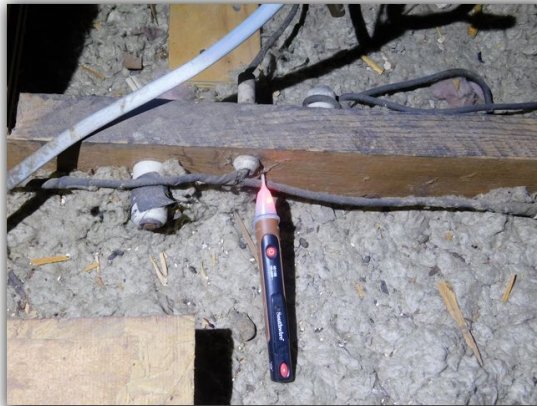
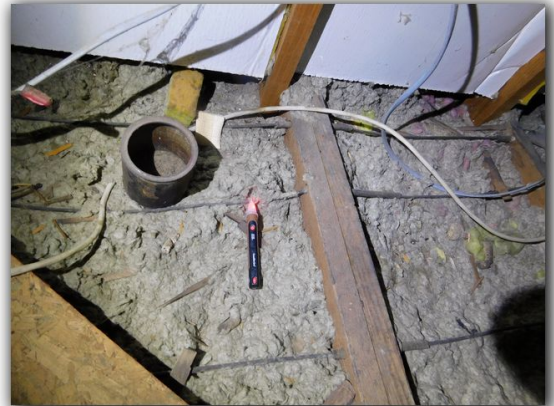
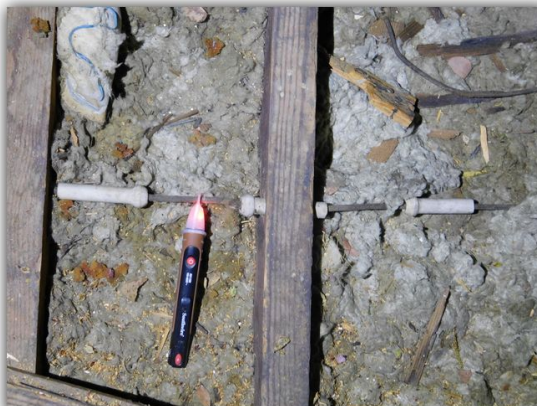
Knob and tube electrical components were observed. Knob and tube type electrical systems are no longer an accepted electrical standard. Knob and tube electrical systems are considered a SAFETY HAZARD under current building standards. Knob and tube electrical systems should be further evaluated and replaced as needed by a certified, licensed electrical specialist.

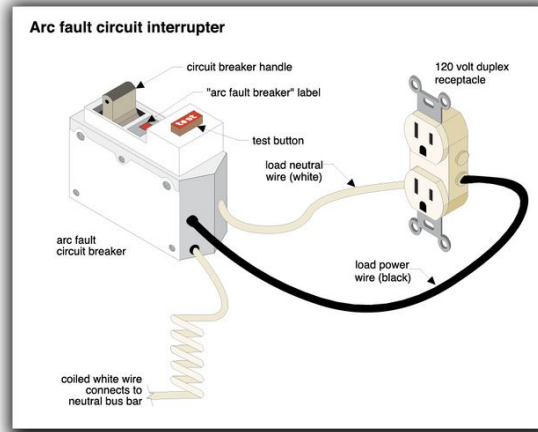
standards, AFCI protection is now required in family rooms, dining rooms, living rooms, parlors, libraries, dens, bedrooms, sun rooms, recreation rooms, closets, hallways, kitchens and laundry rooms. Lack of AFCI protection in required locations is a SAFETY HAZARD.

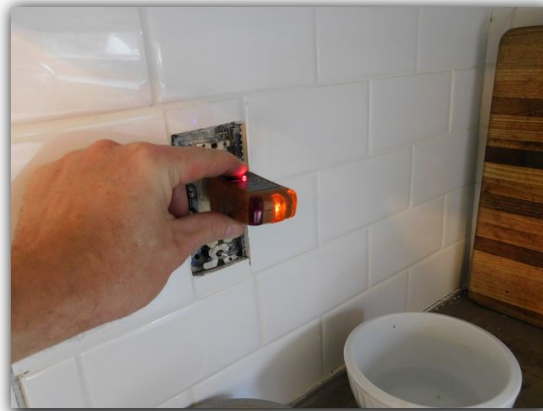
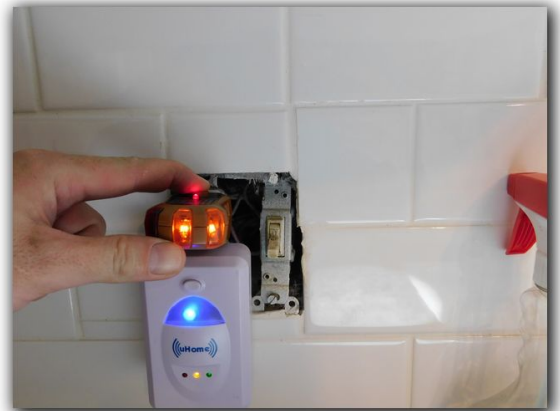
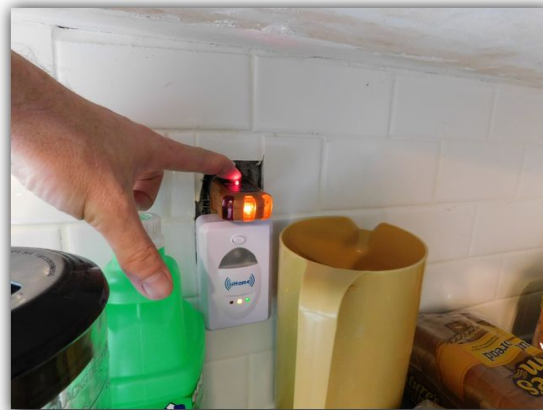
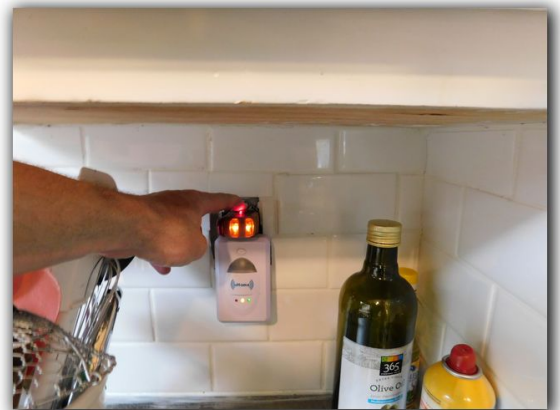
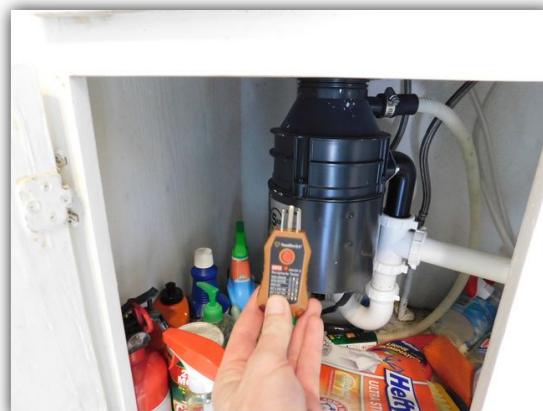
The food waste disposer electrical receptacle was observed to lack ground fault circuit interrupter (GFCI) device protection. According to the 2014 NEC electrical standards, food waste disposer electrical receptacles should be GFCI protected. Lack of GFCI protection in required locations is a SAFETY HAZARD.

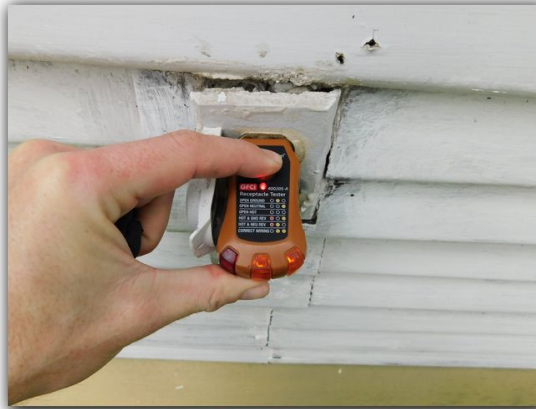
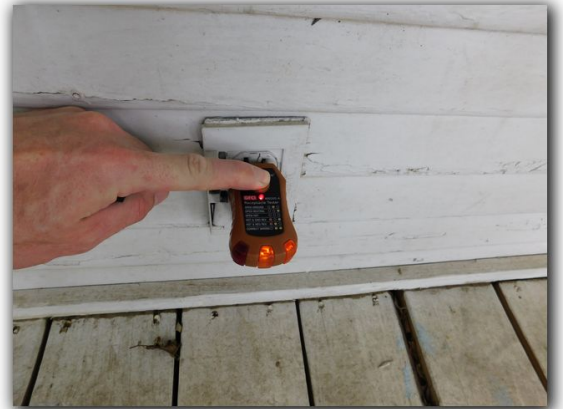
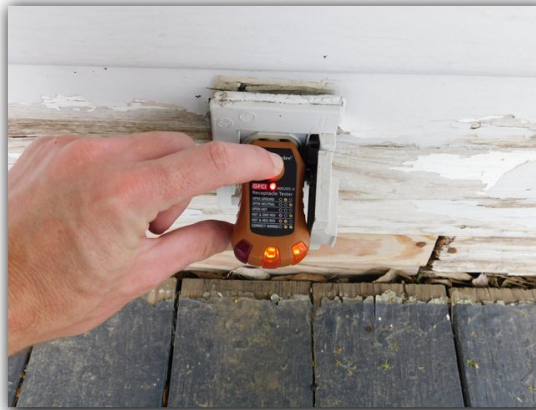
Exterior electrical receptacles were observed to lack ground fault circuit interrupter (GFCI) device protection. Under current electrical standards, all of the exterior receptacles should have GFCI protection. Lack of GFCI protection in required locations is a SAFETY HAZARD.

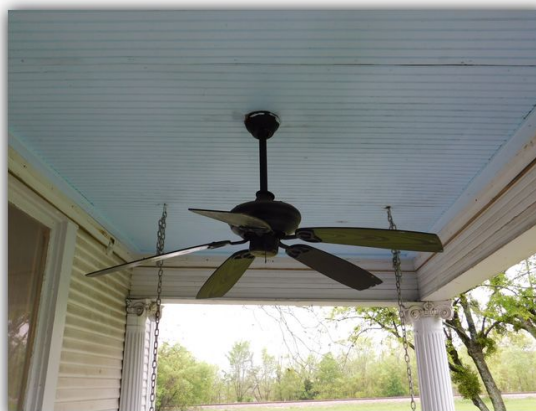
- Inoperative ceiling fans were observed to be in need of repair or replacement.

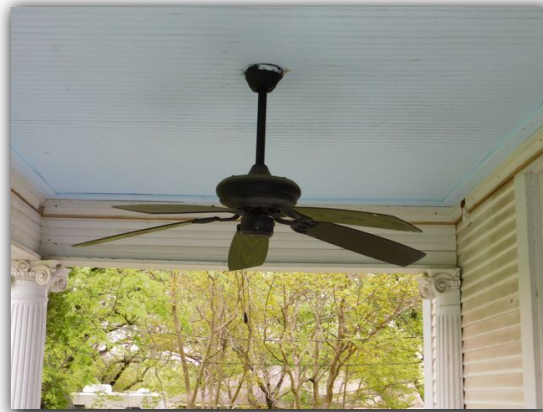
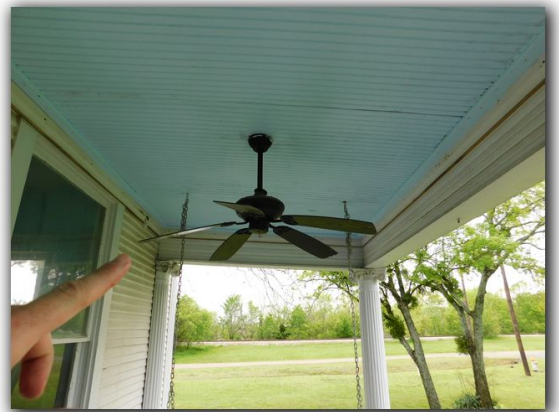
- Damaged, missing, sagging or warped ceiling fan blades should be replaced.

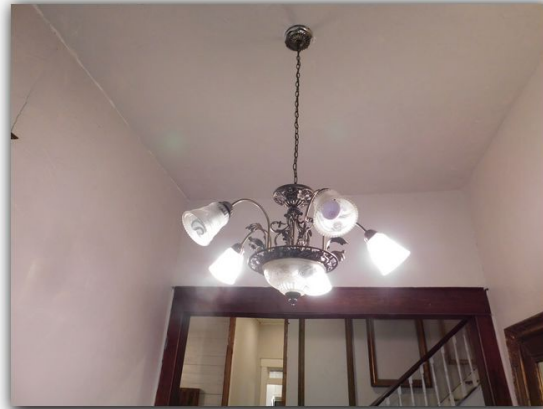
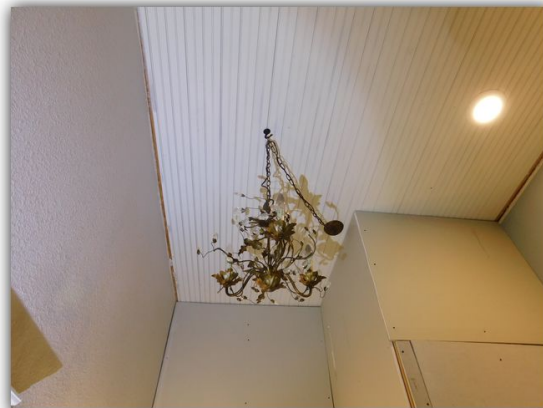
Light fixtures that are inoperative, missing bulbs or have burned out bulbs should be repaired or replaced as needed.

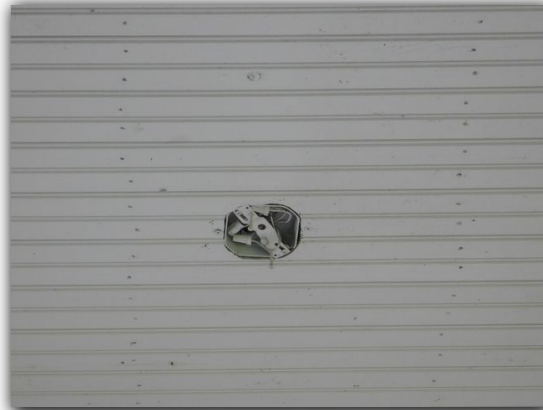
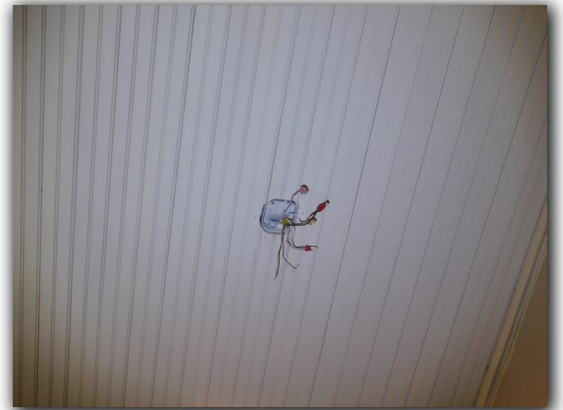
Missing electrical fixtures should be replaced.

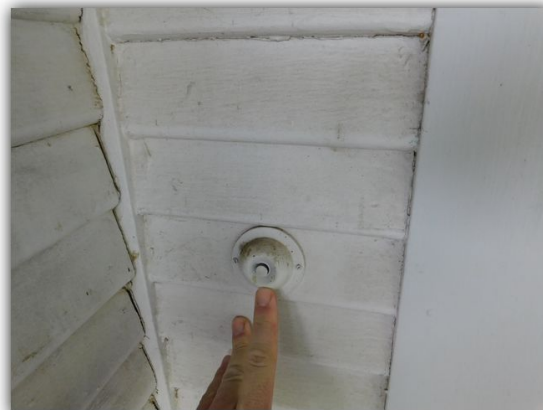
The doorbell was inoperative and was in need of repair or replacement.

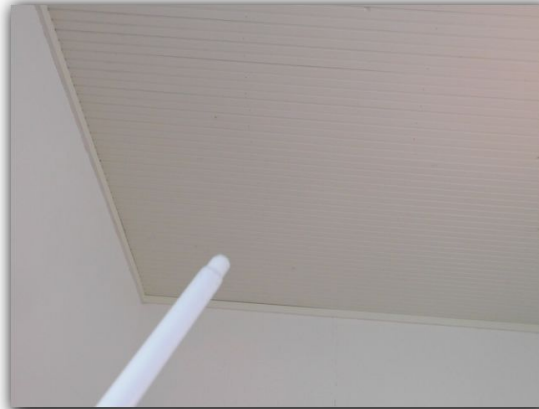
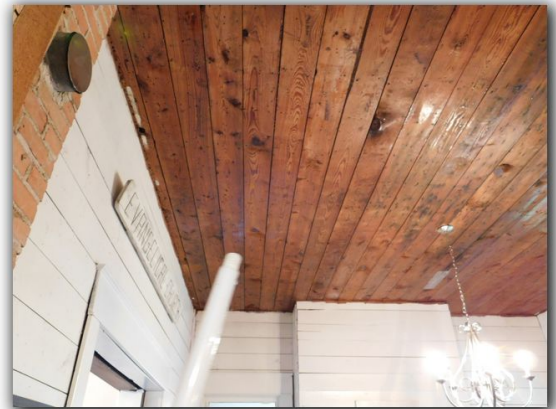
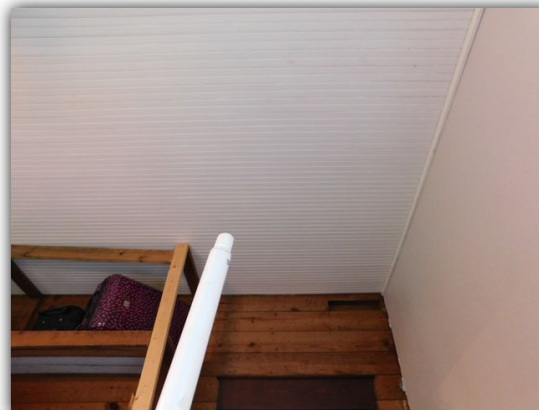
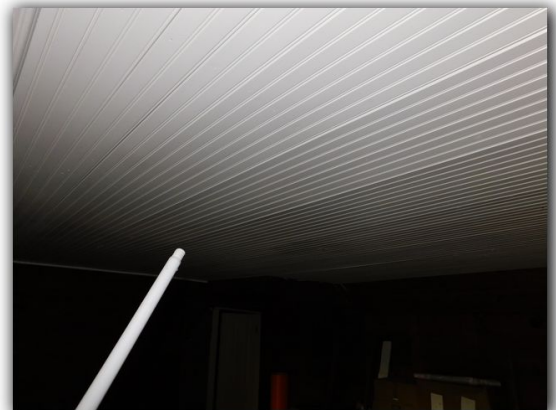
There did not appear to be enough smoke alarms located in required locations (SAFETY HAZARD). Under current building standards, there should be a smoke alarm located in each sleeping room, outside each separate sleeping area in the immediate vicinity of the sleeping rooms, and on each additional story of the dwelling, including basements but excluding crawl spaces and uninhabitable attics (in dwellings with split levels and without an intervening door between the levels, a smoke alarm installed on the upper level and the adjacent lower level shall suffice provided that the lower level is less than one full story below the upper level).

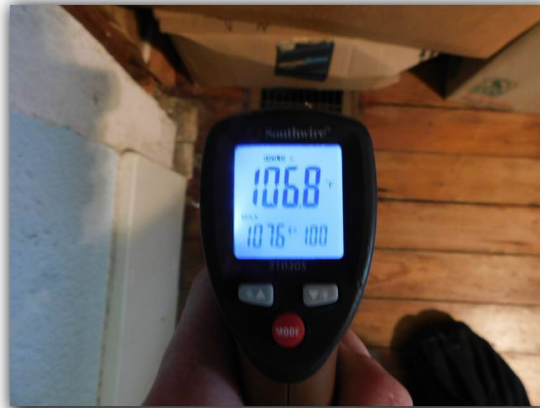
- Unit 1: Downstairs
  - Within Normal Range    Inadequate - In need of service, repair or replacement
- The heating equipment temperature output reading: 106.8 °F

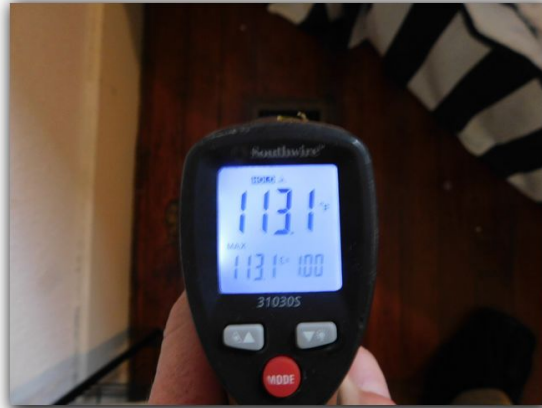
Dirty or damaged heating equipment air filters may not perform as intended and should be replaced as needed or per manufacturer instructions. Dirty or damaged heating equipment air filters may result in damage to the heating equipment.

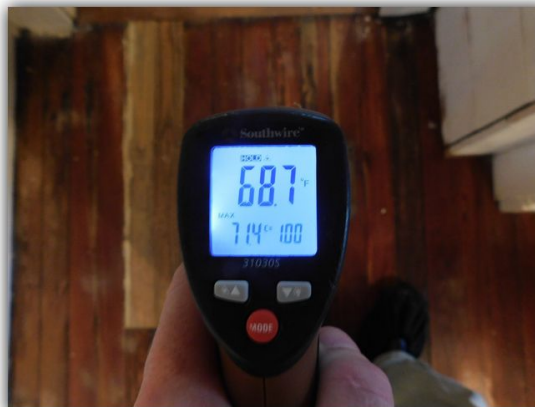
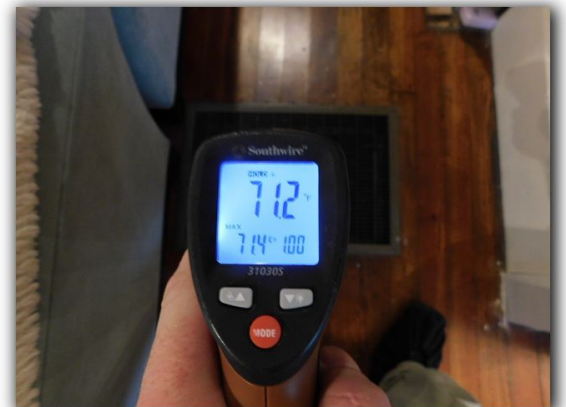
Cooling equipment temperature differentials were not within range of 14-23 degrees Fahrenheit (Above). The inspector recommends that the cooling equipment be further evaluated and serviced by a licensed specialist when the temperature differential is not within the acceptable range. Temperature differential readings are a fundamental standard for testing the proper operation of the cooling system. The normal acceptable range is considered to be approximately between 14 to 23 degrees F. total difference between the return air and conditioned air. Unusual conditions such as excessive humidity, low outdoor temperature and restricted airflow may indicate abnormal operation even though the equipment is functioning as designed and occasionally may indicate normal operation in spite of an equipment malfunction.

Supply Air Temp: 68.7 °F      Return Air Temp: 71.2 °F      Temp. Differential: 2.5 °F

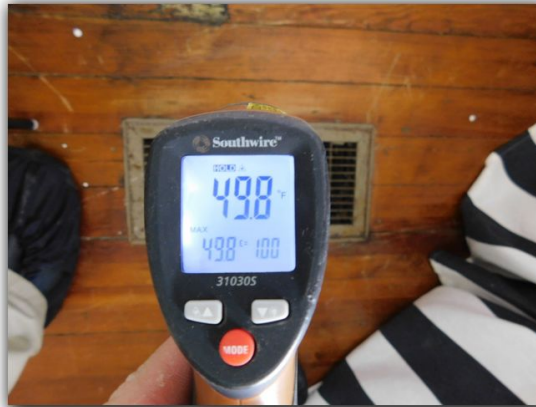
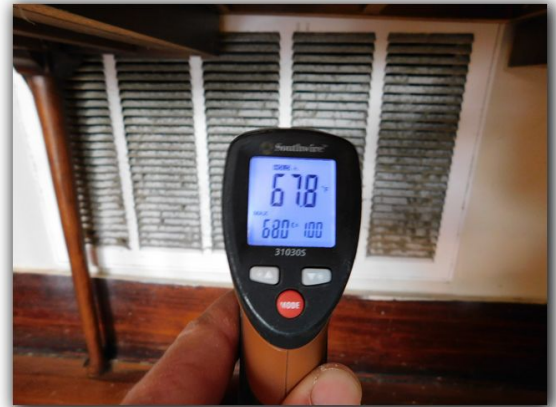
Dirty or damaged cooling equipment air filters may not perform as intended and should be replaced as needed or per manufacturer instructions. Dirty or damaged cooling equipment air filters may result in damage to the cooling equipment.

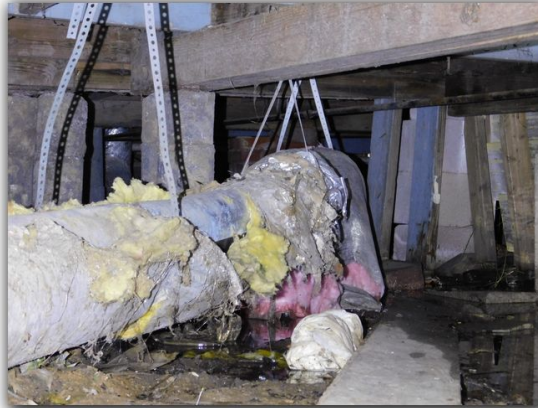
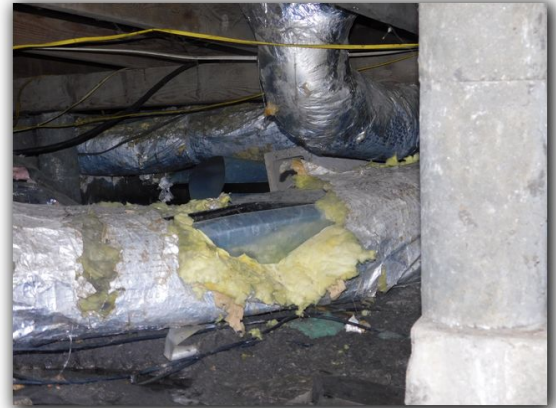
The HVAC ductwork insulation was observed to be damaged. Damaged HVAC ductwork insulation may allow conditioned air to escape into unwanted areas. Damaged HVAC ductwork insulation may create conducive conditions for condensation or other moisture intrusion defects.

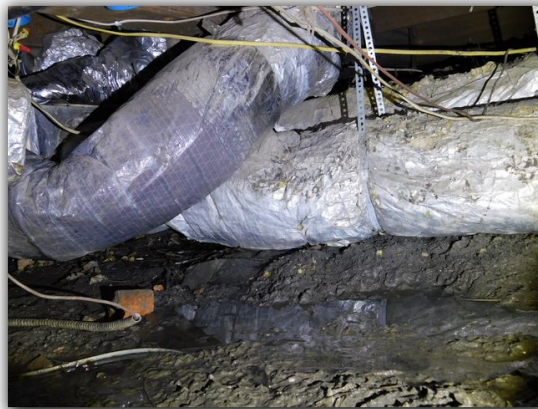
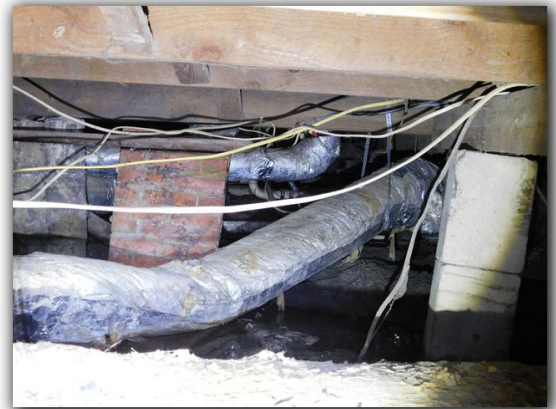
Ductwork installed in the crawlspace was observed to be in contact with the ground and should be properly supported.

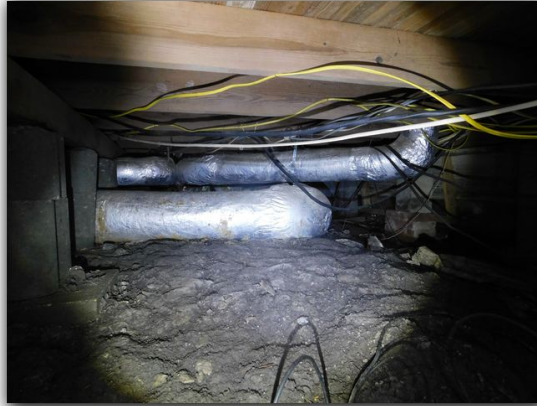
The absence of airflow at heating/cooling supply registers was an indication of disconnected or damaged ducts. The cause of inadequate airflow at the heating/cooling supply registers should be determined and repaired as needed.

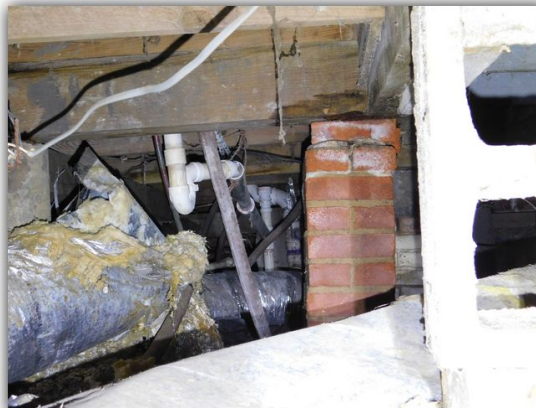
Water supply lines in the crawl space were observed to lack adequate insulation. Lack of insulation or inadequate insulation at water supply lines in the crawl space should be corrected to prevent water damage.

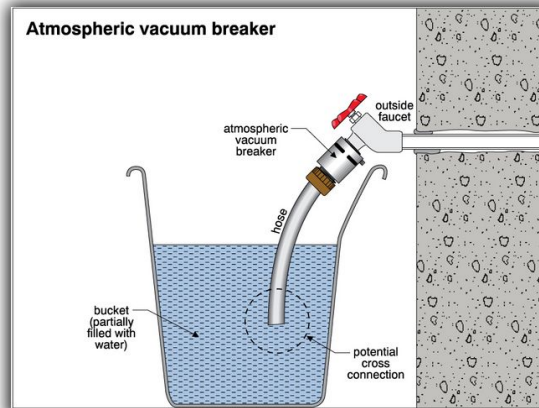
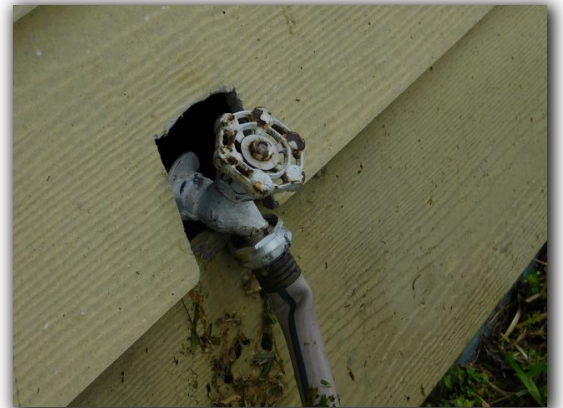
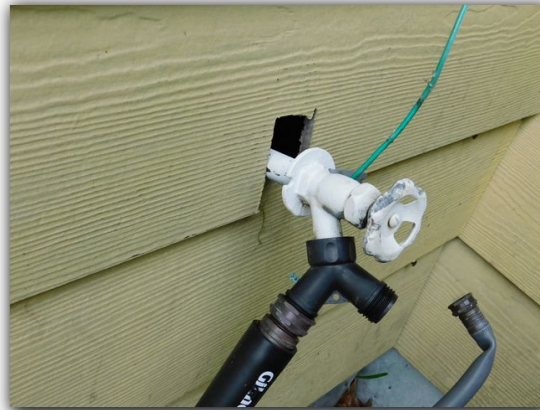
Exterior water supply faucets were missing an anti-siphon device to prevent contaminants from entering the water supply. Lack of anti-siphon devices at exterior water supply faucets is a SAFETY HAZARD. Current building standards require non-removable vacuum breakers on all hose faucets.

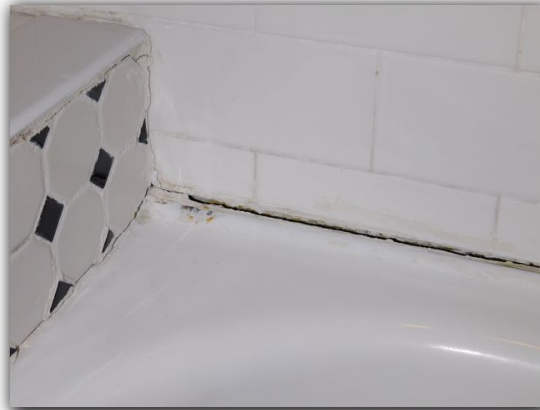
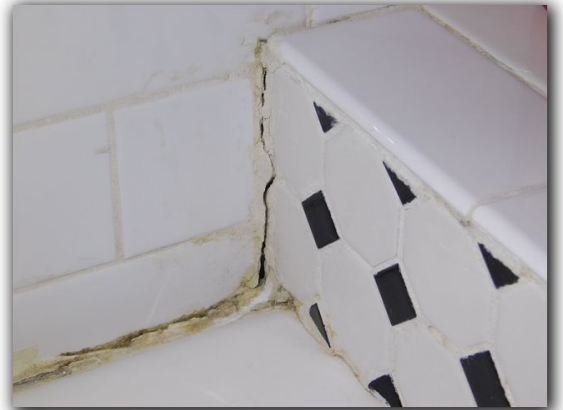
The tub/shower tile grout and sealants were observed to be in need of repair or replacement to prevent water penetration at interior walls. When tub/shower tile grout and sealants are damaged, there may be concealed water damage and or wood destroying insect damage.

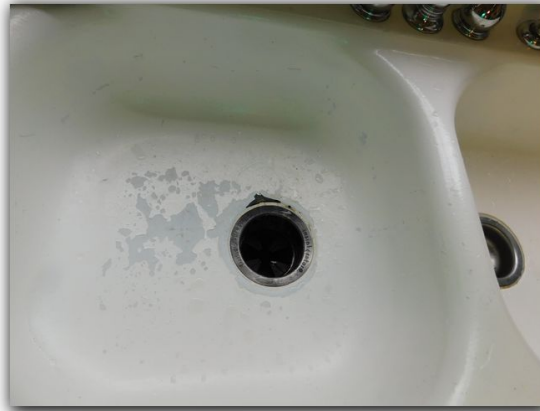
- Surface damage was observed at the kitchen sink.

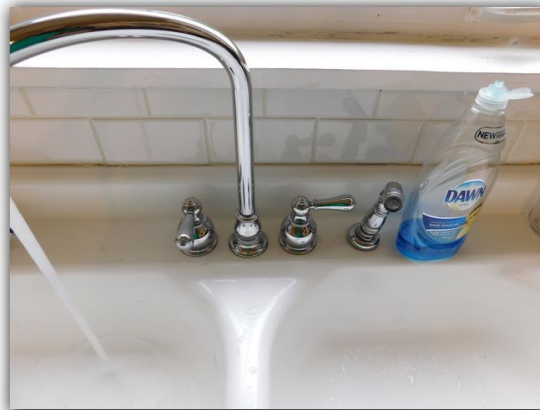
- The temperature indicators are missing at the kitchen sink water supply fixture. Missing water supply temperature indicators are considered a SAFETY HAZARD.

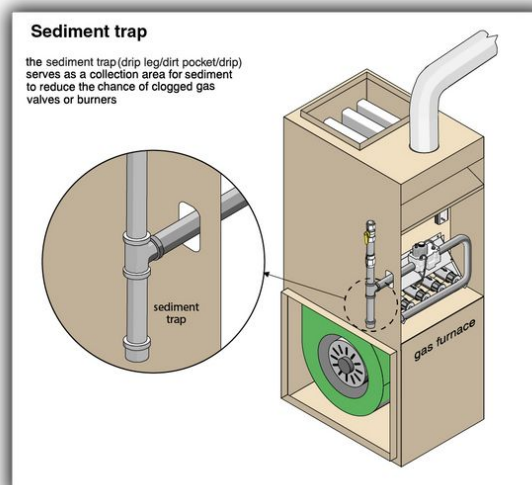
There were gas fired appliances that did not have a "drip leg" installed. Under current construction standards, drip legs are required at the black iron gas pipe prior to a flexible gas line connection.

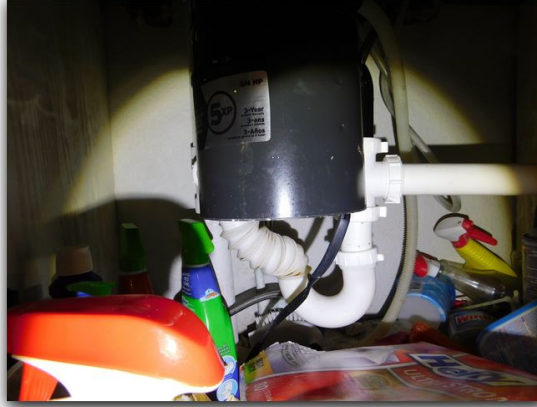
Temporary accordion type plumbing at the waste drains should be repaired. Temporary

plumbing at sink waste drains are a hidden fouling hazard and may cause water damage and create conducive conditions for wood destroying insects.

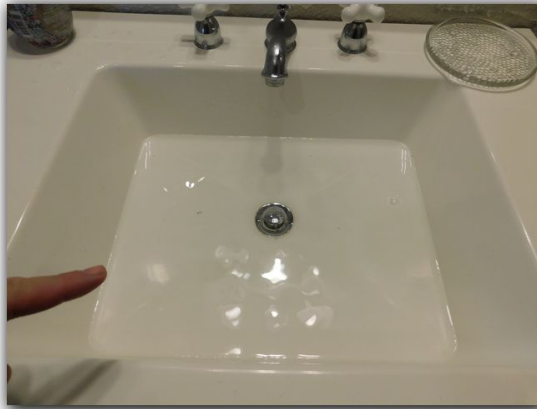
Waste drains were slow to drain at sinks or tubs. The cause of slow drains should be determined and should be repaired or replaced as needed.

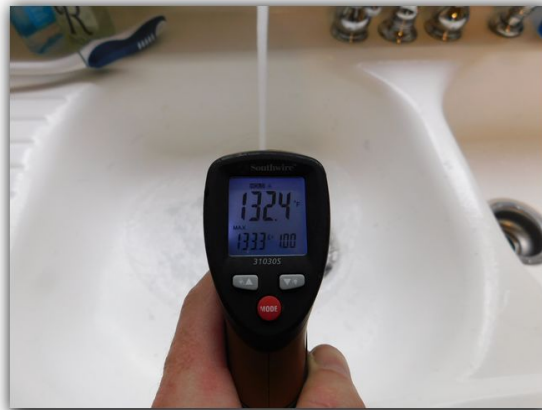
**Heated Water Temperature ( 132.4 °F):**

Heated water temperature was observed to be greater than 120 degrees Fahrenheit F and was a SAFETY HAZARD. Adequate and safe heated water temperatures are considered to be between 100 degrees and less than 120 degrees Fahrenheit. The cause of improper heated water temperature should be determined and should be corrected as needed. The water heater thermostats may be turned up too high or there may be other defects in the water heating equipment.

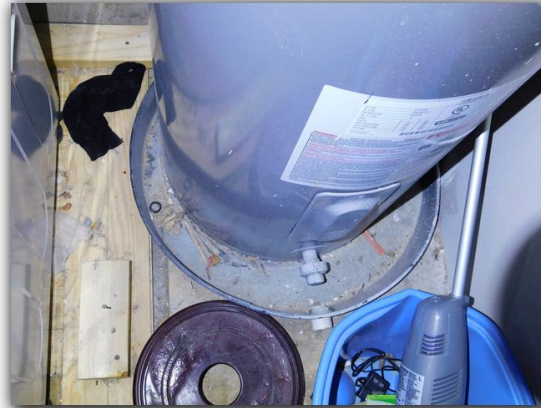
The water heating equipment overflow pan lacks a drain to the exterior of the structure. Current building standards state that all water heaters should be equipped with an overflow pan with a drain which drains to the exterior of the structure if leaks would cause damage.

- The water heating equipment overflow pan lacks a drain to the exterior of the structure. Current building standards state that all water heaters should be equipped with an overflow pan with a drain which drains to the exterior of the structure if leaks would cause damage.

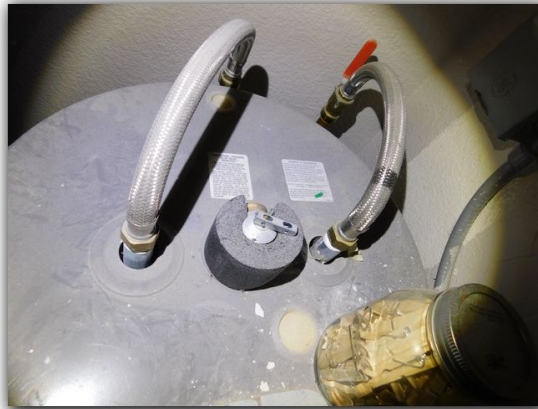
- The water heating equipment TPR valve was inspected and verified, but was not tested. It is common for TPR Drain valves to fail under testing and leak water.
- The water heating equipment TPR valve had no drain line plumbing installed. Lack of properly installed TPR drain line plumbing may result in water damage and should be repaired by a qualified plumbing specialist.

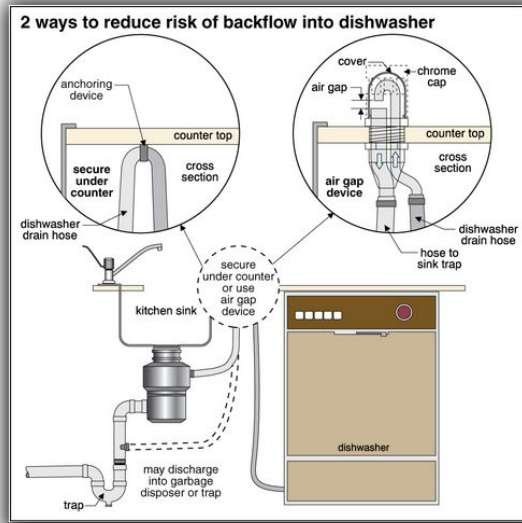
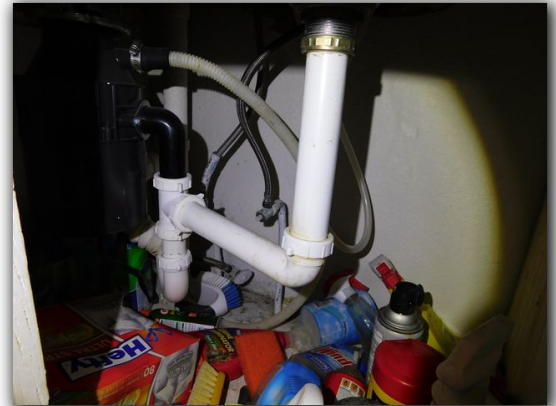
- A visible anti-siphon loop or back flow prevention device was not installed at the dishwasher drain line. Some newer dishwashers may have built in anti-siphon devices that are not visible. The buyer is encouraged to consult the owner's manual or contact the manufacturer if an anti-siphon device is not visible. Lack of an anti-siphon device at a dishwasher is a SAFETY HAZARD.

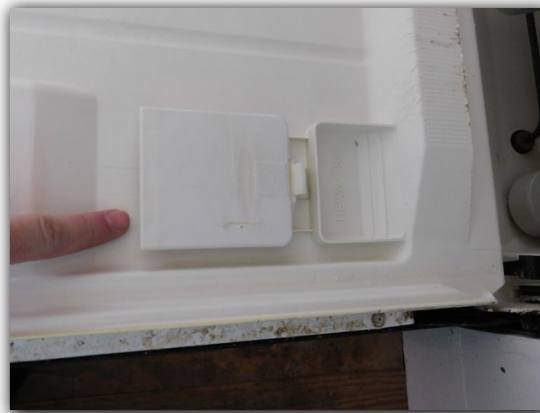
The dishwasher soap dispenser was not functioning properly. Dishwasher soap dispensers that do not perform as intended were an indication that repair or replacement is needed.

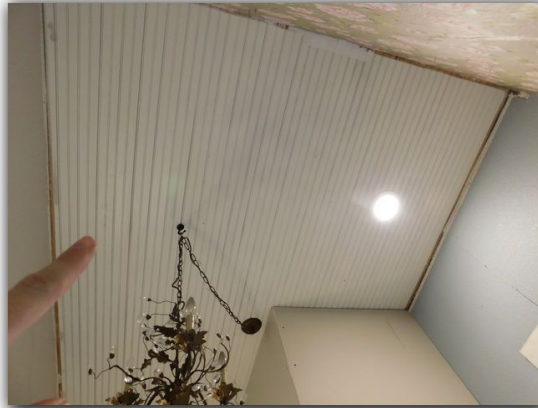
Current building standards require that all bathrooms have installed a mechanical exhaust vent or an operable window to remove moisture from the air. Lack of an operable window or a mechanical exhaust vent in bathrooms is a deficiency and should be repaired.

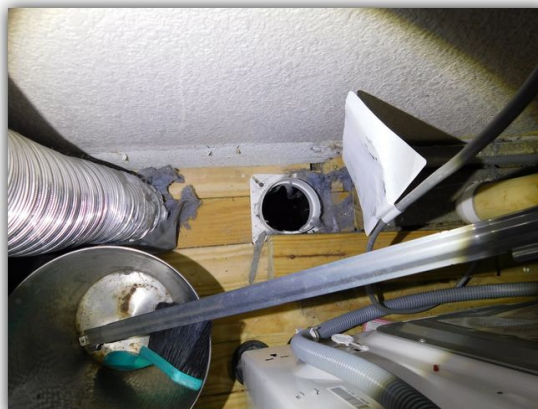
The dryer vent was vented directly into the crawl space and was observed to be a SAFETY HAZARD. Under current building standards, dryer vents should terminate at the exterior of the structure.

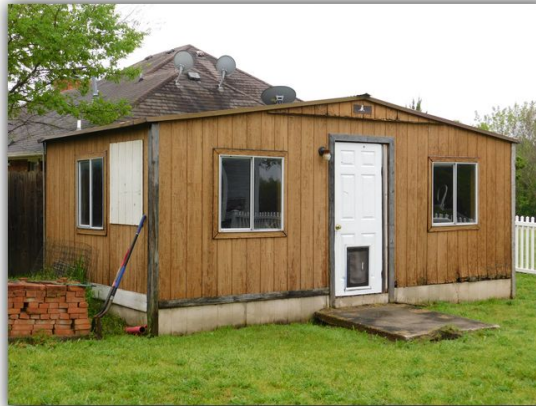
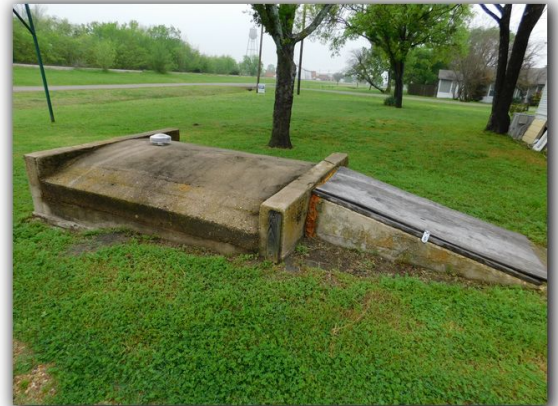
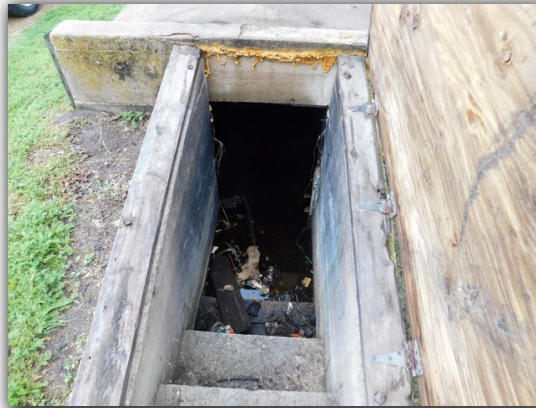
The exterior outbuilding wood veneer siding was observed to have some deterioration and/or damage. Damaged and deteriorated outbuilding exterior wooden siding should be repaired to prevent wall damage, moisture penetration and wood destroying insects.
