Fouries Home Inspection

NEW HOME INSPECTION
Prepared Exclusively For: Buyer Name

Any Street, Irving, TX, 75063

PROPERTY INSPECTION REPORT

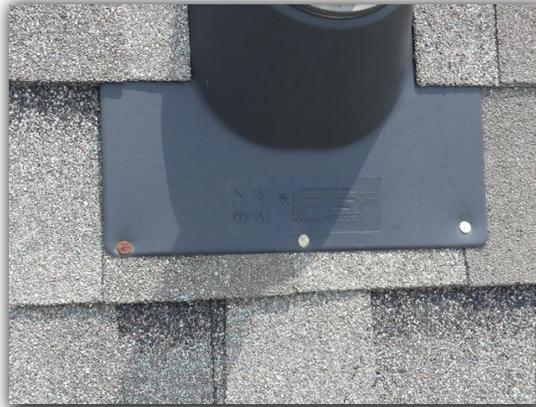
Roof covering drip edge and flashings were observed to be missing, damaged or improperly installed and were in need of repair or replacement. Missing, damaged or improperly installed flashings may allow water penetration.

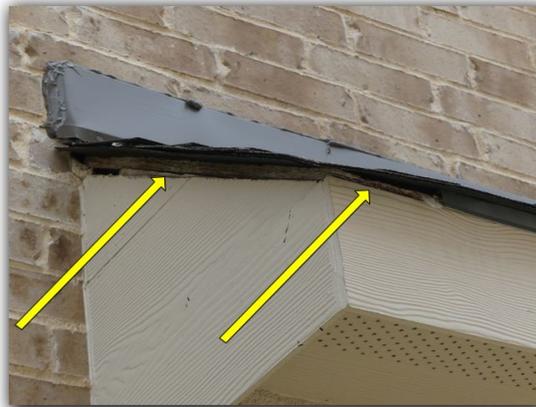
Current construction standards require a kick out flashing at the roof coverings and wall intersections. Kick out flashings prevent water leaks, damage and discoloration to walls.

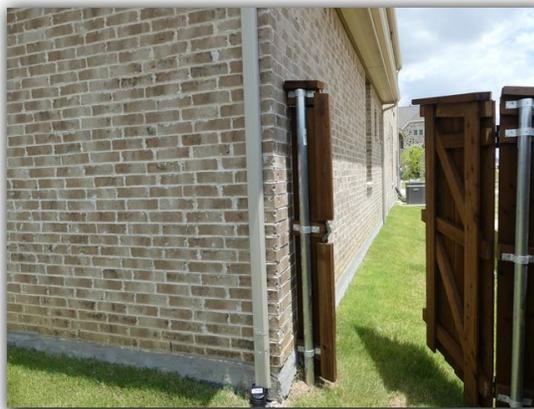
Wood fencing in contact with the structure creates conducive conditions for wood destroying insects. Wood fencing materials should be trimmed back so as not to be in contact with the exterior wall surfaces.

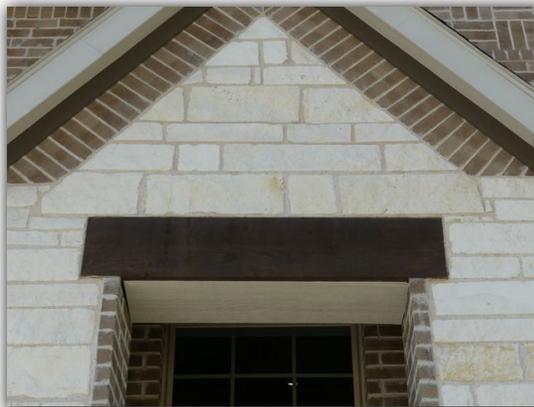
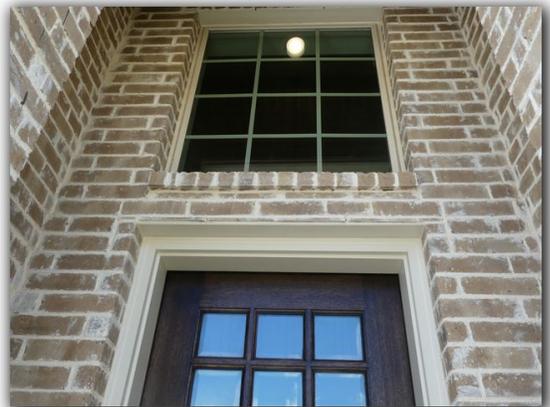
Weep holes were not installed in the brick/stone masonry above the exterior doors in required locations. Under current building standards, weep holes should be installed in the brick/stone masonry above exterior doors to provide proper wall ventilation.

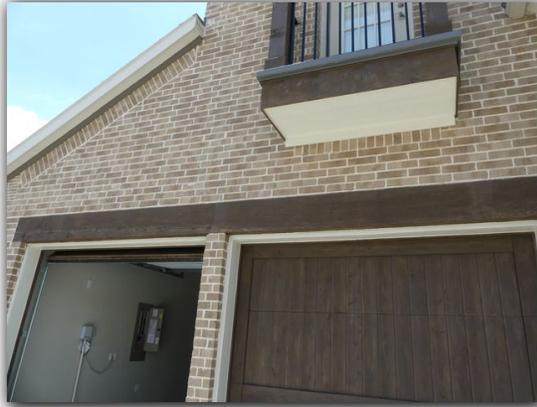
Weep holes were not installed in the brick/stone masonry above the windows in required locations. Under current building standards, weep holes should be installed in the brick/stone masonry above windows to provide proper wall ventilation.

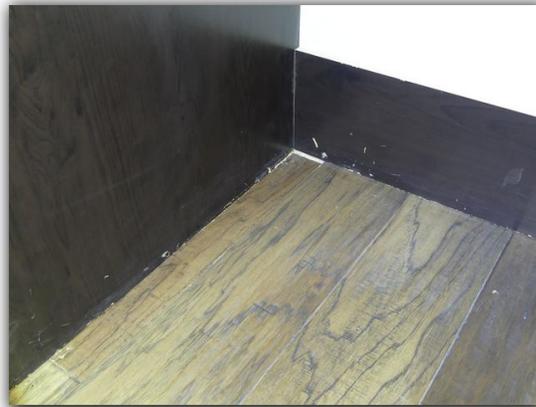
- Missing sealant should be repaired to avoid water penetration.

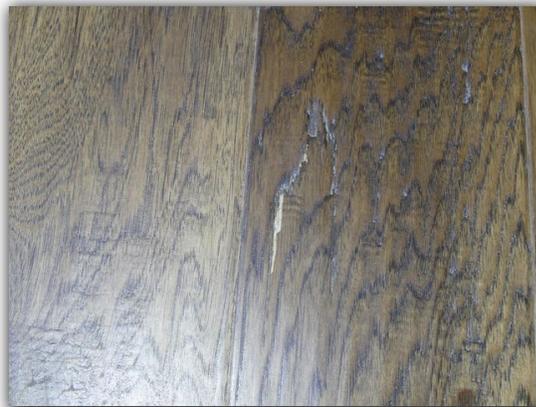
- The floor covering was noticeably damaged and was in need of repair or replacement.

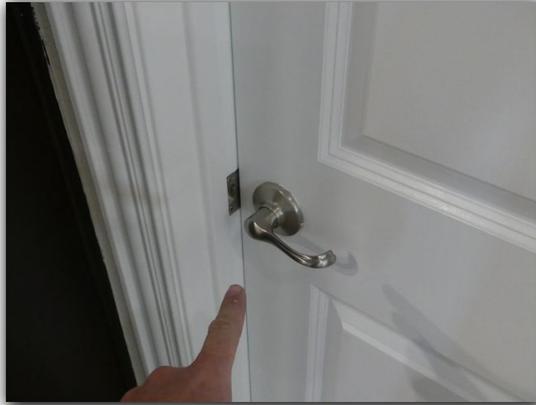
Interior doors were observed to rub, stick or hit the door frames. The cause of doors sticking or hitting door frames should be determined and repaired as needed.

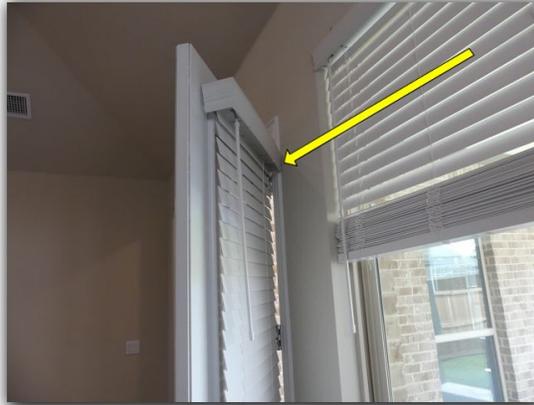
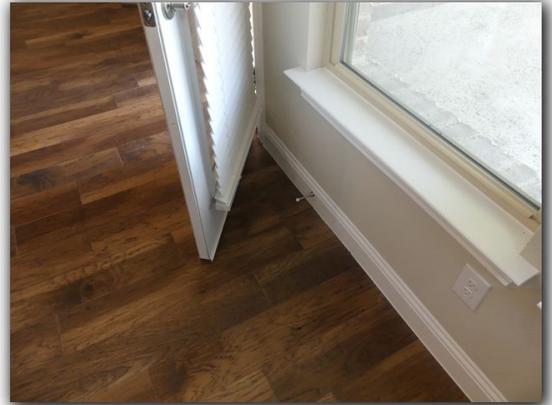
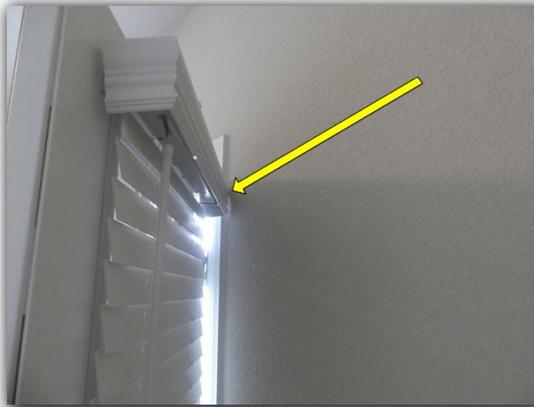
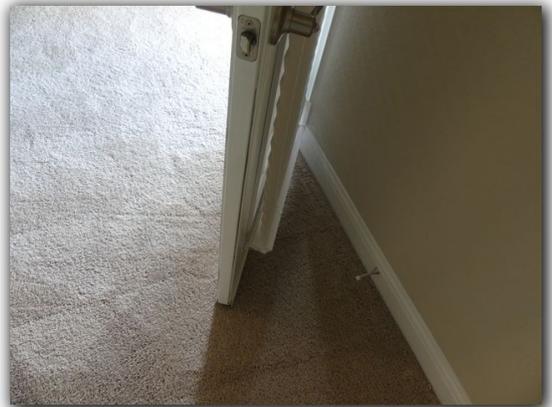
Damaged or missing exterior door weather stripping should be replaced. Missing or damage exterior door weather stripping creates conducive conditions for moisture intrusion and conditioned air loss.

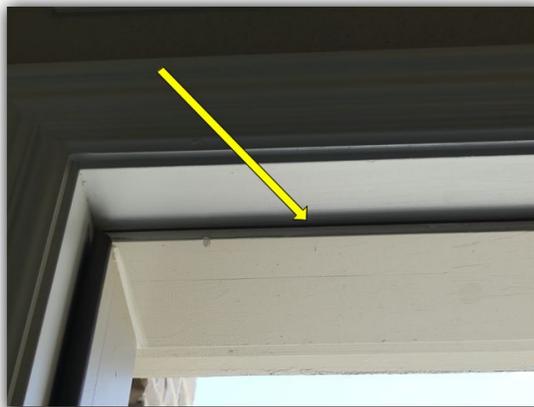
Garage Entry Door:

Garage entry doors should have installed operational self closing hinges according to today's Texas Standards of Practice . Per Texas Standards of Practice we are required to report this condition as a deficiency because it is no longer an excepted building standard.

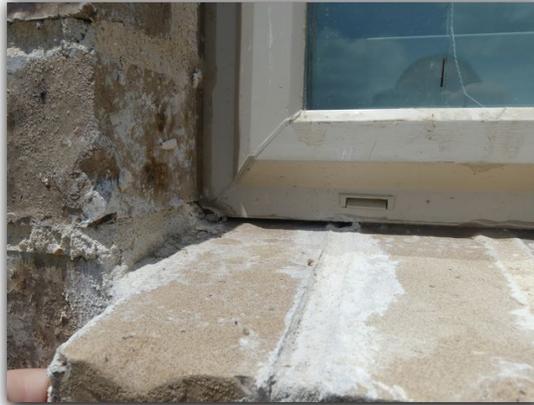
The windows need sealant between the window frames and interior wall cladding. Lack of, damaged or deteriorating sealant around window frames should be repaired as needed.

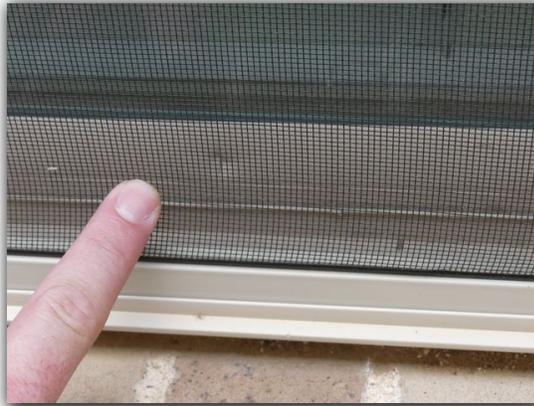
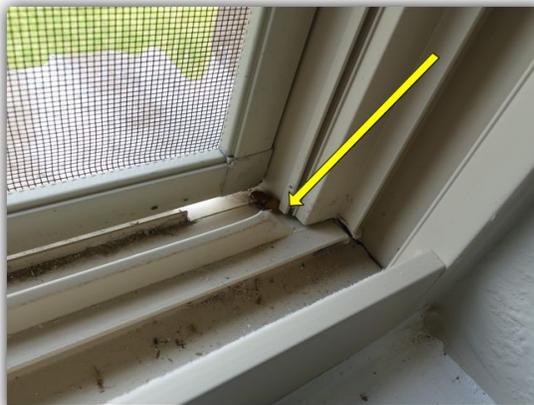
The window frames were observed to be damaged. Damaged windows may allow moisture penetration, conditioned air loss and insect penetration and should be repaired.

Damaged window screens were observed. Window screens help protect window glass from minor impact damage and prevent insect penetration at the windows. Damaged window screens should be repaired or replaced.

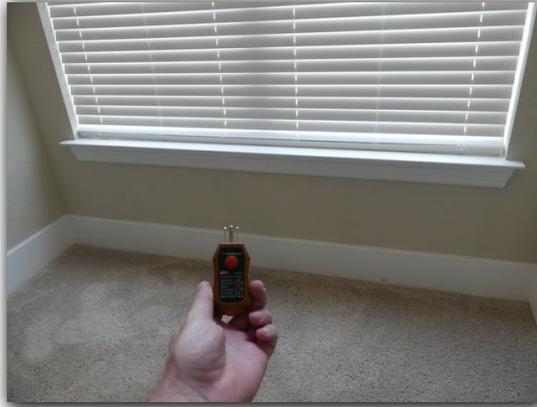
Electrical receptacles, switches and or covers were observed to be loose, damaged, missing or missing screws and were in need of repair. Damaged or missing electrical receptacles or switches should be repaired by a certified, licensed electrical specialist.

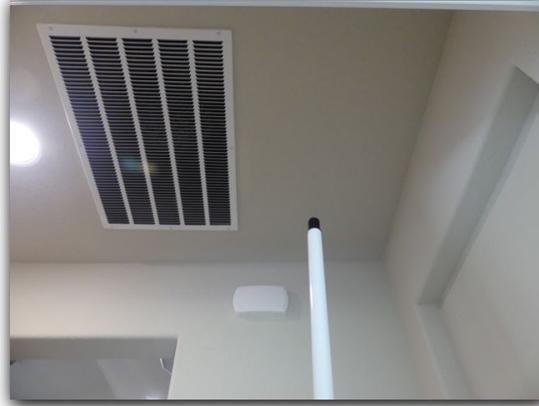
There did not appear to be enough smoke alarms located in required locations (SAFETY HAZARD). Under current building standards, there should be a smoke alarm located in each sleeping room, outside each separate sleeping area in the immediate vicinity of the sleeping rooms, and on each additional story of the dwelling, including basements but excluding crawl spaces and uninhabitable attics (in dwellings with split levels and without an intervening door between the levels, a smoke alarm installed on the upper level and the adjacent lower level shall suffice provided that the lower level is less than one full story below the upper level).

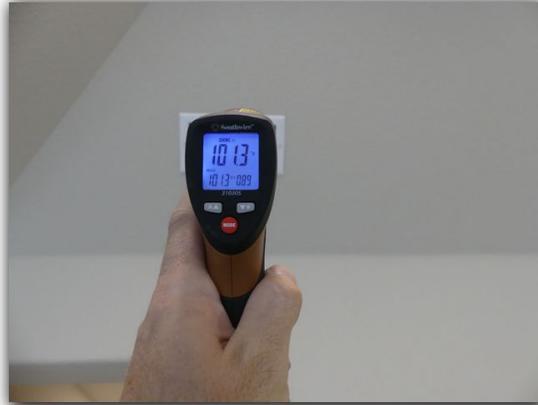
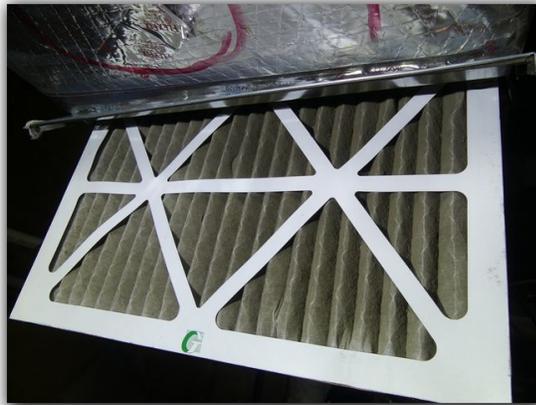
Dirty heating equipment air filters may not perform as intended and should be replaced as needed or per manufacturer instructions. Dirty or damaged heating equipment air filters may result in damage to the heating equipment.

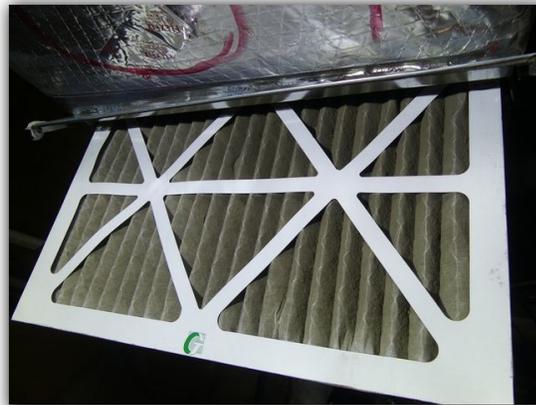
Dirty cooling equipment air filters may not perform as intended and should be replaced as needed or per manufacturer instructions. Dirty or damaged cooling equipment air filters may result in damage to the cooling equipment.

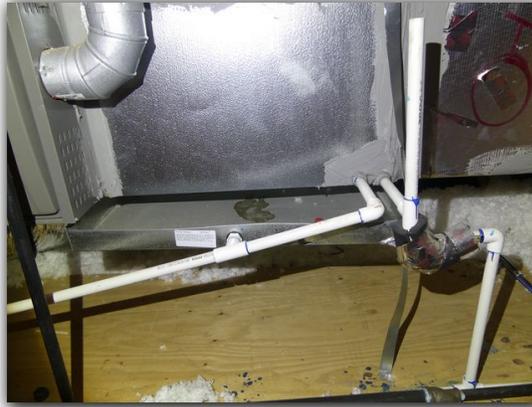
The cooling equipment condensation overflow pan or drain lines installed above ceilings were not equipped with water or moisture sensors/alarms. Cooling equipment condensation drain pans or drain line sensors and alarms should be installed at cooling equipment installed above ceilings for additional protection against water damage.

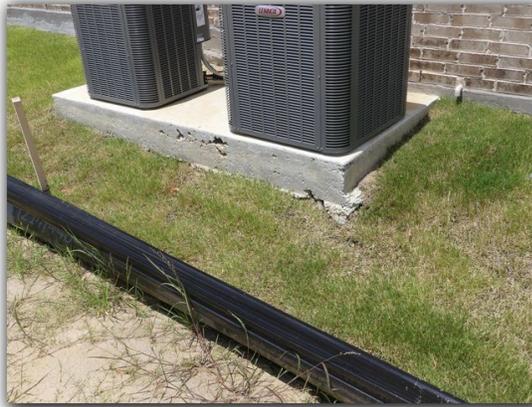
Erosion underneath the exterior HVAC equipment support pad was observed. Erosion underneath the exterior HVAC equipment may result in equipment damage, inadequate performance, or other defects and should be repaired.

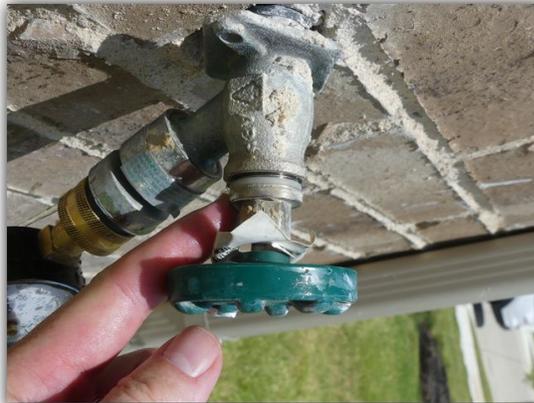
Exterior Plumbing:

Leaking exterior water supply hose bibs should be repaired or replaced as needed.

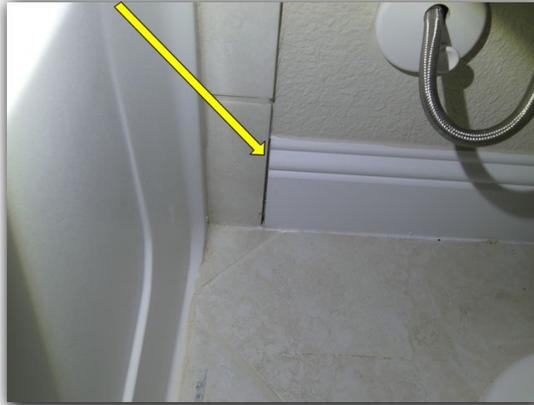
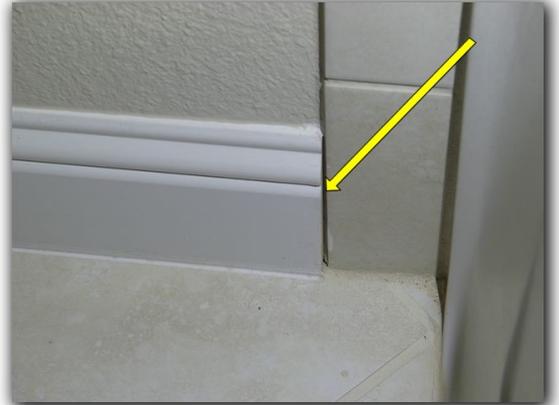
Tubs & Showers:

The tub/shower tile grout and sealants were observed to be in need of repair or replacement to prevent water penetration at interior walls.

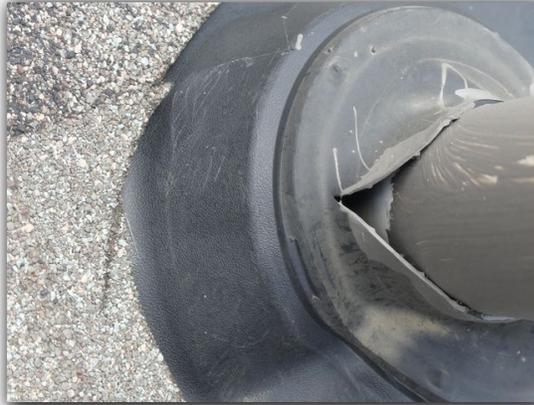
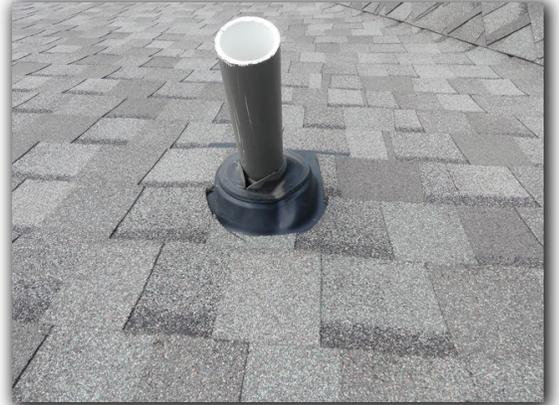
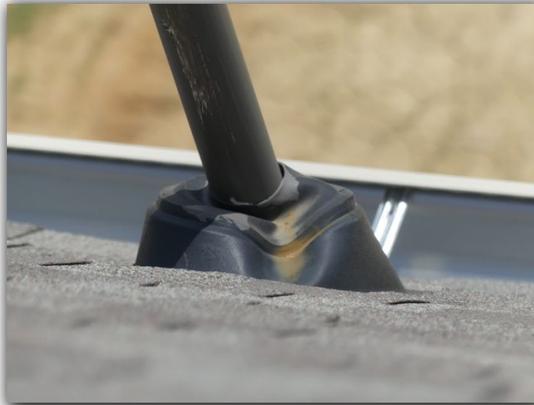
Roof penetration plumbing vent boots were damaged and may allow water penetration. Replacement is recommended.

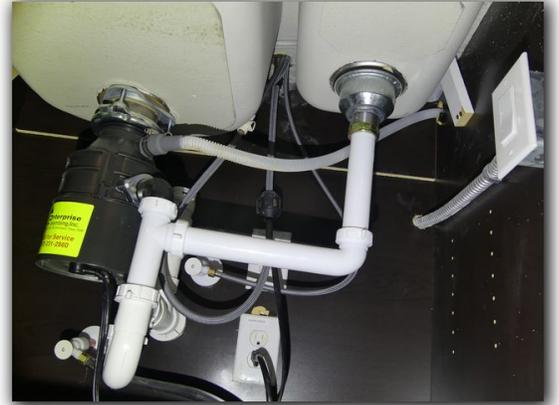
A visible anti-siphon loop or back flow prevention device was not installed at the dishwasher drain line. Some newer dishwashers may have built in anti-siphon devices that are not visible. The buyer is encouraged to consult the owner's manual or contact the manufacturer if an anti-siphon device is not visible. Lack of an anti-siphon device at a dishwasher is a SAFETY HAZARD.

- There did not appear to be enough smoke alarms located in required locations (SAFETY HAZARD).
- A visible anti-siphon loop or back flow prevention device was not installed at the dishwasher drain line. Some newer dishwashers may have built in anti-siphon devices that are not visible. The buyer is encouraged to consult the owner's manual or contact the manufacturer if an anti-siphon device is not visible. Lack of an anti-siphon device at a dishwasher is a SAFETY HAZARD.

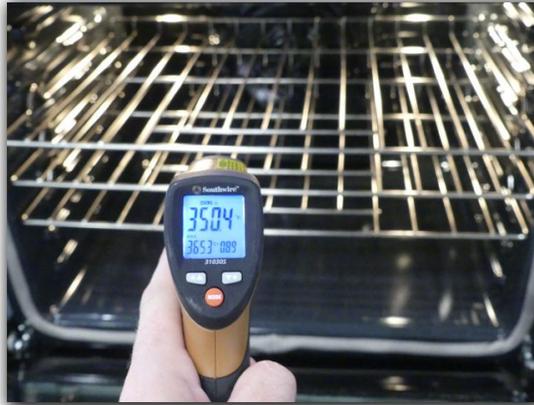
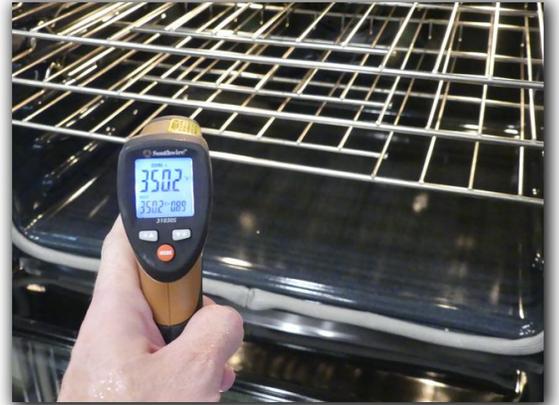
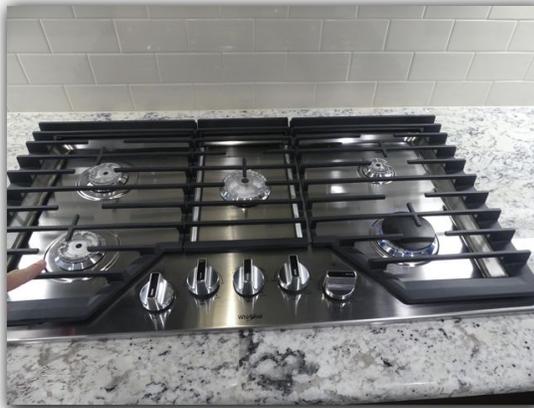
Gas Oven Or Range:

The gas cooktop burner caps were missing. The missing cooktop gas burner caps should be replaced as needed.

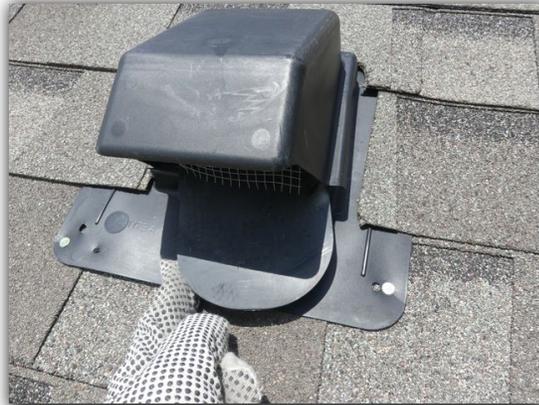
- Damaged mechanical exhaust vent covers should be replaced.
