# Fouries Home Inspection

1 YEAR WARRANTY HOME INSPECTION  
Prepared Exclusively For: Buyer Name

Any Street, Prosper, TX, 75078

## PROPERTY INSPECTION REPORT

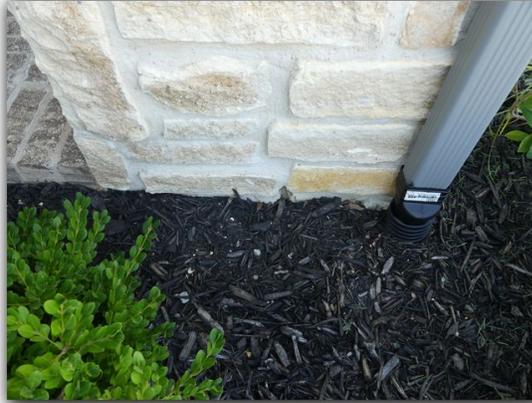
High soil levels were observed at the foundation/brick line. 4 to 6 inches of the foundation perimeter beam should be visible. High soil levels may block weep holes and prevent proper wall ventilation. High soil levels create conducive conditions for wood destroying insects and water intrusion. High soil levels prevent the inspector from observing the foundation perimeter beam.

Correction of inadequate grading clearance to exterior wall and foundation surfaces is recommended.

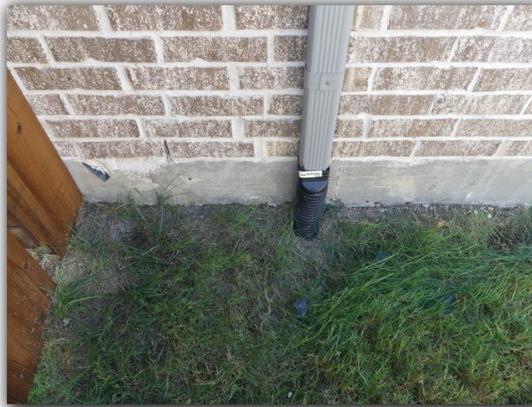
There is a subsurface or below grade drainage system installed. The inspector has no way of knowing if below grade drainage systems are performing as intended. The inspector recommends that the below grade drainage system be monitored for performance.

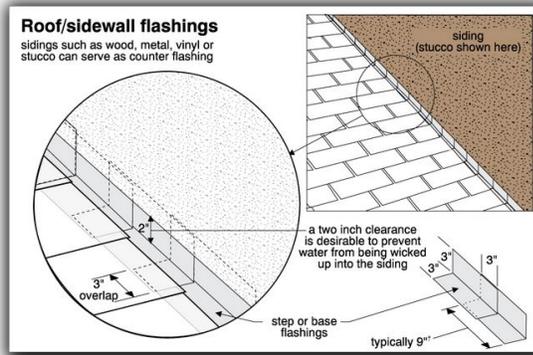
Inadequate clearance between exterior siding and roof covering materials was observed. There should be a space between the siding and roof covering. Space between the roof covering and siding provides proper ventilation and prevents water damage to the siding.

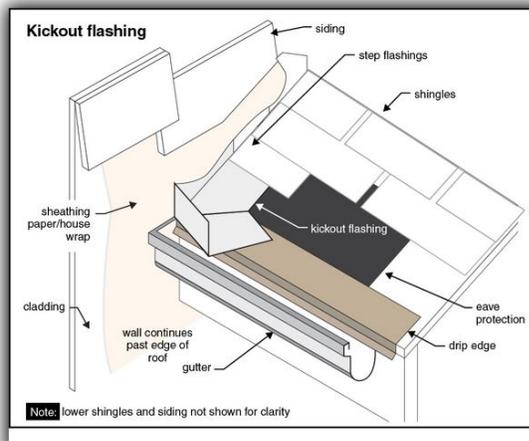
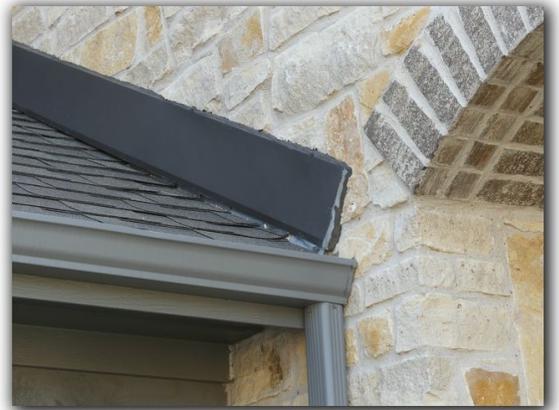
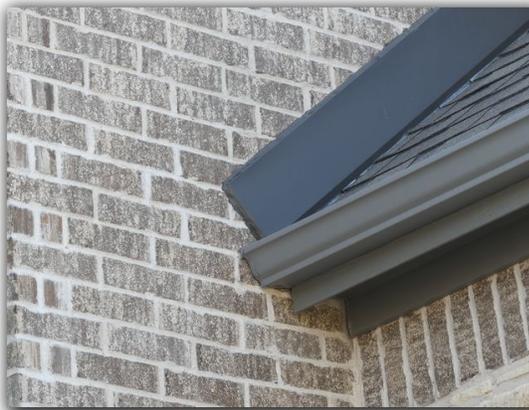
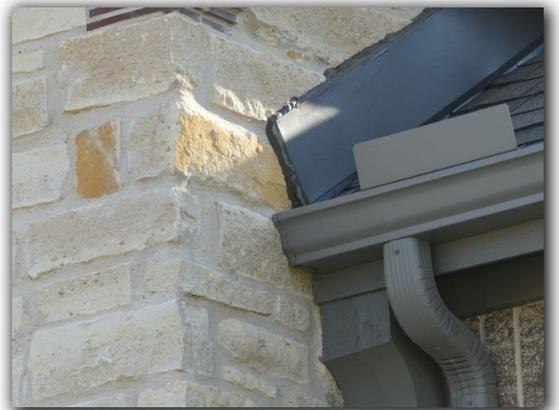
intersections. Kick out flashings prevent water leaks, damage and discoloration to walls.

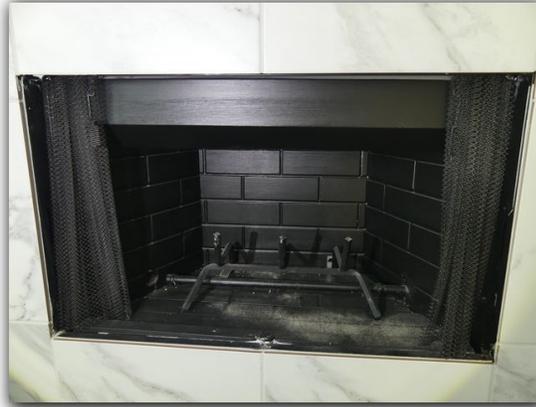
The fireplace firebox was not sealed at the hearth or lintel and was a SAFETY HAZARD. Inadequate fireplace seals may allow heat to transfer to flammable materials and is a SAFETY HAZARD that should be repaired by a qualified fireplace specialist.

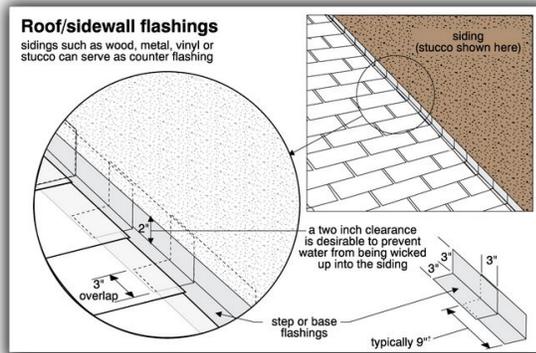
Inadequate clearance between the chimney siding and roof covering materials was observed. Inadequate clearance between roof covering materials and the chimney siding creates conducive conditions for moisture penetration and wall cladding deterioration.

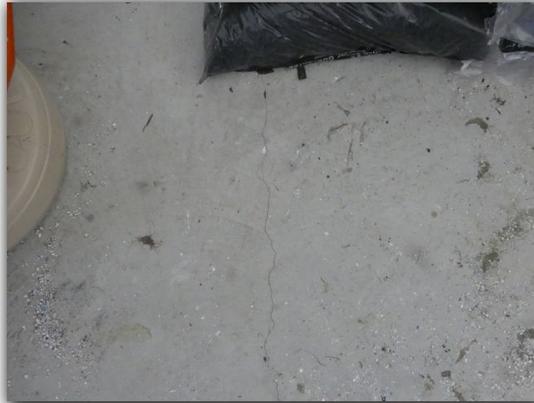
Cracks and/or deficiencies were observed in the poured concrete such as sidewalks, driveways, garage floors, porches and or patios. Cracks and other defects in poured concrete should be repaired and monitored over time for movement, deflection and deterioration.

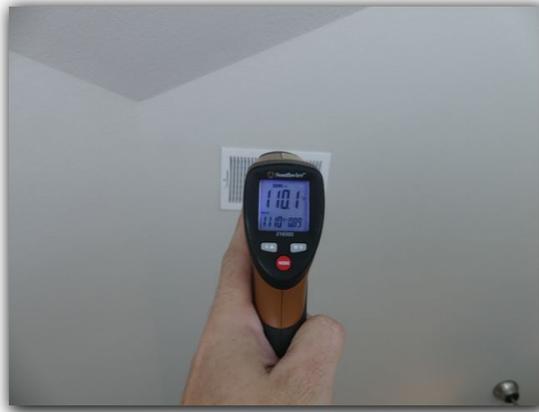
- Unit 1: Downstairs
  - Within Normal Range     Inadequate - In need of service, repair or replacement
- The heating equipment temperature output reading: 110.1 °F

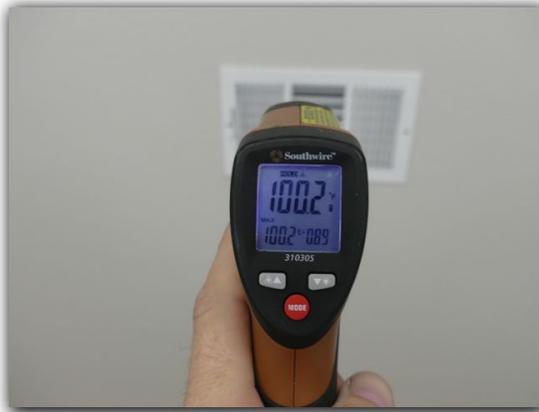
- Unit 2: Upstairs
  - Within Normal Range     Inadequate - In need of service, repair or replacement
- The heating equipment temperature output reading: 100.2 °F

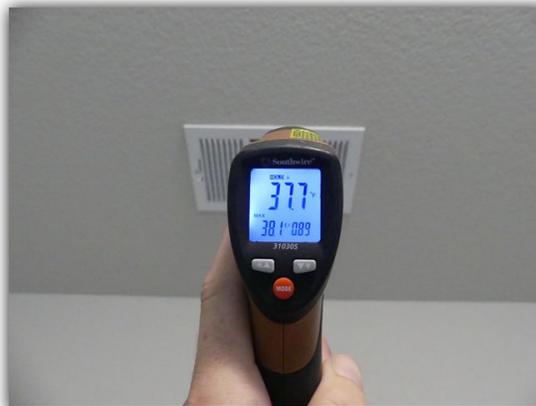
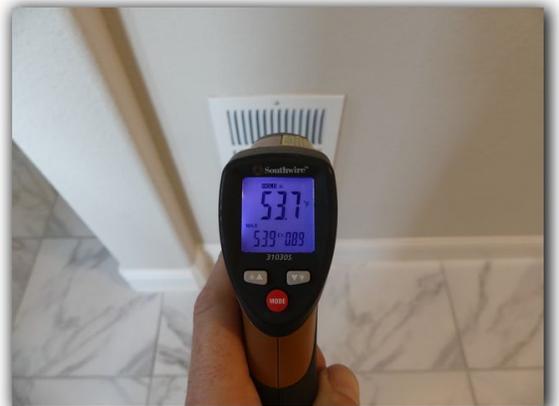
- Unit #1: Downstairs
- Within Normal Range     Inadequate - In need of service, repair or replacement
- Supply Air Temp: 37.7 °F      Return Air Temp: 53.7 °F      Temp. Differential: 16.0 °F

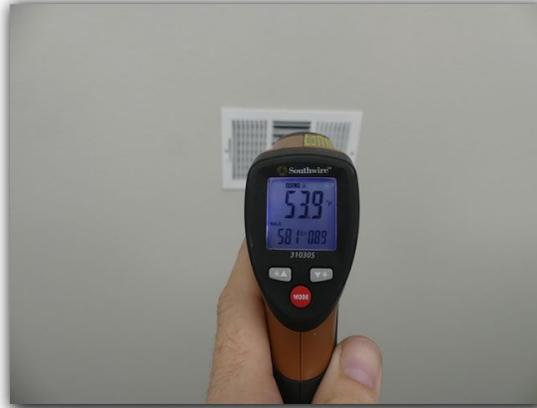
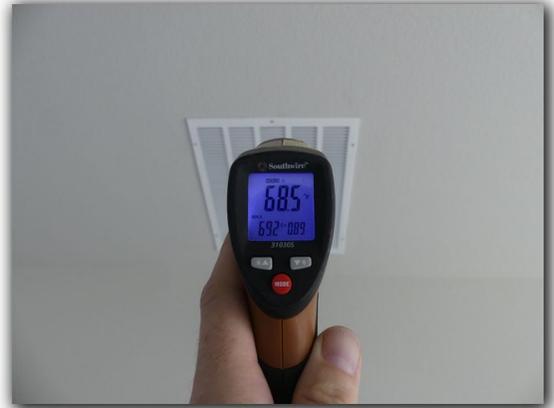
- Unit #2: Upstairs
- Within Normal Range     Inadequate - In need of service, repair or replacement

Return Air Temp: 68.5 °F

Temp. Differential: 14.6 °F

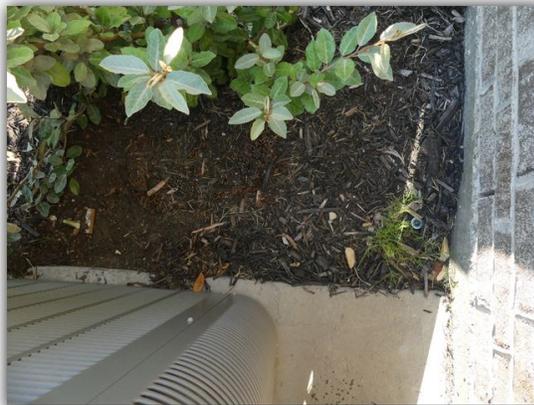
The exterior HVAC equipment was not installed 3" above grade and was in need of repair. Inadequate elevation of the exterior HVAC equipment may allow moisture to penetrate the equipment, reduce equipment life and may affect performance.

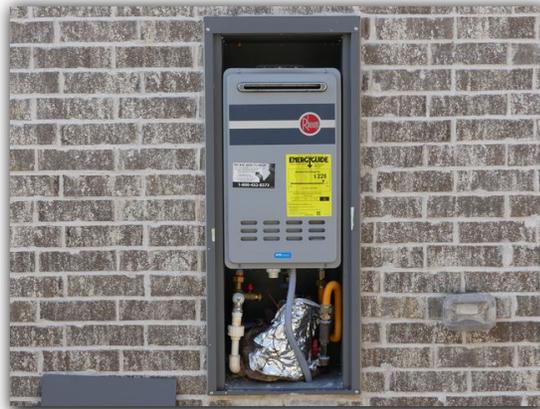
Heated Water Temperature ( 133.8 °F ):

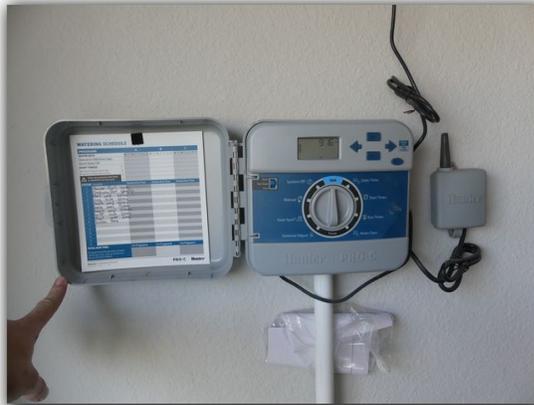
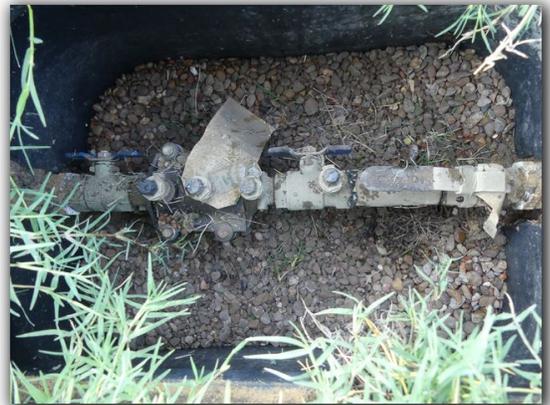
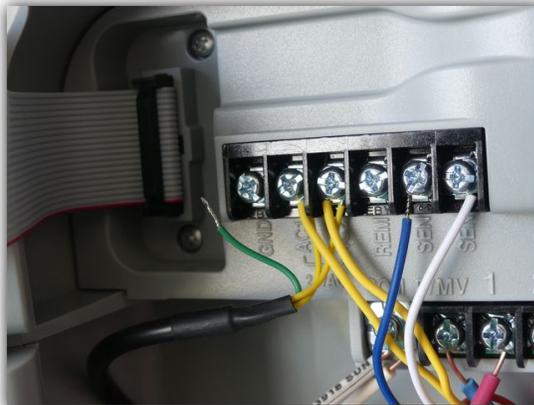
The landscape irrigation system electrical grounding wire were loose and should be repaired.

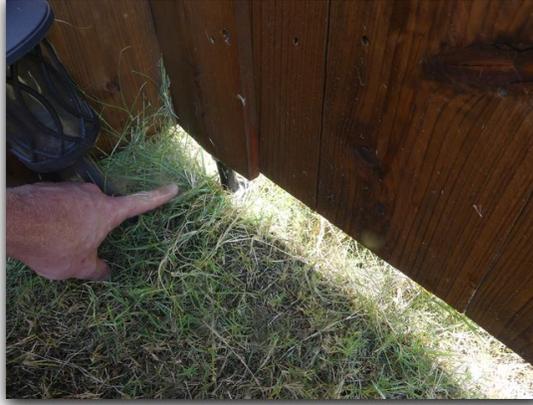
- The landscape irrigation system had misplaced heads that should be replaced.
