Fouries Home Inspection

COMPLETE HOME INSPECTION
Prepared Exclusively For: Buyer Name

Any Street, Grand Prairie, TX, 75052

Inspected by Paul Fourie, Lic.#: 22325 on 08/26/2019
Phone: (972)989-2479, Email: paul@fourieshomeinspection.com

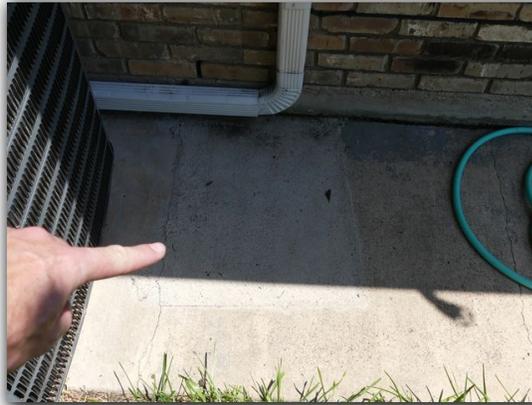
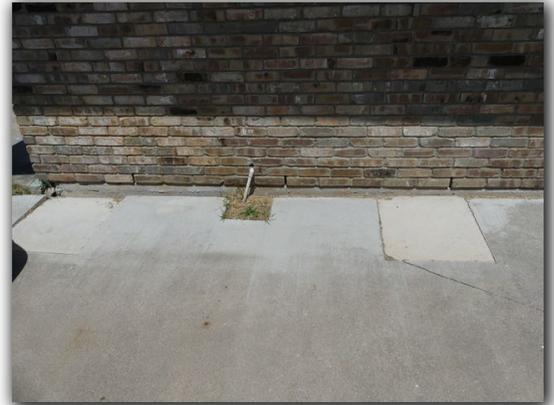
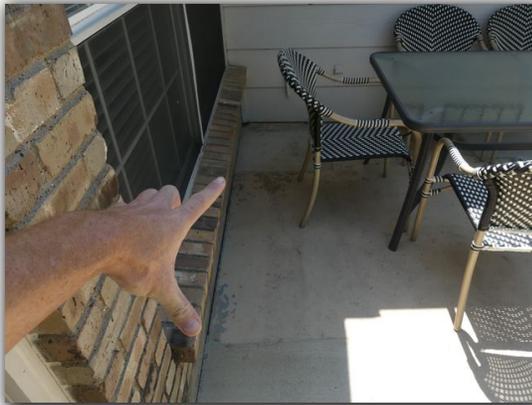
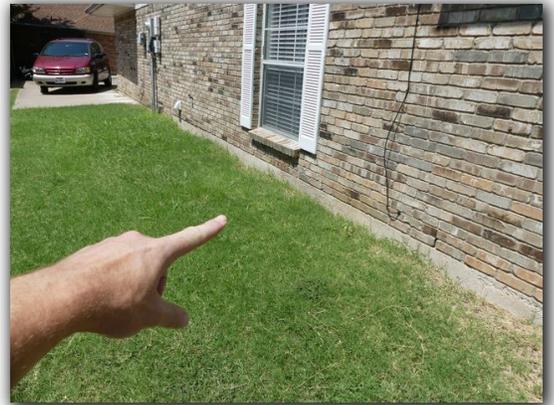
Cracks in the foundation slab may be an indication of movement or settlement. Cracks in the foundation slab may lead to additional foundation deterioration and adverse foundation performance. This condition should be closely monitored and repaired as needed by a foundation specialist.

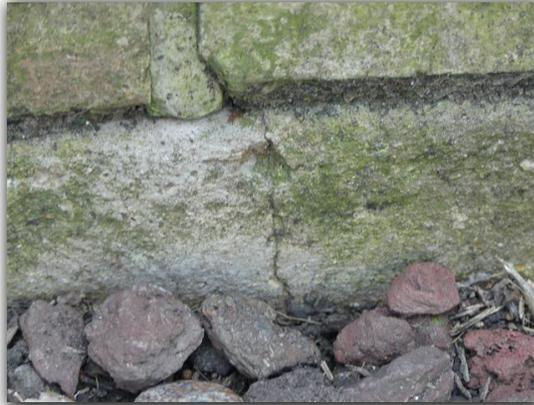
Foundation slab corners have been sheared off (corner pop). This is a common condition in slab on grade foundations and should be repaired. Repairing corner pops is recommended to prevent moisture and wood destroying insect penetration.

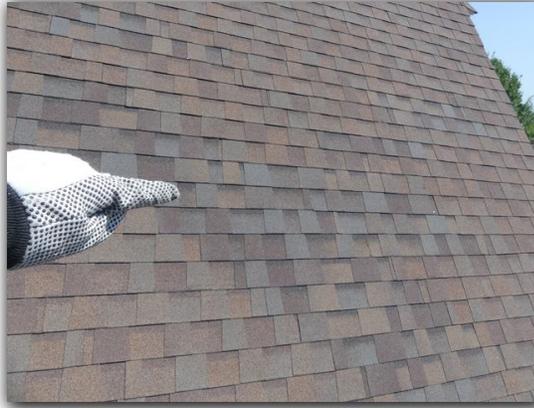
Previous repairs to the roofing covering materials and/or flashings were observed.

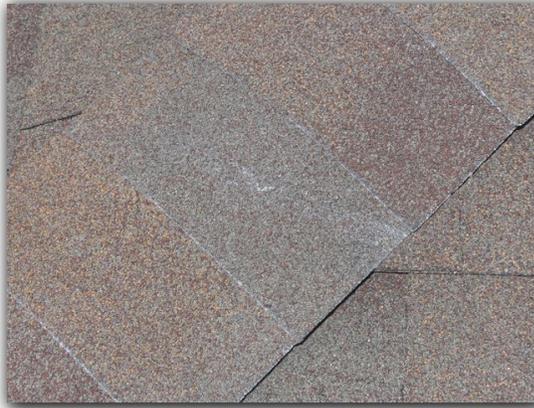
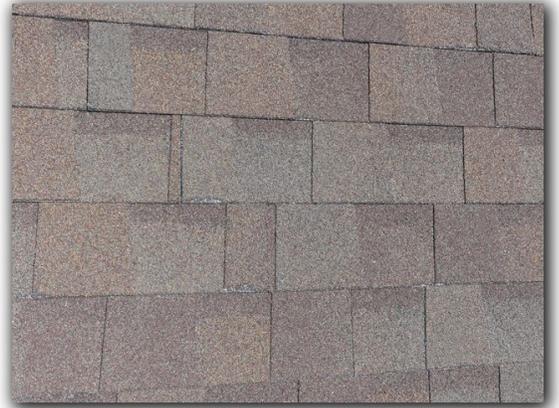
Composition shingle tab granules were observed to be thinning on the roof covering. You are encouraged to have your insurance company and a certified, licensed roofing contractor physically inspect the roof, prior to closing, to fully evaluate the insurability and condition of the roofing material.

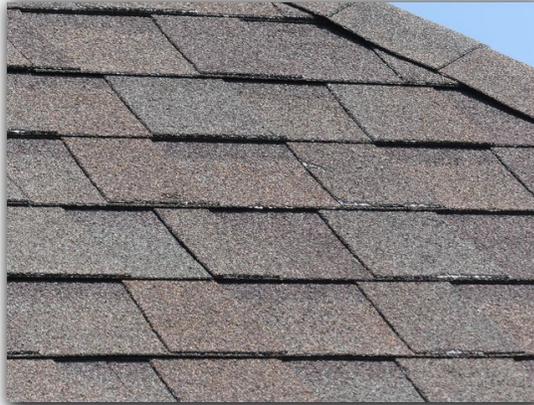
Broken and damaged roof covering materials were observed.

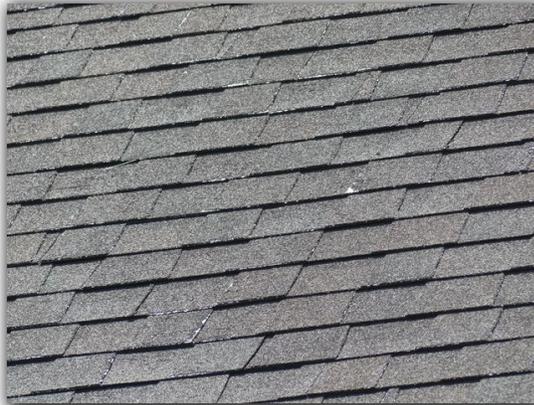
There were indications of impact damage on the roof covering. Impact damaged roof covering shingles may allow further deterioration of the roof covering, deterioration of the roof structure, water penetration or other damage.

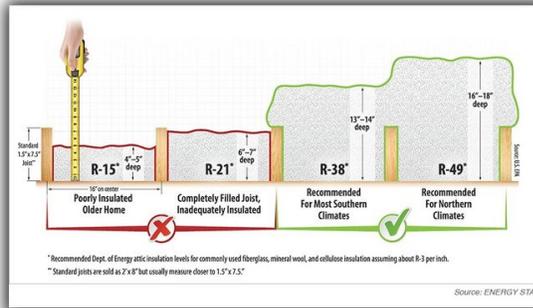
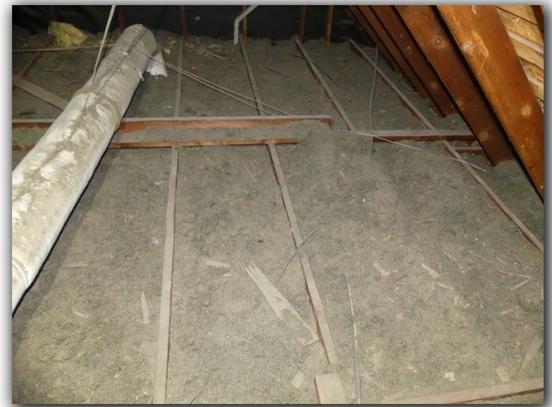
Insulation voids were observed in the attic space. Insulation voids may allow greater than normal loss of conditioned air and should be repaired.

The attic insulation depth or thickness was inadequate. The recommended depth of attic floor insulation is 13+ inches to achieve an R38 rating. Inadequate attic insulation depth or thickness may allow greater than normal loss of conditioned air.

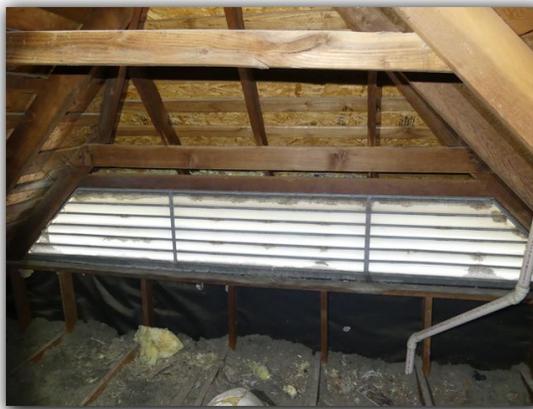
Soffit vents were observed to be dirty, blocked by insulation or debris. Clogged soffit vents are an indication of inadequate attic ventilation and should be repaired as needed.

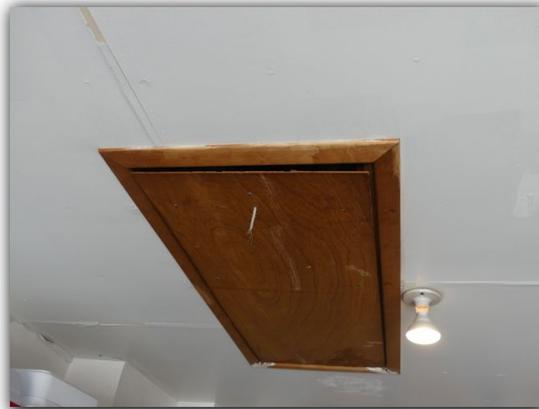
Access doors from conditioned spaces to unconditioned spaces such as attics should be weather stripped and insulated to a level equivalent to the insulation on the surrounding surfaces. A wood framed or equivalent baffle or retainer should be installed when loose fill insulation is installed to assist in maintaining a consistent R-value.

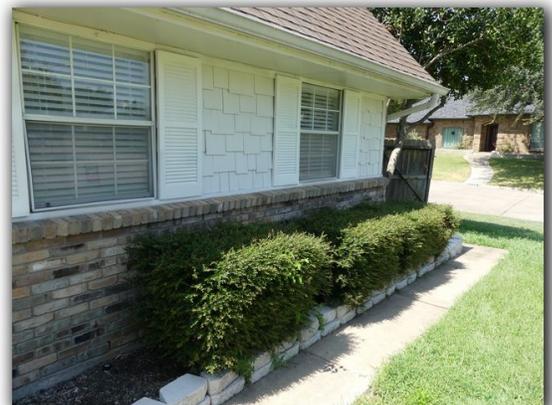
Several cracks in the exterior brick/stone veneer masonry walls were observed. These cracks in the exterior brick/stone veneer wall cladding were indications that movement or settlement has occurred. The inspector recommends that cracks in exterior walls be repaired and closely monitored. If concerns about the current or future foundation performance exist, the inspector recommends further evaluation by a certified, licensed foundation specialist.

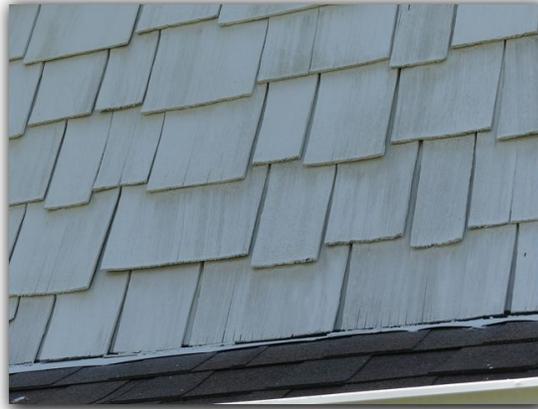
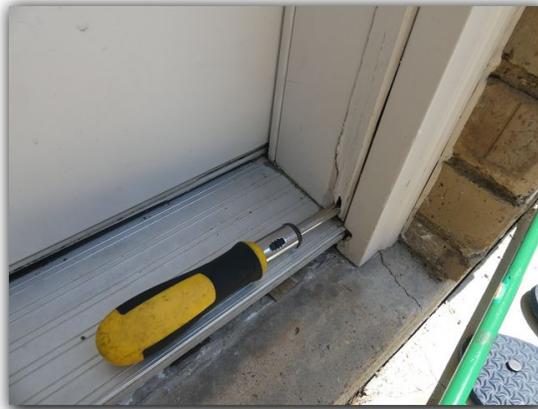
Water damage and/or wood rot was observed at the exterior siding and/or trim. Damaged and deteriorated exterior wooden siding should be repaired to prevent wall damage, moisture penetration and wood destroying insects.

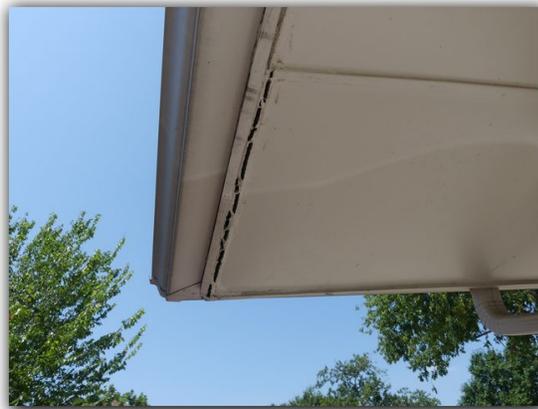
Exterior sealants (caulking) were deteriorated or missing in some areas. Sealants applied in appropriate locations prevents moisture intrusion and insect penetration.

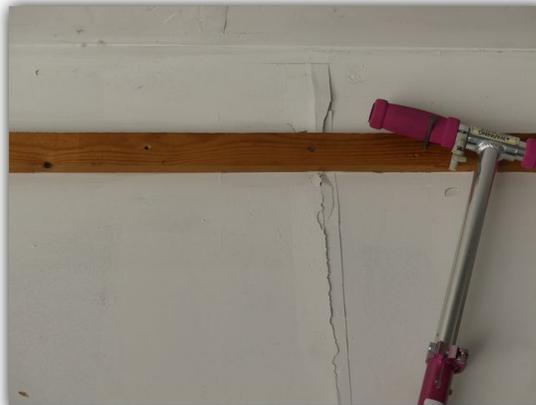
At least one interior wall crack was observed and may be an indication of structural settling, movement or other defects. The cause of any interior drywall, texture and paint wall cracks should be determined and repaired as needed and monitored over time for additional movement. If concerns about the foundation performance exist, the inspector recommends further evaluation by a certified, licensed foundation specialist.

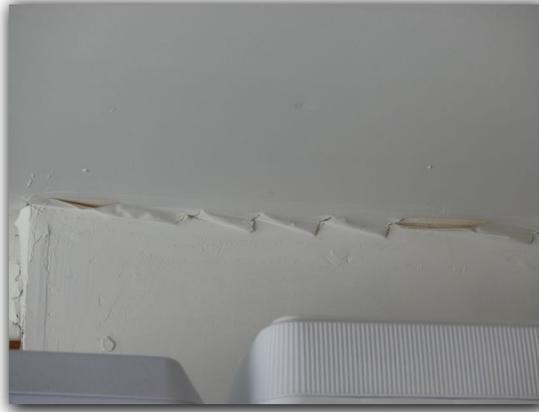
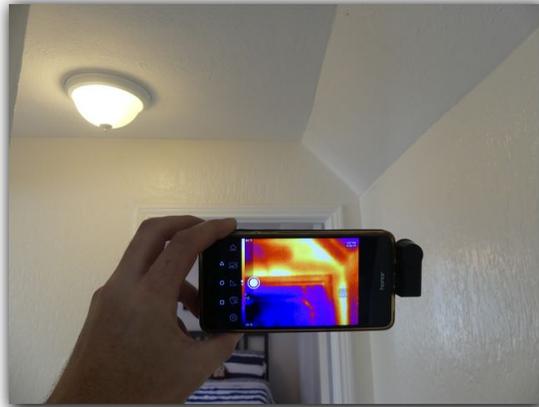
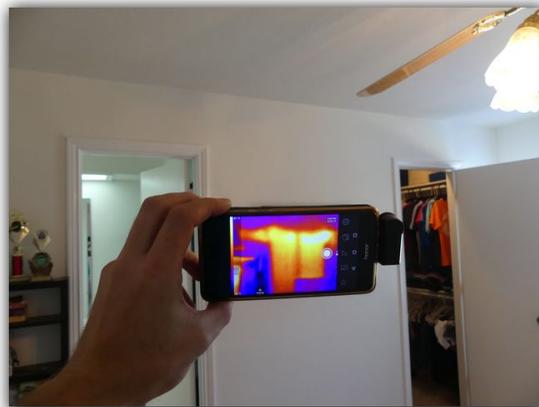
Using a thermal imaging camera, there are areas of temperature anomalies in the walls which may be indication of missing or damaged insulation. The reason for the temperature anomalies should be further evaluated and repaired as needed.

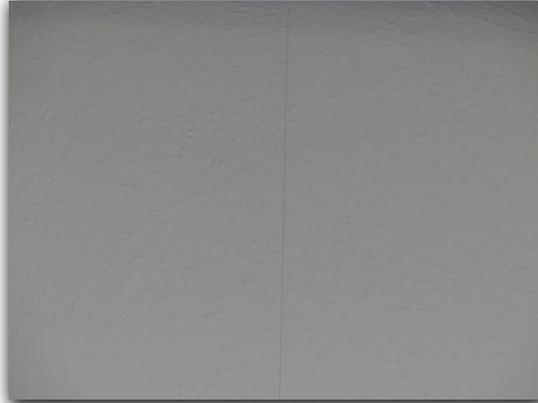
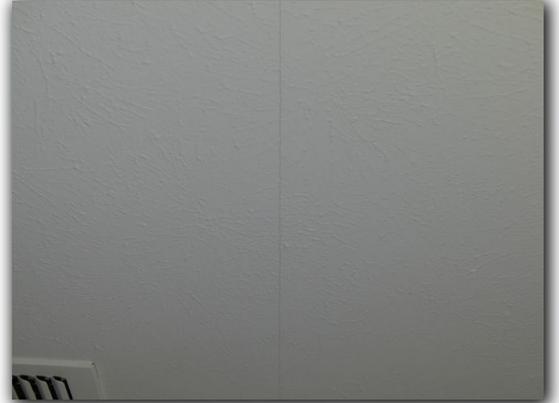
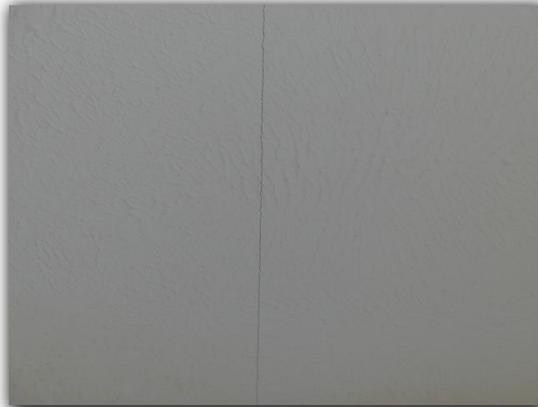
Several interior ceiling cracks were observed which is an indication of structural settling, movement or other defects. Ceiling drywall, texture and paint cracks should be repaired and monitored over time for additional movement. Further evaluation of the foundation and structure by a certified, licensed foundation and structural specialist may be needed.

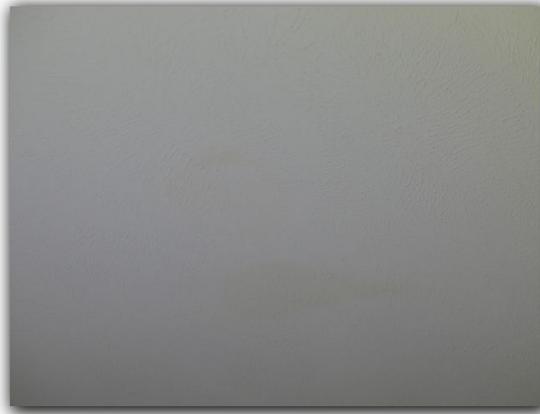
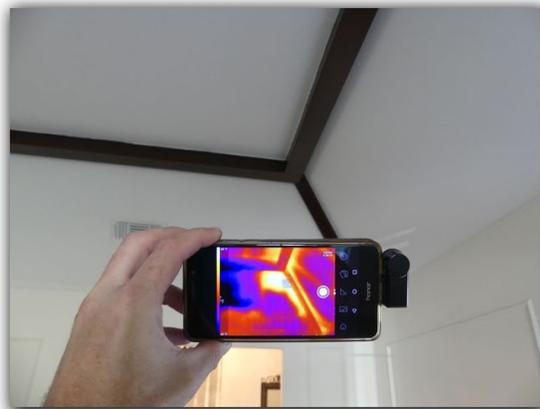
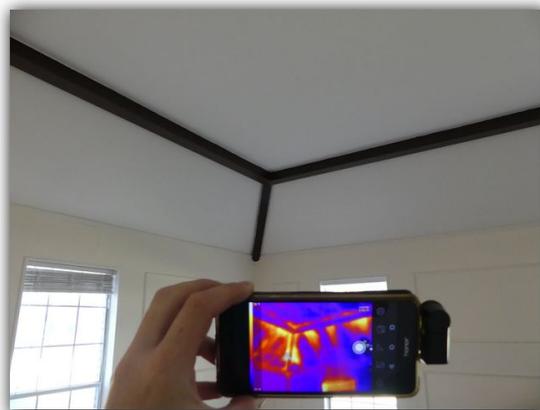
Using a thermal imaging camera, there are areas of temperature anomalies in the ceilings which may be indication of missing or damaged insulation. The reason for the temperature anomalies should be further evaluated and repaired as needed.

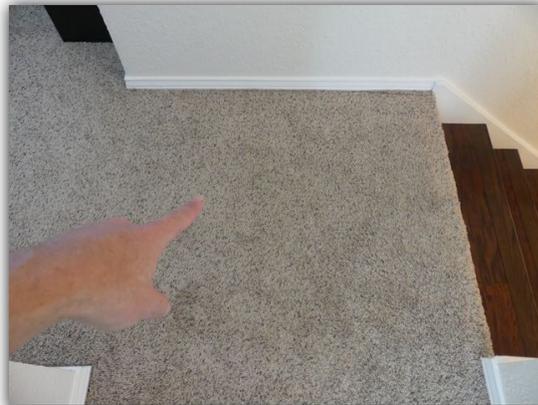
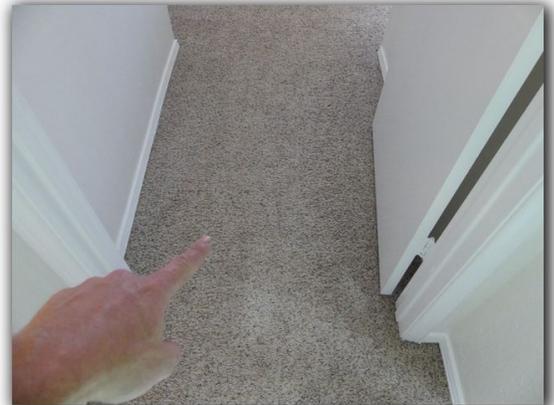
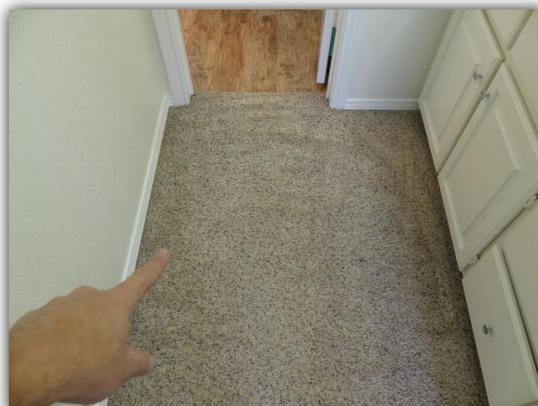
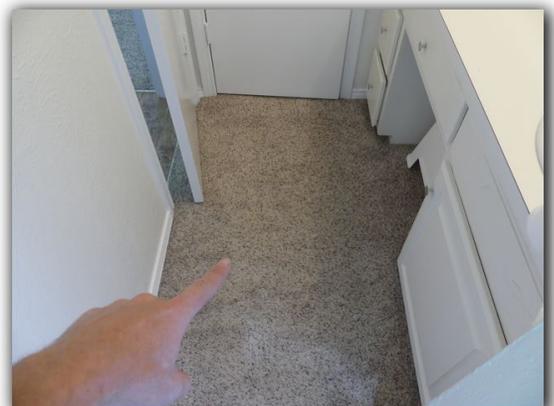
Sub-floor squeaks were heard in the upstairs flooring. Subfloor squeaks may indicate that the nails have pulled out and are loose. The buyer should have the subfloor evaluated and secured when the floor covering is replaced if not before.

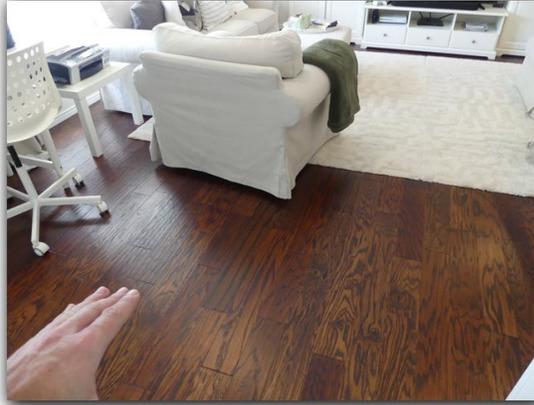
Areas of the interior floors did not appear to be level and were an indication of movement, settlement or other defects. The cause of un-level floors should be further evaluated by a structural specialist and repaired as needed.

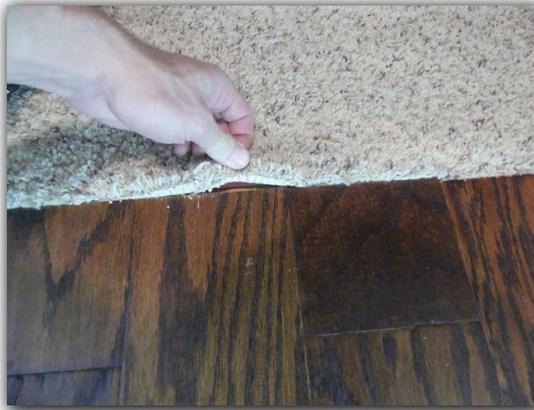
Missing, loose or damaged floor covering transition strips should be repaired to avoid additional damage and trip hazards.

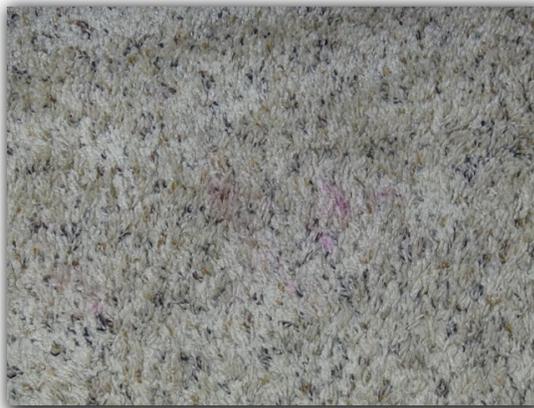
The floor covering was noticeably stained or damaged and was in need of cleaning, repair or replacement.

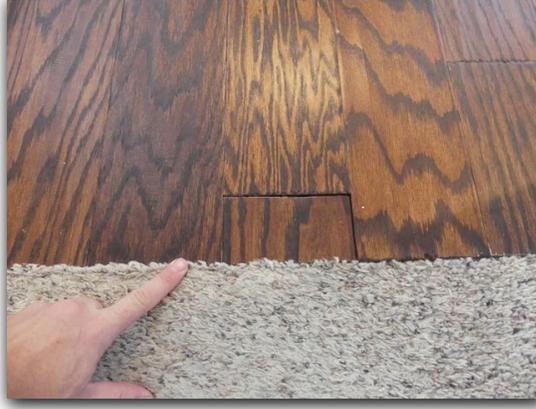
The wood floor covering was observed to be damaged. The cause of damaged wood flooring should be determined and repaired as needed.

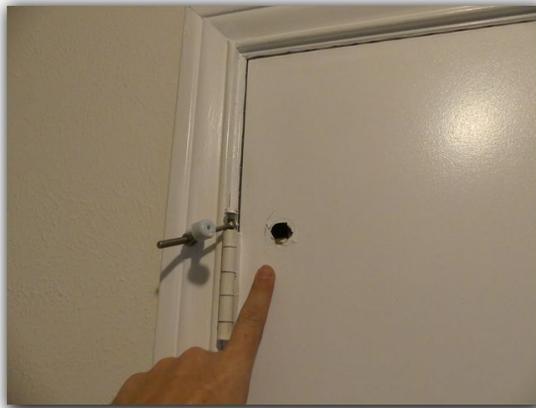
Damage to interior doors should be repaired.

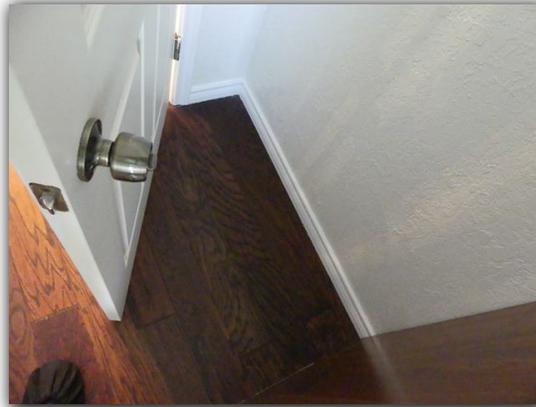
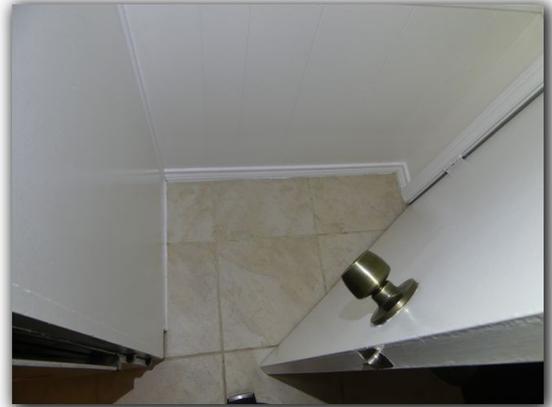
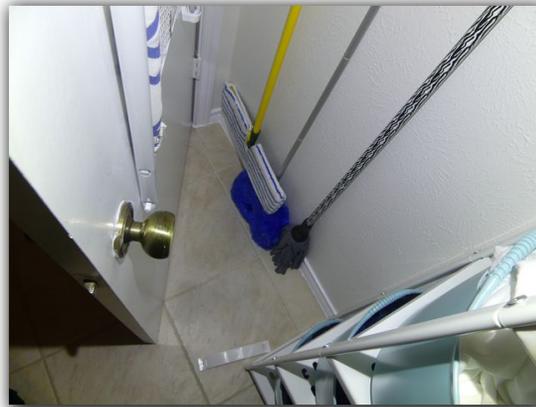
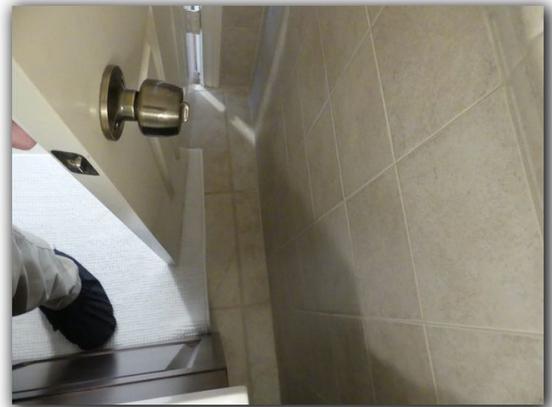
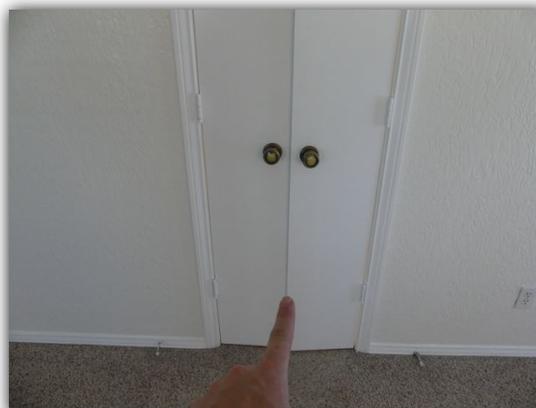
Interior doors were observed to rub, stick or hit the door frames. Interior doors, that stick or hit the door frame may be an indication of movement, settlement or other defects. The cause of doors sticking or hitting door frames should be determined and repaired as needed.

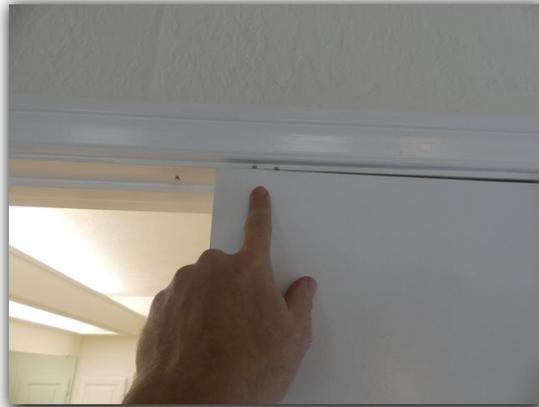
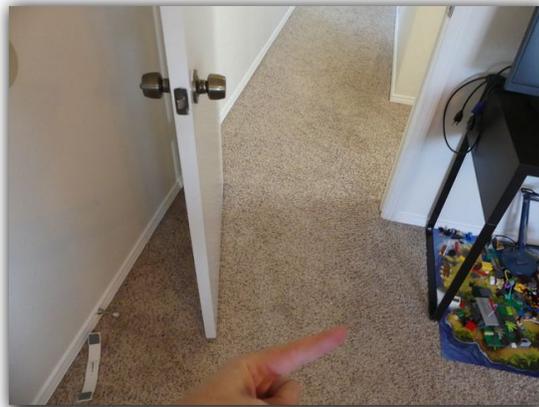
Interior doors which drift closed were observed. Interior doors, which drift, are an indication of movement, settlement or other defects. The cause of door drift should be determined and repaired as needed.

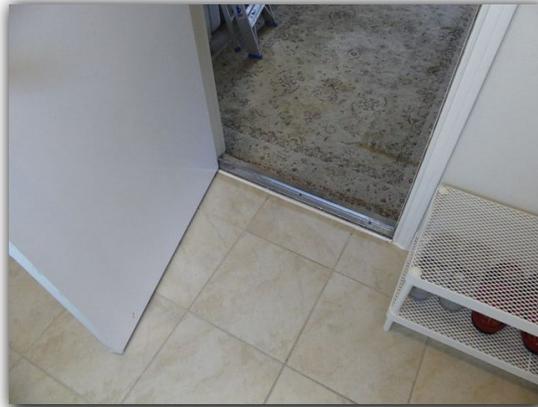
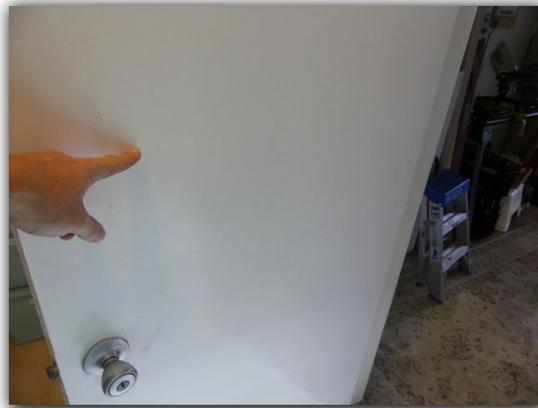
The garage entry door was observed to be a non-fire rated door. Under current building standards, the entry door between the garage and the living area should have a minimum of a 20-minute fire block rating for improved FIRE SAFETY. Lack of a fire rated garage entry door is a SAFETY HAZARD.

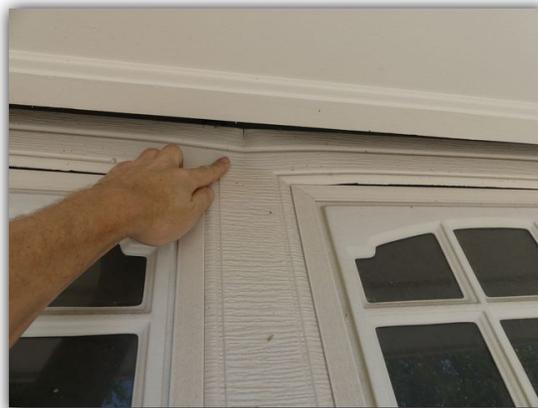
The garage door or garage door hardware was observed to be damaged. Damaged garage door hardware, door panels and components should be repaired or replaced as needed.

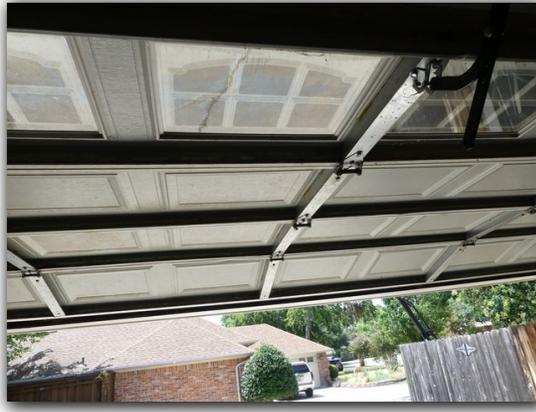
The overhead garage door appeared to lack a lift handle. Garage overhead doors should have installed at least one interior lift handle in accordance with manufacturer's instructions.

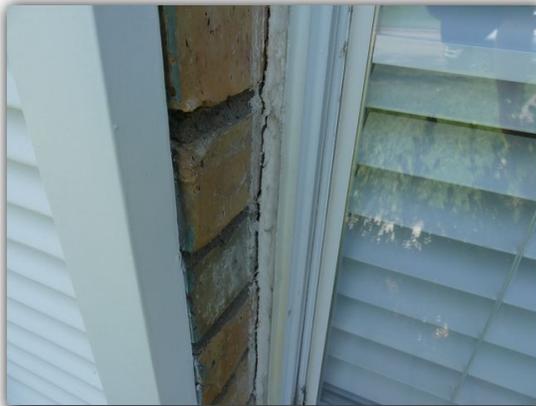
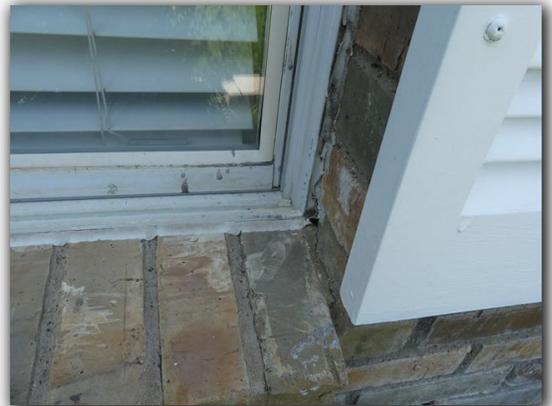
The windows need sealant between the window frames and exterior wall cladding. Lack of, damaged or deteriorating sealant around window frames may allow moisture and insect penetration and should be repaired as needed.

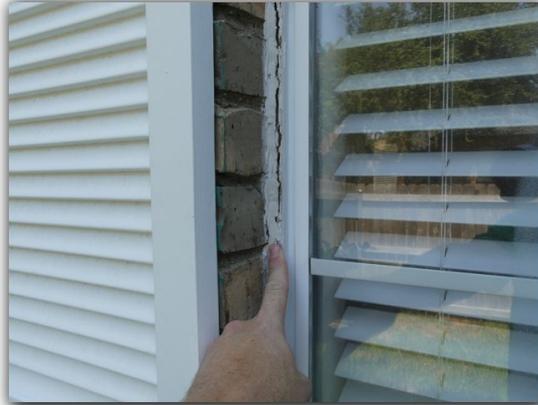
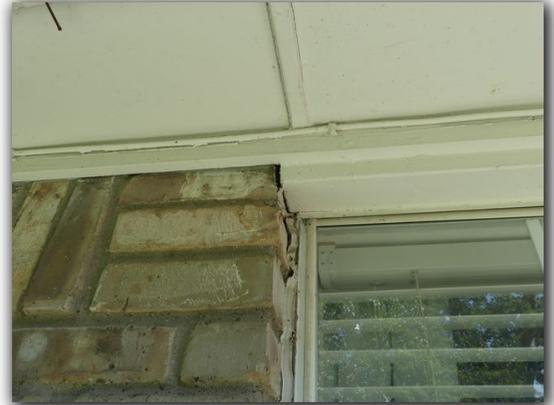
The window weather-stripping was observed to be damaged. Damaged or missing weather stripping around windows may allow moisture penetration, conditioned air loss and insect penetration and should be repaired.

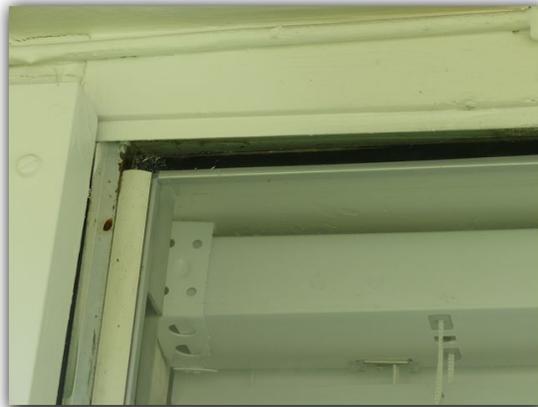
Windows that are difficult to open or close were observed. The cause of windows that are difficult to open or close should be determined and repaired as needed.

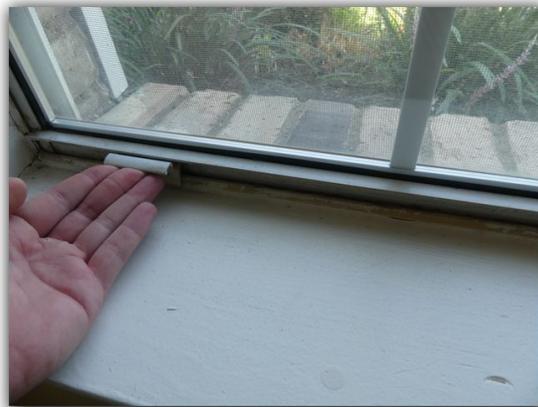
Damaged window lift supports were observed. Damaged window lift supports may not hold windows in the open position and may allow glass or window frame damage. Damaged window lift

supports should be repaired or replaced as needed.

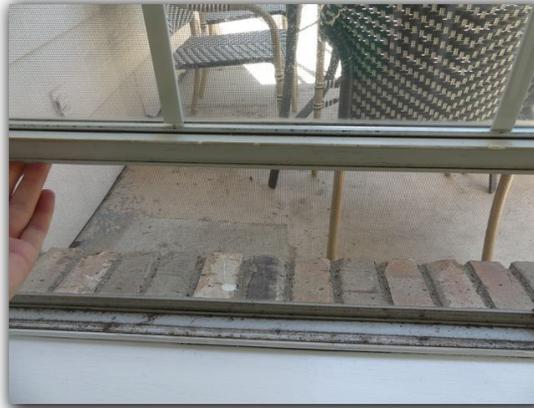
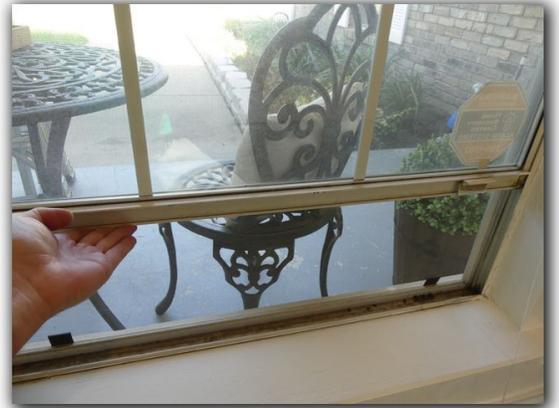
Damaged window screens were observed. Window screens help protect window glass from minor impact damage and prevent insect penetration at the windows. Damaged window screens should be repaired or replaced.

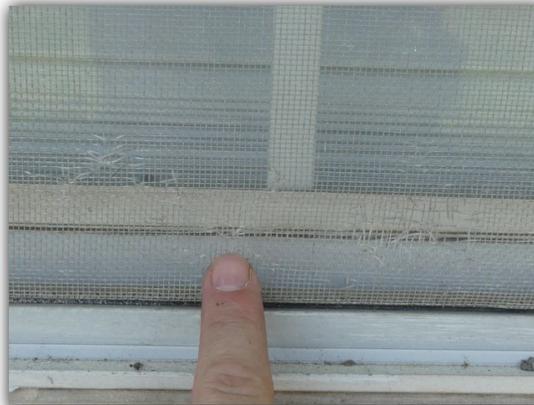
Windows were observed to be missing window screens. Window screens help protect window glass from minor impact damage and prevent insect penetration at the windows. Missing window screens should be replaced.

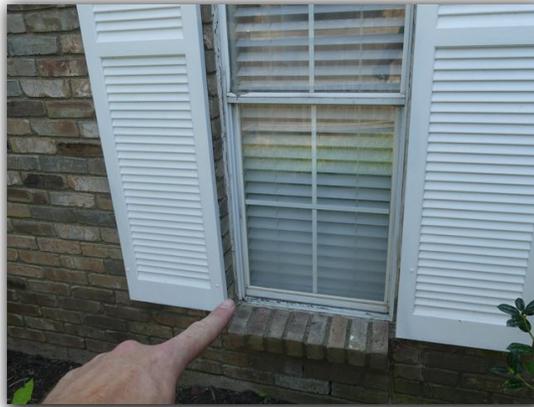
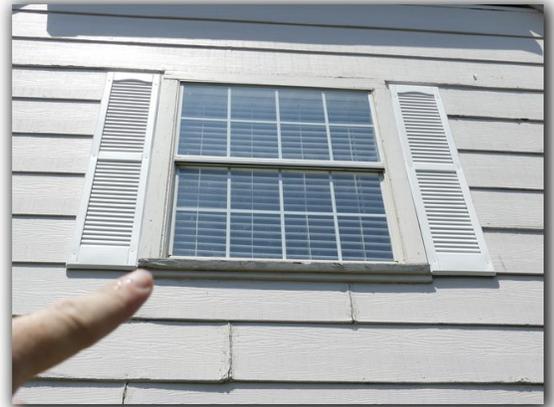
Windows were observed to be missing cap flashing. Missing window flashing should be repaired or replaced as needed.

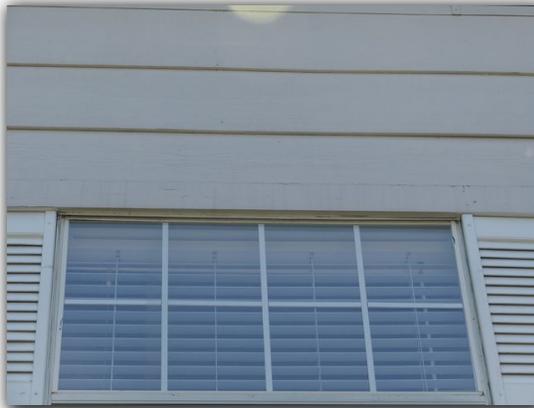
Bedroom windowsill height exceeds 44" egress and is a SAFETY HAZARD. Window sill heights greater than 44" from the floor may not be accessible to all persons in the event of an emergency. Children, the elderly, the disabled and others may not be physically capable of egress at windows with a sill height above 44". Repair, replacement or other safety amendments should be addressed prior to occupancy.

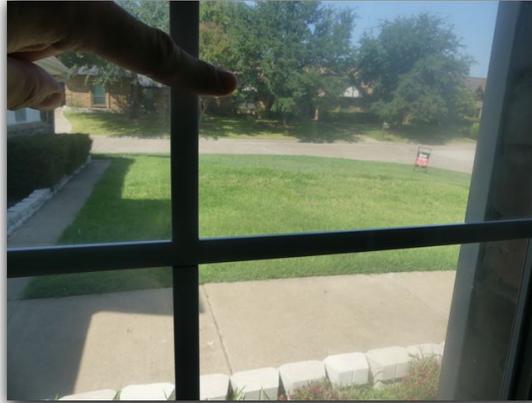
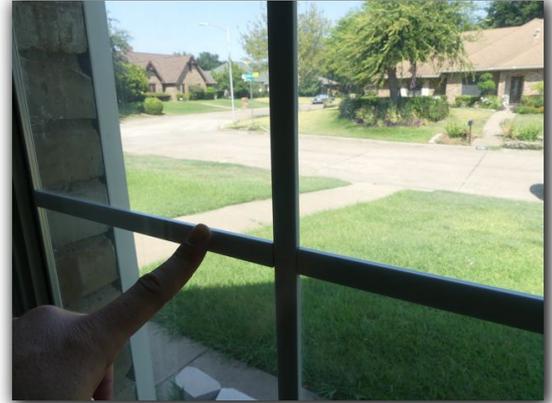
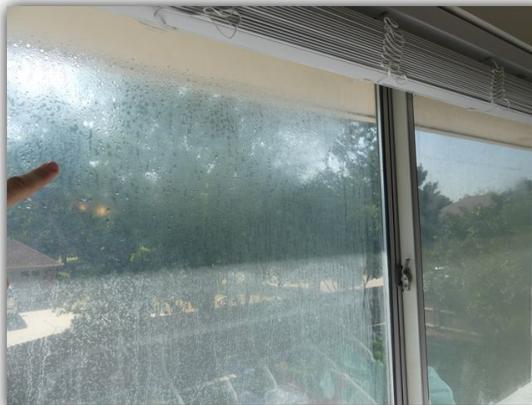
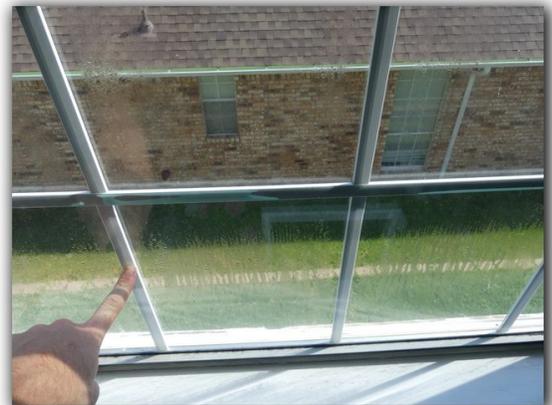
Thermal pane window seals have failed. Moisture and or discoloration is present between window glass panes. This has resulted in condensation or a fog like film to develop between the panes of glass. The thermal pane windows no longer function as designed when they loose their seal and repair or replacement is needed.

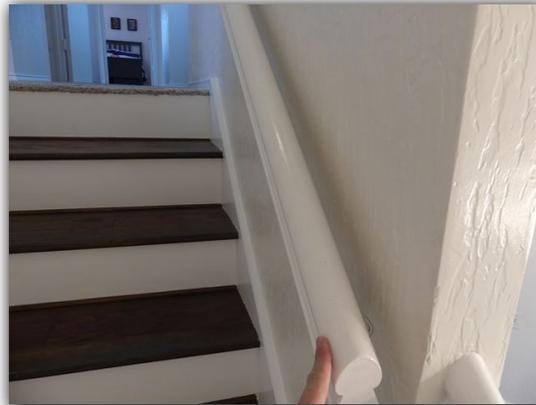
The stairway handrail height was observed to be inadequate and was a SAFETY HAZARD. Under current building standards, the stairway handrail height should be 34"-36" and should be corrected prior to closing.

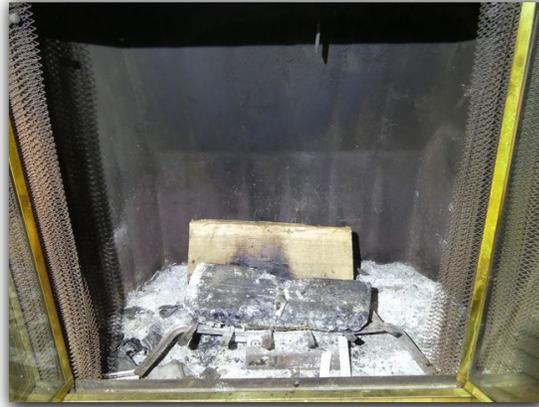
The fireplace and chimney flue needs to be cleaned by a qualified chimney sweep. A creosote or soot build-up was observed in the visible areas and was a SAFETY HAZARD at the time of the inspection. A creosote or soot build-up may be flammable and should be corrected prior to fireplace use.

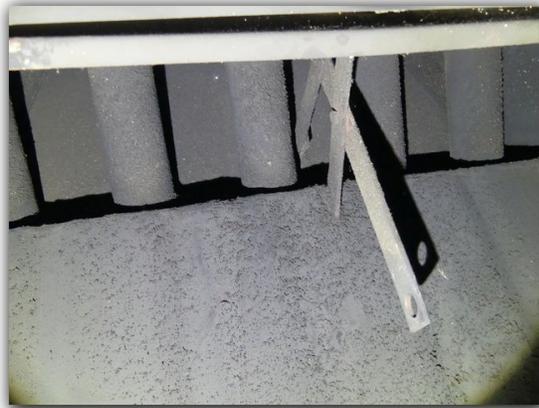
The fireplace firebox brick/mortar was not sealed at the hearth or lintel and was a SAFETY HAZARD. Inadequate fireplace seals may allow heat to transfer to flammable materials and is a SAFETY HAZARD that should be repaired by a qualified fireplace specialist.

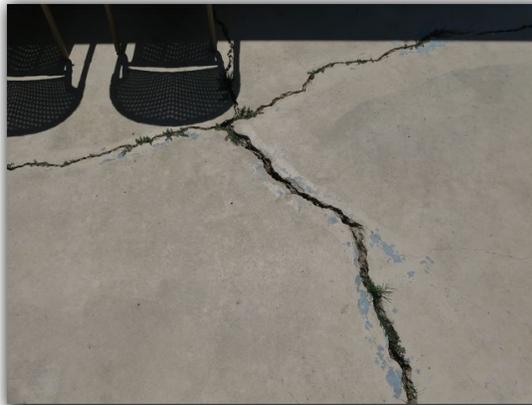
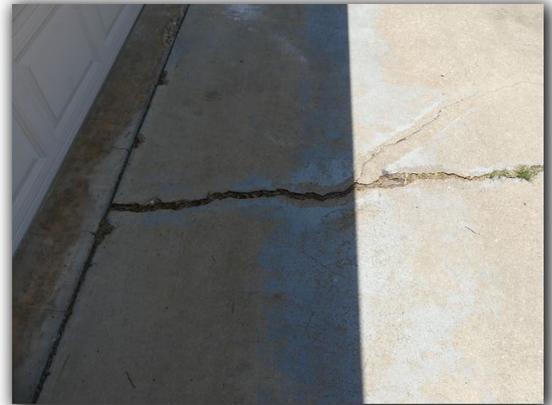
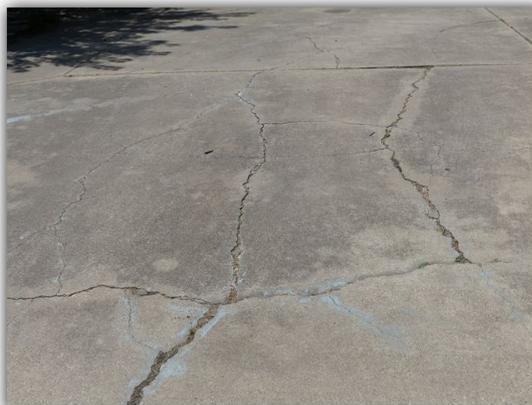
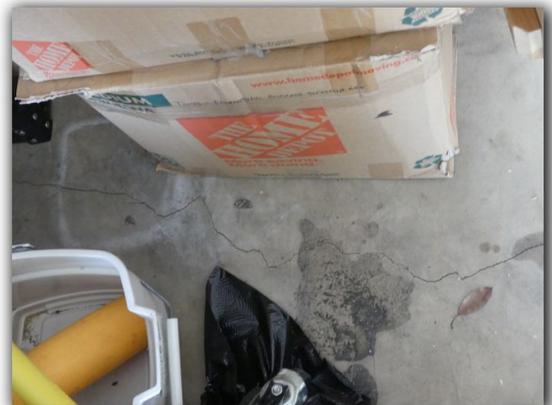
Cracks and/or deficiencies were observed in the poured concrete such as sidewalks, driveways, garage floors, porches and or patios. Cracks in poured concrete may be an indication of material defects, lack of maintenance, movement or settlement. Cracks and other defects in poured concrete should be repaired and monitored over time for movement, deflection and deterioration.

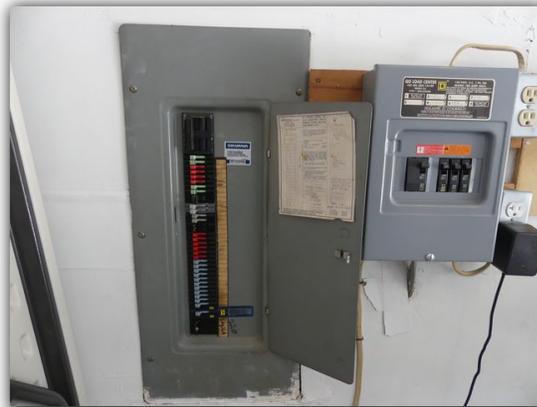
The electric service panel did not have adequate clearance or accessibility. Adequate clearance and accessibility of 36" around the electric service panel should be maintained for reasons of safety.

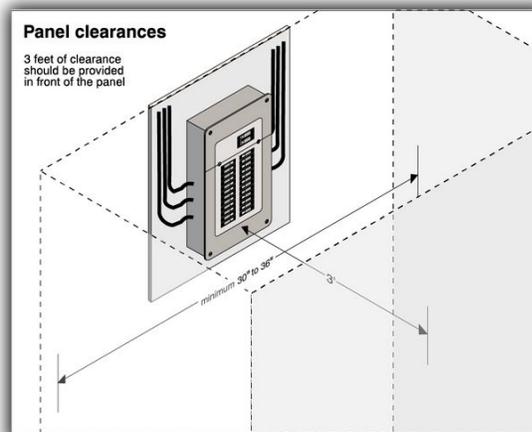
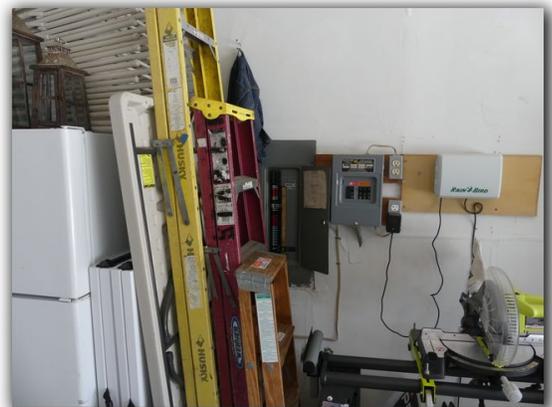
The electric service panel breaker use was not labeled. Each electric service panel breaker should be adequately labeled as to what appliance or circuit it serves.

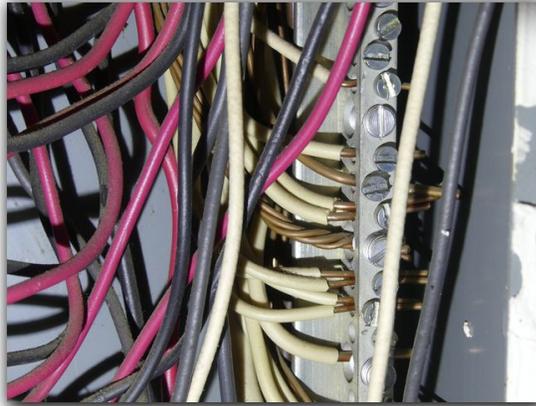
Neutral electrical conductors were observed to be “double tapped” on the neutral bus bar in the electric service panel. Each neutral electrical conductor in the electric service panel should terminate individually unless the terminals are made for more than one conductor. Double tapped neutral electrical conductors should be further evaluated and repaired as needed by a qualified electrical specialist.

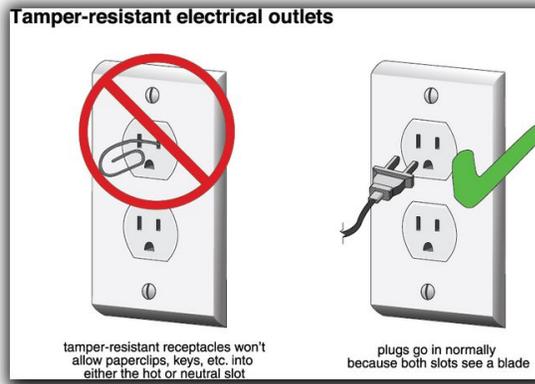
Inoperative electrical receptacles were observed. The cause of inoperative electrical receptacles should be further evaluated and repaired or replaced as needed by a certified, licensed electrical specialist.

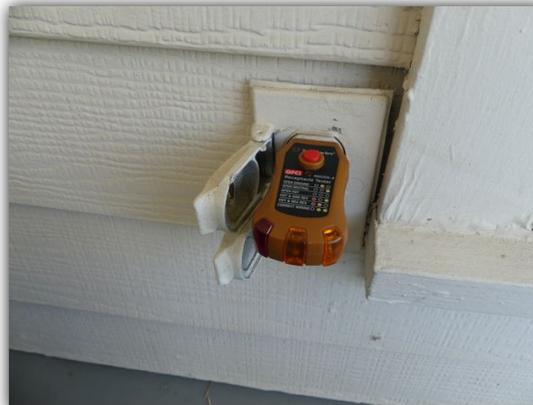
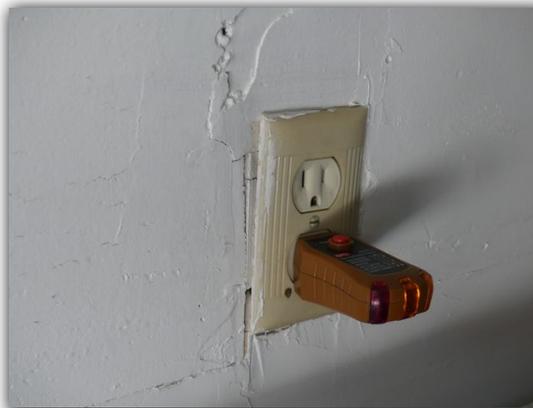
Open ground connections were observed at electrical receptacles. Open ground electrical receptacles are a SAFETY HAZARD and may cause damage to modern electric appliances. The cause of open ground electrical receptacles should be determined and repaired or replaced as needed by a certified, licensed electrical specialist.

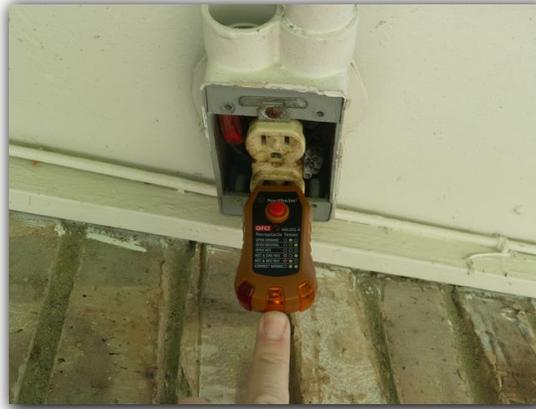
One or more 220V electrical receptacle was observed to be without electric power. The reason for a lack of electric power at 220V electrical receptacles should be determined and repaired as needed by a certified, licensed electrical specialist.

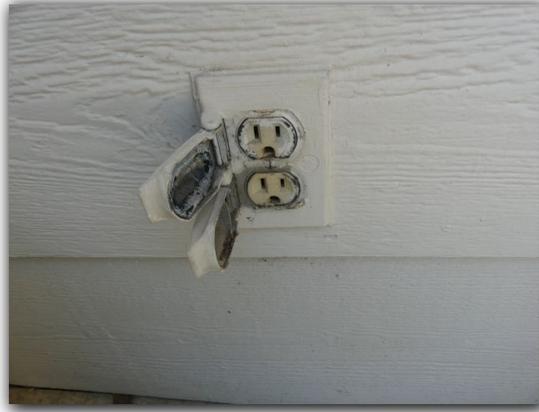
Painted electrical receptacles were observed. Painted electrical receptacles are considered damaged and should be replaced by a certified, licensed electrical specialist for improved safety and performance.

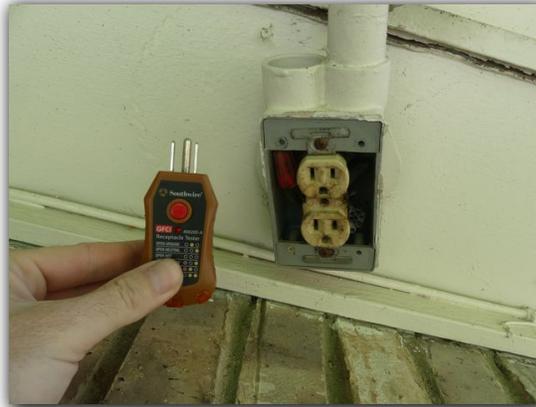
Current building standards require a GFCI protected electrical receptacle near the exterior HVAC equipment for technician use.

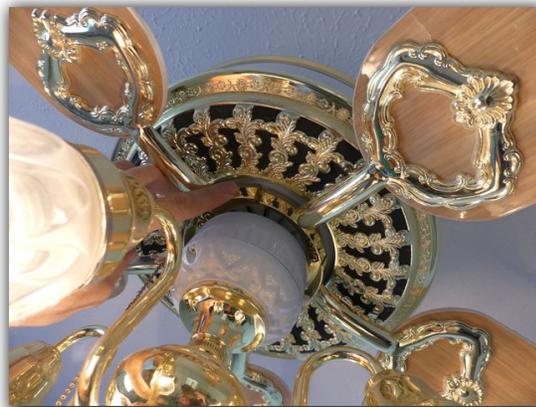
Ceiling fans that are not balanced and wobble when operated should be repaired or replaced.

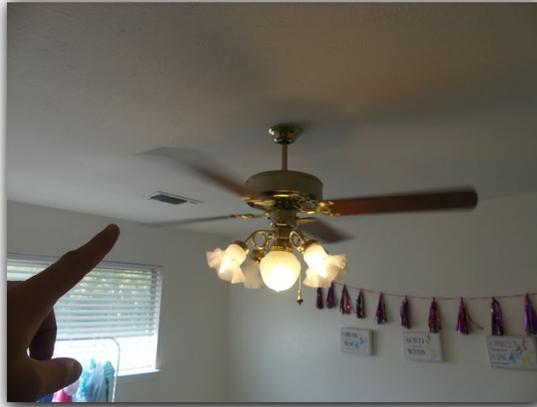
Light fixtures that are inoperative, missing bulbs or have burned out bulbs should be repaired or replaced as needed.

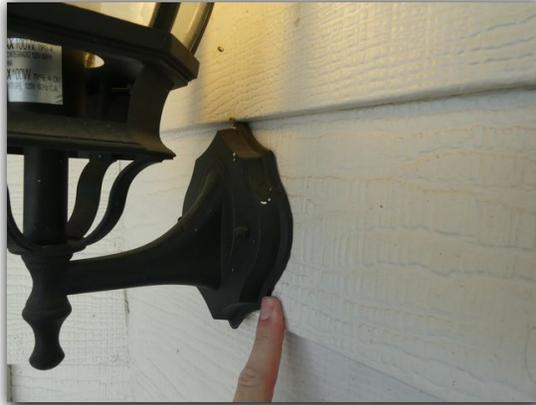
Missing electrical fixtures should be replaced.

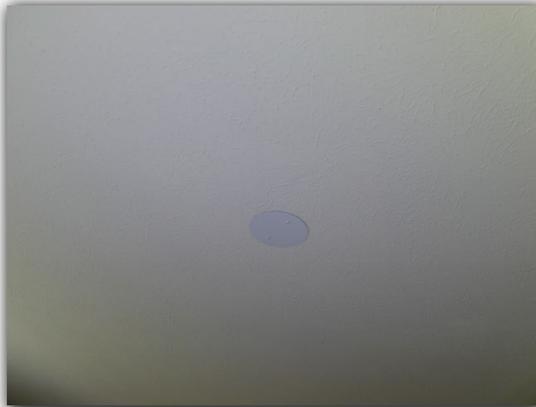
The doorbell was inoperative and was in need of repair or replacement.

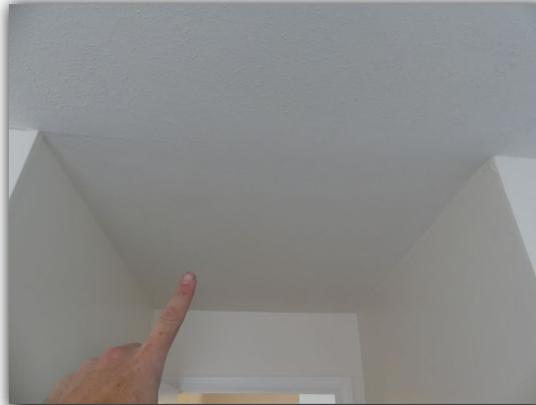
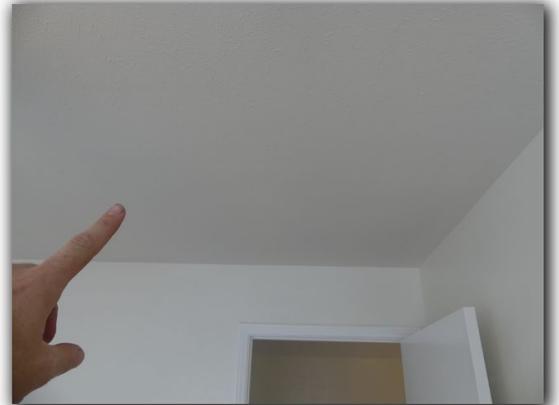
The smoke alarms were not electrically interconnected. Under current building standards, if one smoke alarm sounds, all other smoke alarms should be activated.

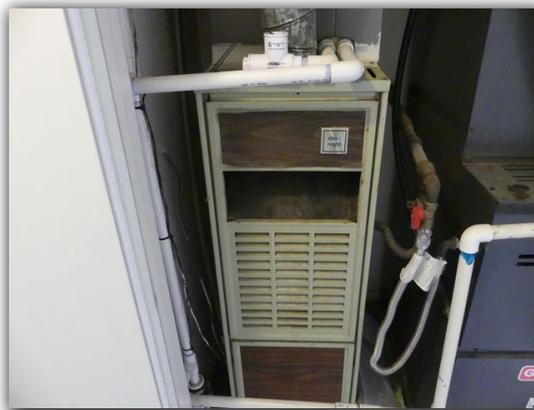
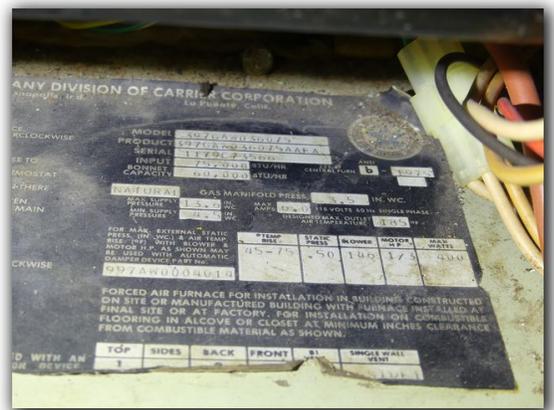
The heating equipment appeared to be older equipment and showed indications of age and wear. Future life expectancy can not be determined. You may continue to use the heating equipment until repair or replacement is needed. Repairs or improvements are needed at the heating equipment. The observations made to support this opinion are listed but not limited to the following:
