Fouries Home Inspection

COMPLETE HOME INSPECTION
Prepared Exclusively For: Buyer Name

Any Street, Grand Prairie, TX, 75052

Inspected by Paul Fourie, Lic.#: 22325 on 08/26/2019
Phone: (972)989-2479, Email: paul@fourieshomeinspection.com

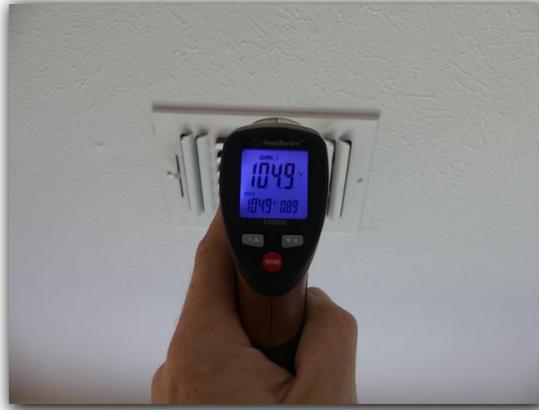
The heating equipment temperature output reading: 104.9 °F

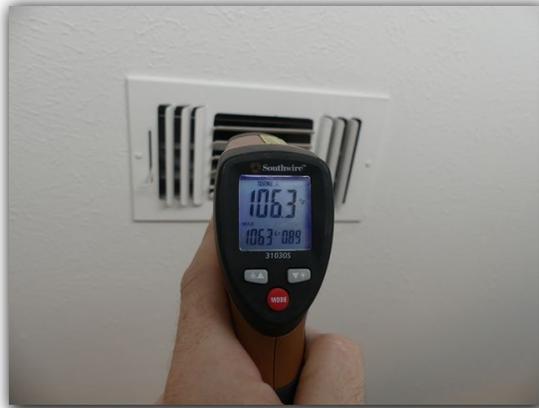
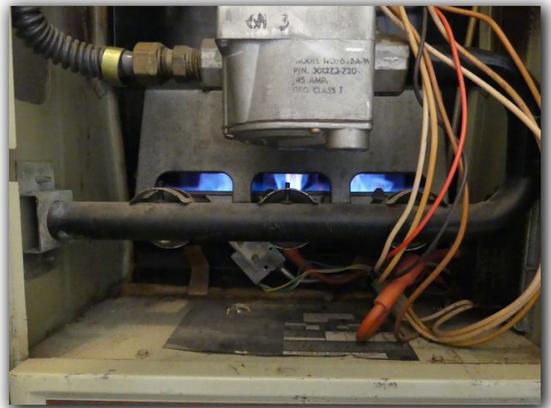
Unit 2: Upstairs

The heating equipment temperature output reading: 106.3 °F

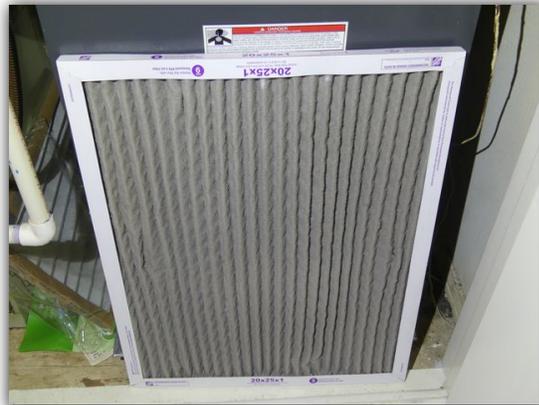
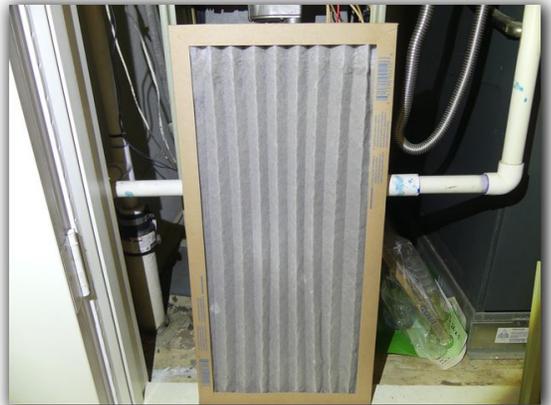
Dirty or damaged heating equipment air filters may not perform as intended and should be replaced as needed or per manufacturer instructions. Dirty or damaged heating equipment air filters may result in damage to the heating equipment.

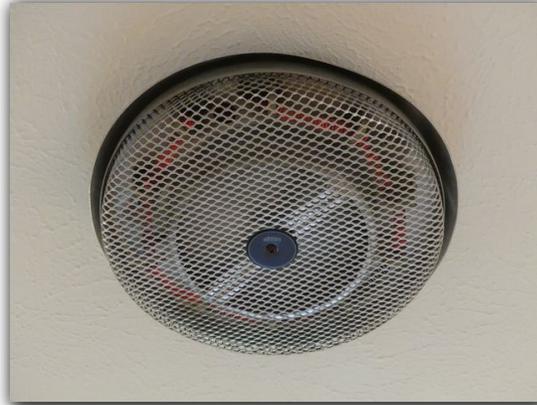
Older style electric coil bathroom heaters were present. Older style electric coil bathroom heaters should be replaced for reasons of safety.

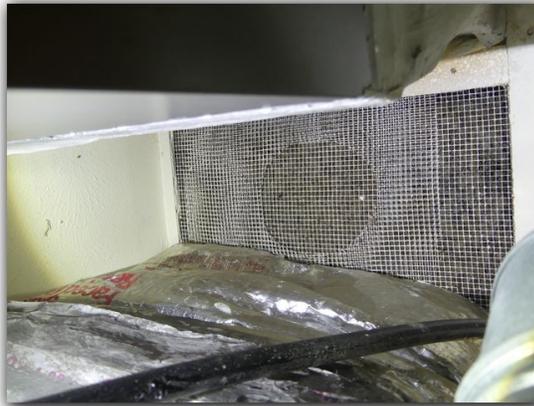
The combustion, and or dilution air for the gas fired heating equipment was observed to be inadequate and was a SAFETY HAZARD. Inadequate combustion or dilution air at the gas heating equipment may allow vapors to accumulate or create conducive conditions for improper flame.

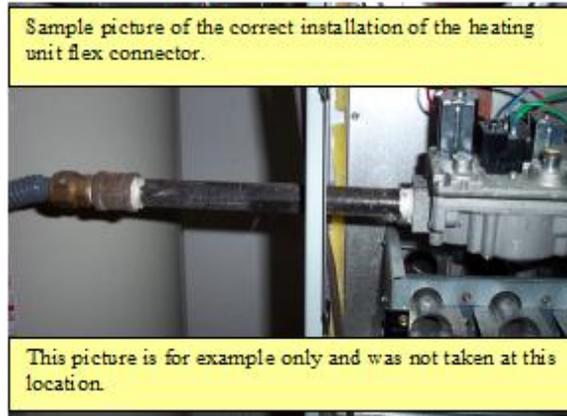
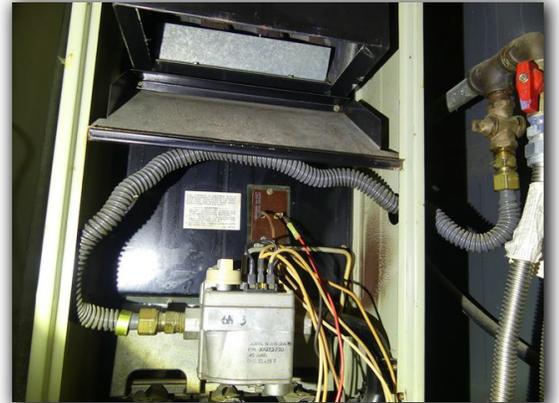
Flexible gas supply connectors at the heating equipment that pass through the heating unit cabinet wall were observed to be a SAFETY HAZARD. Current building standards require that the black iron gas pipe pass through the heating equipment cabinet wall before being connected to flexible gas connectors for reasons of safety.

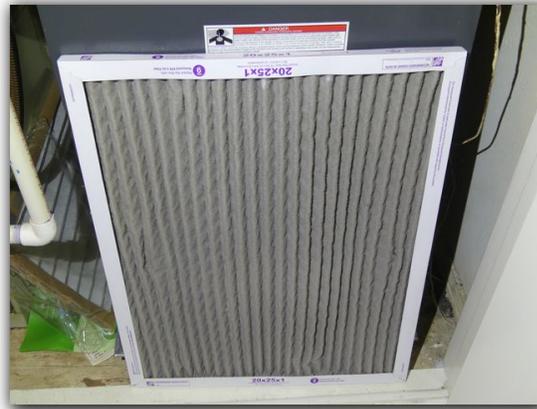
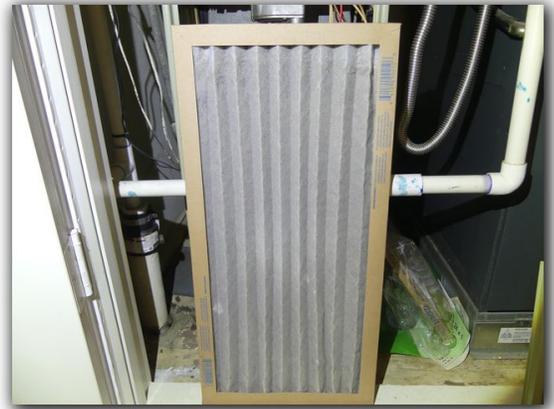
Dirty or damaged cooling equipment air filters may not perform as intended and should be replaced as needed or per manufacturer instructions. Dirty or damaged cooling equipment air filters may result in damage to the cooling equipment.

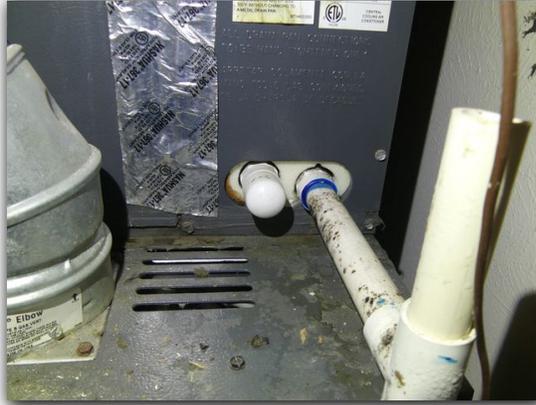
- ☑ The cooling equipment secondary condensation drain was not installed and did not have a secondary drain float switch installed. Current building standards state that all cooling equipment secondary condensation drain lines should drain to an observable location or have a float switch installed in the secondary drain port.

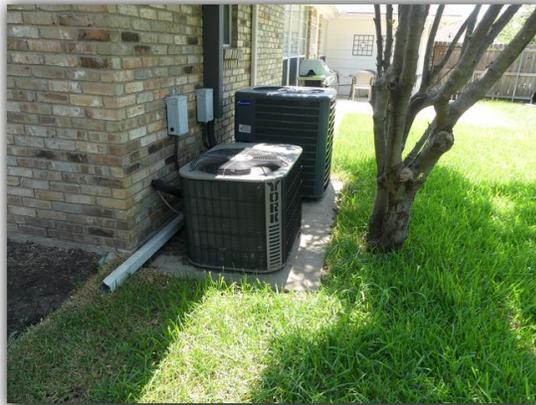
- ☑ The exterior HVAC equipment or support pad was not level and was in need of repair or replacement. Un-level HVAC equipment may not perform as intended. Inadequate HVAC support pads may affect HVAC performance.

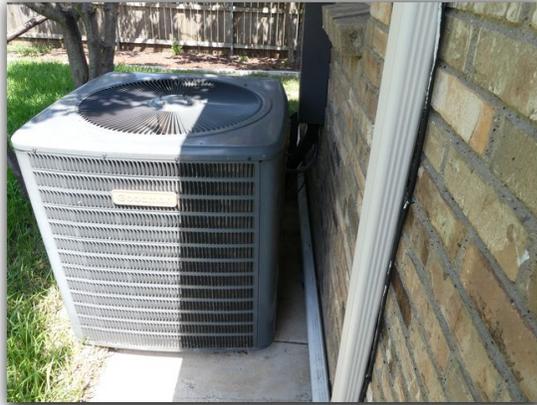
- ☑ The exterior HVAC equipment was not installed 3" above grade and was in need of repair. Inadequate elevation of the exterior HVAC equipment may allow moisture to penetrate the equipment, reduce equipment life and may affect performance.

- ☑ The exterior HVAC equipment was installed too close to structure (<18"). Inadequate clearances at the exterior HVAC equipment may result in equipment damage, inadequate performance, reduced equipment life or other defects.

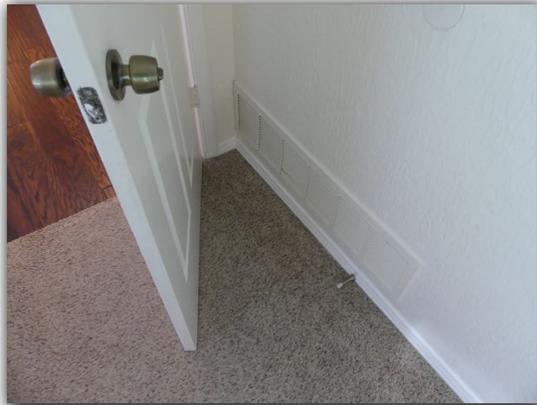
Cooling and heating equipment return air ducts should not be installed behind doors or have household items blocking the return. Return air ducts installed behind doors or other items may restrict air flow and affect equipment performance.

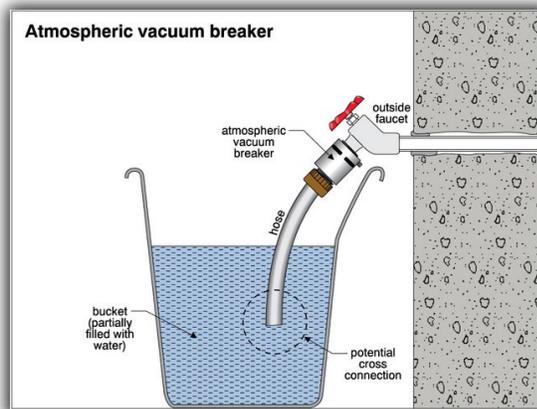
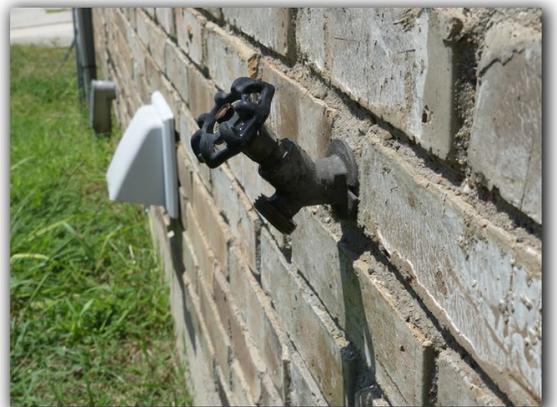
Exterior water supply faucets were missing an anti-siphon device to prevent contaminants from entering the water supply. Lack of anti-siphon devices at exterior water supply faucets is a **SAFETY HAZARD**. Current building standards require non-removable vacuum breakers on all hose faucets.

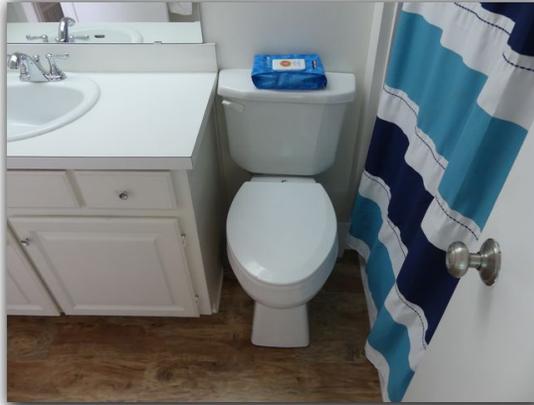
The clearance between the toilet and adjacent wall or other surfaces was observed to be inadequate.

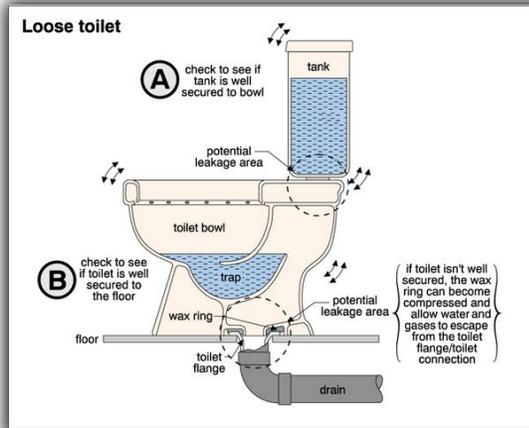
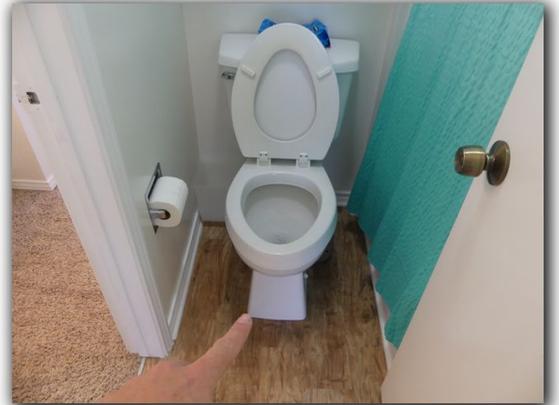
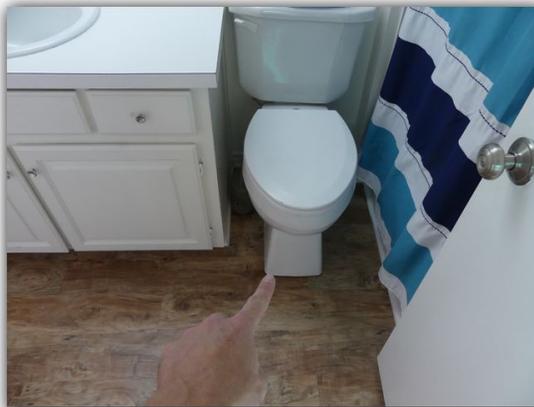
Toilets that are loose from the floor mountings should be reset.

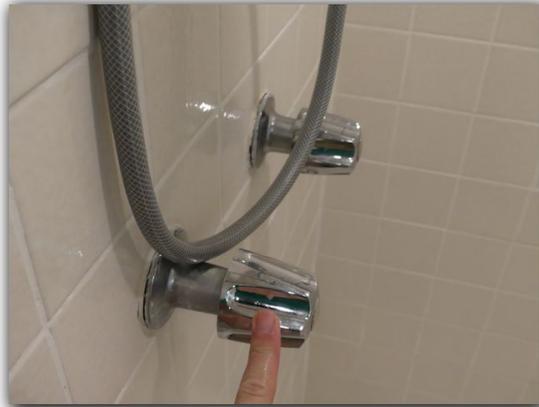
The shower water supply plumbing was observed to be loose in the wall.

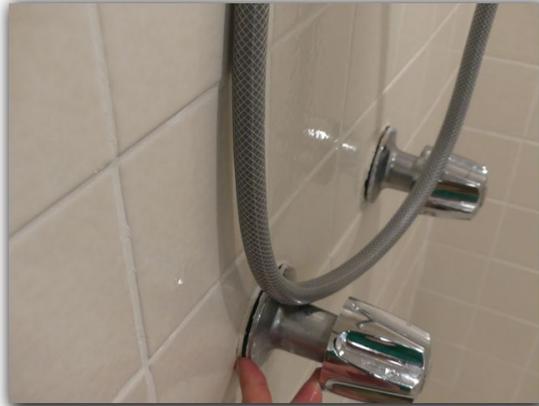
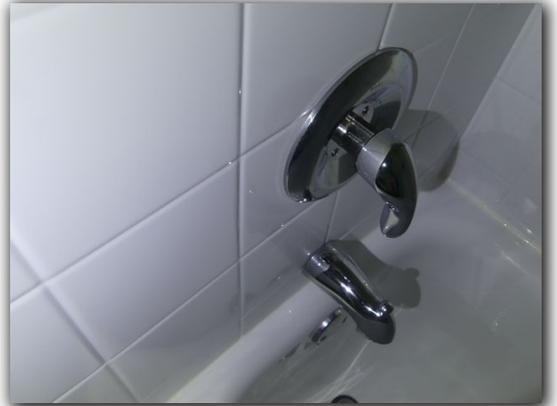
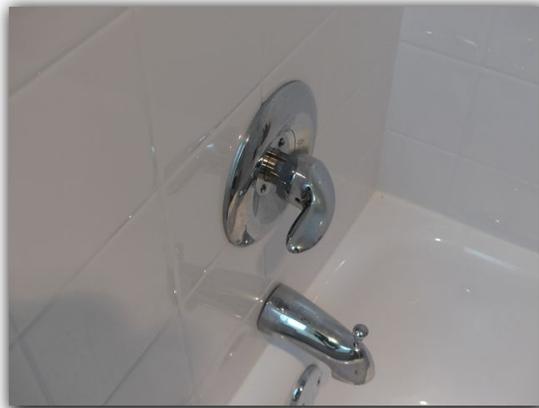
The tub/shower water supply fixtures lacked adequate sealant at the wall. Tub/shower water supply fixtures should be properly sealed at the wall to prevent water damage.

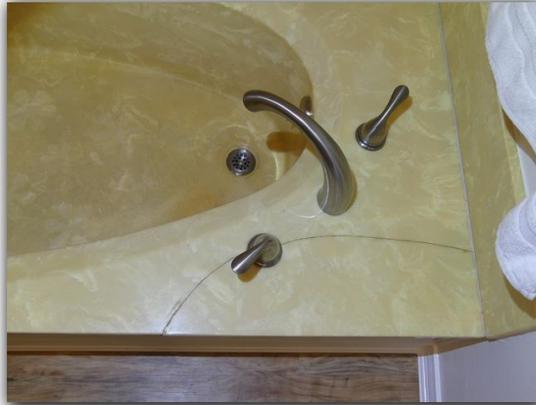
Damage to one or more bathtubs was observed.

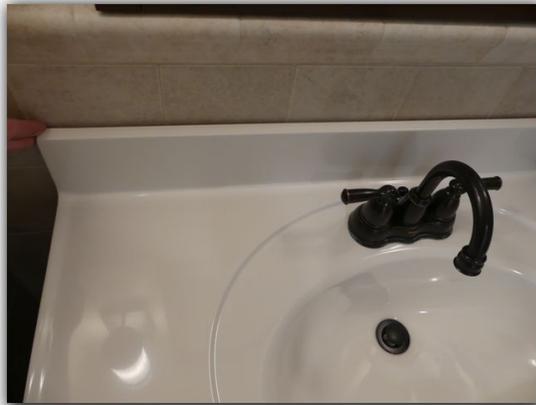
- The lavatory sink was observed to be loose at the wall.

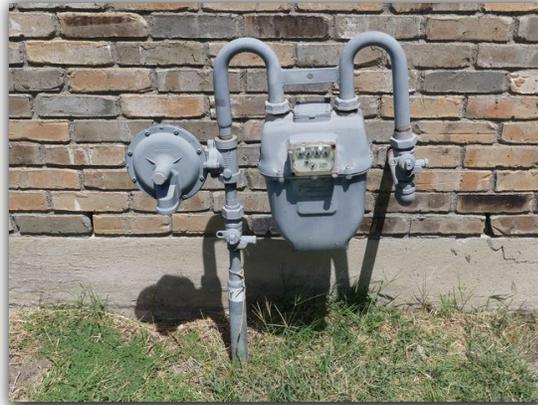
Older style gas valves require a tool to operate. Under current building standards, gas valves should be operable by hand for reasons of safety.

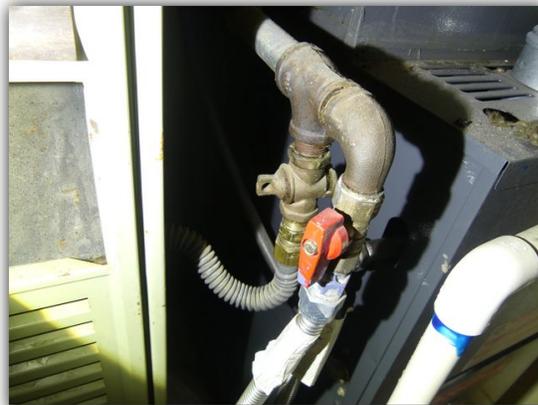
The gas supply flex connector at the heating equipment was observed to be passing through the heating equipment cabinet. Only rigid black gas pipe is allowed to pass through the heating equipment cabinet (appliance wall) (SAFETY HAZARD).

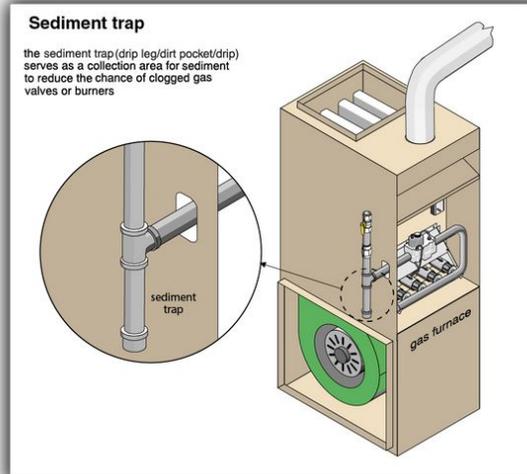
There were gas fired appliances that did not have a "drip leg" installed. Under current construction standards, drip legs are required at the black iron gas pipe prior to a flexible gas line connection.

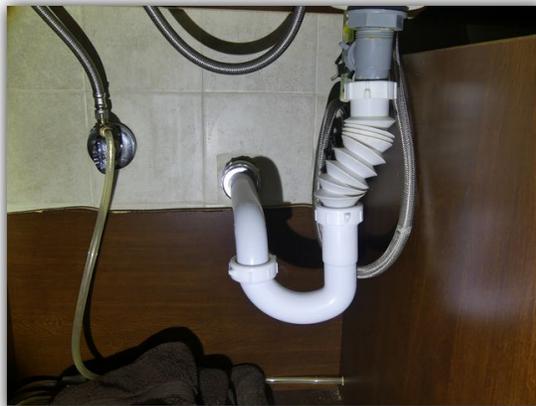
Temporary accordion type plumbing at the waste drains should be repaired. Temporary plumbing at sink waste drains are a hidden fouling hazard and may cause water damage and create conducive conditions for wood destroying insects.

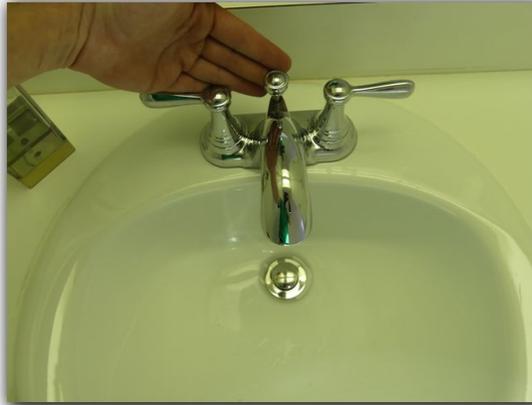
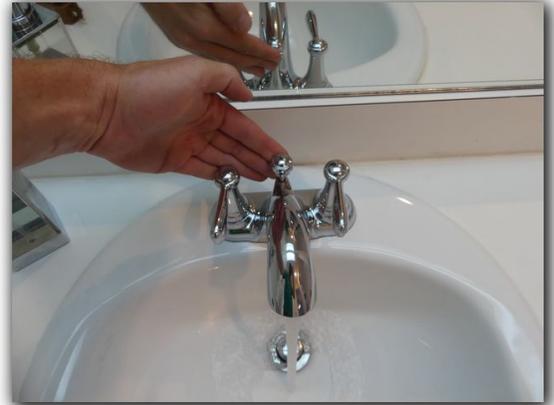
Missing, damaged or inoperative mechanical drain stops at the sinks/tubs should be repaired.

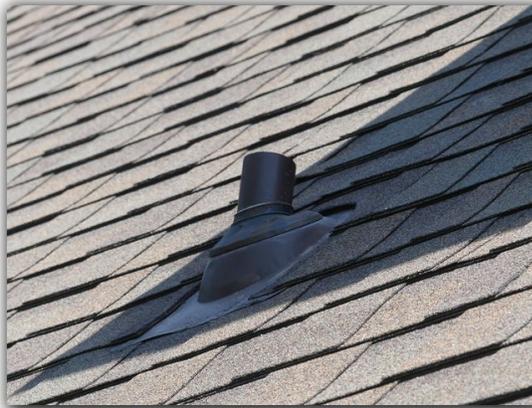
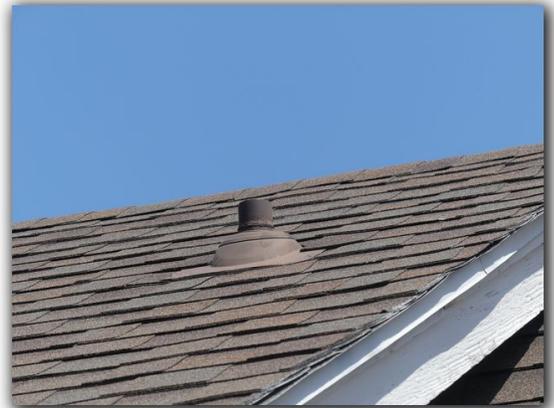
Roof penetration plumbing vents were installed too short and should extend at least 6 inches above the roof covering.

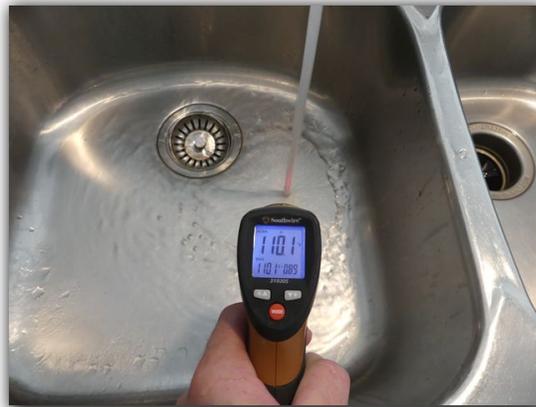
Heated Water Temperature (110.1 °F):

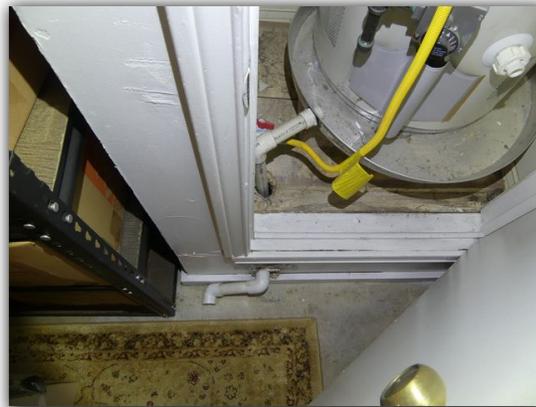
The water heating equipment overflow pan lacks a drain to the exterior of the structure. Current building standards state that all water heaters should be equipped with an overflow pan with a drain which drains to the exterior of the structure if leaks would cause damage.

☑ The water heating equipment overflow pan lacks a drain to the exterior of the structure. Current building standards state that all water heaters should be equipped with an overflow pan with a drain which drains to the exterior of the structure if leaks would cause damage.

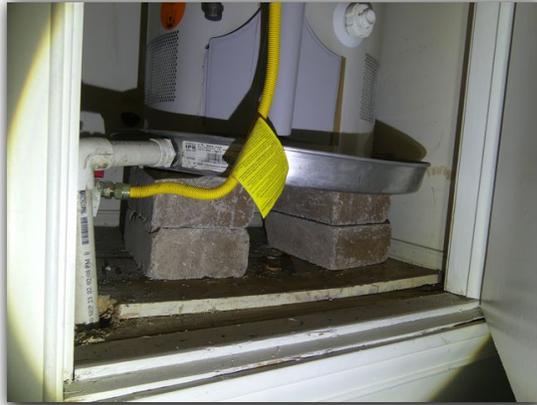
Improper water heating equipment base supports or floors were observed. Improper water heating equipment base supports may not provide adequate support and should be repaired to prevent water heater damage, plumbing damage and water damage.

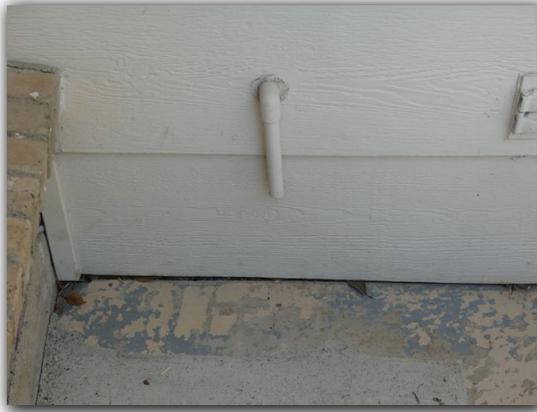
- The water heating equipment TPR valve was inspected and verified, but was not tested. It is common for TPR Drain valves to fail under testing and leak water.
- The water heating equipment TPR drain line was improperly terminated at the grade level. Current building standards require that the TPR drain plumbing terminate with a 90 degree elbow facing down and be within 6" of the grade or other surface.

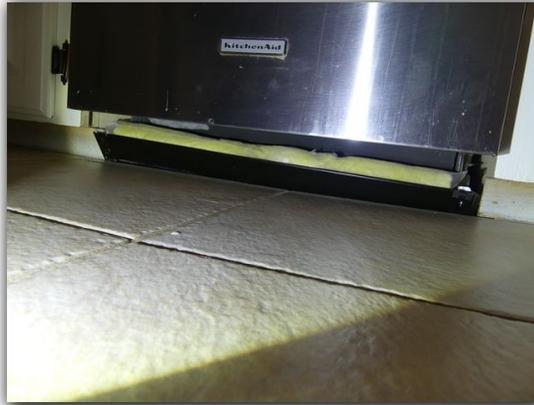
- The dishwasher lower kick plate was not properly installed. Missing dishwasher components should be replaced as needed.

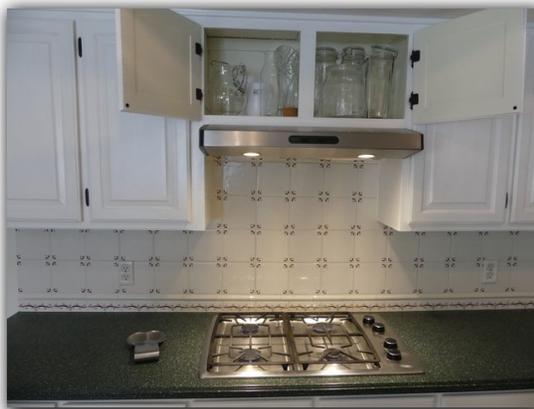
A gas oven, gas range or gas cooktop was installed with a range hood exhaust system which was not vented to the exterior. All gas appliances should be vented to the exterior of the structure. Lack of ventilation to the exterior of the structure is considered a SAFETY HAZARD and may allow harmful vapors to accumulate in the living area. There may be appliance manufacturer's guidelines that allow alternative ventilation of gas cooktops, ovens or ranges. Further evaluation is recommended.

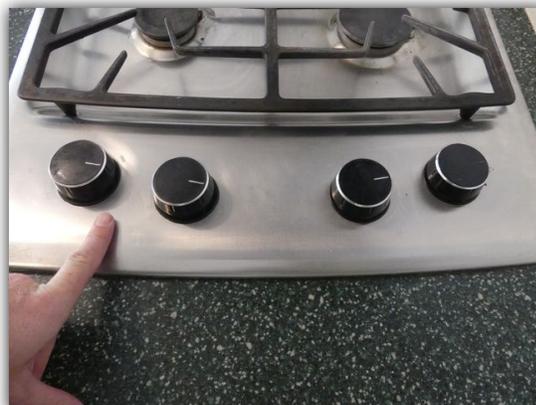
Missing and or damaged control knob indicators on the range/cooktop/oven should be repaired or replaced.

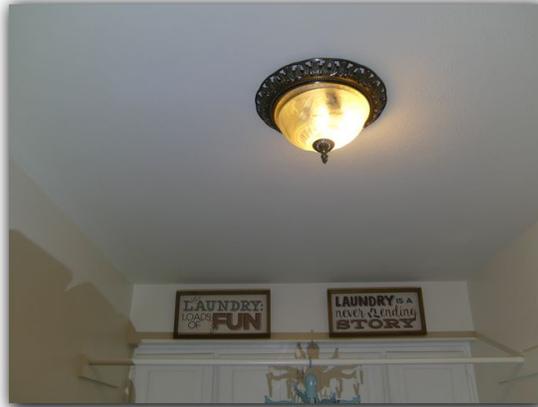
Current building standards require that all utility rooms have a mechanical exhaust vent or an operable window for the removal of moisture from the air. Lack of an operable window or a mechanical exhaust vent in utility rooms is a deficiency and should be repaired.

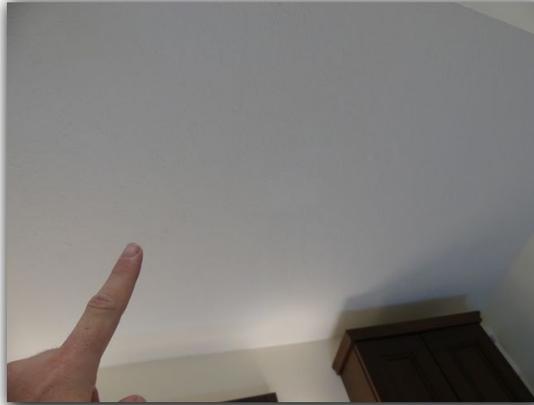
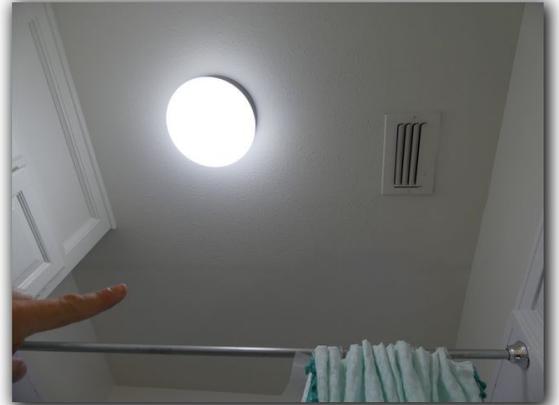
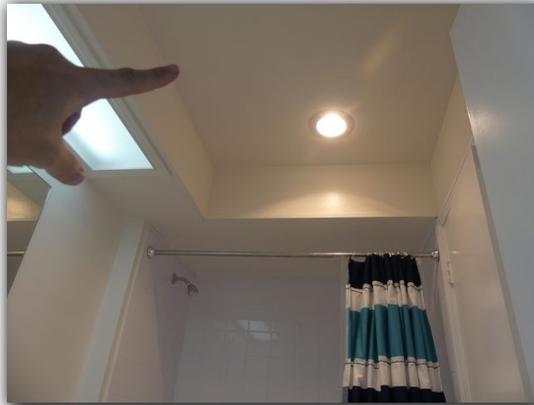
Current building standards require that all bathrooms have installed a mechanical exhaust vent or an operable window to remove moisture from the air. Lack of an operable window or a mechanical exhaust vent in bathrooms is a deficiency and should be repaired.

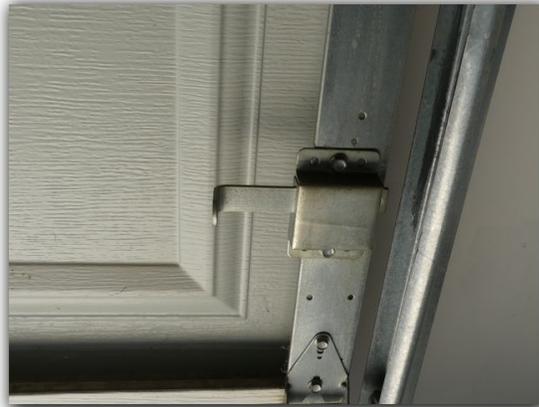
When an automatic garage door opener is installed the manual door locks should be disabled or removed to prevent damage to the garage door, garage door hardware and automatic garage door operator.

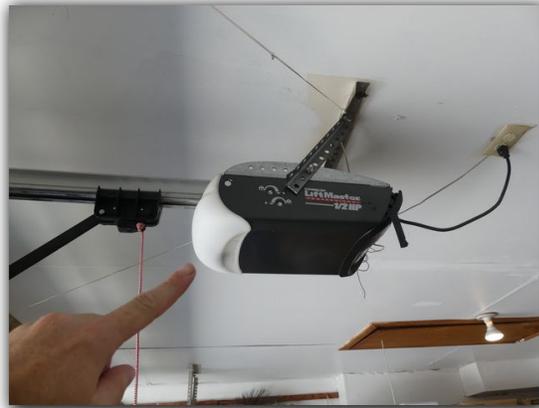
The automatic garage door opener light was inoperative. The cause of inoperative automatic garage door opener lights should be determined and should be repaired or replaced as needed.

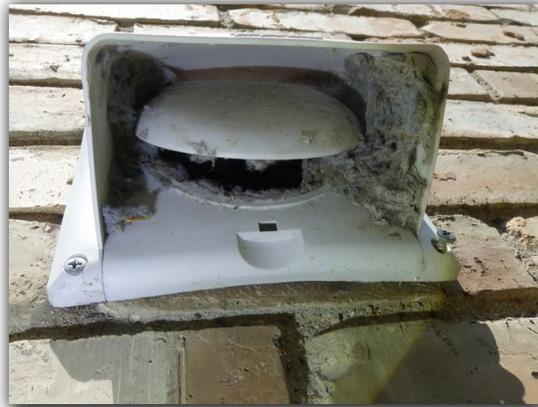
The dryer vent flapper was stuck in open position and was in need of repair or replacement. Dryer vent flappers that are stuck in the open position may allow moisture, insect and unwanted wildlife intrusion.

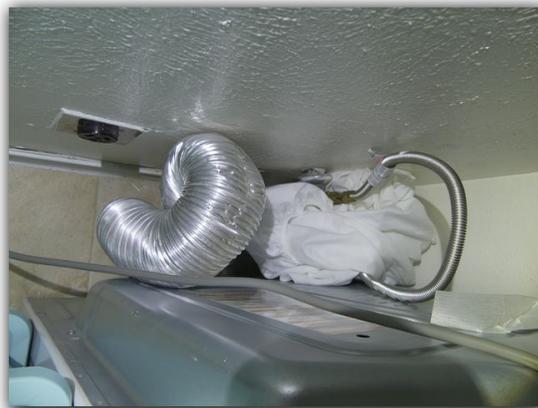
The dryer vent for a gas fired dryer should be smooth metal with no screws in the air flow. Inadequate materials at the dryer vent pipe or duct were observed to be a SAFETY HAZARD and should be replaced.

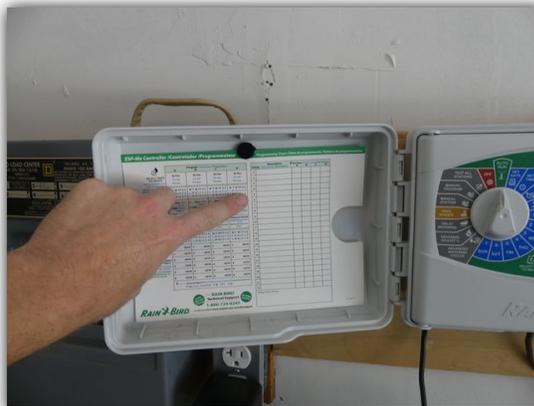
The landscape irrigation system could be improved with a zone map or diagram.

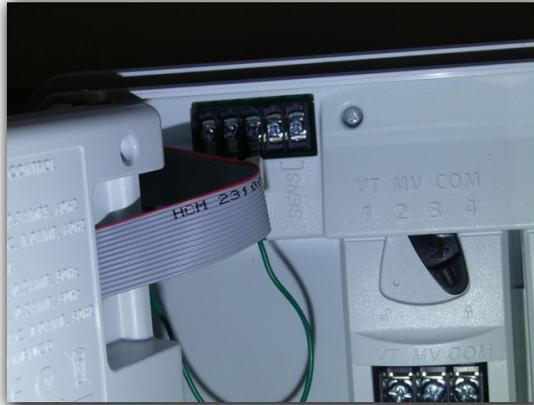
The landscape irrigation system lacks a sensor to disable the system in the event of rain or freezing temperatures.

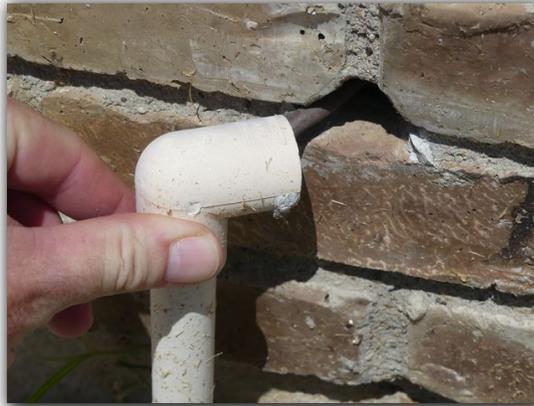
The landscape irrigation system electrical conduit needs sealant at the wall and should be repaired.

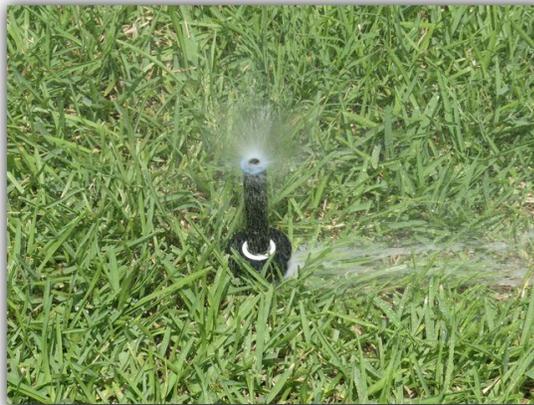
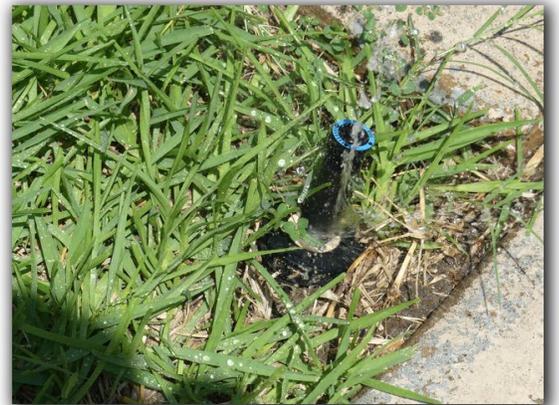
The landscape irrigation system had missing and/or damaged sprinkler heads that should be replaced.

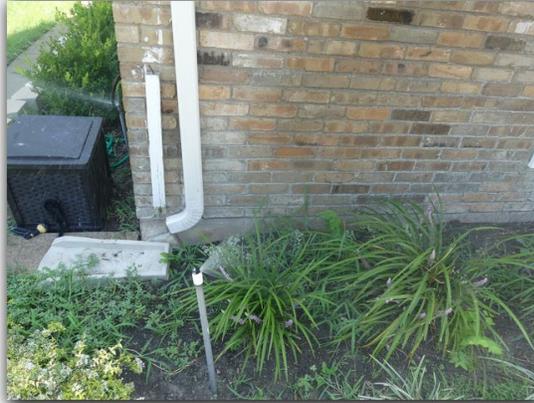
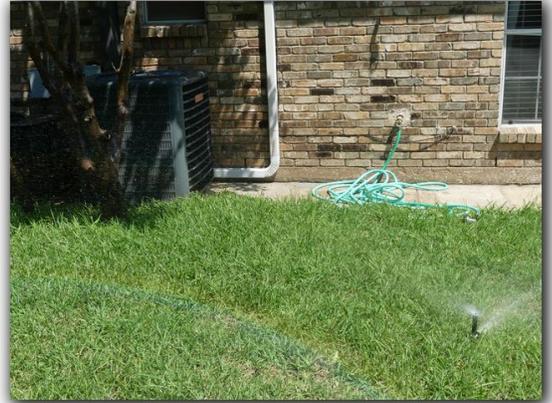
The landscape irrigation system sprinkler heads were observed to spray the structure or in unwanted directions and require repair, replacement or adjustment.

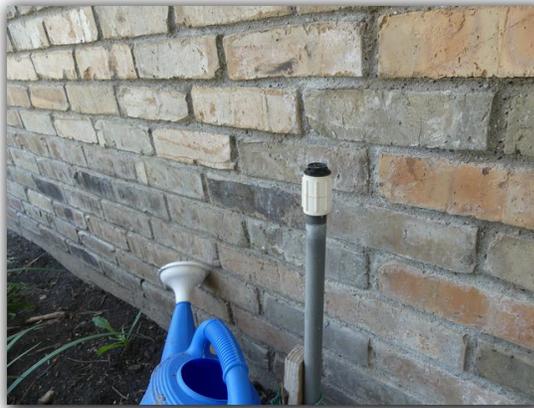
The landscape irrigation system had no water supply to one or more stations. The cause should be determined and should be repaired as needed.
