# Fouries Home Inspection

Condo Inspection  
Prepared Exclusively For: Buyer Name

Any Street, Fort Worth, TX, 76107

## PROPERTY INSPECTION REPORT

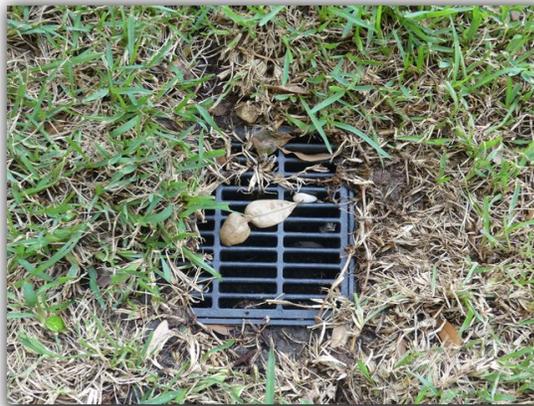
There is a subsurface or below grade drainage system installed. The inspector has no way of knowing if below grade drainage systems are performing as intended. The inspector recommends that the below grade drainage system be monitored for performance.

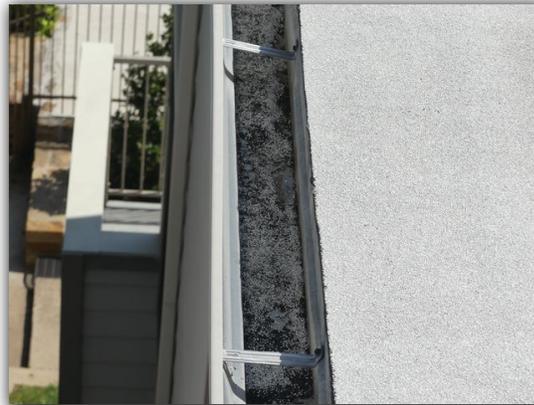
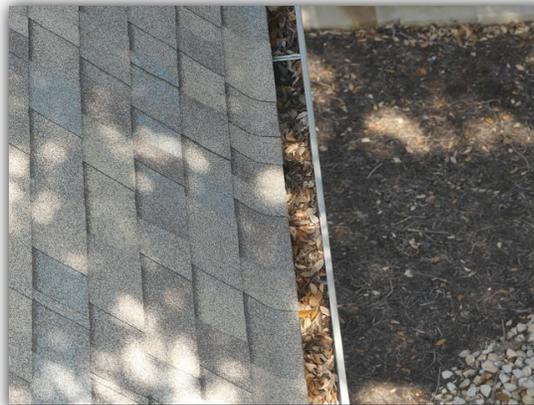
The gutters and downspouts contained leaves and other debris and should be cleaned out to allow for proper drainage.

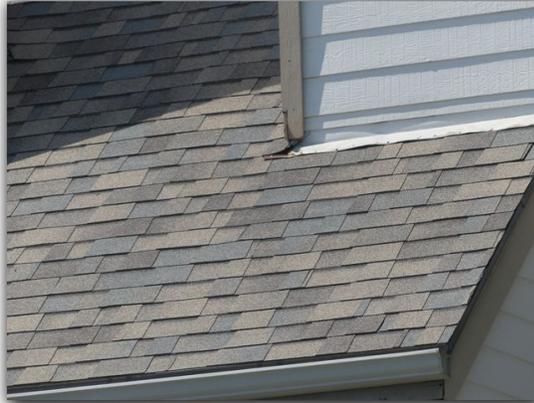
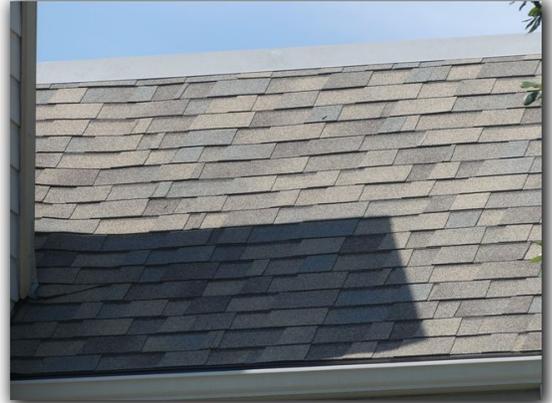
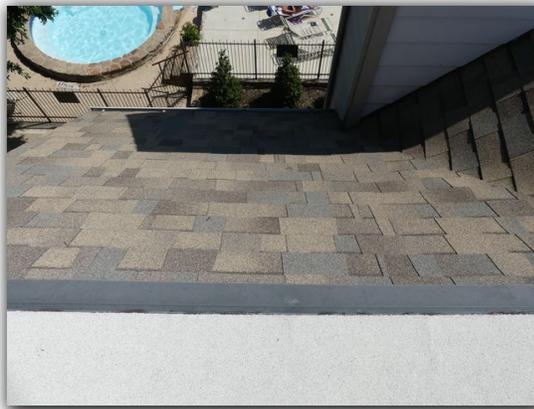
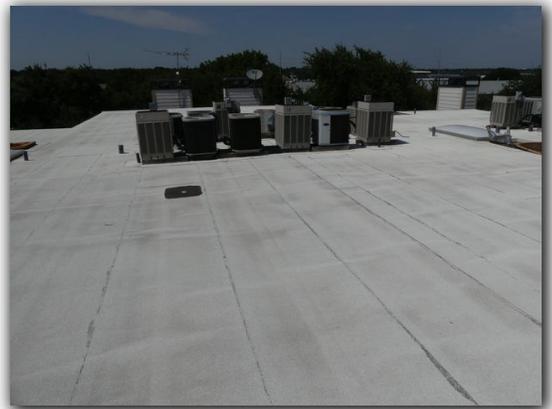
The roof covering materials were performing as intended at the time of the inspection. The roof covering materials were inspected according to today's Texas Standards of Practice. Roof coverings should be closely monitored over time for wear and weather damage. **If the buyer has any remaining concerns about the roof covering materials, the inspector recommends that a roof covering specialist be consulted.**

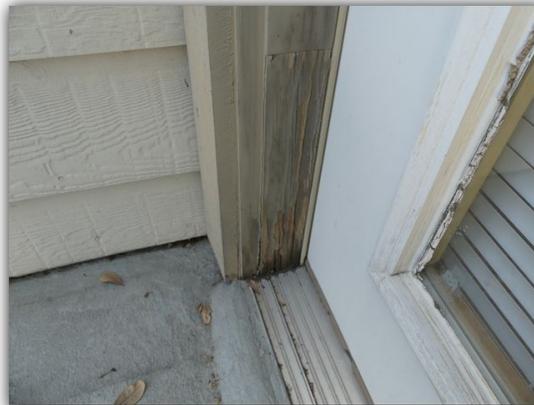
The exterior wood trim was observed to have some deterioration and/or damage. Damaged and deteriorated exterior wood trim should be repaired to prevent wall damage, moisture penetration and wood destroying insects.

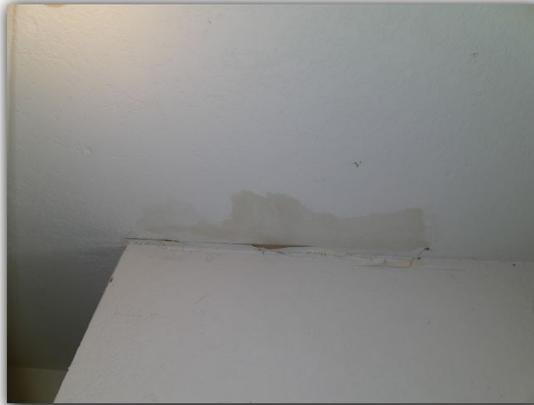
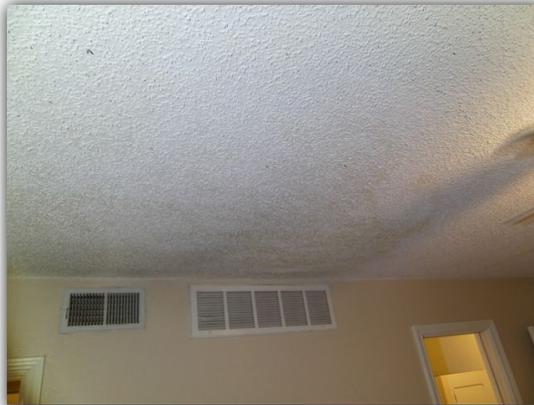
Cosmetic damages to ceiling drywall, texture and paint should be repaired.

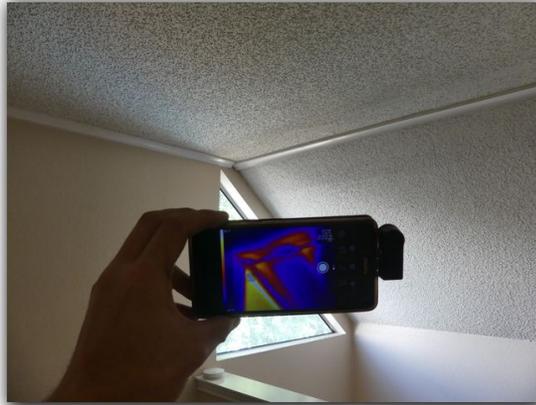
At least one interior ceiling crack was observed which is an indication of structural settling,

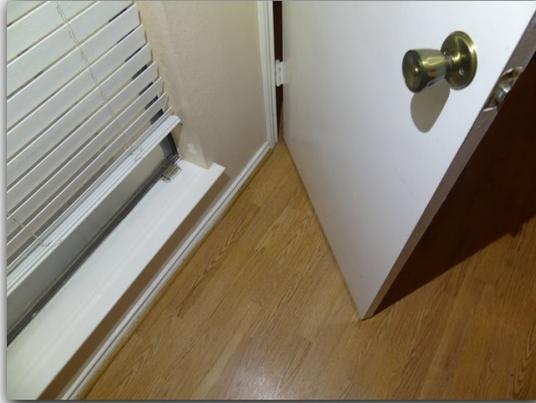
All interior doors should have door stops installed to prevent damage to adjacent interior wall coverings.

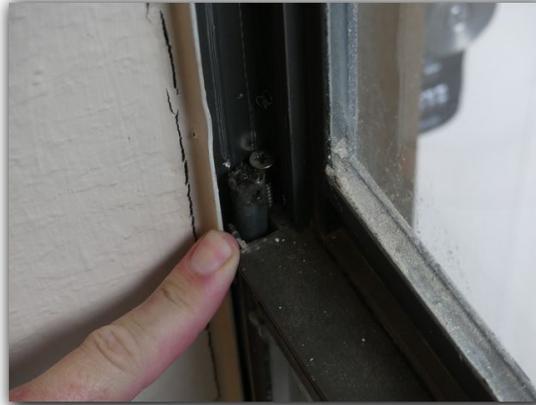
Damaged window lift supports were observed. Damaged window lift supports may not hold windows in the open position and may allow glass or window frame damage. Damaged window lift supports should be repaired or replaced as needed.

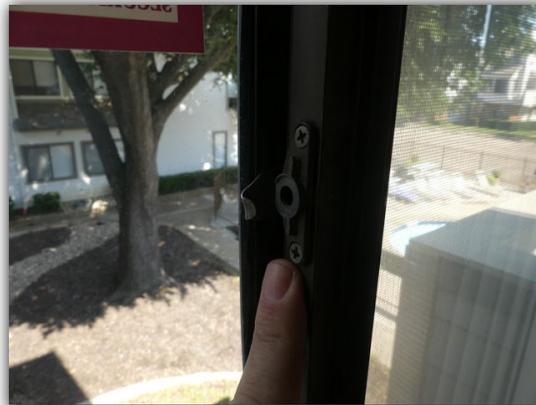
Damaged, missing or inoperative window lock(s) were observed. Damaged, missing or inoperative window locks are a SAFETY HAZARD and should be repaired prior to occupancy.

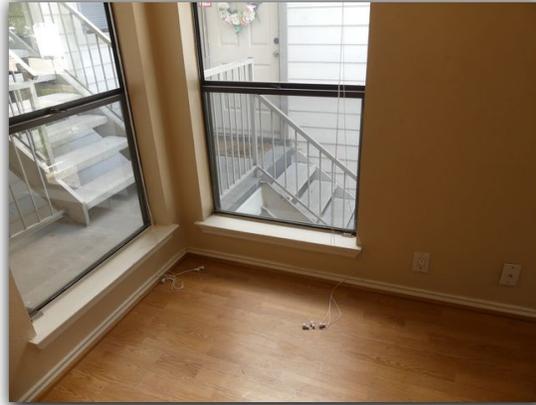
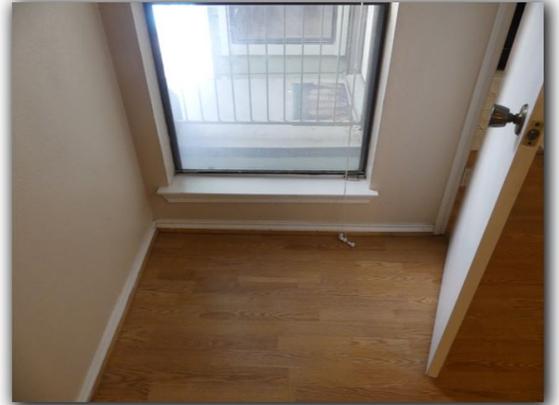
Window glass within 24" of a window above the first story is a SAFETY HAZARD. Window glass within 24" of the floor above the first story present a fall SAFETY HAZARD. Protective measures should be taken to prevent falls from windows above the first story.

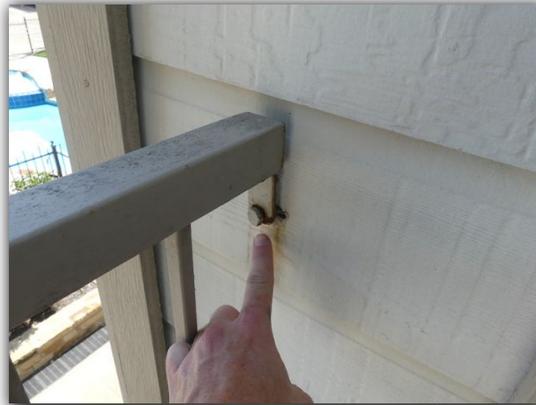
Loose or damaged guard railing should be repaired or replaced for reasons of safety. Lack of properly installed stairway handrails is a SAFETY HAZARD.

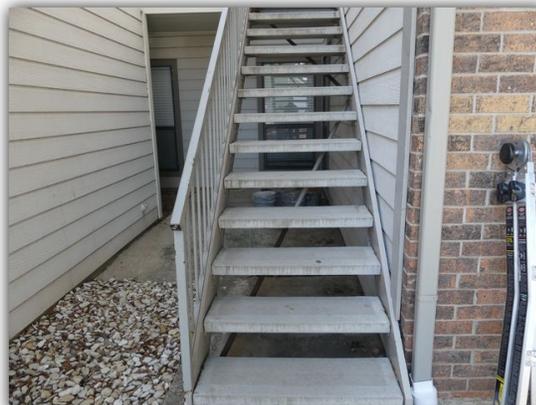
The stairway risers were open and were observed to be a SAFETY HAZARD. Under current building standards, stairway risers should not allow passage of any object greater than 4".

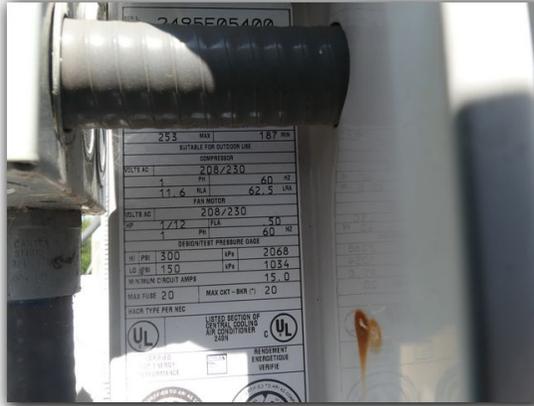
Mismatched breaker sizes between the exterior HVAC equipment (Max./Min. Amperage), electric disconnect and/or the electric service panel breaker were observed. Mismatched breaker sizes between HVAC equipment and the electric service panel should be further evaluated and repaired or replaced by a qualified electrical or HVAC specialist.

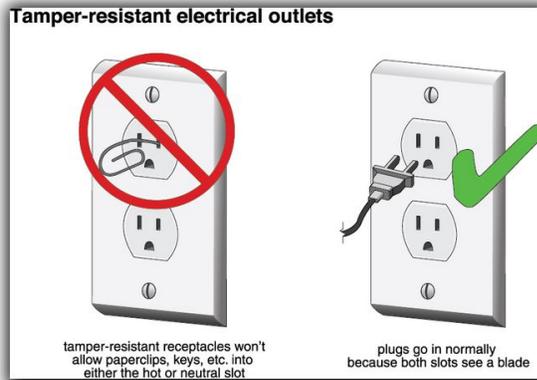
Electrical receptacles within five feet of the floor should be tamper resistant safety receptacles according to current building standards. This may be an "as-built" condition and was an accepted building practice at the time this home was constructed. Lack of tamper resistant electrical receptacles is no longer an excepted building standard according to current National Electric Code (NEC).

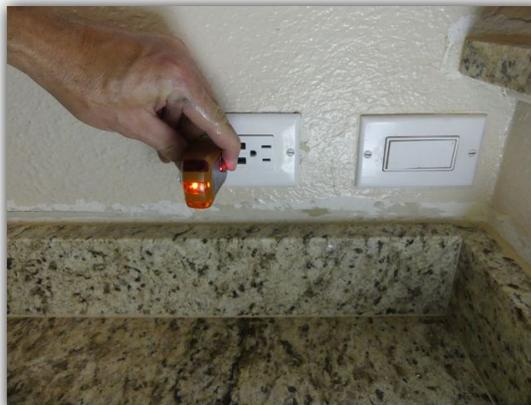
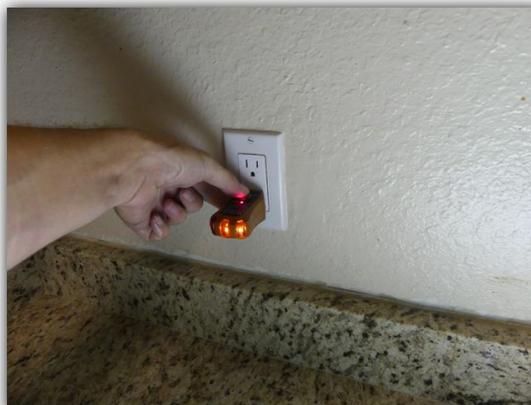
☑ Kitchen counter top electrical receptacles were observed to lack ground fault circuit interrupter (GFCI) device protection. Under current electrical standards, all of the kitchen counter top receptacles should have GFCI protection. Lack of GFCI protection in required locations is a SAFETY HAZARD.

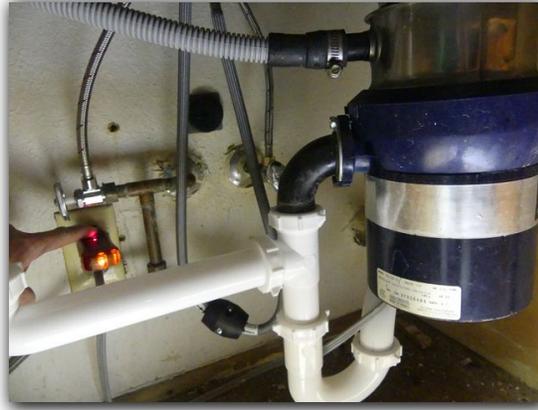
☑ The food waste disposer electrical receptacle was observed to lack ground fault circuit interrupter (GFCI) device protection. According to the 2014 NEC electrical standards, food waste disposer electrical receptacles should be GFCI protected. Lack of GFCI protection in required locations is a SAFETY HAZARD.

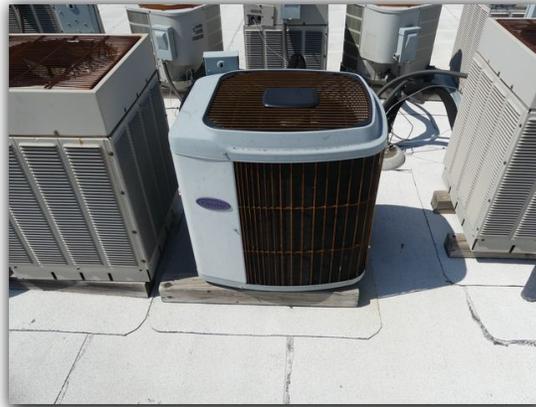
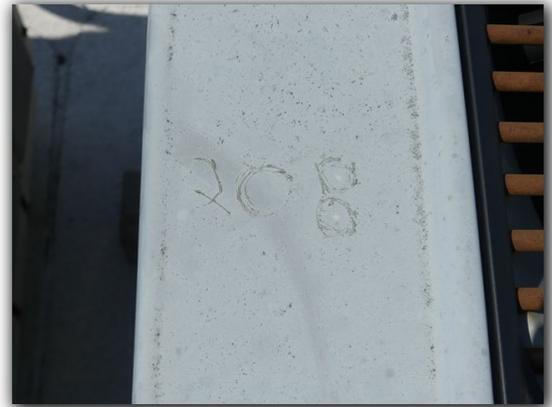
The cooling equipment appeared to be older equipment and showed indications of age and wear. Future life expectancy can not be determined. You may continue to use the cooling equipment until repair or replacement is needed. Repairs or improvements were needed at the cooling equipment. The observations made to support this opinion are listed but not limited to the following:

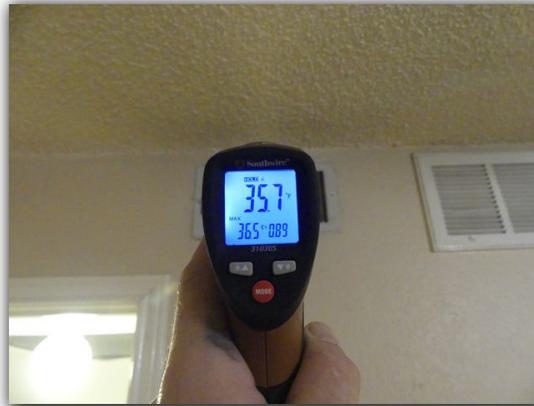
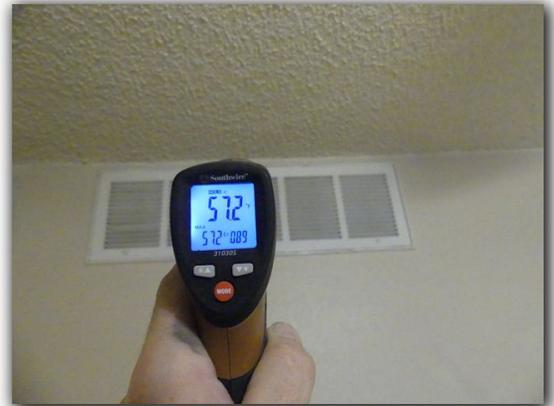
Return Air Temp: 57.2 °F

Temp. Differential: 21.5 °F

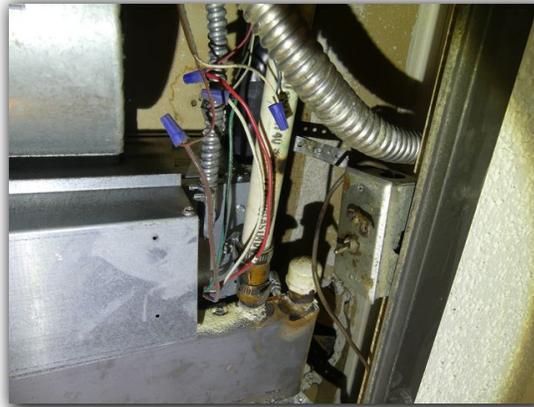
The cooling equipment secondary condensation drain was not installed and did not have a secondary drain alarm or sensor installed. Current building standards state that all cooling equipment secondary condensation drain lines should drain to an observable location or have a water sensor/alarm installed in the secondary drain port.

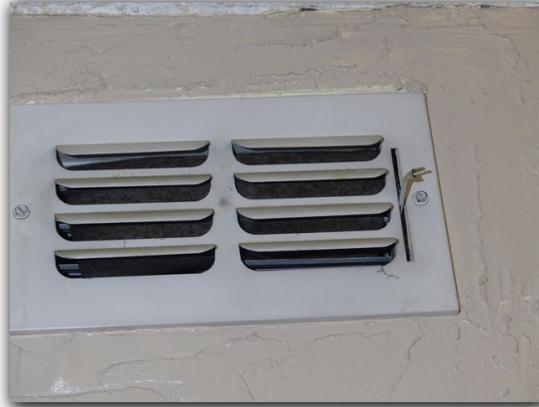
Blocked HVAC air register vent covers were observed at the time of the inspection.

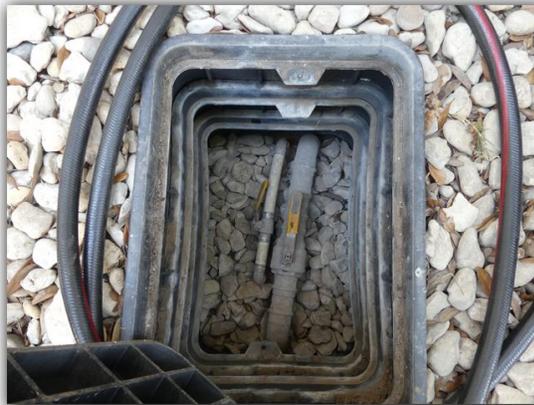
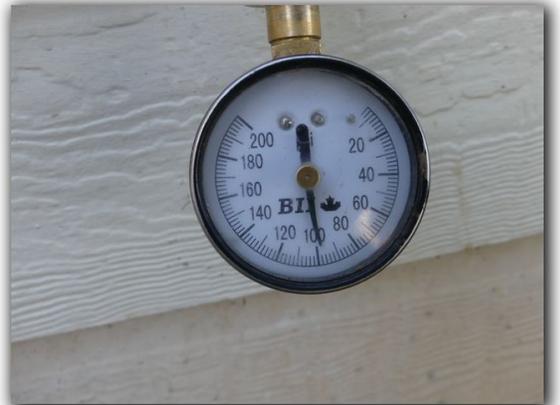
**Static Water Pressure:** High Pressure - Above 80 psi

High water pressure was observed. Water pressure above 80 psi may be an indication that a water pressure regulator or other corrections are needed. The inspector recommends that the water supply and meter system be further evaluated by a certified, licensed plumbing specialist.

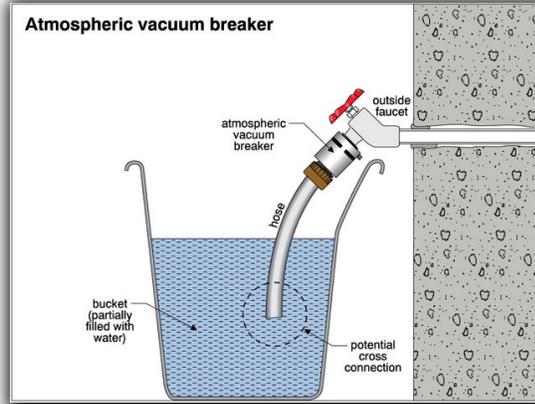
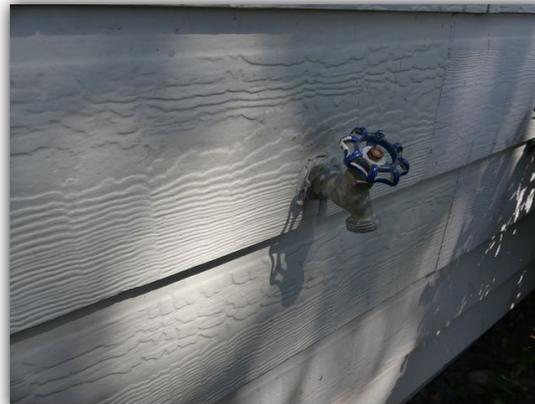
Exterior water supply faucets were missing an anti-siphon device to prevent contaminants from

entering the water supply. Lack of anti-siphon devices at exterior water supply faucets is a SAFETY HAZARD. Current building standards require non-removable vacuum breakers on all hose faucets.

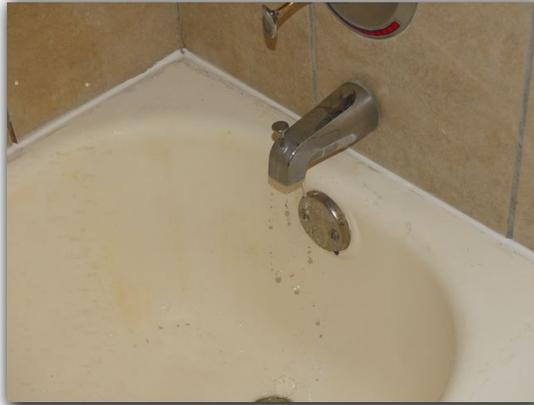
The shower diverter valve did not perform as intended at the time of the inspection and was in need of repair or replacement.

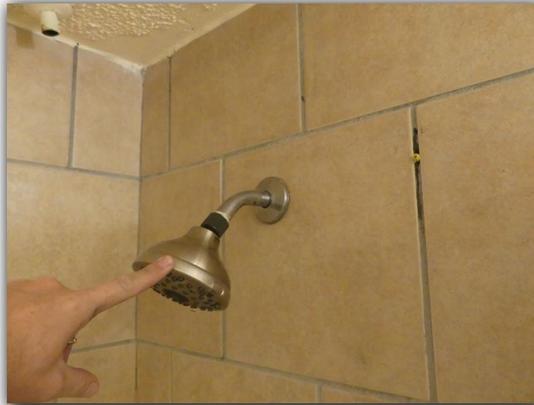
The shower water supply plumbing was observed to be loose in the wall.

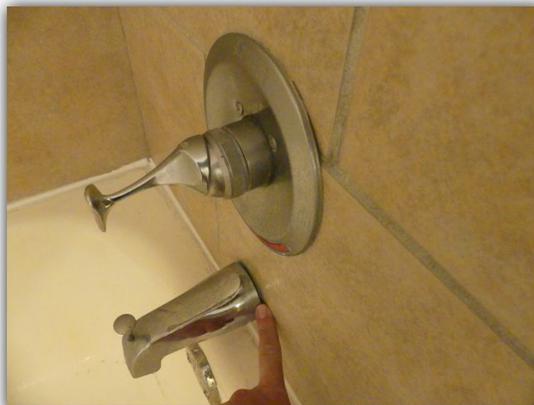
The tub/shower water supply fixtures lacked adequate sealant at the wall. Tub/shower water supply fixtures should be properly sealed at the wall to prevent water damage.

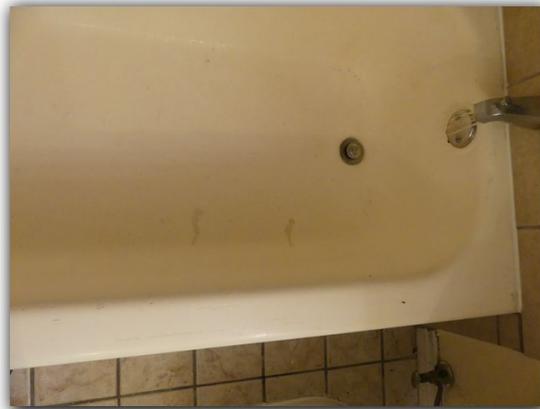
Surface damage to one or more bathtubs was observed.

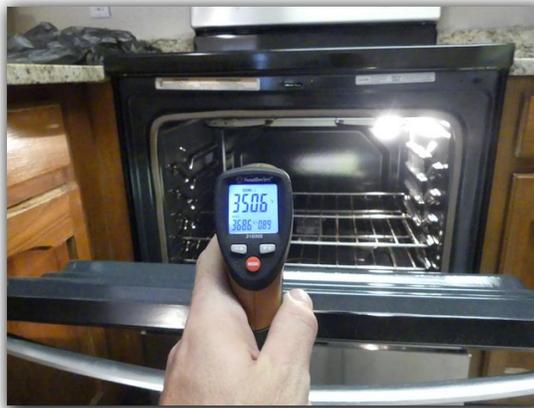
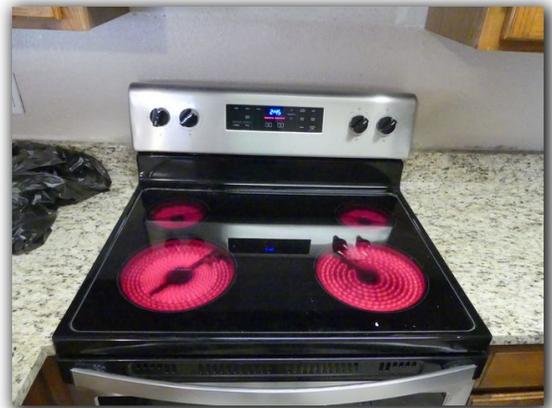
The absence of an anti-tilt device on freestanding ovens/ranges was observed to be a SAFETY HAZARD. An anti-tilt device should be installed prior to use of the appliance. Should the oven or range tilt, hot cooking items may fall creating conducive conditions for injury.

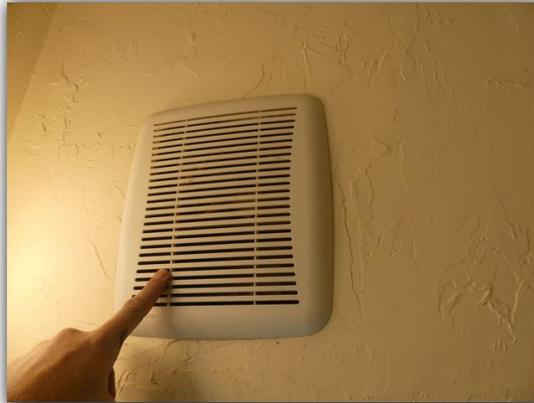
- There were inoperative mechanical exhaust vents. Inoperative mechanical exhaust vents should be repaired or replaced as needed.
