Fouries Home Inspection

COMPLETE HOME INSPECTION
Prepared Exclusively For: Buyer Name

Any Street, Mesquite, TX, 75150

By: Paul Fourie, Lic #22325 07/22/2019
(Name and License Number of Inspector) (Date)

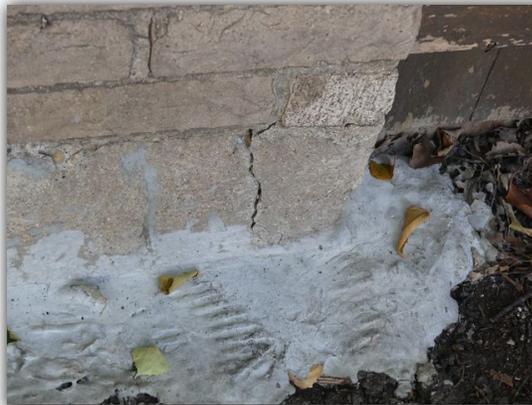
Foundation slab corners have been sheared off (corner pop). This is a common condition in slab on grade foundations and should be repaired. Repairing corner pops is recommended to prevent moisture and wood destroying insect penetration.

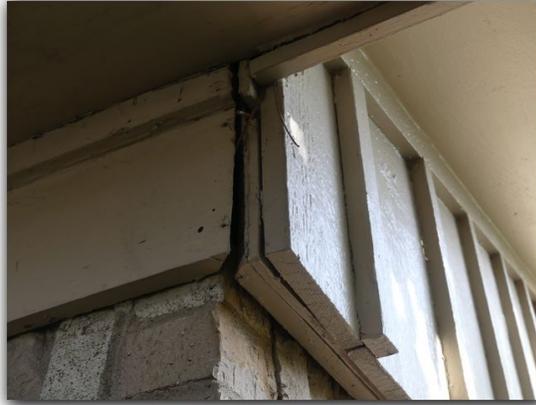
The inspector observed frieze board separations that were an indication of movement or settlement.

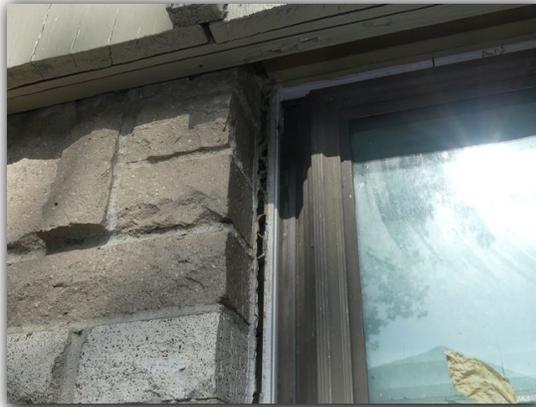
Greater than normal separations between window frames and walls were observed which is an indication of movement, settlement or other defects that should be repaired. The cause of separations between walls and window frames should be determined and repaired as needed.

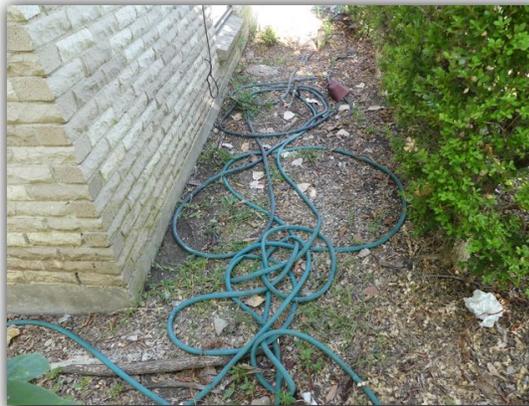
Inadequate grade slope away from the structure was observed. The recommended grade slope away from the structure is 6 inches per 10 feet. Improper grade slopes away from the structure create conducive conditions for water intrusion and inadequate foundation performance. Improper grade slope away from the structure is in need of repair.

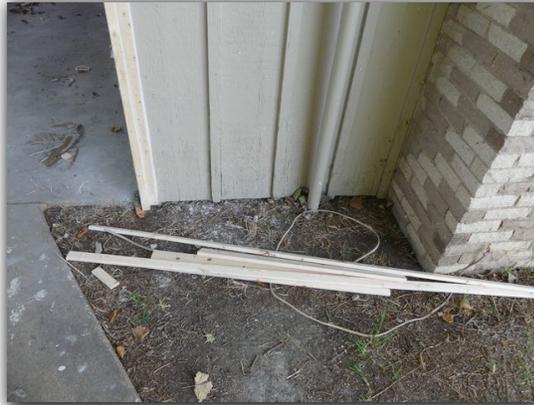
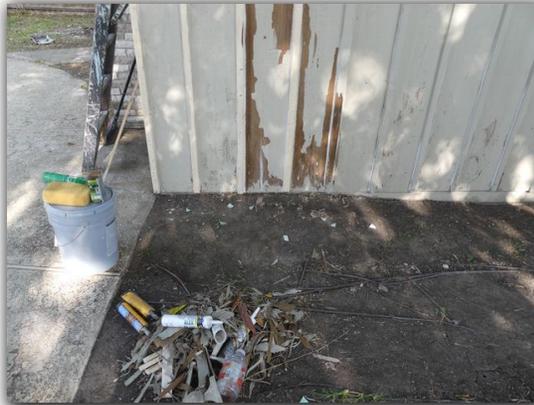
High soil levels were observed at the foundation/brick line. 4 to 6 inches of the foundation perimeter beam should be visible. High soil levels may block weep holes and prevent proper wall ventilation. High soil levels create conducive conditions for wood destroying insects and water intrusion. High soil levels prevent the inspector from observing the foundation perimeter beam. Correction of inadequate grading clearance to exterior wall and foundation surfaces is recommended.

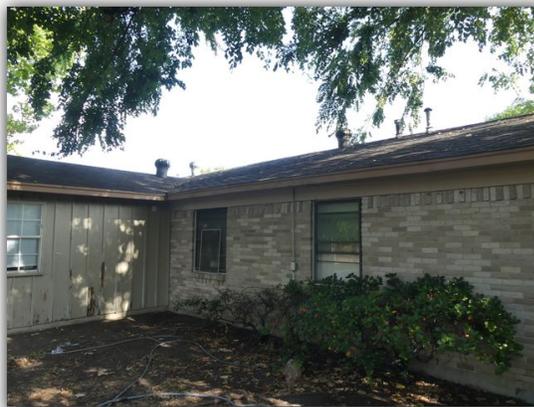
Grading and drainage could be improved with the installation of rain gutters. Properly installed rain gutters can prevent erosion and water ponding and help direct water away from the foundation.

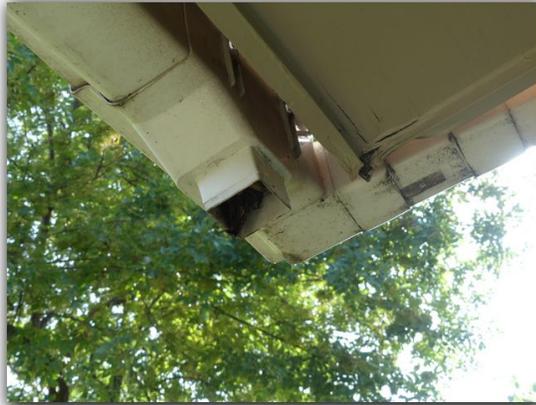
Damaged or leaking rain gutters and downspouts should be repaired. Damaged or leaking rain gutters and downspouts create conducive conditions for siding deterioration, soffit/eave damage, roof covering damage, water penetration and inadequate grade drainage.

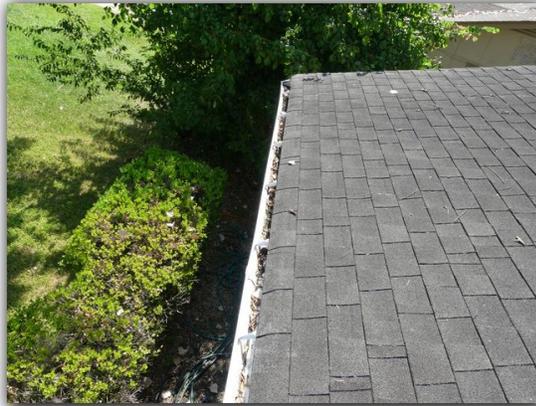
The gutters and downspouts contained leaves and other debris and should be cleaned out to allow for proper drainage.

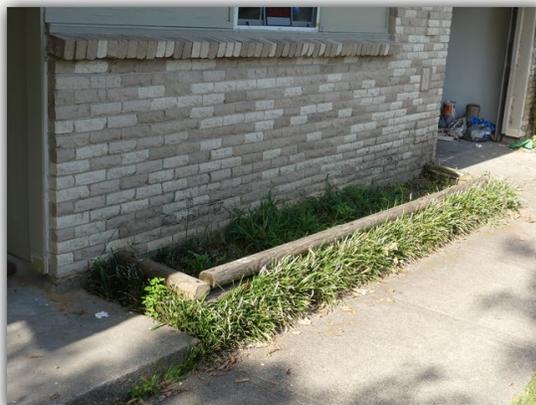
Planter(s) adjoining the structure create conducive conditions for wood destroying insects, moisture penetration and prevent the inspector from observing the foundation and or walls in these areas.

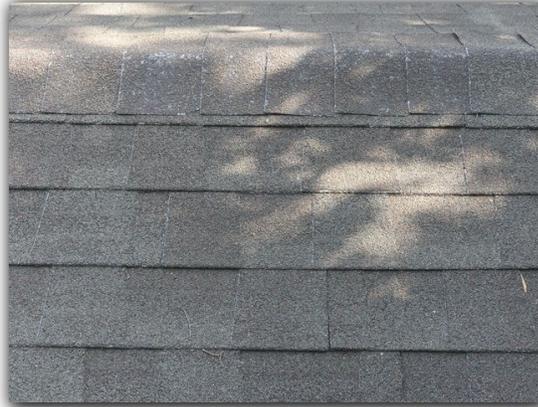
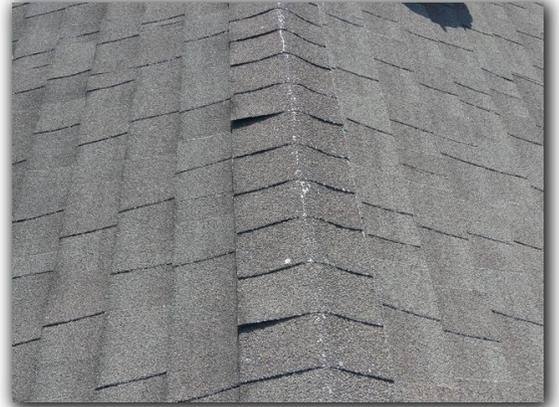
Composition shingle tab granules were observed to be thinning on the roof covering. You are encouraged to have your insurance company and a certified, licensed roofing contractor physically inspect the roof, prior to closing, to fully evaluate the insurability and condition of the roofing material.

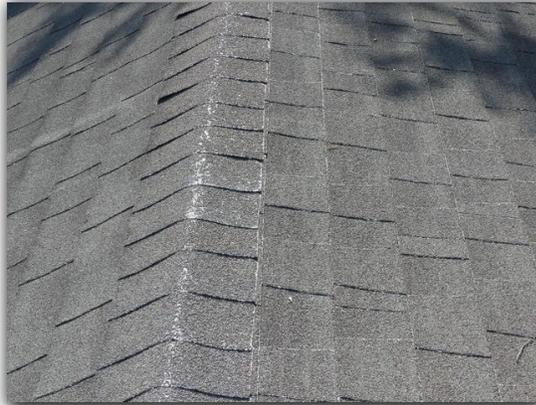
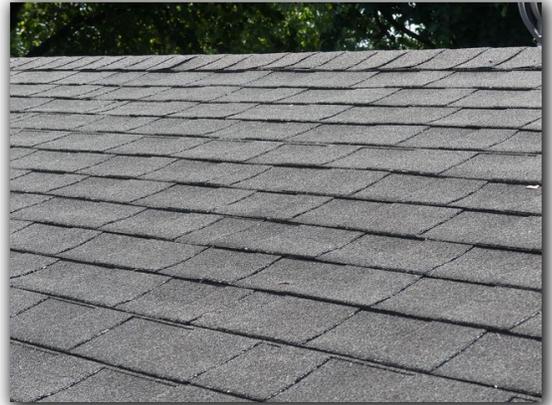
Broken and damaged roof covering materials were observed.

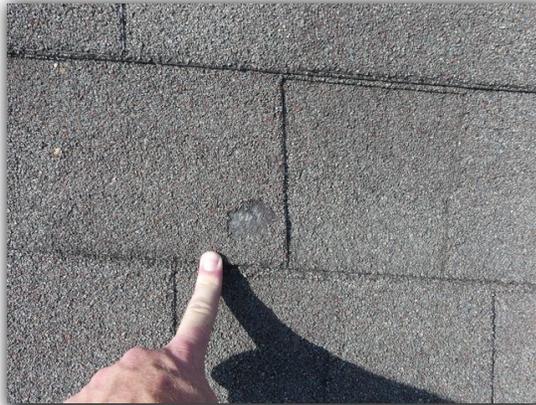
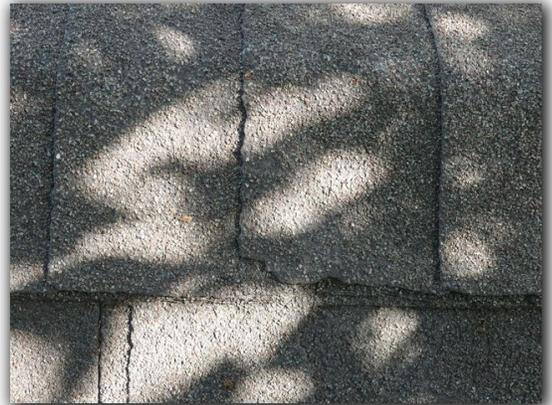
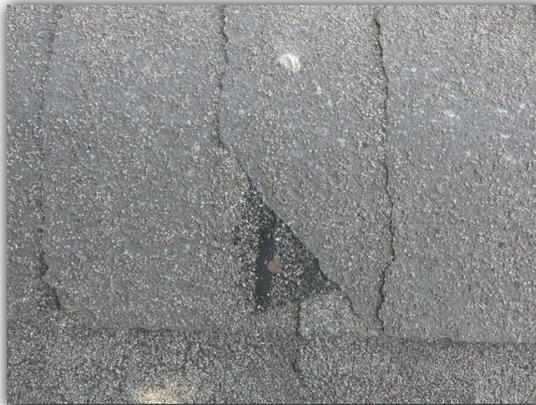
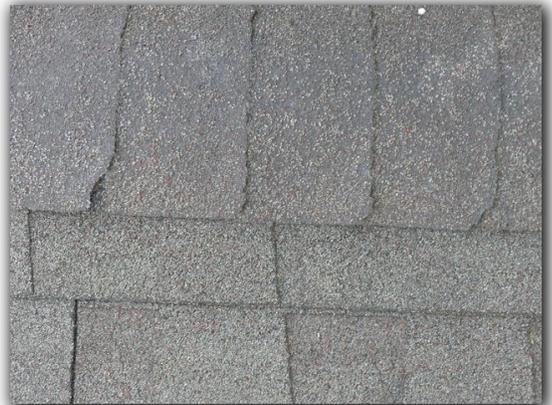
Roof covering shingles that do not lay flat on the roof deck were observed. Roof covering shingles that do not lay flat on the roof deck were an indication of improper installation, damaged underlayment or other defects. Roof covering shingles that do not lay flat on the roof deck may allow further deterioration of the roof covering, deterioration of the roof structure, water penetration or other damage.

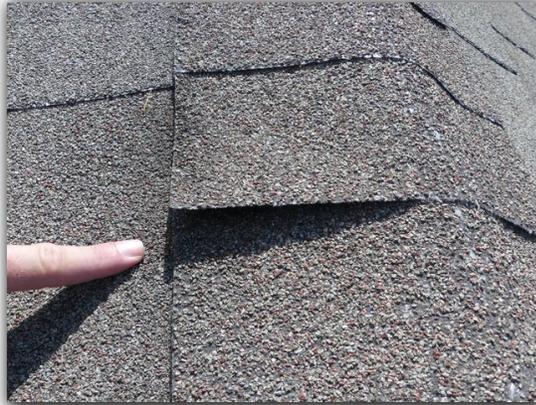
Additional sealants were installed at the roof covering materials or flashings. Added sealants may be an indication of previous repairs, water intrusion, improper installation or other defects.

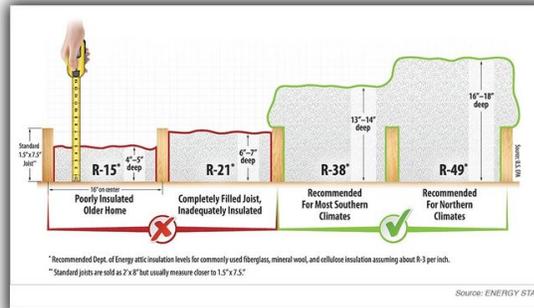
The attic insulation depth or thickness was inadequate. The recommended depth of attic floor insulation is 13+ inches to achieve an R38 rating. Inadequate attic insulation depth or thickness may allow greater than normal loss of conditioned air.

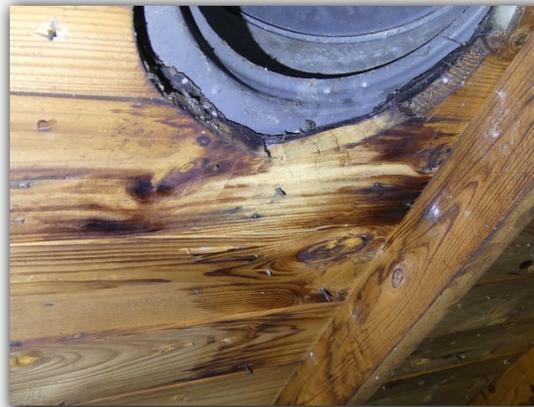
Water stains were observed on the roof sheathing (decking). The cause of the water stains should be determined. You are strongly encouraged to have your insurance company and a certified, licensed roofing contractor to physically inspect the roof covering materials, prior to closing, to fully evaluate the insurability and condition of the roofing material.

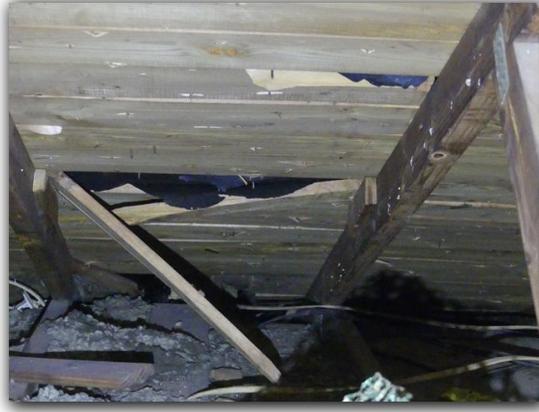
Damaged roof sheathing was observed in the attic. Damaged roof sheathing may not support the roof covering materials as intended and or may allow water penetration. Damaged roof sheathing should be replaced by a certified, licensed roof covering specialist.

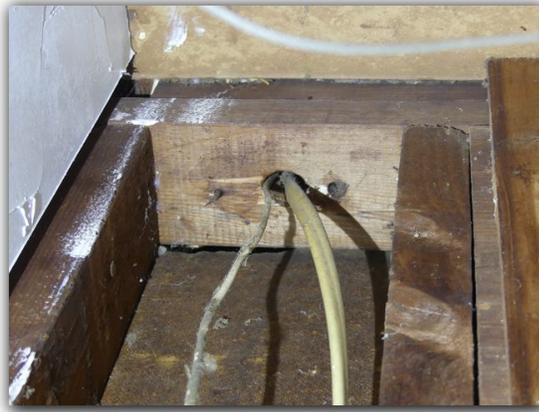
Openings were observed in the attic at electrical, plumbing, duct work or other penetrations where they pass through structural framing. These opening should be sealed for improved FIRE SAFETY.

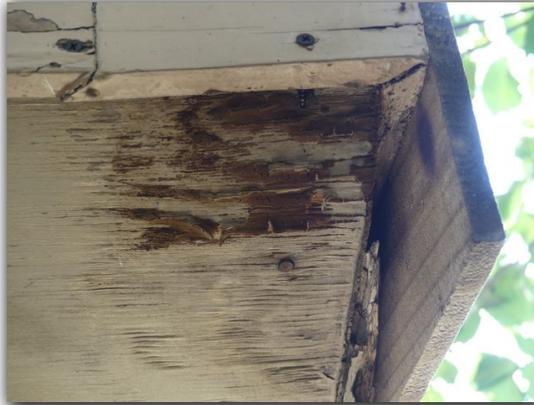
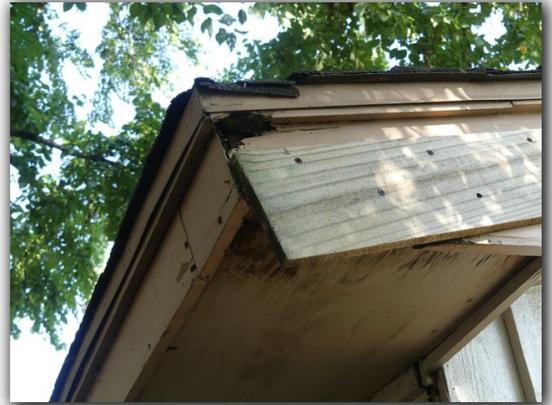
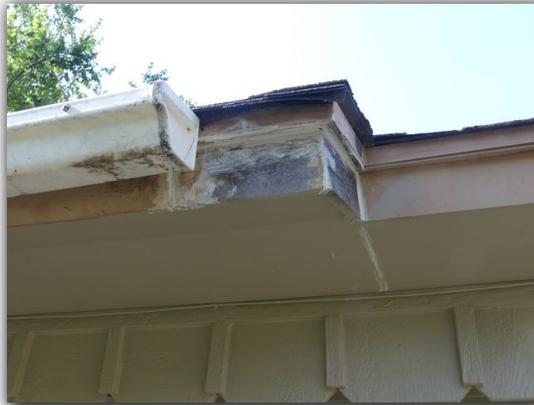
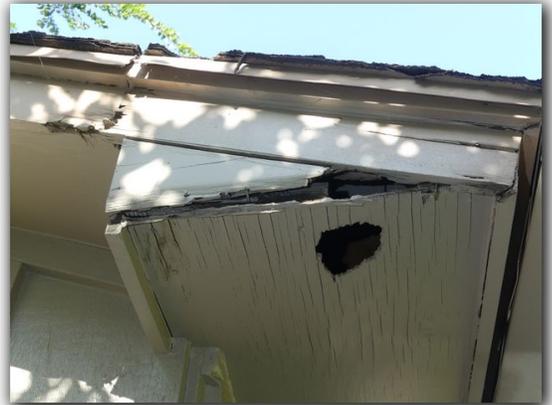
Fascia, soffit, eaves and or trim materials were observed to be damaged. Damaged fascia, soffits, eaves and trim materials should be repaired as needed to prevent further damage, wildlife penetration and moisture penetration.

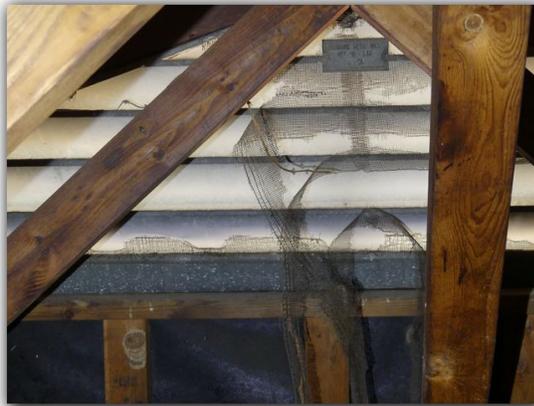
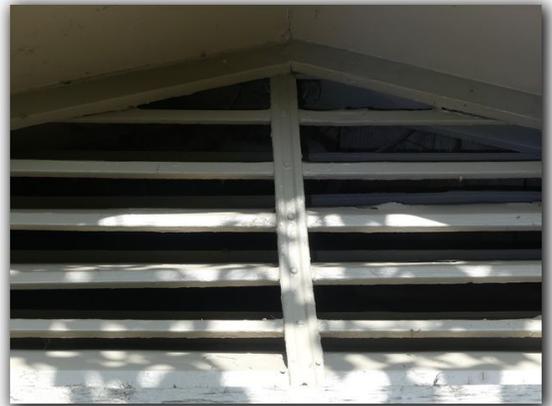
Damaged or missing attic gable vents or vent screens should be repaired to prevent wildlife penetration and other defects.

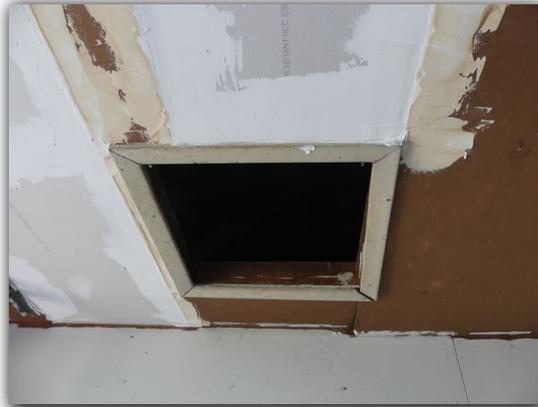
The attic access stair or attic access port cover in the vehicle storage area (garage) was missing, damaged or was not fire rated and may allow vehicle storage area vapors to penetrate the attic and/or living area (SAFETY HAZARD).

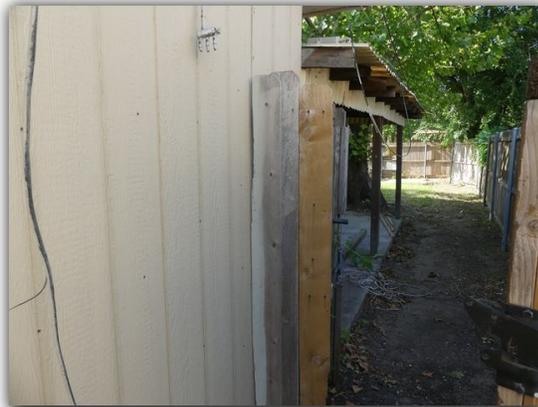
Wood fencing in contact with the structure creates conducive conditions for wood destroying insects. Wood fencing materials should be trimmed back so as not to be in contact with the exterior wall surfaces.

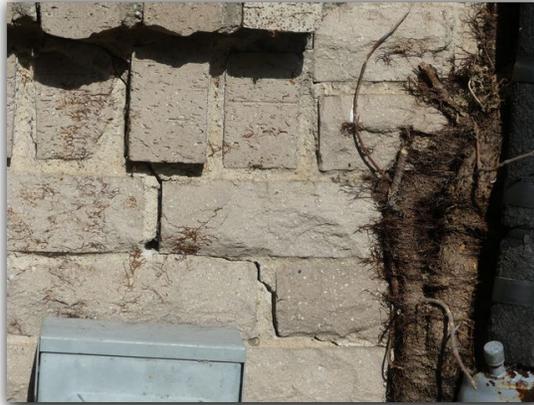
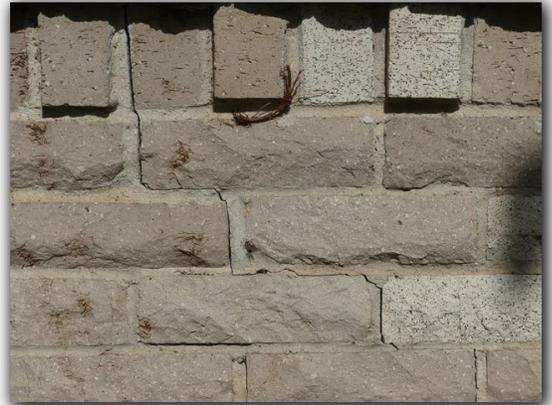
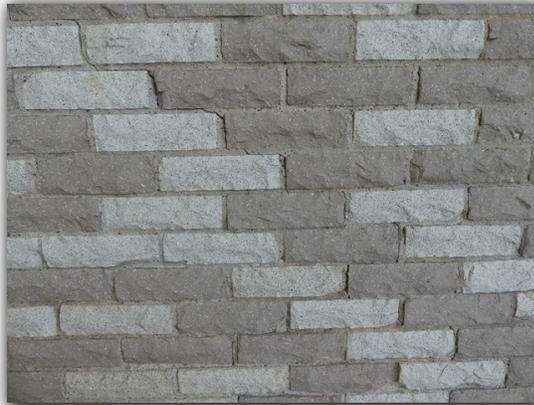
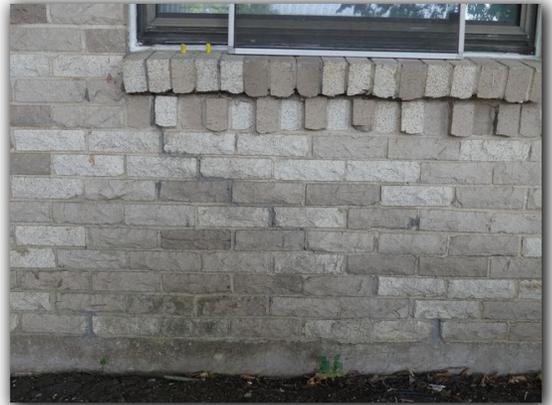
Several cracks in the exterior brick/stone veneer masonry walls were observed. These cracks in the exterior brick/stone veneer wall cladding were indications that movement or settlement has occurred. The inspector recommends that cracks in exterior walls be repaired and closely monitored. If concerns about the current or future foundation performance exist, the inspector recommends further evaluation by a certified, licensed foundation specialist.

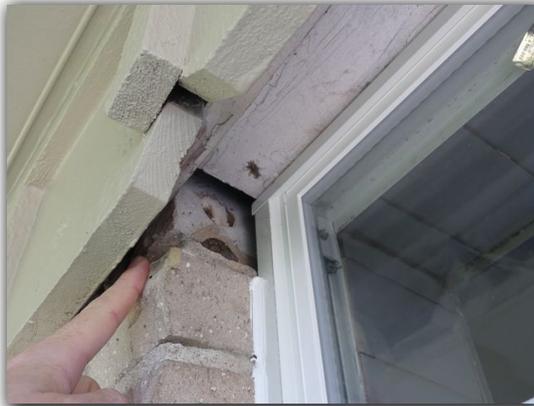
Mortar is damaged, separated or missing in one or more areas. Missing, separated or damaged exterior masonry mortar may allow moisture penetration and should be repaired.

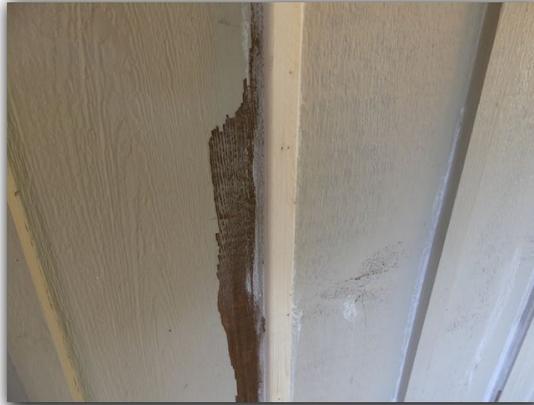
Peeling, damaged or deteriorating paint, stain and/or sealant was observed at the exterior wall cladding. Peeling, damaged and deteriorating paint or sealant should be repaired to prevent moisture penetration and deterioration of materials.

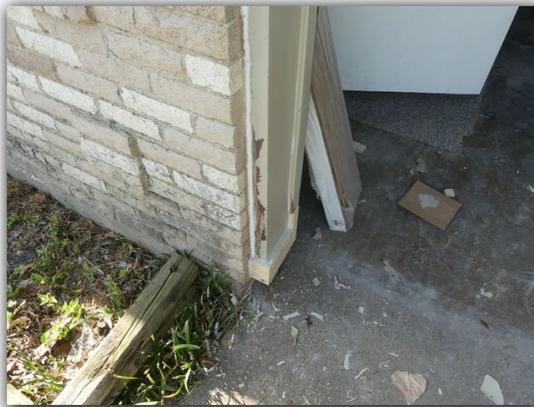
Peeling, damaged or deteriorating paint, stain and/or sealant was observed at the exterior trim. Peeling, damaged and deteriorating paint or sealant should be repaired to prevent moisture penetration and deterioration of materials.

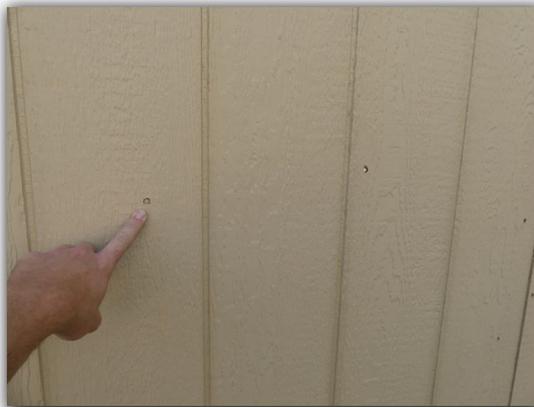
Some siding fasteners were observed to be not painted. Unpainted siding fasteners should be repaired.

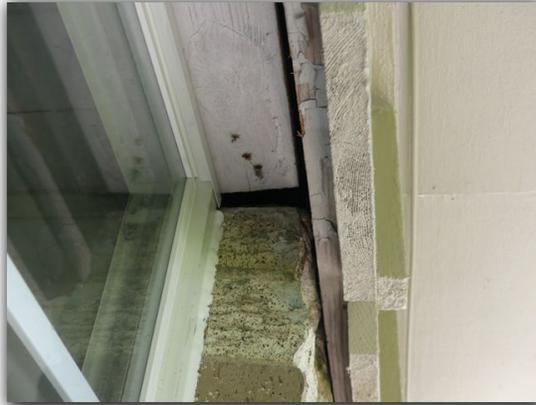
Exterior sealants (caulking) were deteriorated or missing in some areas. Sealants applied in appropriate locations prevents moisture intrusion and insect penetration.

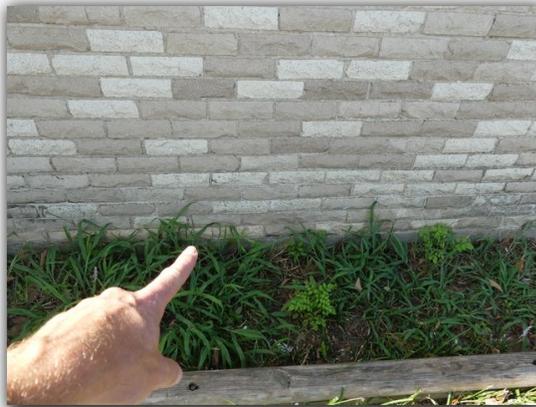
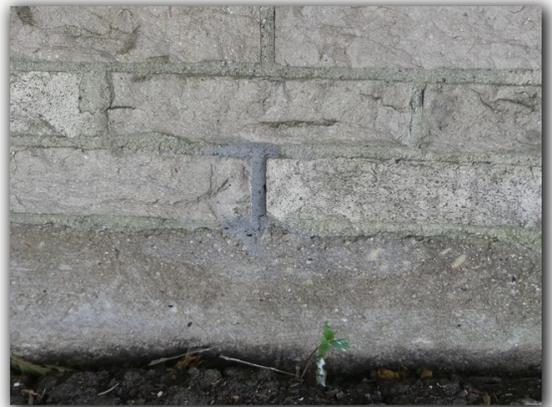
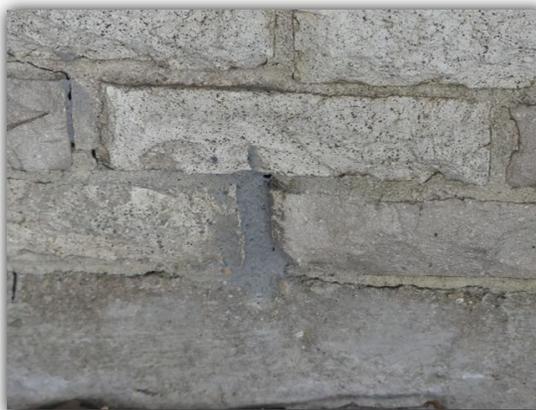
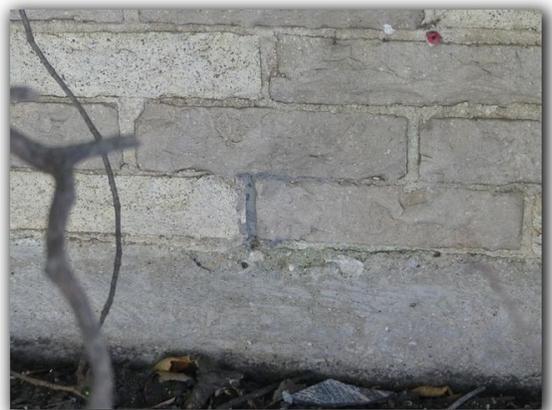
Weep holes were not open, were missing and/or were improper spaced at the lower brick/stone of the exterior walls. Weep holes should be installed and properly spaced to provide proper wall ventilation.

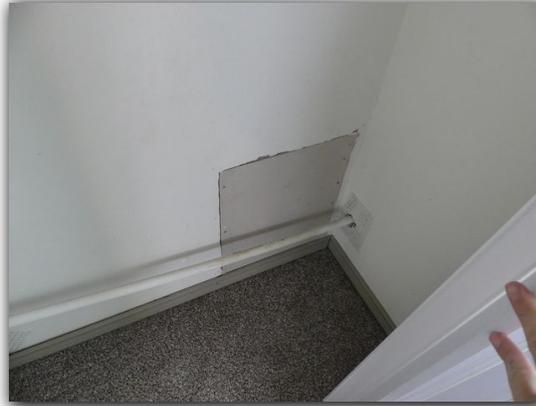
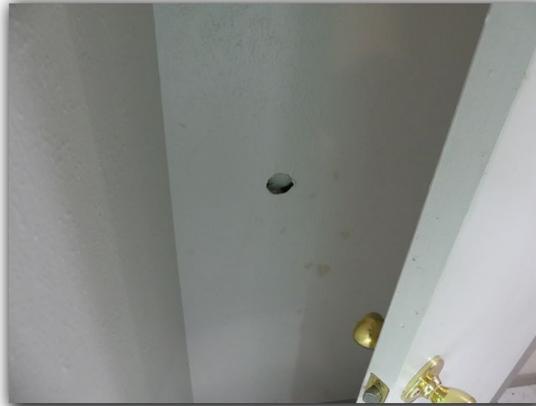
Cosmetic damages to interior wall coverings, drywall, texture and paint were observed to be in need of repair.

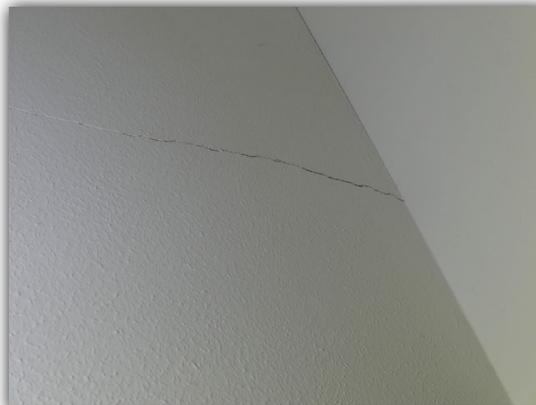
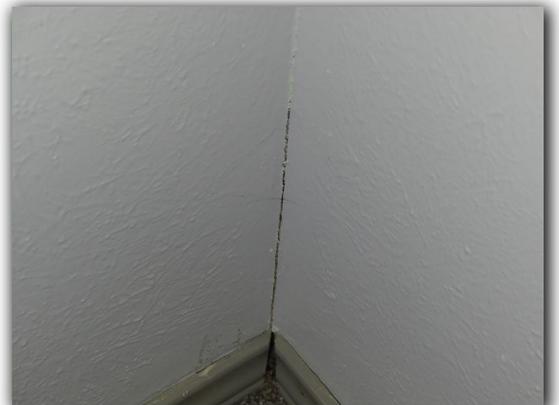
Multiple interior wall cracks were observed and were an indication of structural settling, movement or other defects. The cause of any interior drywall, texture and paint wall cracks should be determined and repaired as needed and monitored over time for additional movement. Further evaluation of the foundation and structure by a certified, licensed foundation and structural specialist is recommended.

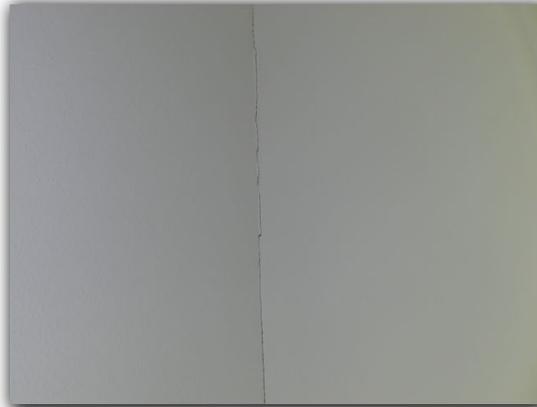
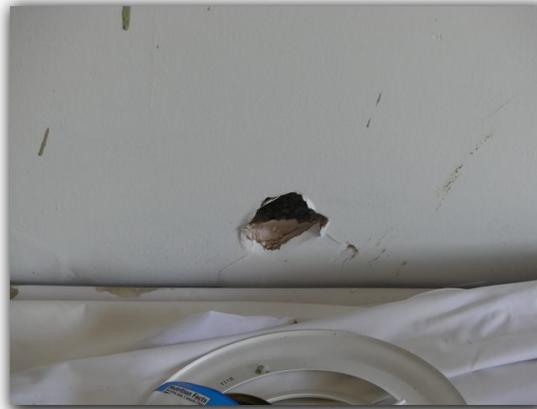
Damaged or unfinished drywall was observed in the garage. Penetrations in ceiling or wall drywall between vehicle storage areas and living spaces are considered a SAFETY HAZARD and should be repaired.

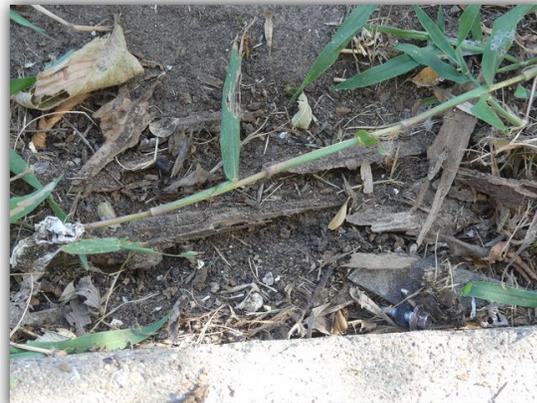
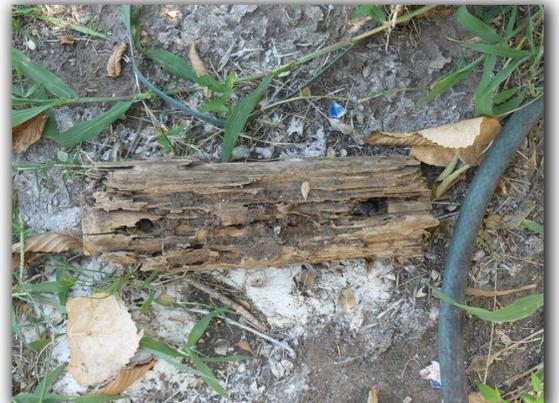
Indications of **wood destroying insect damage or activity** was observed. There may be more damage than what was visible at the time if the inspection. Further evaluation is recommended.

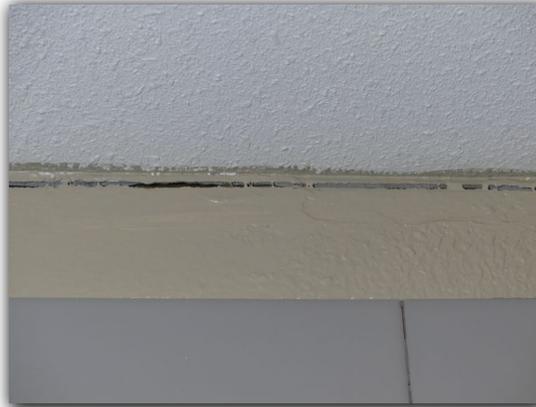
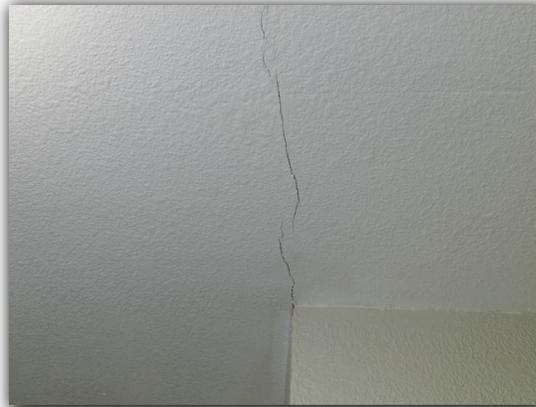
Multiple interior ceiling cracks were observed which is an indication of structural settling, movement or other defects. The cause of any interior ceiling drywall, texture and paint wall cracks should be determined and repaired as needed. Further evaluation of the foundation and structure by a certified, licensed foundation and structural specialist is recommended prior to closing.

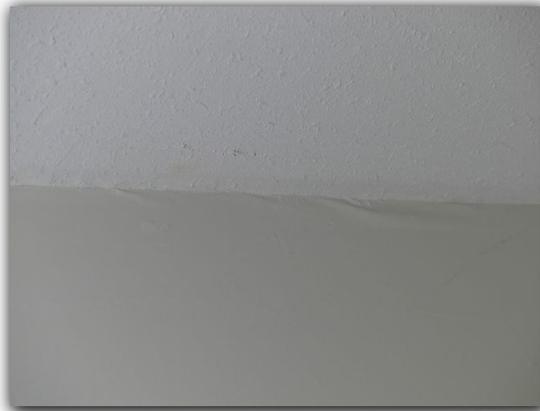
The ceiling drywall corner tape was observed to be pulling and twisting where walls and ceilings intersect. This condition is related to adverse foundation or structural performance and should be further evaluated by a certified, licensed foundation or structural specialist and repaired as needed.

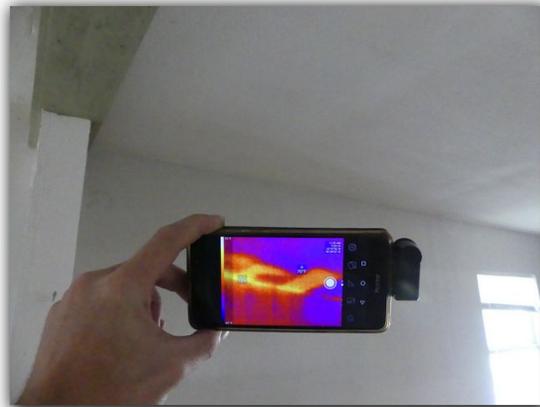
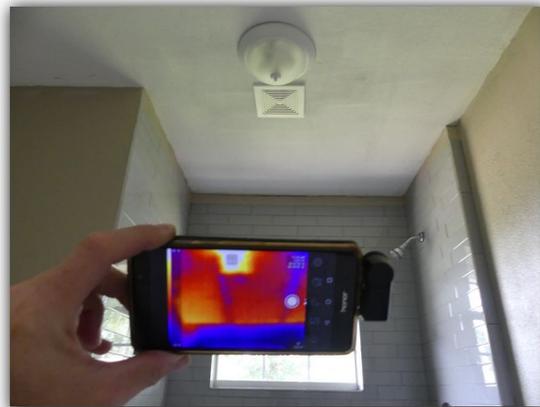
Using a thermal imaging camera, there are areas of temperature anomalies in the ceilings which may be indication of missing or damaged insulation. The reason for the temperature anomalies should be further evaluated and repaired as needed.

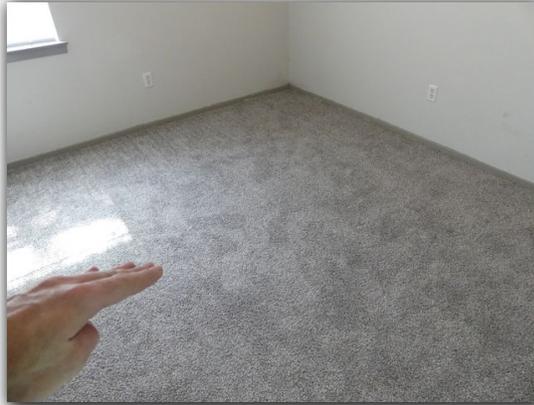
Areas of the interior floors did not appear to be level and were an indication of movement, settlement or other defects. The cause of un-level floors should be further evaluated by a structural specialist and repaired as needed.

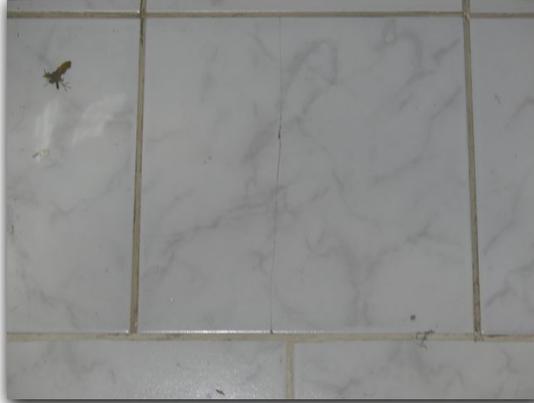
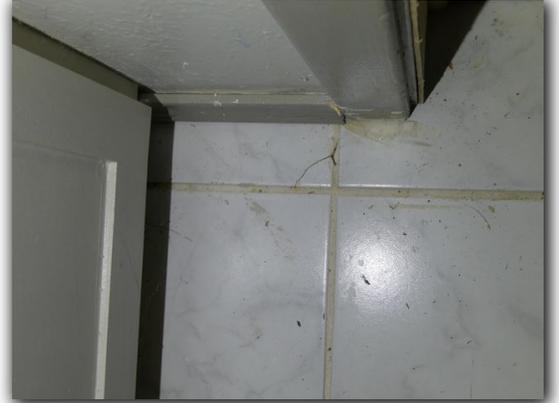
Cosmetic cracks and damaged floor tile(s) and or tile grout should be repaired.

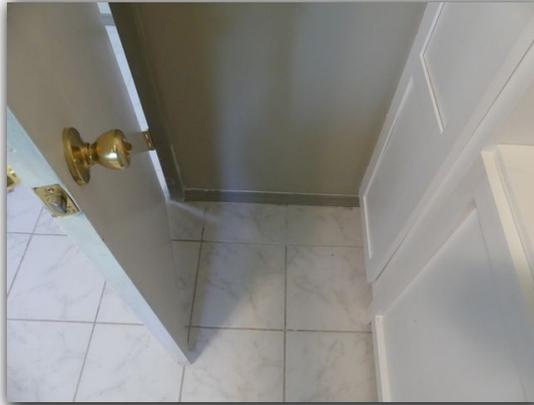
All interior doors should have door stops installed to prevent damage to adjacent interior wall coverings.

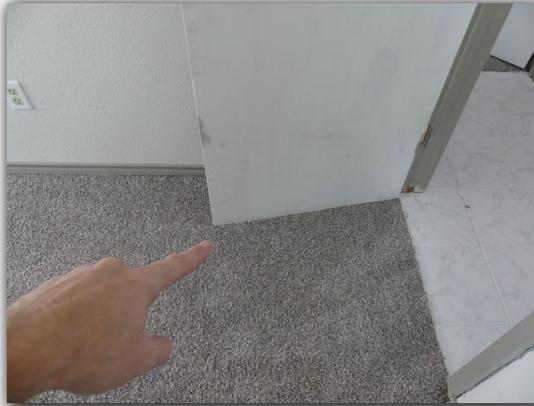
Interior doors which are in contact with the floor covering should be repaired. Door which are in contact with floor covering may damage the flooring.

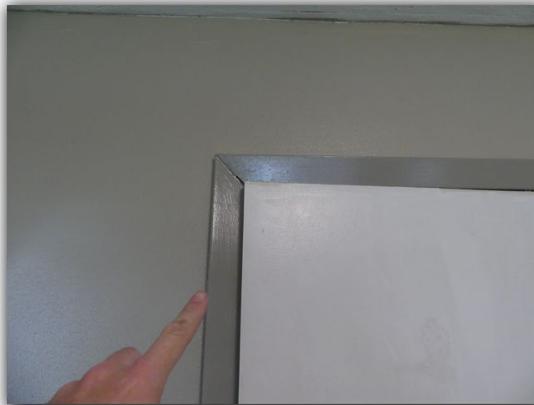
Interior doors were observed to rub, stick or hit the door frames. Interior doors, that stick or hit the door frame may be an indication of movement, settlement or other defects. The cause of doors sticking or hitting door frames should be determined and repaired as needed.

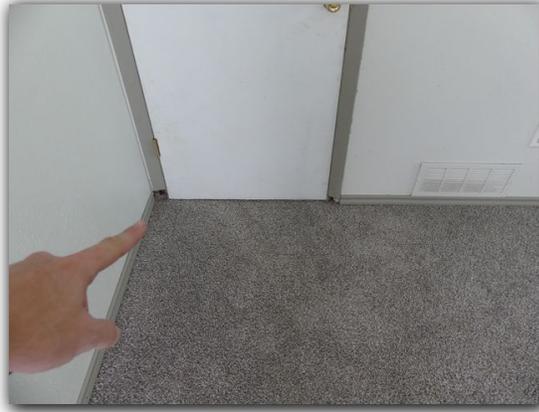
Interior doors should be cut at the bottom to allow for return HVAC air circulation..

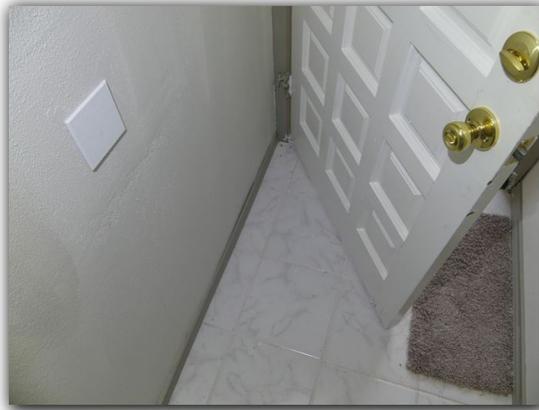
All exterior doors should have door stops installed to prevent damage to adjacent interior wall coverings.

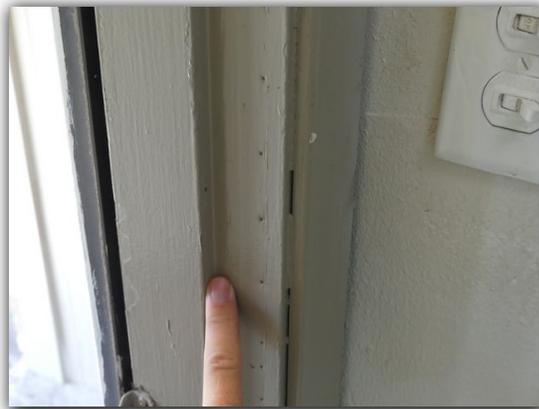
Damaged or missing exterior door weather stripping should be replaced. Missing or damage exterior door weather stripping creates conducive conditions for moisture intrusion and conditioned air loss.

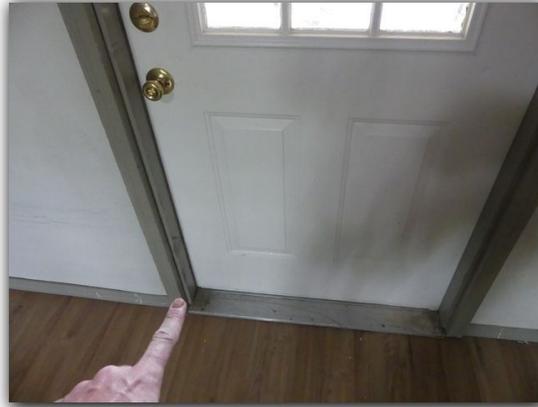
Exterior doors that rub, stick or hit door frames were observed. Exterior doors that stick, rub, hit the door frame or do not perform as intended are indications of movement, settlement or other defects. The cause of exterior doors that rub, stick or hit door frames should be determined and repaired as needed.

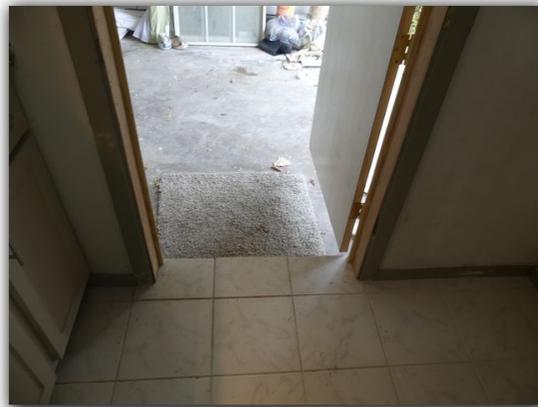
Garage entry doors should have installed self closing hinges according to today's Texas Standards of Practice - This may be an *"as-built"* condition and was an accepted building practice at the time this home was constructed. Per Texas Standards of Practice we are required to report this condition as a deficiency because it is no longer an excepted building standard.

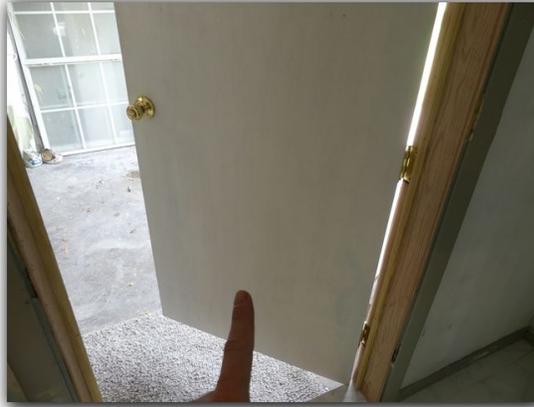
The garage entry door was observed to be a non-fire rated door. Under current building standards, the entry door between the garage and the living area should have a minimum of a 20-minute fire block rating for improved FIRE SAFETY. Lack of a fire rated garage entry door is a SAFETY HAZARD.

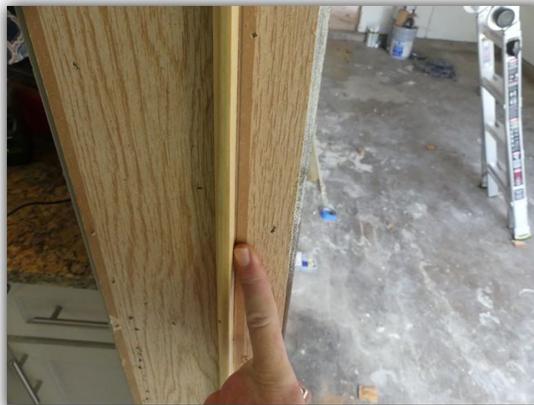
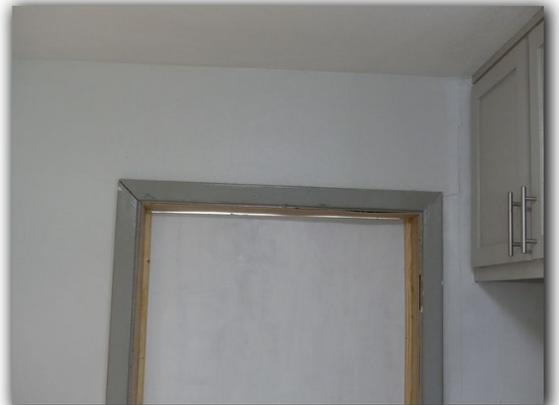
The garage entry door was observed to have damaged weather stripping. Under current building standards, the entry door between the garage and the residence should be well sealed to prevent vehicle storage area fumes from penetrating the structure. Lack of an airtight garage entry door is a SAFETY HAZARD.

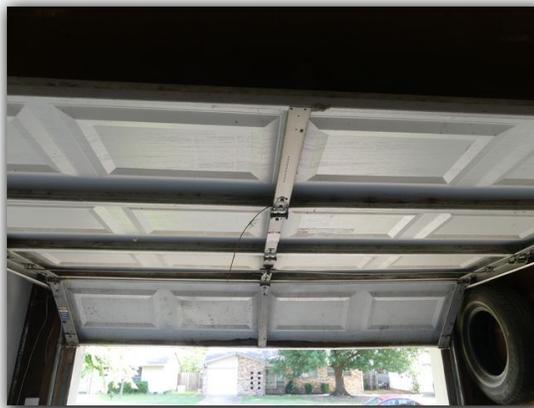
The overhead garage door appeared to lack a lift handle. Garage overhead doors should have installed at least one interior lift handle in accordance with manufacturer's instructions.

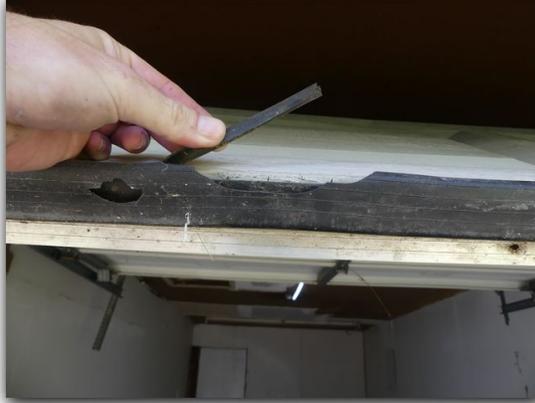
- Damaged or missing garage door weather stripping should be replaced.

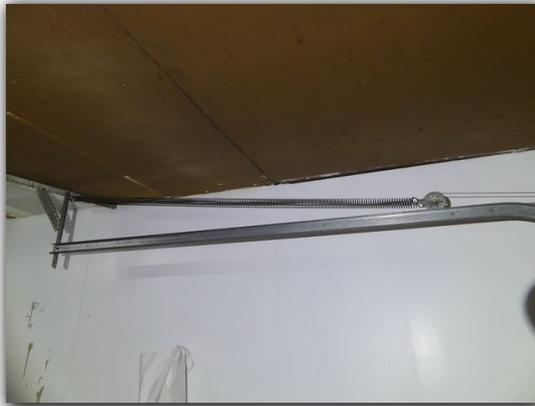
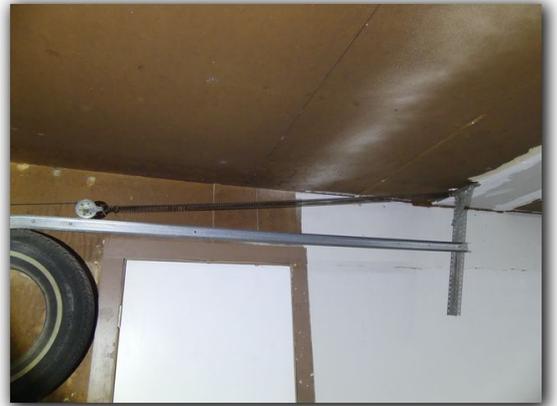
- Older style garage door locks, hinges, springs or side ropes that have not been made safe or disabled are a SAFETY HAZARD and should be replaced prior to closing.

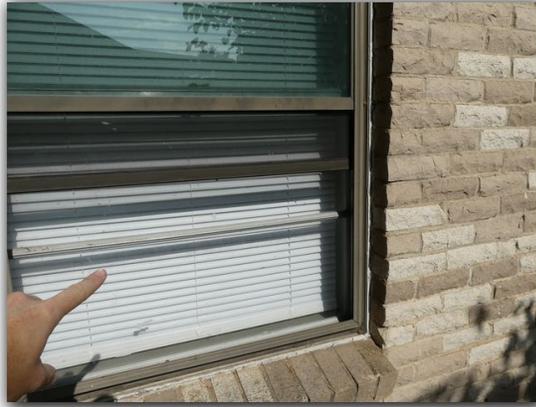
The windows need sealant between the window frames and exterior wall cladding. Lack of, damaged or deteriorating sealant around window frames may allow moisture and insect penetration and should be repaired as needed.

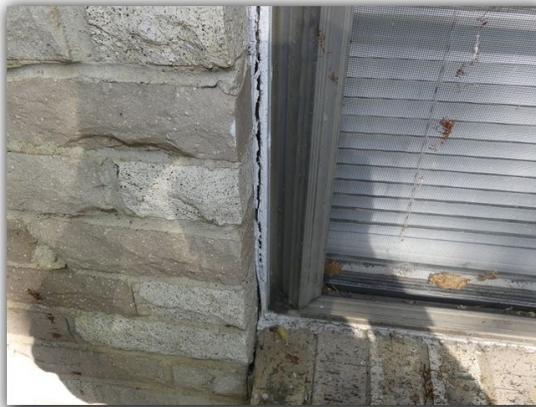
The window weather-stripping was observed to be damaged. Damaged or missing weather stripping around windows may allow moisture penetration, conditioned air loss and insect penetration and should be repaired.

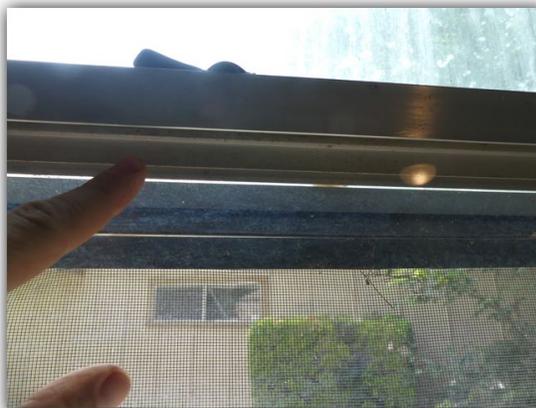
Damaged, missing or inoperative window lock(s) were observed. Damaged, missing or

inoperative window locks are a SAFETY HAZARD and should be repaired prior to occupancy.

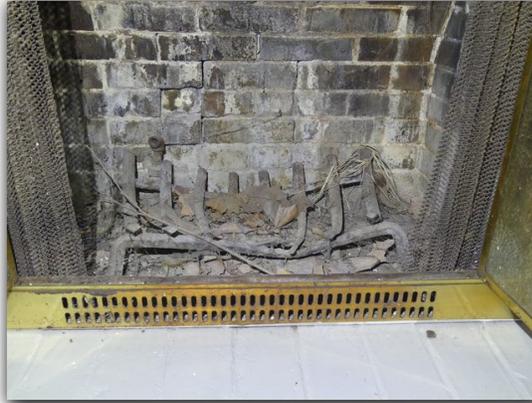
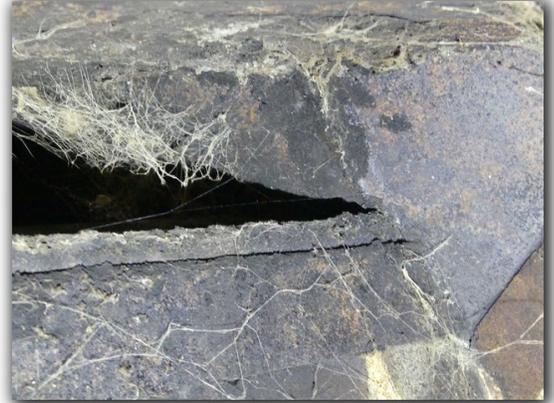
The fireplace and chimney flue needs to be cleaned by a qualified chimney sweep. A creosote or soot build-up was observed in the visible areas and was a SAFETY HAZARD at the time of the

inspection. A creosote or soot build-up may be flammable and should be corrected prior to fireplace use.

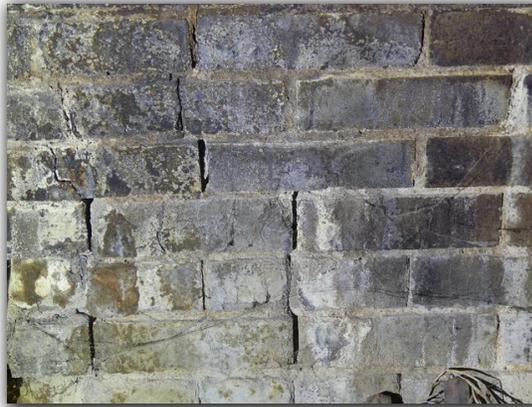
The fireplace firebox brick and or brick mortar have been damaged. Damaged firebox brick or mortar may allow heat to transfer to flammable materials and is a SAFETY HAZARD that should be repaired by a qualified fireplace specialist.

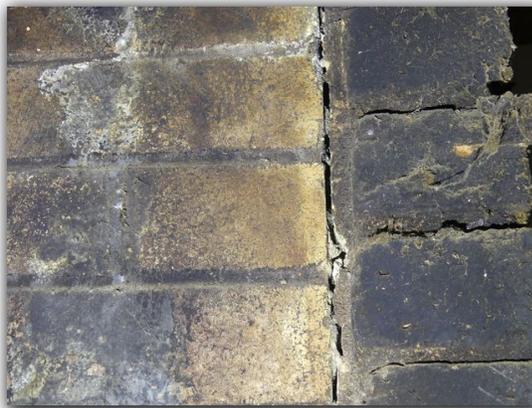
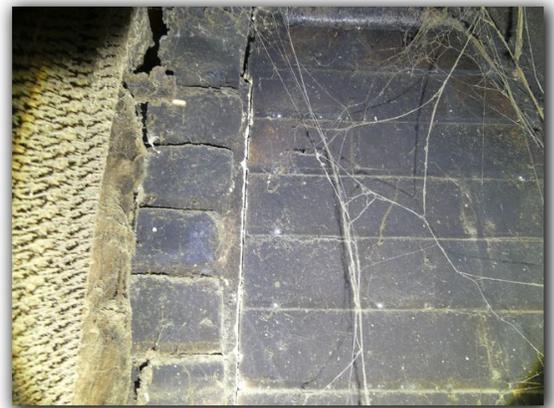
The fireplace firebox brick/mortar was not sealed at the hearth or lintel and was a SAFETY HAZARD. Inadequate fireplace seals may allow heat to transfer to flammable materials and is a SAFETY HAZARD that should be repaired by a qualified fireplace specialist.

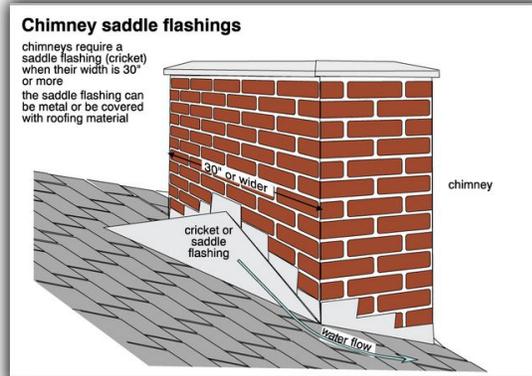
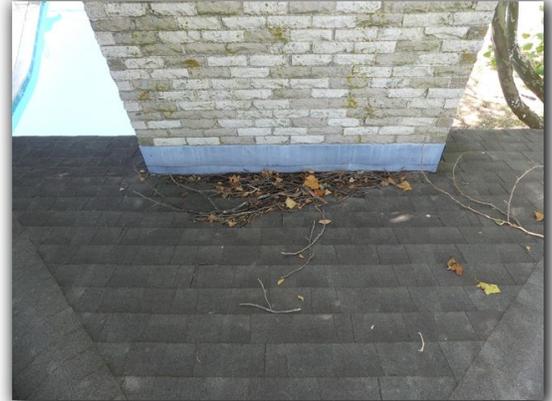
There is no cricket or saddle in place behind the roof level chimney structure. Under current building standards, there should be a cricket or saddle installed behind the ridge side of any chimney greater than 30-inches wide. You are encouraged to have your Insurance Company and/or certified, licensed roofing contractor to physically inspect the roof, prior to closing, to fully evaluate the insurability and condition of the roofing material.

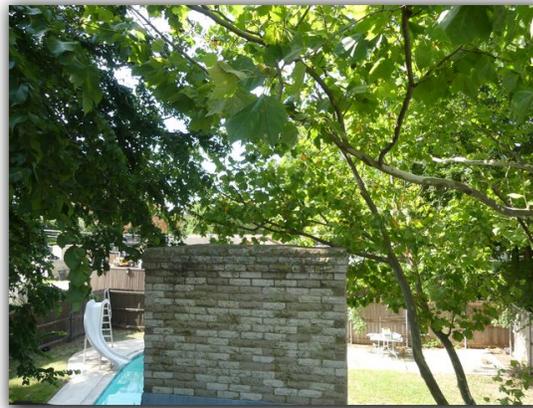
The tree branches within 10' of the chimney were observed to be a SAFETY HAZARD and should be removed. Flammable materials such as tree limbs should not be within 10' of the chimney for reasons of safety.

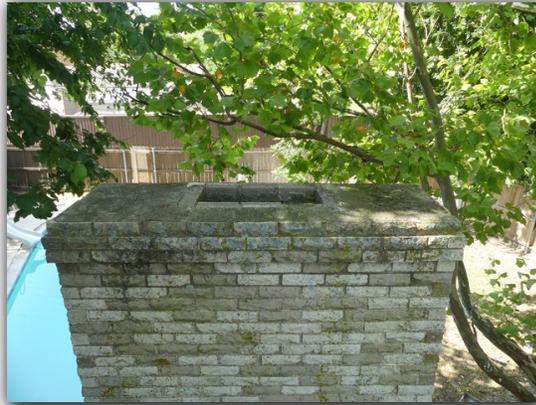
A damaged or missing chimney spark arrester was observed to be a SAFETY HAZARD and should be repaired or replaced by a qualified chimney specialist.
