Fouries Home Inspection

COMPLETE HOME INSPECTION
Prepared Exclusively For: Buyer Name

Any Street, Mesquite, TX, 75150

By: Paul Fourie, Lic #22325 07/22/2019
(Name and License Number of Inspector) (Date)

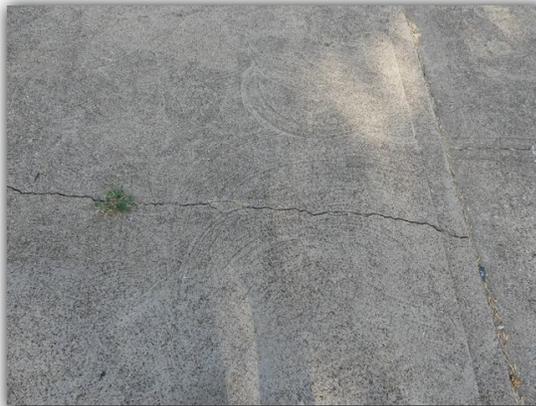
Cracks and/or deficiencies were observed in the poured concrete such as sidewalks, driveways, garage floors, porches and or patios. Cracks in poured concrete may be an indication of material defects, lack of maintenance, movement or settlement. Cracks and other defects in poured concrete should be repaired and monitored over time for movement, deflection and deterioration.

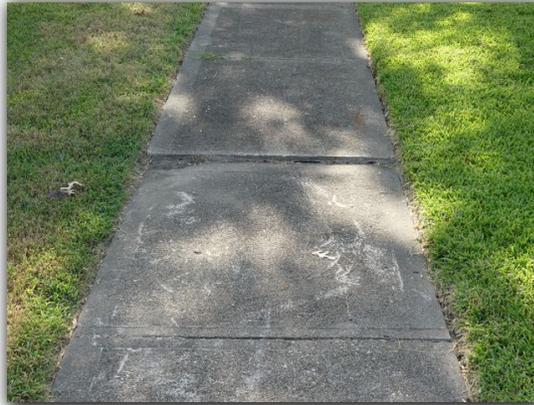
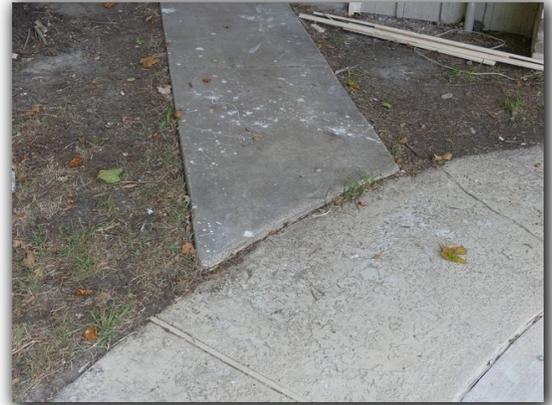
Differential movement of the flatwork such as garage floors, driveways, walkways or patios was observed. Differential movement in flatwork may be an indication of movement, settlement or other defects and should be repaired as needed.

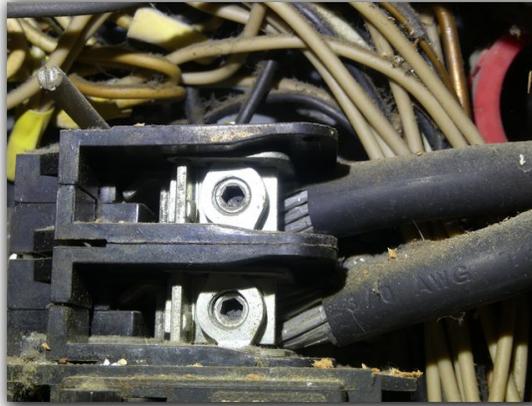
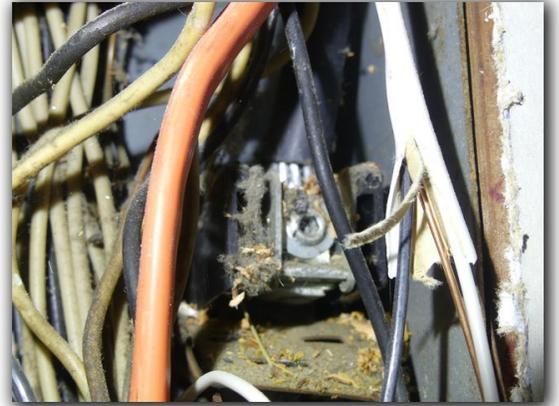
NOTE: Homes built between 1960 and 1980 may have installed aluminum electrical

conductors for branch circuits. Aluminum wiring may not be visible or accessible and may not be inspected. There may be aluminum wiring connected to electrical fixtures, switches, receptacles or other devices that are not CO/ALR rated. If there exist concerns that a home may have aluminum electrical conductors, the buyer is encouraged to have the electrical system further evaluated and repaired or replaced as needed by a certified, licensed electrical specialist.

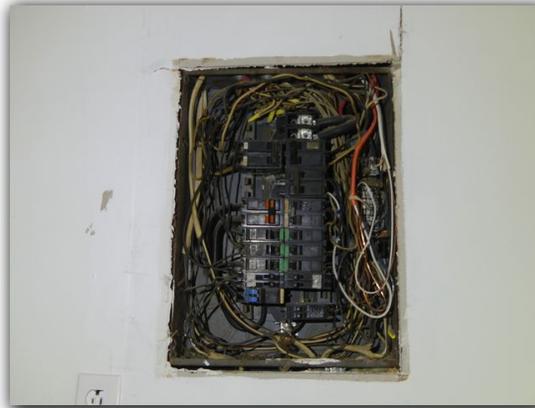
There did not appear to be a main electric disconnect within the electric service panel. Current standards require that the main disconnect be located in the electric service panel when there are six or more breaker switches. The inspector may not locate or inspect main disconnects or other electrical devices not installed within the electric service panel. If the main disconnect is not installed in the electric service panel, the buyer should have the electric service entrance, service panel and electrical system further evaluated by a certified, licensed electrical specialist.

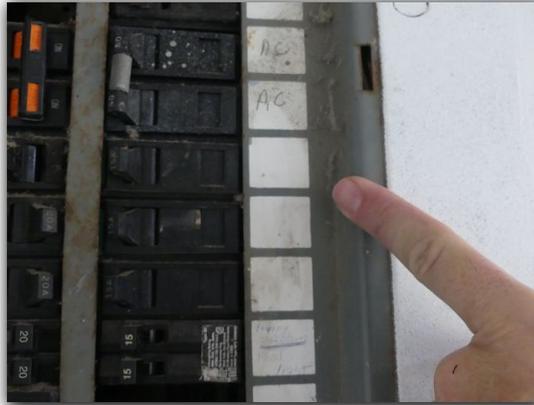
The electric service panel breaker use was not labeled. Each electric service panel breaker should be adequately labeled as to what appliance or circuit it serves.

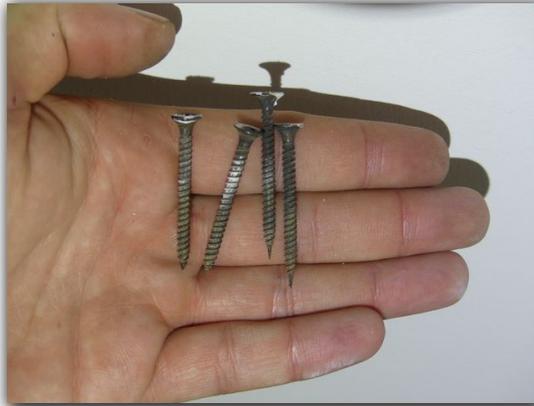
The electric service panel cabinet cover plate or dead-front screws were observed to be sharp (SAFETY HAZARD) and should be replaced with the proper screws.

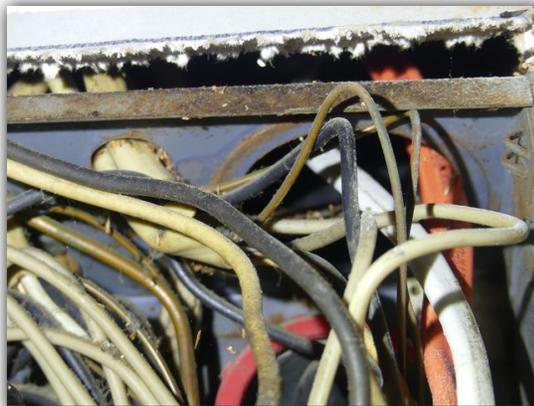
The electric service panel electrical conductors have not been properly secured or protected from the sharp edges and/or the dead front cover of the cabinet. Electrical conductors that are in contact with the service panel dead front cover and/or not protected from sharp edges are a SAFETY HAZARD and should be repaired by a qualified electrical specialist.

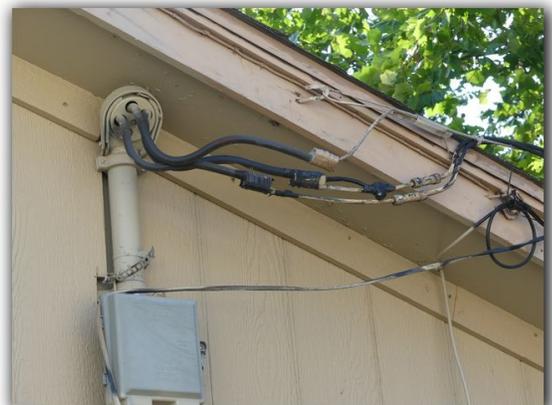
☑ The overhead service drop electrical conductors had inadequate clearance from tree branches.

This condition may result in abrasion and damage to the electrical conductors. The inspector recommends correction by a qualified contractor. Work around electric service conductors should be performed by a qualified contractor only. Injury or death may result from attempts at correction by those without proper qualifications.

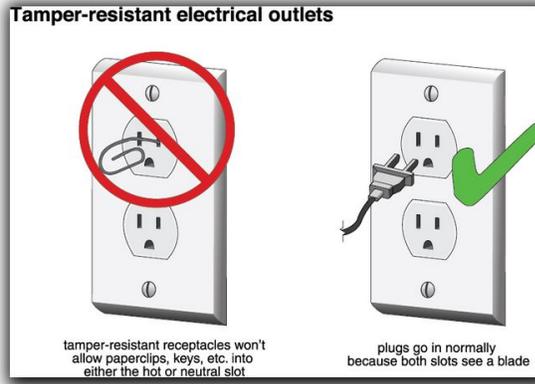
Inoperative electrical receptacles were observed. The cause of inoperative electrical receptacles should be further evaluated and repaired or replaced as needed by a certified, licensed electrical specialist.

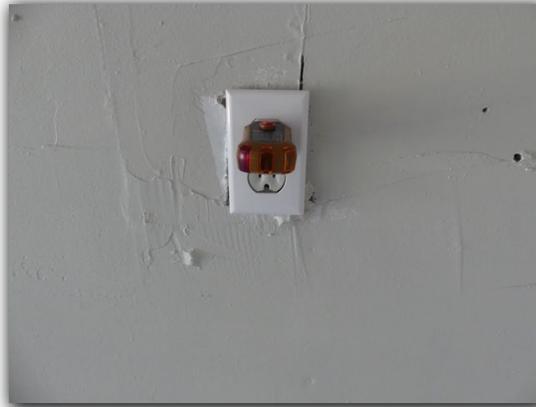
Open ground connections were observed at electrical receptacles. Open ground electrical receptacles are a SAFETY HAZARD and may cause damage to modern electric appliances. The cause of open ground electrical receptacles should be determined and repaired or replaced as needed by a certified, licensed electrical specialist.

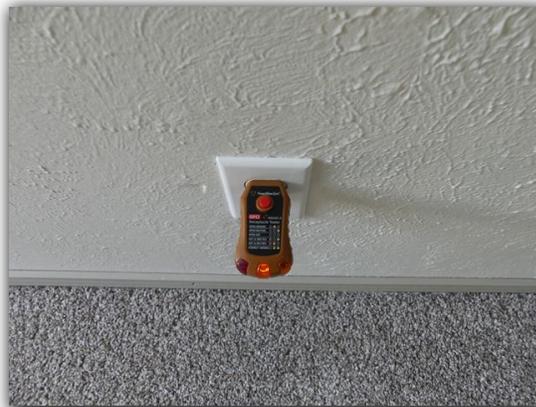
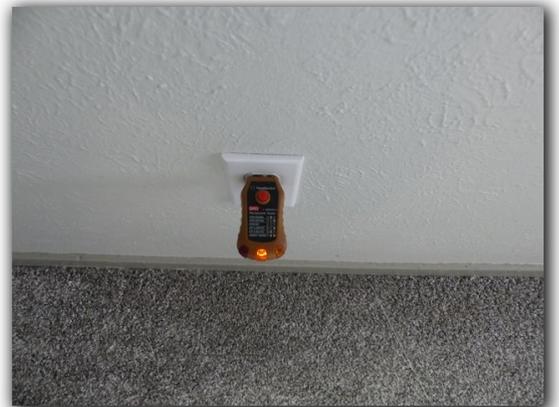
Painted electrical receptacles were observed. Painted electrical receptacles are considered

damaged and should be replaced by a certified, licensed electrical specialist for improved safety and performance.

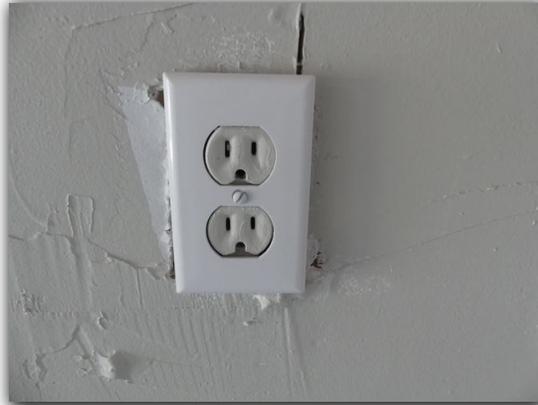
Electrical receptacles, switches and or covers were observed to be loose, damaged, missing or missing screws and were in need of repair. Damaged or missing electrical receptacles or switches should be repaired by a certified, licensed electrical specialist.

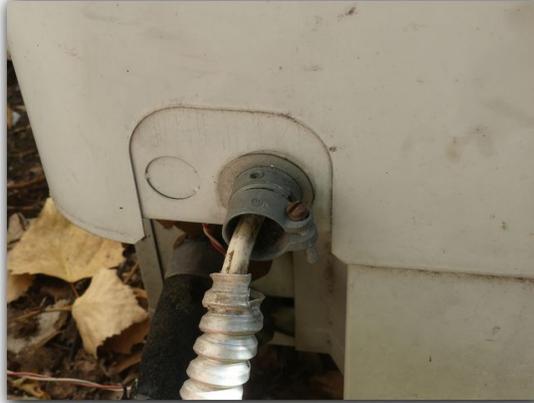
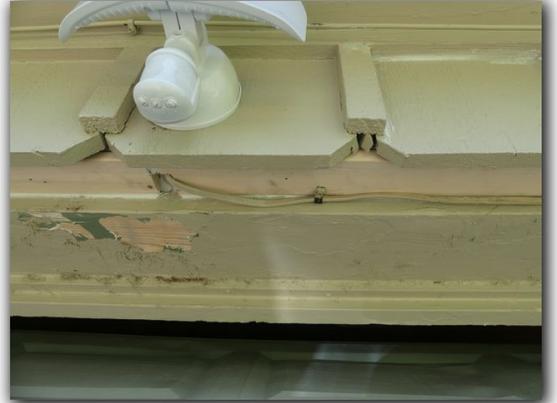
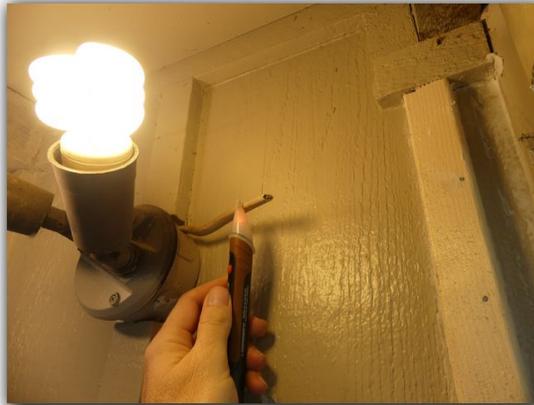
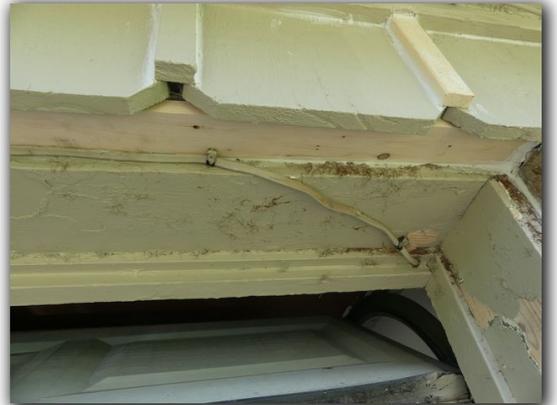
Improperly terminated electrical conductors were observed. All electrical conductor connections should be installed in sealed junction boxes for reasons of safety. Improperly terminated electrical conductors should be repaired by a certified, licensed electrical specialist.

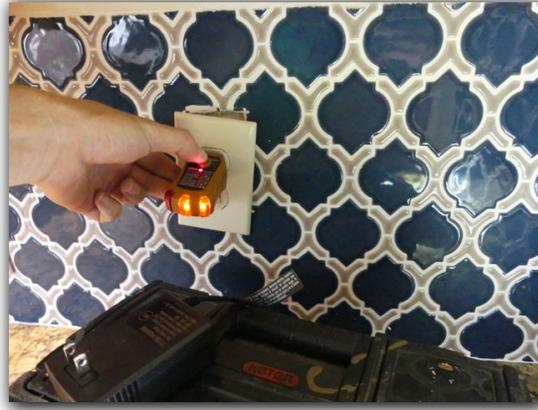
The food waste disposer electrical receptacle was observed to lack ground fault circuit interrupter (GFCI) device protection. According to the 2014 NEC electrical standards, food waste disposer electrical receptacles should be GFCI protected. Lack of GFCI protection in required locations is a SAFETY HAZARD.

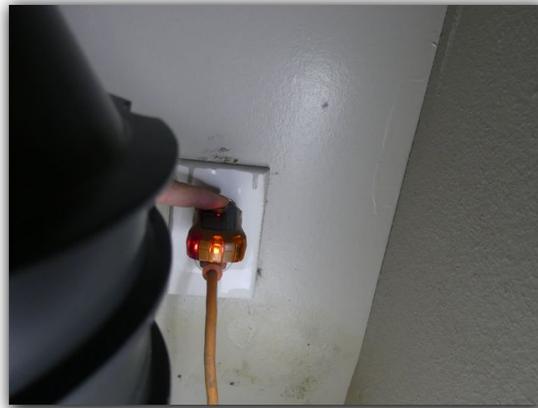
The refrigerator electrical receptacle was observed to lack ground fault circuit interrupter (GFCI) device protection. According to the 2014 NEC electrical standards, refrigerator electrical receptacles should be GFCI protected. Lack of GFCI protection in required locations is a SAFETY HAZARD.

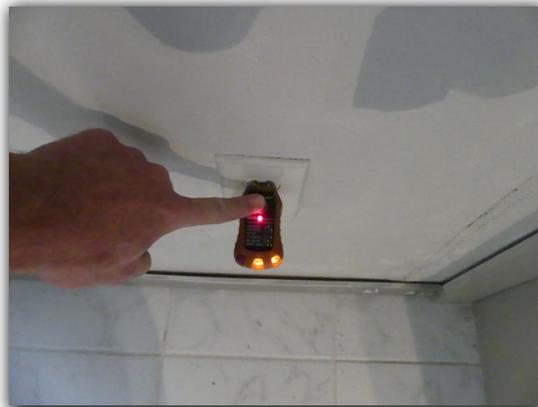
Current building standards require at least one GFCI protected electrical receptacle for every four feet of kitchen counter space. Improper spacing or the lack of GFCI protected electrical receptacles at the kitchen counters may not provide an adequate number of receptacles for modern kitchen appliances.

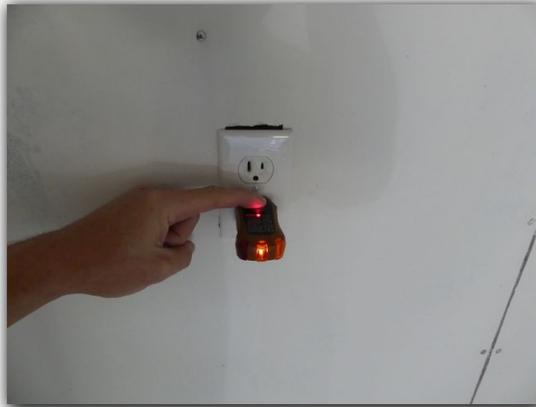
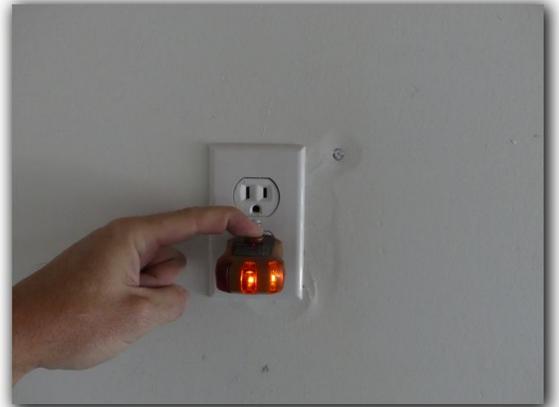
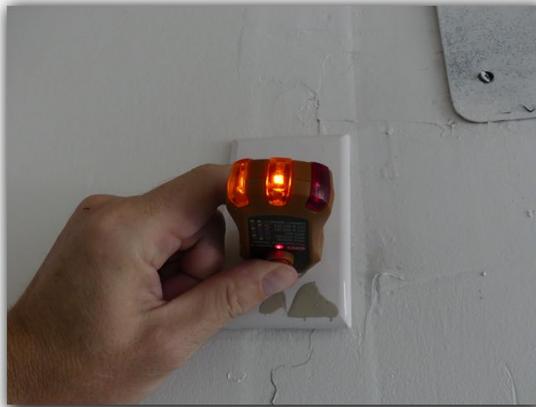
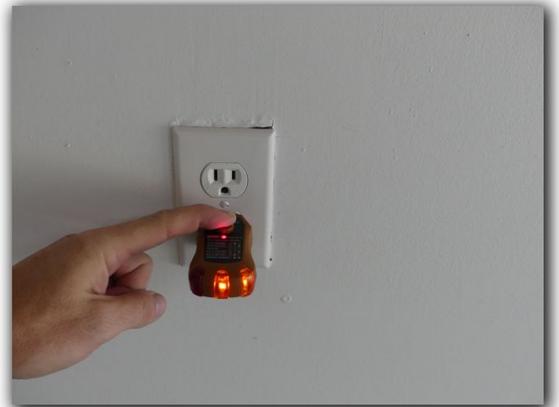
Light fixtures that are inoperative, missing bulbs or have burned out bulbs should be repaired or replaced as needed.

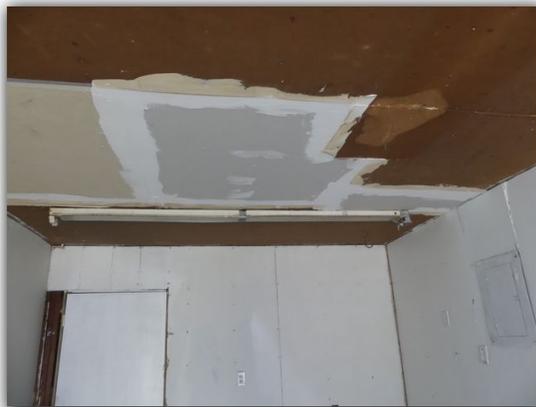
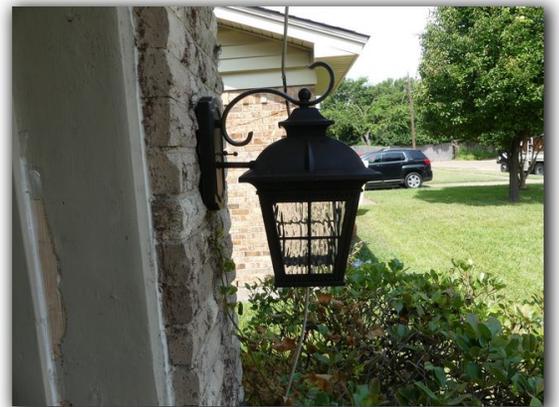
Light fixtures with missing/damaged globes or covers were observed to be in need of repair or replacement.

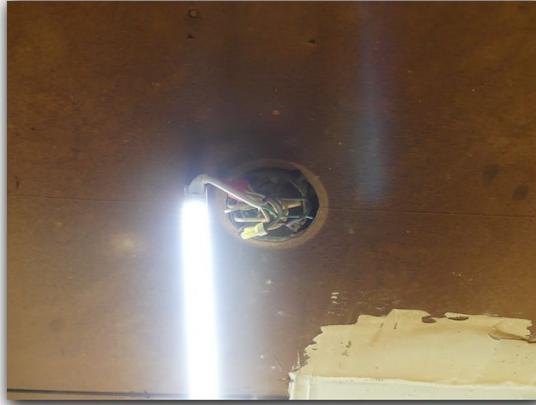
Exterior light fixtures should be sealed at the wall to prevent water intrusion for reasons of SAFETY.

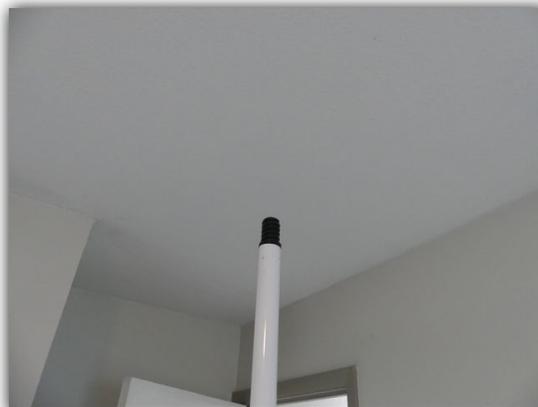
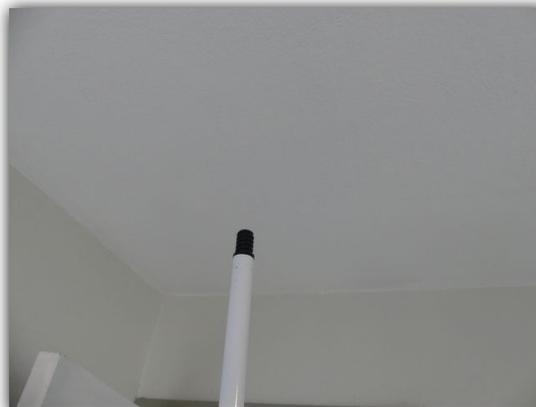
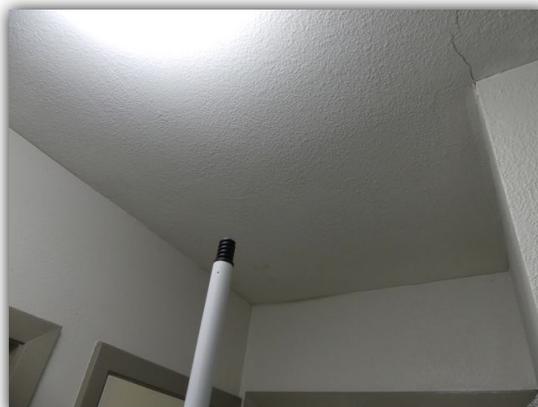
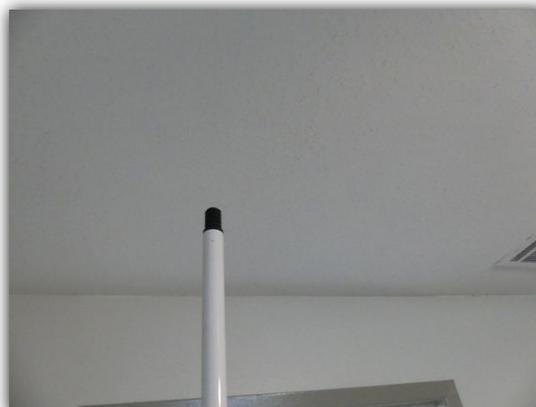
There did not appear to be enough smoke alarms located in required locations (SAFETY HAZARD). Under current building standards, there should be a smoke alarm located in each sleeping room, outside each separate sleeping area in the immediate vicinity of the sleeping rooms, and on each additional story of the dwelling, including basements but excluding crawl spaces and uninhabitable attics (in dwellings with split levels and without an intervening door between the levels, a smoke alarm installed on the upper level and the adjacent lower level shall suffice provided that the lower level is less than one full story below the upper level).

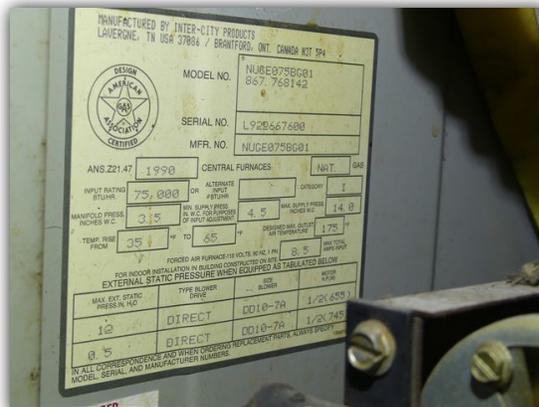
The heating equipment appeared to be older equipment and showed indications of age and wear. Future life expectancy can not be determined. You may continue to use the heating equipment until repair or replacement is needed. Repairs or improvements are needed at the heating equipment. The observations made to support this opinion are listed but not limited to the following:

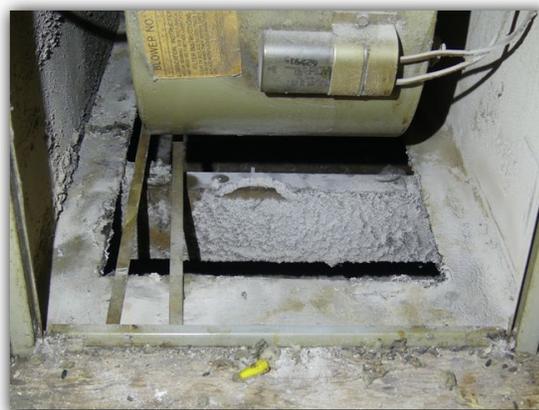
The heating equipment air filter was not installed. Missing heating equipment air filters may result in damage to the heating equipment. Heating equipment air filters should be installed and maintained per manufacturer instructions.

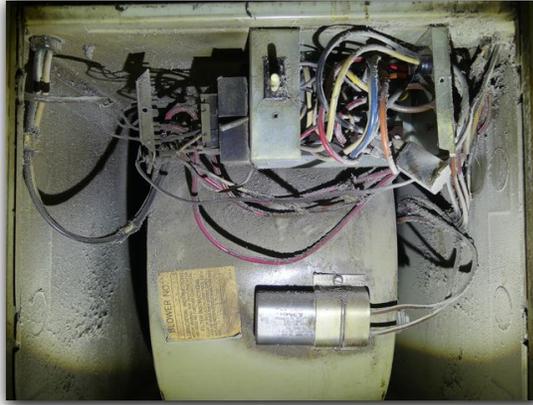
Heating equipment showed signs of being dirty and a lack of maintenance. Improperly maintained heating equipment may not perform as intended. The inspector recommends cleaning, servicing, and further evaluation of the heating equipment by a licensed professional.

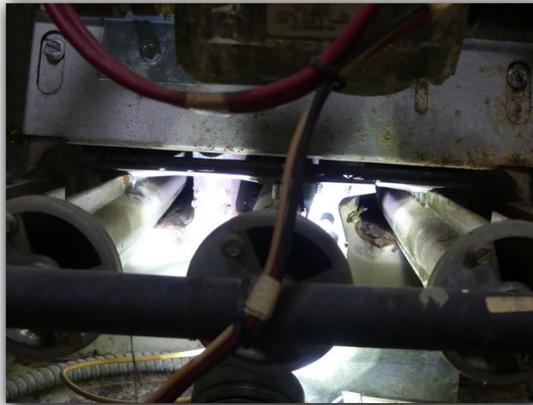
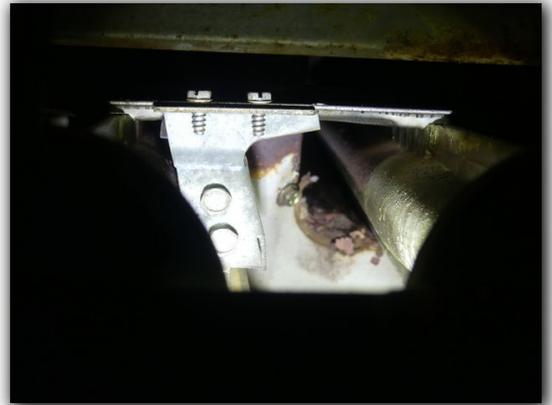
Signs of rust or corrosion were observed at the heating equipment. Rust, corrosion or discoloration may be indications of age, wear, lack of maintenance or other defects. The heating equipment should be further evaluate by a certified, licensed heating equipment specialist and repaired or replaced as needed.

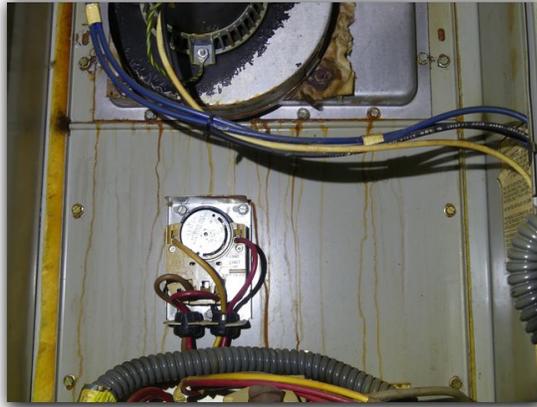
There were indications of water penetration at the heating equipment gas exhaust flu. The cause of the water staining or leakage should be determined an should be repaired as needed.

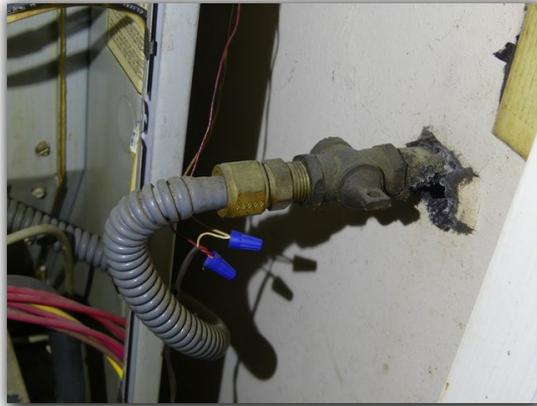
Older style gas valves require a tool to operate at the heating equipment. Under current building standards, gas valves should be operable by hand.

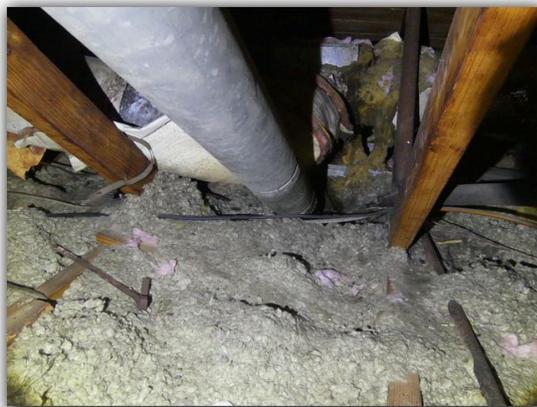
The heating equipment gas exhaust flue was observed to be too close to combustible materials and was a SAFETY HAZARD. Defects in gas exhaust flues should be repaired prior to use of the equipment.

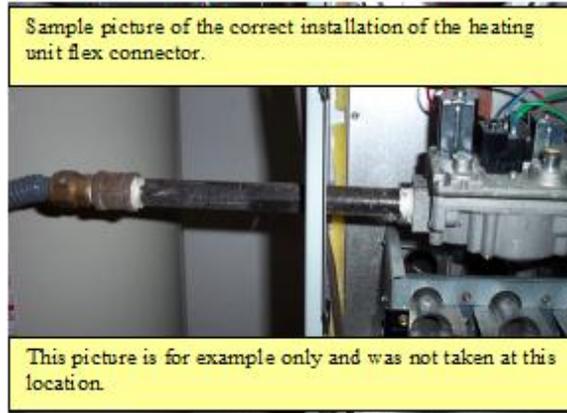
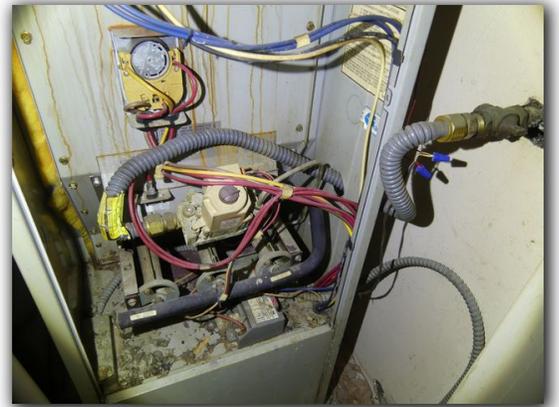
Flexible gas supply connectors at the heating equipment that pass through the heating unit cabinet wall were observed to be a SAFETY HAZARD. Current building standards require that the

black iron gas pipe pass through the heating equipment cabinet wall before being connected to flexible gas connectors for reasons of safety.

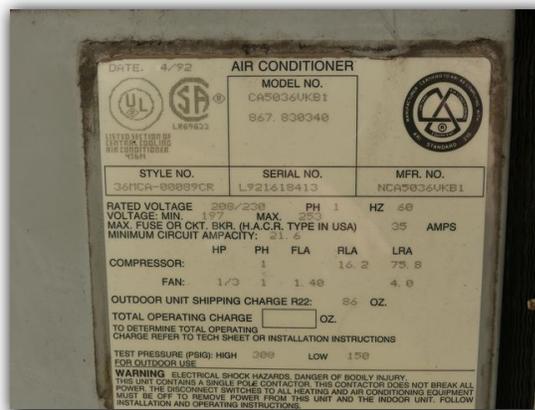
The cooling equipment appeared to be older equipment and showed indications of age and wear. Future life expectancy can not be determined. You may continue to use the cooling equipment until repair or replacement is needed. Repairs or improvements were needed at the cooling equipment. The observations made to support this opinion are listed but not limited to the following:

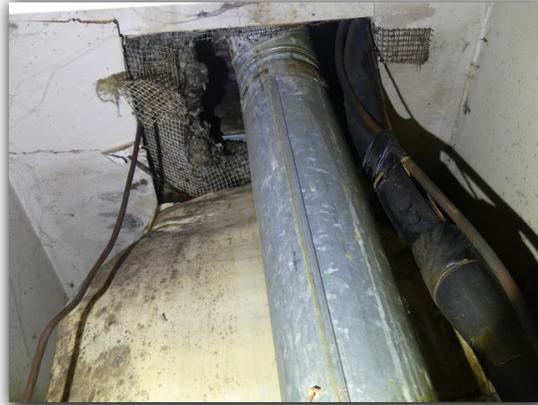
The ceiling in the cooling equipment closet was missing, damaged, improperly sealed or lacked an adequate screen. Open ceilings in cooling equipment closets may allow loss of conditioned air, reduce energy efficiency or may allow entry of unwanted wildlife. Repair is recommended.

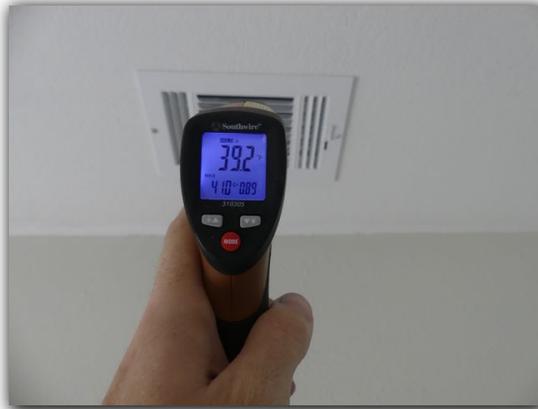
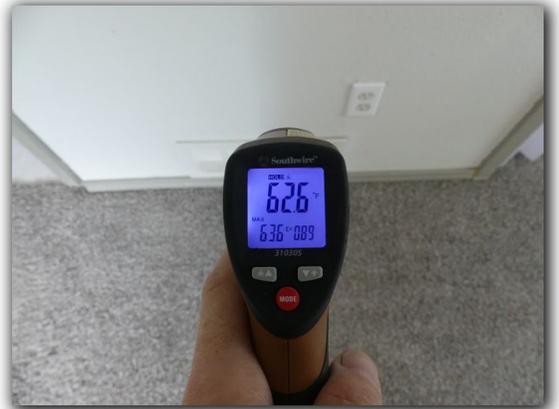
Return Air Temp: 62.6 °F

Temp. Differential: 23.4 °F

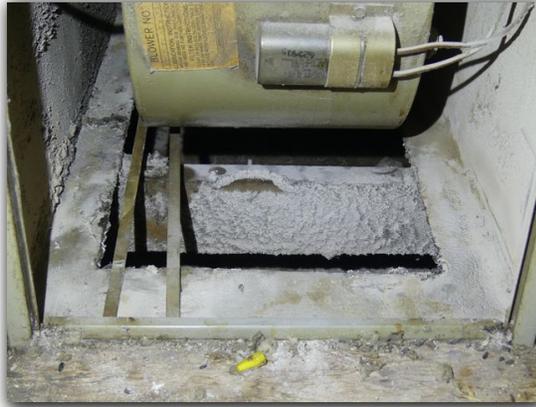
The cooling equipment air filter was not installed. Missing cooling equipment air filters may result in damage to the cooling equipment. cooling equipment air filters should be installed and maintained per manufacturer instructions.

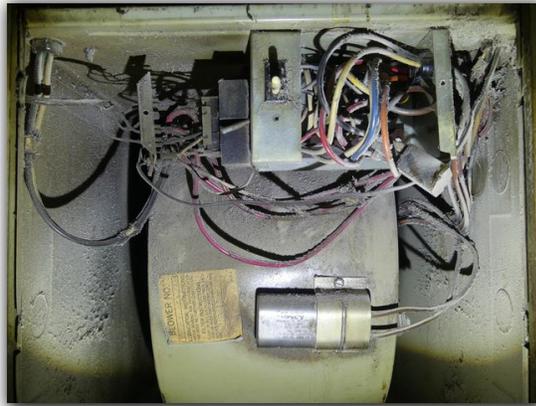
The cooling equipment showed signs of being dirty. Cleaning, servicing and / or further evaluation by a licensed professional is recommended.

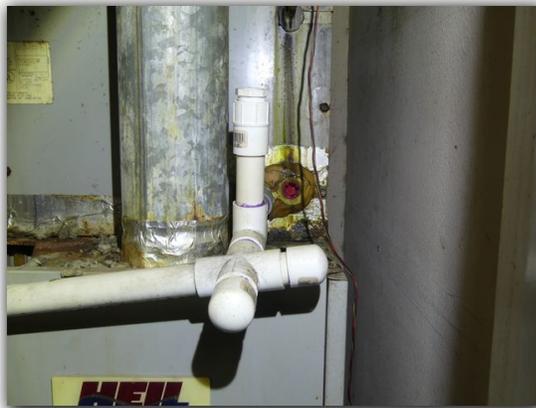
The cooling equipment secondary condensation drain was not installed and did not have a secondary drain alarm or sensor installed. Current building standards state that all cooling equipment secondary condensation drain lines should drain to an observable location or have a water sensor/alarm installed in the secondary drain port.

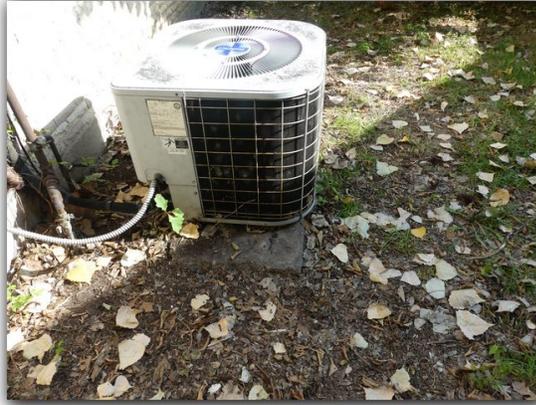
The exterior HVAC equipment support pad is too small. Inadequate exterior HVAC equipment

pads may not provide adequate support and may affect equipment performance. Inadequate exterior HVAC equipment pads should be replaced.

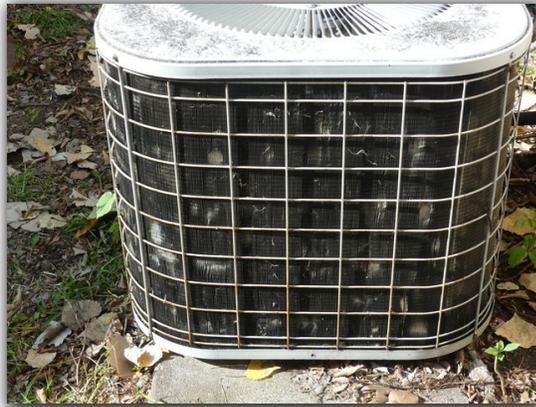
The HVAC condenser unit coil fins were damaged / dirty and in need of service, repair or replacement. Dirty or damaged HVAC equipment coil fins may result in equipment damage, inadequate performance, reduced equipment life or other defects.

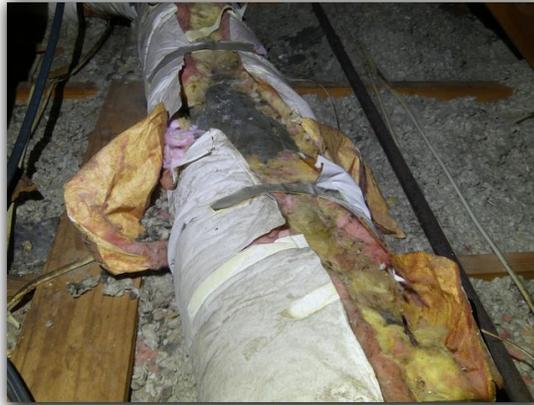
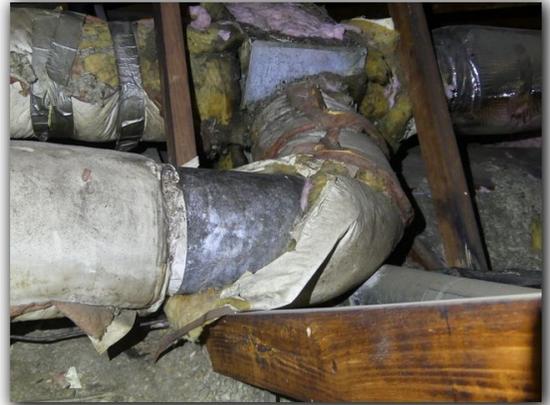
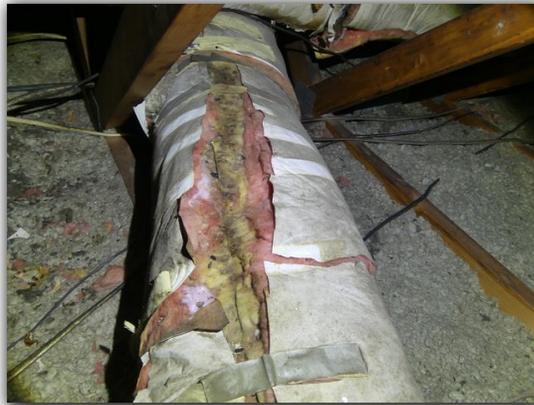
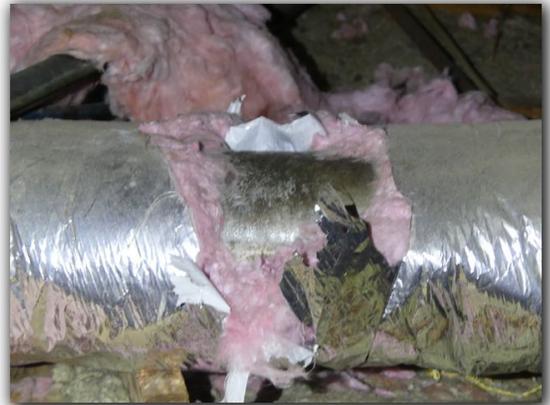
The HVAC ductwork insulation was observed to be damaged. Damaged HVAC ductwork insulation may allow conditioned air to escape into unwanted areas. Damaged HVAC ductwork insulation may create conducive conditions for condensation or other moisture intrusion defects.

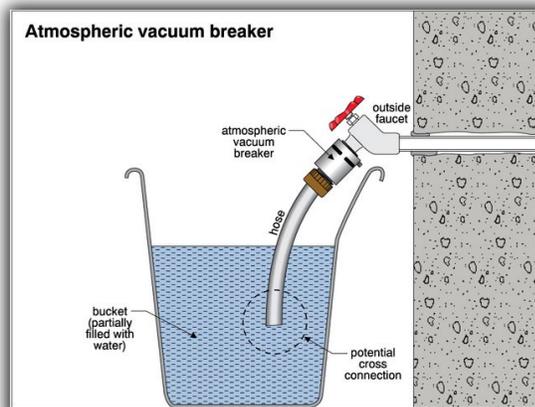
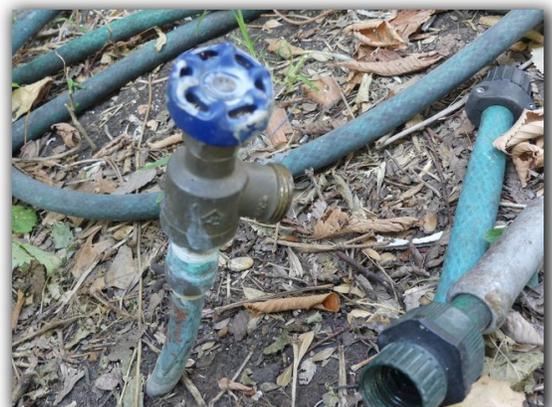
Exterior water supply faucets were missing an anti-siphon device to prevent contaminants from entering the water supply. Lack of anti-siphon devices at exterior water supply faucets is a **SAFETY HAZARD**. Current building standards require non-removable vacuum breakers on all hose faucets.

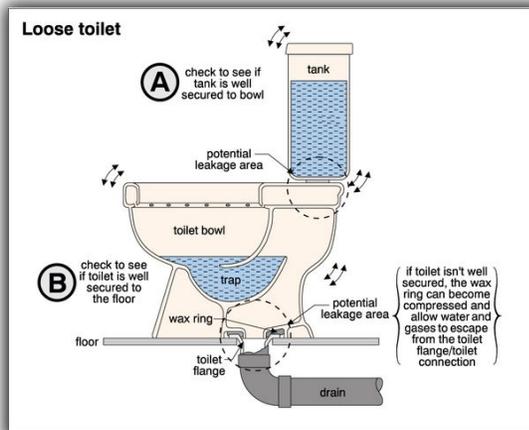
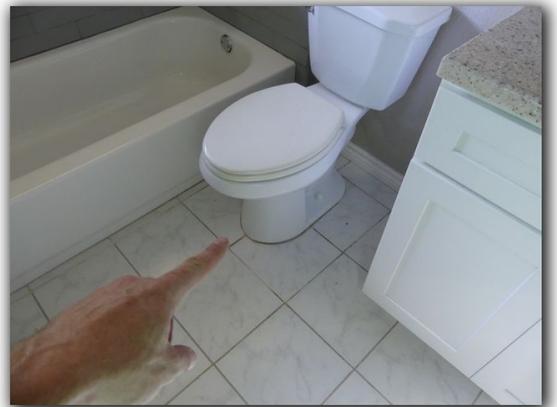
- Toilets that are loose from the floor mountings should be reset.

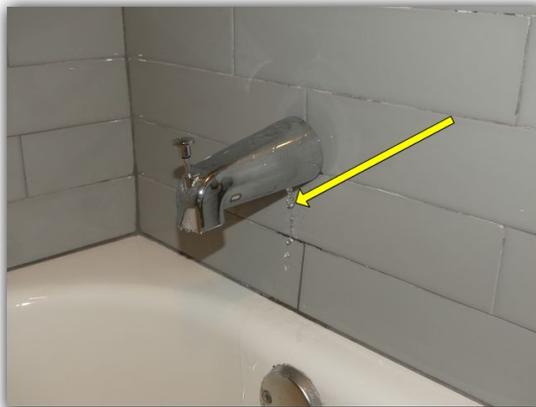
- Leaking tub/shower water supply fixtures should be repaired or replaced.

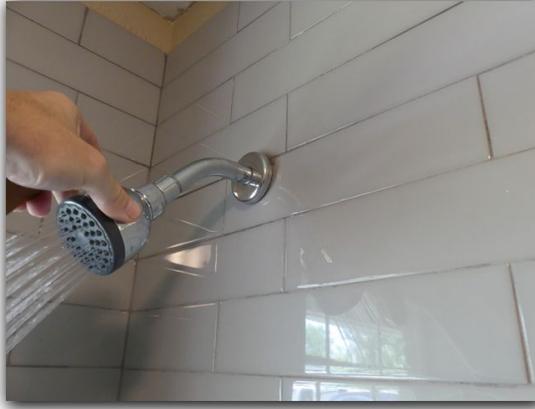
- The shower water supply plumbing was observed to be loose in the wall.

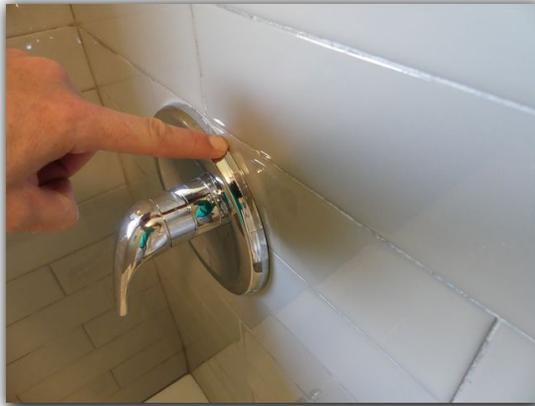
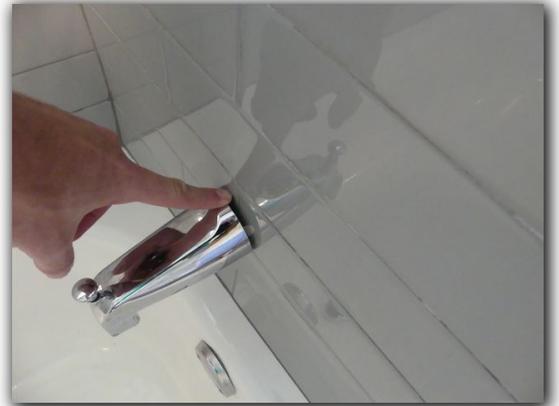
- The tub/shower water supply fixtures lacked adequate sealant at the wall. Tub/shower water supply fixtures should be properly sealed at the wall to prevent water damage.

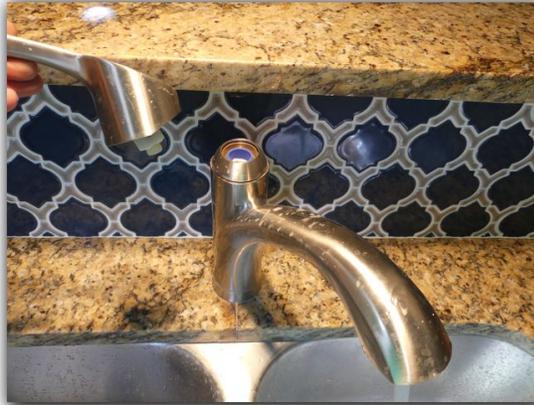
- Damaged kitchen sink water supply fixtures should be repaired or replaced to prevent water leaks and water damage.

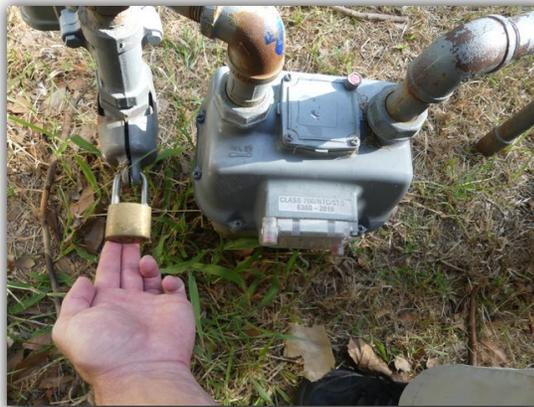
Older style gas valves require a tool to operate. Under current building standards, gas valves should be operable by hand for reasons of safety.

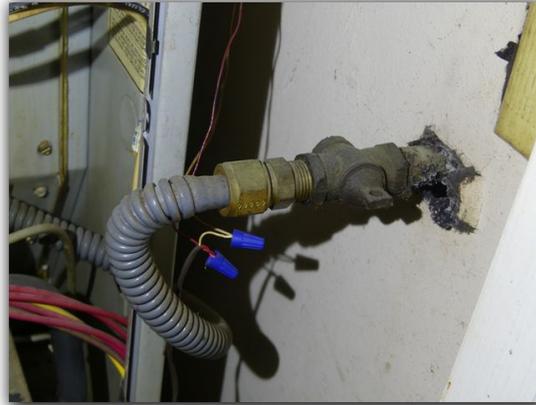
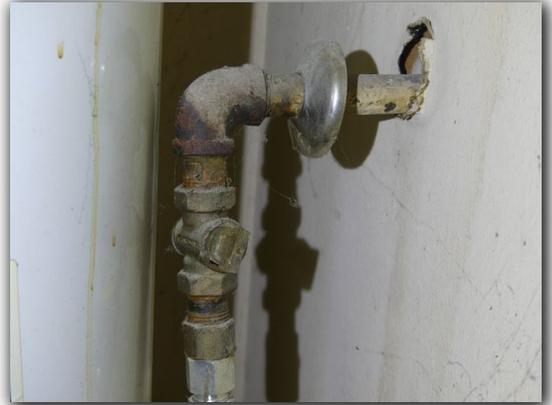
The gas supply flex connector at the heating equipment was observed to be passing through the heating equipment cabinet. Only rigid black gas pipe is allowed to pass through the heating equipment cabinet (appliance wall) (SAFETY HAZARD).

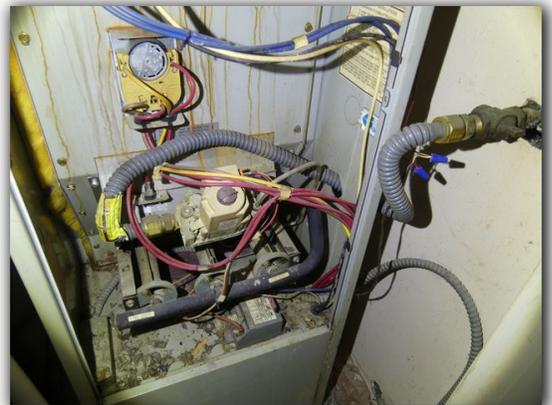
There were gas fired appliances that did not have a "drip leg" installed. Under current construction standards, drip legs are required at the black iron gas pipe prior to a flexible gas line connection.

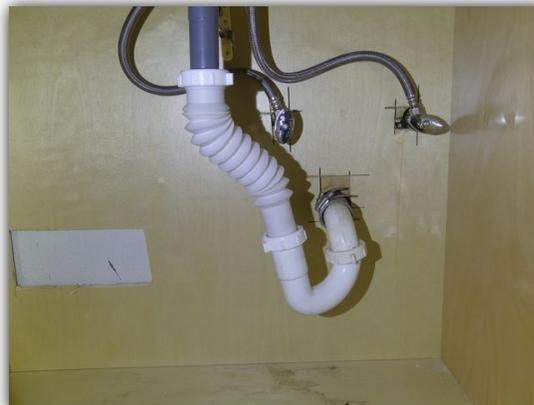
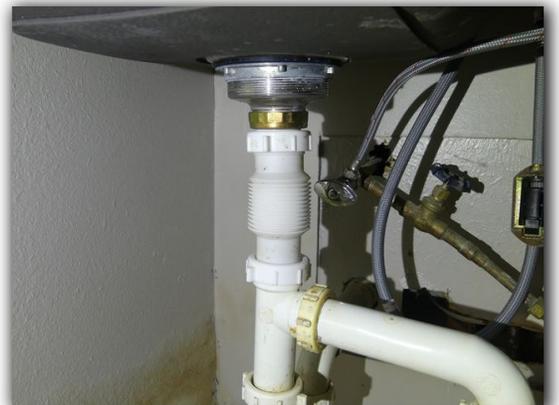
- Waste drains were slow to drain at sinks or tubs. The cause of slow drains should be determined and should be repaired or replaced as needed.

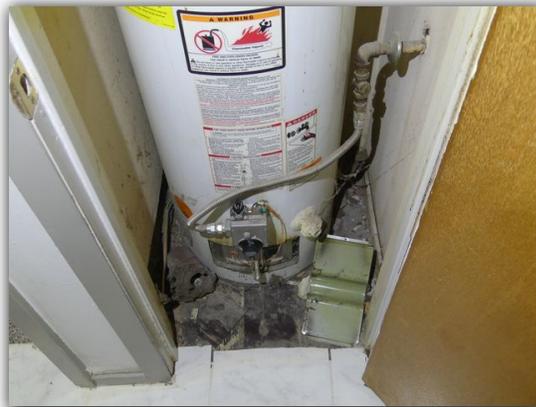
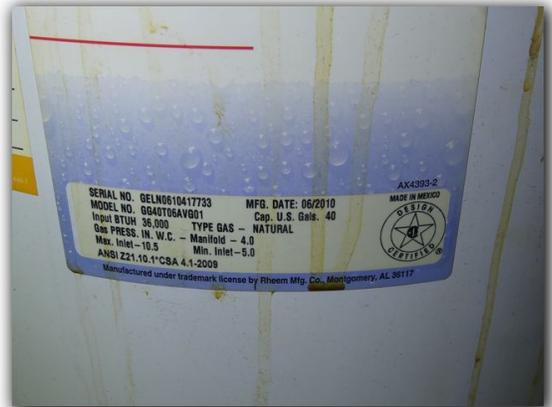
The water heating equipment appeared to be an older appliance at the end of its lifespan and the future life expectancy cannot be determined. The Average lifespan of a water heater is 8-12 years depending on usage and other factors. Yearly maintenance and close monitoring for rust, leaks or other defects is recommended. You can continue to use and service the water heating equipment until replacement is necessary.

The water heating equipment tank showed indications leaking and was in need of repair or replacement.

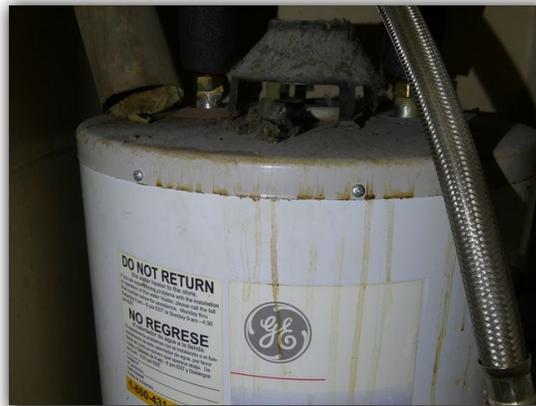
The water heating equipment was installed without an overflow pan. Current building standards state that all water heaters should be equipped with an overflow pan with a drain that drains to the exterior of the structure if leaks would cause damage.

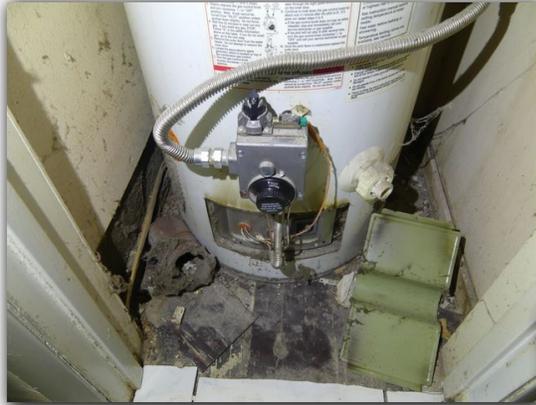
Corrosion and / or signs of an intermittent water leaks were observed at the water supply valve or water heating equipment plumbing connections. Water leaks and corrosion at the water heating equipment may cause water damage and should be repaired or replaced as needed by a certified, licensed water heating equipment specialist.

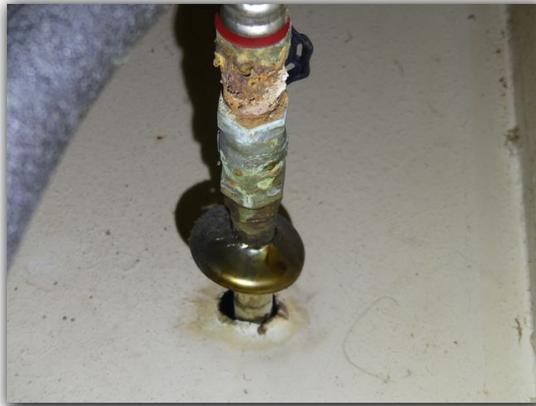
The gas-fired water heating equipment was installed too close to combustible materials and was observed to be a SAFETY HAZARD at the time of the inspection. Adequate clearance from flammable materials should be maintained at all times for reasons of safety.

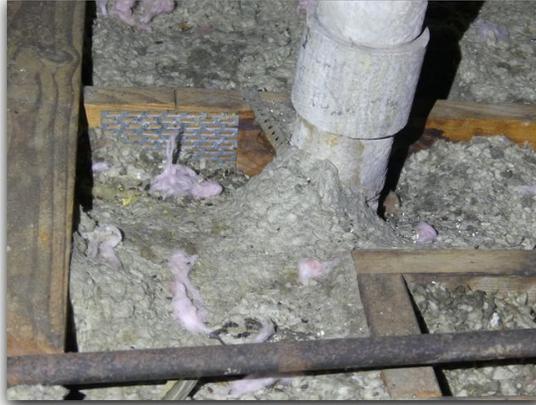
The gas/flu vent has some portion that appears to be an asbestos material which is a known health risk and SAFETY HAZARD. Asbestos materials require specialized handling by a qualified specialist and should not be handled otherwise.

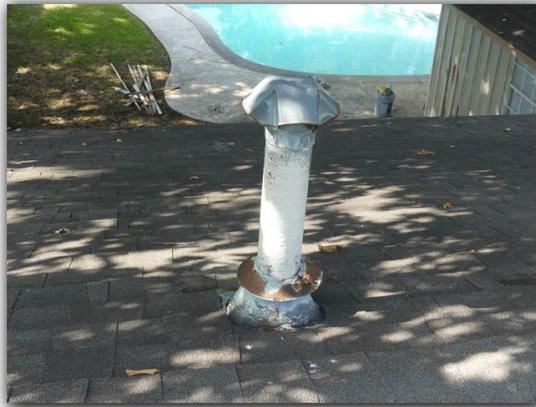
The water heating equipment gas exhaust vent draft hood lacks screws that secure the draft hood to the flu. The draft hood and gas exhaust flu should be connected with screws to prevent separation. Separations between the draft hood and the gas exhaust flu are a SAFETY HAZARD and should be repaired prior to operation of the water heating equipment.

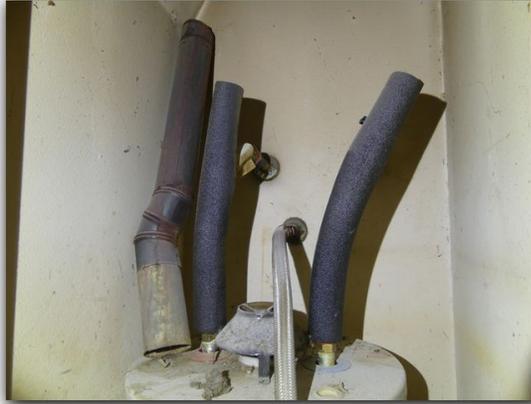
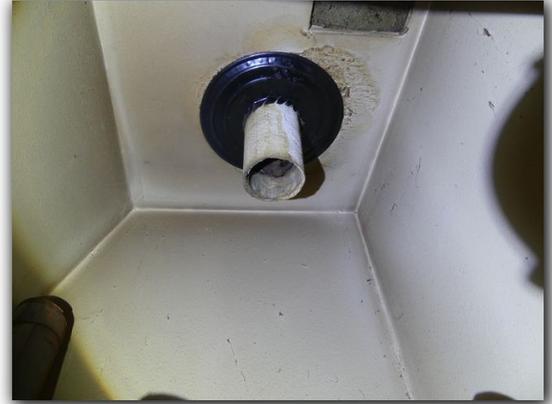
Gas flue/vent is loose, damaged, improperly installed or poorly connected at water heating equipment and was observed to be a SAFETY HAZARD. Loose, damaged, improperly installed or poorly connected gas exhaust flu should be corrected. Loose, damaged, improperly installed or poorly connected gas exhaust flues are a SAFETY HAZARD and should be repaired prior to operation of the water heating equipment.

The gas-fired water heating equipment was not properly vented for combustion and dilution air. Improper ventilation at the gas water heating equipment was observed to be a SAFETY HAZARD and may allow unwanted vapors to accumulate. Improper gas water heater ventilation may affect water heater performance. Further evaluation is recommended.

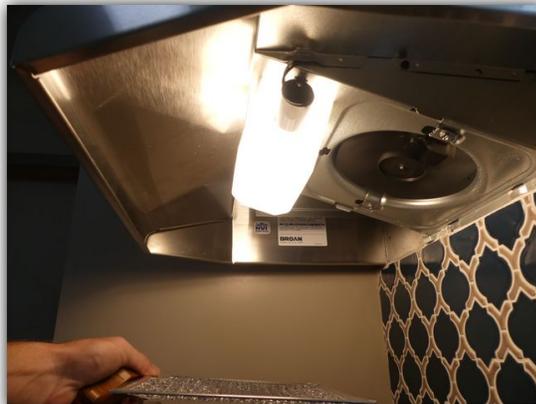
The range exhaust vent system was inoperative or did not perform as intended and is in need of repair or replacement.

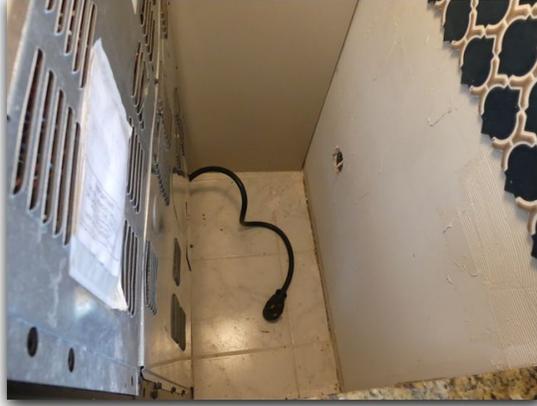
The range, cooktop or oven was observed to be inoperative and did not perform as intended and is in need of repair or replacement.

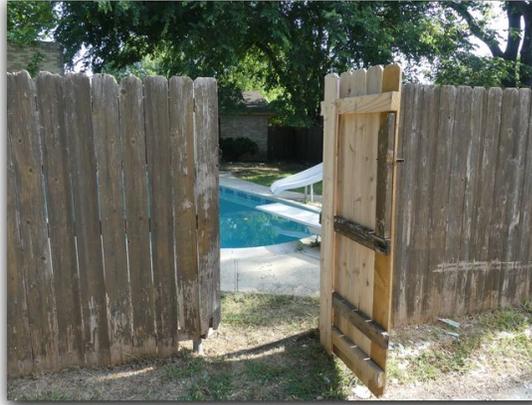
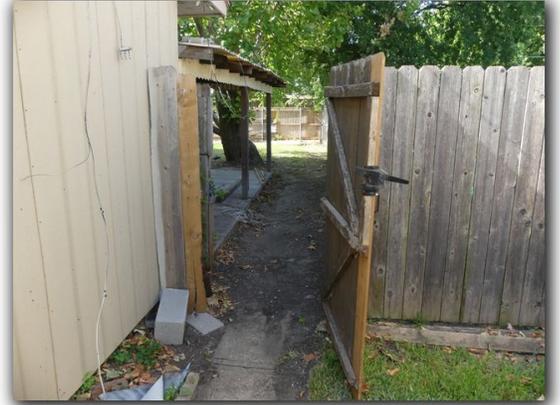
inches from the bottom of the gate. A second release mechanism should be located on the pool side of the gate at least 3 inches below the top of the gate. Improperly installed pool/spa access gates and gate latches were observed to be a SAFETY HAZARD and should be repaired as needed.
