Fouries Home Inspection

COMPLETE HOME INSPECTION
Prepared Exclusively For: Buyer Name

Any Street, Mesquite, TX, 75150

By: Paul Fourie, Lic #22325 07/22/2019
(Name and License Number of Inspector) (Date)

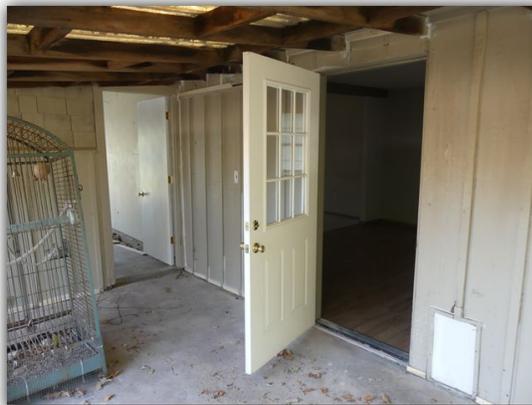
The homes entry doors that give access to the pool area should be equipped with an audible alarm that can be heard throughout the house, sounds continuously for 30-seconds, and be mounted at least 54-inches from the doors threshold. A self-closing and self-latch door device can be used in lieu of the audible alarm system as long as the protection is not less than the audible alarm. Lack of an audible alarm or self-closing door with egress to pool/spa areas was observed to be a SAFETY HAZARD.

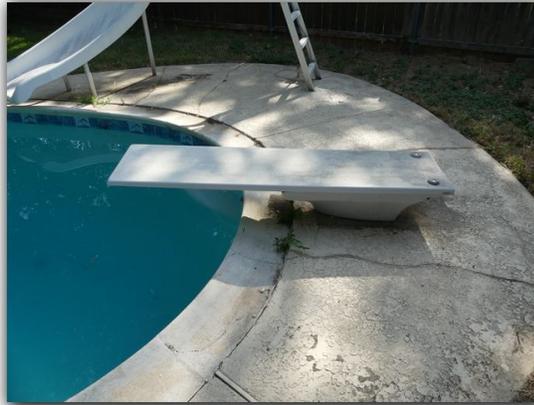
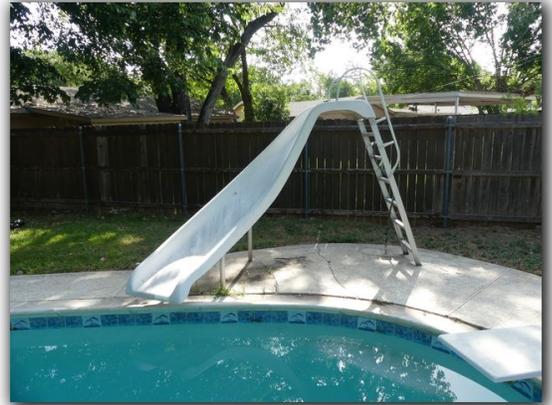
There was a diving board and/or slide installed at the pool/spa. The U.S. Consumer Product Safety Commission strongly recommends that all diving boards and/or slides be removed from pools for reasons of SAFETY. The buyer is also encouraged to learn more about how an installed diving board or slide may affect insurance.

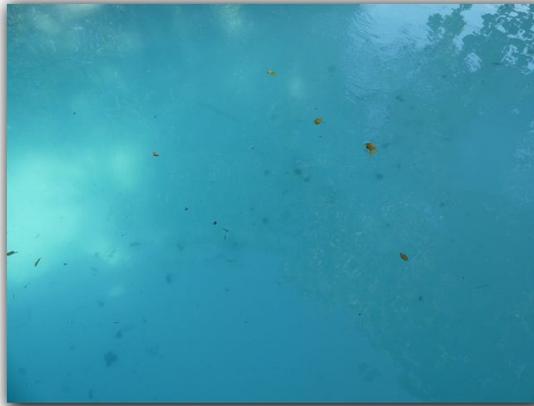
- The pool/spa water was cloudy, discolored, and was an indication that maintenance and or repairs are needed.

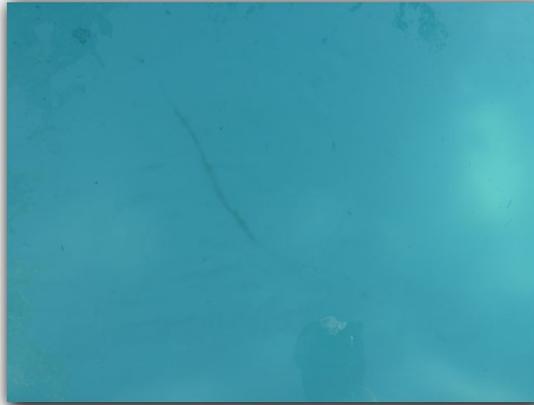
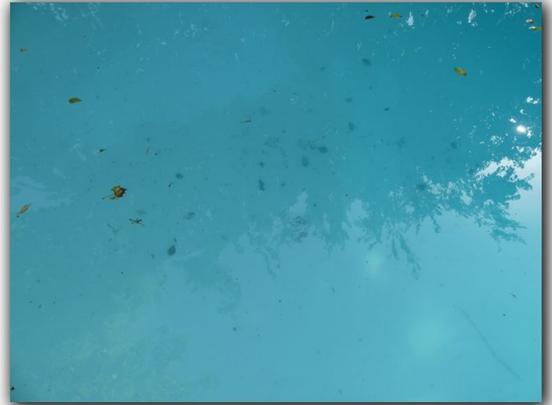
- The pool/spa surface was obscured by leaves, dirt or other debris which limits the inspection of pool/spa surfaces. Leaves, dirt or other debris in the pool were an indication that maintenance or repairs were needed.

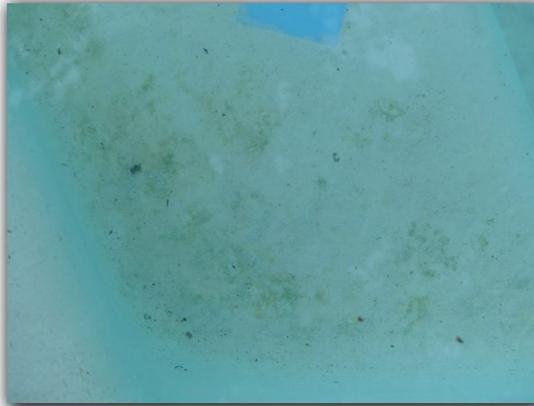
There was algae growth on the pool/spa surfaces. Algae growth was an indication that pool/spa maintenance or repairs are needed.

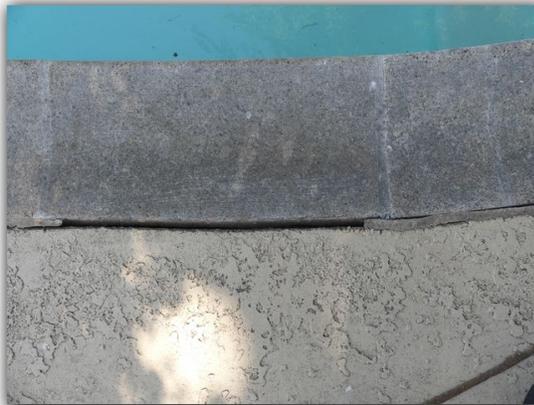
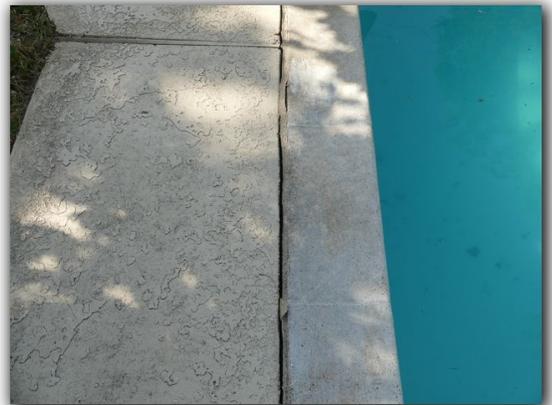
The pool/spa sealant (Deck-O-Seal) between the coping and decking was in need of repair or replacement.

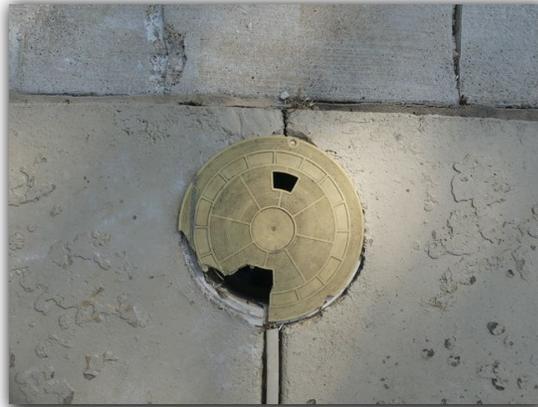
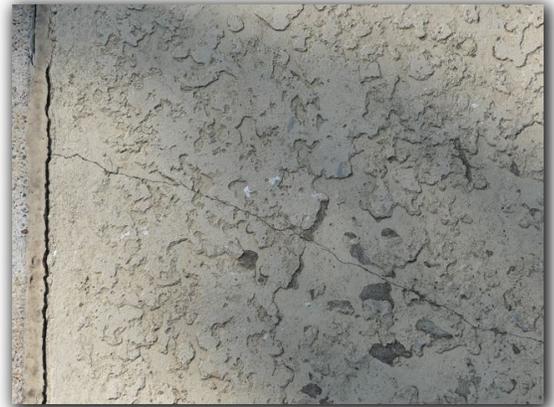
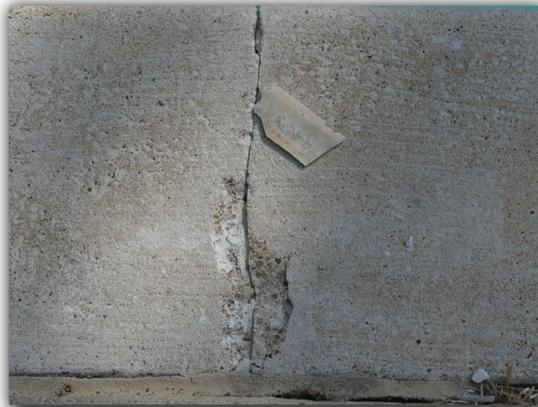
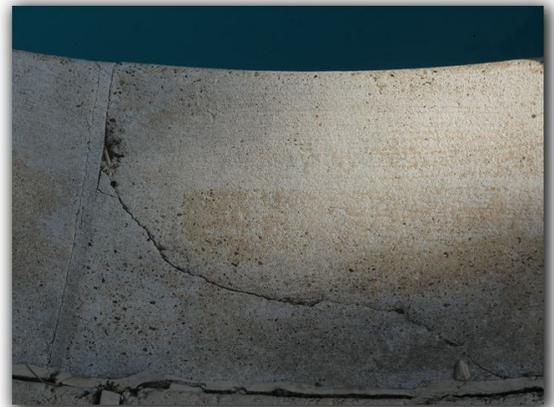
Pool/spa tiles, coping, and decks were observed to be cracked or damaged. The cause of cracked or damaged tiles, coping and decks should be determined and should be repaired or replaced as needed.

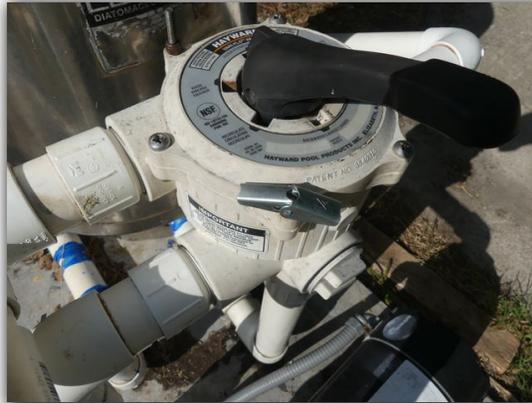
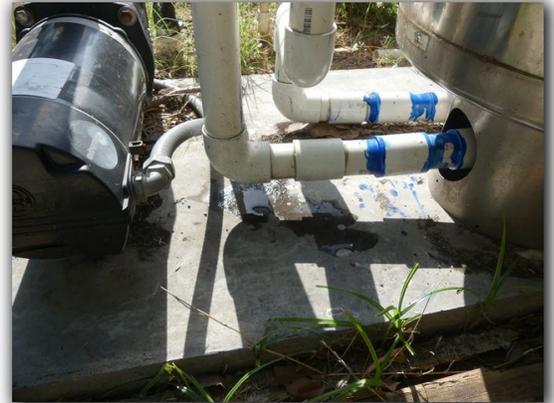
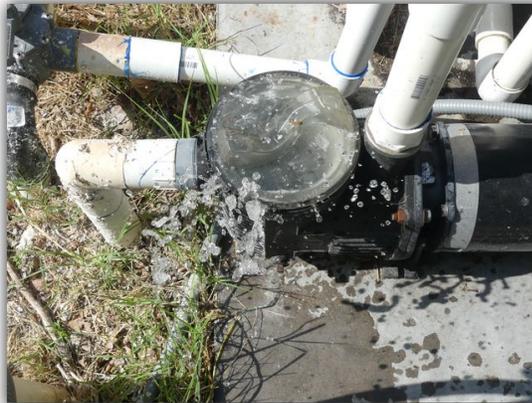
Pool/Spa Plumbing And Equipment:

- The pool/spa lighting fixtures were inoperative and should be repaired or replaced as needed by a qualified pool/spa specialist.
- Water leaks in the pool/spa aboveground pipes and/or equipment were observed to be in need of repair.

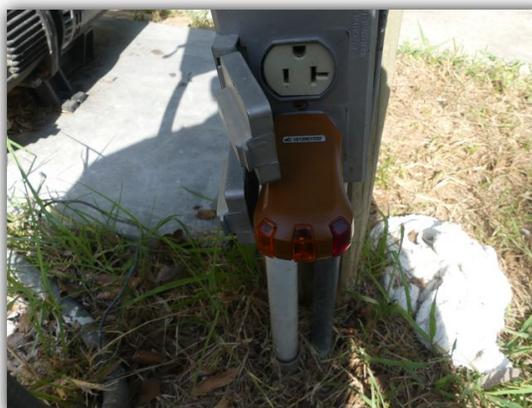
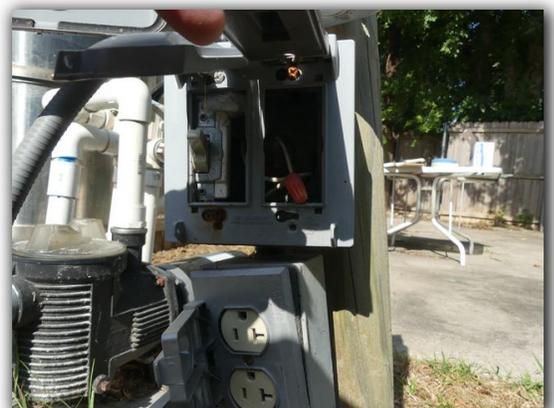
The lack of pool/spa required ground-fault circuit interrupter protection was observed to be a SAFETY HAZARD. All pool/spa electrical equipment and electrical receptacles should be GFCI protected and properly bonded.

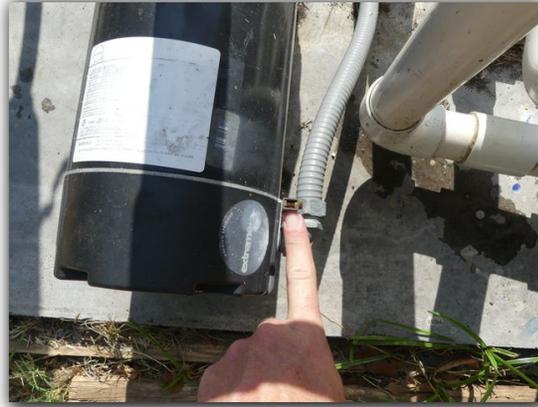
Lack of bonding at pump motor, water heater, blower, or other electrical equipment to ground was observed to be a SAFETY HAZARD. Inadequate electrical bonding should be further evaluated by a qualified specialist.
