September 15, 2014

Property Inspection Report

**170 Sturla Court
Santa Monica, CA 90403**

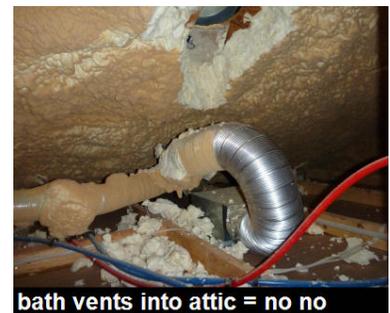
Attic is full size. The inspector entered all accessible areas of the attic. The attic access panel is located in a closet. *Although not required, we recommend protective covers or cages be installed on light bulb/s to prevent injury as a property upgrade.*

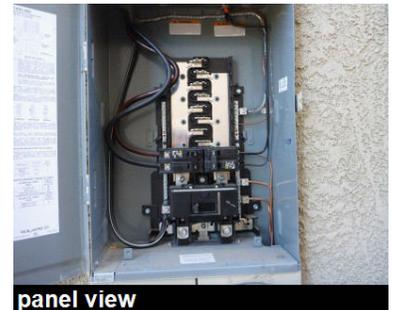
panel view

Underground. 120/240 volt, 200 ampere service with circuit breakers. This was determined by the rating on the main disconnect.

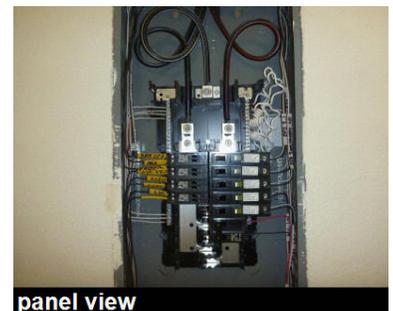
panel view

The electrical equipment panel is located in a laundry room. **Circuit/s are completely and clearly labeled.** However, this inspection does not verify the accuracy of this legend.
