YOUR INSPECTION REPORT

[REDACTED]
Vancouver, BC V6J 3S2

RE: Report No. 1054
[REDACTED]

GENERAL DESCRIPTION OF PROPERTY

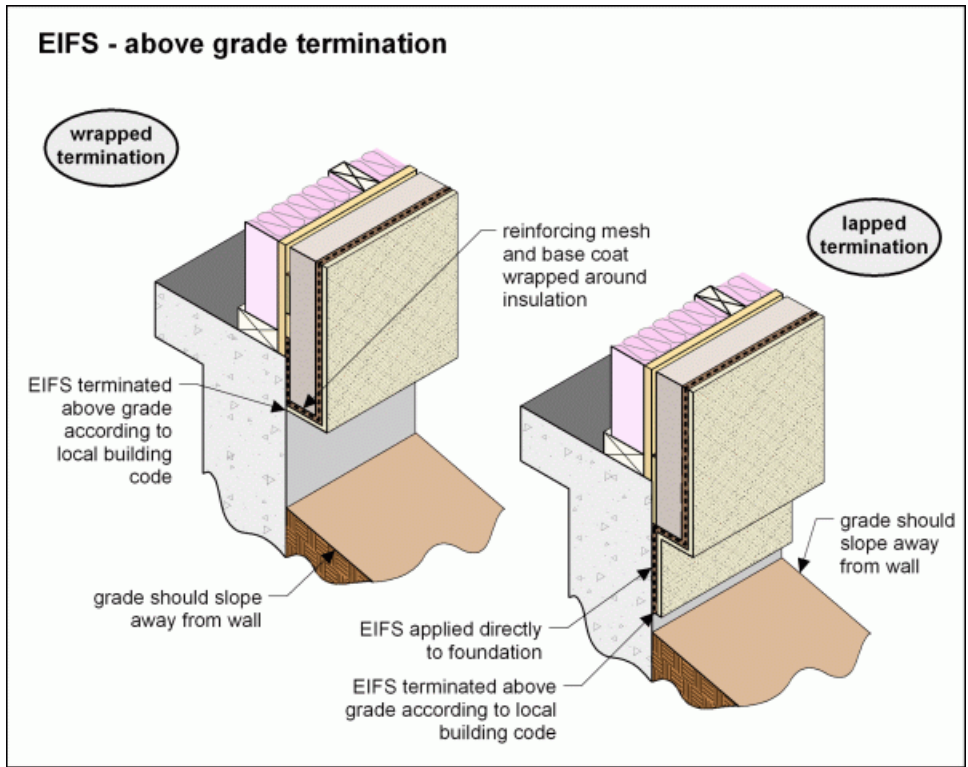
11. Too close to grade

Condition: • [Too close to grade](#)

The stucco siding is in contact with the ground and requires a clearance of 6" to 8" from the bottom of the siding to the top of the ground to ensure no moisture damage.

Implication(s): Chance of water damage to structure, finishes and contents | Material deterioration

Task: Improving stucco clearance is recommended.

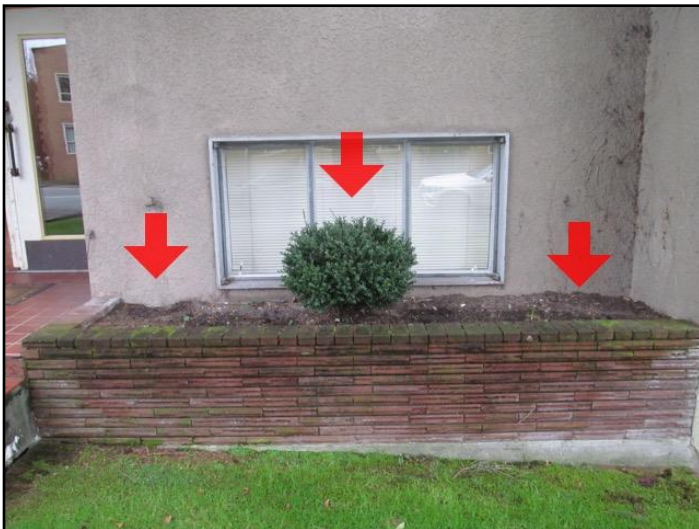
18. Planters and gardens against walls

Condition: • [Planters and gardens against walls](#)

Implication(s): Chance of water entering building | Chance of damage to structure | Chance of structural movement

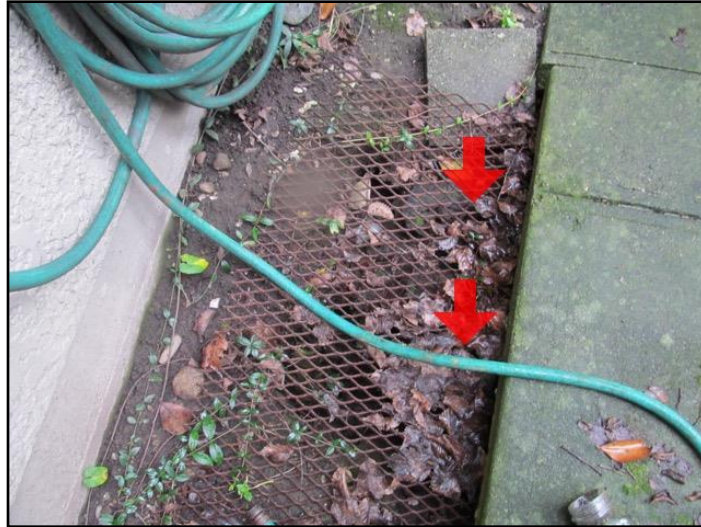
21. Disturbed ground

Condition: • [Disturbed ground](#)

Observed disturbed soil on the west side of the building. At the time of the inspection there were no any evidence of moisture inside the building or any other damage.

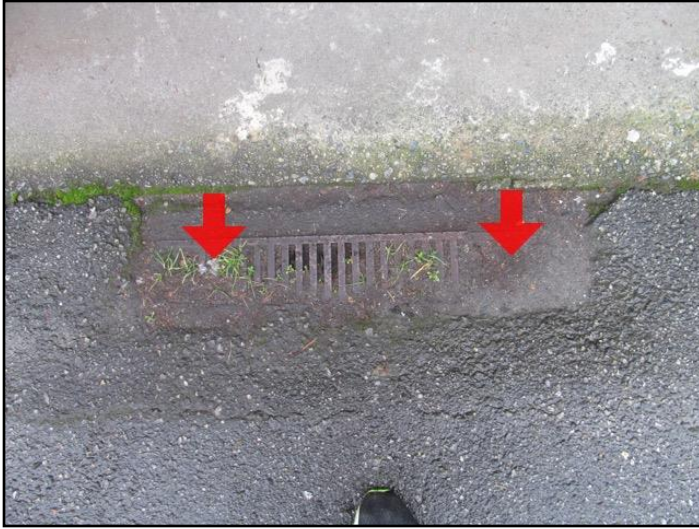
24. Drainage system

Condition: • Observed that drainage at the back of the building is damaged and plugged wit debris and dirt. It is recommended contacting a licensed drainage company for investigation and evaluation of the drainage system.

Task: I recommend cleaning and repairing drainage system.

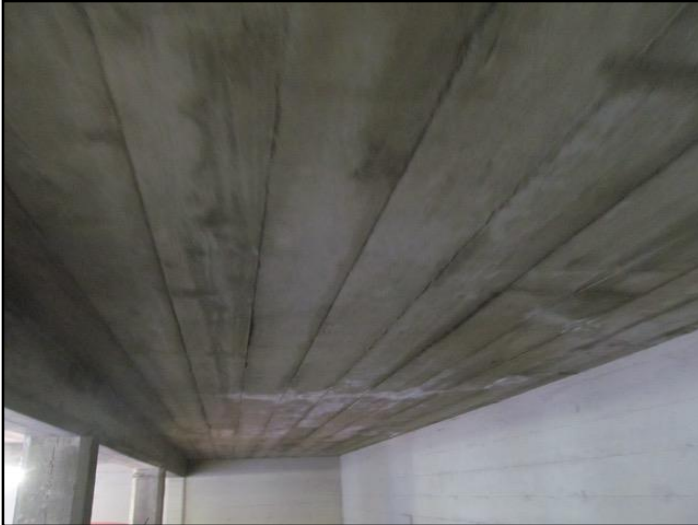
26.

General: • The main buildings concrete reinforced columns and foundation walls are partially visible in the parking area and appear to remain in satisfactory condition. No evidence of any significant deficiencies, movement or unusual settlement is apparent. Observed only some small common visible cracks.

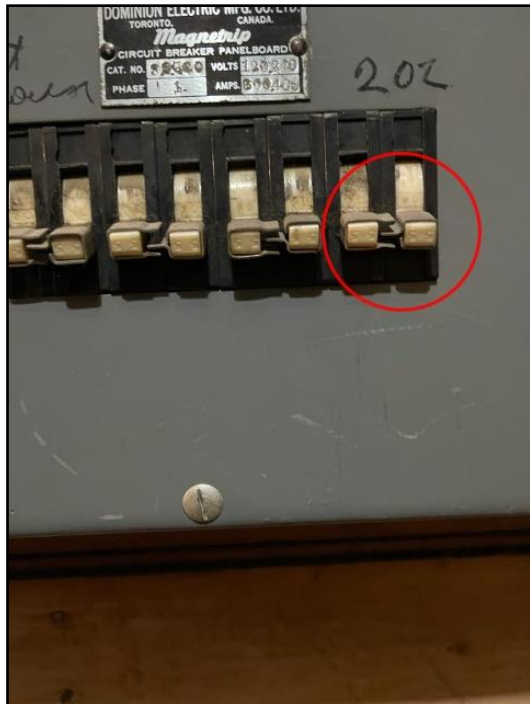
32. 55-amp

General: • All renovated units are upgraded with 60-amp breaker electrical panel (some electrical panels don't have a main disconnect). Units that are not renovated, has a fuse electrical panels. Fuses electrical panels are now red flagged by most insurance companies.

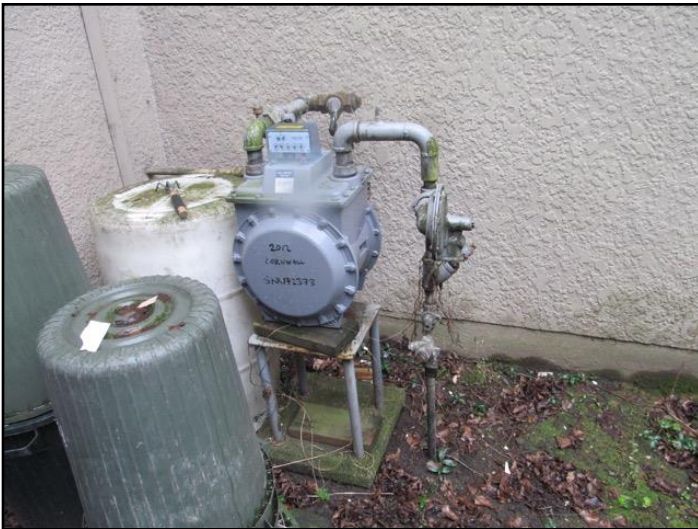
41. Gas meeter

The property has overhead electrical services supplied to the main electrical room (West side) of the building, and a natural gas service provided to a single meter located on the West of the building. These services all remain in functional condition.

I recommend keeping the area around your natural gas meter clear ensures that you, the meter reader or emergency responders can reach it safely at all times.

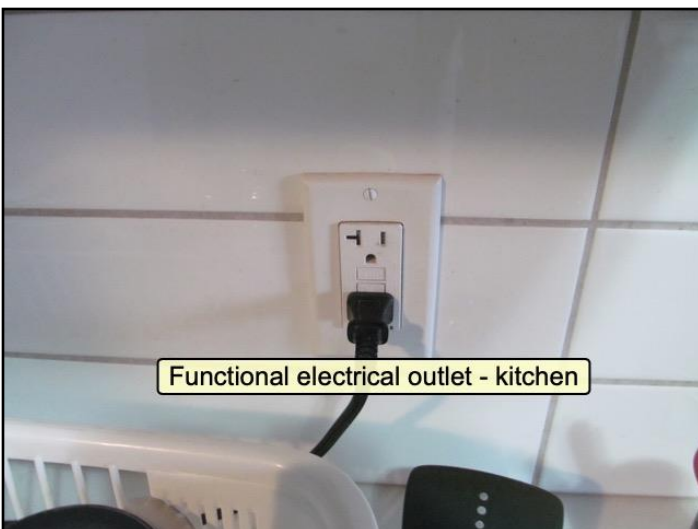
Circuit interrupters: Ground Fault (GFCI) & Arc Fault (AFCI): • The electrical receptacles that are tested were functional at the time of the inspection. All inspected renovated apartments have GFCI receptacles installed in the bathroom and the kitchen and all were functional at the time of the inspection.

45. Functional electrical outlet - kitchen

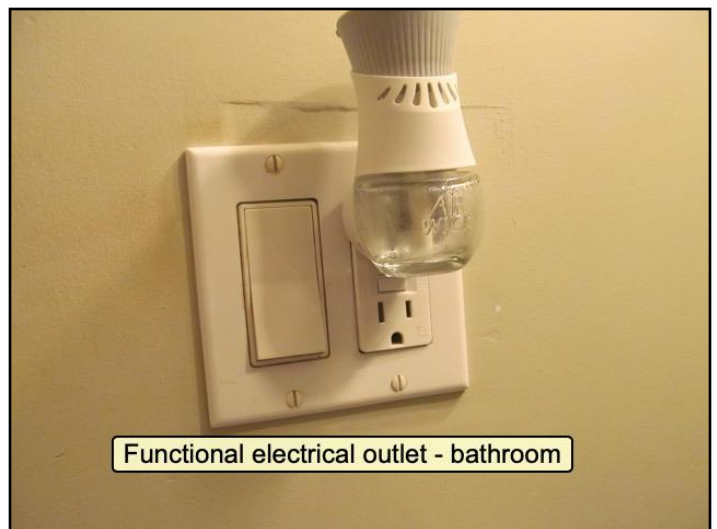
46. Functional electrical outlet - bathroom

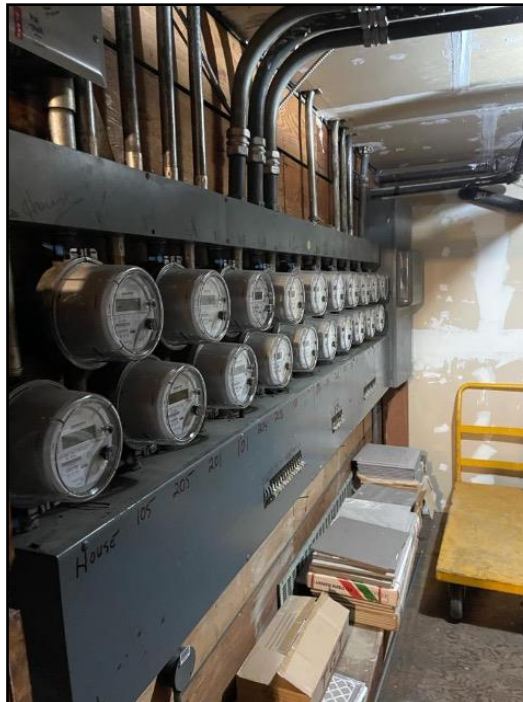
47.

14. Condition: • This service equipment is original and remains in fairly satisfactory and operational condition. I suggest replacing the equipment in the near future to avoid unexpected equipment failure as well recommend contacting insurance provider for more information about this old equipment.

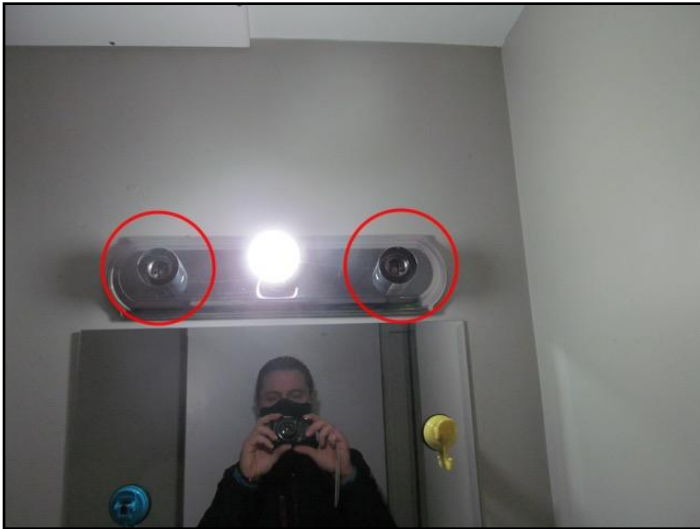
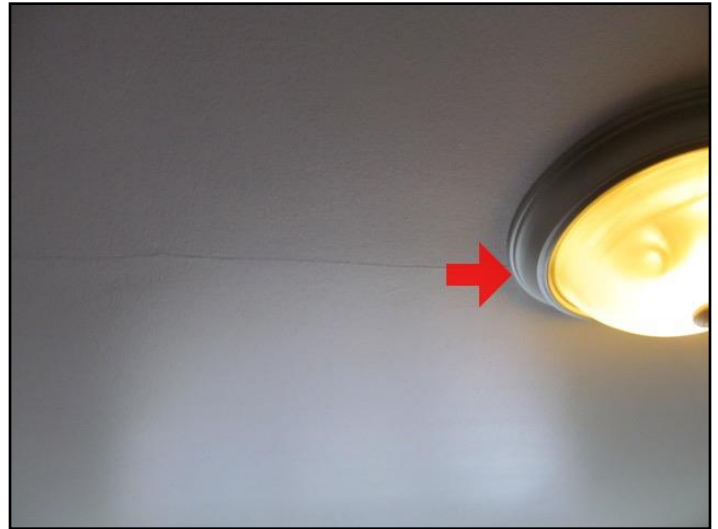
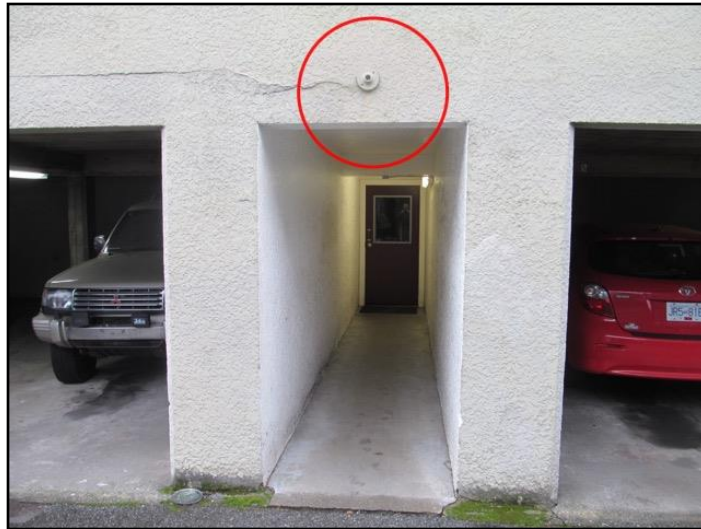
15. Condition: • The various exterior wall mounted light fixtures were noted to be in fair satisfactory condition with only minor repairs required and some missing fixture covers to be replaced.

The interior lighting inspected is all in fair satisfactory condition, some damaged fixtures need repair or to be replaced.

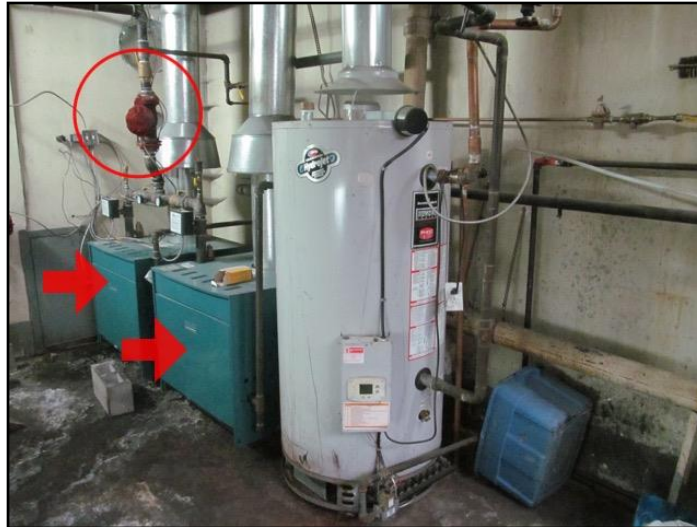
General: • The building has two natural gas hot water boilers that are in good operating condition with no visible damage. The manufacturing date of the boiler was not determined, it appears to be installed within the last 6 to 8 years and has an expected service life of 15-20 years. All circulation pumps are functional and appear to remain in good condition.

51. Gas hot water boilers

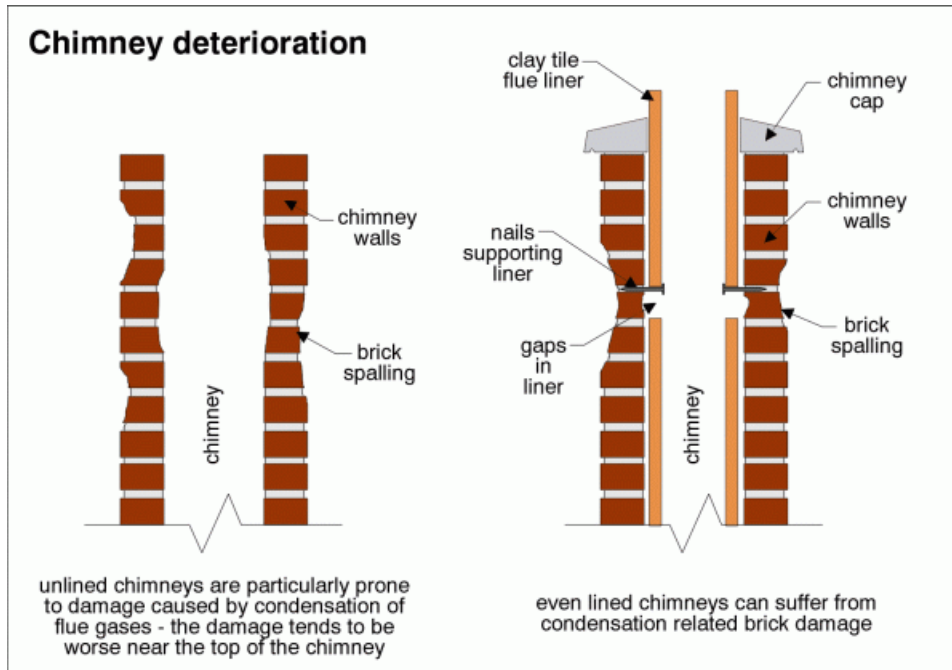
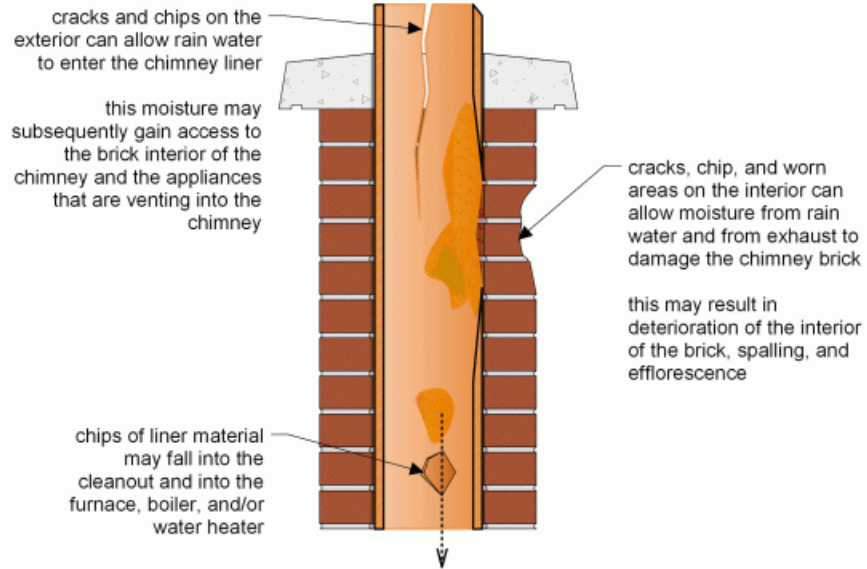
Observed damaged chimney that needs to be repaired.

Deteriorated clay chimney liner

54. Loose, missing or deteriorated masonry

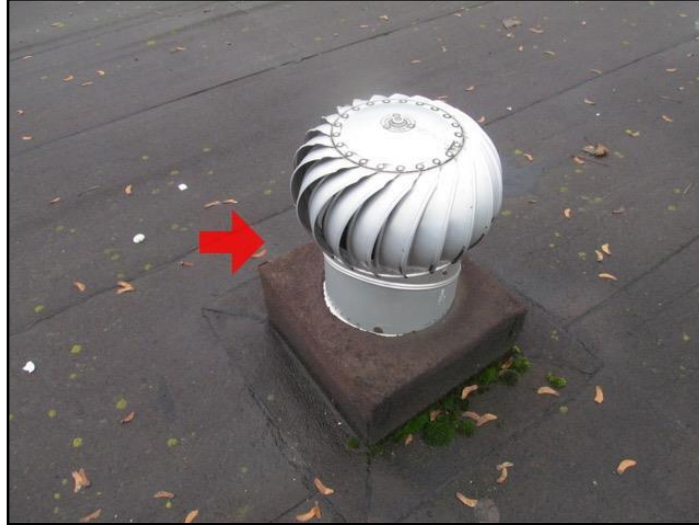
A turbine is installed directly on the top of a roof and uses wind power to suck hot and humid air out of the attic.

55. Turbine vent

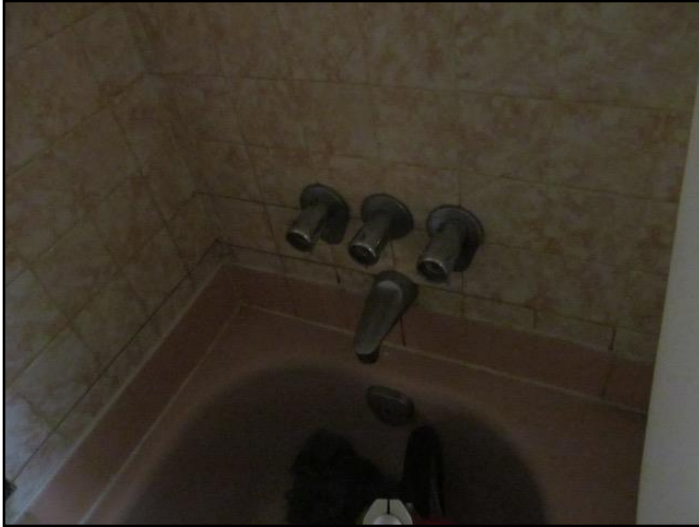
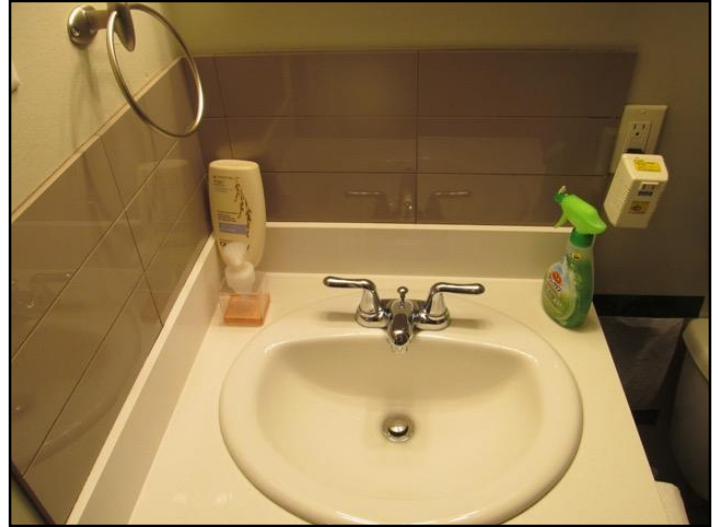
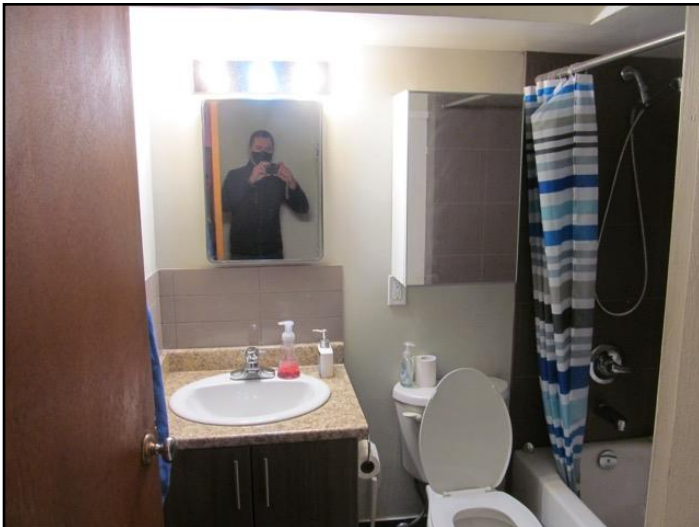
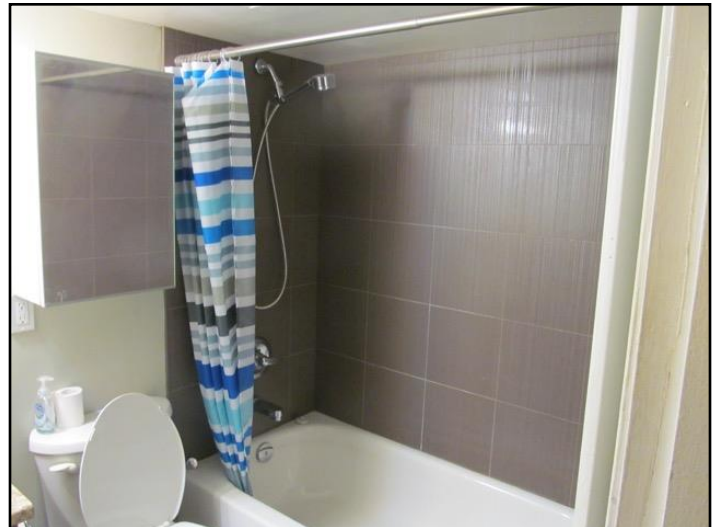
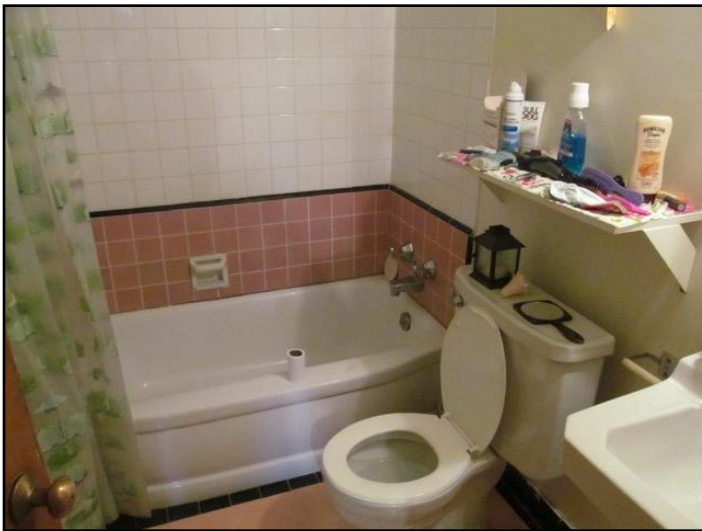
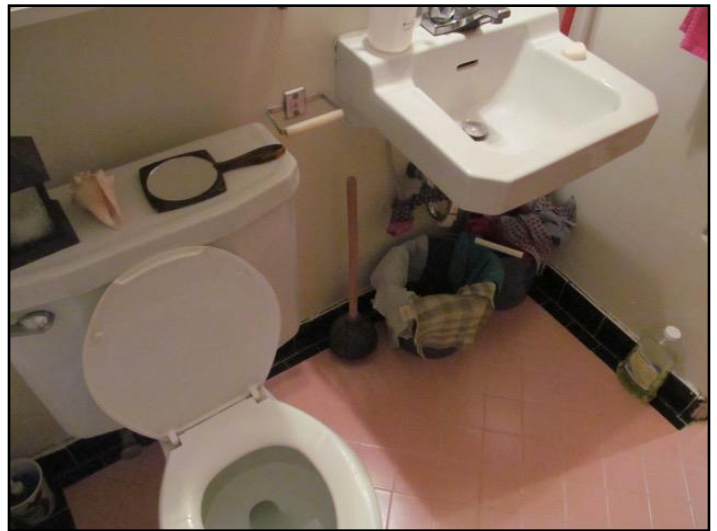
General: • The various faucets and fixtures include stainless-steel kitchen sinks. All faucets and fixtures inspected are in unsatisfactory to fairly satisfactory and satisfactory condition with some chipped, stained and damaged on sinks toilets and tubs.

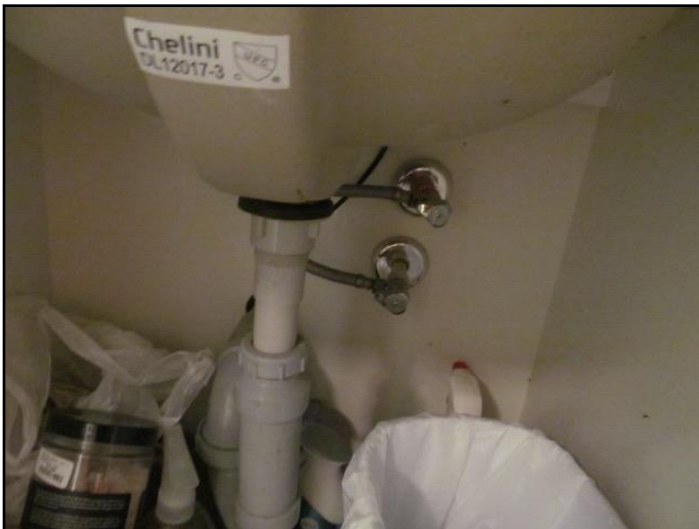
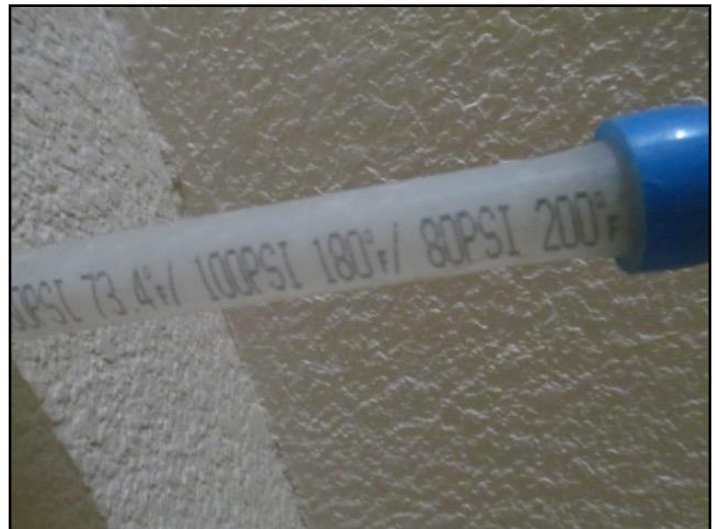
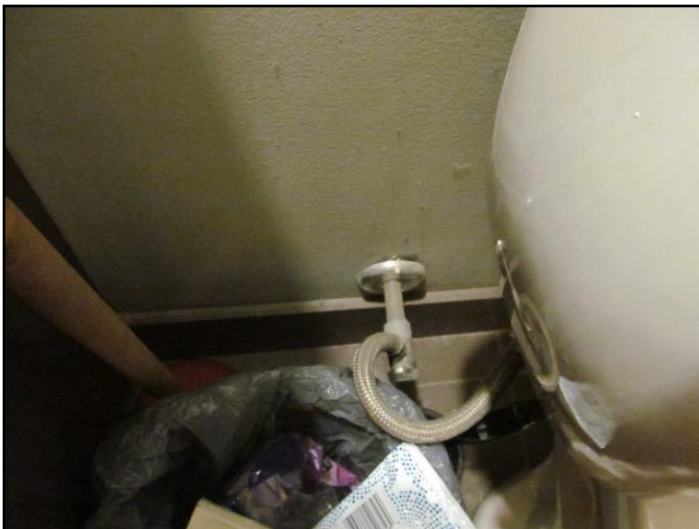
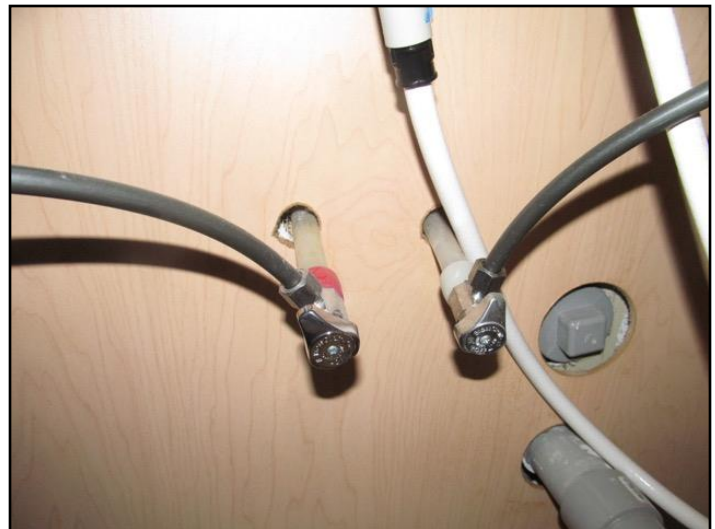
The water to the building is supplied by a metered city service. The city water enters the building in the boiler room. The visible waterline is the copper pipe and all renovated apartments are upgraded with PEX water piping. The domestic water plumbing system as a whole appears to be in fair satisfactory condition to satisfactory condition. Some copper piping in the building has reached an age where pinhole type leaks may develop, and replacement may be necessary within the next 5 years or so.

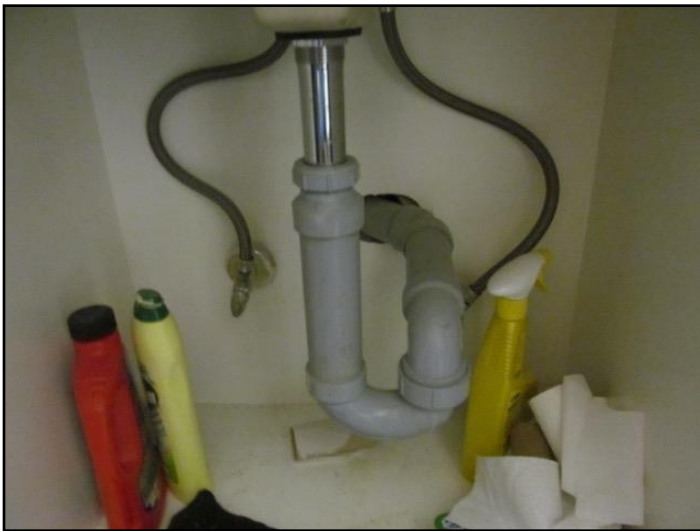
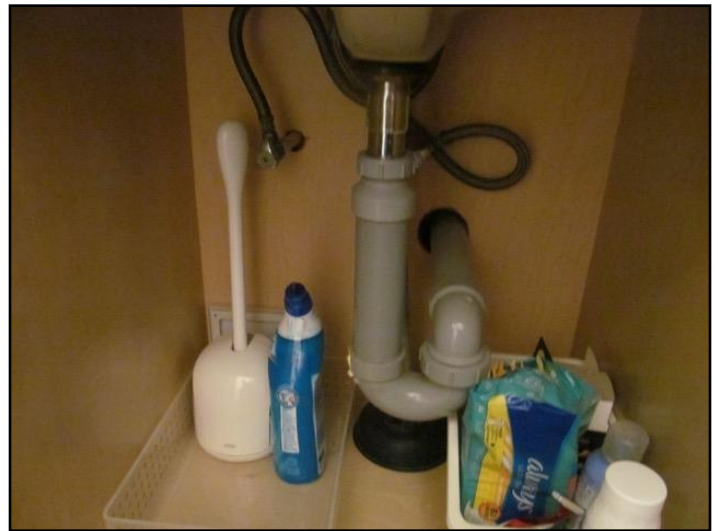
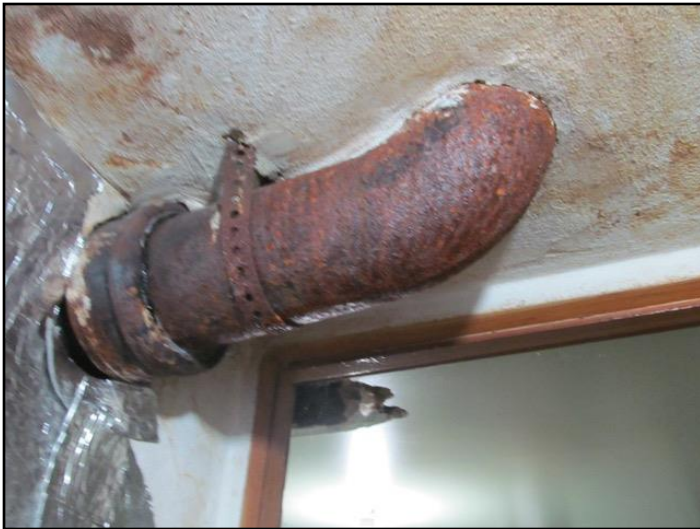
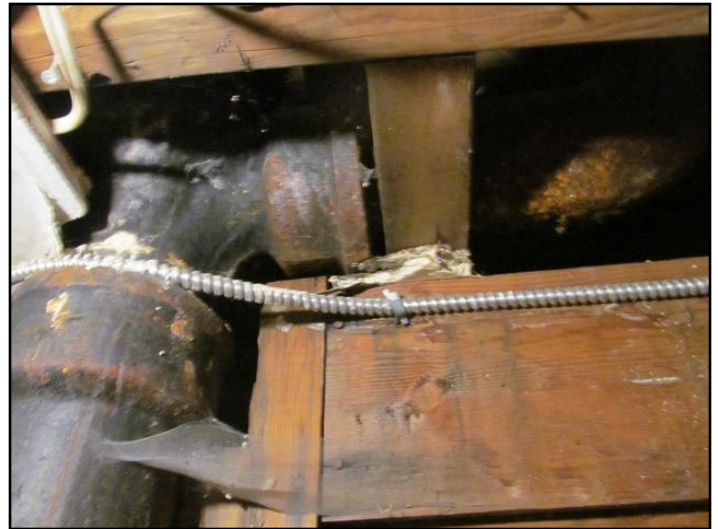
Waste and vent piping in building: • During the inspection, observed waste disposal piping cast iron and some upgraded plastic piping in the building. All drainage that were tested at various sinks and toilets throughout the building were functional on the time of the inspection.

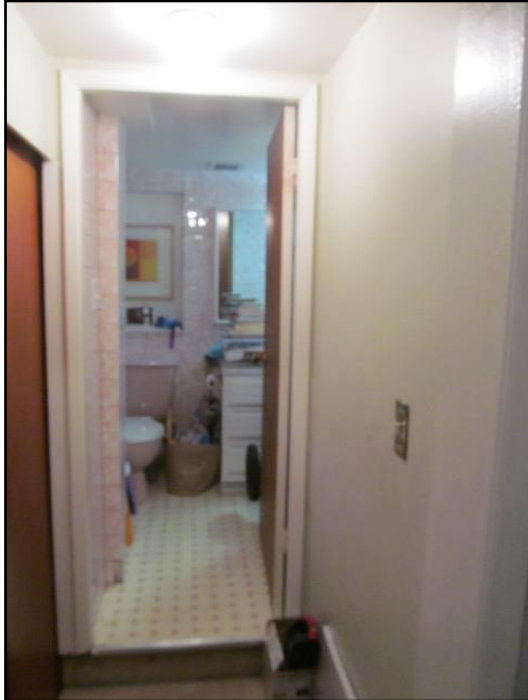
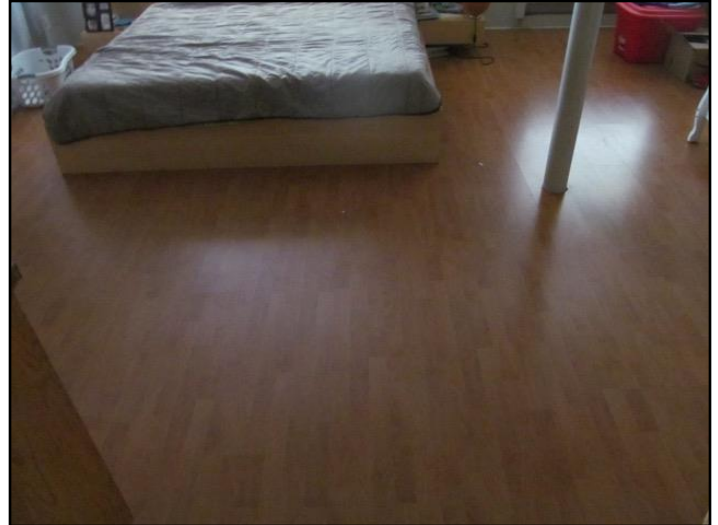
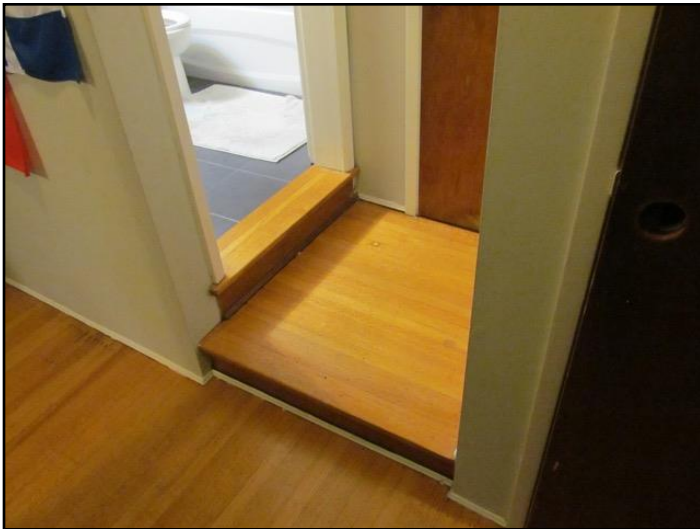
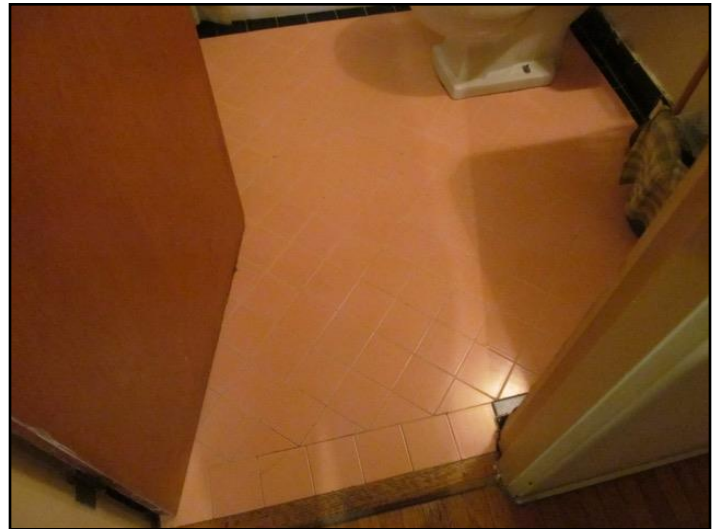
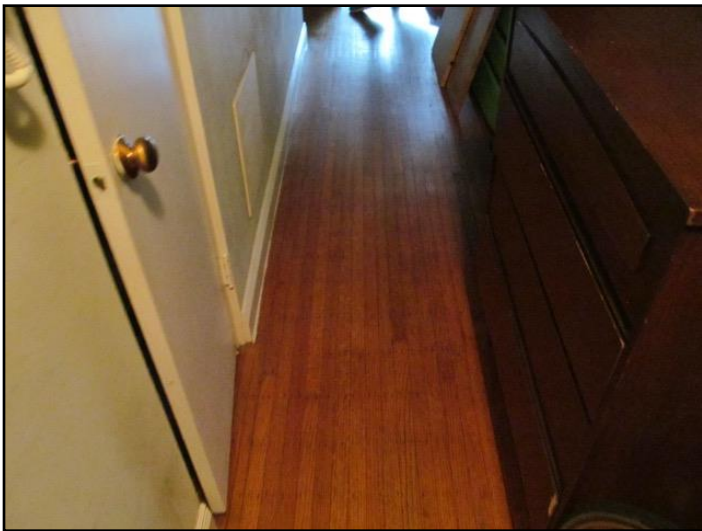
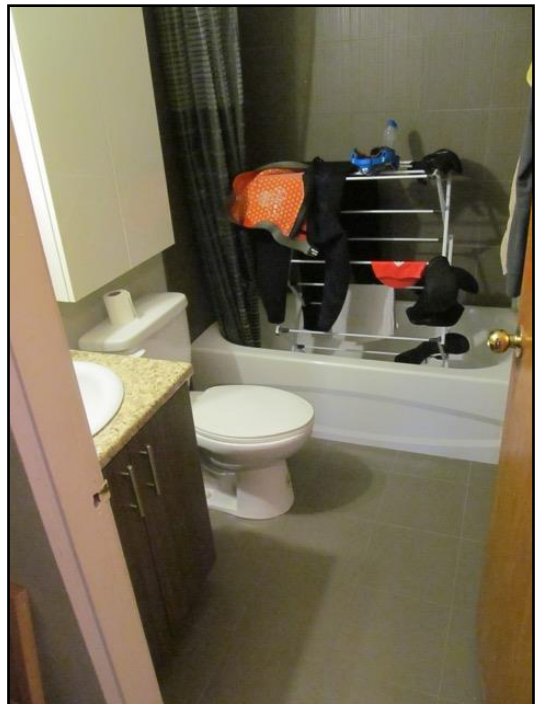
General: • The interior flooring materials throughout the building is a mixture of ceramic tile, carpet, laminate and hardwood floors. Overall, the flooring is in fairly satisfactory condition to satisfactory condition with no major damage or issues that need immediate repairs.

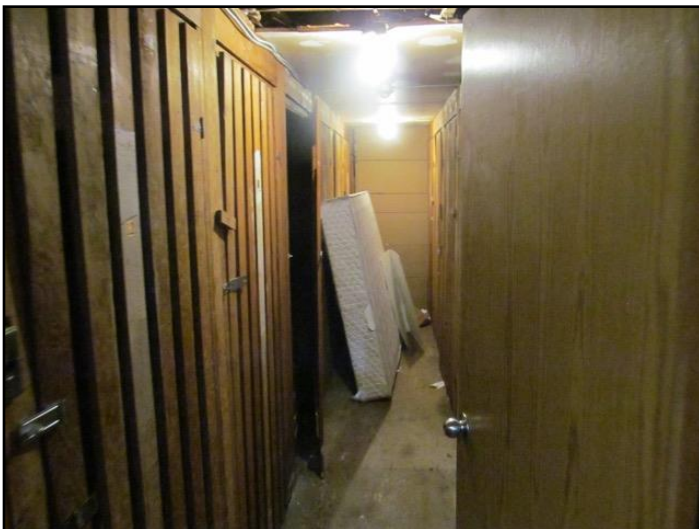
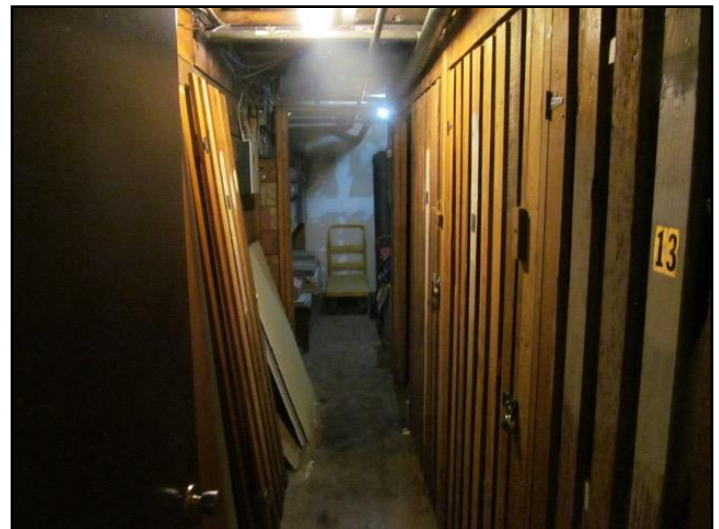
General: • The building has two storage rooms with wood lockers. The ceiling in these storage rooms has large holes that need to be repaired. All walls around need to be repaired and painted. Many locker doors are damaged and need to be repaired.

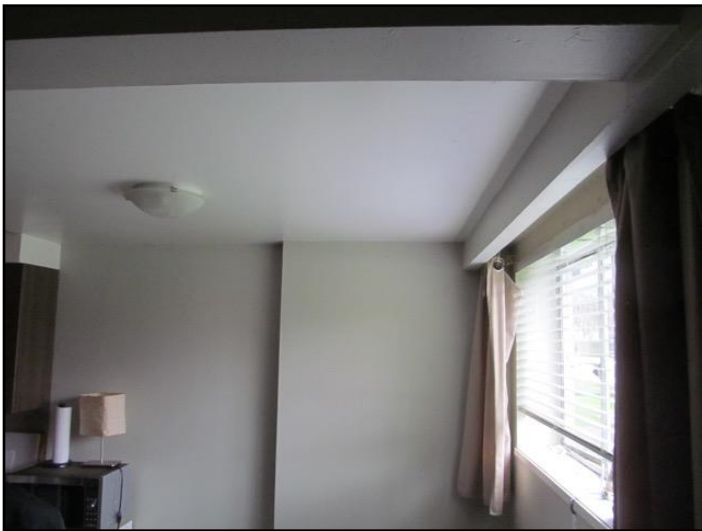
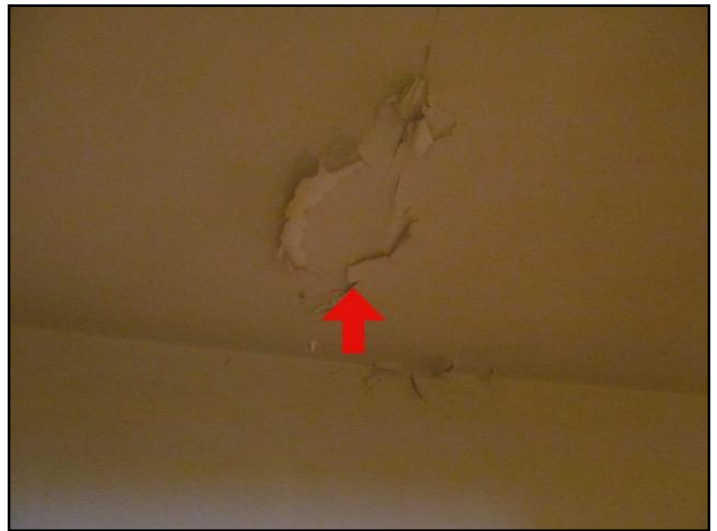
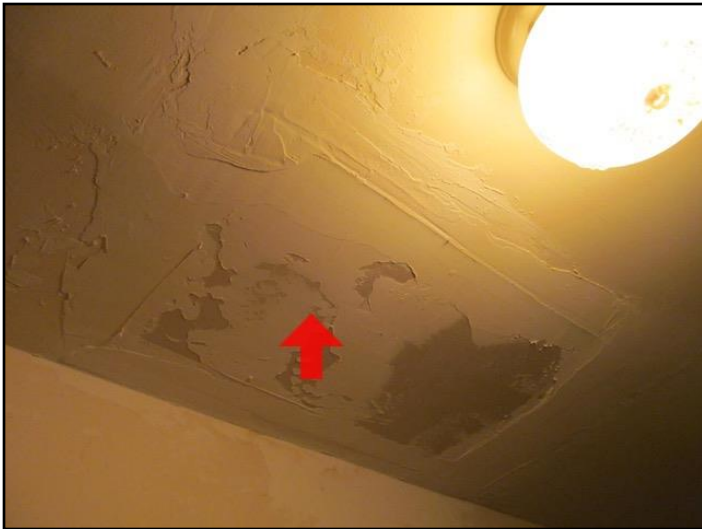
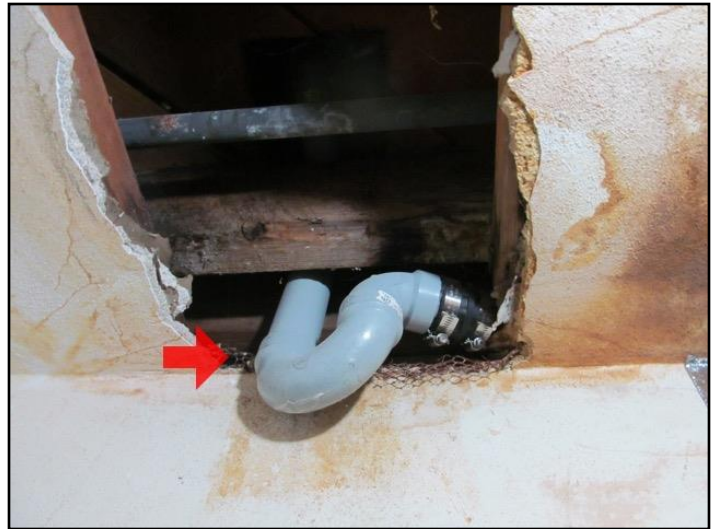
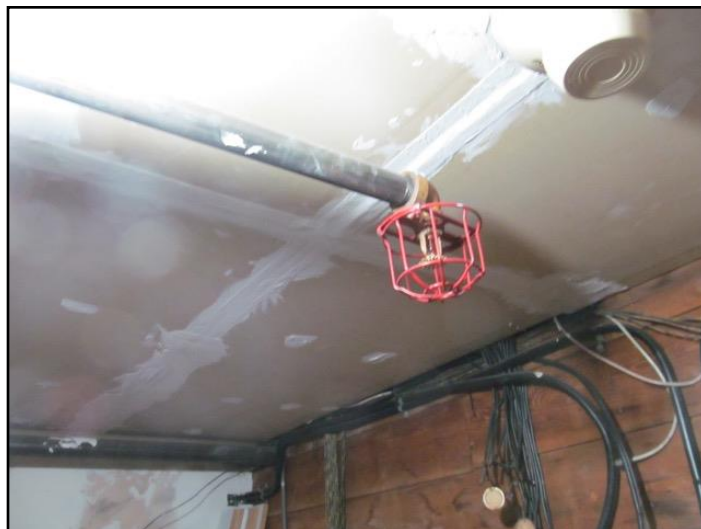
Major wall and ceiling finishes: • The interior walls and ceiling materials throughout the building is a mixture of painted and textured gypsum board and are in unsatisfactory to fairly satisfactory and satisfactory condition. The most unsatisfactory walls and ceilings are in units that are not renovated, locker rooms and common area bathroom. Various suites have dry water stained and repaired ceilings from previous leaks. Observed not properly installed drainage located in the common area bathroom ceiling.

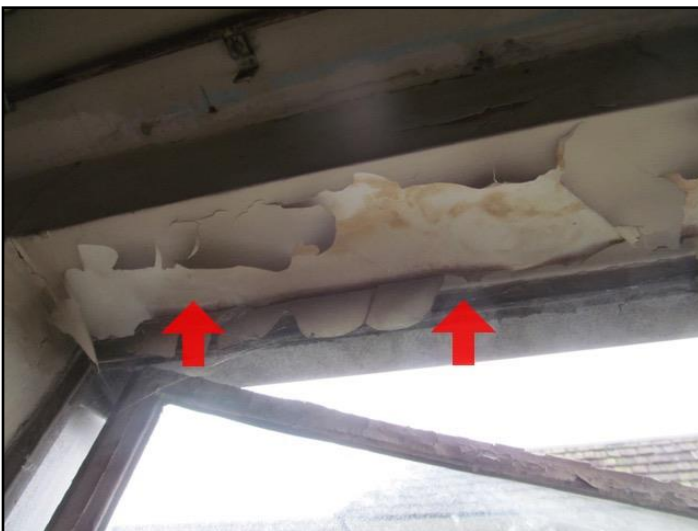
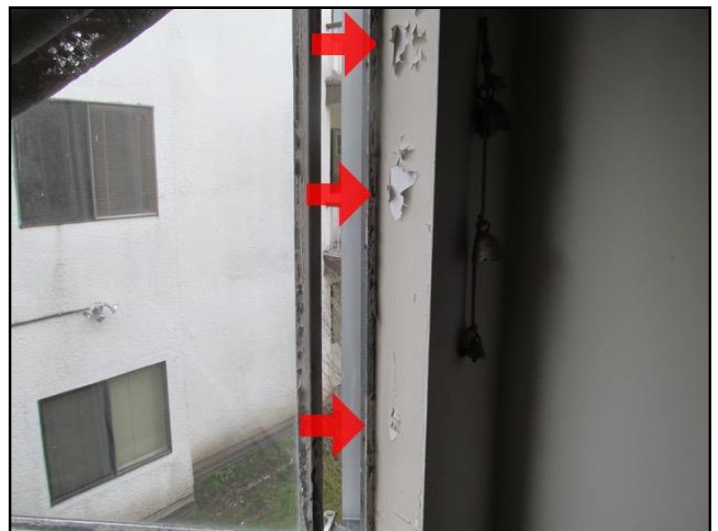
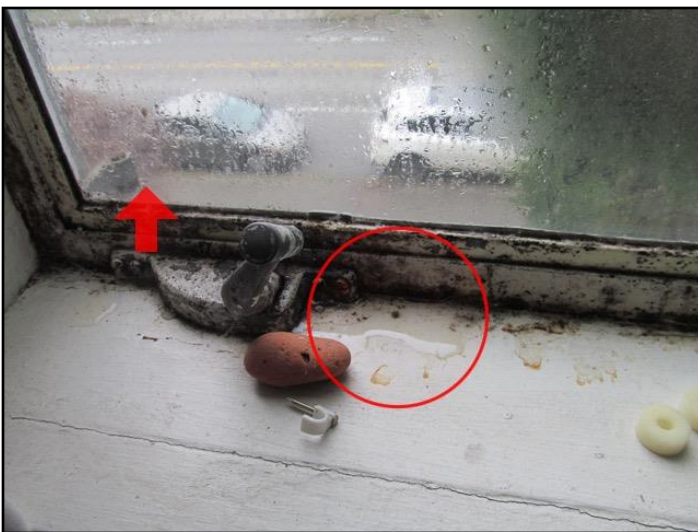
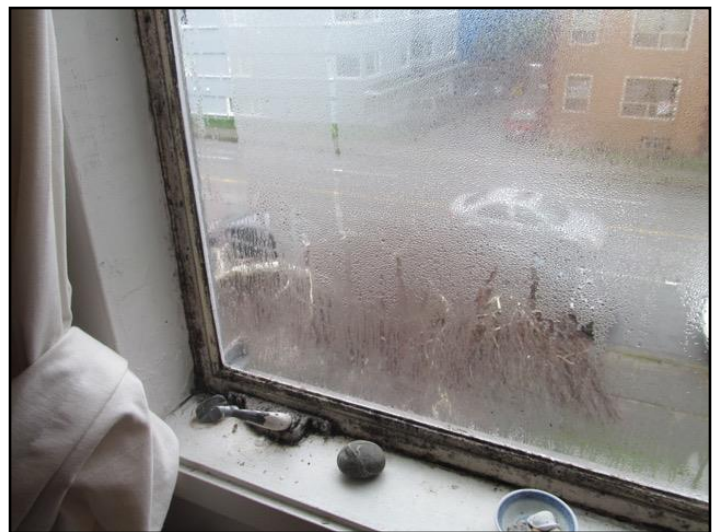
Windows: • The patio doors and windows installed throughout the building are the original single metal framed units that are in unsatisfactory condition to fairly satisfactory condition with some visible damage, and deterioration.

Various window sills inspected have some moisture damage caused by leaving window open during wet weather and condensation buildup.

In some units observed water present on the window sill which is caused by windows condensation. Condensation on the inside of single glazed windows is a common problem and it requires more maintenance than on double glaze windows.

I recommend possible replacement of patio doors & windows.

Time: Less than 6 years

Cost: \$45,000 - \$50,000

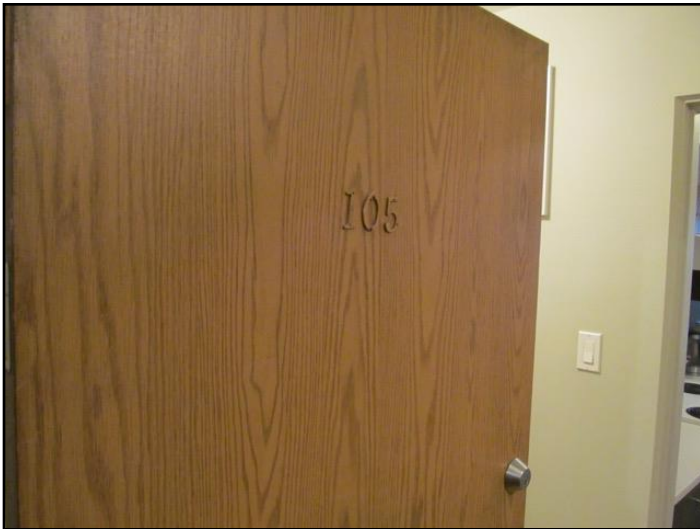
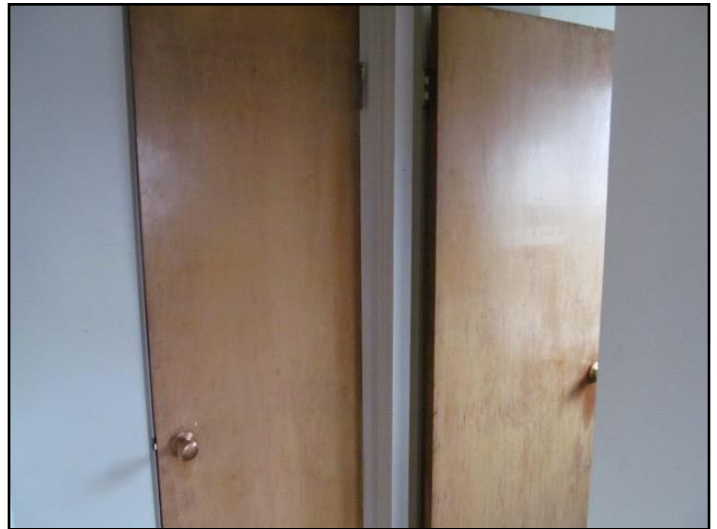
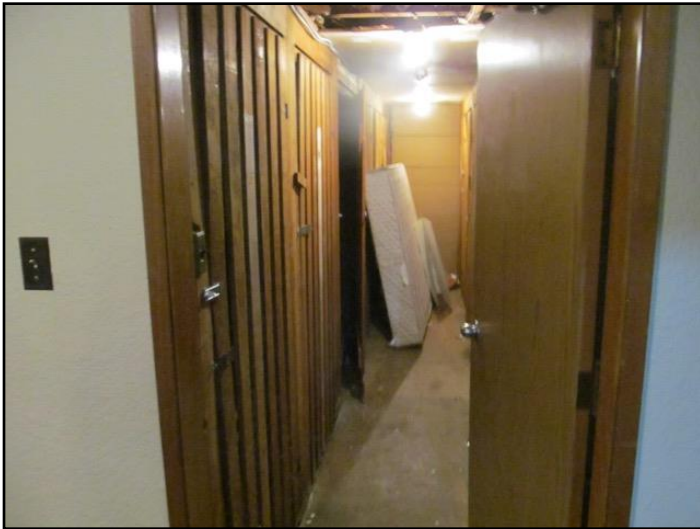
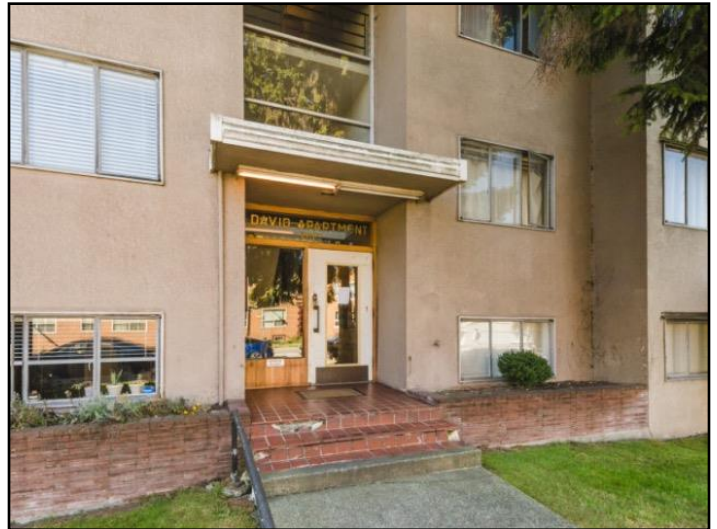
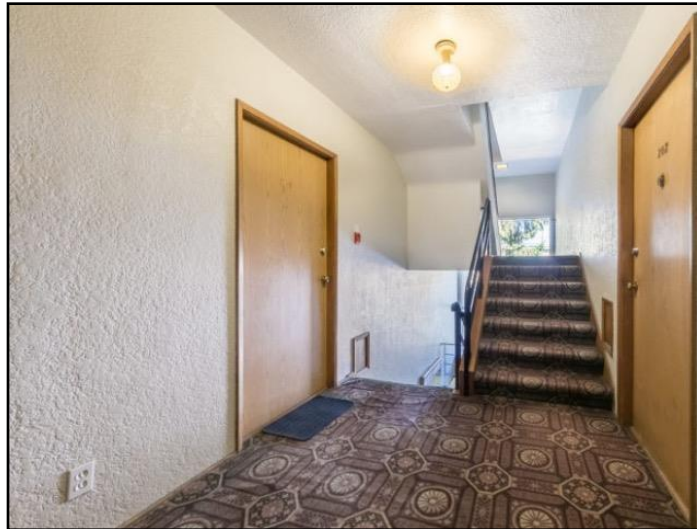
visible damage and some minor wear and tear. The rear entrance door and service entrance door are fairly satisfactory condition with some wear and tear and some repairs are required.
