YOUR INSPECTION REPORT

[REDACTED]
Vancouver, BC V6J 3S2

RE: Report No. 1054
[REDACTED]

GENERAL DESCRIPTION OF PROPERTY

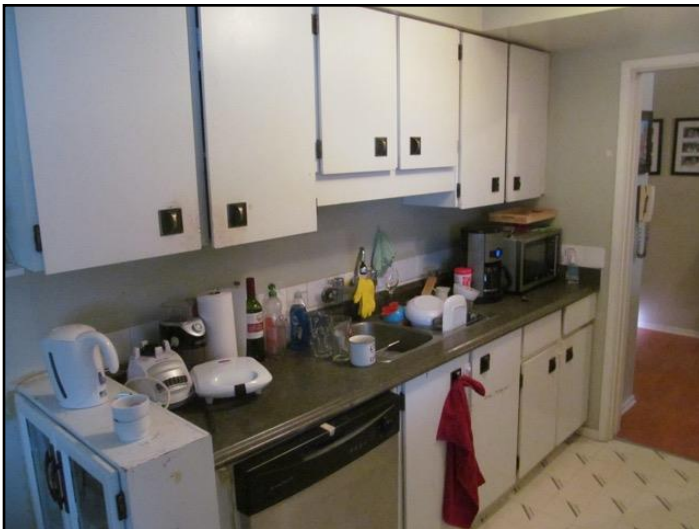
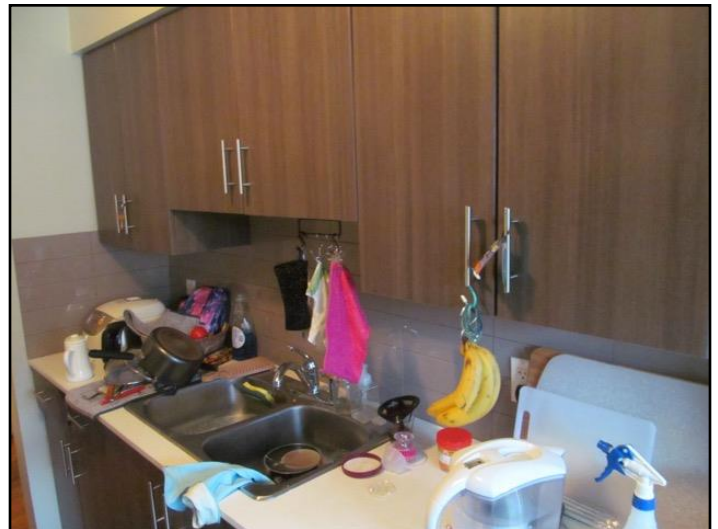
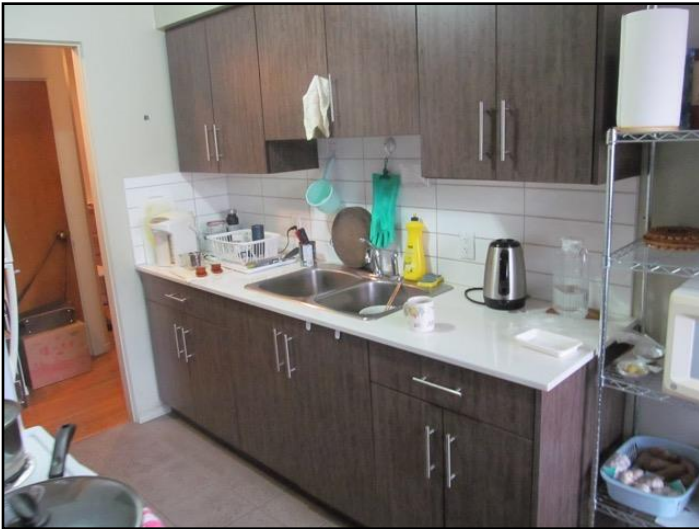
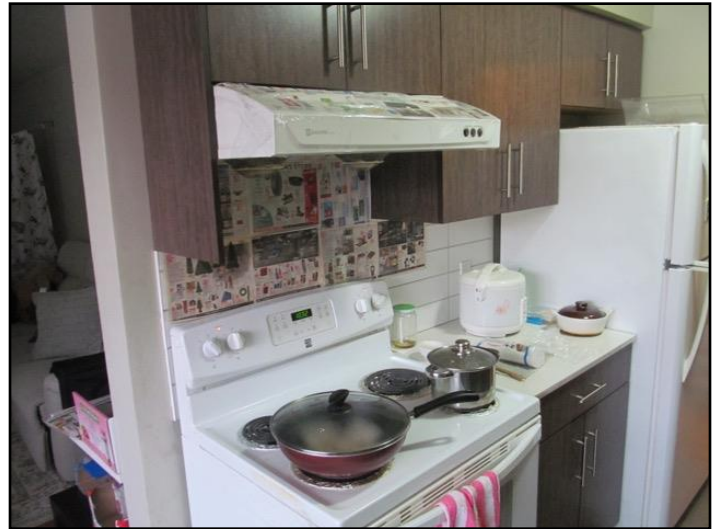
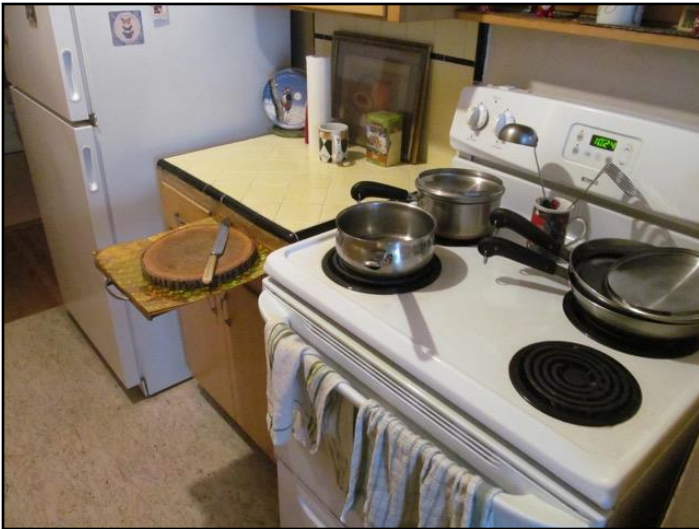
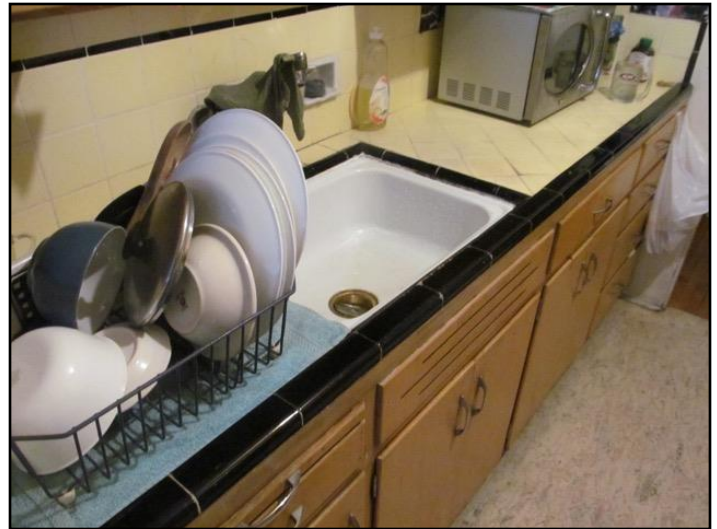
Counters and cabinets: • The suites inspected in the building have different type and materials of the cabinets and counter tops. They are in fairly satisfactory condition to satisfactory condition with some stains along with typical wear and tear type damage. All inspected door and drawer hardware were functional.

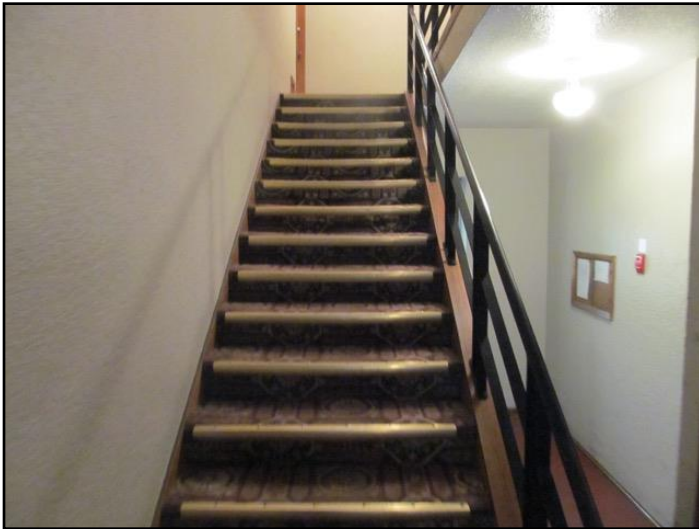
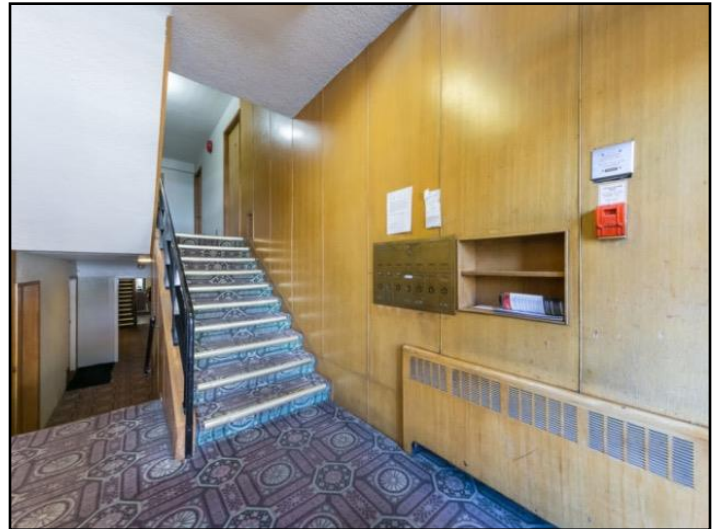
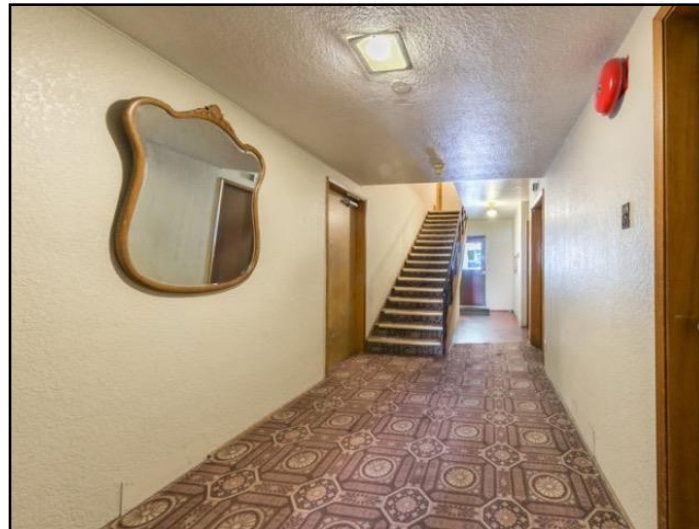
Stairs and railings: • The building has two separate sets of interior wood framed stairs with floor mounted handrails. These stairs and handrails are in fairly satisfactory condition with no visible trip hazards or damage.

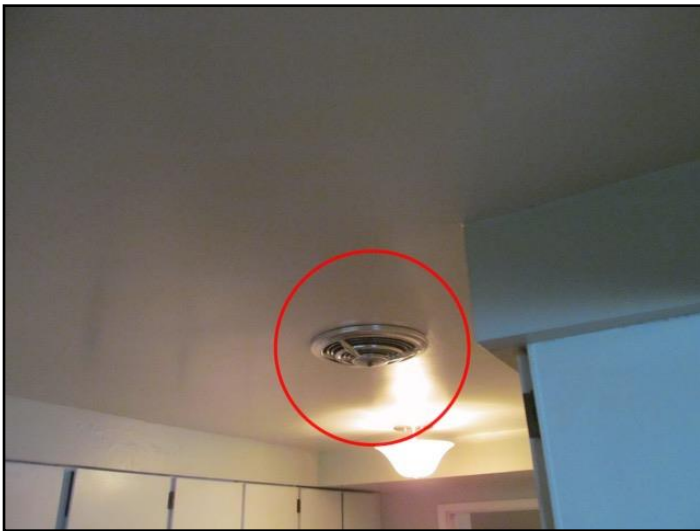
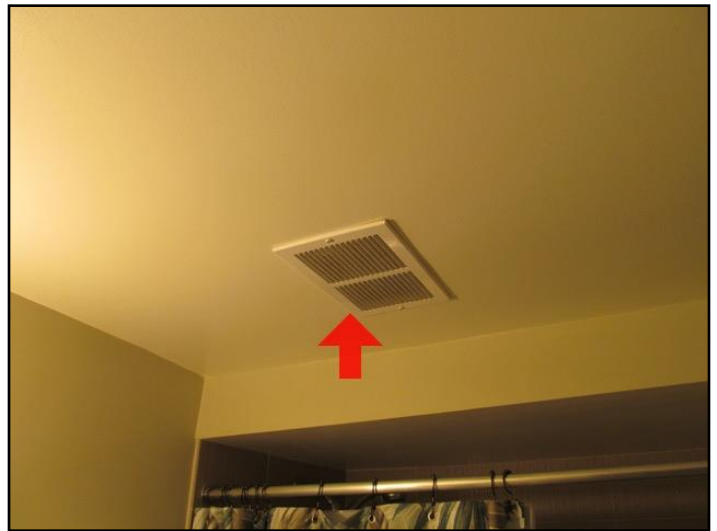
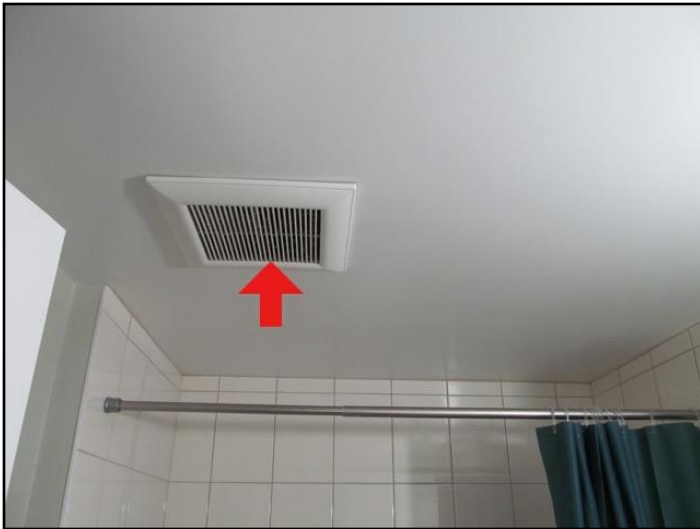
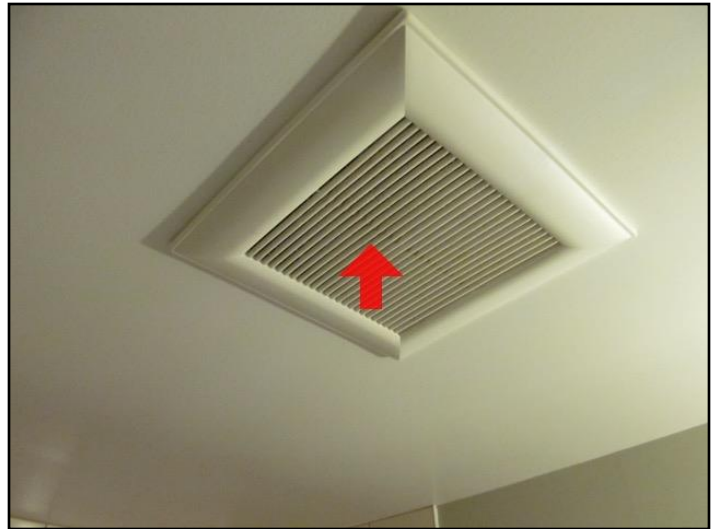
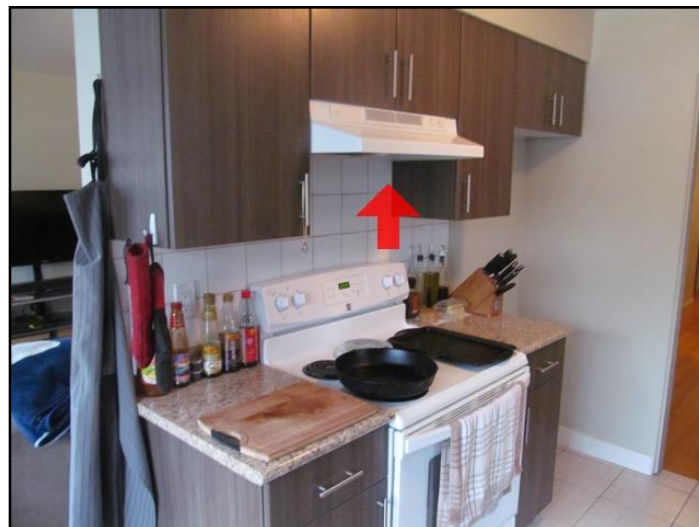
Inventory Exhaust Fan: • There are various bathroom exhaust fans and kitchen fans. Some inspected bathroom fans are noisy and some are partially blocked with debris and need cleaning but are otherwise in fairly satisfactory operating condition. There is no installed bathroom exhaust fan in penthouse suite 301.
