RIGHT AT HOME

Property Inspection Report

Property address: **3500 Shields**

Inspection date: **Wednesday, February 14, 2018**

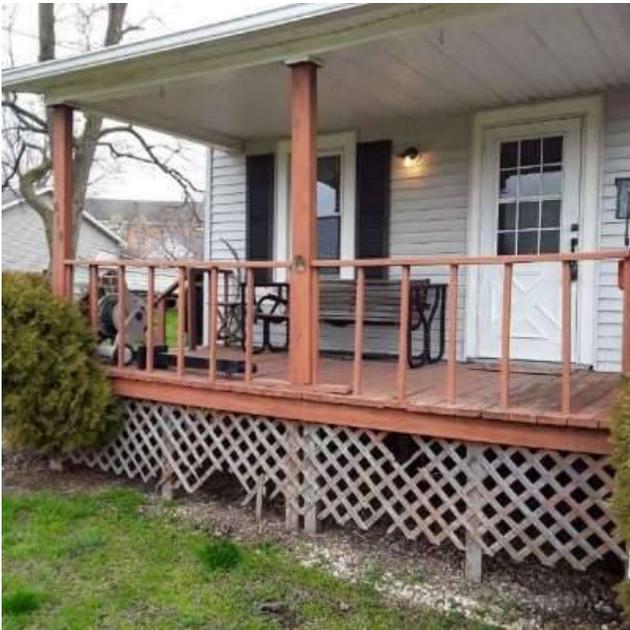
Photo 3-1

Guardrails at one or more locations with drop-offs higher than 30 inches had gaps that were too large. This poses a safety hazard for children (e.g. falling, getting stuck in railing). Guardrails should not have gaps or voids that allow passage of a sphere equal to or greater than 4 inches in diameter, or 6 inches in diameter at triangular spaces between stair edges and guardrails. At a minimum, the client should be aware of this hazard. Recommend that a qualified contractor repair or replace guardrails per standard building practices.

Area of main concern is front porch.

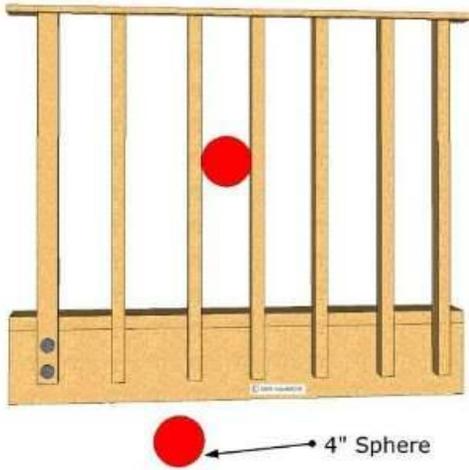
Photo 3-3

The rear porch is measured approximately 23 inches. Consider adding guardrail here for added safety.

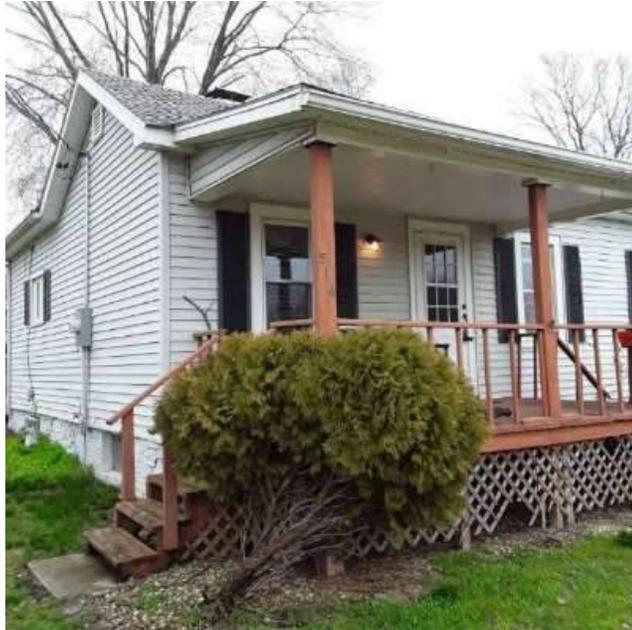
Photo 4-2

Soil was in contact with or close to wooden stairs at one or more locations. This is a conducive condition for wood-destroying organisms. Soil should be graded and/or removed so no wood-soil contact is present, if possible. Otherwise, installing products such as borate-based Impel rods may help to prevent infestation and damage. For more information, visit: <http://www.reporthost.com/?IMPEL>

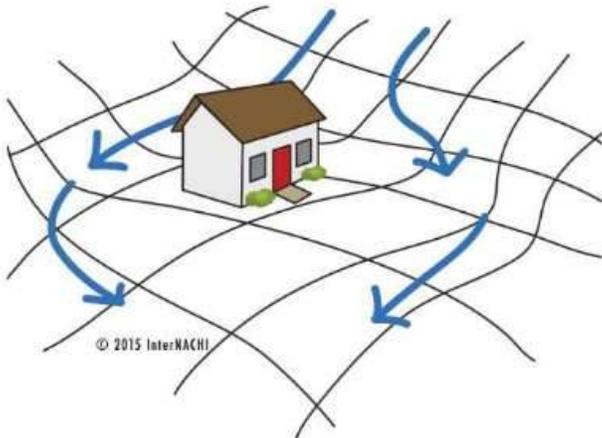
Photo 7-3

The soil or grading sloped down towards building perimeters in one or more areas. This can result in water accumulating around building foundations or underneath buildings. At a minimum, monitor these areas, and areas under the structure in the future for accumulated water. If water does accumulate, recommend grading soil so it slopes down and away from buildings with a slope of at least 1 inch per horizontal foot for at least 6 feet out from buildings.

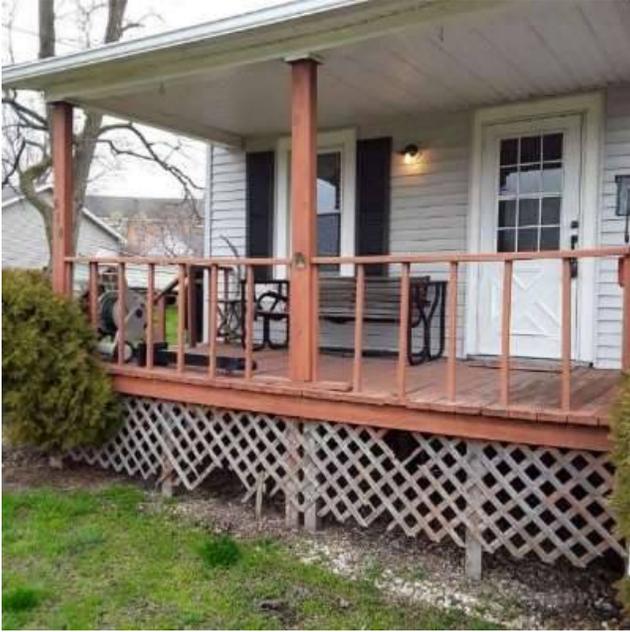
Photo 8-1

Most areas of the deck and/or porch substructure were inaccessible due to permanently installed skirting. These areas couldn't be evaluated and are excluded from the inspection.

Area of concern is front porch.

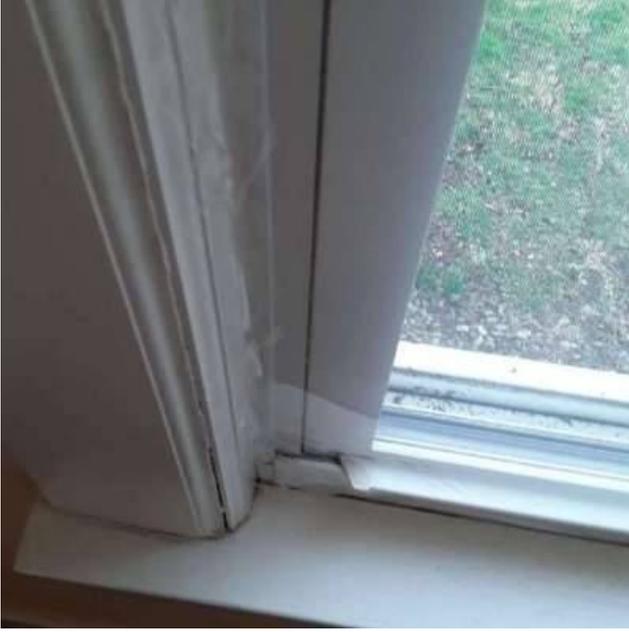
Photo 65-1

65) **i** Some windows were covered with plastic shrink-type material commonly used in winter. These so does are not fully evaluated.
