RIGHT AT HOME

Home Inspection Report

Property address: **1060 West Addison
Chicago, Il 60611**

Inspection date: **Saturday, April 14, 2018**

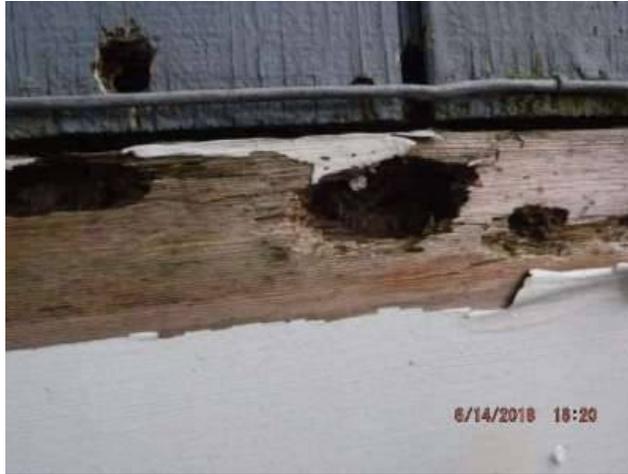
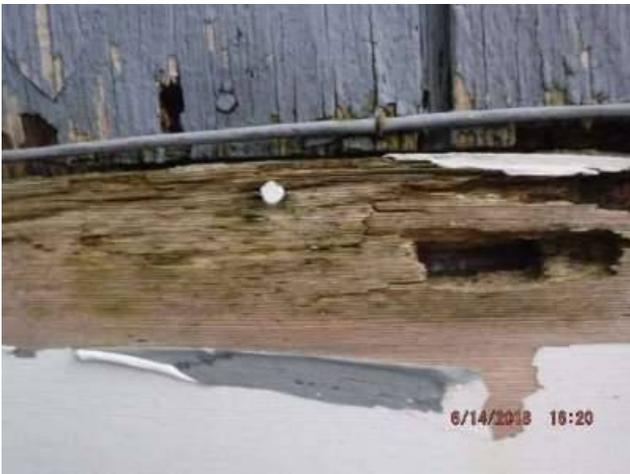
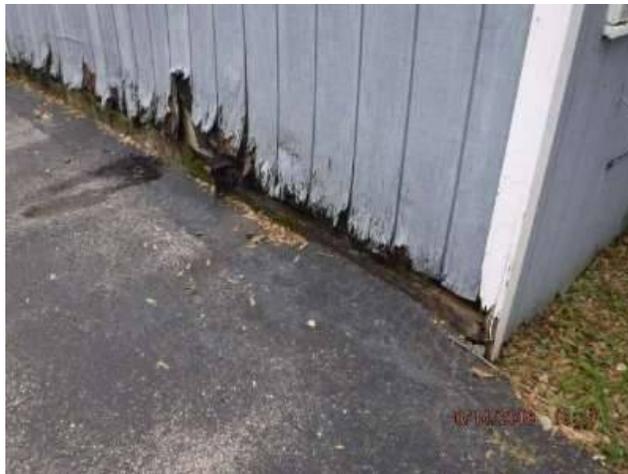
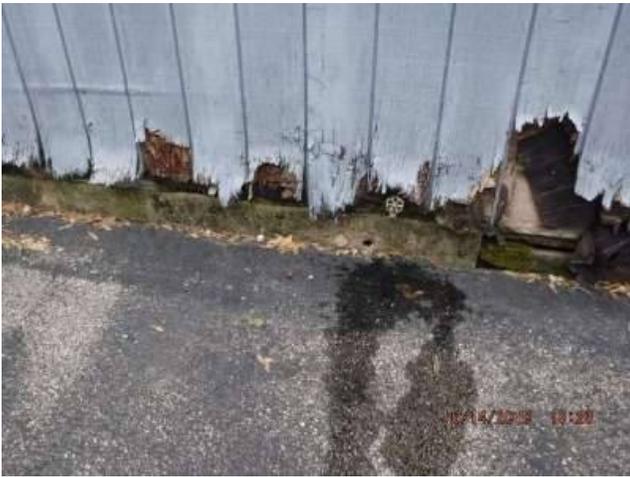
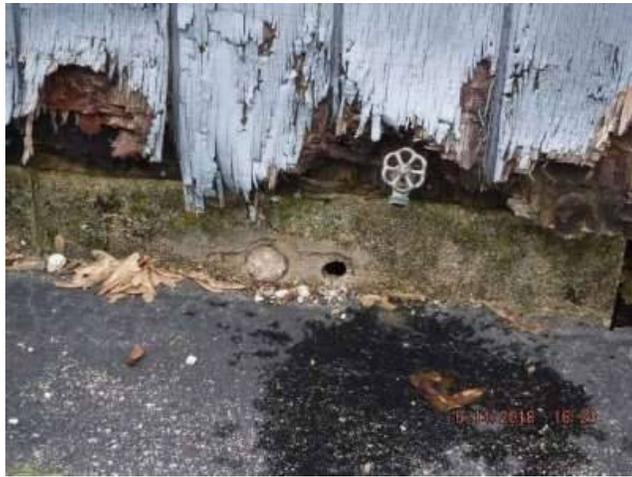
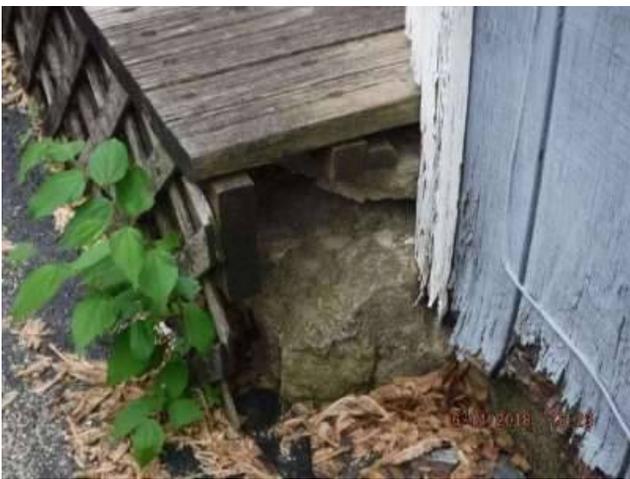
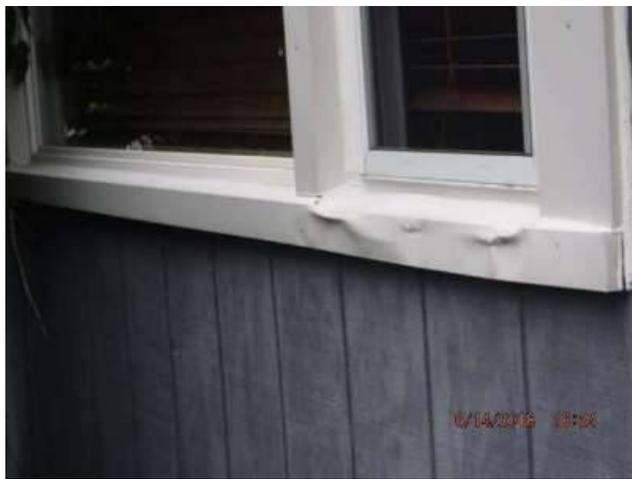
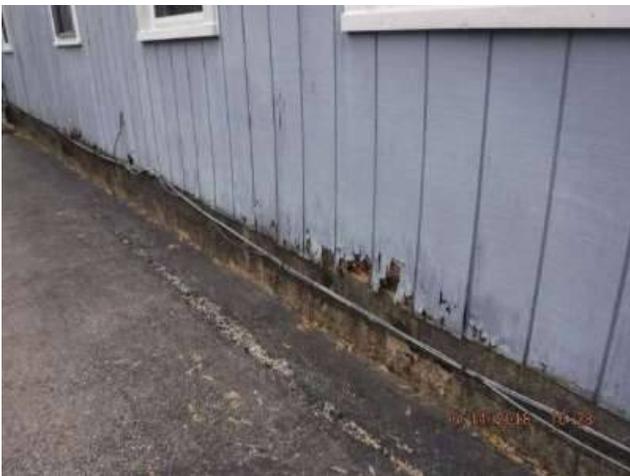
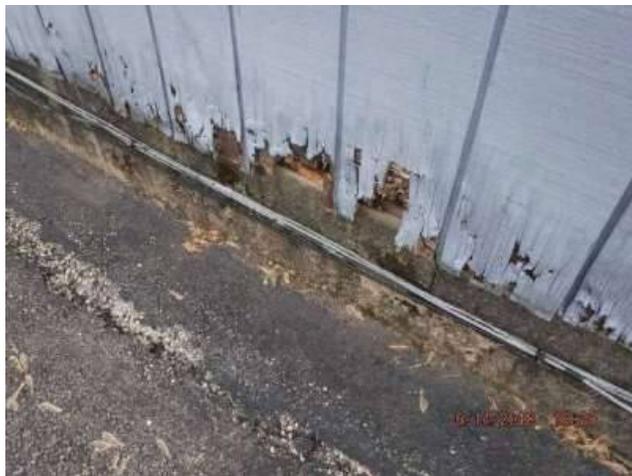
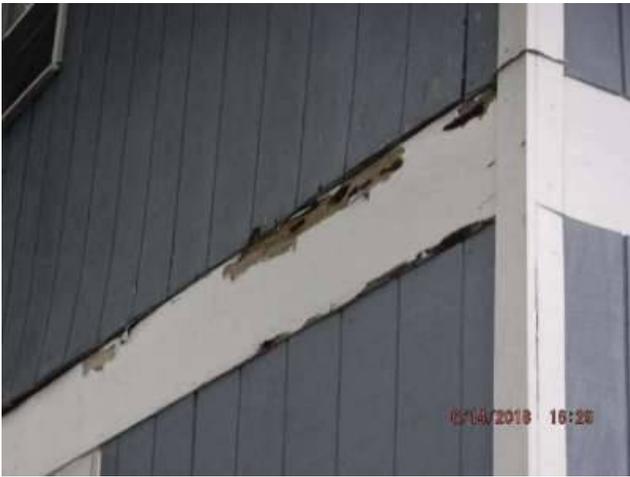
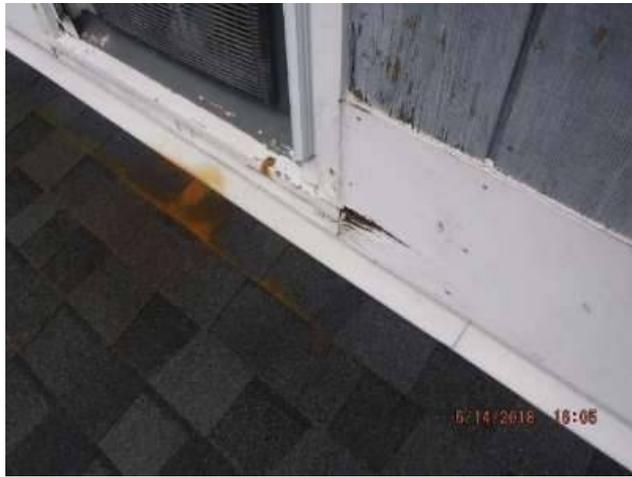
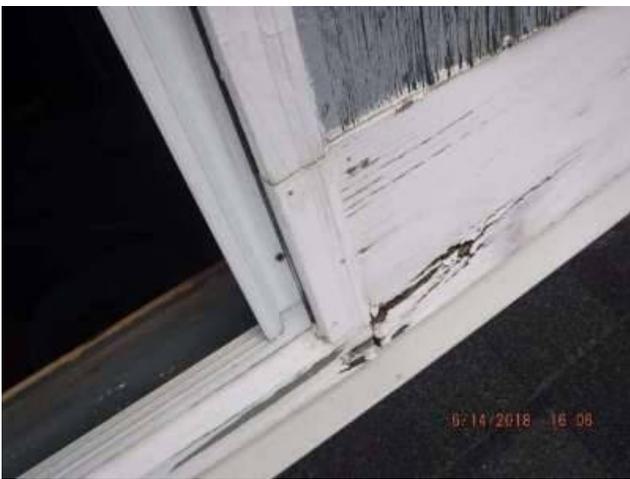
Siding is damaged and/or deteriorated in one or more areas. A qualified contractor should evaluate and make repairs and/or replace siding as necessary to prevent water and vermin intrusion.

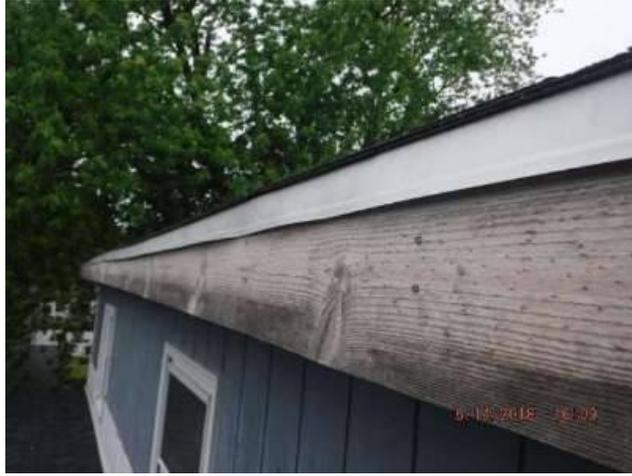
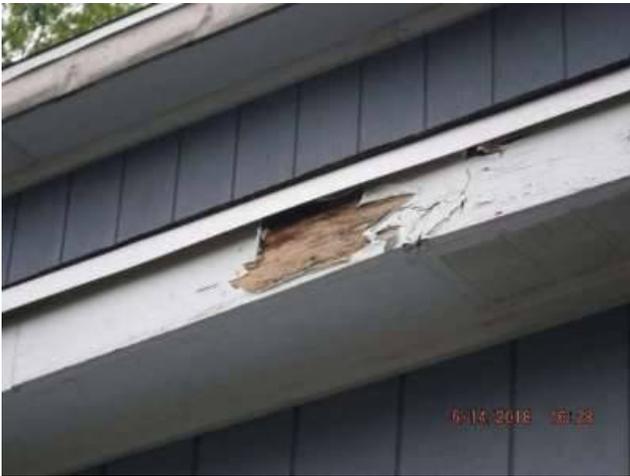
Fascia boards are damaged or deteriorated in one or more areas. A qualified contractor should evaluate and make repairs as necessary.

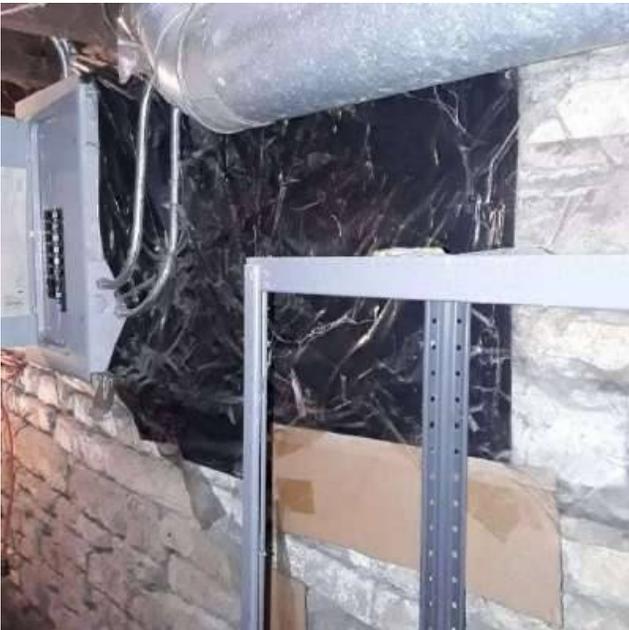
Photo 57-1

There is black plastic covering something the right of electric service panel. This was not removed. Consider asking the current owner why this is there.
