## Gaskell and 152<sup>nd</sup> Well

### **Gaskell and 160<sup>th</sup>SE Well**

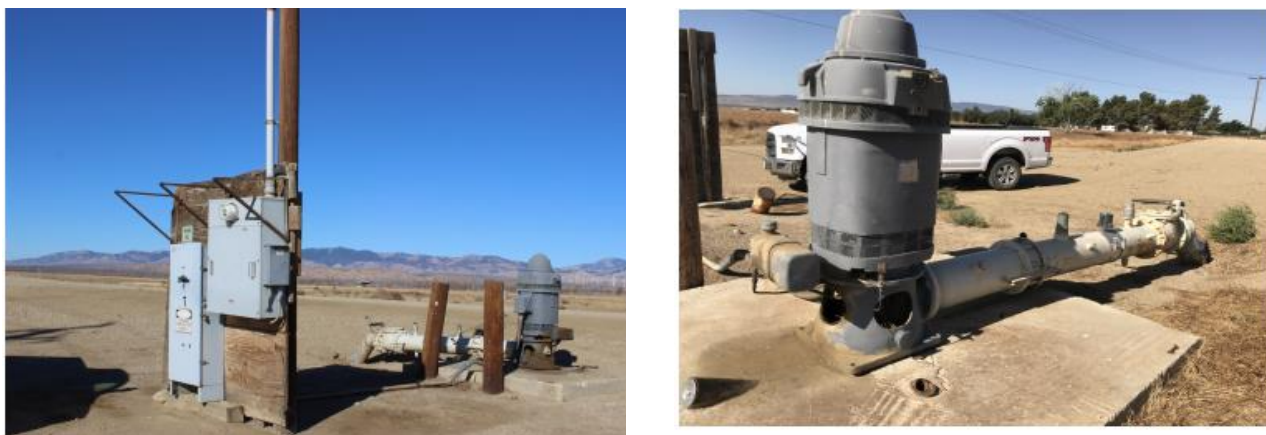
**Figure 1. Well at Gaskell and 152<sup>nd</sup>**

SCE performed well tests on the WSWB wells in October and November of 2021. These tests (Table 1) found some results for the Gaskell/152<sup>nd</sup> (G152) well that were worrisome. Historically this well had produced about 1,200 gpm but that production level had dropped to between 919 and 819 gpm. Especially worrisome was the drawdown of between 111 and 125 feet. This meant that the well was pumping water out faster than the water could enter the well casing.

A well video log was performed to find out what was the issue was. The well casing was perforated with vertical slots approximately 1/8 inch in width and 1 inch in length, spaced about 2-inch intervals to let water into the well itself. Significant tuberculation (iron oxide blisters formed by aerobic bacteria known as biofouling) was observed. Below about 490 feet deep 80 percent of the casing slots were blocked (Figure 2), increasing to 100 percent of the casing slots blocked below 580 ft (the well is about 800 ft deep) as Figure 3 shows. This biofouling was an issue. Not only did it compromise the ability of the well to produce water but, under an APH scenario where we are putting water back down into the well, this would force the biofouling into the aquifer, contaminating the aquifer.

Rehabilitation of the well would include mechanically cleaning the casing, acidifying the well with phosphoric acid and swabbing it out, and purging the well to try and remove accumulated sediment. The cost of this rehabilitation would be several hundred thousand dollars with no guarantee of success – the biofouling on the well casing usually indicates that gravel pack and

formation on the outside of the casing is also plugged and simply cleaning the well casing will not solve the problem

The Interconnection application (NST-206659) approved by SCE on March 22, 2022. We notified SCE that we were not going to use this well for the APH demonstration project due to biofouling issue and needed to switch to an adjacent well.

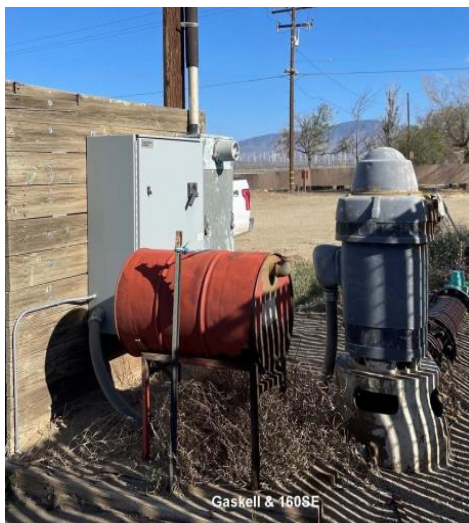
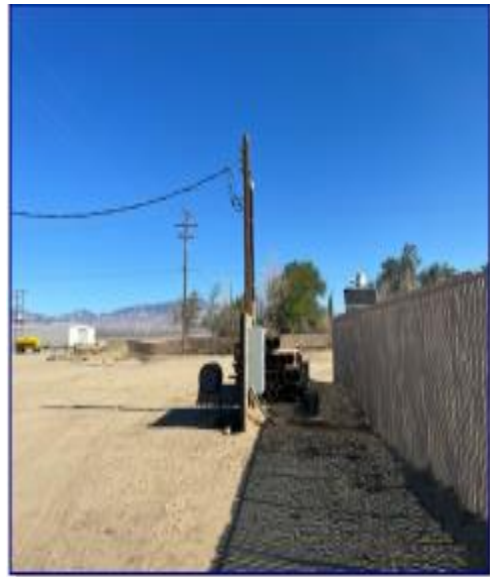
**Figure 4. Well at Gaskell and 160thSE**

The well just around the corner (Gaskell and 160thSE) from the original fouled well was selected for the replacement demonstration project. It is a slightly smaller well (200 hp versus 250hp) but there was no indication of any issues with this well from the pump tests (Table 1). The interconnection application (NST-290291) was submitted in early July 2022.

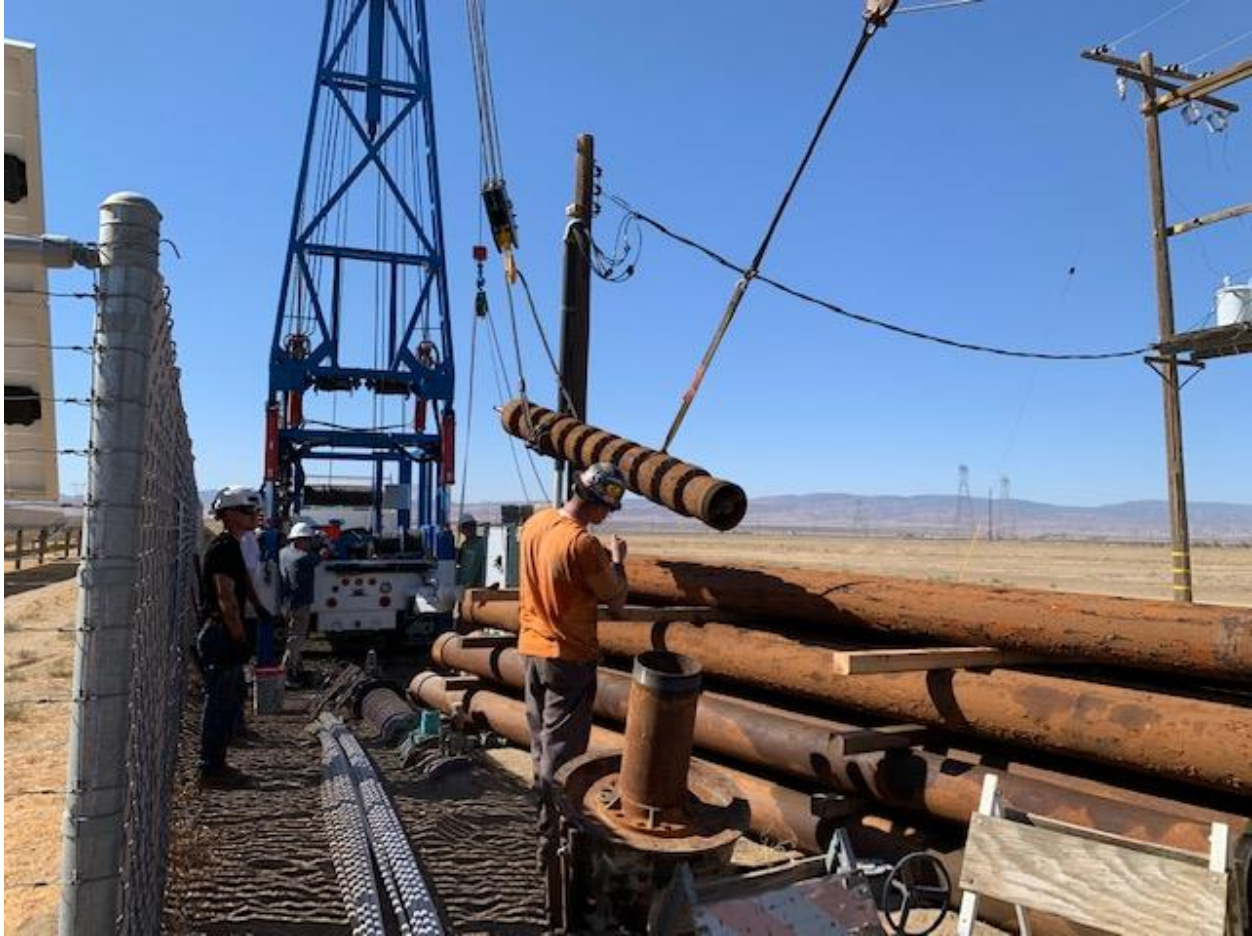
**Figure 5. Pump Bowls and Impellers**

Pulling the well (removing all the well pipe in the well hole) and installing the APH valve below the pump impellers (Figure 5) and then reinstalling the pipe down the well hole was scheduled August 30-September 2, 2022. We immediately ran into two problems.

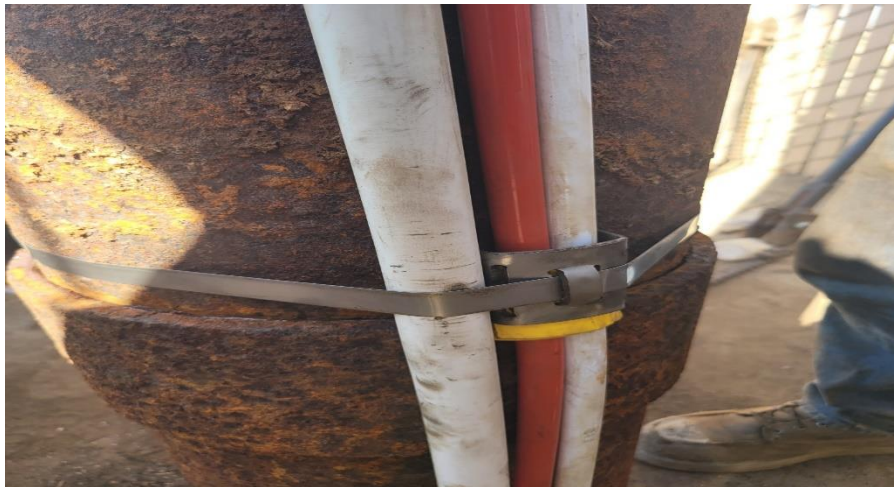
**Figure 7. APH Valve Hydraulic Hoses on Exterior of Well Pipe**

This was a serious problem. The APH valve at the bottom of the well operates using hydraulic tubing running down the side of the well pipes (Figure 7), and the protrusions at 553 ft would chafe and eventually sever the tubing, rendering the APH valve inoperable.
