INFORMATION FOR MEMBERS OF THE PUBLIC ON CREUX HARBOUR

Visual Inspection & Geotechnical Assessment

Creux/Maseline Harbour & La Coupée, Isle of Sark

Report No. 3265-01

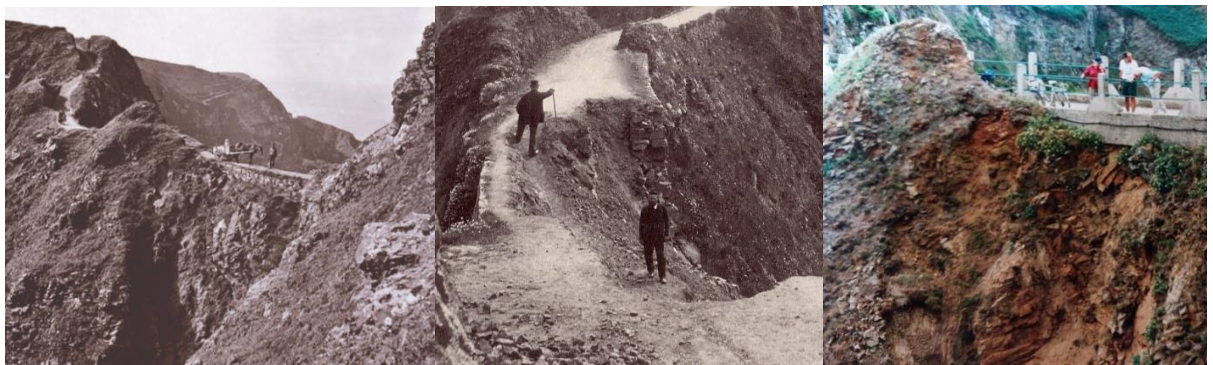
Figure 2 – From left to right. Photograph showing La Coupée as a narrow track for horse and carts, photograph showing a failure of the blockwork wall to the northern extent of La Coupée and a photograph showing a more recent failure circa 1996. (See Appendix C for further photographs – Credit La Société Sercquaise).

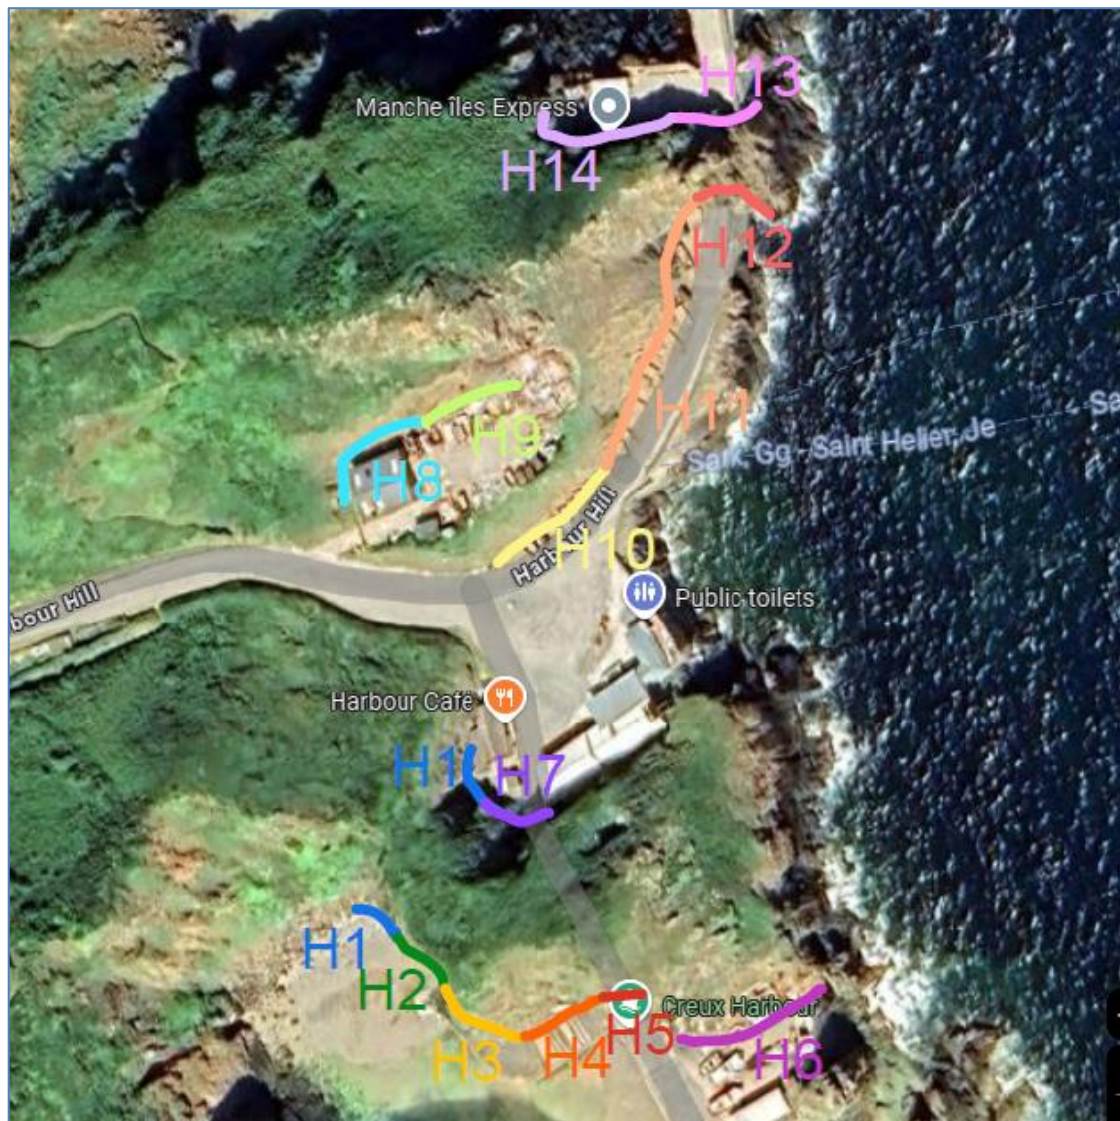
Figure 4 – Markup of locations inspected within the Creux/La Maseline harbour area (H1 – H14).
