Report for
Chief Pleas of Sark

Visual Inspection & Geotechnical Assessment

Creux/Maseline Harbour & La Coupée, Isle of Sark

Report No. 3265-01

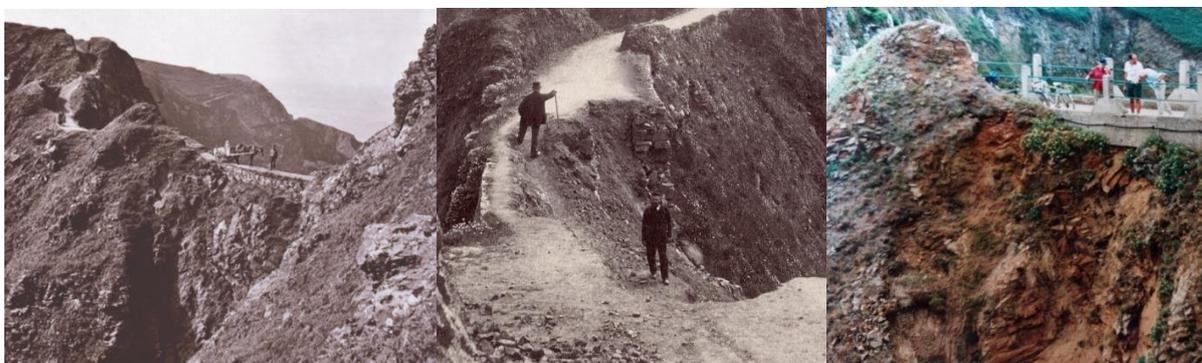
Figure 2 – From left to right. Photograph showing La Coupée as a narrow track for horse and carts, photograph showing a failure of the blockwork wall to the northern extent of La Coupée and a photograph showing a more recent failure circa 1996. (See Appendix C for further photographs – Credit La Société Sercaquaise).

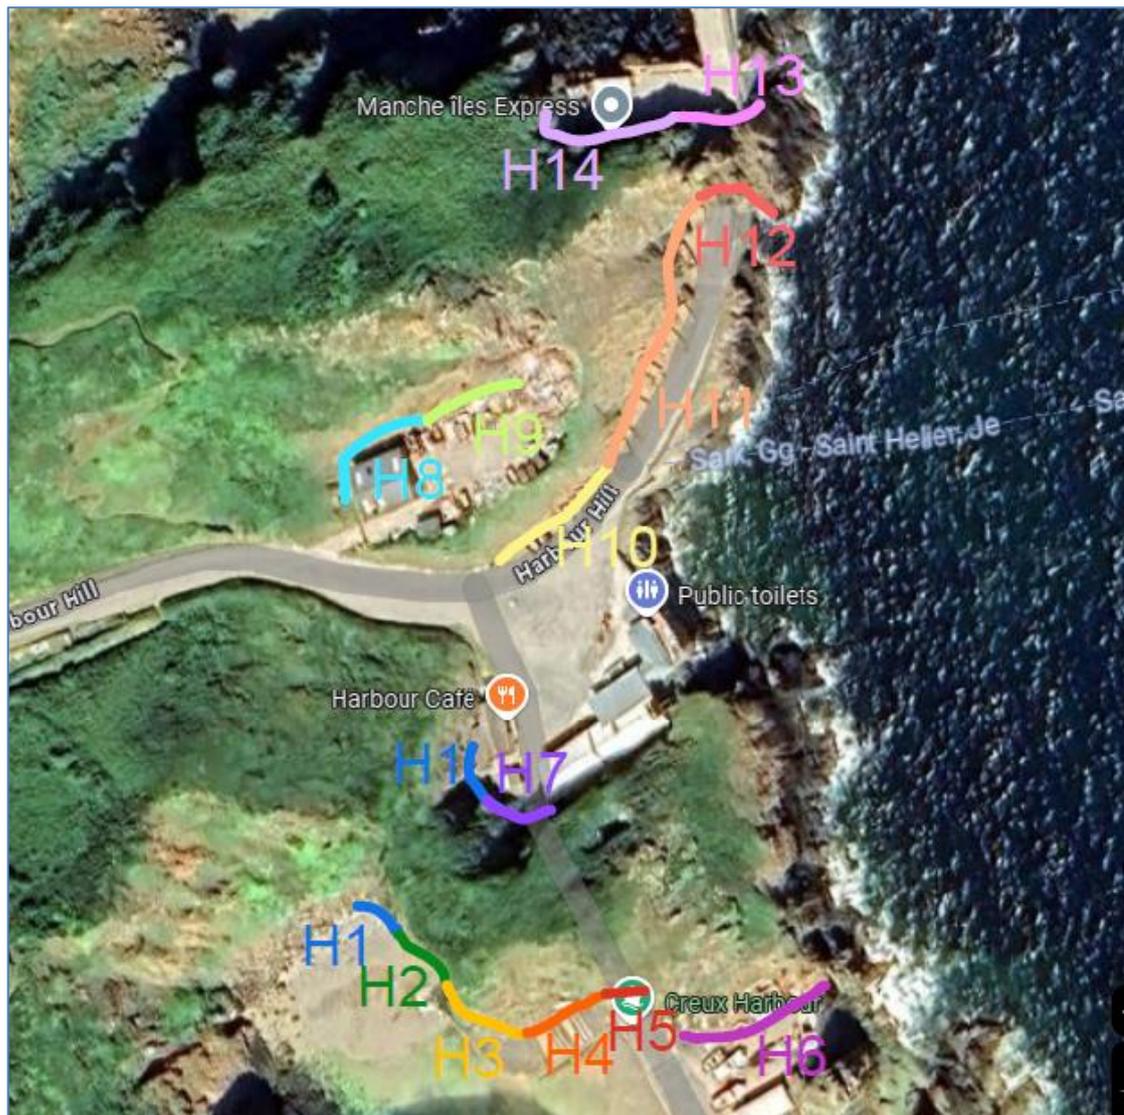
Figure 4 – Markup of locations inspected within the Creux/La Maseline harbour area (H1 – H14).
