GENSER-FORMAN INC.

TRIUMPH DISTRIBUTORS

BULLETIN #T-60-7
DATE: FEBRUARY 23, 1960
SUBJECT: TR-3 REAR AXLE CROSS PIN
PART NO. 100844 EFFECTIVE FROM
COMMISSION NO. TS-56886 TO
TS-59204

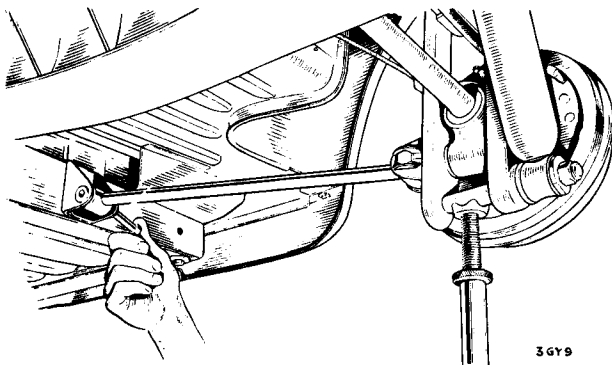
Fig. 4. Utilizing a jack to relieve load on damper

1. Jack up rear of vehicle and support on chassis stands.
2. Remove hub disc, wheel nuts and road wheel.
3. Disconnect the flexible brake hose, at its inner end, from the chassis bracket and steel pipe.
4. Disconnect the handbrake cable, at its outer end, from the handbrake lever.
5. Utilize a jack, as shown on Fig. 4 to relieve the damper of load.
6. Remove the four nyloc nuts and bolts that secure the universal coupling flange of the outer axle shaft to the flange of the inner axle shaft.
7. Remove the nyloc nuts, washers and bolts from the radius arm attachment eyes (Fig. 4) and detach radius arm.

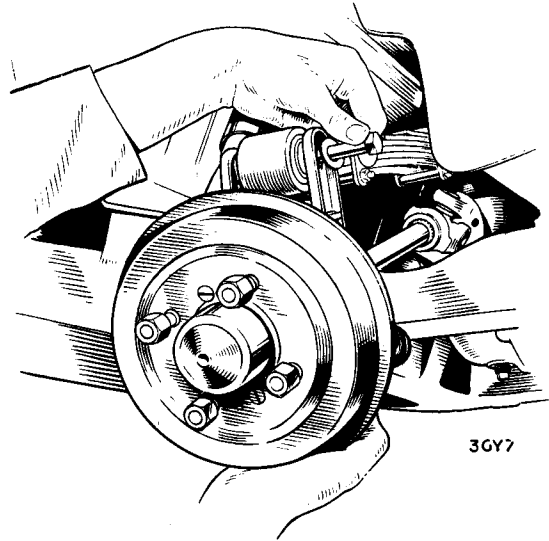
Fig. 5. Removing spring eye bolt

8. Remove the nyloc nut (11), and washer (10) from each damper attachment eye.
9. Remove the bolt from the damper upper attachment eye and withdraw the damper and rubber bushes (9).
10. Lower and remove jack from beneath vertical link plates.
11. Whilst supporting brake assembly remove the nyloc nut, plain washer, and bolt from the road spring eye, Fig. 5.
12. Withdraw the hub and outer axle shaft assembly from vehicle.
