## Home Integrity Home Inspection

## Home Inspection Report

**123 Main Street**

**Anywhere, OH 44123**

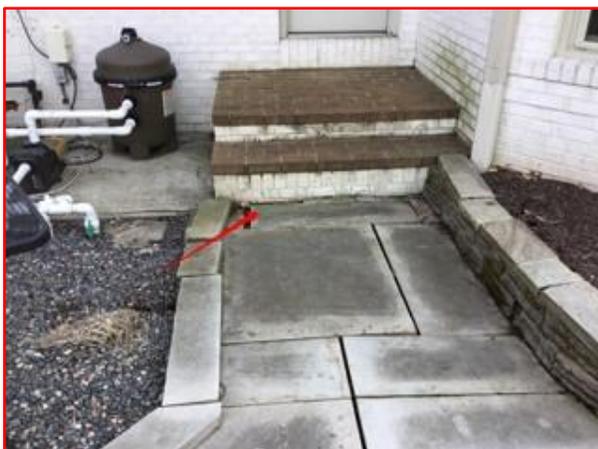
Figure 1-4

1) In the backyard there are several areas of the sand stone patio that have settled and cracked. There are a few step treads that have movement as you step on them. Recommend repair as needed by a professional patio contractor

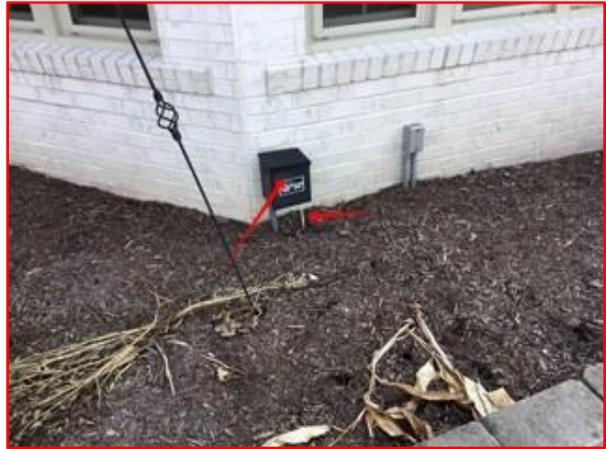
Figure 5-2

5) In the backyard it appears like they used Romex 110 volt wiring to run the low-voltage lighting wiring from the transformers. There is an outlet in the far back garden bed that is not functional. Recommend further evaluation of the wiring by a certified electrician.

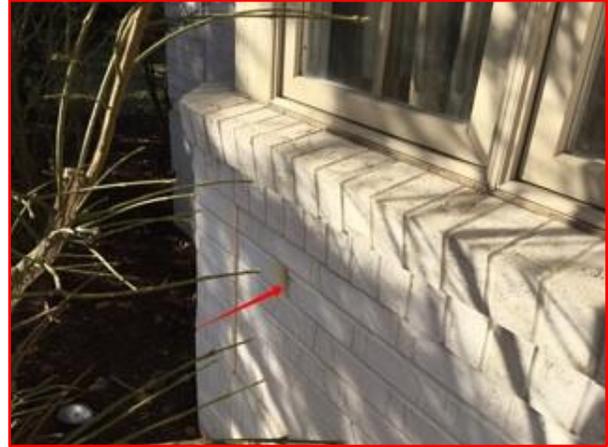
Figure 6-2

6) At the front south corner of the house there is a hole in the brick. Recommend sealing this hole properly.

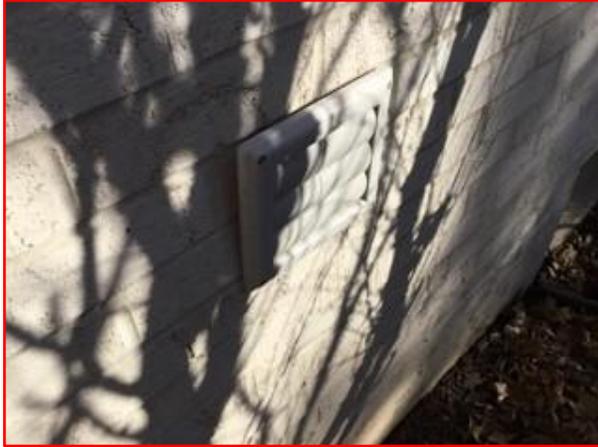
Figure 21-3

17) The back outside AC Condenser is close to the dryer vent. This condenser is an air cooled unit and it can get covered in lint and debris which can lower the efficiency and life of the unit. Recommend maintaining this condenser a few time per summer to keep these cooling fins cleaned by a professional HVAC technician

The dryer vent siding cap is loose. Recommend securing it properly to the brick.

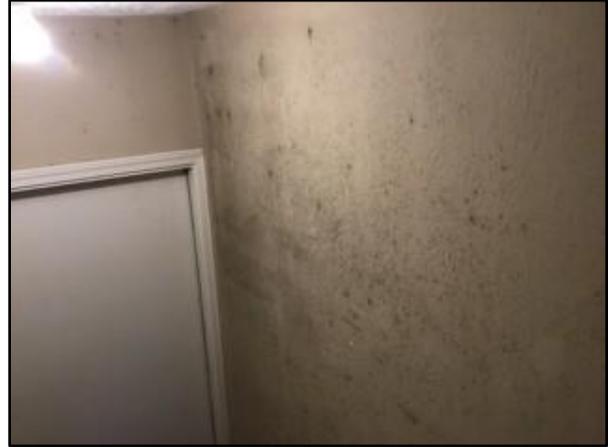
Figure 7-2

7) In the garage on the drywall at the base of the walkout stairway is some discoloration that may be mold. This can be easily treated and removed by a professional. Recommend further evaluation and mediation by a mold specialist.

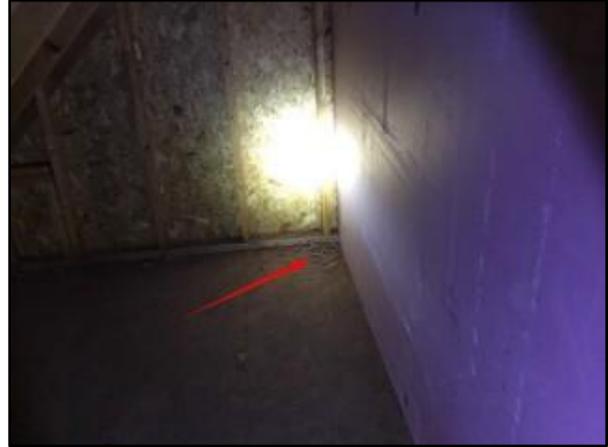
Figure 8-2

8) In the attic there are indications of mice present. Recommend having a pest control specialist evaluate and treat the home as needed.

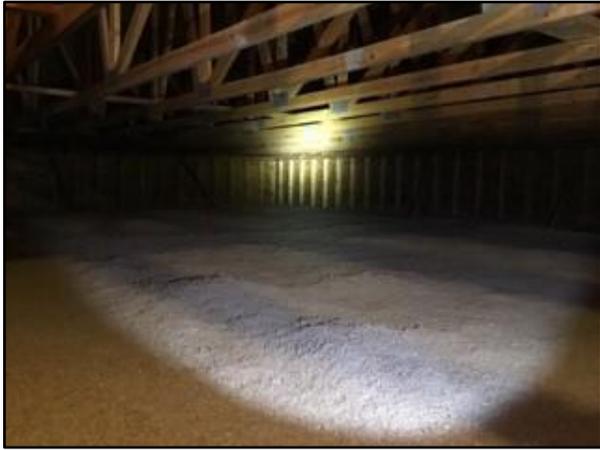
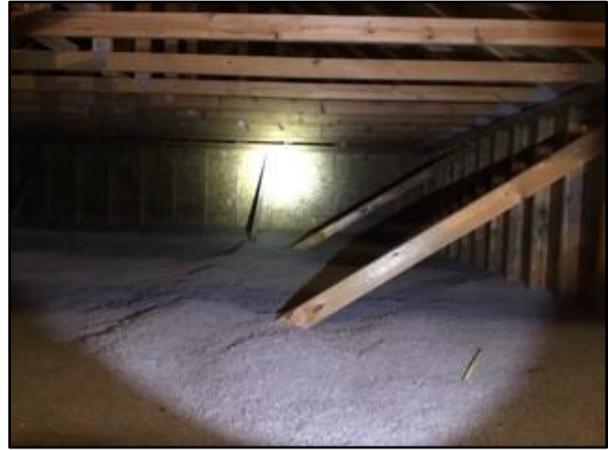
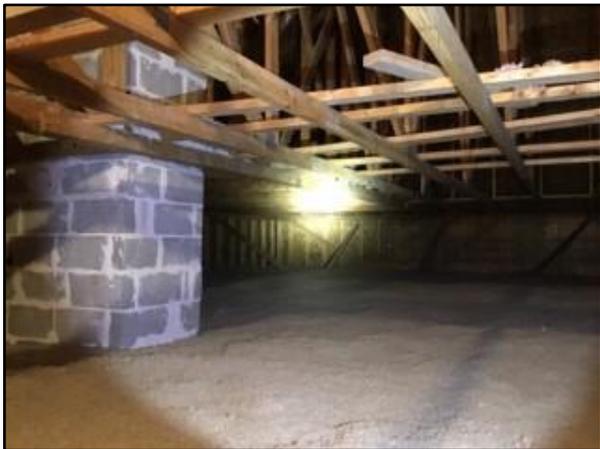
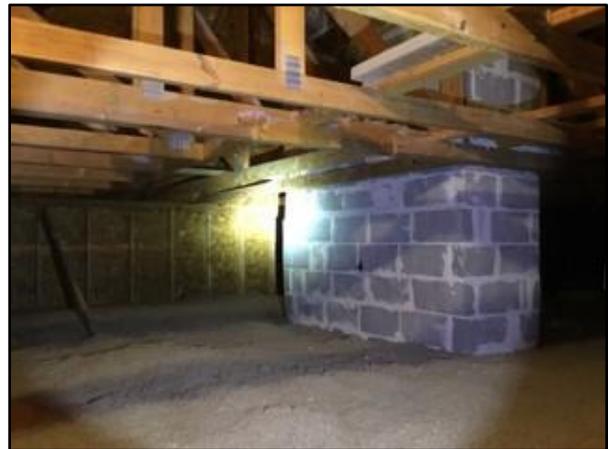
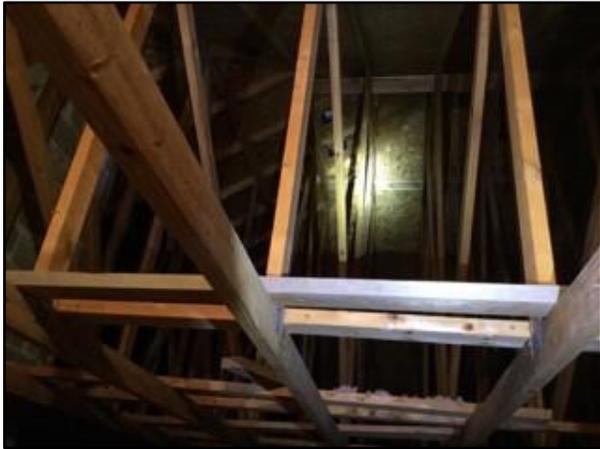
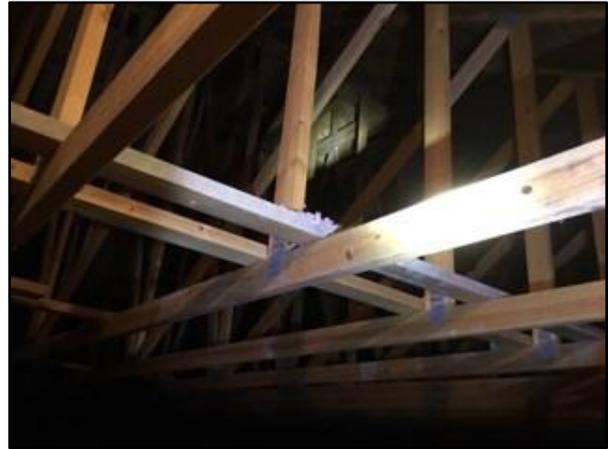
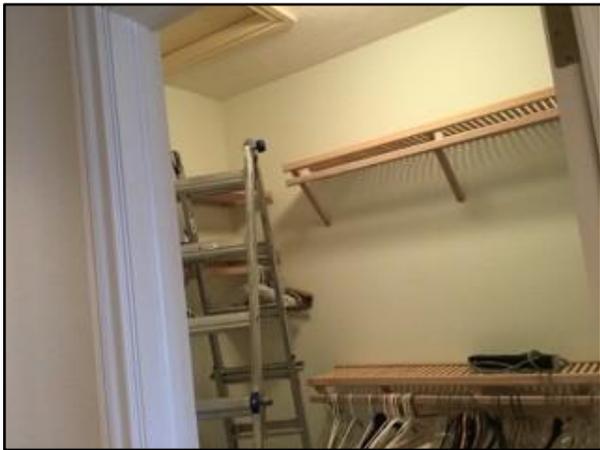
Attic view trusses and insulation at south closet hatch.

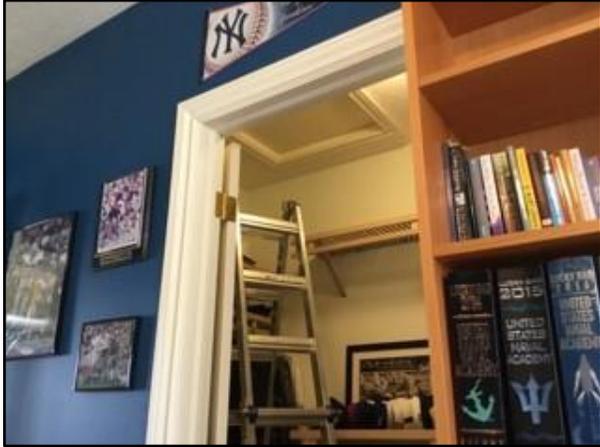
Figure 12-1

The attic hatch in the blue bedroom closet was not accessible. The hatch would not open with heavy pressure

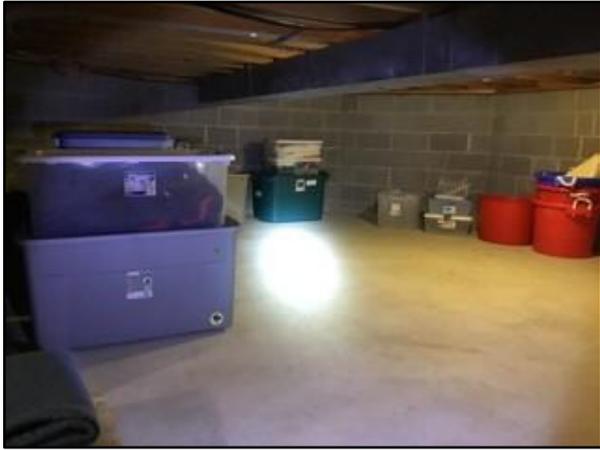
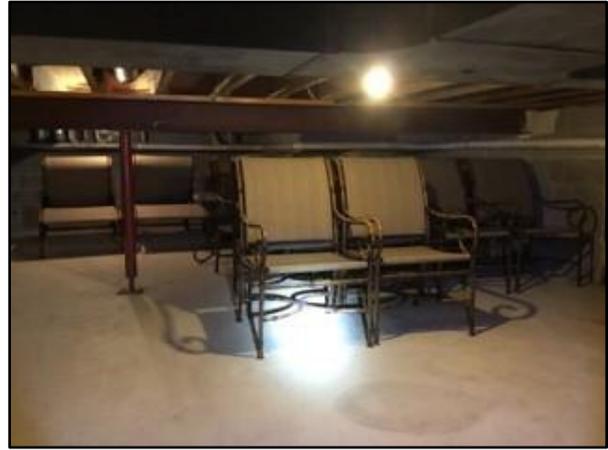
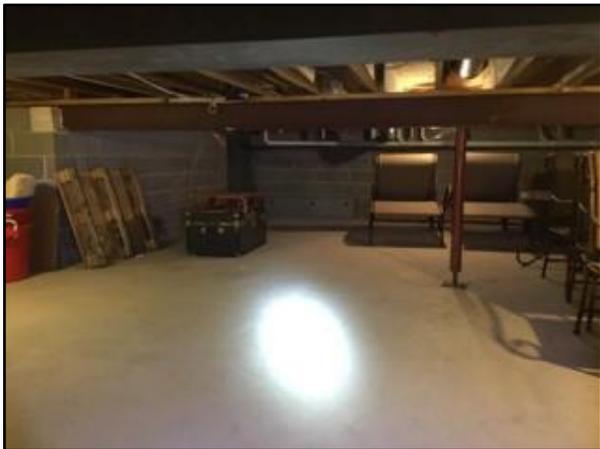
Crawl space views with homeowners belongings .

In the crawlspace there are some bait traps present. There are mouse droppings present. Recommend further evaluation by a pest control specialist

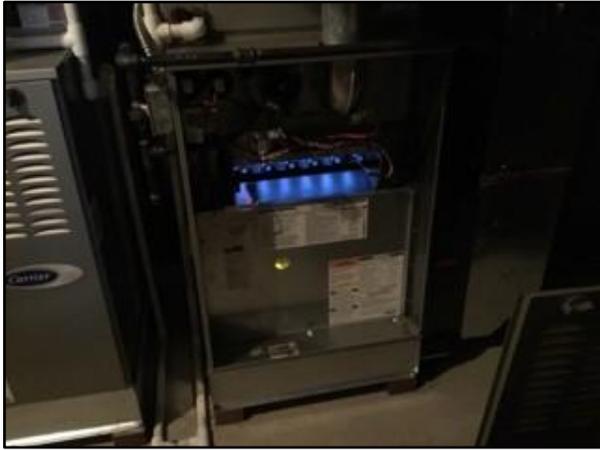
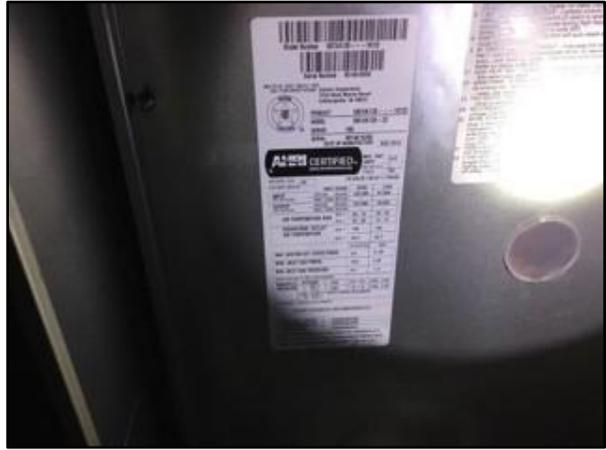
Comment 17:  
2014 Carrier furnace fired.

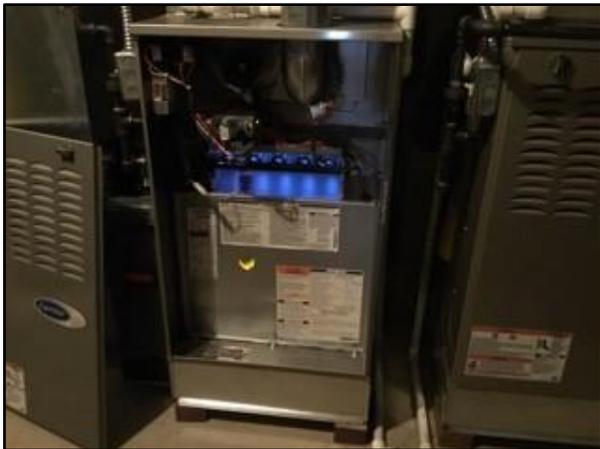
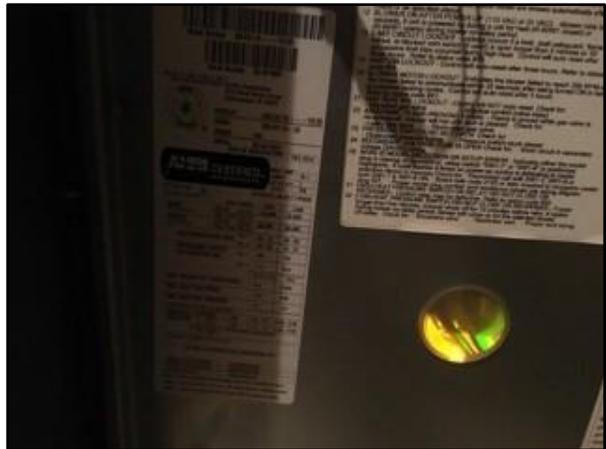
Comment 18:  
2014 Carrier furnace fired.

Furnaces over 10 years old should be checked, cleaned and serviced yearly by a licensed contractor.

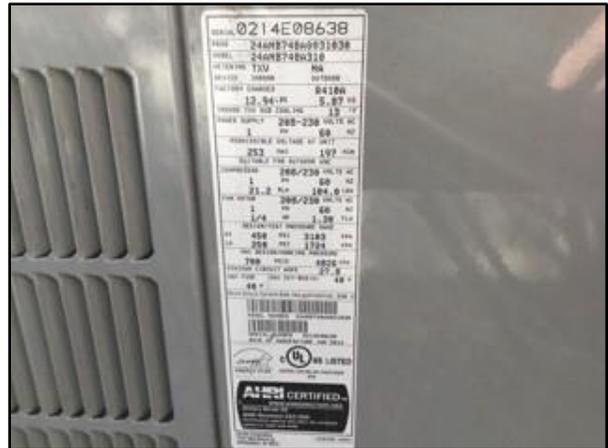
Figure 20-2

The air conditioning was not tested due to the outside temperature. It must be over 65 degrees for several days in order to run the system or damage can be done to the condenser. Recommend further evaluation as needed.

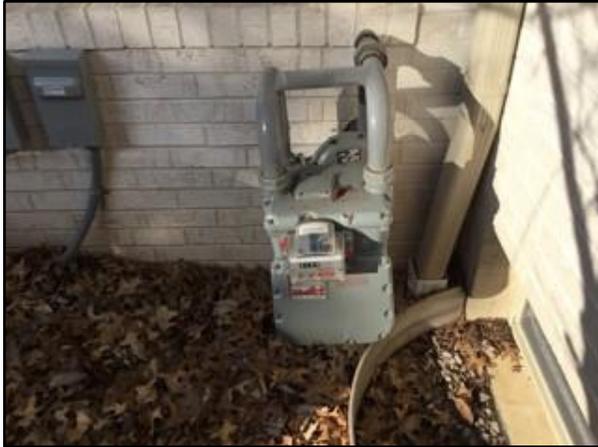
Figure 22-1

Comment 22:  
Outside gas shut off at the meter.

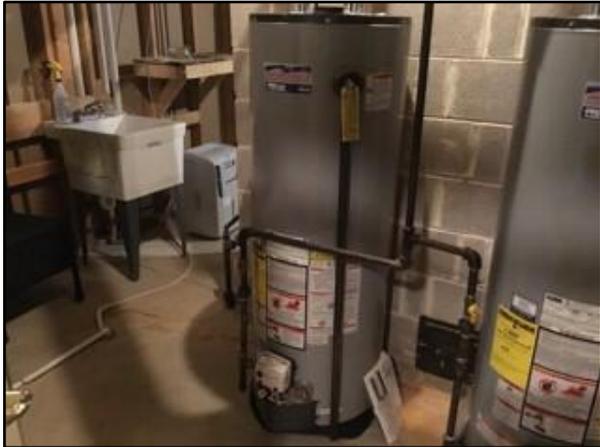
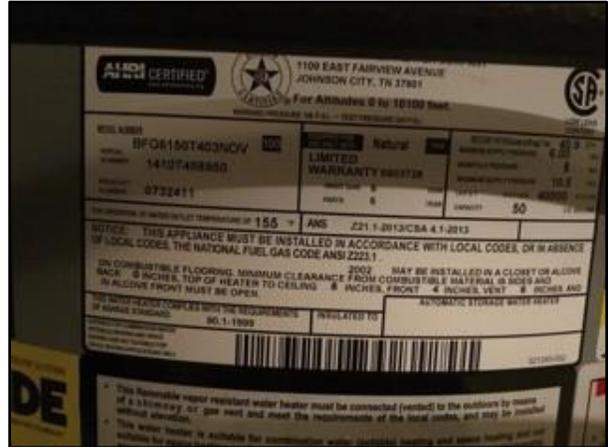
Comment 24:  
American 2014 50G.

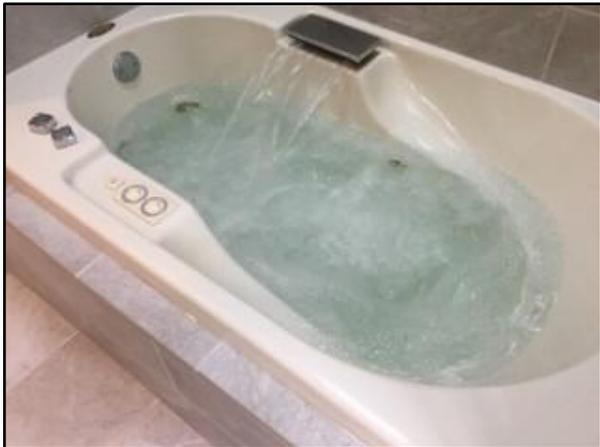
Figure 28-1

Comment 28:  
Spa was filled and tested. Normal operation

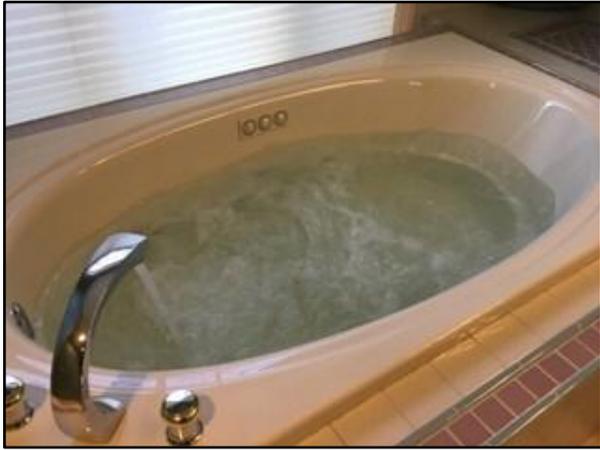
Figure 29-1

Comment 29:  
Spa was filled and tested. Normal operation

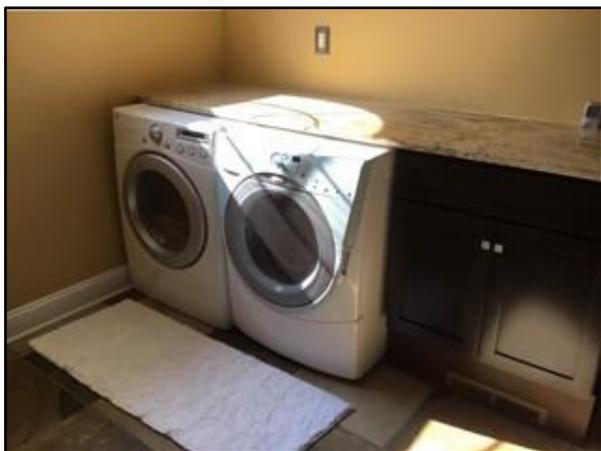
Figure 32-1

The master laundry room washing machine was not tested. There are clothes in the washer.
