Hi-Tide Condominium Association

Report #: 19269-14

Level of Service: Update "With-Site-Visit"

January 1, 2025 through December 31, 2025

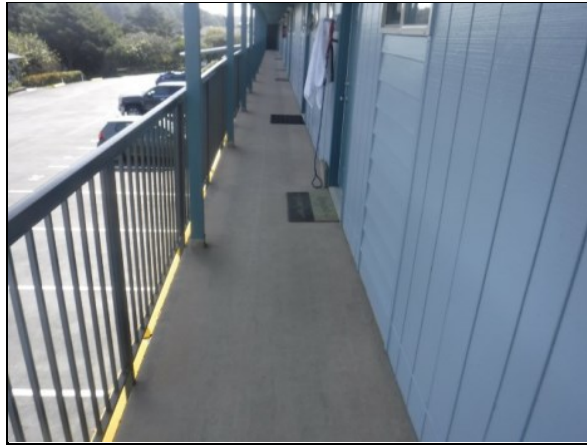
Comp #: 543 Vinyl Walkway: Bldg A - Replace

Comments: Vinyl walkway surfaces at building A appeared intact and generally damage free. No issues or unusual wear/damage observed or reported.

Typical service life of Duradek vinyl surface covering is 20 to 25 years. In our experience, this type of covering will eventually fade and wear over time, lose adhesion, necessitating replacement. Best to plan for regular cycles of replacement at roughly the time frame indicated below.

As routine maintenance, this surface should be inspected regularly for holes, gouges, voids or lifting and promptly repaired to ensure that the weather proofing of the adjacent/underlying building structure is maintained. Clean as needed with mild solution to prevent mildew.

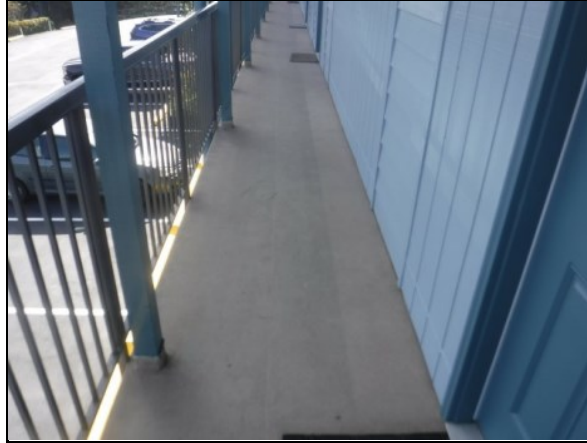
Comp #: 544 Vinyl Walkway: Bldg C - Replace

Comments: No significant damage or unusual deterioration observed with vinyl walkway surfaces at building C, and none reported.

Typical service life of Duradek vinyl surface covering is 20 to 25 years. In our experience, this type of covering will eventually fade and wear over time, lose adhesion, necessitating replacement. Best to plan for regular cycles of replacement at roughly the time frame indicated below.

As routine maintenance, this surface should be inspected regularly for holes, gouges, voids or lifting and promptly repaired to ensure that the weather proofing of the adjacent/underlying building structure is maintained. Clean as needed with mild solution to prevent mildew.

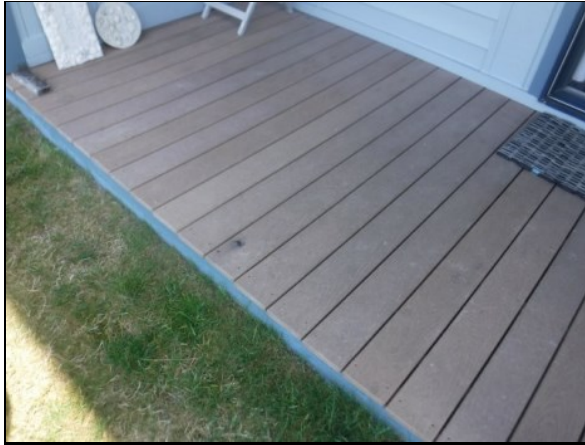
Comp #: 545 Composite Decks - Repair/Replace

History: Some repairs to deck structure reported in 2017

Comments: Composite decking observed at the first floor decks on building A. Generally stable, however, span at joists underneath composite walking surface may exceed recommendations resulting in a localized sagging appearance of walking surface over time.

Funding is included for replacement of only the composite boards that form the walking surface and does not include funding for replacement of structural framing. Evaluate structure framing prior to replacement to better determine scope of project. Costs can vary depending on scope of replacement.

Inspect boards and structure periodically and repair as needed.

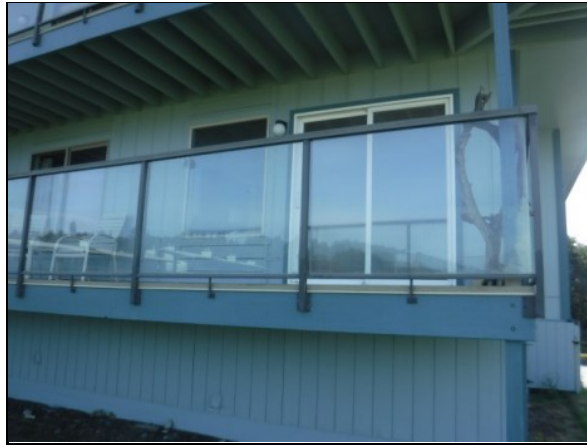
Comp #: 550 Glass Railing - Repair/Replace

Comments: Deck side railings are metal with glass inserts. Generally railing is mounted to the fascia, however occasionally mounted to the side privacy walls. Some surface deterioration (corrosion/peeling) observed due to harsh marine environment but mostly at mounting brackets. Overall railings appeared stable.

Although railing can last for an extended time with proper maintenance, In our experience, eventual replacement is warranted due to constant wear, usage and exposure over time. Plan to replace at roughly the time frame below.

No anticipation of refinishing of this type of powder coated aluminum rail at this time. Timeline for future painting is difficult to predict, suggest possible inclusion into future reserve study update. As routine maintenance, inspect regularly to ensure stability of railing and repair promptly as needed from general operating funds.

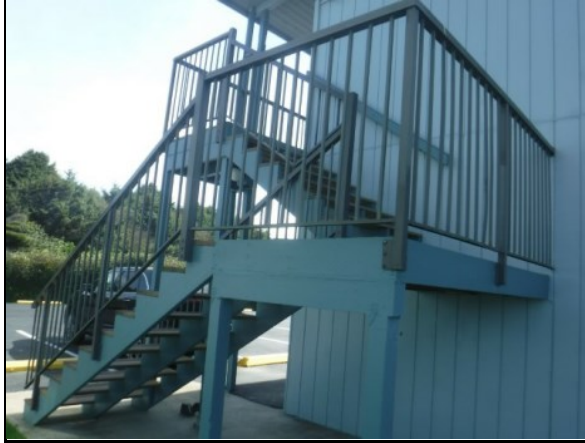
Comp #: 551 Metal Railing - Repair/Replace

Comments: Metal railings appeared generally clean and stable with no systemic damage or unusual deterioration.a

Rails are fascia mounted and not attached through the waterproof surface of the walkways. As routine maintenance these connections should be inspected periodically for structural, safety and/or waterproofing issues. Repair promptly when needed as general maintenance from the Operating budget.

An allowance for eventual replacement factored below for planning purposes.

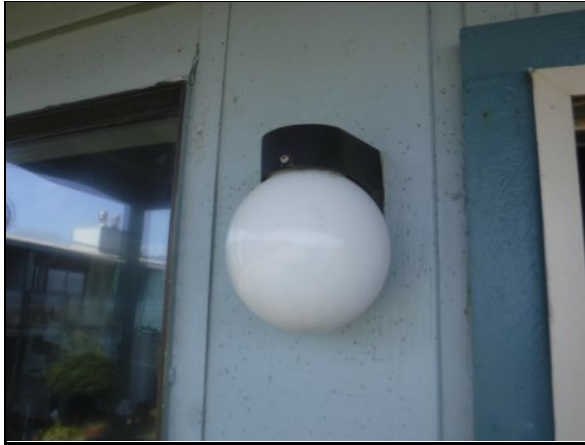
Comp #: 560 Exterior Lights - Replace

History: Reportedly replaced over the years on as-needed basis

Comments: Exterior lighting in varied condition. Historically replaced when needed as general maintenance from the Operating budget.

No large-scale or all-at-once replacement of light fixtures expected at this time. If Board desires, funding may be added in future updates.

As routine maintenance, inspect periodically and repair/replace when needed as general maintenance from the Operating budget.
