Hi-Tide Condominium Association

Moclips, WA

Level of Service: Update "With-Site-Visit"

Report #: 19269-14

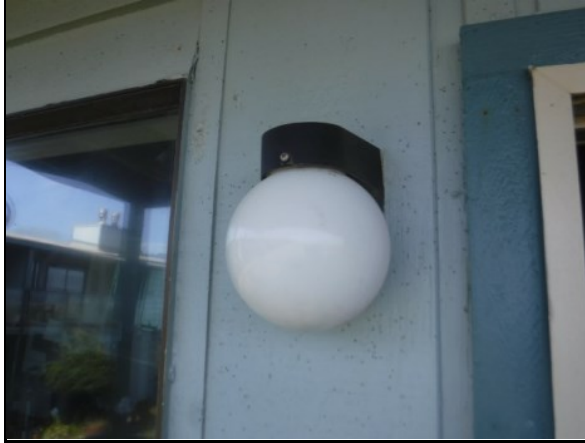
Comp #: 560 Exterior Lights - Replace**Quantity: ~ (90) assorted fixtures**

Comments: Exterior lighting in varied condition. Historically replaced when needed as general maintenance from the Operating budget.

No large-scale or all-at-once replacement of light fixtures expected at this time. If Board desires, funding may be added in future updates.

As routine maintenance, inspect periodically and repair/replace when needed as general maintenance from the Operating budget.

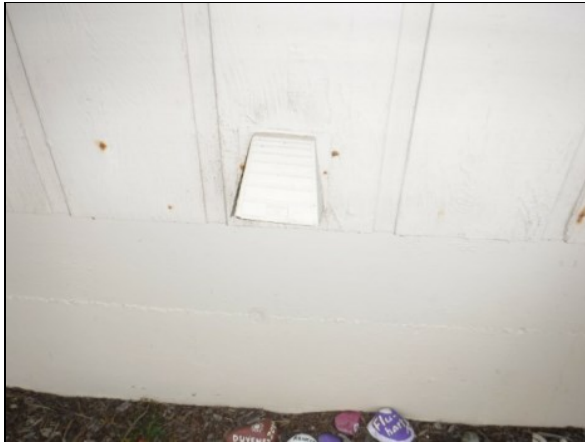
Comments: Functional condition is assumed, no problems were reported. Photo from previous site visit.

We strongly recommend regular professional inspections, cleaning and repair, funded from the Operating budget, to ensure that vents are performing properly and to mitigate any water intrusion damage and/or fire hazard.

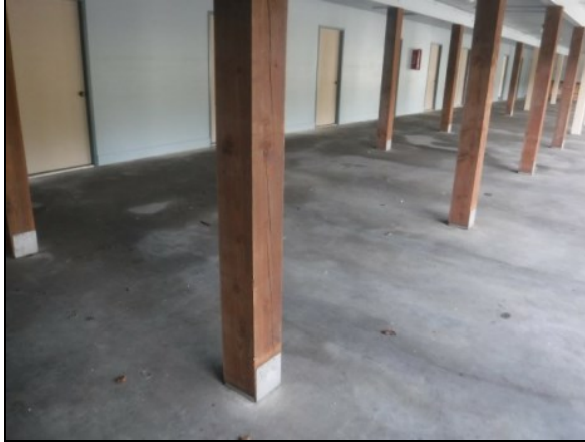
Comp #: 580 Wood Posts - Repair/Replace

History: 40 posts reported replaced as-needed in 2024 - \$60,000

We recommend regular evaluations by a qualified professional to assess stability. Paint posts regularly along with building exteriors. With ordinary care and maintenance there is no predictable expectation for total or large scale replacement. No reserve funding suggested at this time.

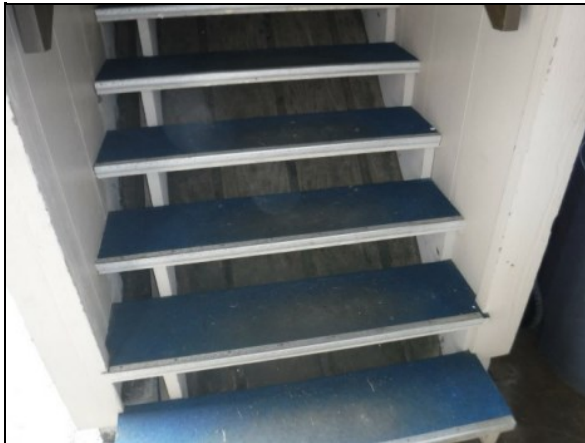
Comp #: 590 Carpeted Stairs - Repair/Replace

Comments: Photo from previous site visit. Replacement of outdoor carpet was reported to be deferred. Wood stairs to upper floor units at buildings B and C are well protected. Some staining/wear but no significant deterioration or damage.

No current plans to replace carpet with carpet. Board previously reported plans to replace carpeting with Duradek vinyl membrane. No reserve funding suggested at this time.

As routine maintenance, inspect regularly to ensure safety and stability; repair promptly as needed using general maintenance funds.

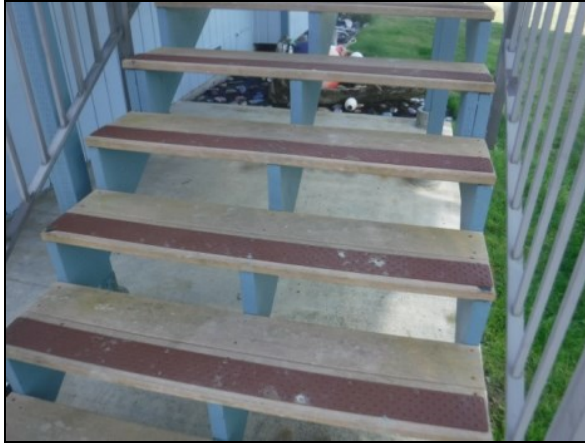
Comp #: 592 Composite Stairs - Repair/Replace

Comments: Composite stairs noted to be in clean and stable with non-skid applique' added for better traction since our previous site visit. Stairs are mostly exposed to the elements. No significant damage or deterioration observed. Historically this component was funded from the Operating budget as needed. Reserve funding is now included here as a result of prior Board request to lower reserve funding threshold.

Funding is for replacement of only the composite boards that form the walking surface and does not include funding for replacement of structural framing. Evaluate structure framing prior to replacement to better determine scope of project. Costs can vary depending on scope of replacement.

Inspect boards and structure periodically and repair as needed.

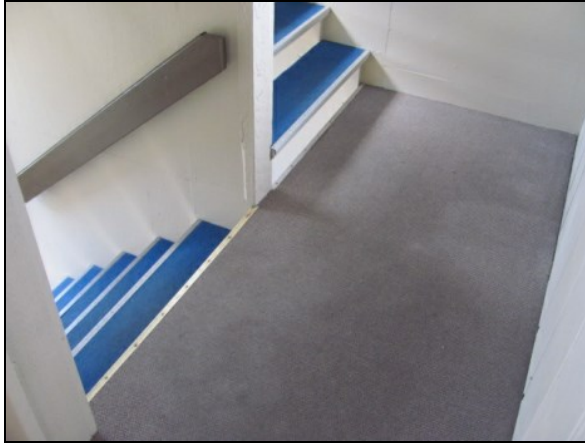
Comp #: 595 Indoor/Outdoor Carpet - Replace**Quantity: ~ 190 SY**

Comments: Photo from previous site visit. Indoor/outdoor carpeting was a short pile type at hallways and landings. Observed in varied condition with some wearing and staining. Carpeting is protected from the elements and rain, however rain can affect surfaces on Building B if windows are left open. Onsite management and maintenance personnel reported in September 2024 that indoor/outdoor carpet replacement at Building B has been deferred.

Typically replacement cycles for indoor carpet can range from 10-15 years depending on various factors. However, Association is investigating replacement of the indoor carpet with a sheet vinyl type surface (Duradek) See next component # 596. No funding included at this time for replacement of carpeting with like like materials. If replaced with Duradek, adjust reserve study as needed.
