## Existing Condition Assessment Report

### Royal Saint Andrew, Sarasota FL

Thornton Tomasetti

February 13, 2024

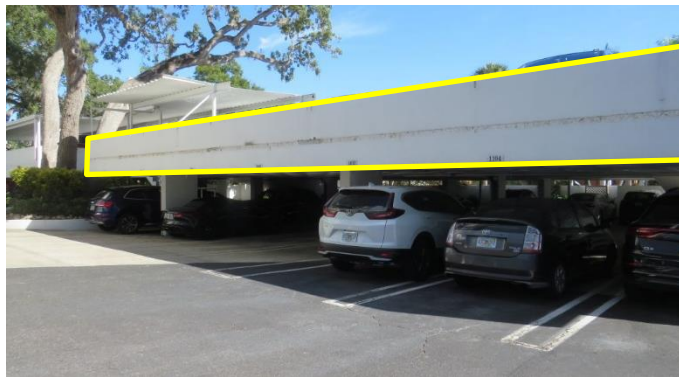
Figure 2: Location of Overhang Canopy (Source: TT)

The Association requested that a six-and-a-half-foot overhang be installed at the west elevation of the parking garage to replace the existing canopy that had previously failed, see Figure 2.

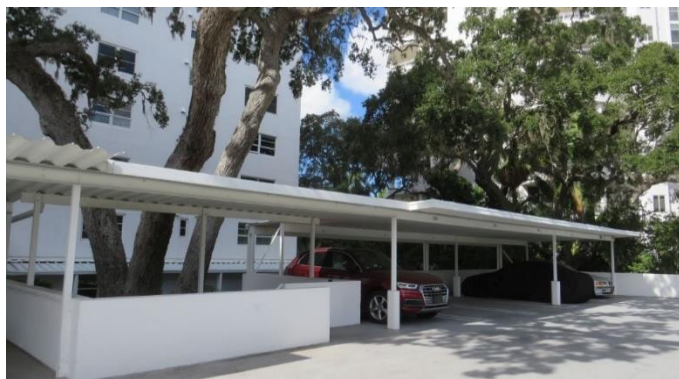
Figure 3: Existing Carport Canopy (Source: TT)

TT performed a preliminary structural analysis of the typical 2<sup>nd</sup> Level Carport Canopy connection, see Figure 3. TT found that the concrete slab was comprised of 3,000 psi concrete and 60,000 psi reinforcement. This information was called out on the as-built drawings provided.

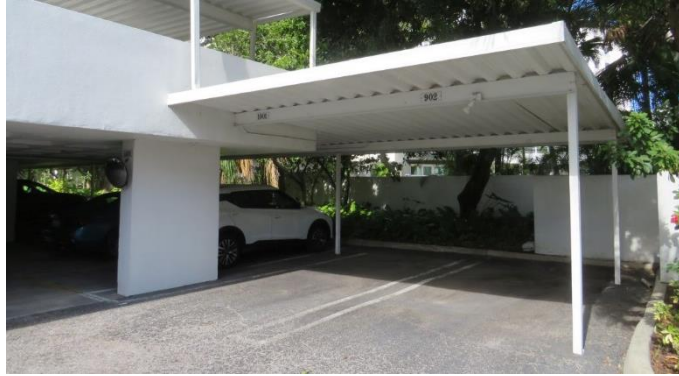
Figure 4: Existing Carport Canopy (Source: TT)

TT performed a preliminary structural analysis of the typical Ground Level Carport Canopy Foundation, see Figure 4. TT was not able to get the dimension and configuration of the canopy foundations but assumed a concrete strength of 3,000 psi and 60,000 psi reinforcement. This information was not called out on the as-built drawings provided.
