**The Royal St. Andrew Association**  
**Non-SIRS Components**  
***Sarasota, FL***

Report #: 51189-0  
Beginning: January 1, 2025  
Expires: December 31, 2025

**RESERVE STUDY**  
**"Full"**

December 6, 2024

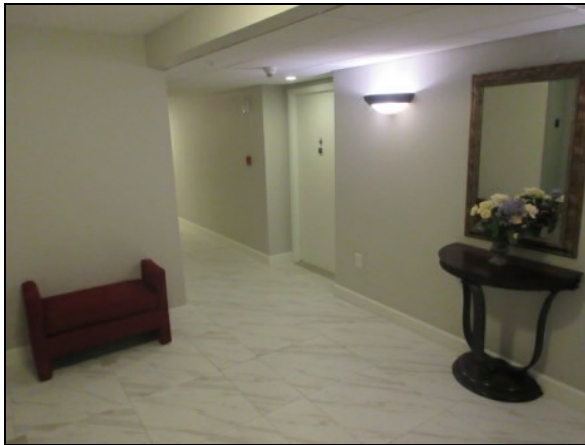
**Comp #: 2743 Hallway Furnishings - Replace**

Comments: \*NOTE: Costs for interior painting and tile flooring replacement are included in separate components 2701 "Interior Surfaces - Repair" and 2709 "Tile Flooring -Replace" within this chapter. This component is solely indicative of replacing furnishings at the upper level hallways/floors.

Fair condition: Elevator landings determined to be in fair condition typically exhibit normal, routine signs of age. At this stage, physical conditions of furnishings and finishes are still good, but design/aesthetic may be becoming dated.

Useful Life:  
15 years

Remaining Life:  
5 years

Periodic remodeling of elevator landing areas is prudent in order to maintain an attractive, desirable appearance for existing owners as well as potential buyers and other guests. Some Clients choose to work with design personnel to maintain a coordinated, attractive aesthetic. Typical projects often include replacement of finishes, furnishings, artwork, lighting, etc. Life estimates can vary greatly depending on level of wear and the subjective preferences of Client. Costs can vary greatly depending on scope of work and types of materials selected for replacement. Funding recommendation shown here is for remodeling to an appropriate standard for this Client. Life and cost estimates should be re-evaluated during future Reserve Study updates based on the most current conditions and information available at that time.

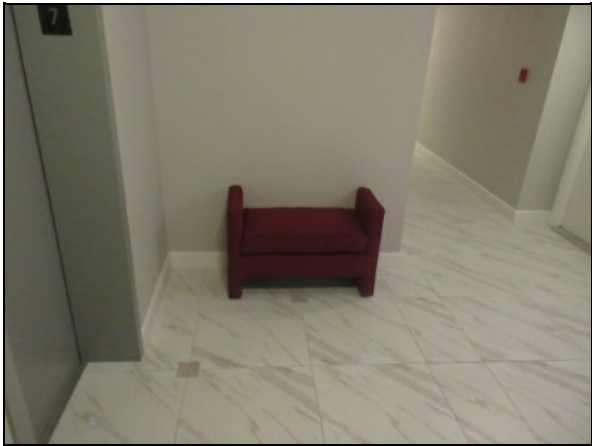
**Comp #: 2744 Hallway Benches - Replace**

Comments: Please refer to the prior component (#2744) in this series for more general information and commentary on hallway furnishing replacement. This component is solely indicative of a one-time expense to replace the hallway benches in 2025. As such, the remaining useful life has been set accordingly, assuming completion in 2025, with no funding included following the 2025 fiscal year.

Useful Life:  
1 years

Remaining Life:  
0 years

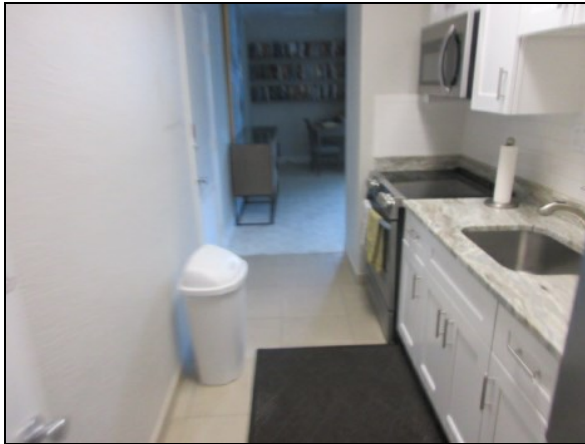
Fair condition: Kitchens determined to be in fair condition typically exhibit some light signs of use and age, especially at countertops and cabinetry. Kitchen appears to be serviceable and clean. Appliances are assumed to be functional, but may be becoming outdated at this stage.

Useful Life:  
20 years

Remaining Life:  
13 years

Kitchen materials typically have an extended useful life. However, many Clients choose to refurbish the kitchen periodically for aesthetic updating. This may include replacement (or addition) of appliances, refurbishment/refinishing of cabinets and countertops, replacement of sinks and fixtures, installation/replacement of under-cabinet lighting, etc. Best practice is to coordinate this project with other amenity areas, such as bathrooms or other amenity rooms. Remaining useful life is based on consideration of materials, evident conditions, and/or remodeling/renovation history provided during the engagement. Costs can significantly vary based on an anticipated scope of work as well as materials chosen for remodeling/renovation. Unless otherwise noted, cost allowances shown below assume remodeling with both similar quantities and qualities as existing materials.

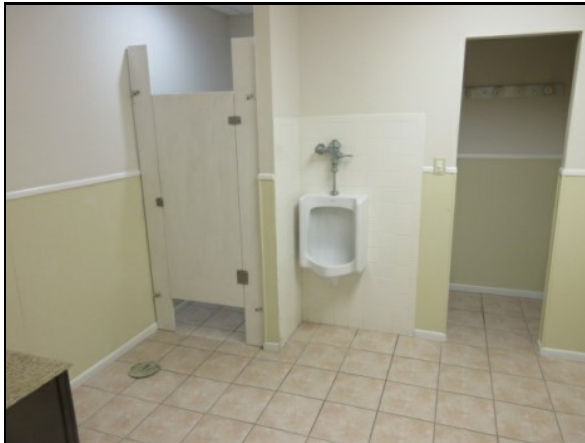
Women's bathroom assumed to be of similar size, style, and condition.

Fair condition: Bathrooms determined to be in fair condition typically exhibit some light to moderate signs of use and age. Finishes are clean but showing some wear. All fixtures are assumed to be functional, but may be becoming outdated at this stage.

Generally in serviceable condition.

Remaining Life:

5 years

As routine maintenance, inspect regularly and perform any needed repairs promptly utilizing general Operating funds. Typical remodeling project can include some or all of the following: replacement of plumbing fixtures, partitions, countertops, lighting, flooring, ventilation fans, accessories, décor, etc. Best practice is to coordinate this project with other amenity areas, such as kitchens or other amenity rooms. Remaining useful life is based on consideration of materials, evident conditions, and/or remodeling/renovation history provided during the engagement. Costs can significantly vary based on an anticipated scope of work as well as materials chosen for remodeling/renovation. Unless otherwise noted, estimates shown are based primarily on light to moderate cosmetic remodeling, not complete "gut" remodel projects.

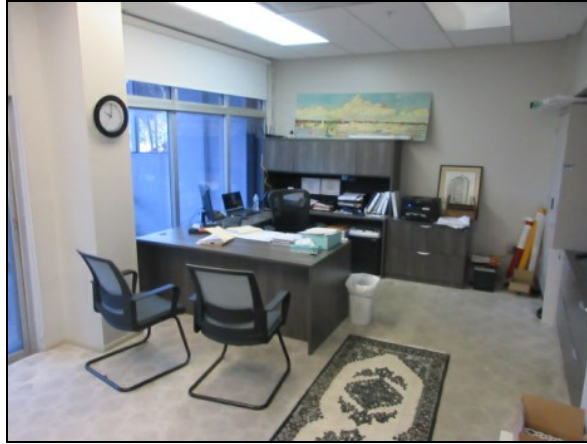
Fair condition: Offices determined to be in fair condition typically exhibit some routine signs of wear and tear, but no unusual or advanced deterioration. FF&E is in serviceable condition with no unusual conditions observed or reported by staff.

Remaining Life:

15 years

Periodic office remodeling is prudent in order to maintain an attractive, functional workspace for personnel. Typical projects often include replacement of room finishes and furnishings, and may also include replacement of IT equipment, phones, office supplies, storage units, etc. Life estimates can vary greatly depending on level of use and preferences of Client. If the office is used as a "public" area for hosting potential buyers and other important visitors, remodeling should be a high priority. Costs can significantly vary based on an anticipated scope of work as well as materials chosen for remodeling/renovation. Unless otherwise noted, cost allowances shown below assume remodeling with both similar quantities and qualities as existing materials. Schedule and cost estimates should be re-evaluated during future Reserve Study updates and adjusted as needed based on any new information obtained and conditions evident at that time.

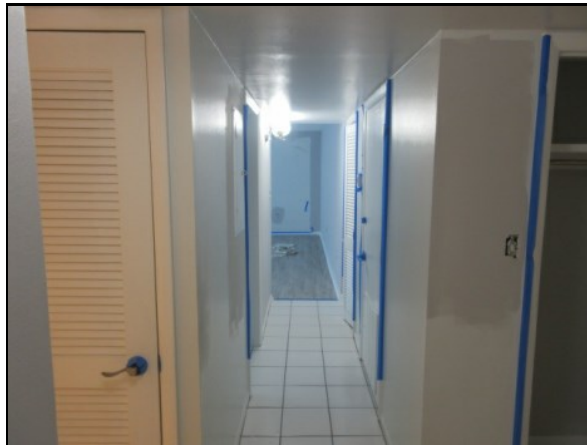
Fair condition: Rental units determined to be in fair condition typically exhibit routine signs of wear and tear, but no unusual or advanced signs of deterioration or over-use.

Remaining Life:

8 years
