# Existing Condition Report

**KEG File: 18RS-0416**  
**October 8, 2018**

***Royal St. Andrew Association,  
Inc.***

**RE:    *Royal St. Andrew  
KEG Project P18RS-0416 REV02  
Professional Engineering Services – Existing Conditions Survey***

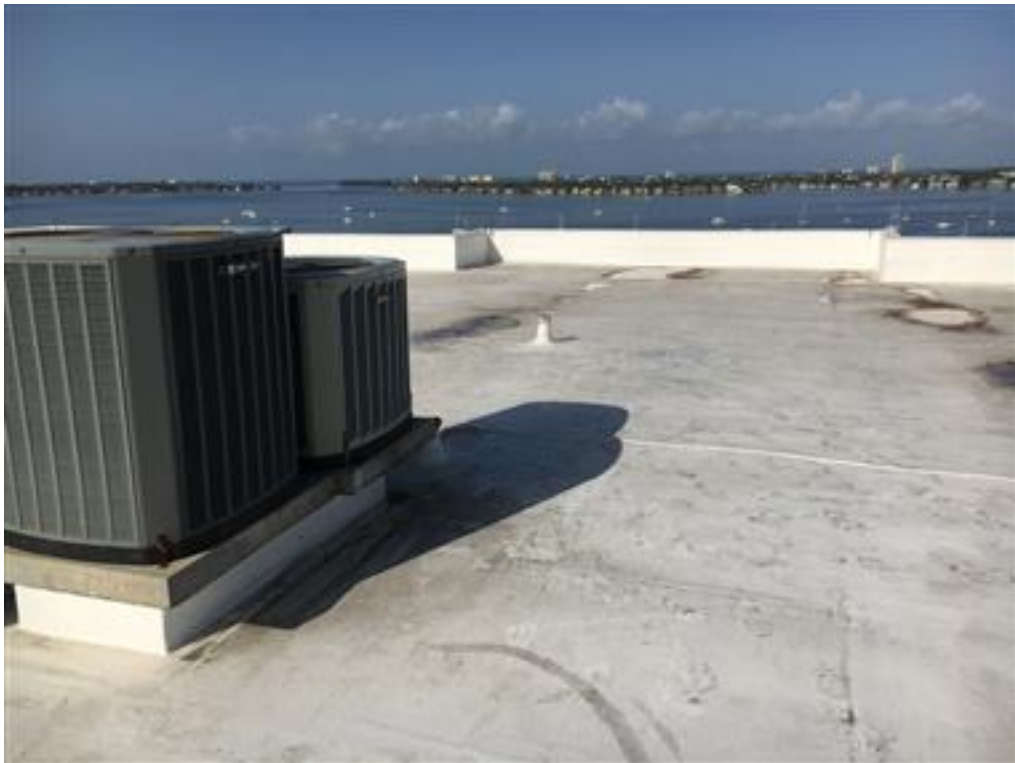
Photo 14-General view, AC curbs, ponding

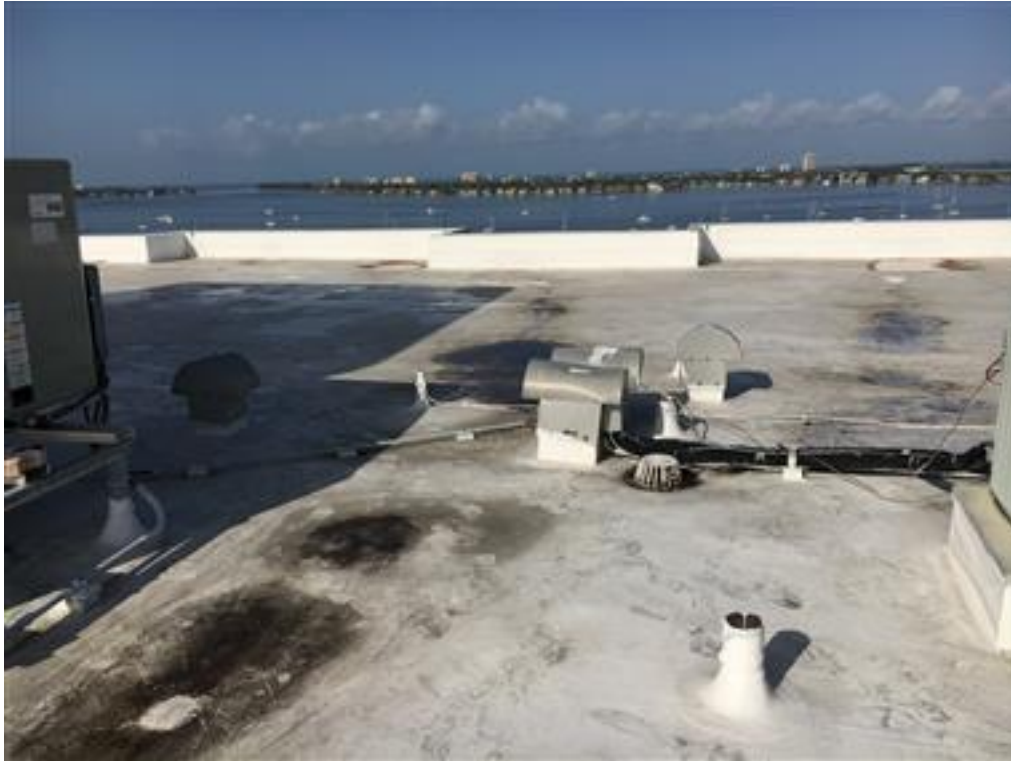
Photo 15-General view, typical vents, ponding

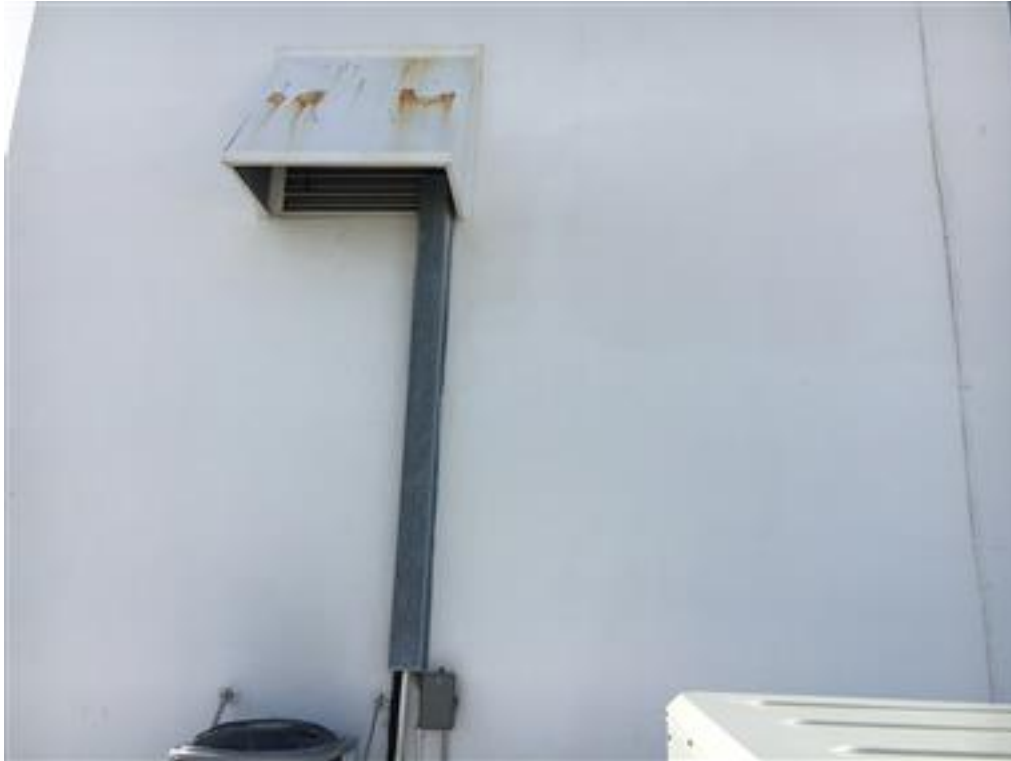
Photo 17-Elevator penthouse, rusted vent hood, north elevator penthouse

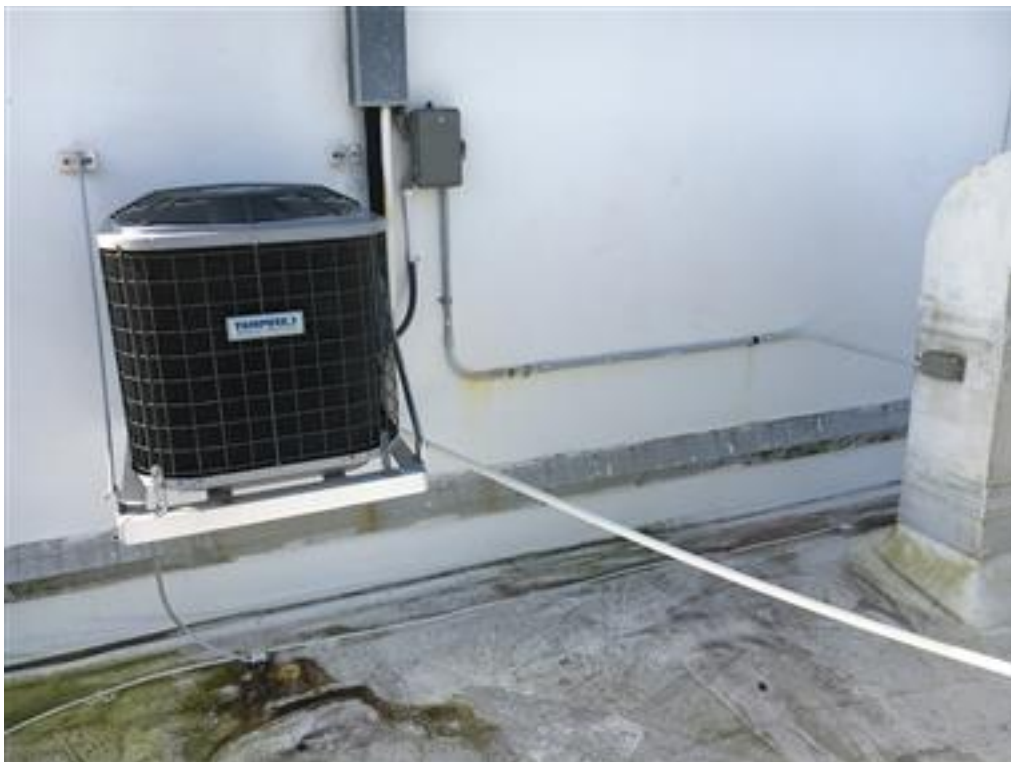
Photo 18-Elevator penthouse AC condenser, good condition, north

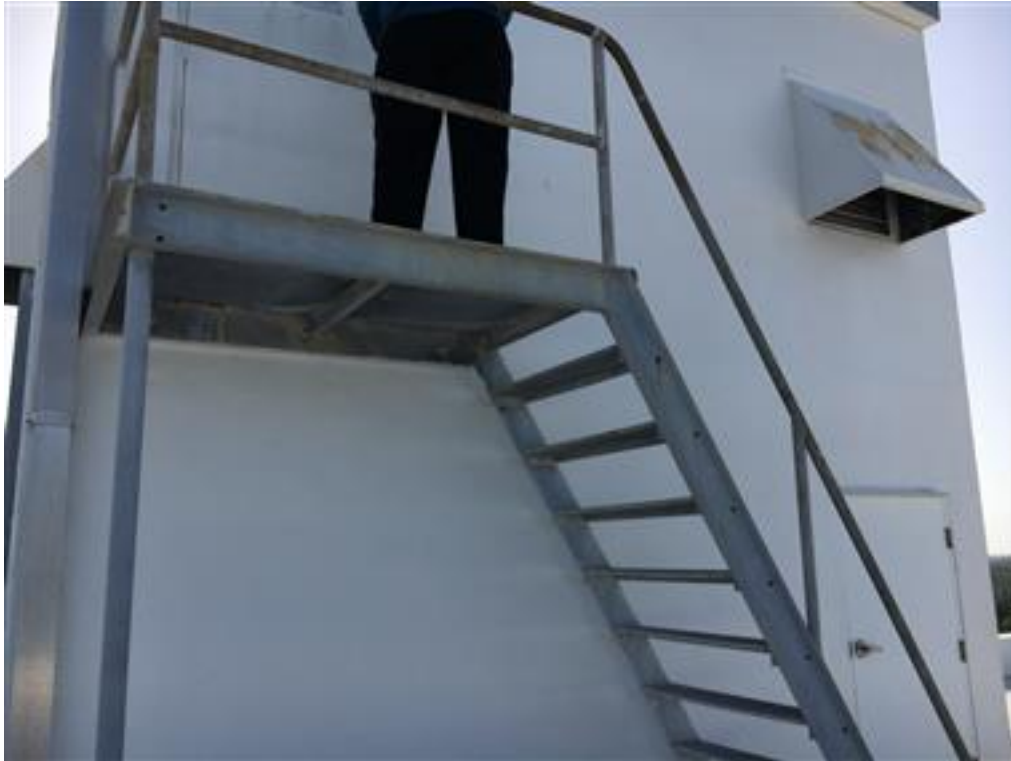
Photo 19-Elevator penthouse, good condition, west

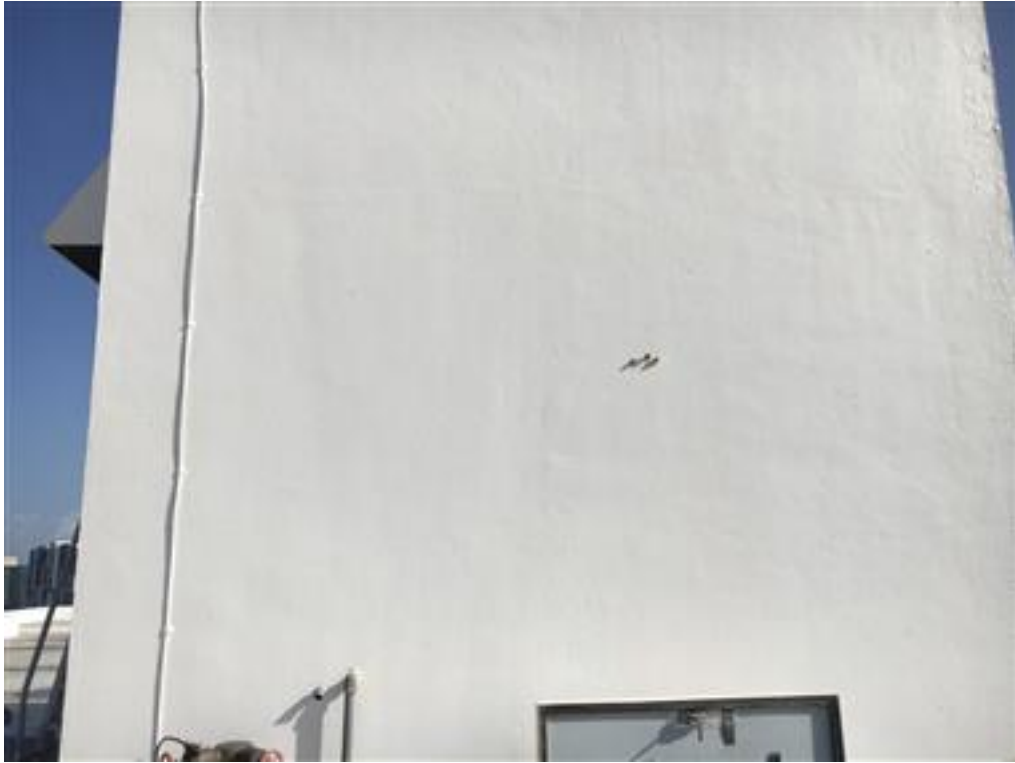
Photo 21-Elevator penthouse, good condition, south

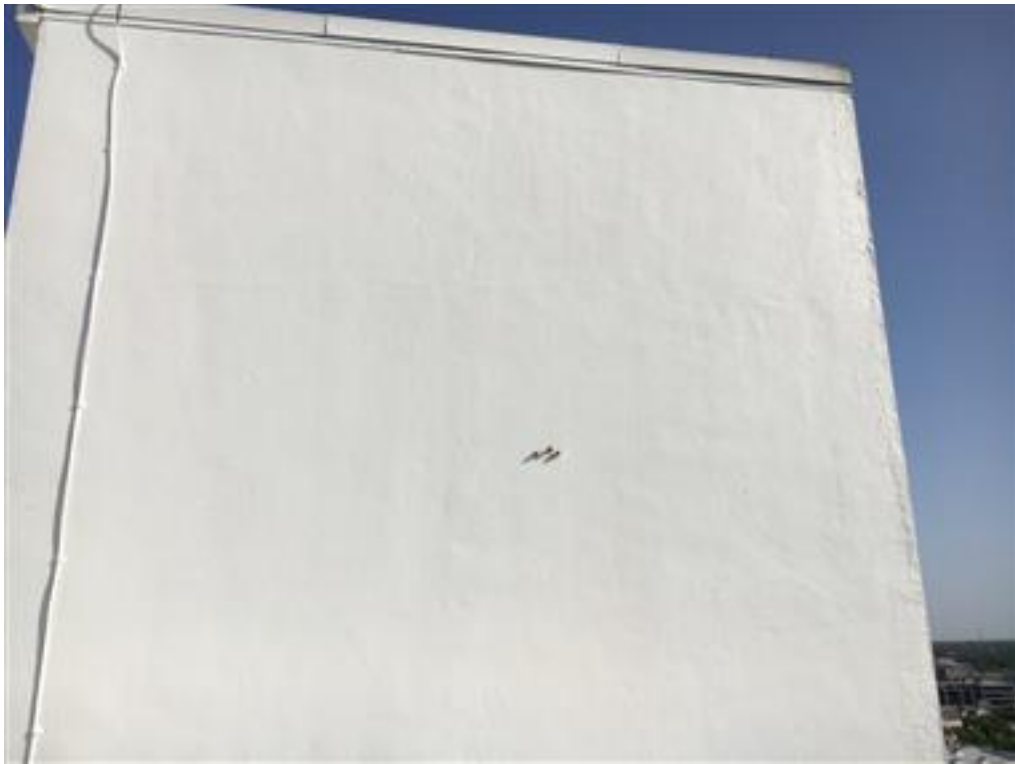
Photo 22-Elevator penthouse, good condition, south

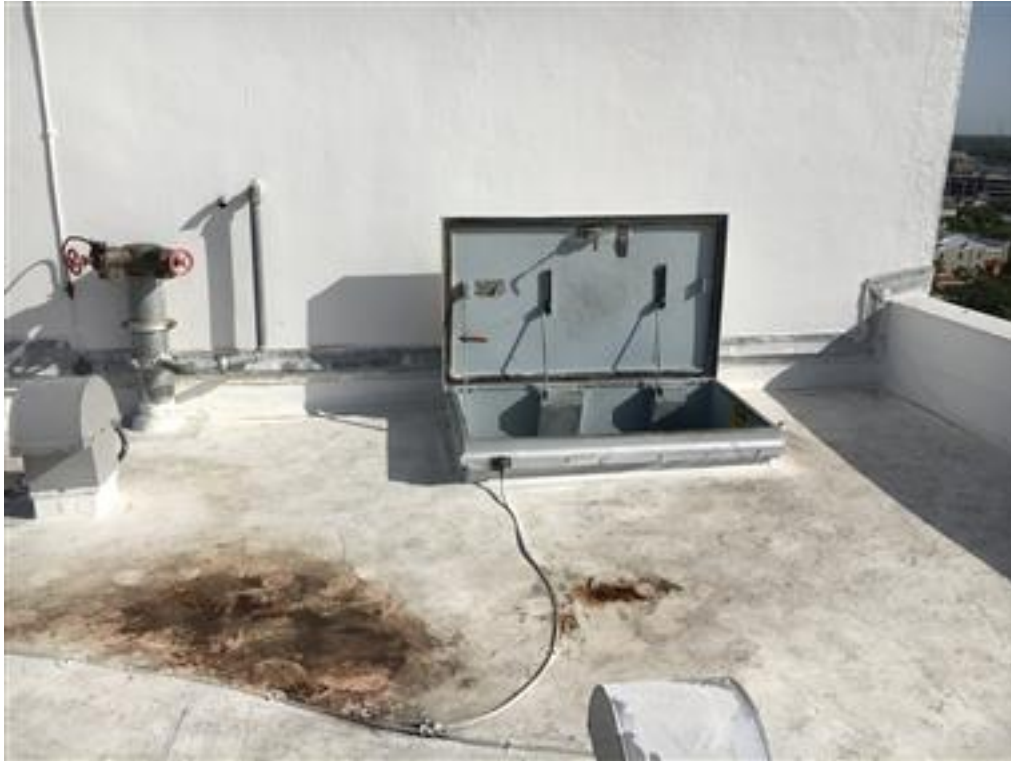
Photo 23-Roof access hatch, average condition, ponding

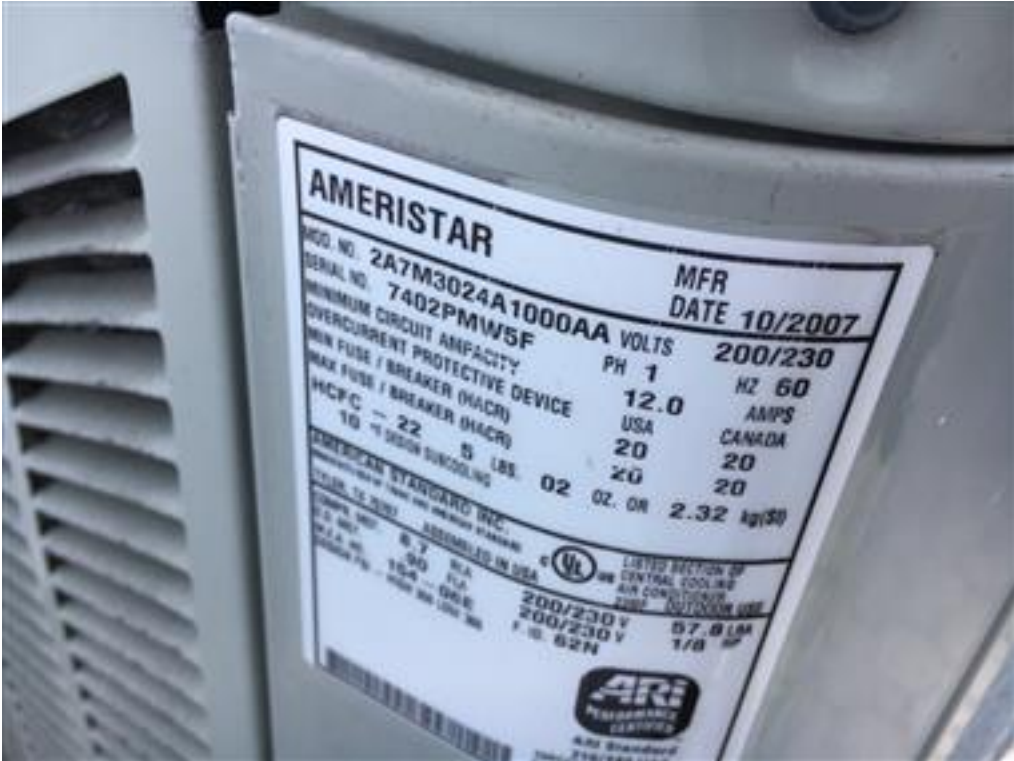
Photo 49-Men's room/storage unit AC condenser, good condition

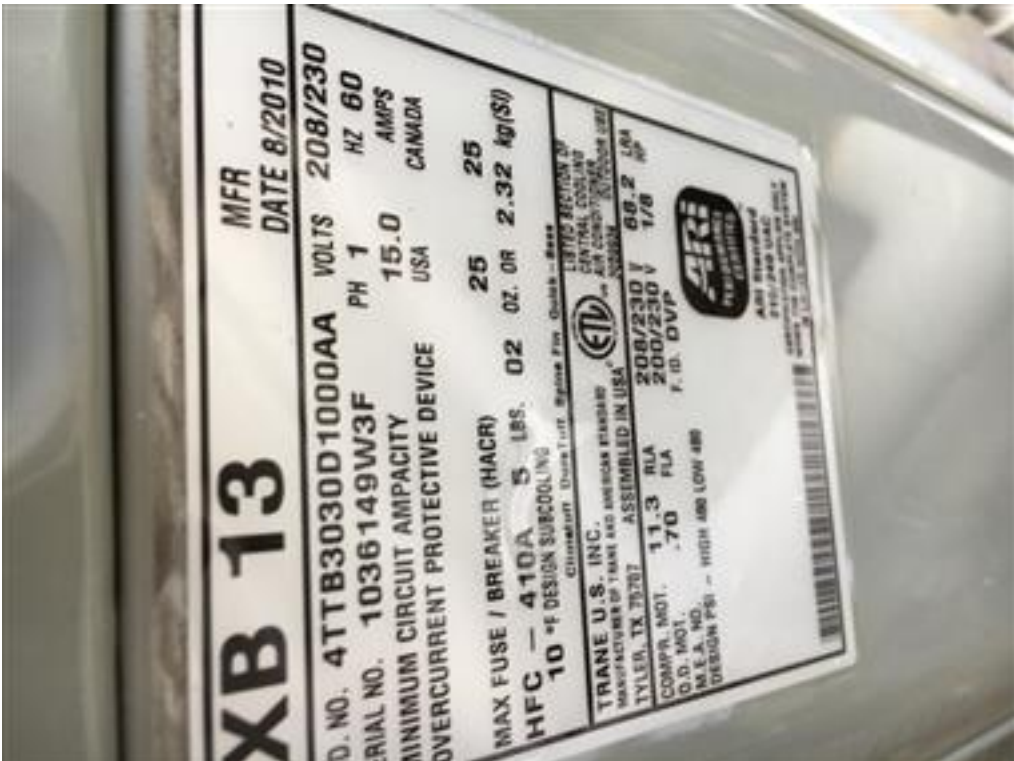
Photo 50-Kitchen AC condenser, good condition

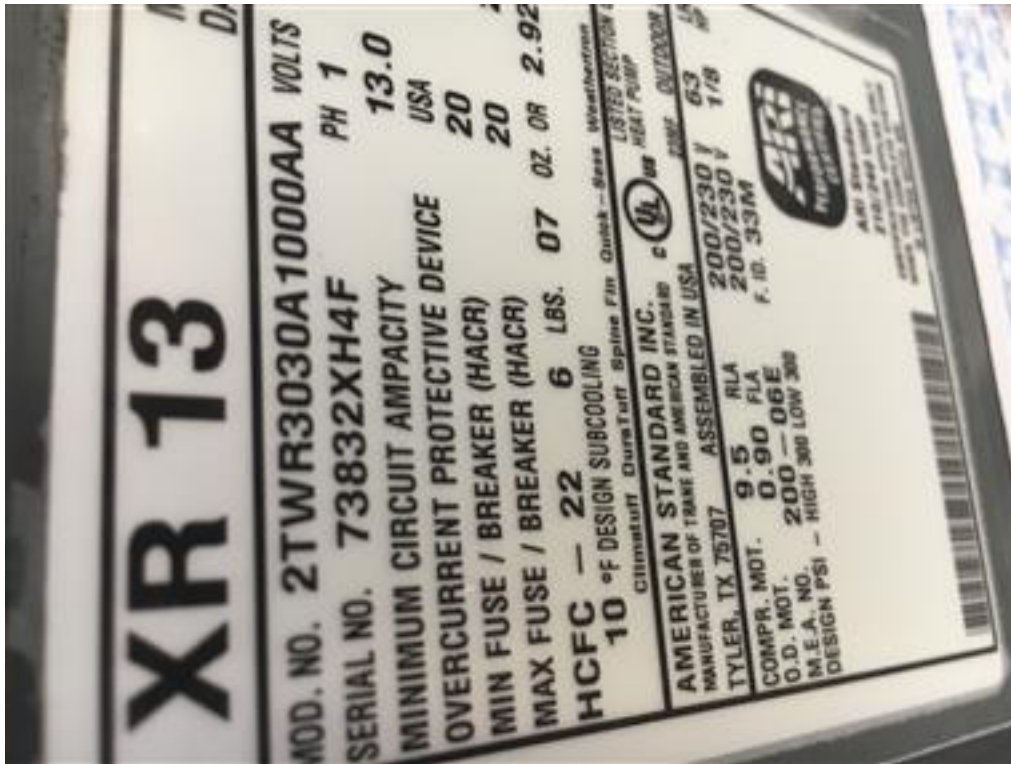
Photo 51-Kitchen AC condenser, good condition

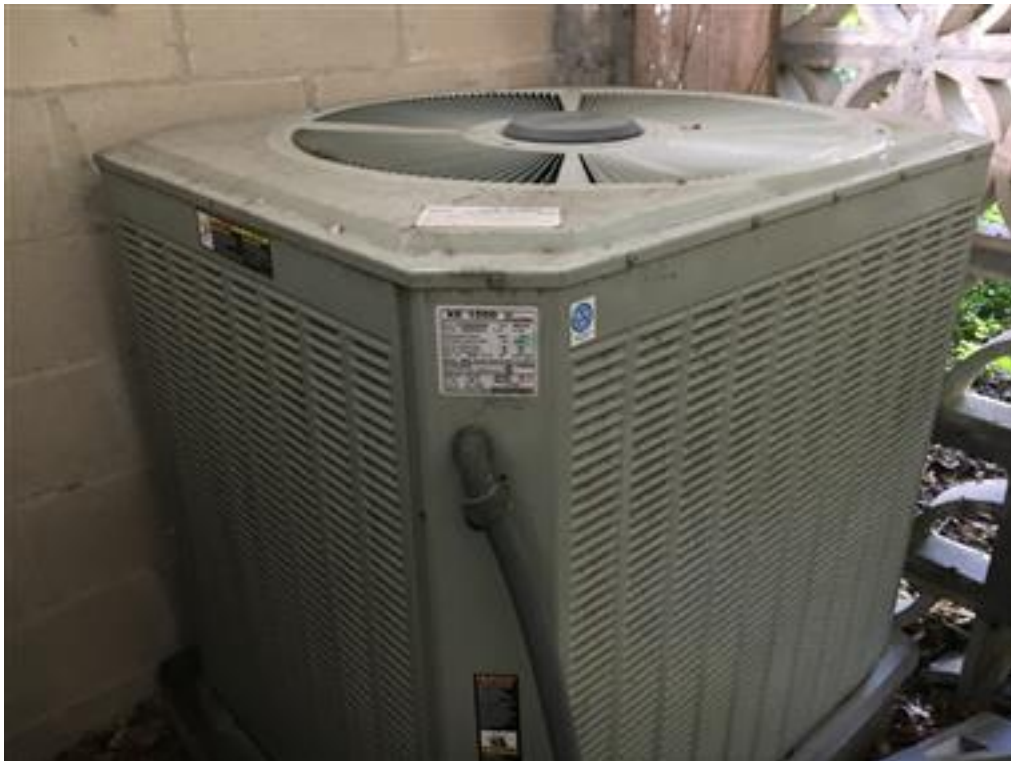
Photo 52-Office Condenser, good condition

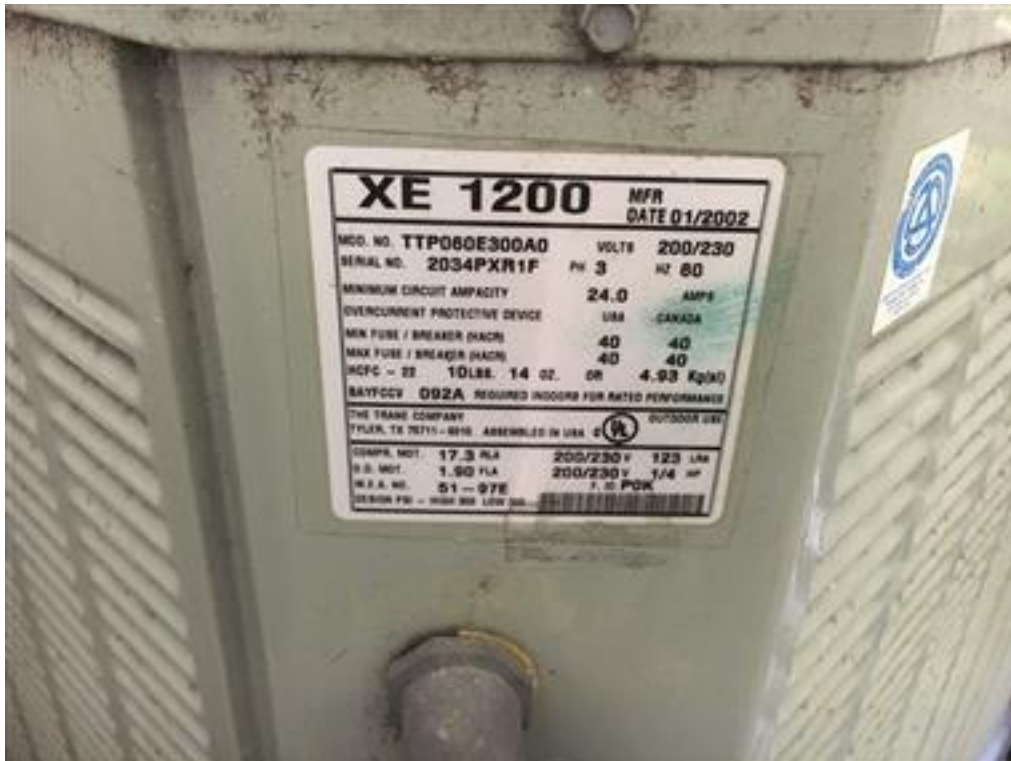
Photo 53-Office Condenser, good condition

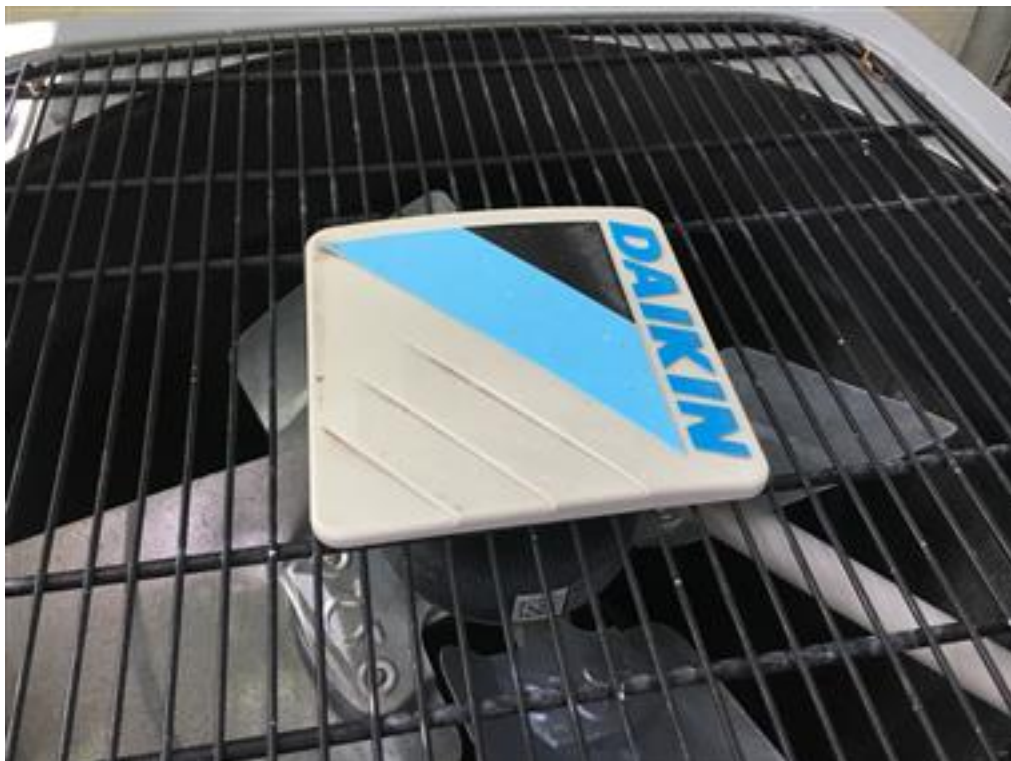
Photo 54-Unit 101 AC condenser, good condition

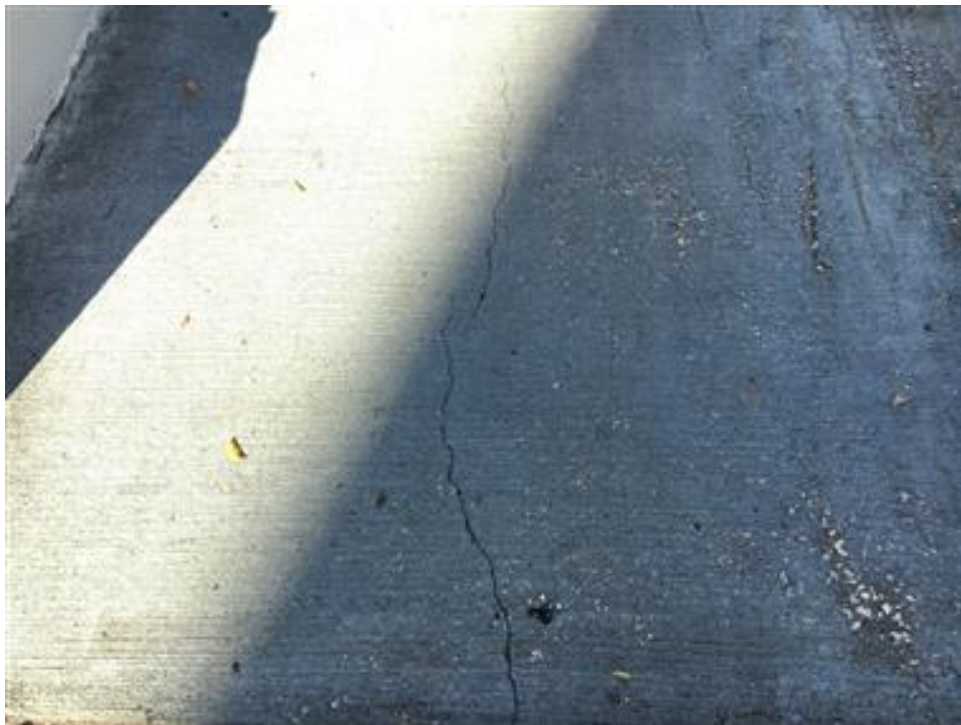
Photo 2-EXIT RAMP- TYPICAL CRACKS

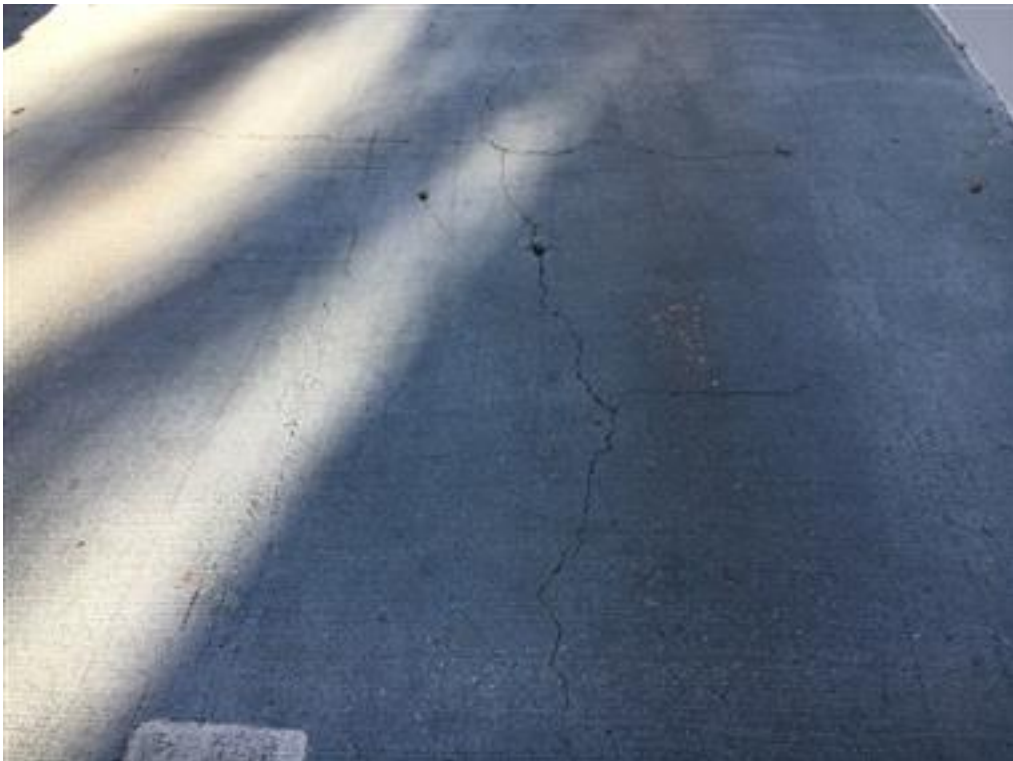
Photo 4-EXIT RAMP- TYPICAL CRACKS

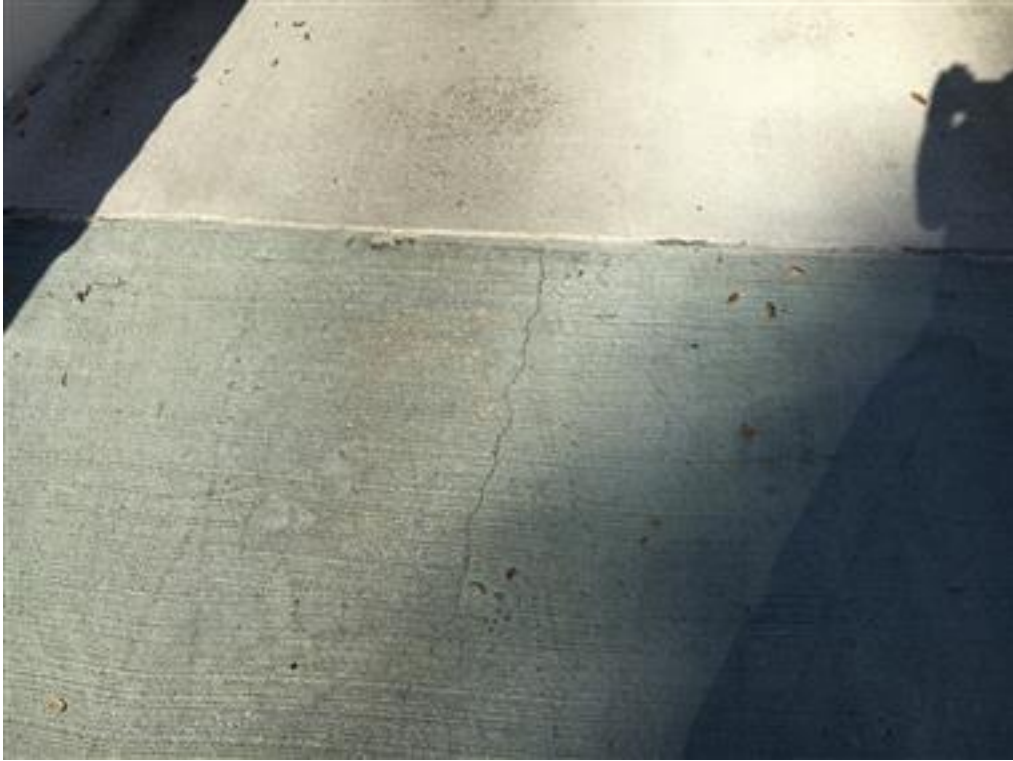
Photo 5-EXIT RAMP- TYPICAL CRACKS

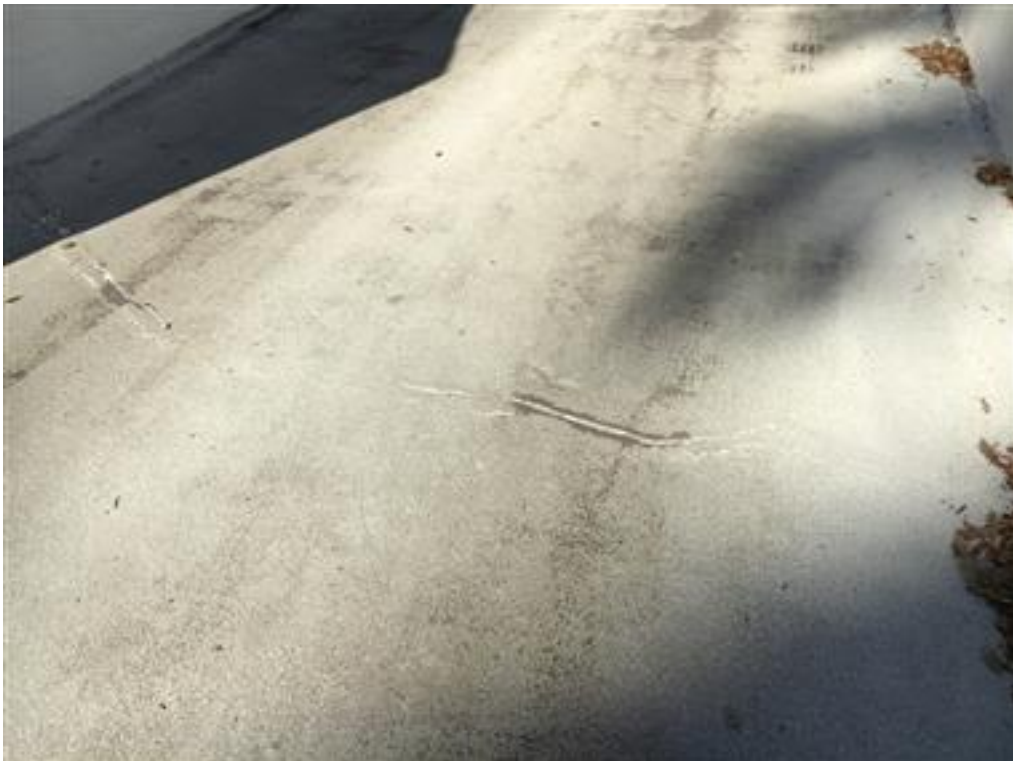
Photo 6-EXIT RAMP- TYPICAL CRACKS

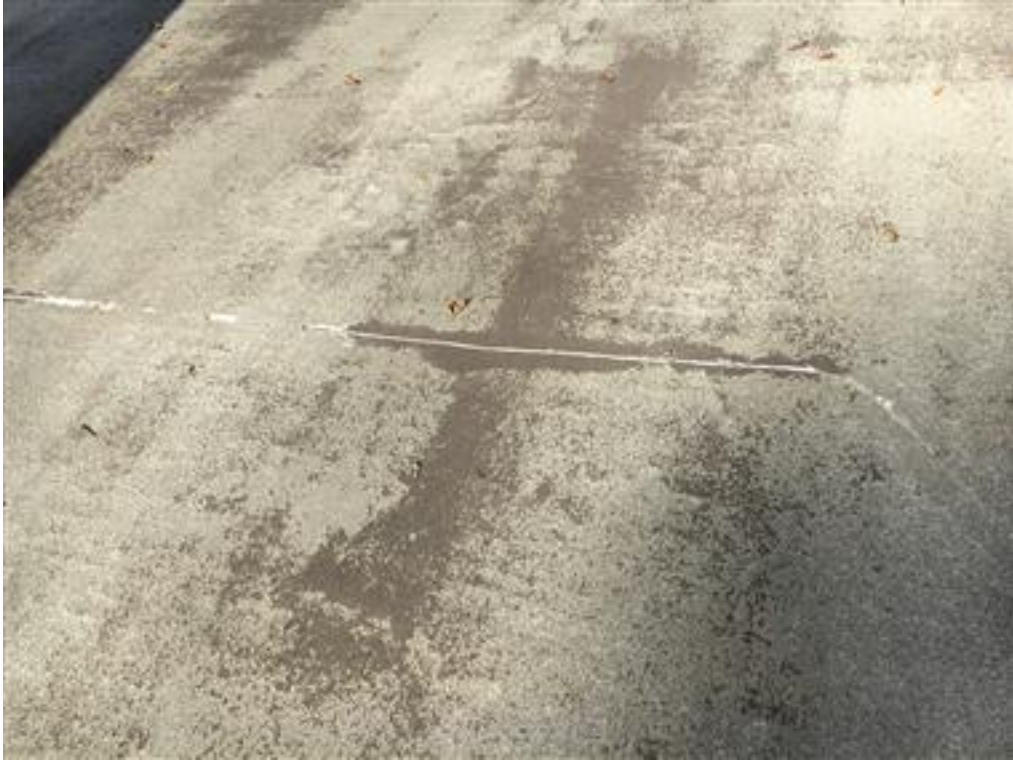
Photo 7-EXIT RAMP- TYPICAL CRACKS

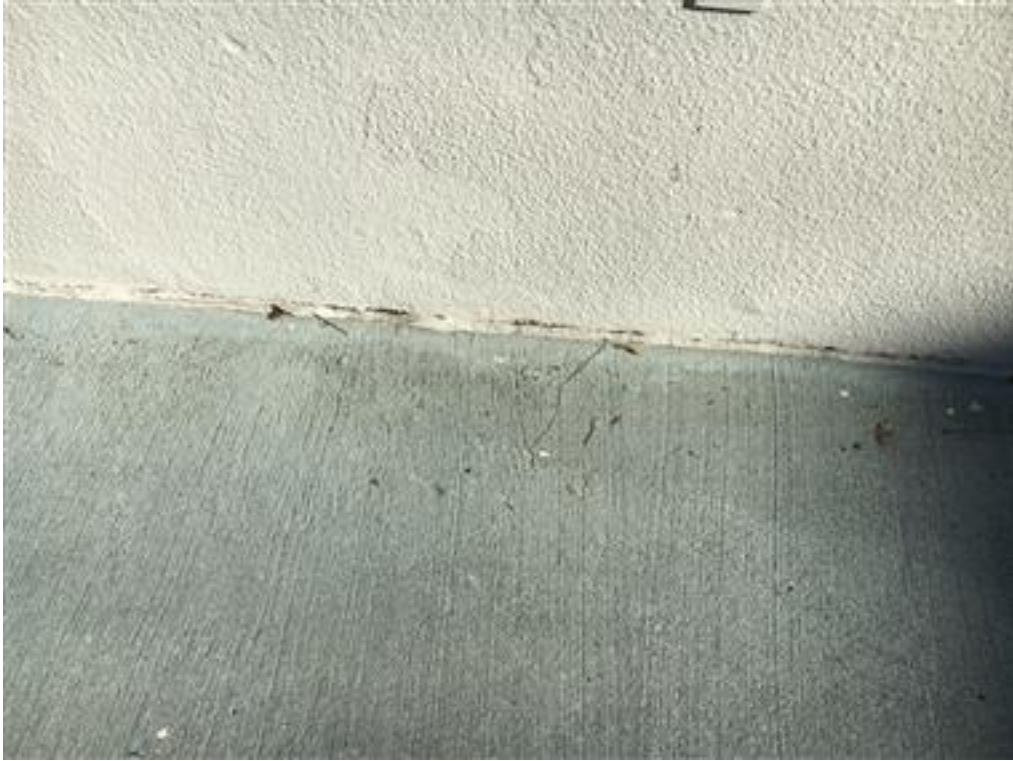
Photo 13-ENTRANCE RAMP- TYPICAL CRACKS

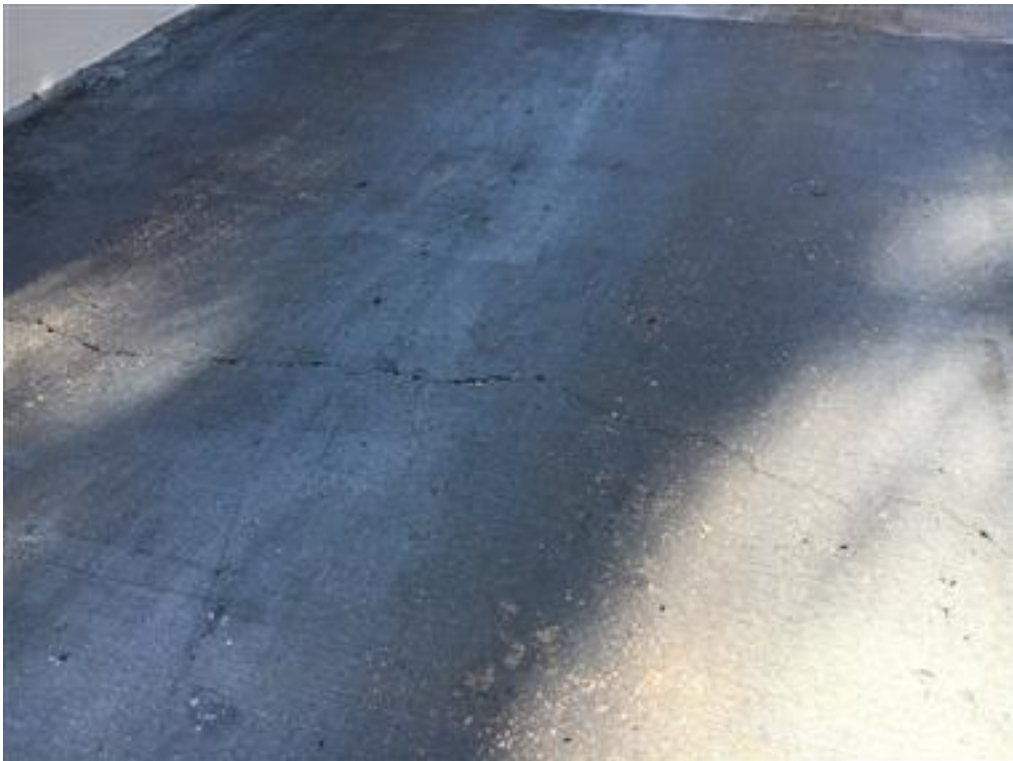
Photo 14-ENTRANCE RAMP- TYPICAL CRACKS

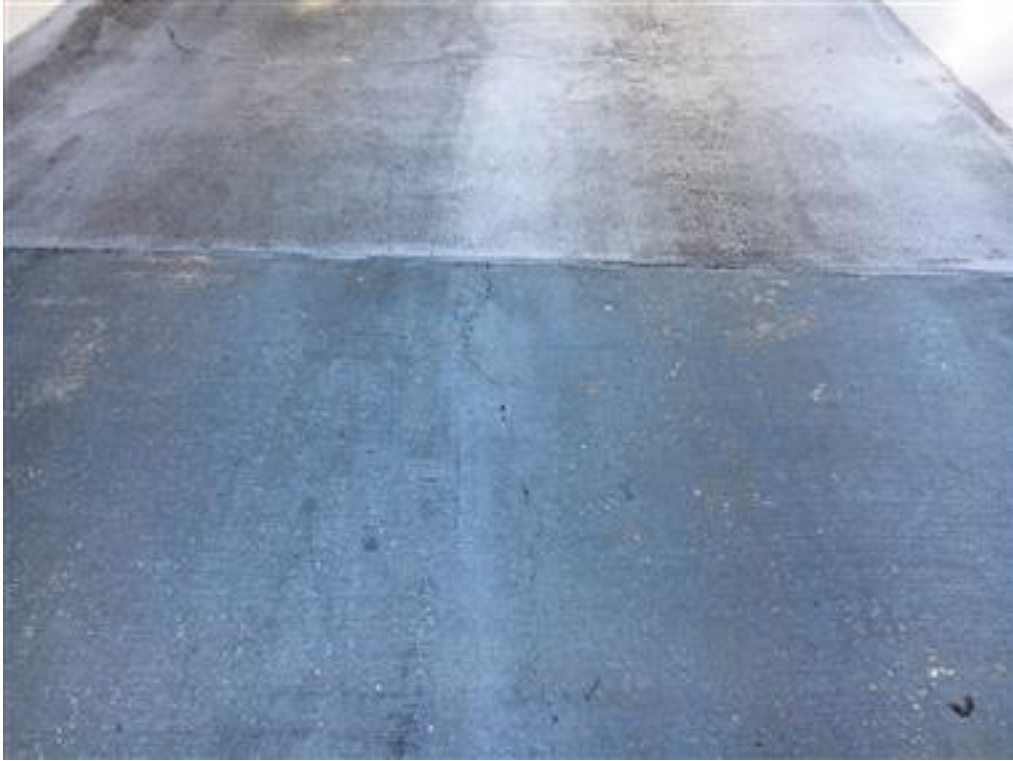
Photo 15-ENTRANCE RAMP- TYPICAL CRACKS

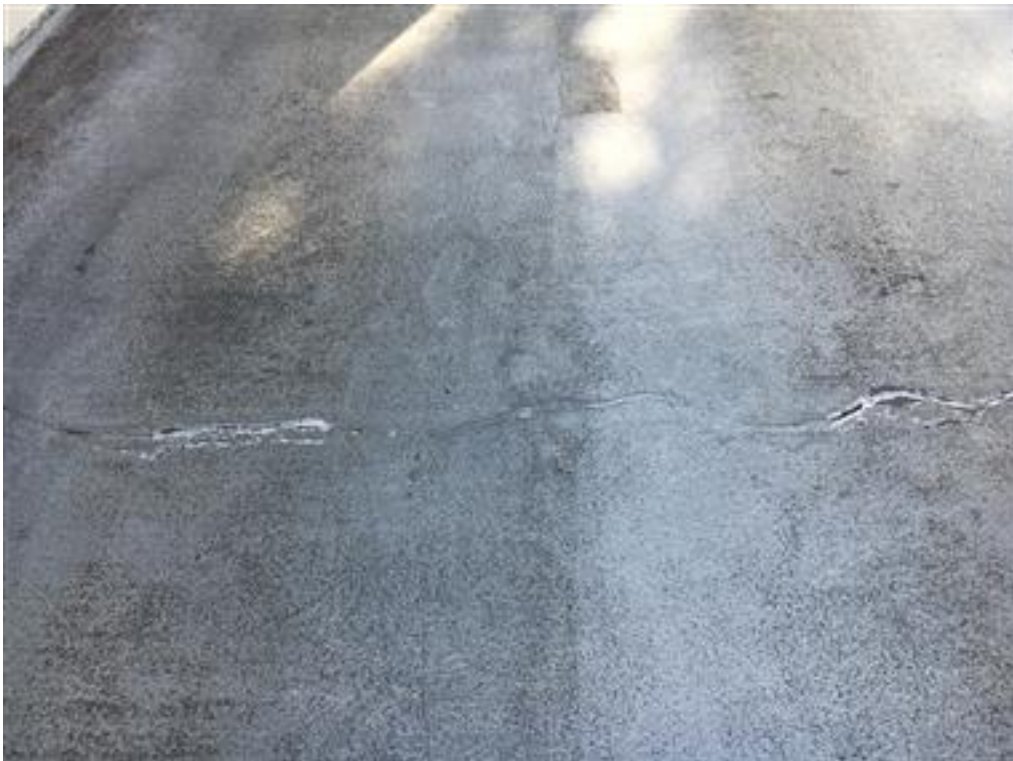
Photo 16-ENTRANCE RAMP- TYPICAL CRACKS

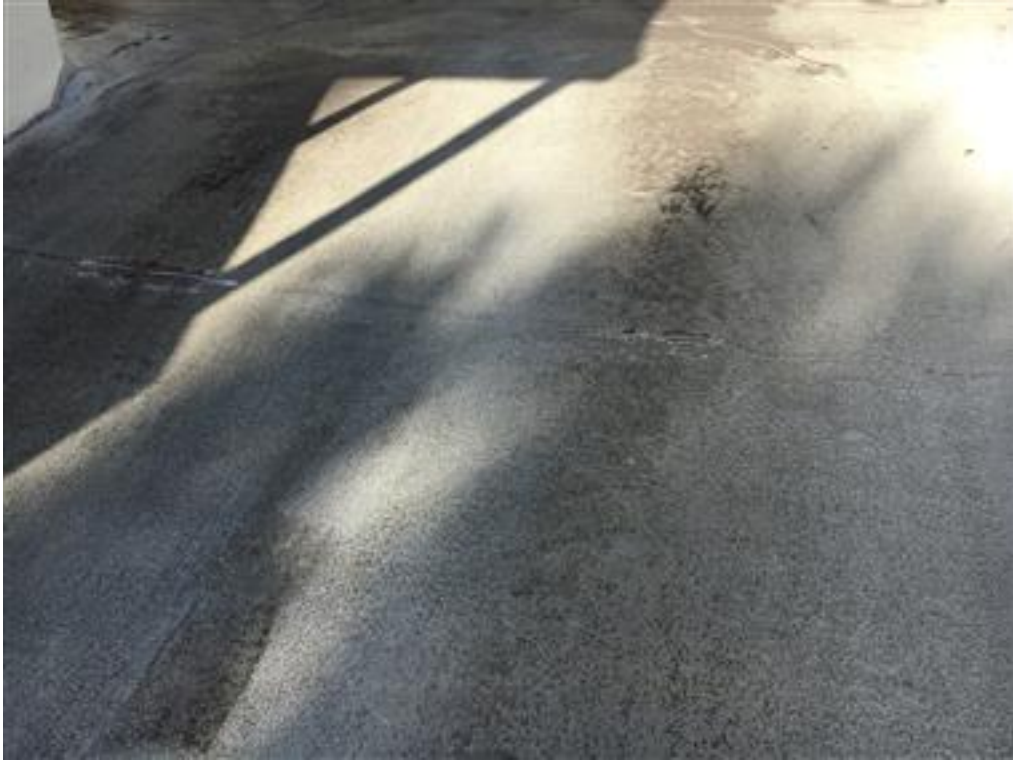
Photo 17-ENTRANCE RAMP- TYPICAL CRACKS

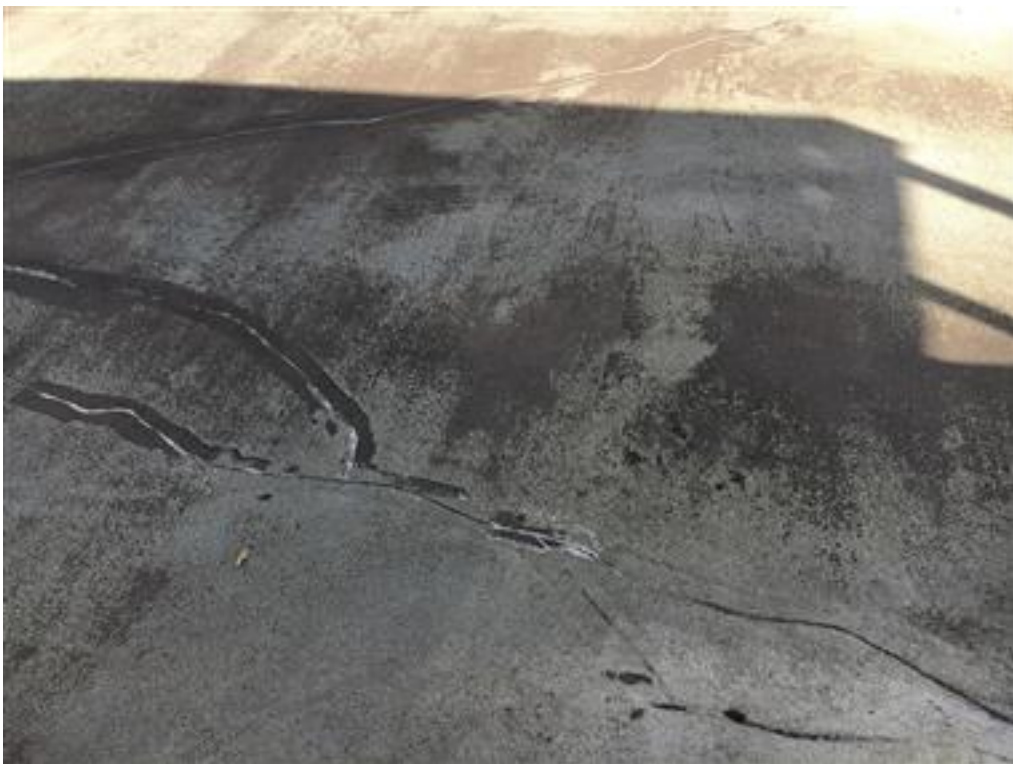
Photo 18-ENTRANCE RAMP- TYPICAL CRACKS

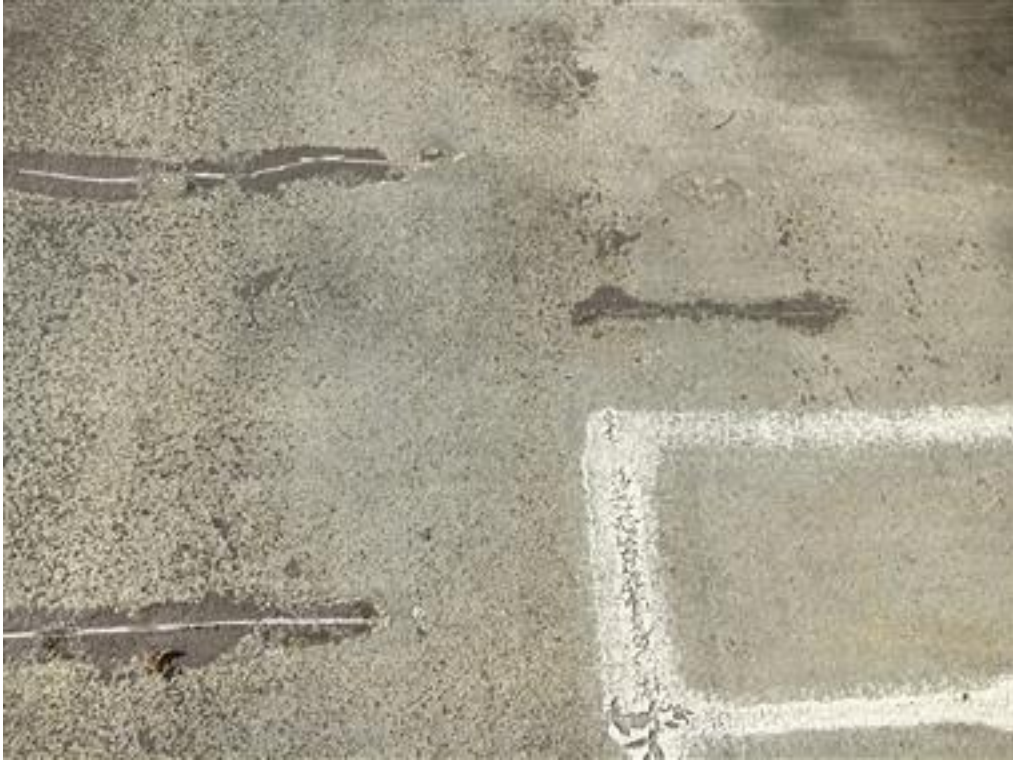
Photo 19- UPPER LEVEL-TYPICAL CRACKS

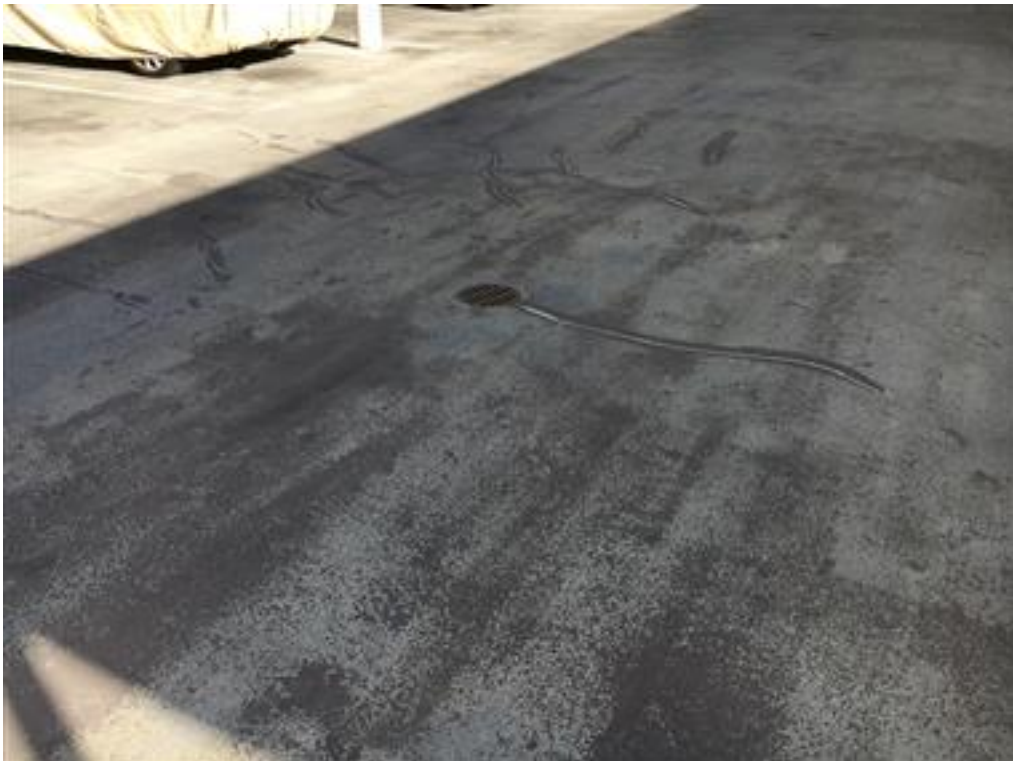
Photo 20- UPPER LEVEL-TYPICAL CRACKS

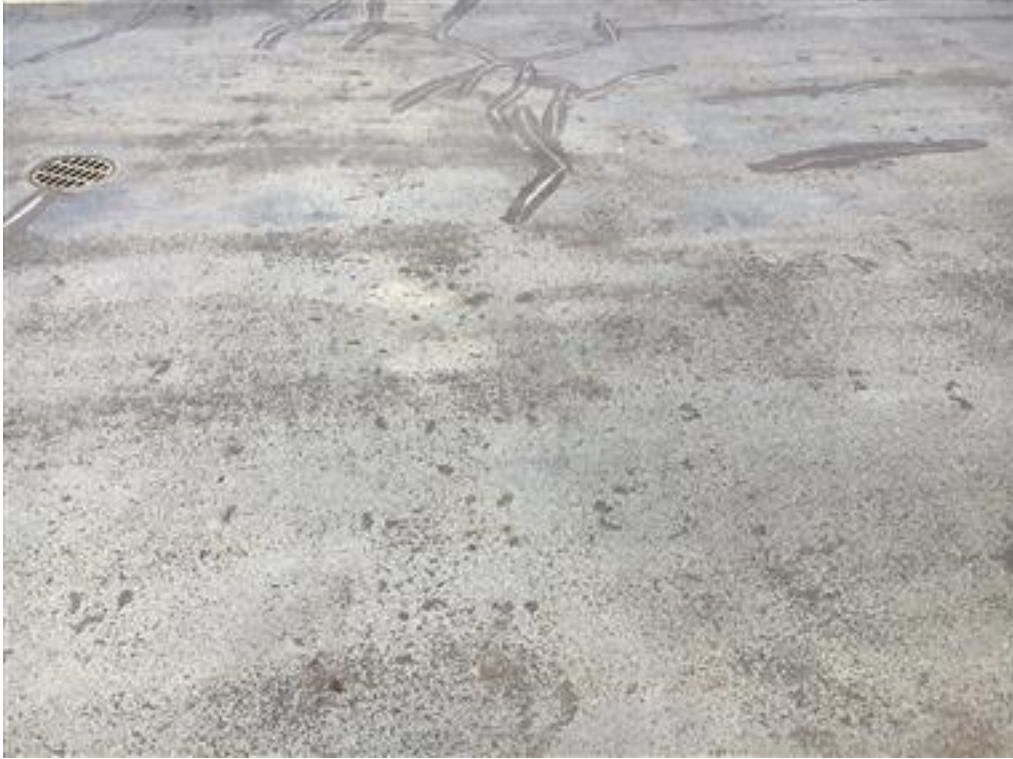
Photo 21- UPPER LEVEL-TYPICAL CRACKS

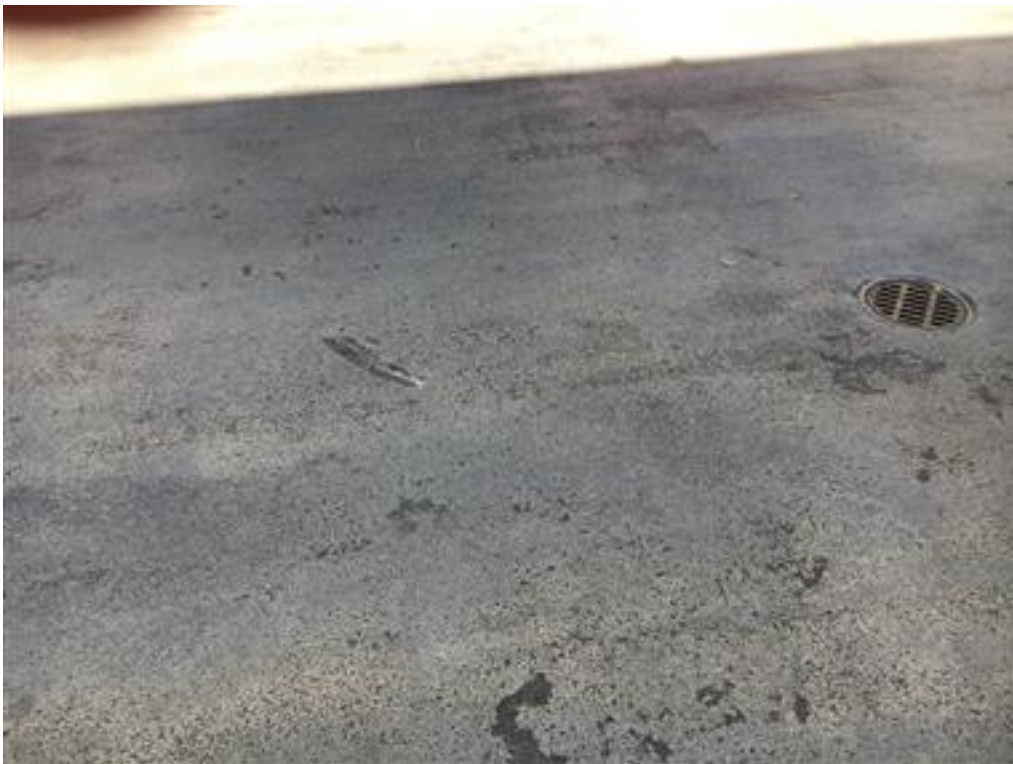
Photo 22- UPPER LEVEL-TYPICAL CRACKS
