# Existing Condition Report

**KEG File: 18RS-0416**  
**October 8, 2018**

***Royal St. Andrew Association,  
Inc.***

**RE:    *Royal St. Andrew  
KEG Project P18RS-0416 REV02  
Professional Engineering Services – Existing Conditions Survey***

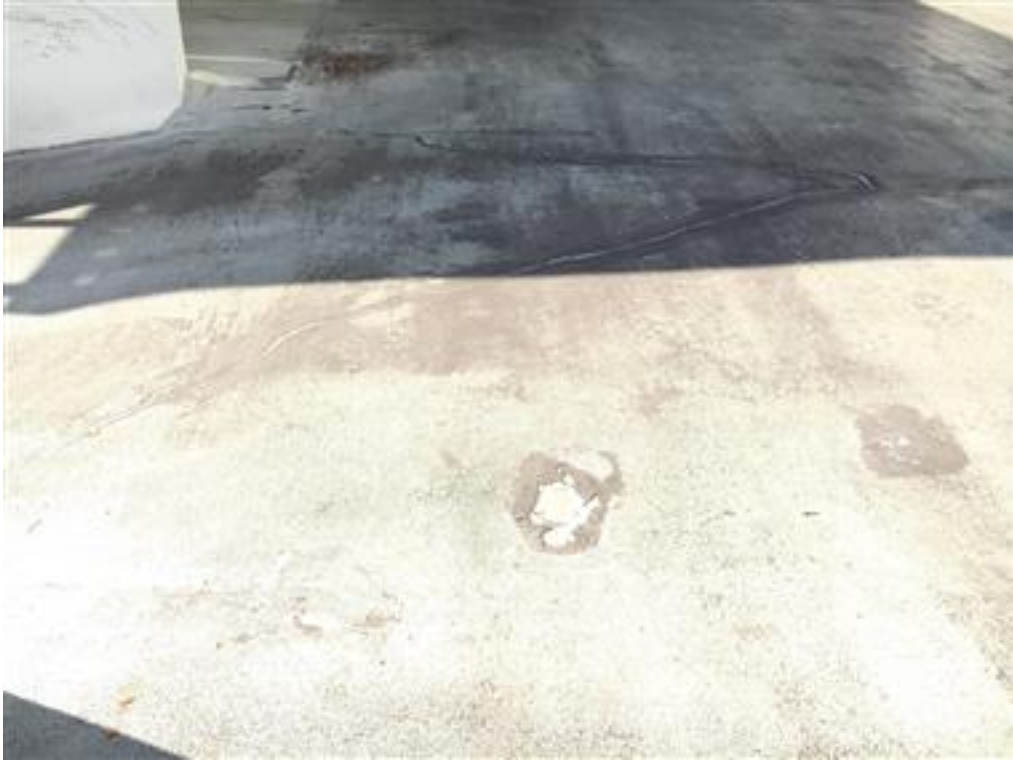
Photo 23- UPPER LEVEL-TYPICAL CRACKS

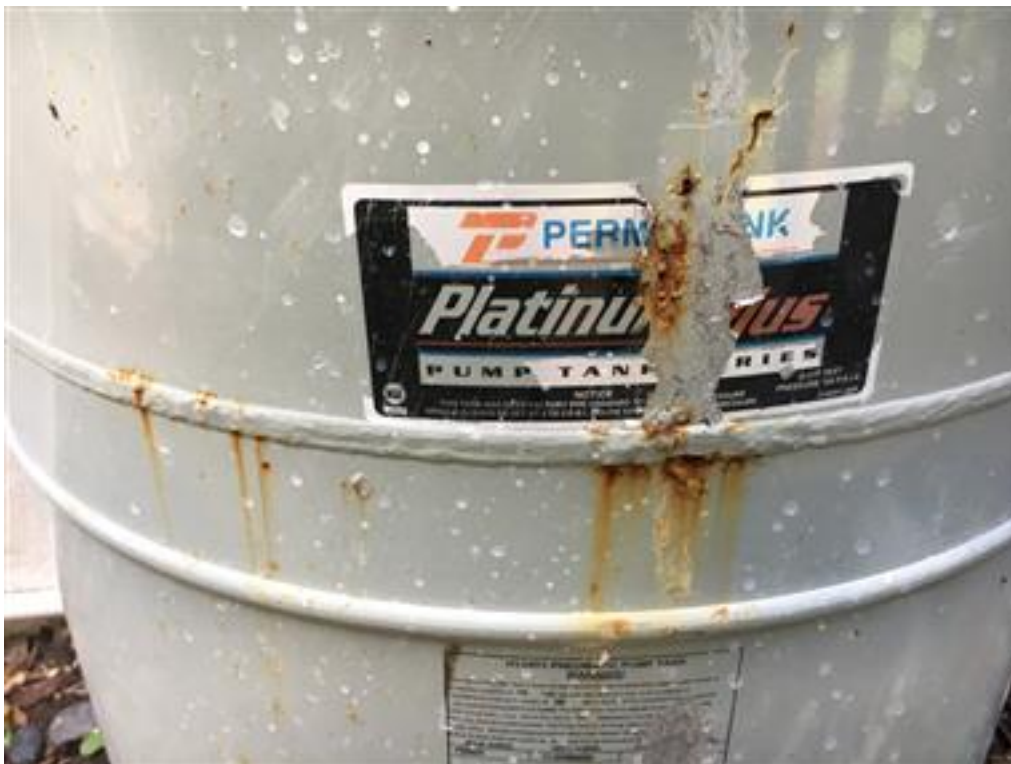
Photo 2- Irrigation pressure tank, average condition

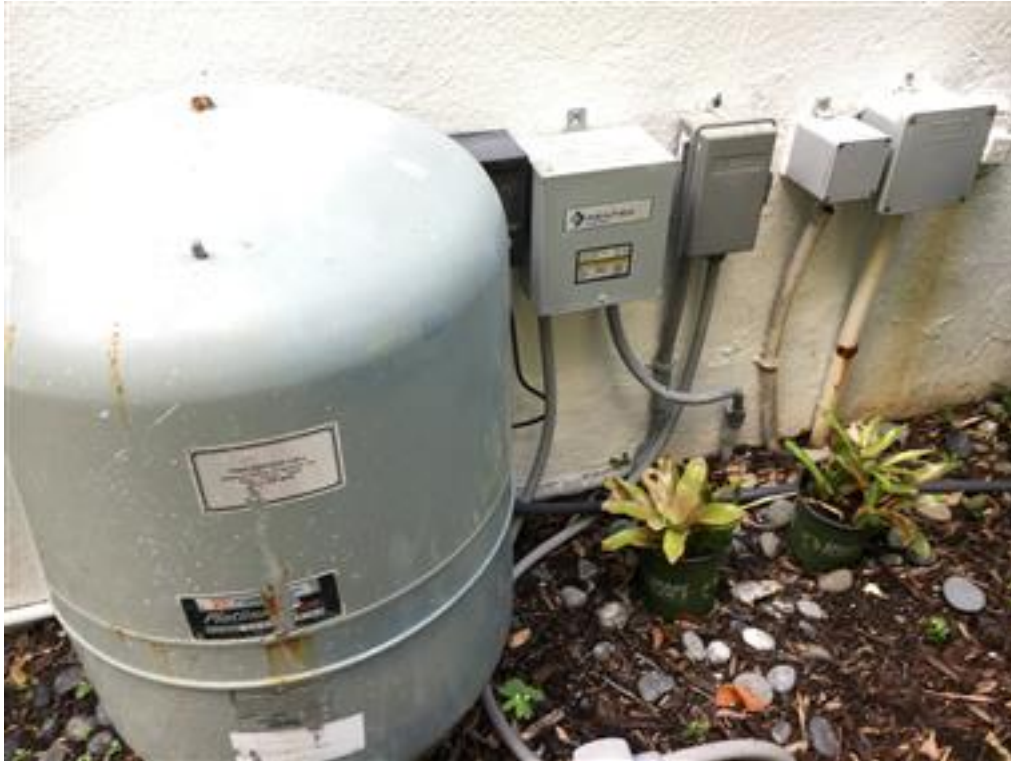
Photo 3- Irrigation controls, good condition

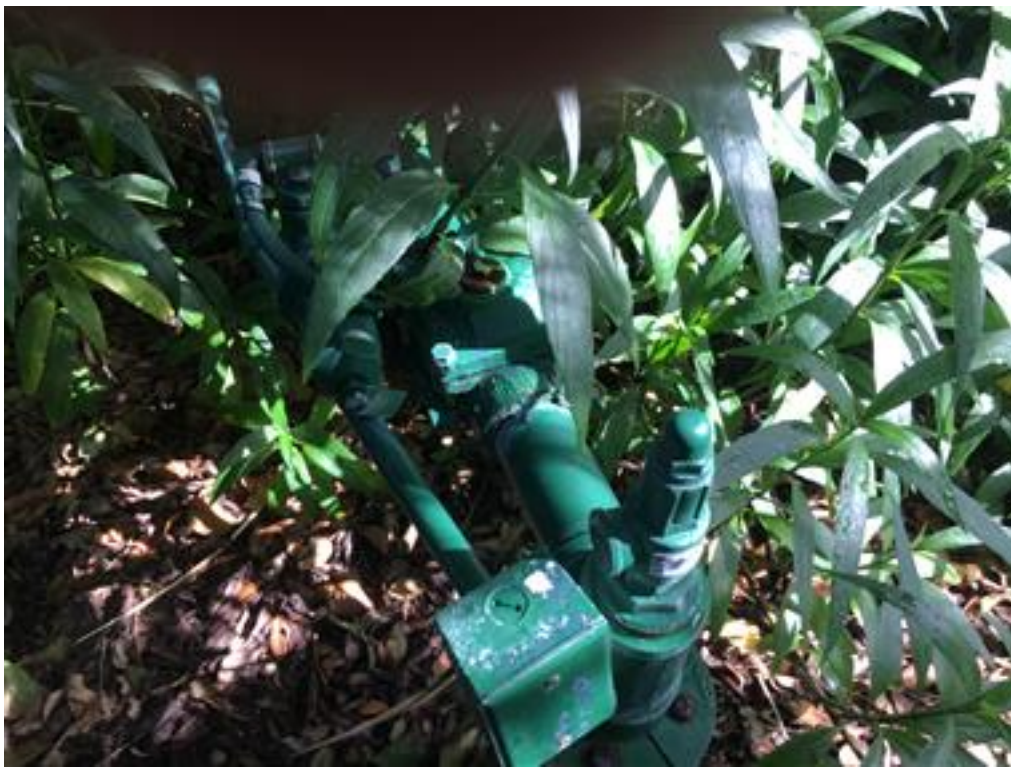
Photo 4- Irrigation well, good condition

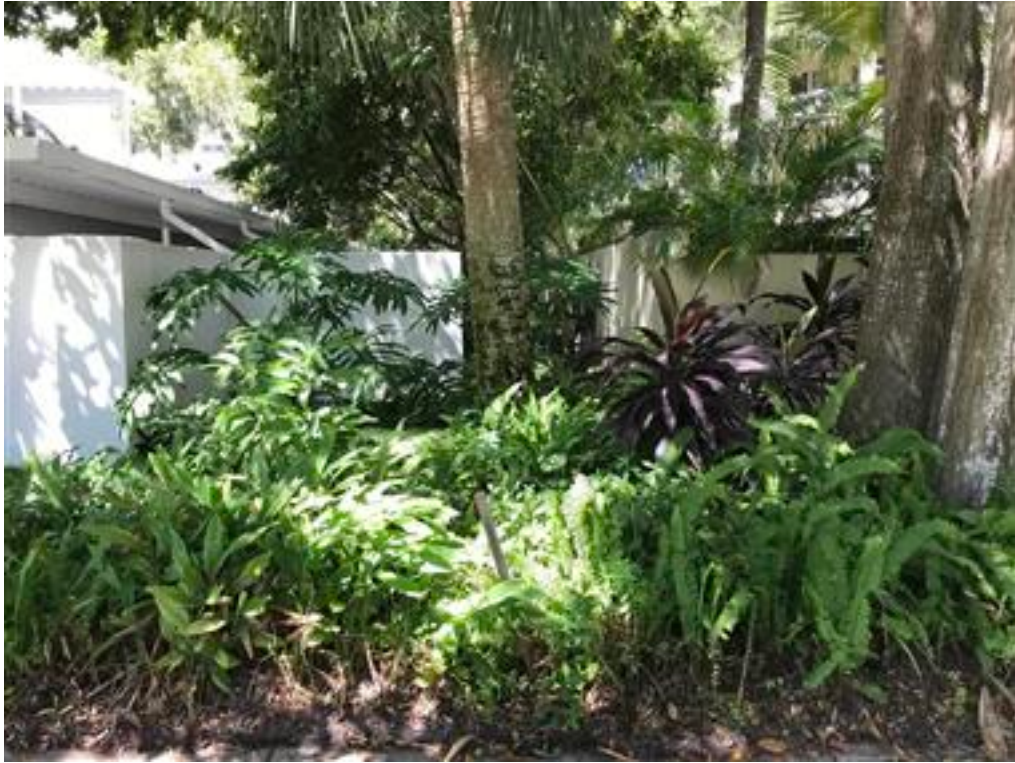
Photo 9- NW PROPERTY LINE AT WOODEN STAKE

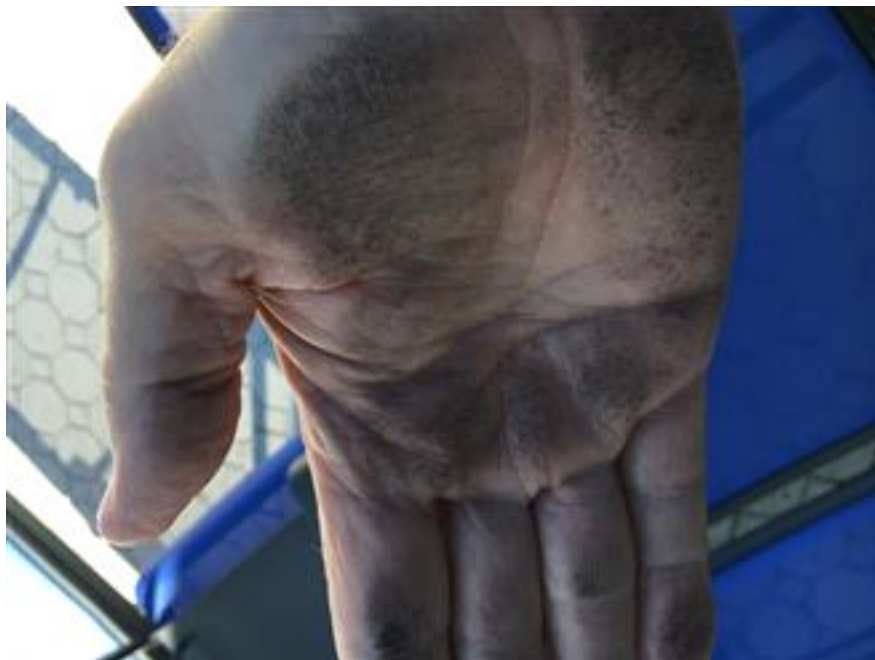
Photo 2- SURFACE DIRT ALL SIDES

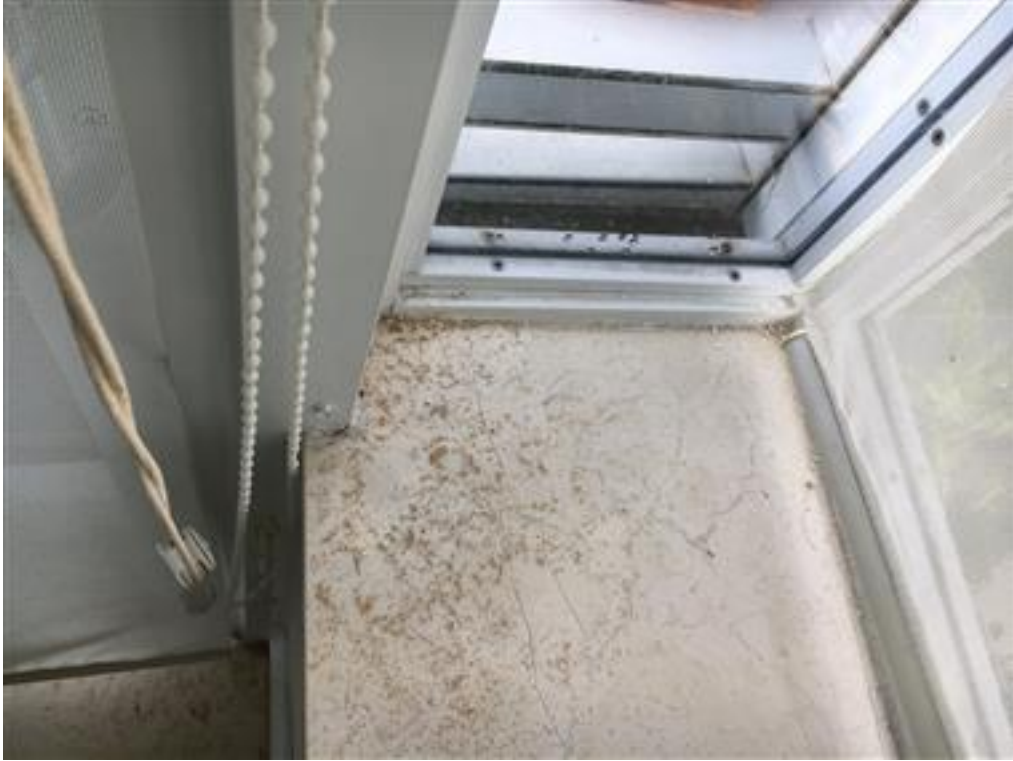
Photo 3-Unit 1601, possible pest infestation

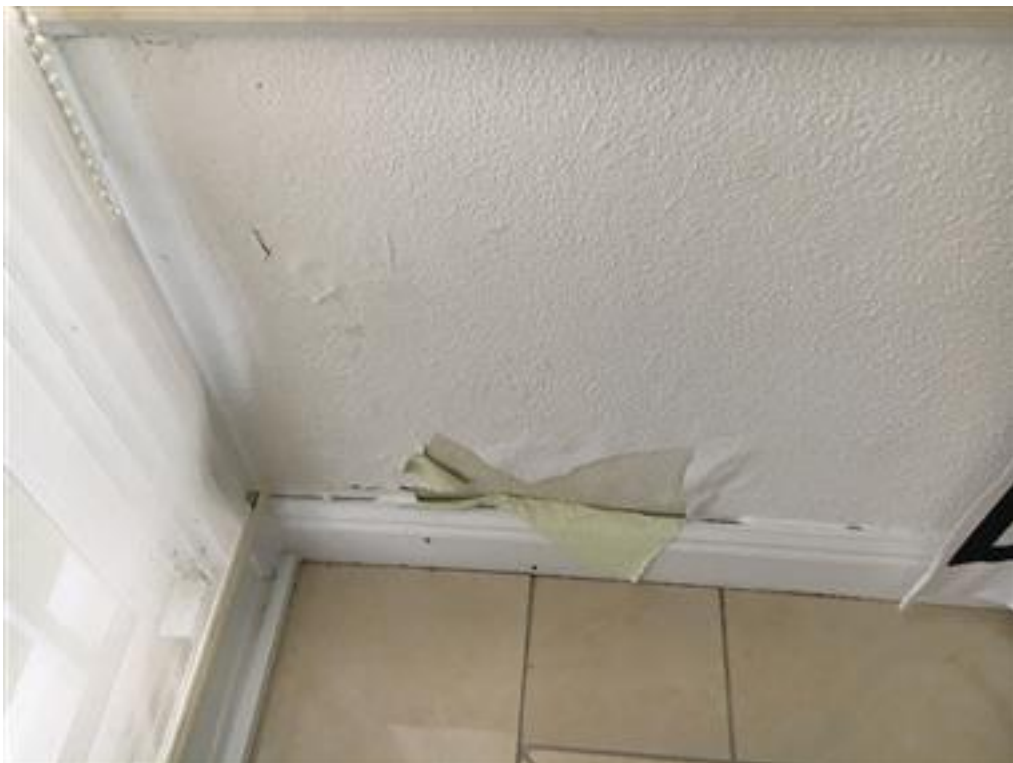
Photo 6-Unit 1601, evidence of water intrusion

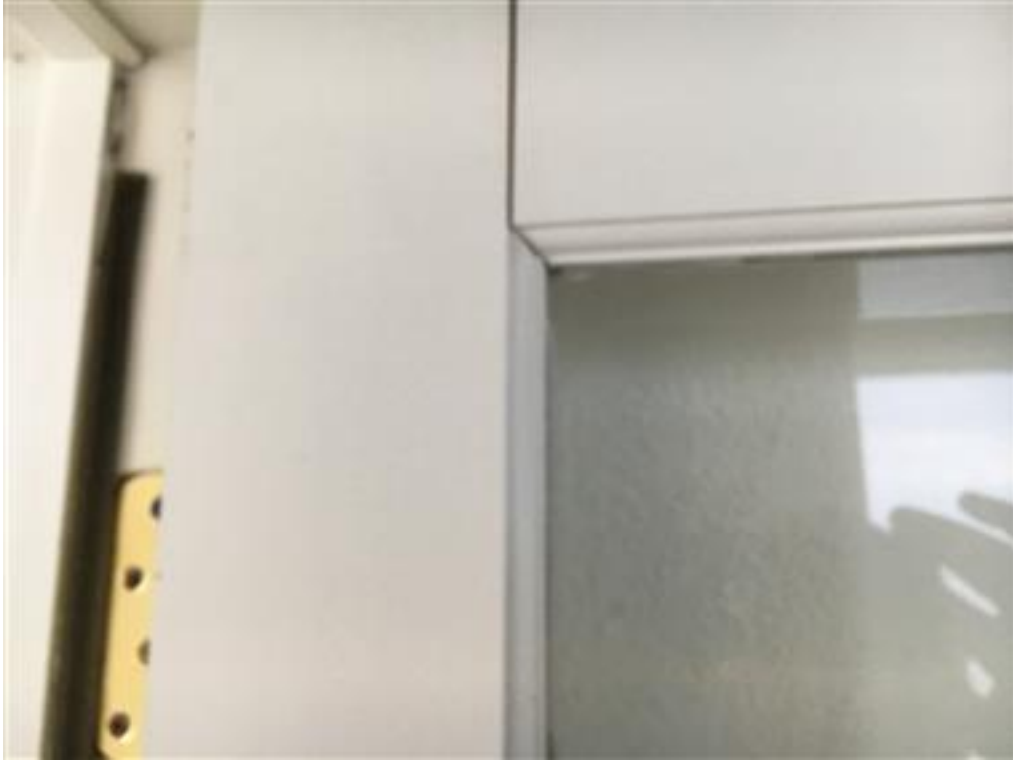
Photo 7-Unit 1601, gap at raised panel door

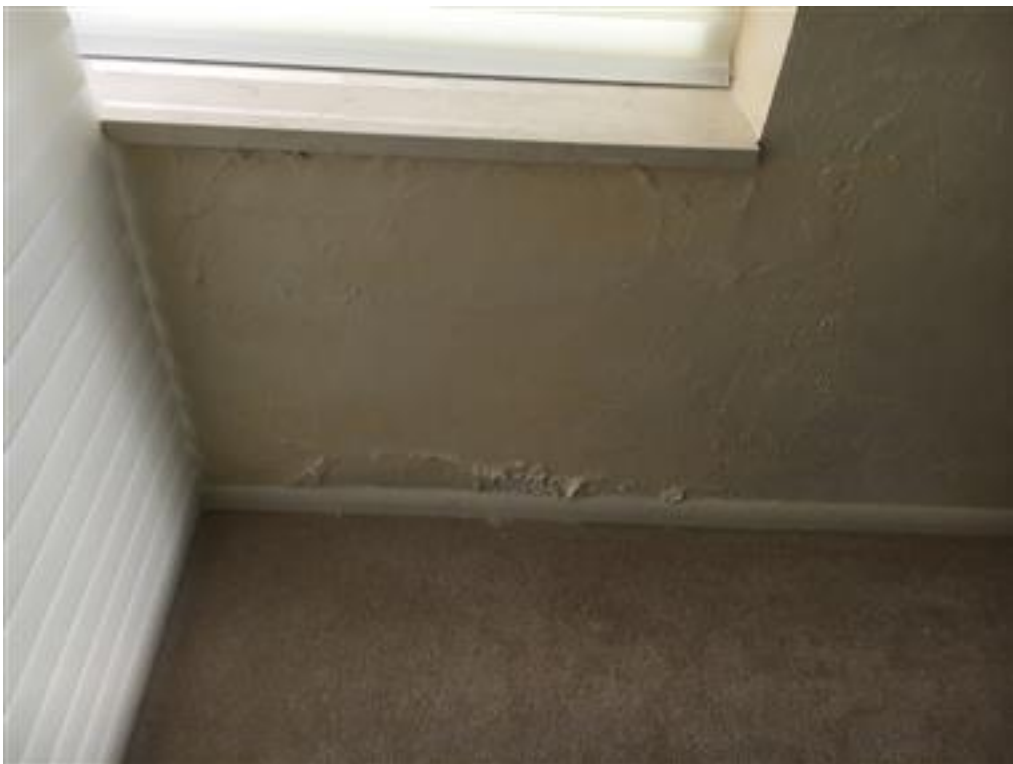
Photo 8-Unit 1602, evidence of water intrusion

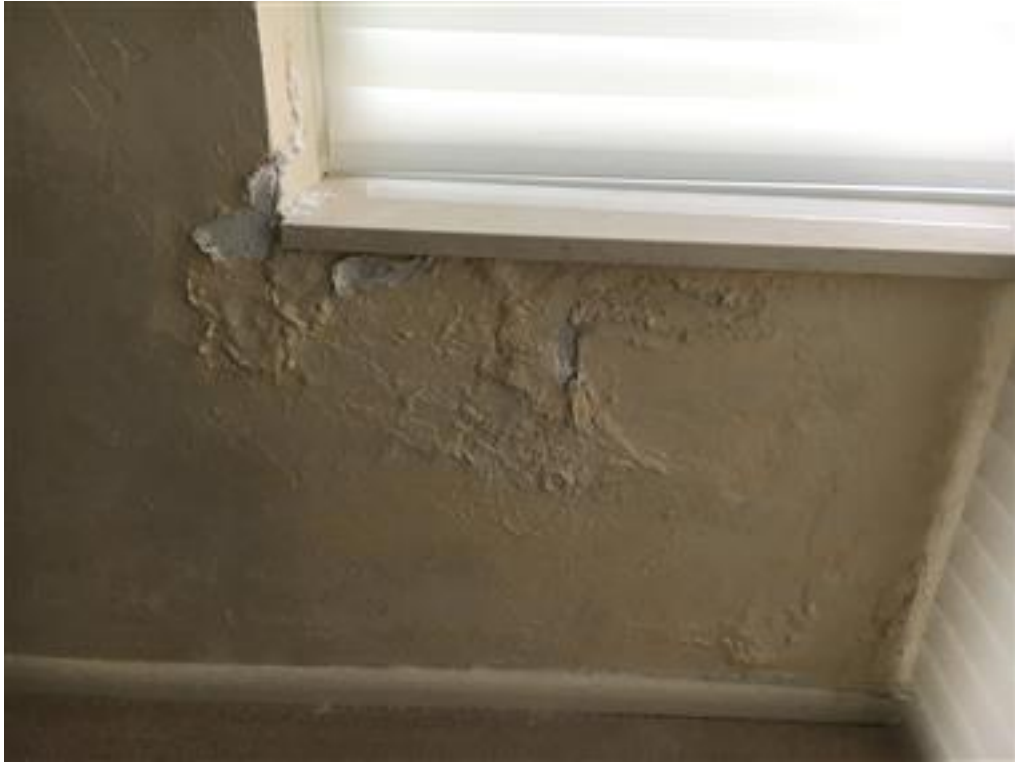
Photo 9-Unit 1602, evidence of water intrusion

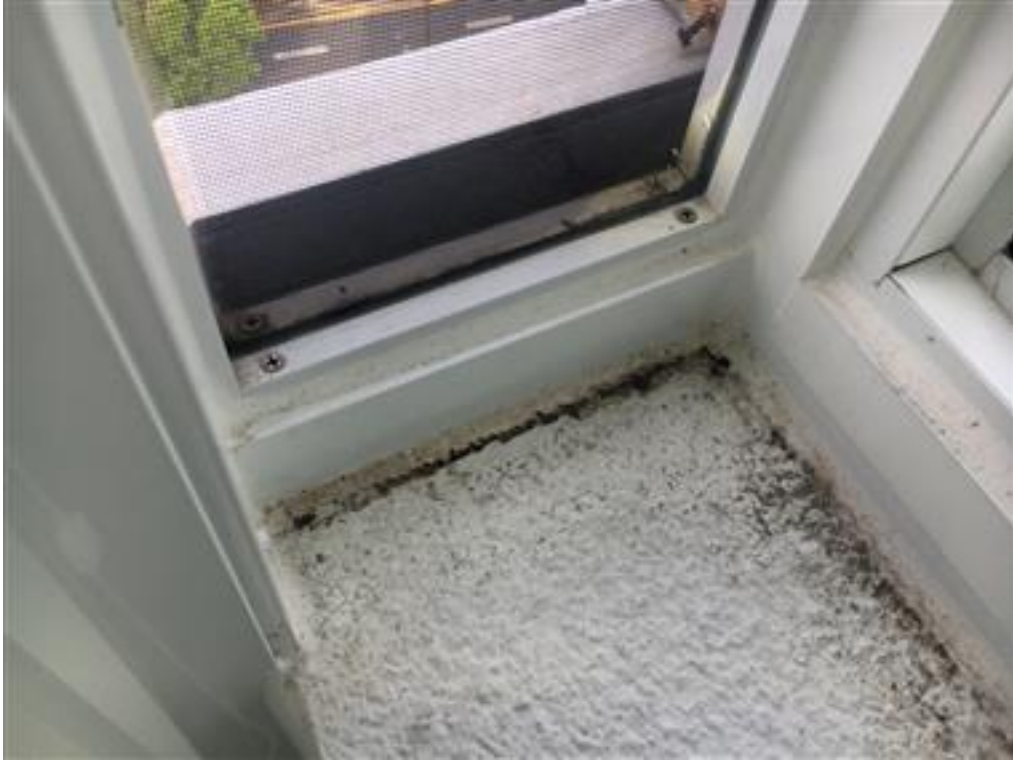
Photo 25-Unit 1404, Water damage at sill, typical

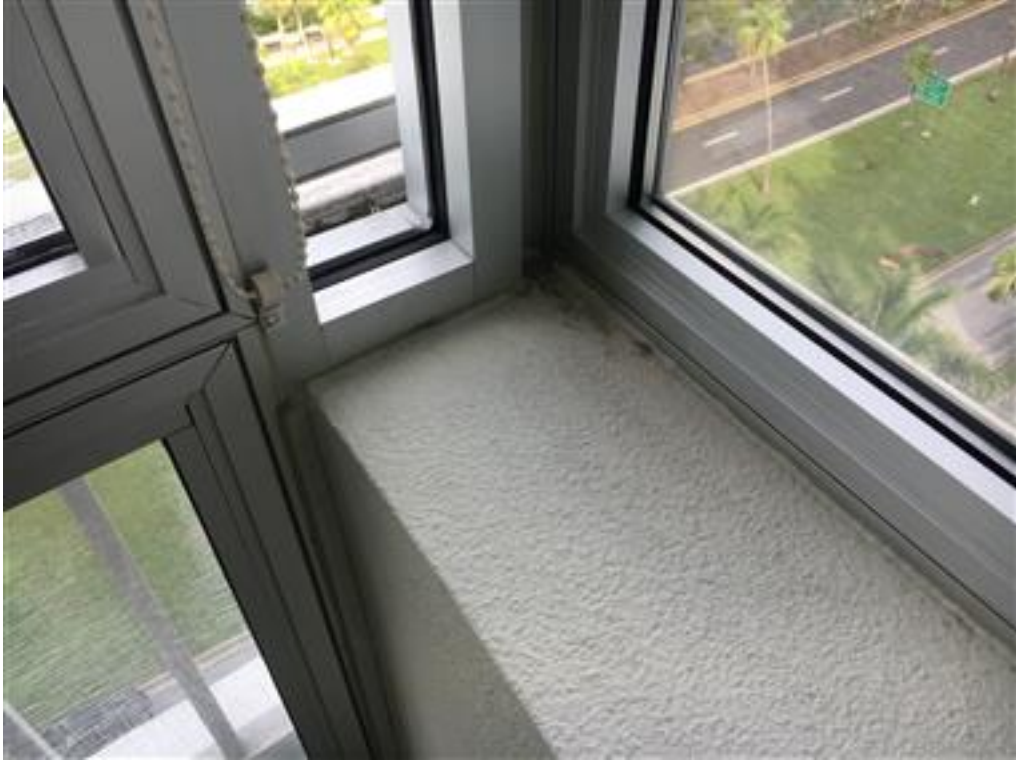
Photo 29-Unit 1404, evidence of water intrusion

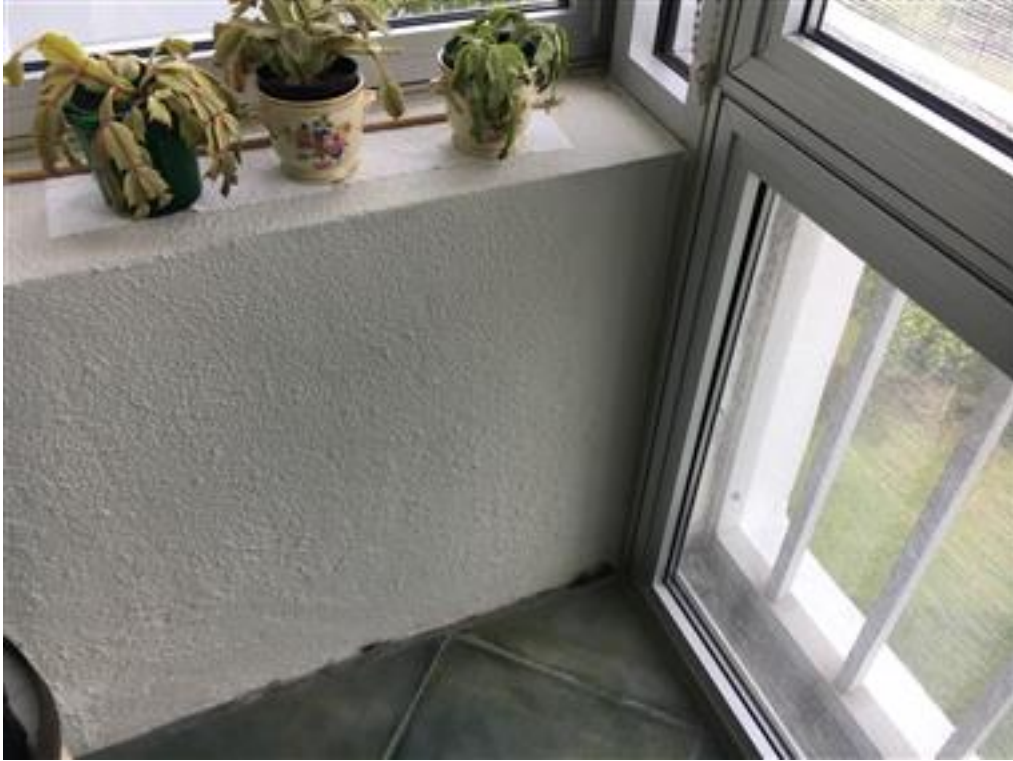
Photo 31-1404, evidence of water damage

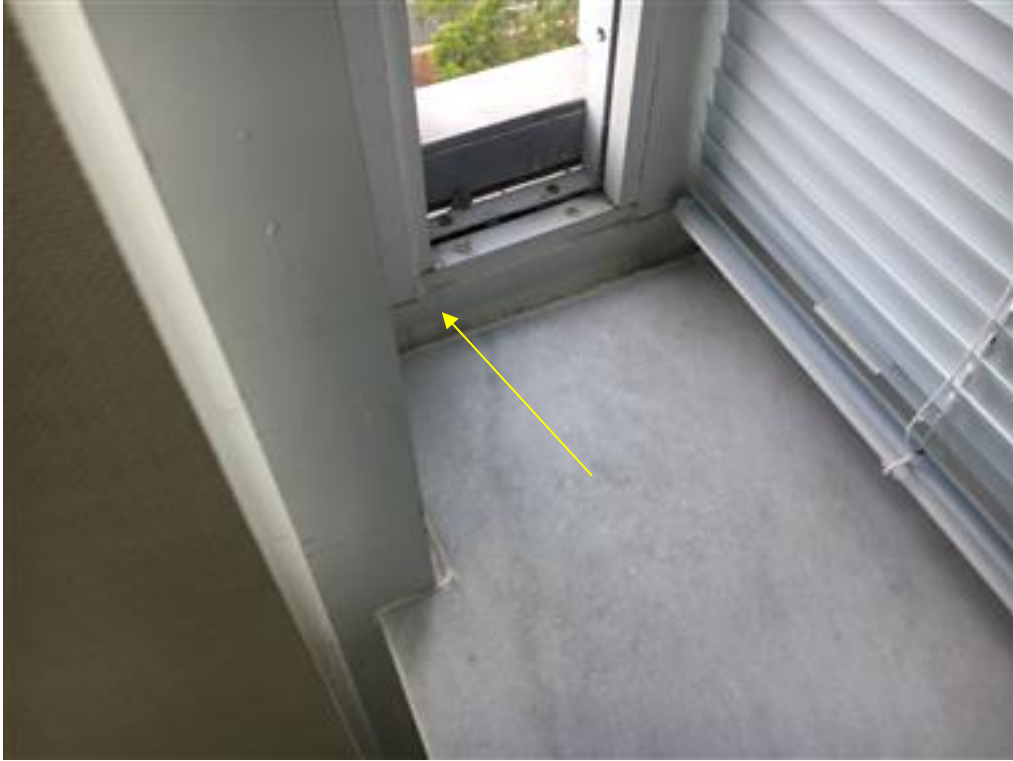
Photo 39-Unit 1203, sealant joint failure

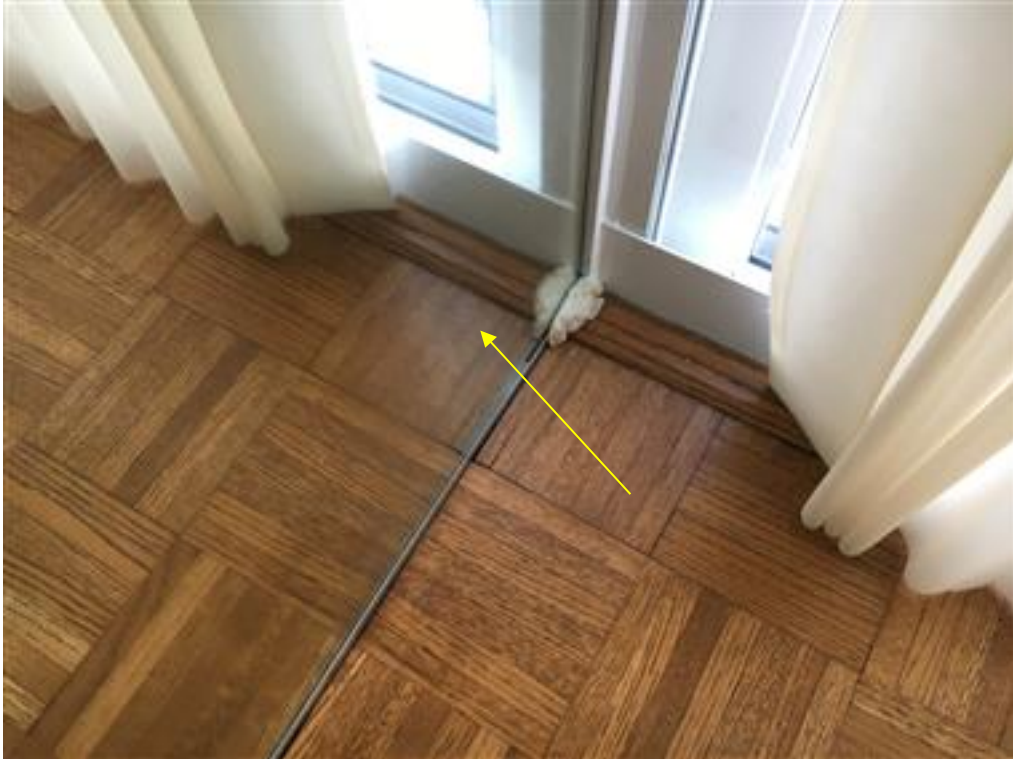
Photo 43-Unit 1201, tissues used to absorb water intrusion at SGD, typical

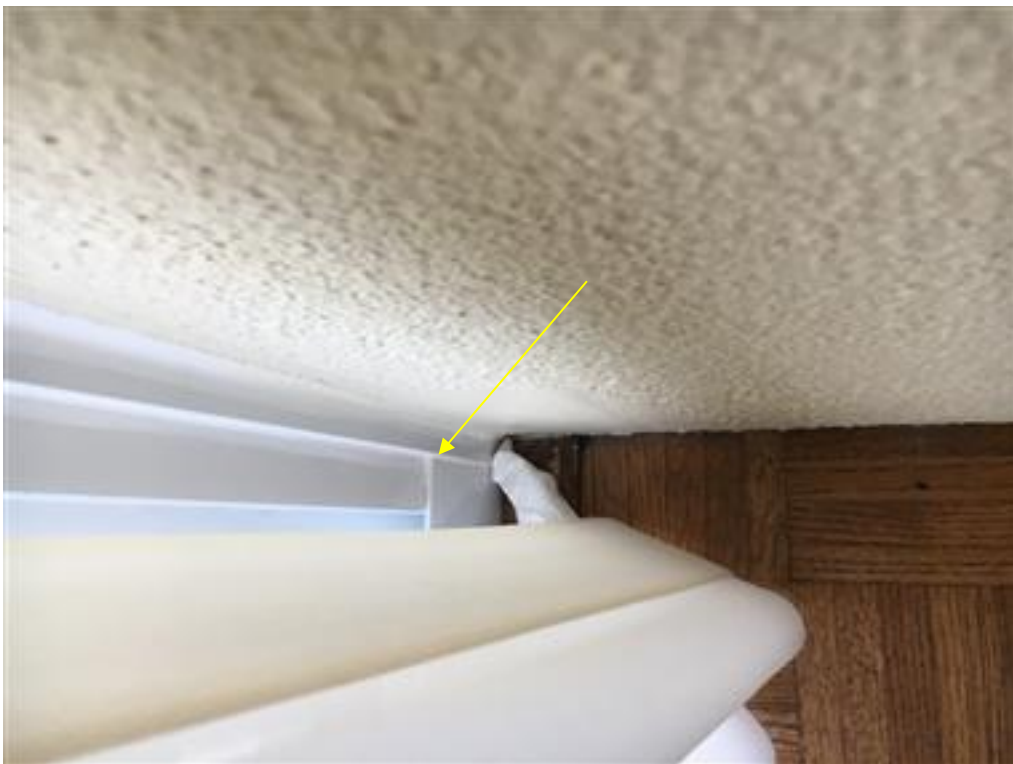
Photo 44-Unit 1201, tissues used to absorb water intrusion at SGD

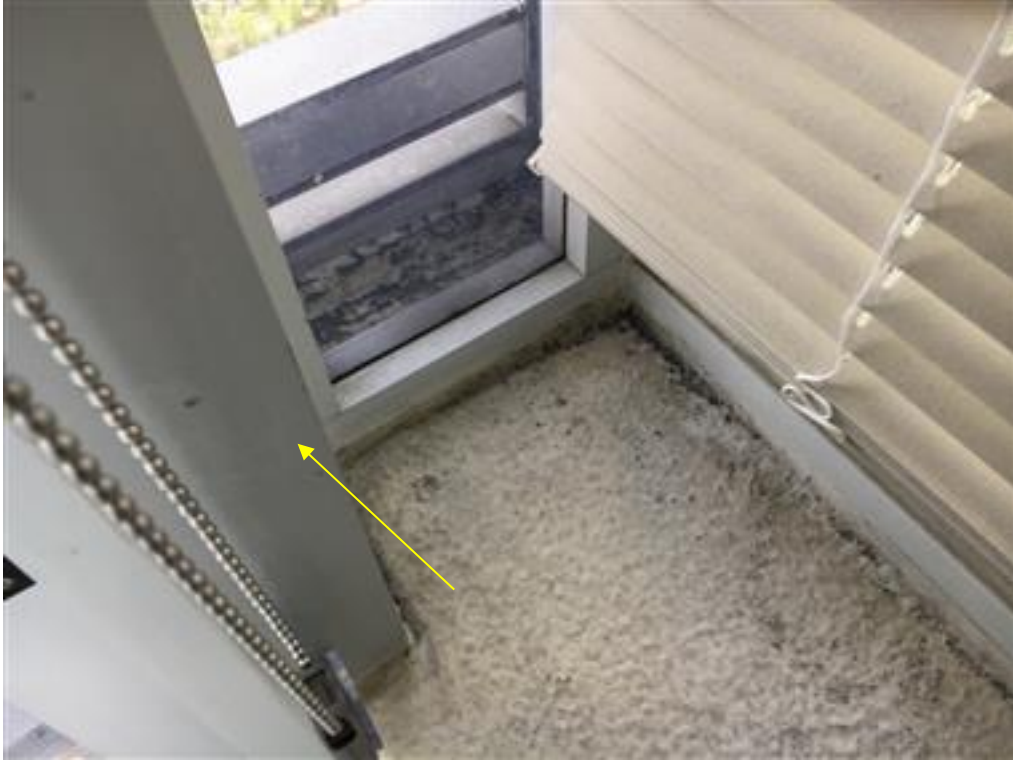
Photo 47-Unit 1202, deteriorated joint sealant

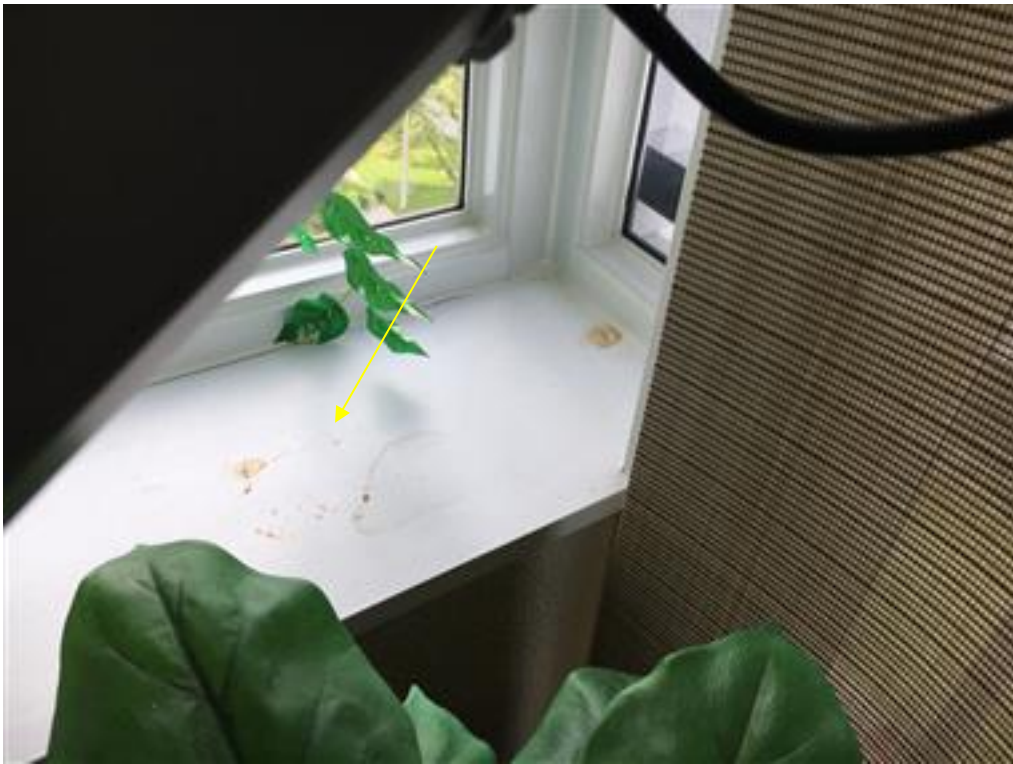
Photo 52-Unit 1103, water stain from evaporated water puddle due to possible water intrusion

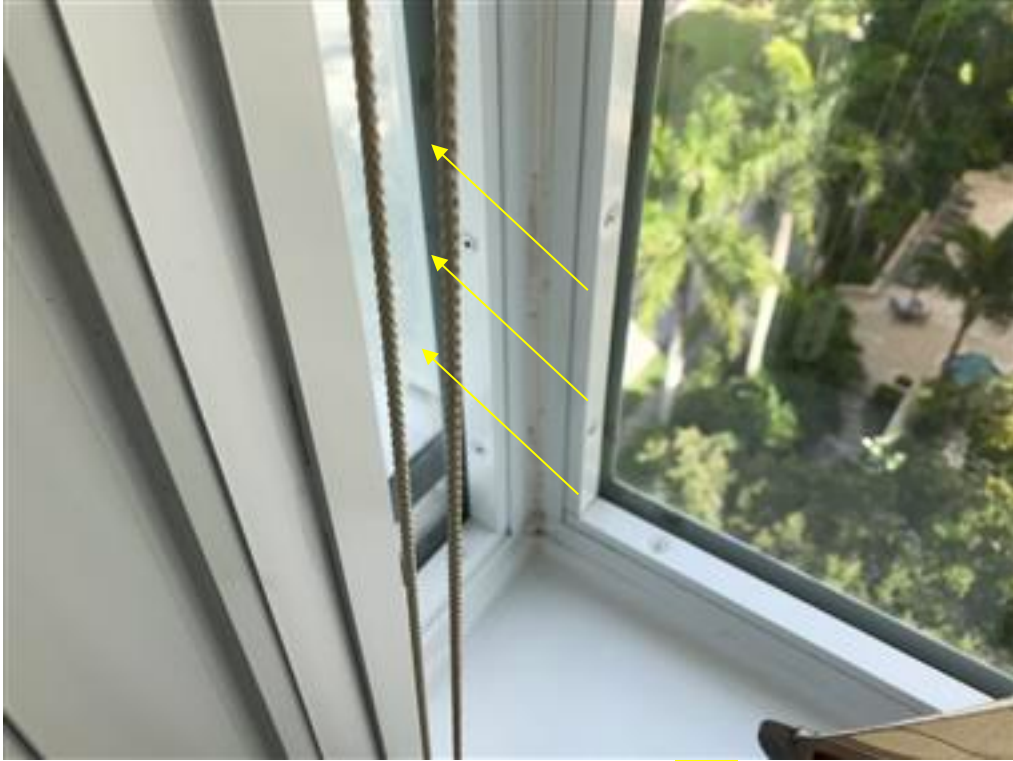
Photo 55-Unit 1101, joint sealant issue

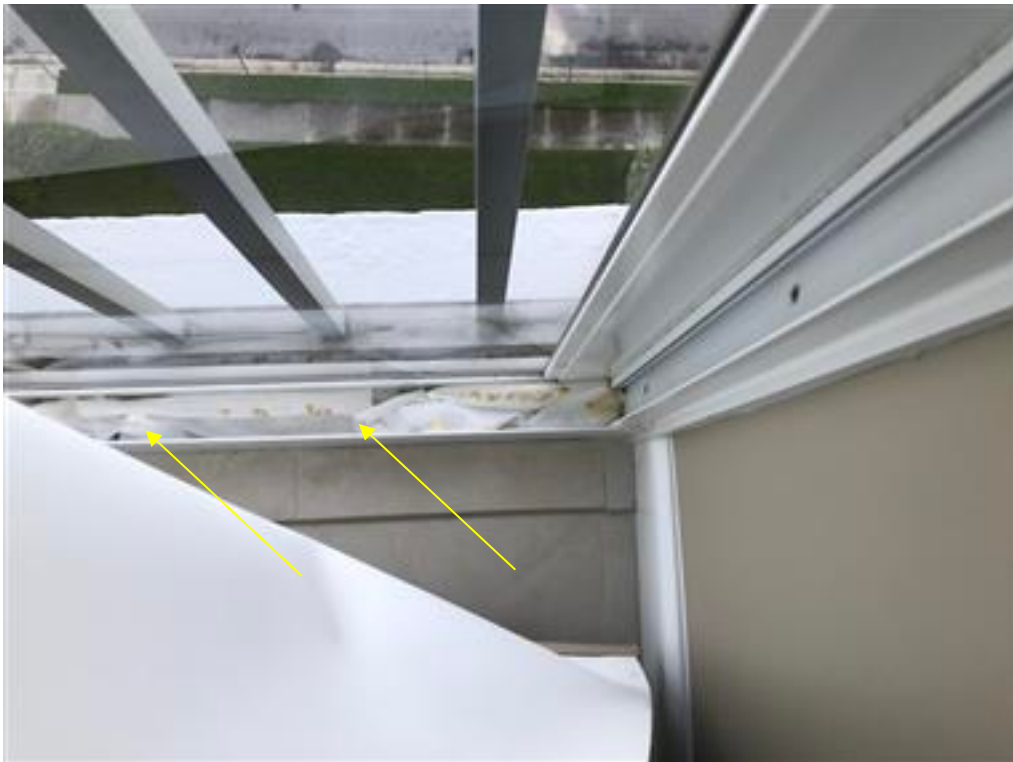
Photo 60-Unit 1001, material used for water absorption at SGD, typical

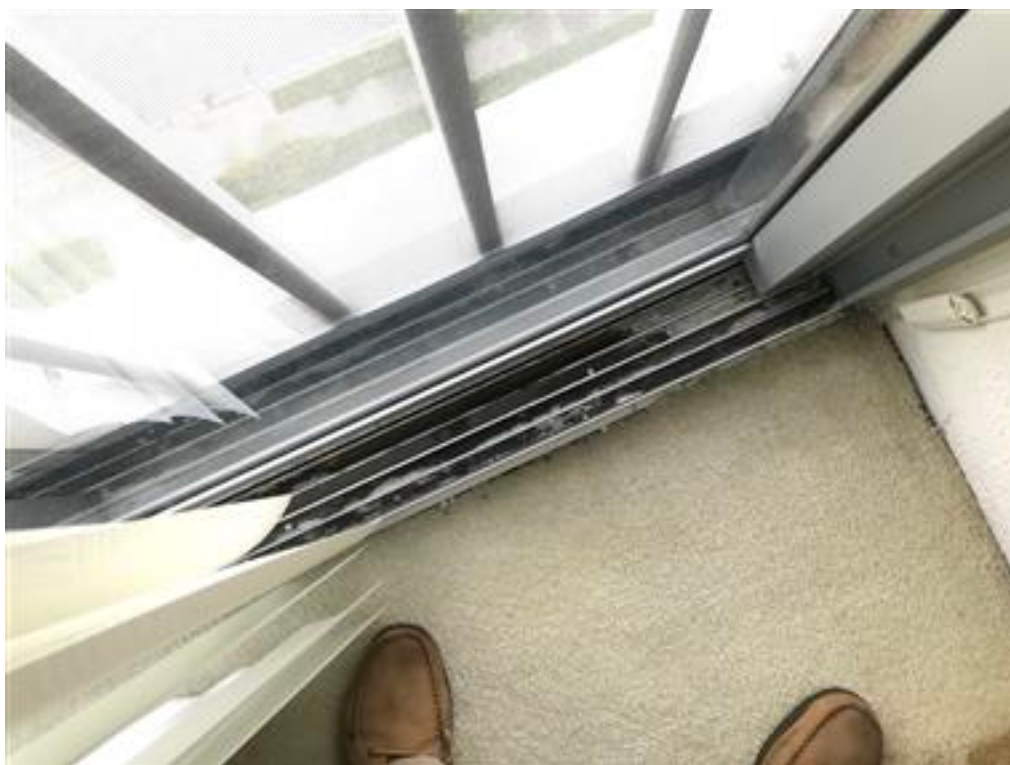
Photo 64-Unit 1002, evidence of water intrusion at SGD threshold

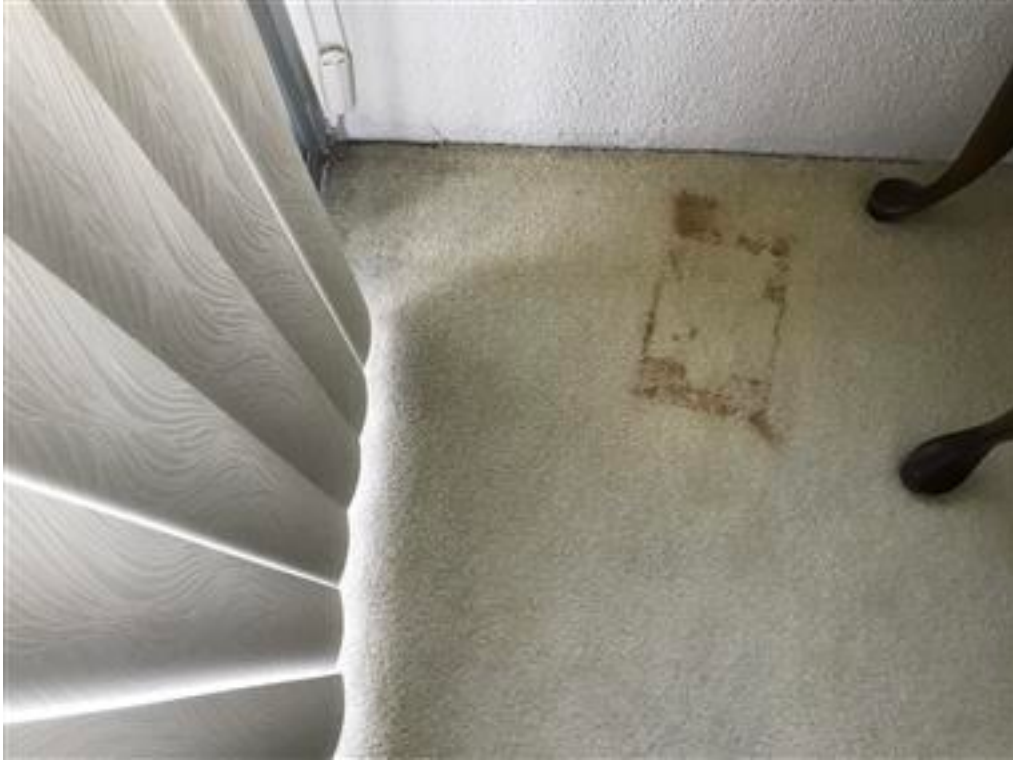
Photo 65-Unit 1002, evidence of water intrusion from rust stain on carpet

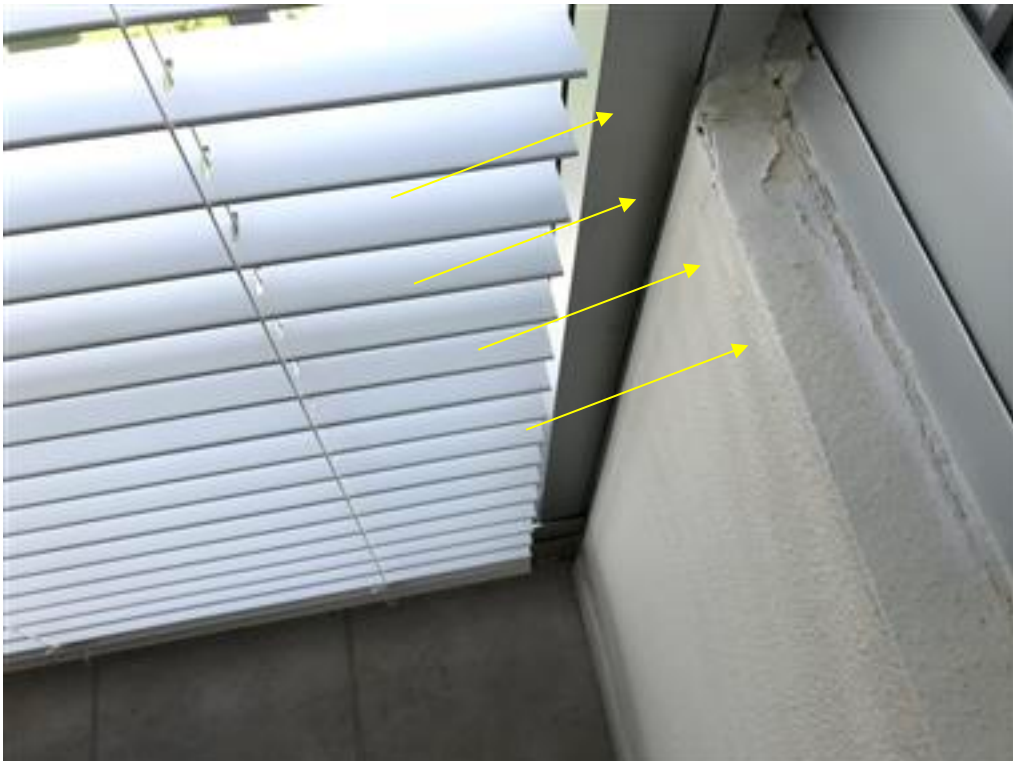
Photo 68-Unit 1004, blistering paint at window sill

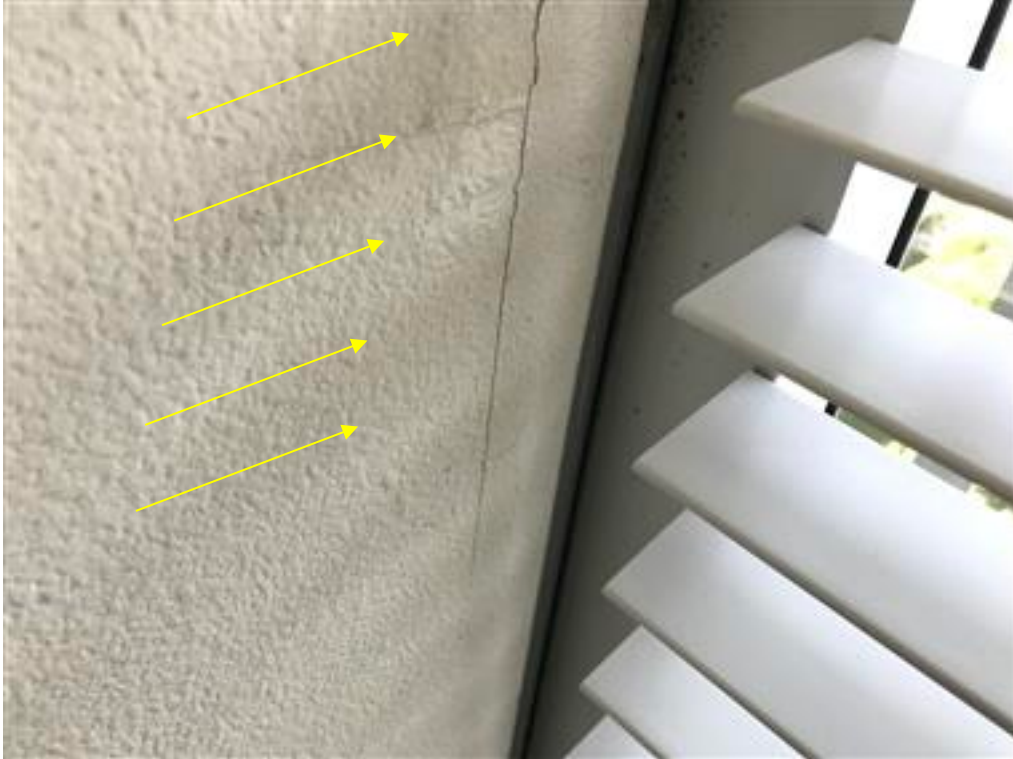
Photo 69-Unit 1002, crack in drywall at SGD, typical

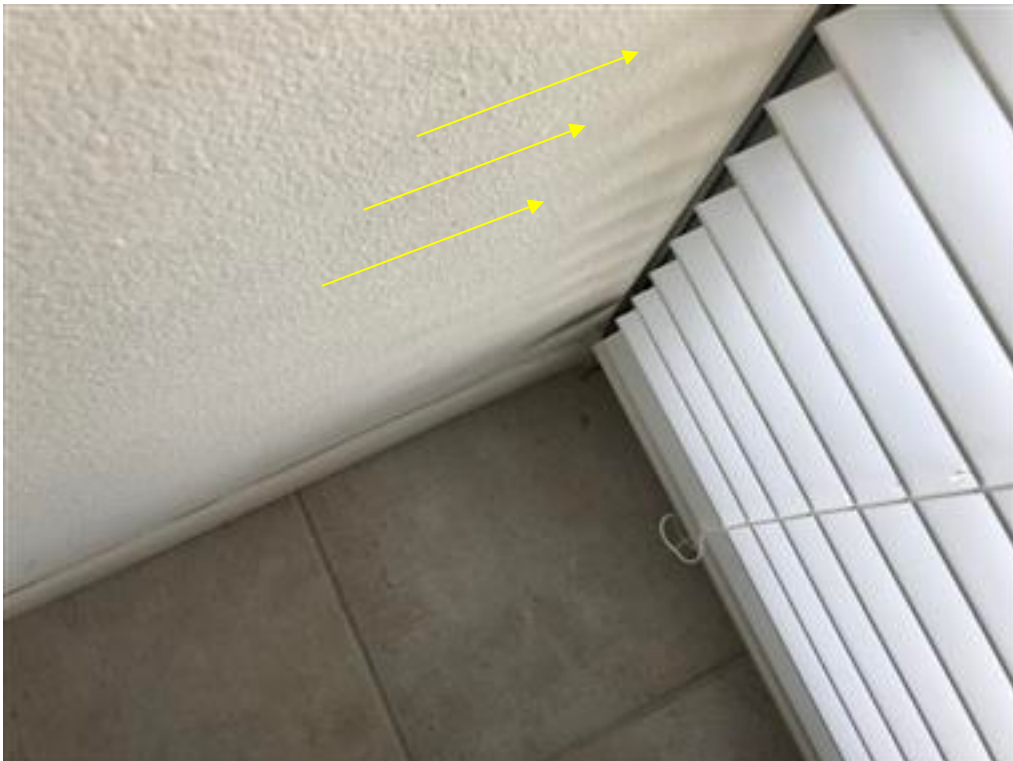
Photo 70-Unit 1002, crack in drywall at SGD

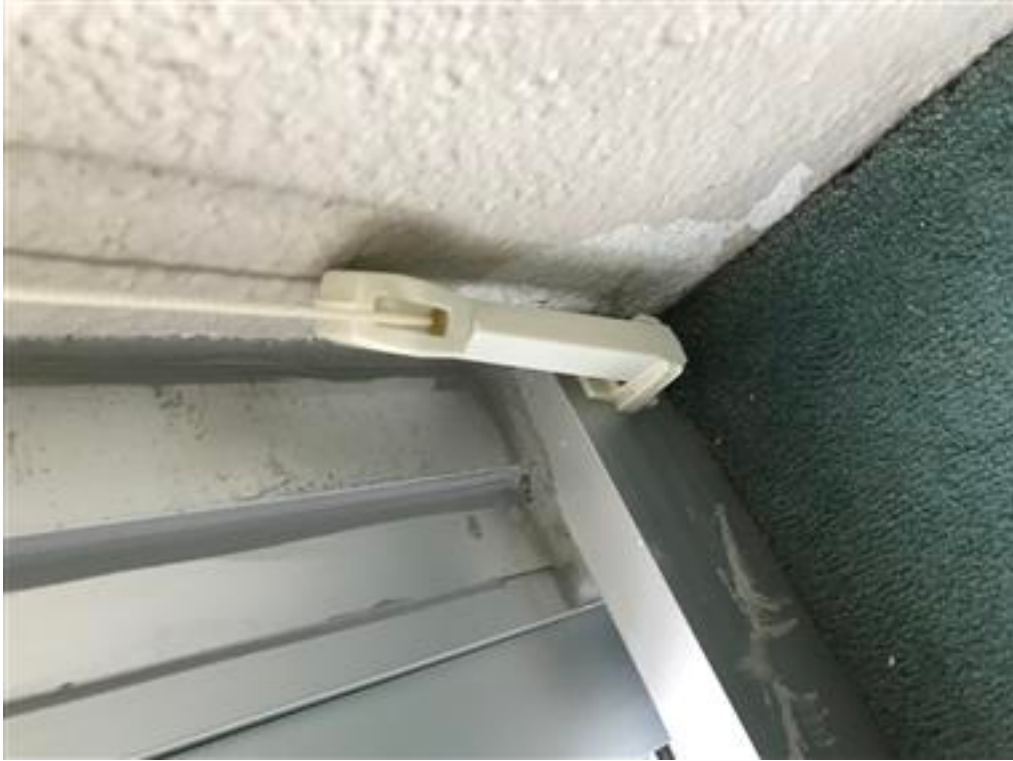
Photo 73-1003, peeling paint at SGD threshold due to water infiltration

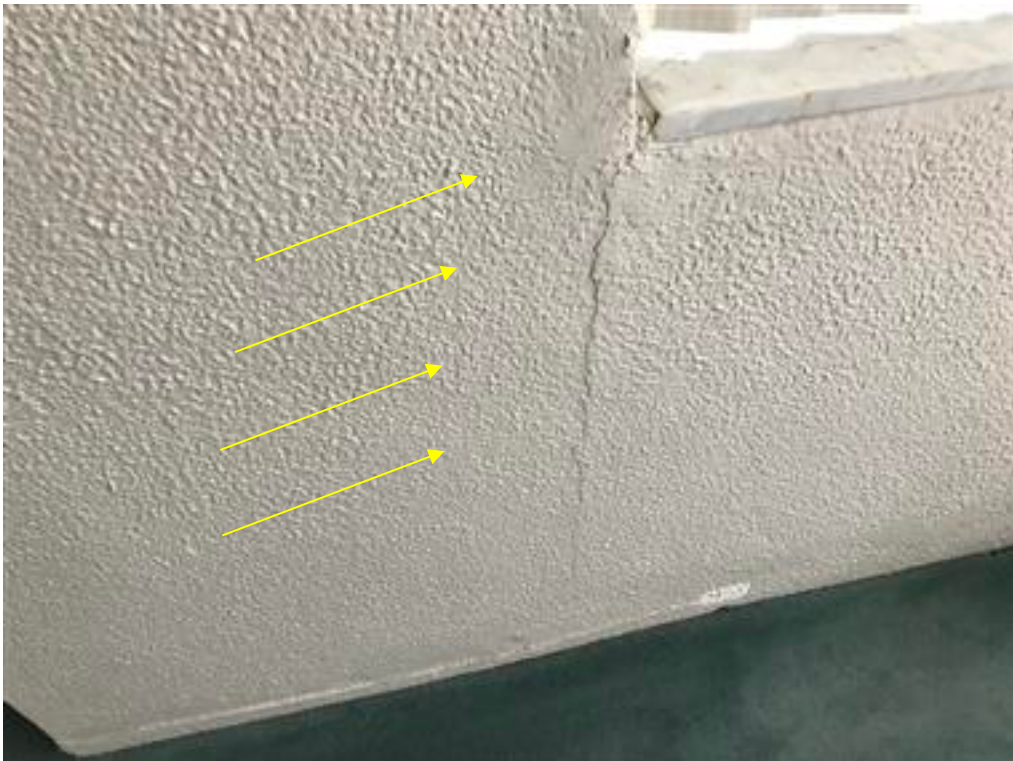
Photo 74-Unit 1003, hairline crack at window sill, typical

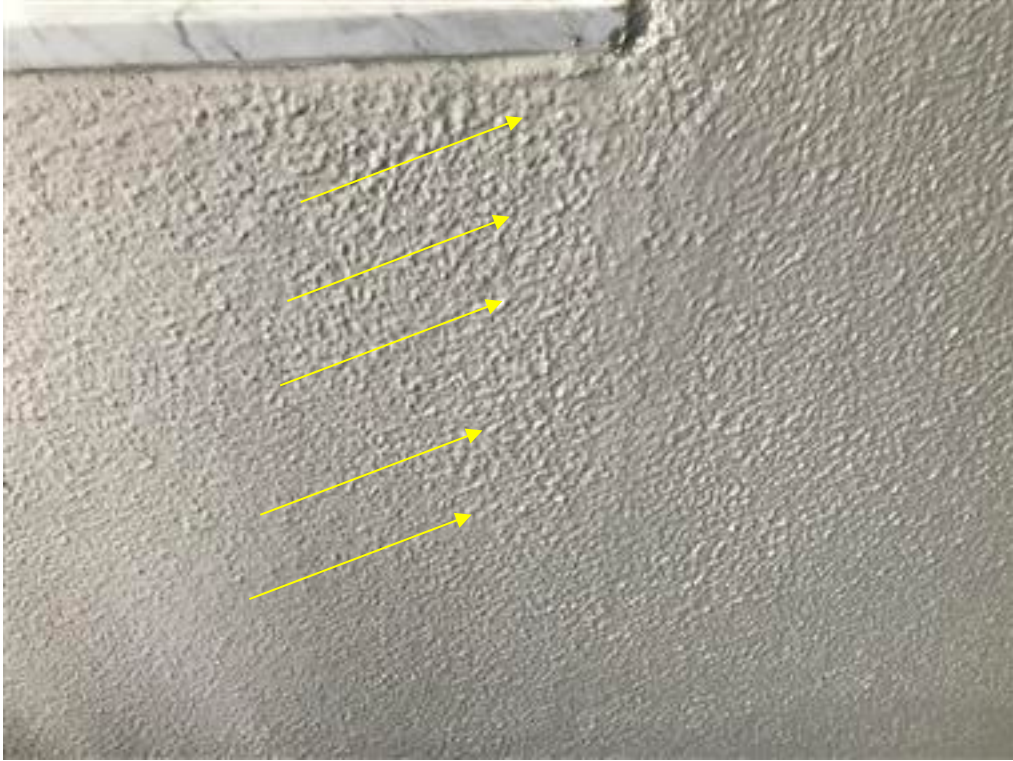
Photo 75-Unit 1002, hairline crack at window sill, typical
