# Existing Condition Report

**KEG File: 18RS-0416**  
**October 8, 2018**

***Royal St. Andrew Association,  
Inc.***

**RE:    *Royal St. Andrew  
KEG Project P18RS-0416 REV02  
Professional Engineering Services – Existing Conditions Survey***

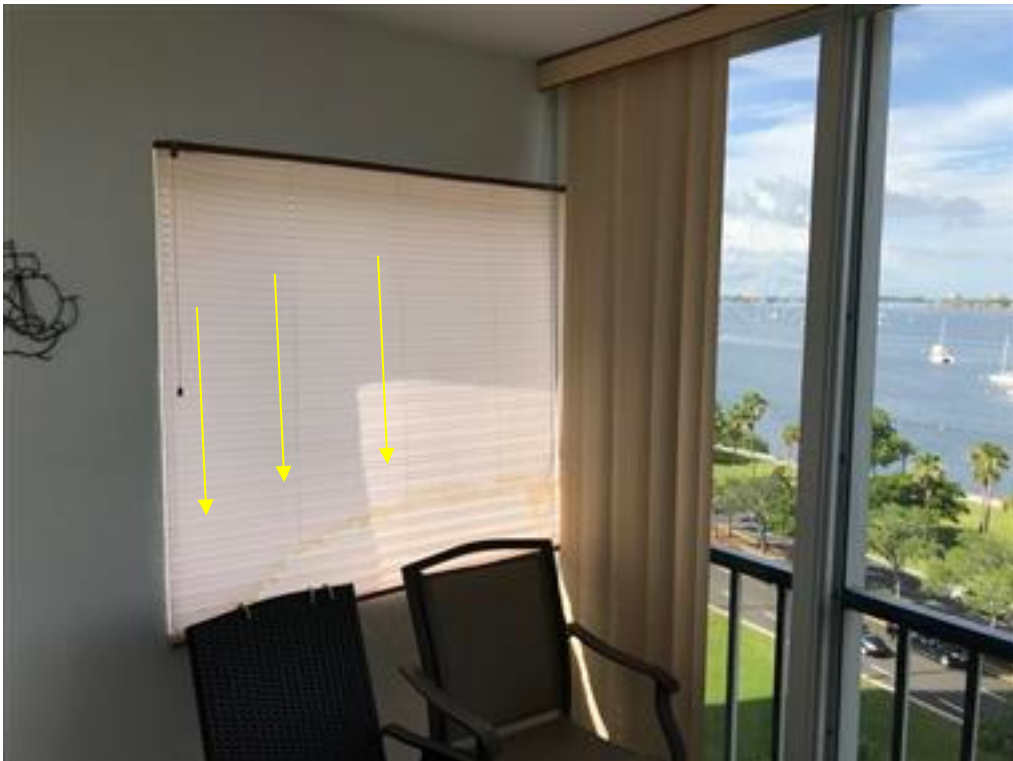
Photo 76-Unit 904, water stain on curtain due to water infiltration

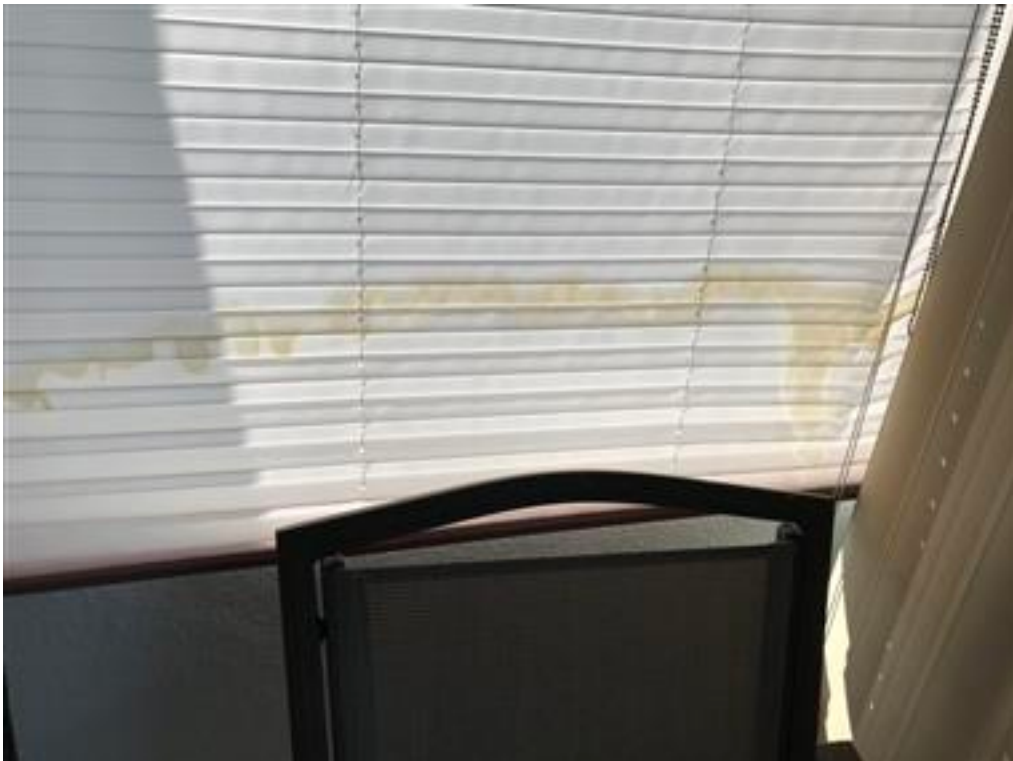
Photo 78-Unit 904, water stain on curtain due to water infiltration

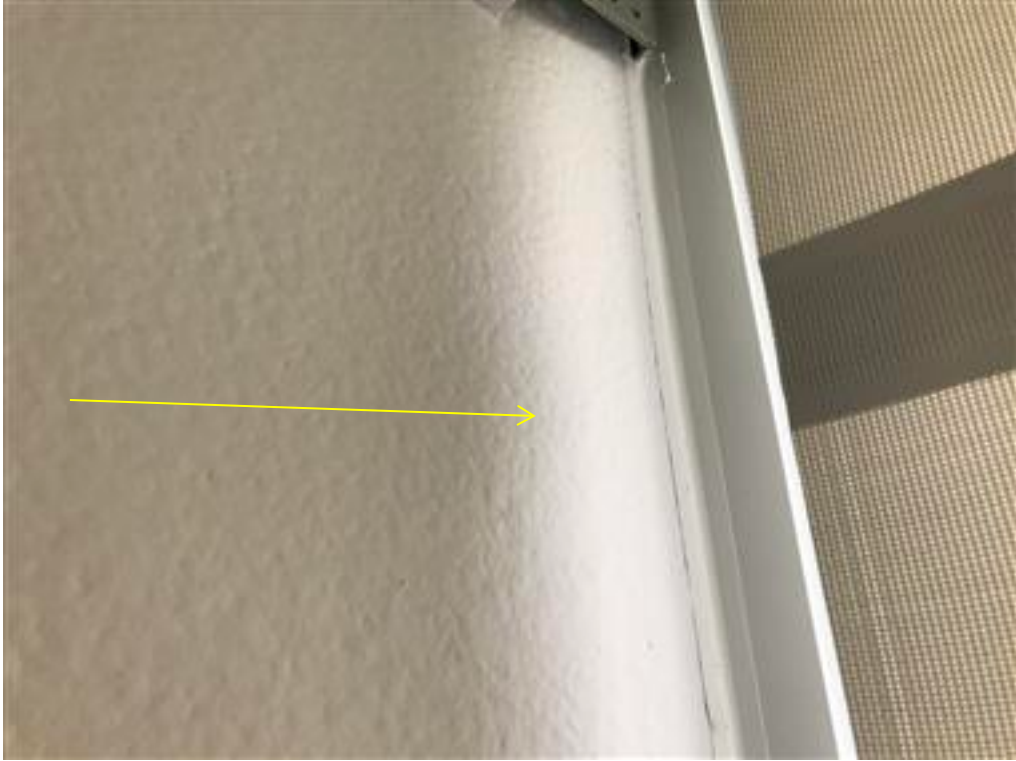
Photo 99-Unit 802, unfamiliar joint at SGD

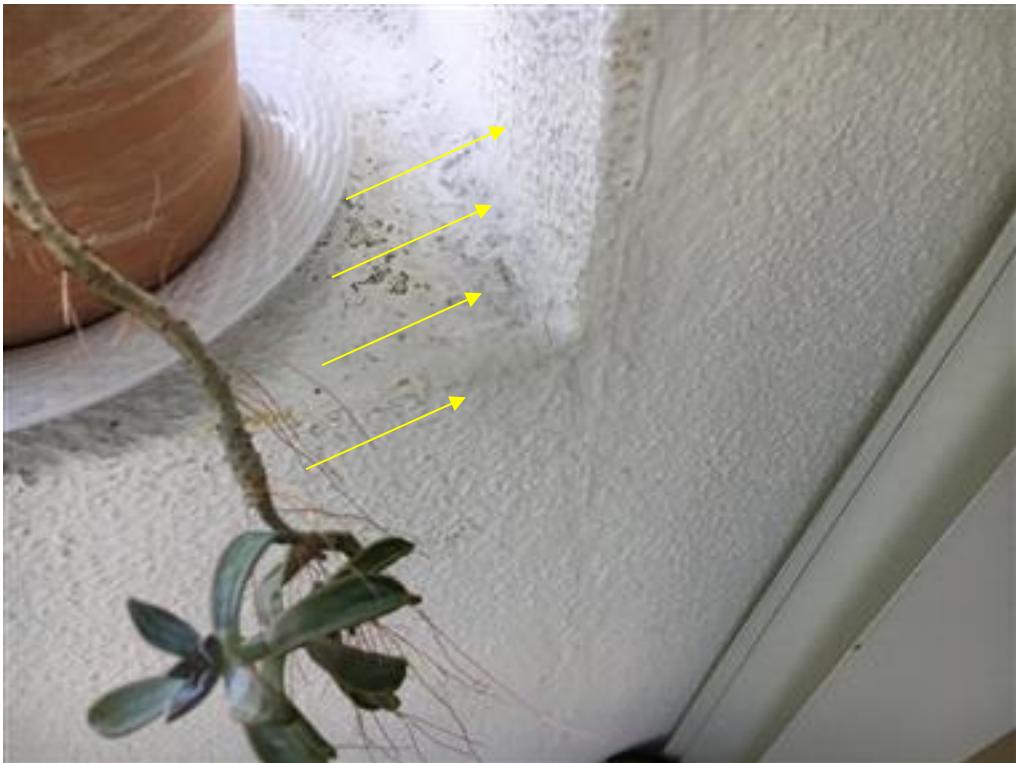
Photo 133-Unit 501, previous hairline crack repair

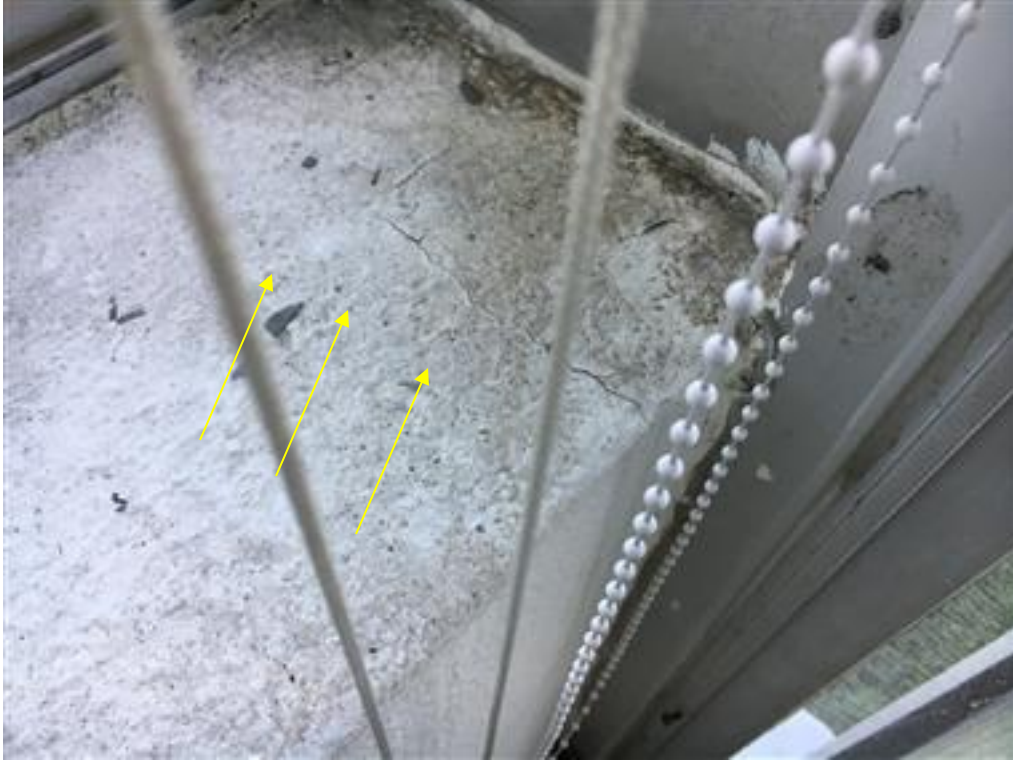
Photo 134-Unit 501, water damage at window sill

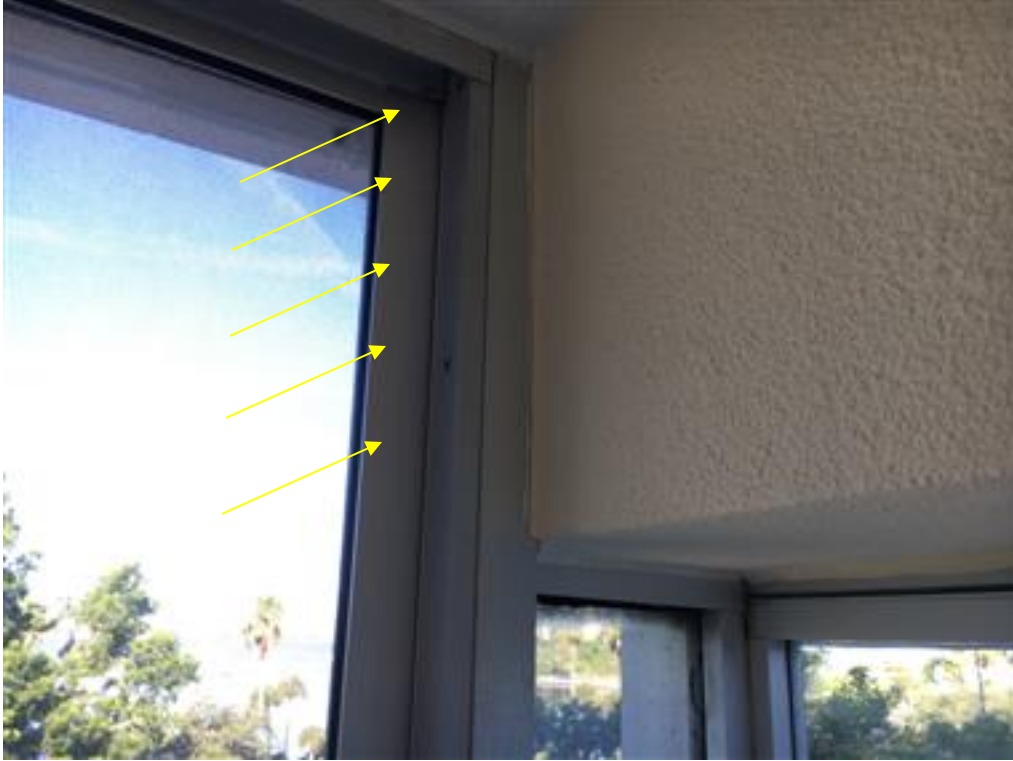
Photo 146-Unit 405, open crack at SGD above window

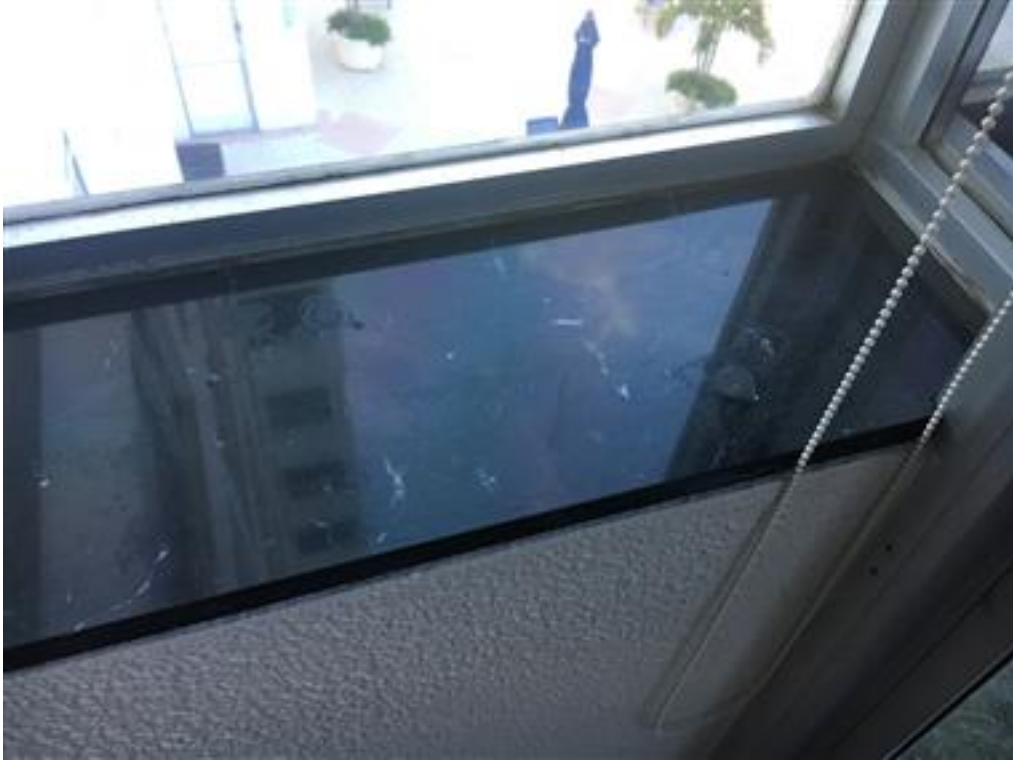
Photo 178-Unit 304, cracked marble sill

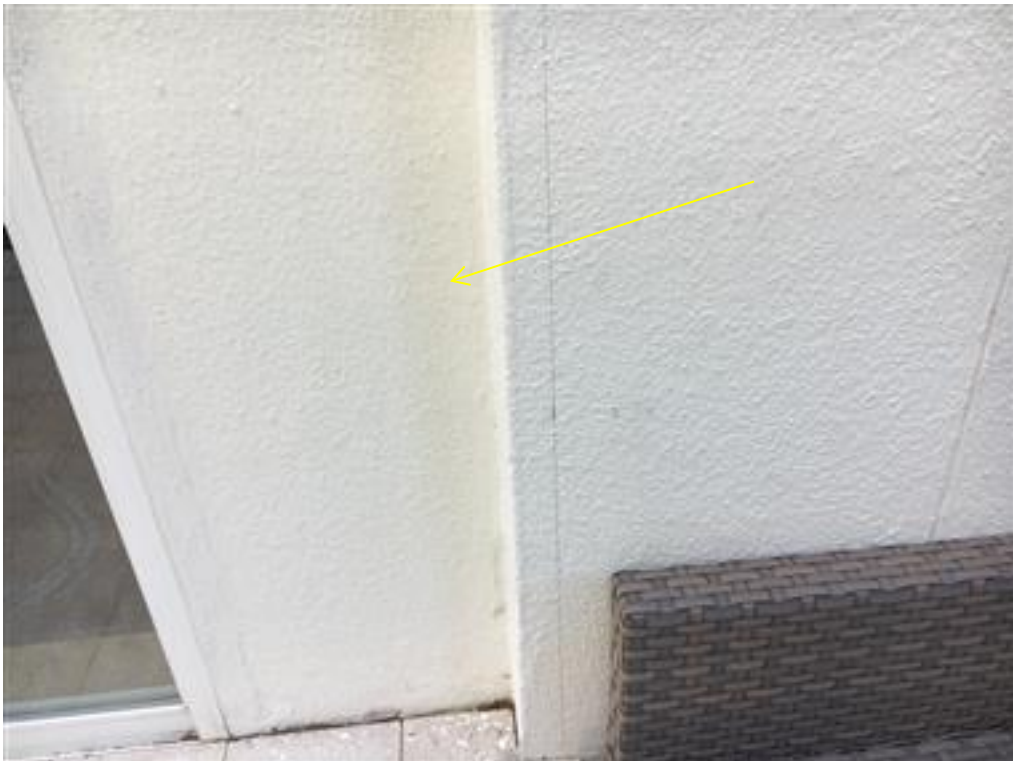
Photo 181-EXTERIOR, vertical stucco crack

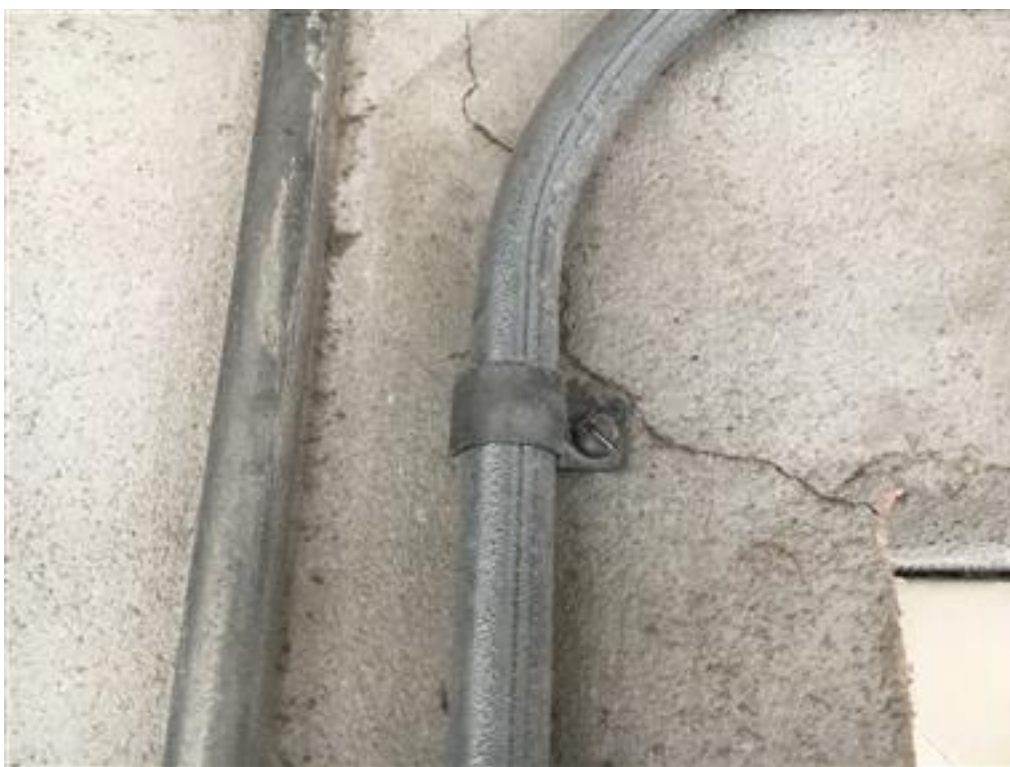
*Photo 10-11<sup>th</sup> FLOOR- HLC*

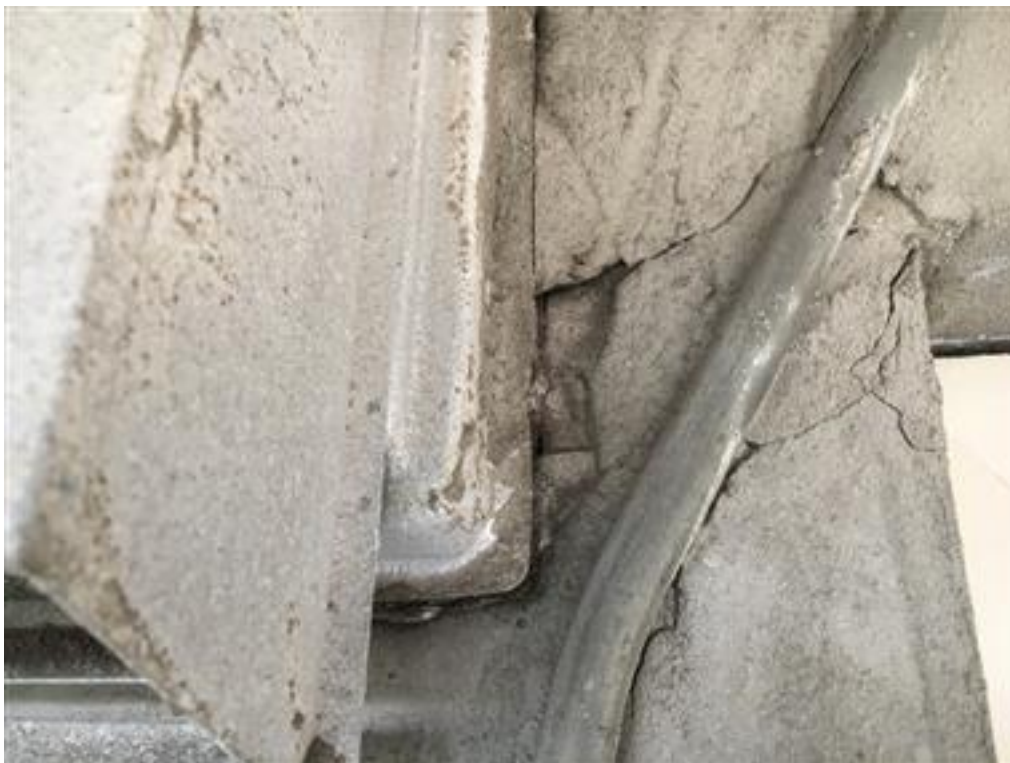
*Photo 13-10<sup>th</sup> FLOOR – CRACKS AT DOOR*

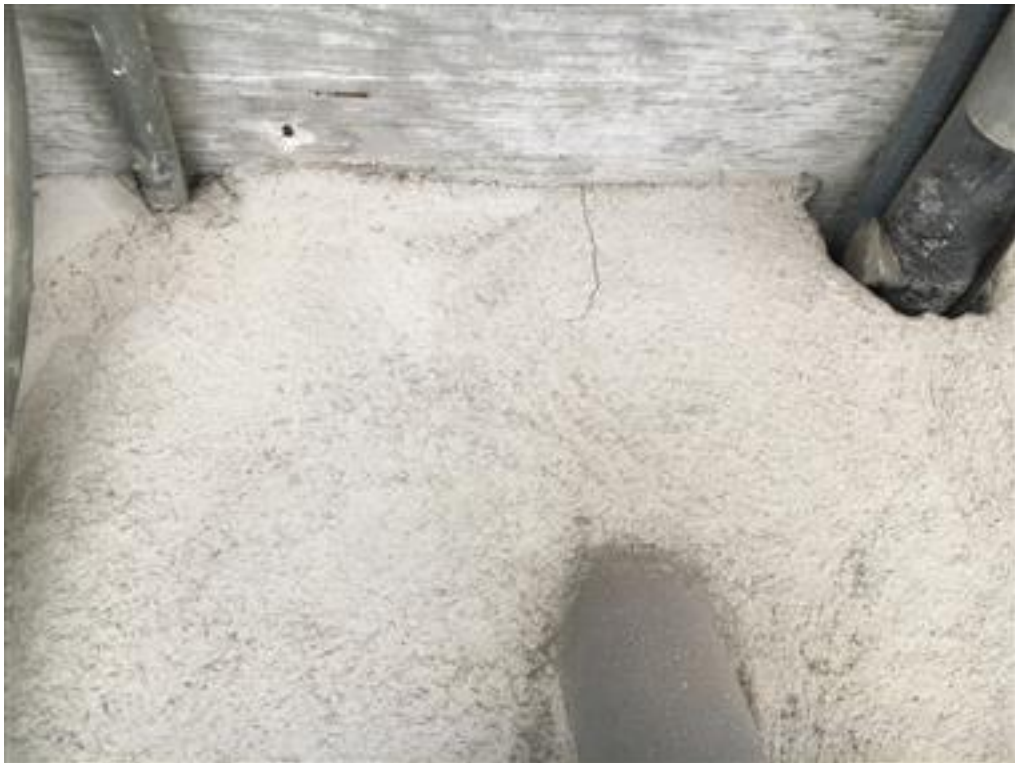
*Photo 16-9<sup>th</sup> FLOOR- HLC*

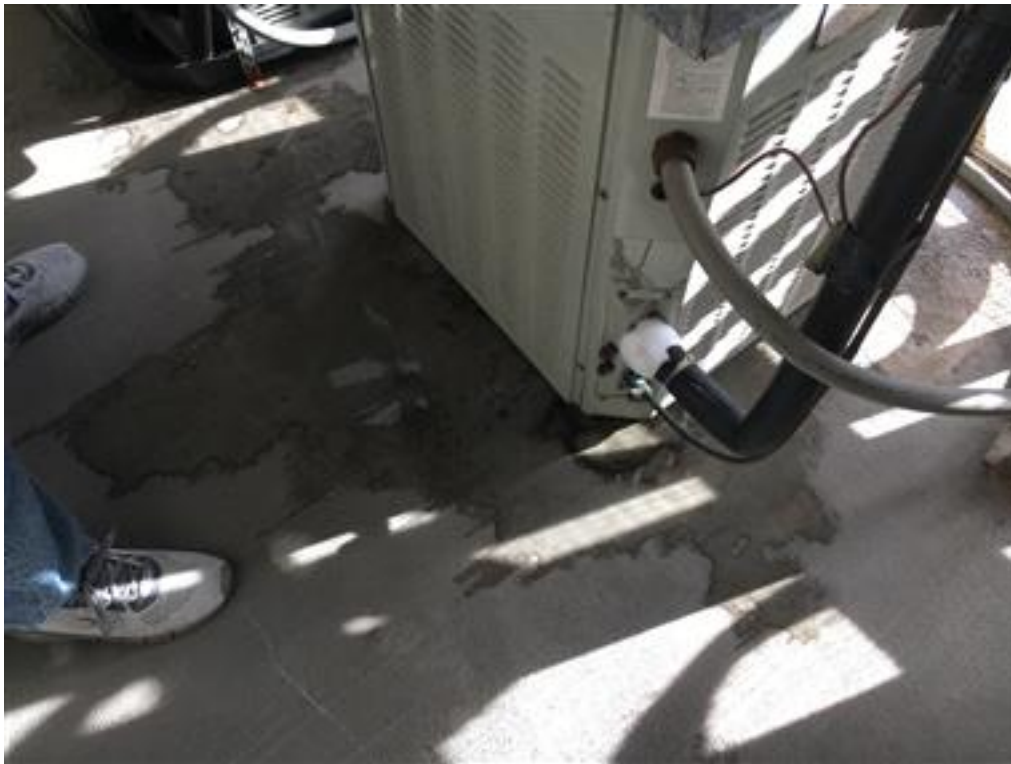
*Photo 19-8<sup>th</sup> FLOOR- AC LEAK*

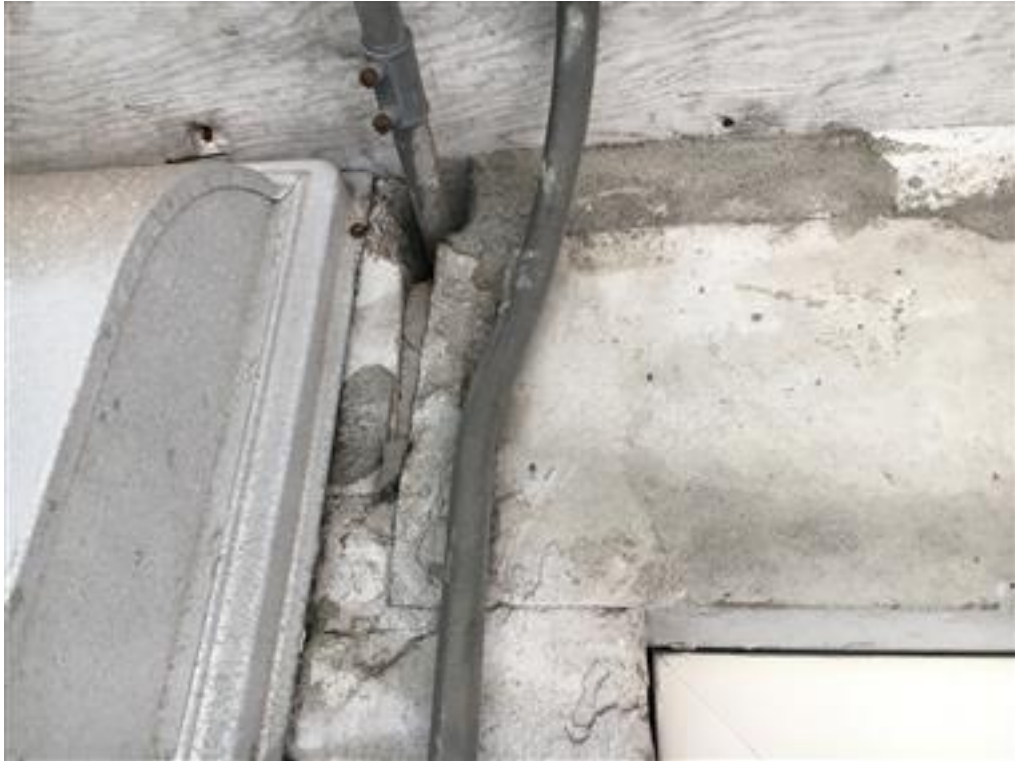
*Photo 23-7<sup>th</sup> FLOOR- VOIDS*

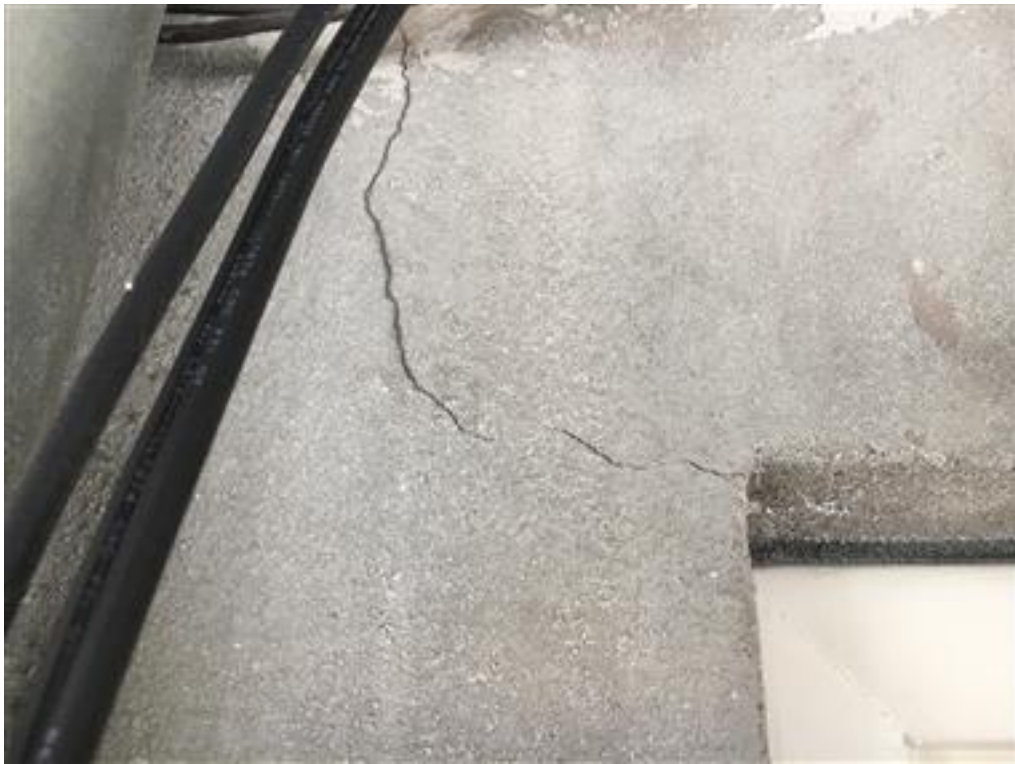
*Photo 28-5<sup>TH</sup> FLOOR- HLC*

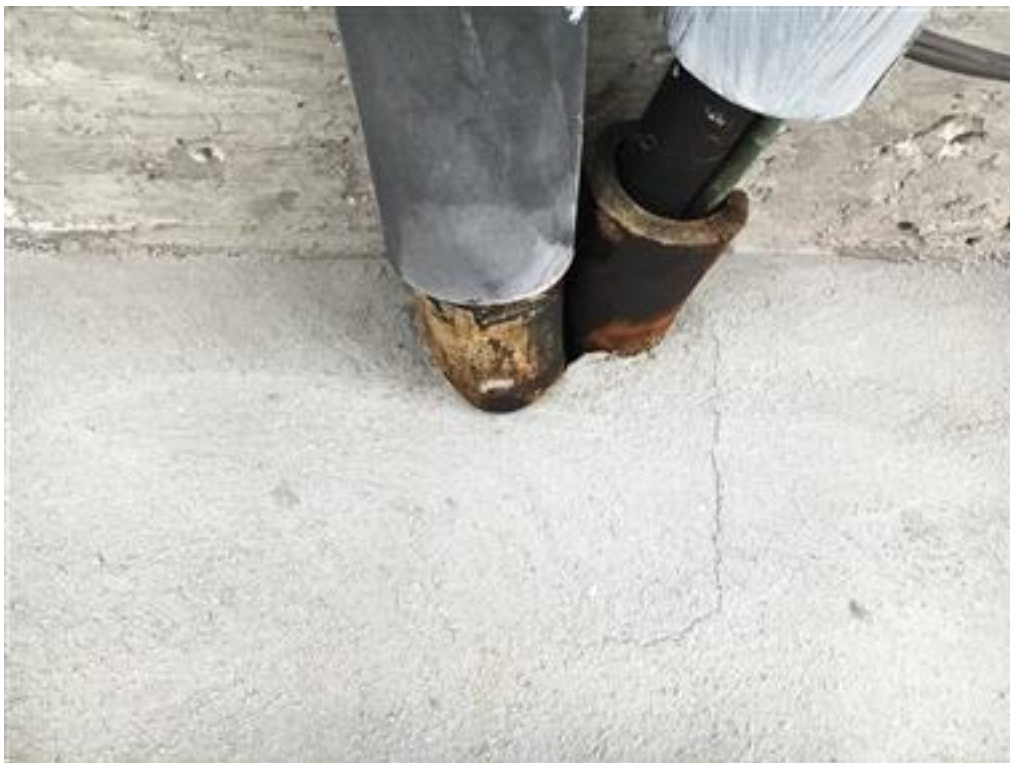
*Photo 29-5<sup>th</sup> FLOOR – HLC*
